Emergency Vehicle Priority System Investigation

7 December 2023

**Queensland Department of
Transport and Main Roads**

Transport Management Consulting

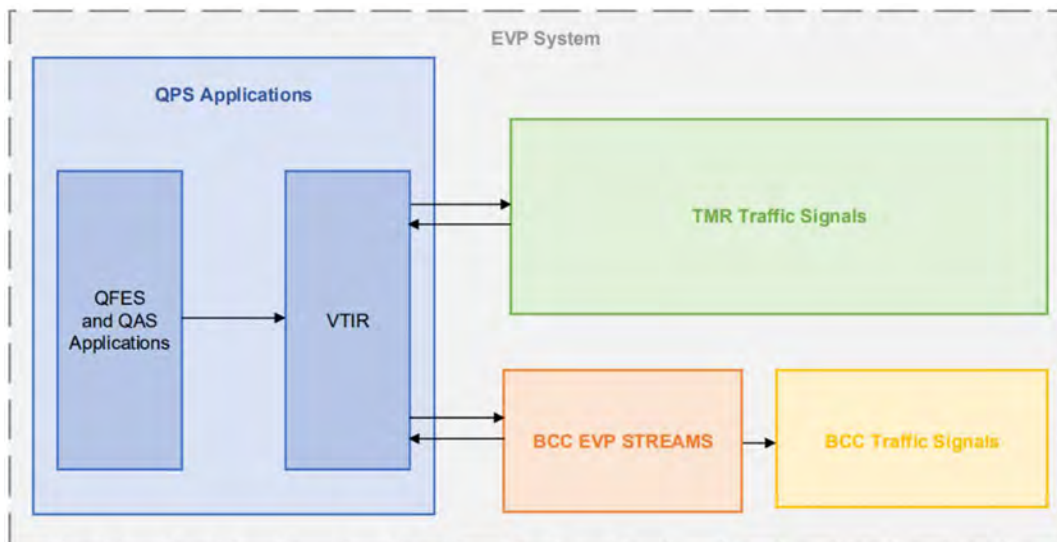
- On 18 October 2022, during an unrelated TMR hardware maintenance upgrade, the BCC EVP STREAMS component (shown in the figure above) became inoperable and the EVP service did not operate for BCC-controlled signals (i.e. no priority green signals were granted for BCC traffic signals). This situation went undetected until 1 March 2023 and was rectified on 8 March 2023. During this period, TMR-controlled signals were unaffected and the EVP service continued to operate for TMR traffic signals.

The 18 October 2022 incident was caused by an incorrect Internet Protocol (IP) address being assigned to a network switch, which was replaced as part of an unrelated TMR hardware upgrade. The IP address provided to the new network switch belonged to the BCC EVP STREAMS server. This IP address error made BCC EVP STREAMS inoperable, and no green signals could be requested for the EVP-enabled BCC traffic signals.

- Establish an agreed and formalised EVP service owner and EVP service customer, along with agreed organisational roles and responsibilities for monitoring and maintaining each EVP system component.
- Once EVP service ownership and management responsibilities are established, develop appropriate service management practices to assure the EVP service, including:
 - an overall EVP service transition management process to ensure service changes are documented, tested, released and appropriately deployed into the live environment
 - a change management policy to define components under change control and to manage them effectively; and implement change management processes to receive, decide, and manage change requests
 - service level monitoring and management of all EVP components and data flows (including status, data content and quality)
