Traffic Incident 17SIT050576I

Details: 25A - Potholes multiple locations (1 Call)

Road: MOUNT LINDESAY HIGHWAY

Location Details: Multiple locations and many potholes - Millstream road / BP garage jimboomba / Cedar grove area.

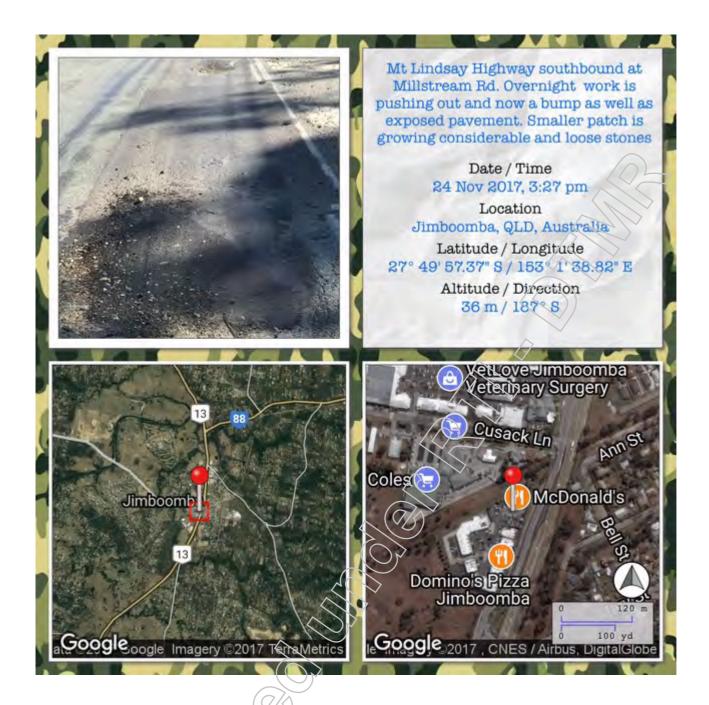
Same patch as discussed numerous times over the last three days. Treatment from last night ??? If rain hits this ???Second failure at top of photo is growing considerably. More quality work from Contractors???

Mt Lindsay Highway southbound at Millstream Rd. Overnight work is pushing out and now a bump as well as exposed pavement. Smaller patch is growing considerable and loose stones
