Fatal collision between passenger train 3C37 and a Ford Falcon station wagon

at the Hesp Road/Bennett Road level crossing
Aloomba 23 May 2003

SEPTEMBER 2003

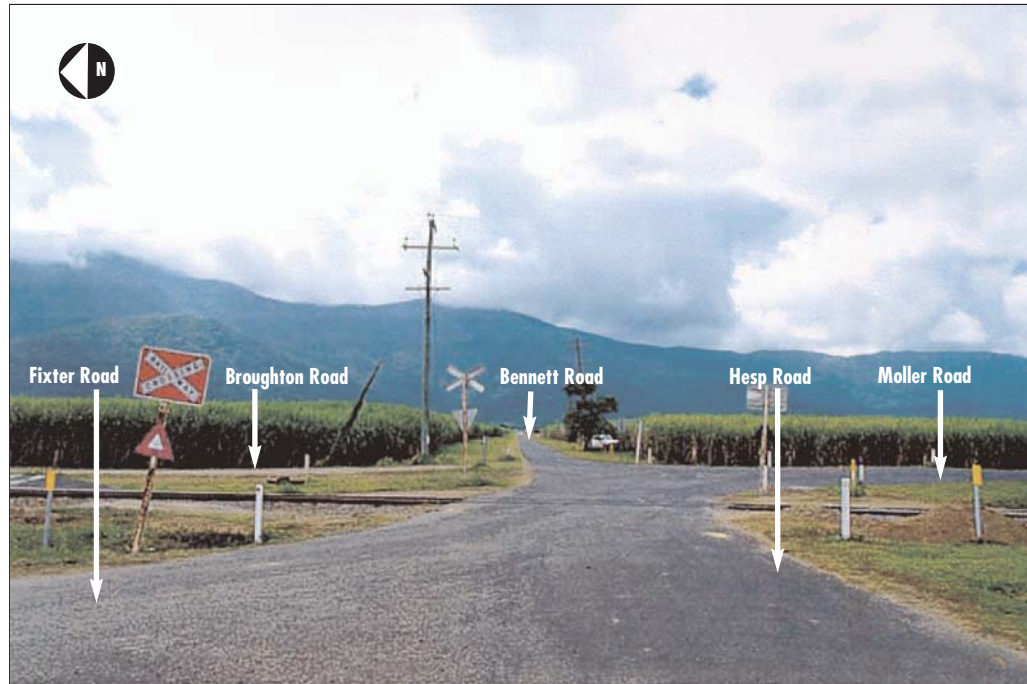
FIGURE 2:
Hesp Road/Bennett Road level crossing at 1651.80 km from Hesp Road

The level crossing at 1651.580 km is about 700 m southeast from the centre of Aloomba. It is also a junction of five roads: Fixter Road runs north of the crossing, parallel with and to the west of the track; Broughton Road north of the crossing, parallel with and to the east of the track; Hesp Road east of the crossing, Bennett Road west of the crossing and Moller Road south of the crossing, parallel with and to the east of the track. Fixter, Hesp, Bennett and Moller roads are paved bitumen roads.
