**Serious Injury Collision, St Vincents Road, Banyo  
14 September 2012**

**Final report, rail incident investigation TMR 4617**

**Major rail incident investigation**

**Final report, incident reference: TMR 4617**

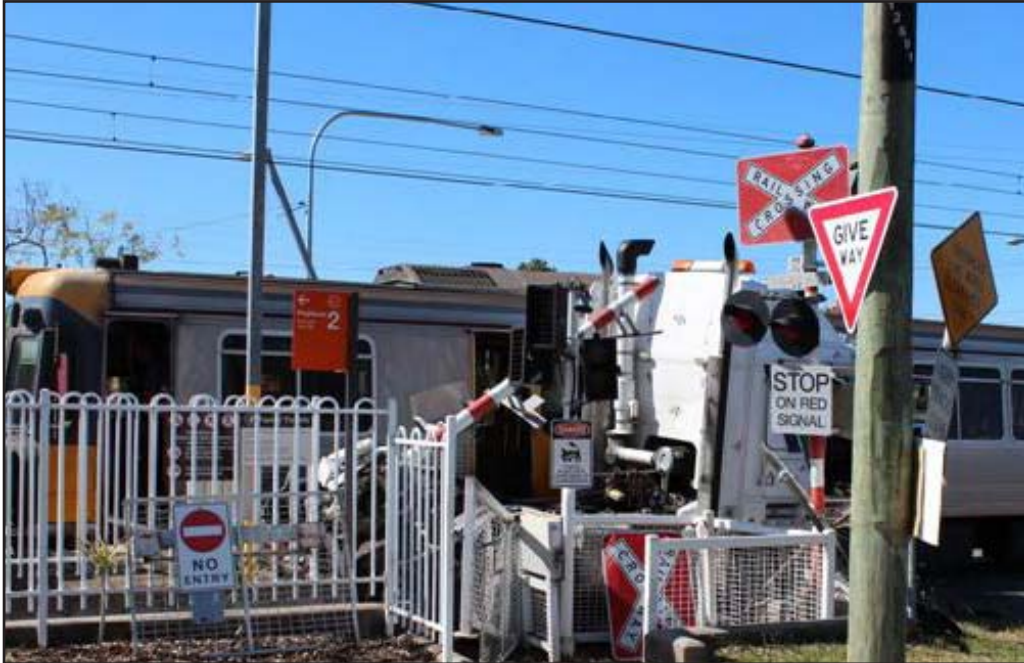
The pedestrian and level crossing protection equipment sustained extensive damage, as shown in Figure 6. The rail infrastructure including tracks and support structures and the overhead electrical lines sustained minor damage.

Figure 6: Damage to rail infrastructure

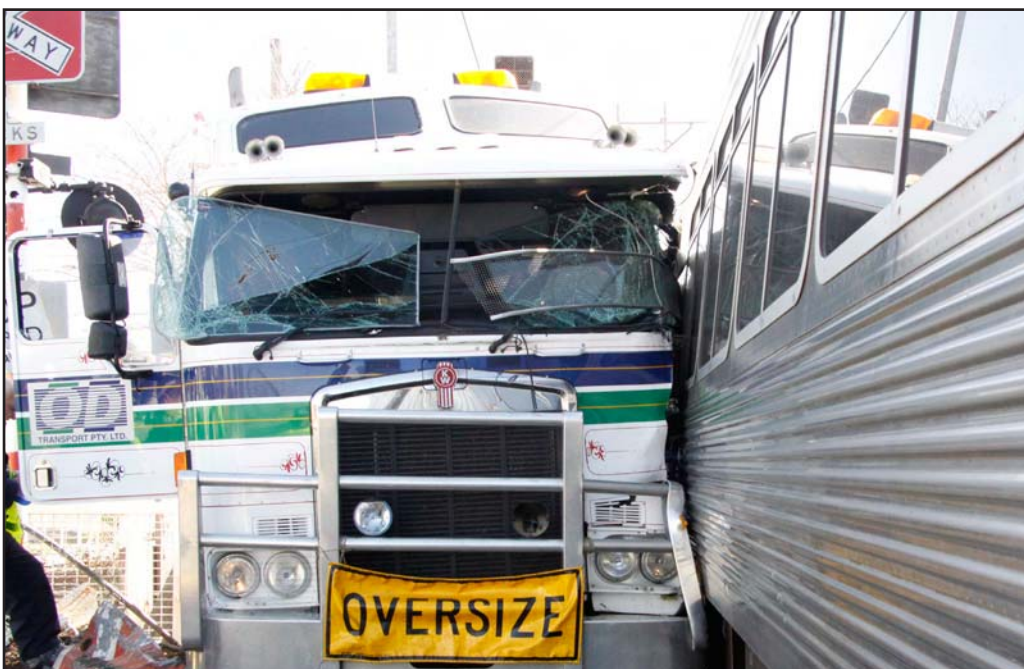
The heavy vehicle sustained extensive damage, as shown in Figure 7.

Figure 7: Damage to heavy vehicle

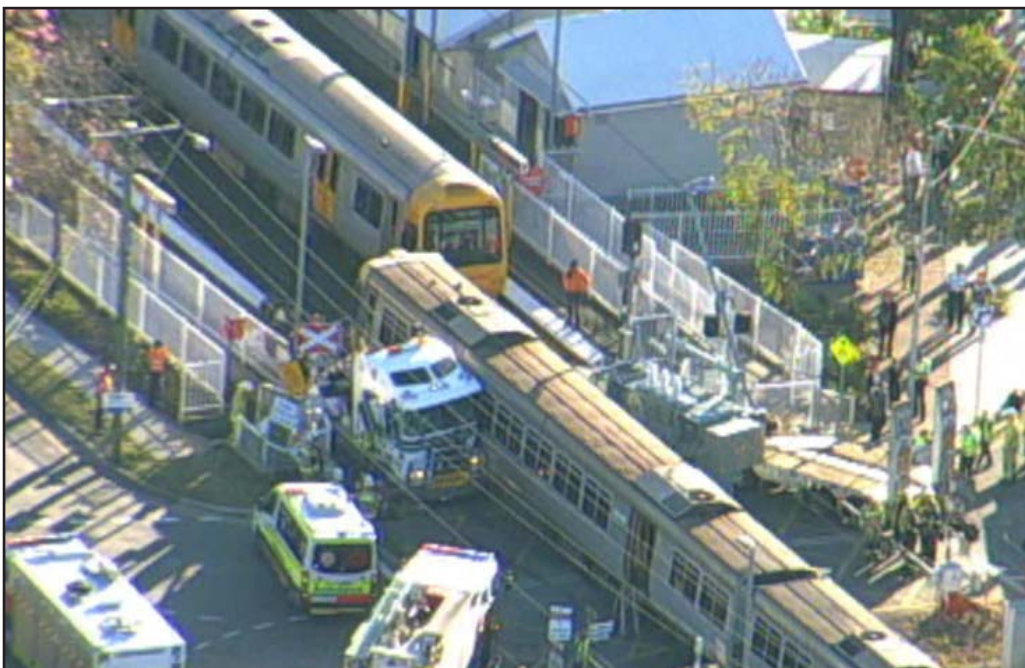
Upon impact, the prime mover was pushed to the western side of the rail corridor against the left hand side of the northbound train. The dolly trailer was pushed north, through the level crossing becoming jammed between the two station platforms and against the stationary southbound train. The low loader trailer, still attached to the dolly trailer, was pushed towards the eastern side of the rail corridor coming to rest against the corridor fencing. The transformer was dislodged and came to rest in an upright position spilling a small amount of oil and fluid on the roadway beside the northbound train. Figure 10 shows an aerial view of the incident site.

Figure 10: Aerial view
