## Main Roads Investigation into the Fatal Crash on South-bound Ramp from Bruce Highway to Sunshine Motorway at Tanawha

**Date** 6 July 2007

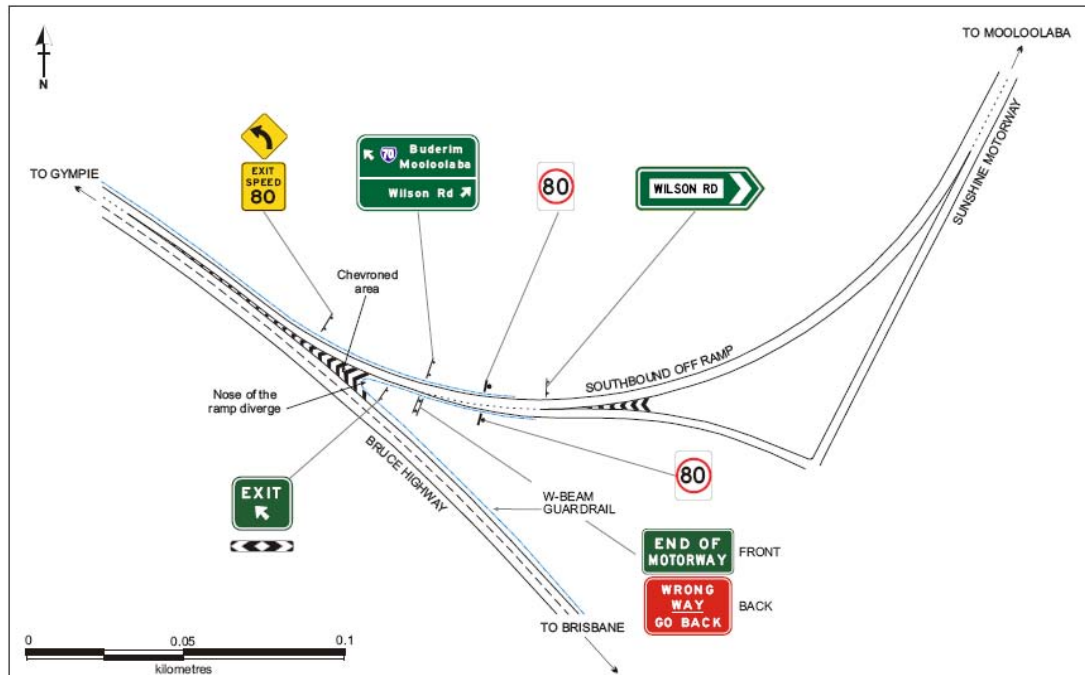
Figure 4 – Permanent signs installed at the time of the crash

As noted earlier, the design speed on the curve was 80 km/h. (This means the curve was designed to be safe at 80km/h). An 80 km/h exit advisory speed sign was in place. Had the advisory signing been done post-construction, the speed value would have been determined by use of a "ball-bank indicator". (This is an instrument which gauges a driver's ability to comfortably negotiate a curve.) During the investigation following this crash, a ball-bank indicator test was undertaken in accordance with the MUTCD guidelines. Using that test, a comfortable curve negotiation speed would be 70 km/h.

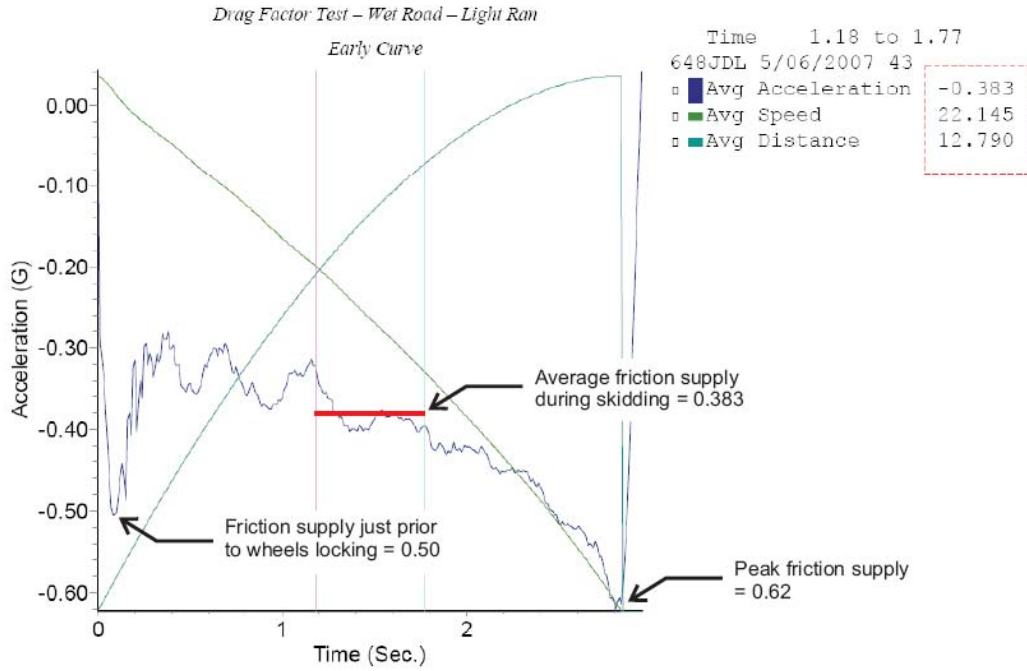
Figure 7 – Interpretation of friction supply data from QPS tests

The QPS preliminary conclusion was based upon test results in wet weather in which the brakes were applied on the approach to the curve<sup>8</sup>. It was noted that the combined lateral and longitudinal acceleration resulting from a driver touching the brake while negotiating the curve at 70 km/h, represented a surface friction demand that would be approaching the friction supply at which locking of wheels occurs.

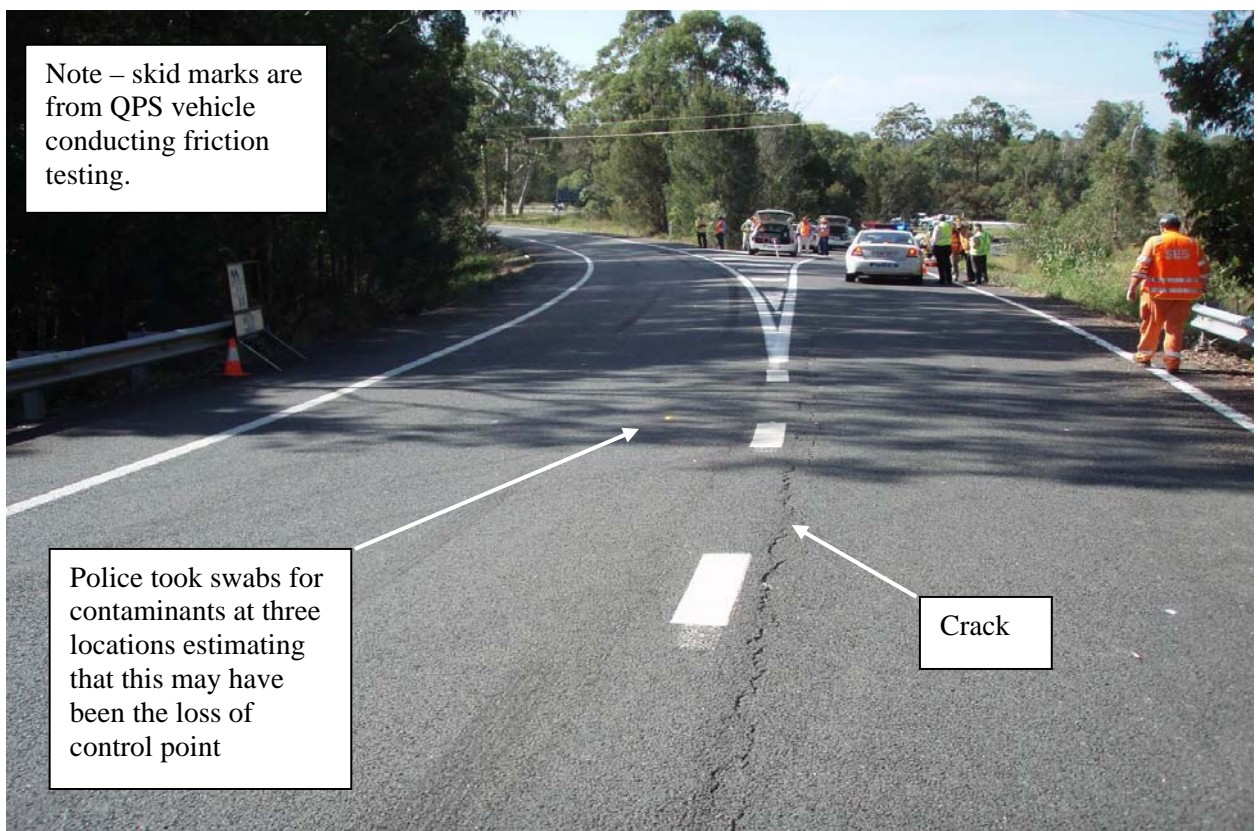
Photo 4 – Point were vehicle may have lost control

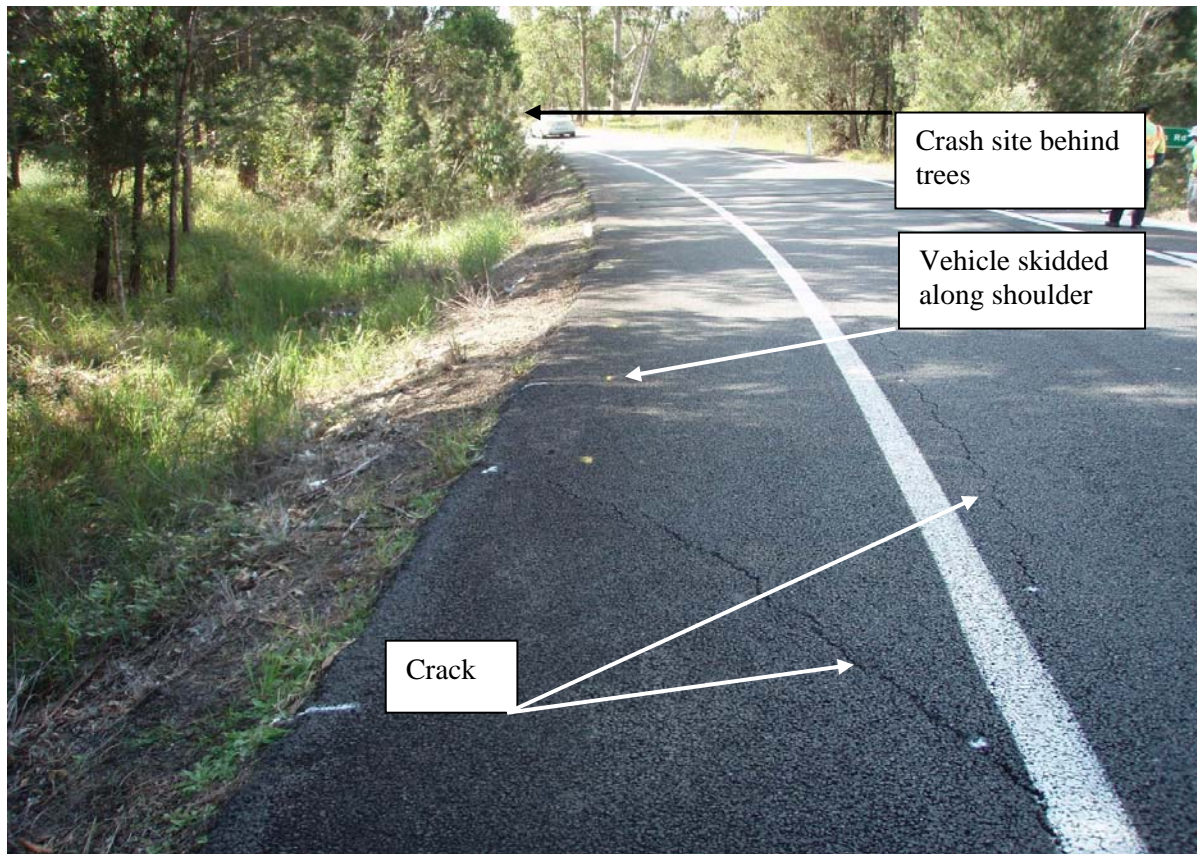
Photo 7 – View along shoulder where vehicle skidded

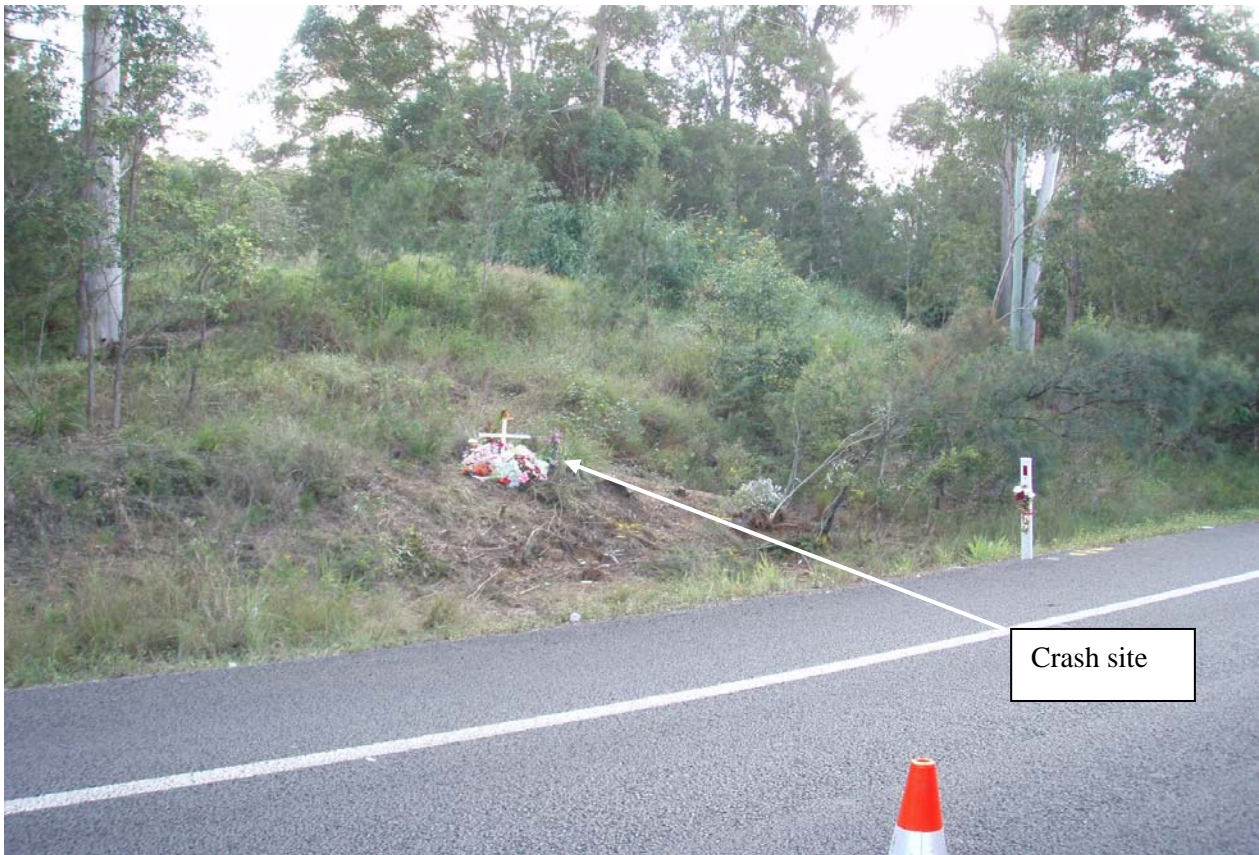
Photo 10 – Crash site

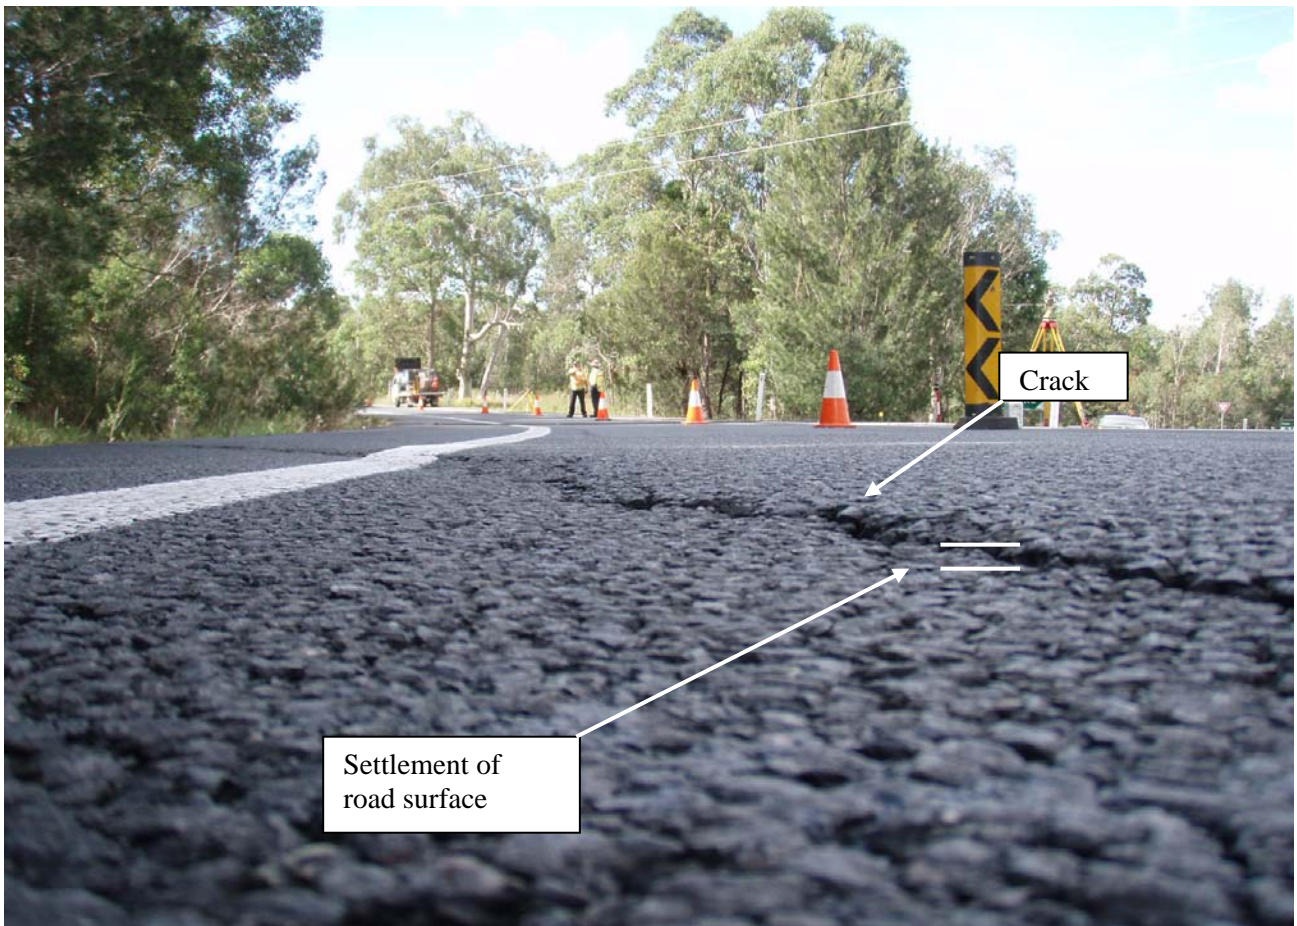
Photo 11 – Settlement of road and environmental crack in pavement

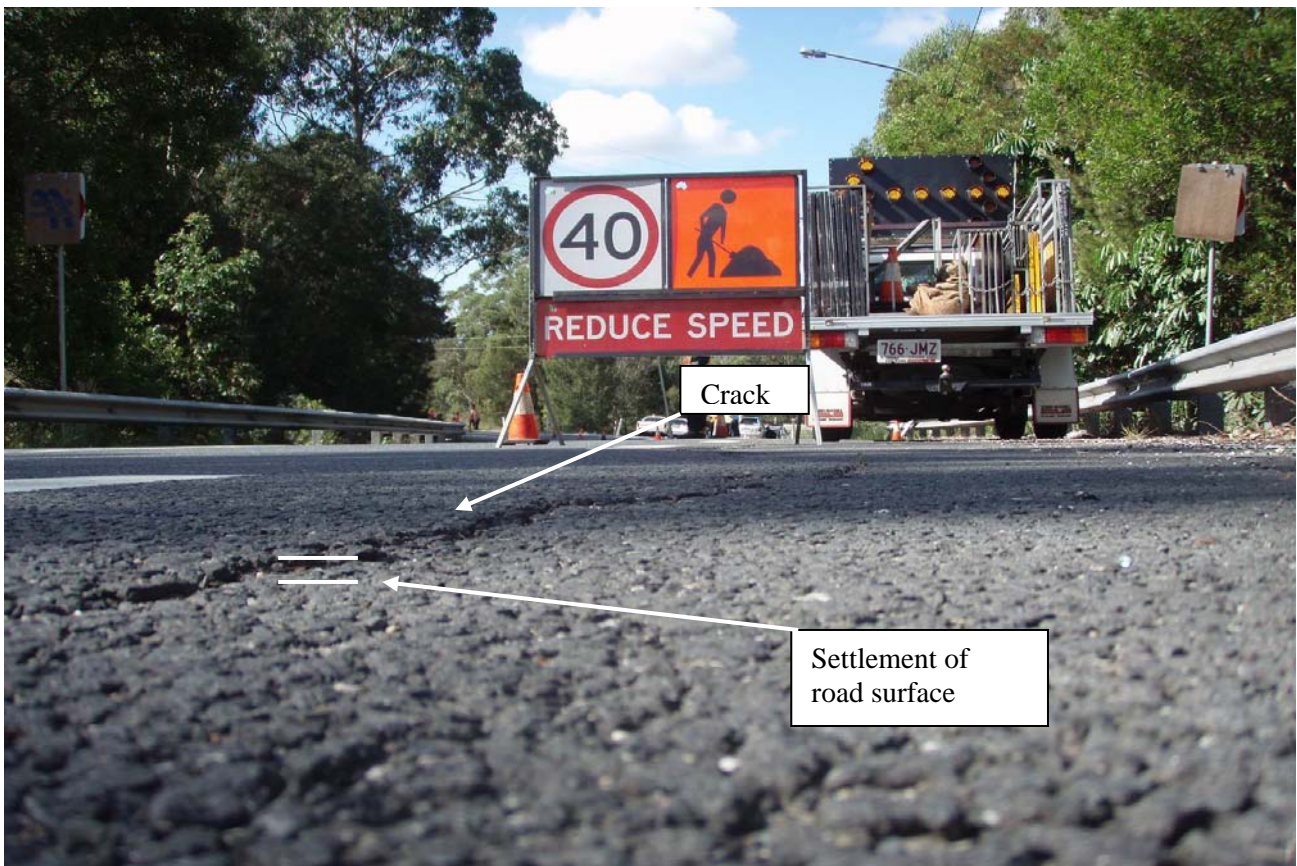
Photo 12 – Settlement of road and environmental crack in pavement

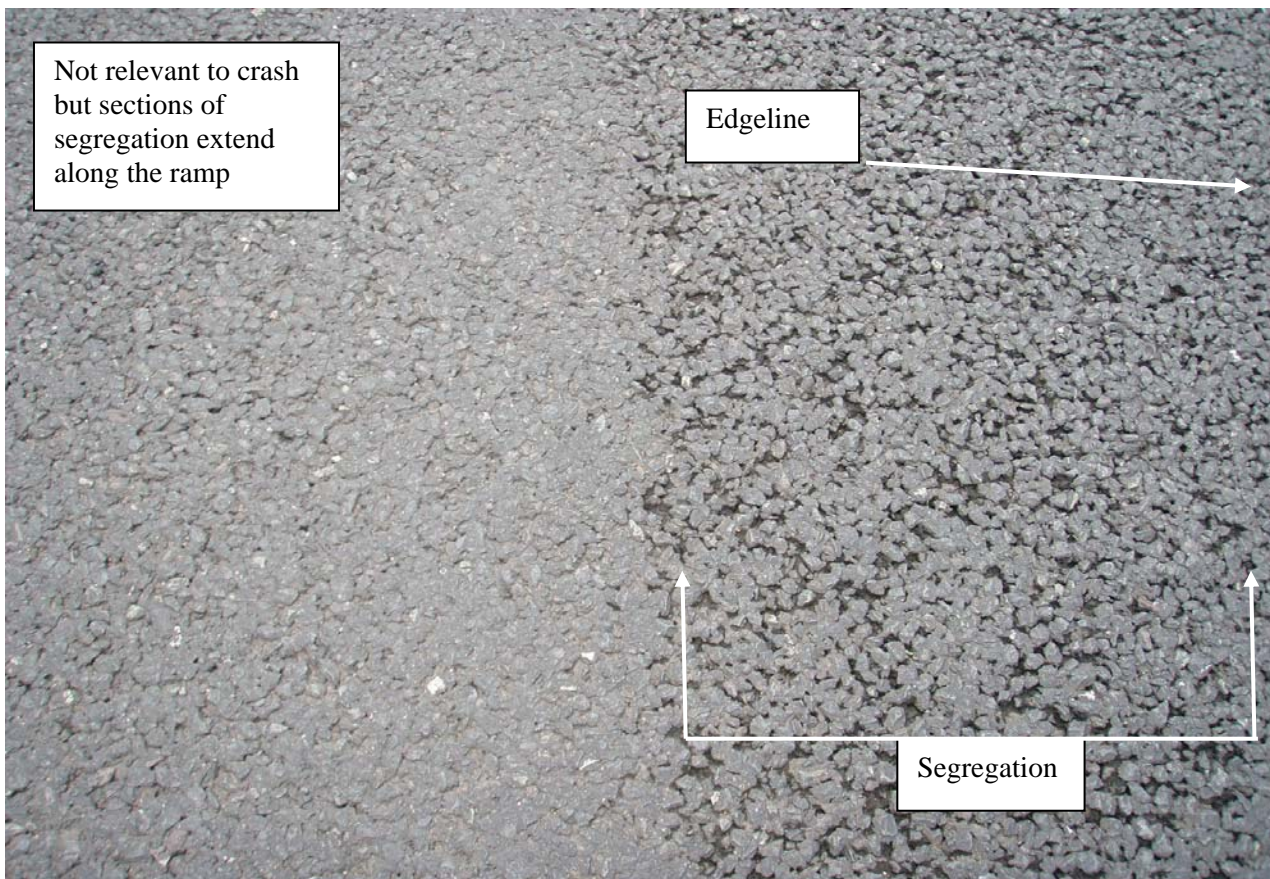
Photo 13 – Segregation of pavement near edgeline

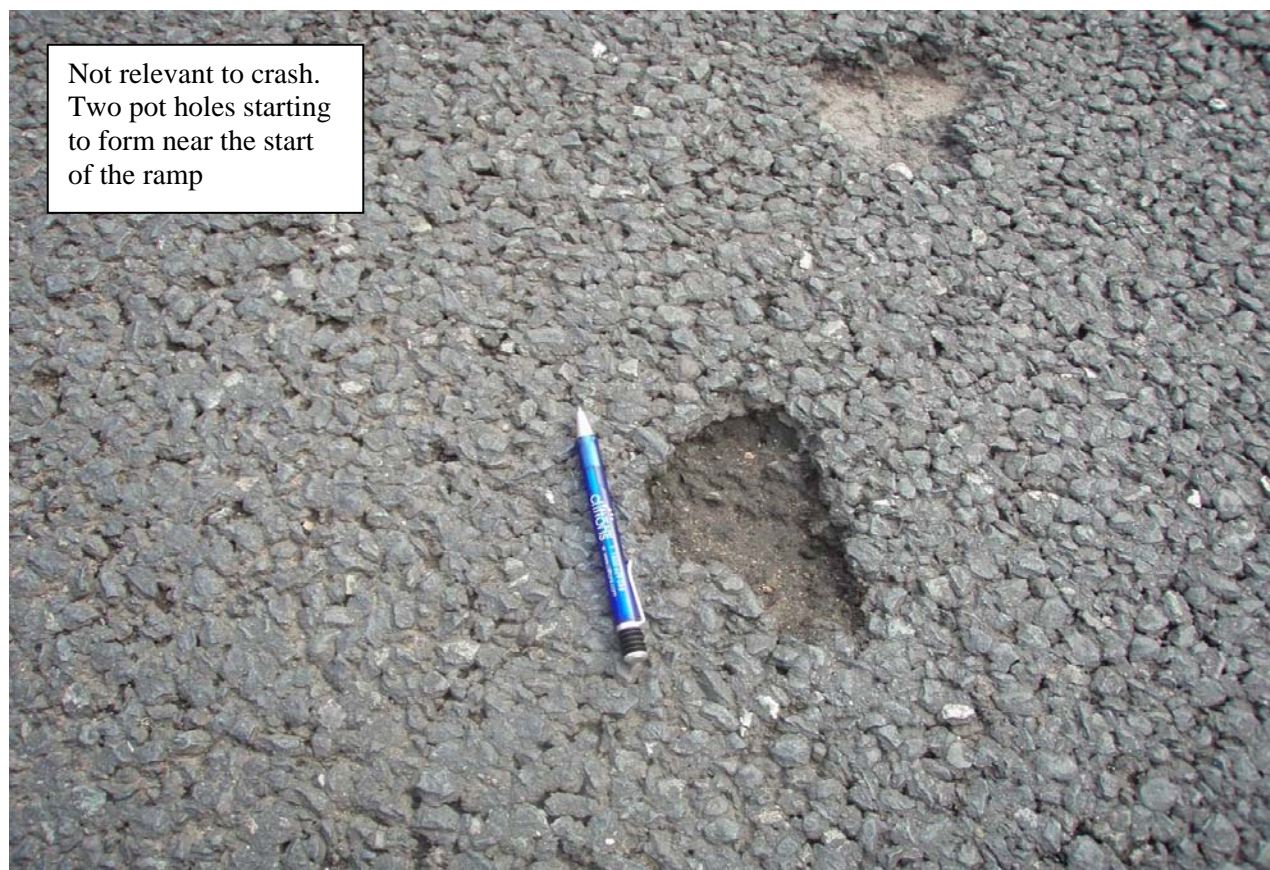
Photo 14 – Small pothole starting to form near start of ramp
