MARITIME SAFETY QUEENSLAND PRE-SALVAGE INSPECTION MV "DEFENDER"

1725-PRE-SALVAGE DEFENDER-R0

03/03/16

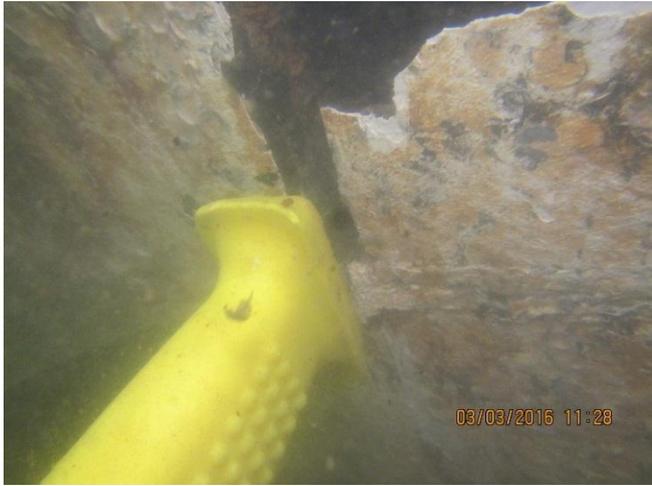
Photograph 1 – DEFECT 1

DEFECT 1

Defect was located on the starboard aft corner of the wheelhouse, 1.1m down from the top of the starboard gunwale. This area showed decaying timber and loose plank ends with deteriorating caulking between the planks. Full penetration on the vertical separation was reported (refer appendix A, photograph 1)

- Dimensions of the vertical defect, 170mm H x 14mm W
- Single planking separation, 1.06m L x max 30mm W (due to decay)

11:21	Crack stb aft 1m from top of Gunwhale to top of crack
	Planking separated due to decay 170mm x 15mm x 1.06m
	full penetration through hull
11:35	Both Pt + stb timbers at the Aft end of wheel house shows

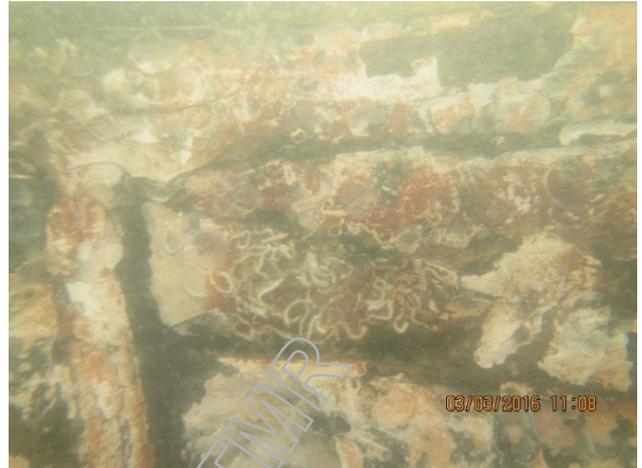
Photograph 2 – DEFECT 2

DEFECT 2

Defect was located on the port aft corner of the wheelhouse, 1.1m down from the top of the port gunwale. This area showed decaying timber and loose plank ends with deteriorating caulking between the planks. Penetration to 50mm (could be internal fixtures) (refer appendix A, photograph 2)

- Dimensions of the vertical defect, 180mm H x 5mm W
- Area of decay approximately 450mm DIA of this defect

11:00	Crack Pt. Aft. 180mm vertical x 5mm wide
	Could penetrate knife in upto 50mm but not able to
	penetrate right through as diver feels solid timber inside
	(like an internal patch).

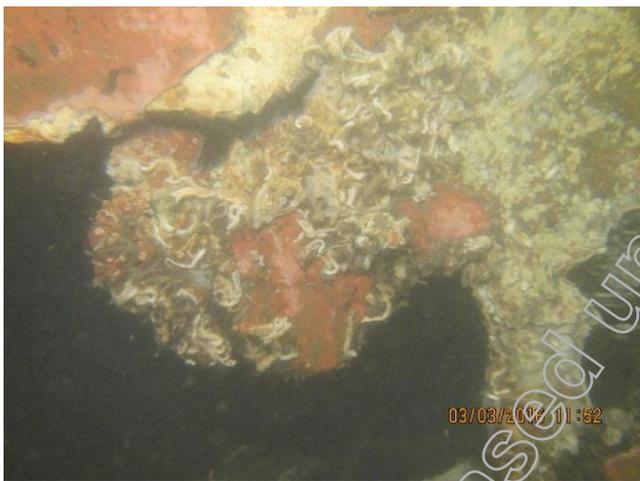
Photograph 3 – DEFECT 3

DEFECT 3

Defect was located between the 3rd and 4th stay strap port side aft (counting from the stern) and 1.95m down from the top of the port gunwale, 220mm below waterline mark. This area showed decaying timber and a hole. (Refer appendix A, photograph 3)

- Dimensions of the hole, 300mm L x 120mm W
- Area of decay approximately 500mm DIA of this defect

The inspection results indicated one hole below water line and two areas of decay just below deck level and above waterline. The vessel has a slight list to starboard approximately 15 degrees and several areas of decay reported throughout the casualty decking.

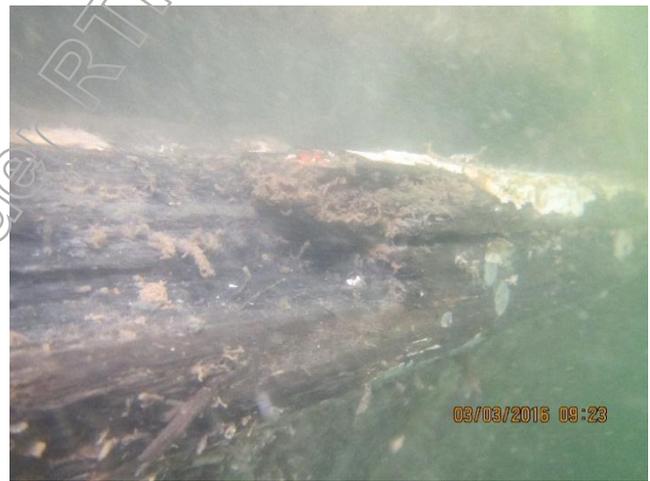
Photograph 4 – General condition of fender

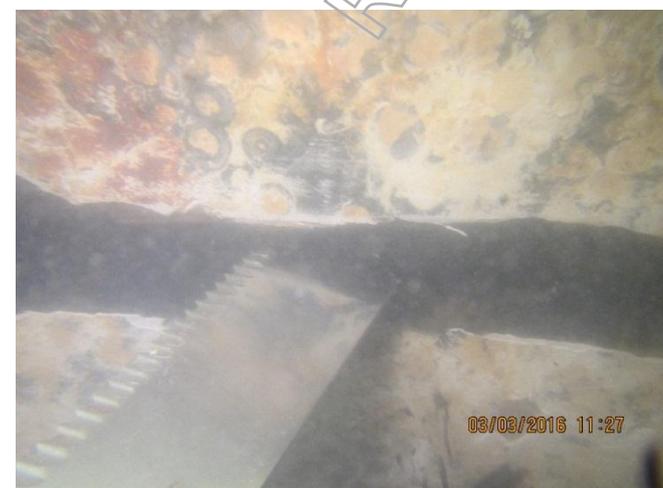
Photograph 5 – Stb plank separation

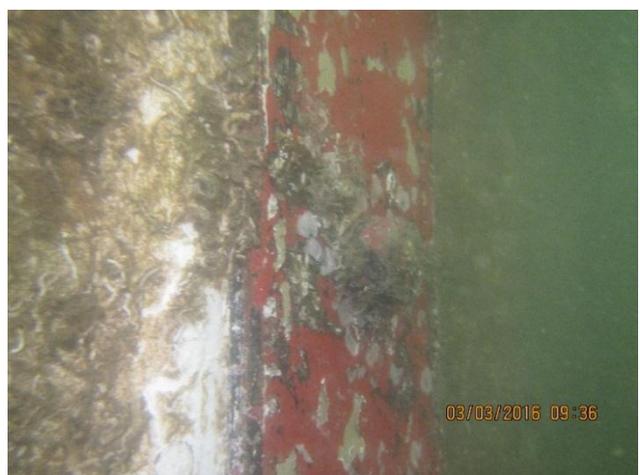
- Five Aft mast stay straps were reported on the starboard side. Straps and bolts secure with no signs of rust. Diver reported to the best of his senses, timbers in this location were of sound condition.

- Five forward mast stay straps were reported on the starboard side. Straps and bolts secure with no signs of rust. Diver reported to the best of his senses, timbers in this location were of sound condition.

Photograph 6 – Condition of Stays
