Summary Report

Our ref 230/02214
Your ref MSQ24900
Date 14/07/2021

Subject Marine incident investigation file – (File No. MSQ24900-2021)

Incident type	Collision
Participant ship/s	YAMOYA [redacted] (Vic) – 11.39m Steel Sailing Boat [redacted] – 7.2m 2012 Cruise Craft Explorer Fiberglass 300hp
Participant person(s)	[redacted] (owner/master of (Yamoya)) [redacted] (owner/master of [redacted])
Location	Humbug Reach, Brisbane River.
Date	18th June 2021

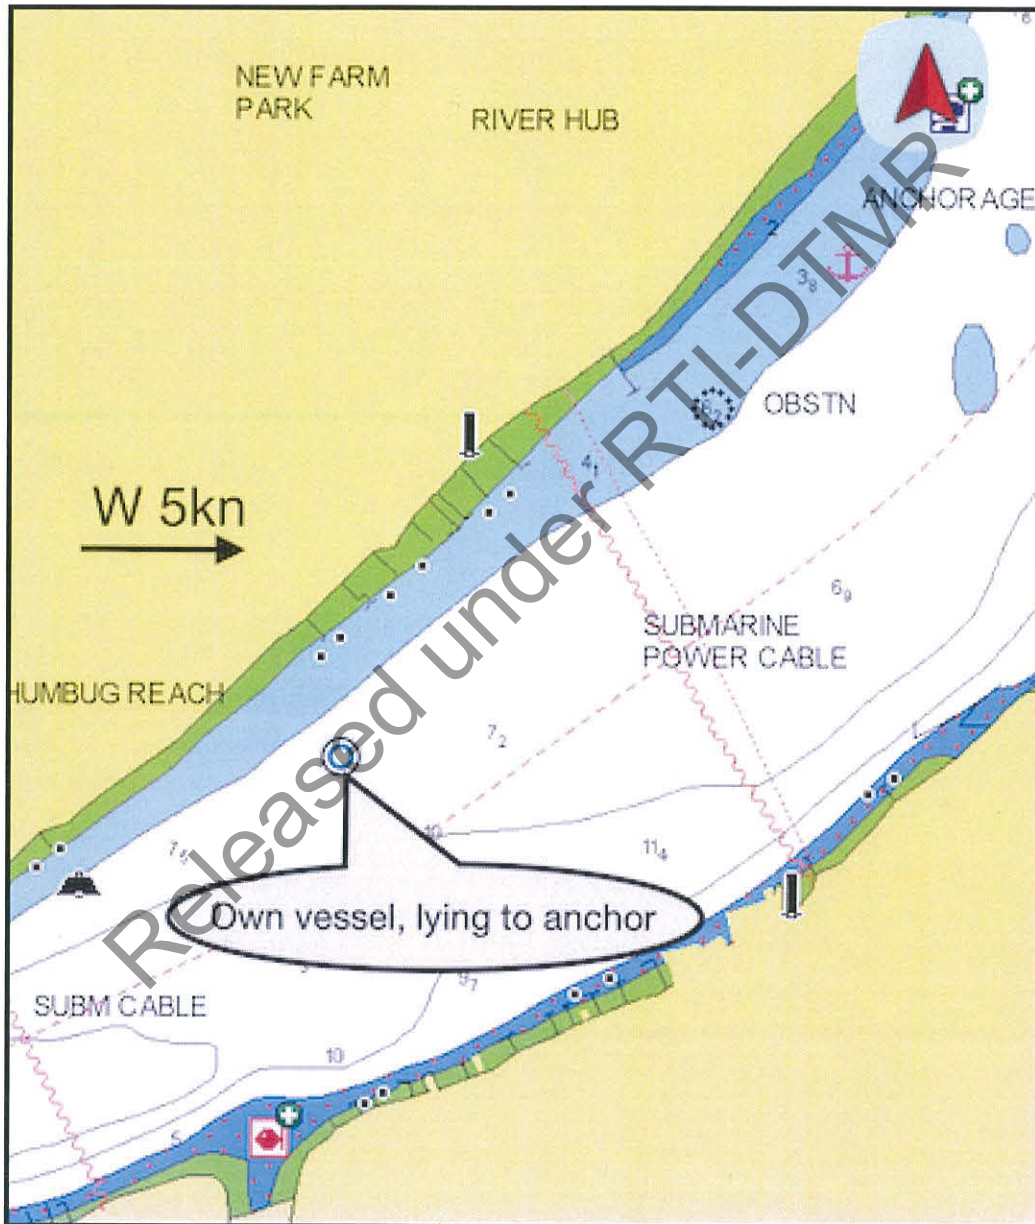
At the time of collision, Yamoya (own vessel) was anchored safely in about 8m of water, and had been at this anchor since 13 Jun (5 days) with approx 40m chain deployed. Holding was excellent. Upstream were moored vessels, downstream were private jetties. There was an ebb tide with a strong tidal flow, and about 5kn of wind from the west. The water was calm, sky was clear, visibility was excellent. Yamoya was showing its anchor light atop its main mast, as well as cabin lights. Outdoor lighting was turned on at the Merthyr Bowls club and the function centre on the shore adjacent to the anchoring position. Other outside lighting was coming from housing and

infrastructure along both shores. Yamoya has a steel hull and superstructure, and provides a good radar target.

The ship's tender (a 3.4m RIB) was stowed on its davits with the outboard still attached. The swim platform was folded upright against the transom.

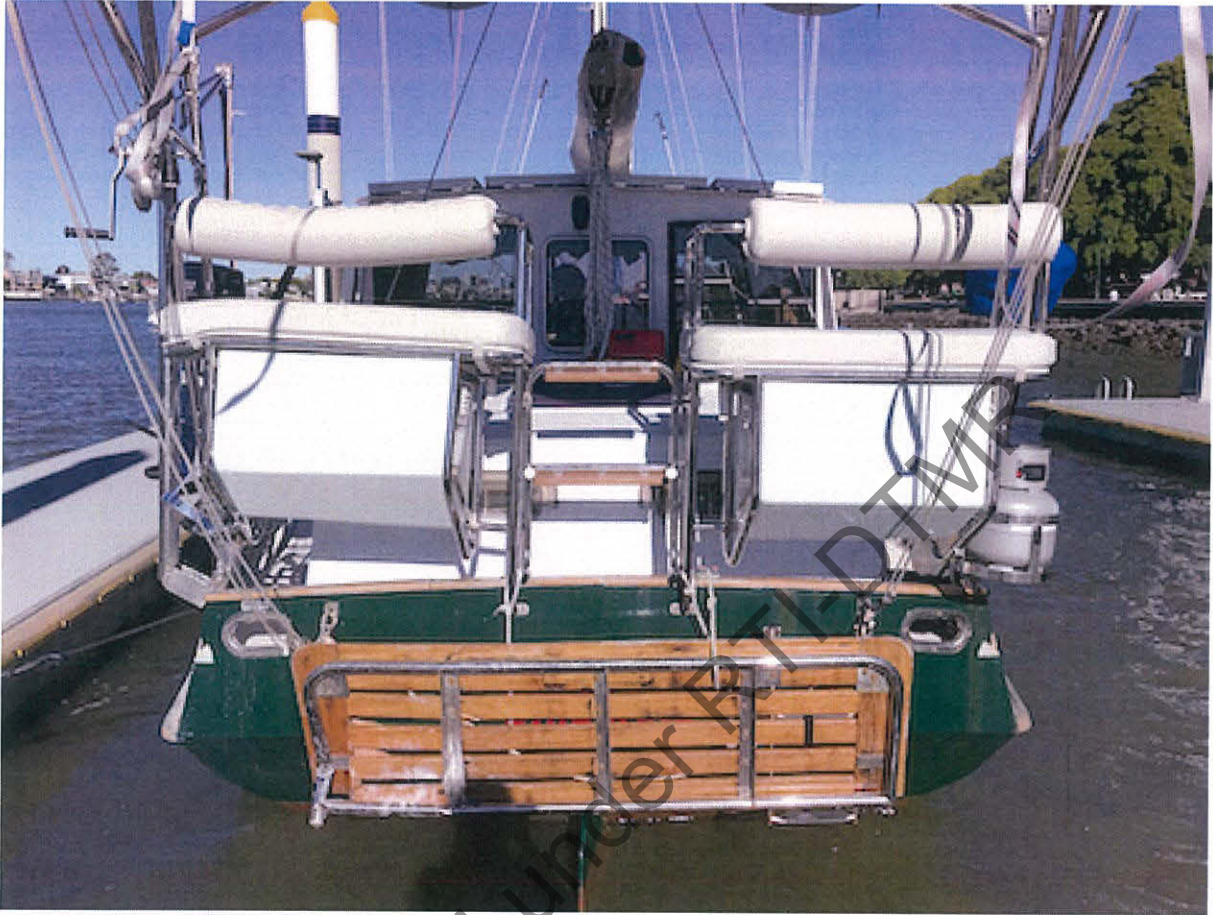
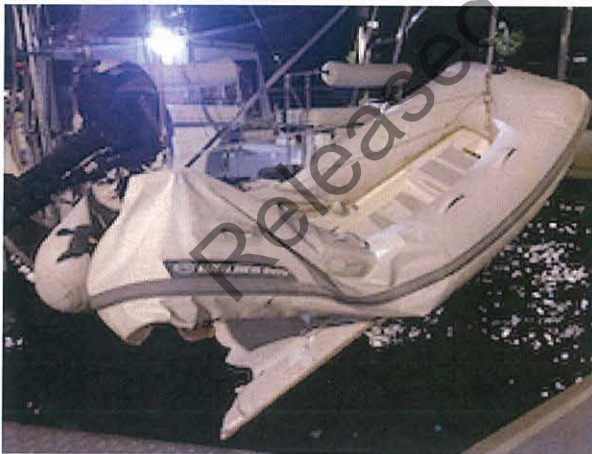
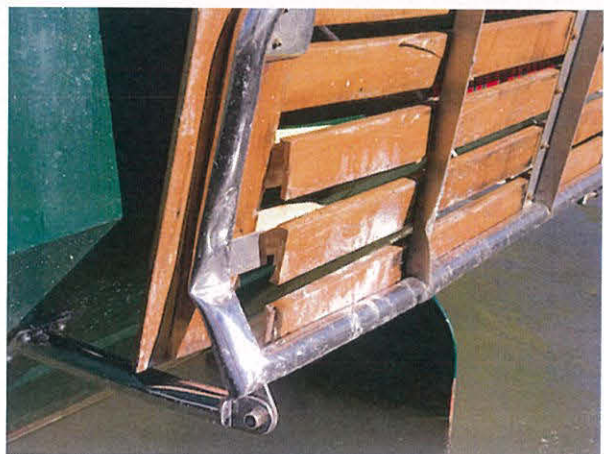
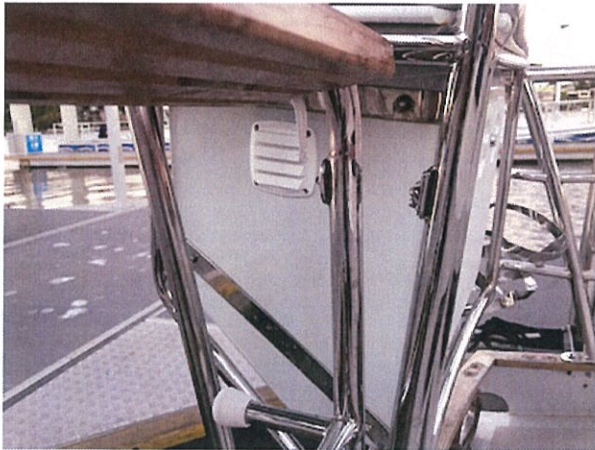
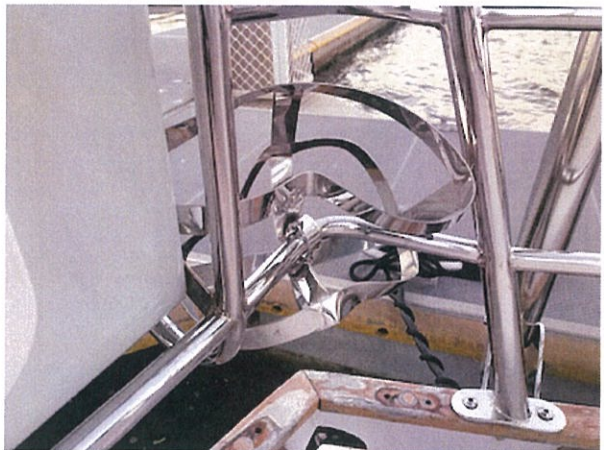
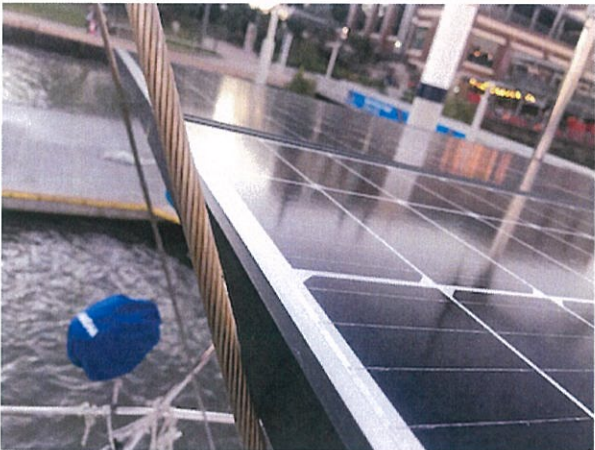
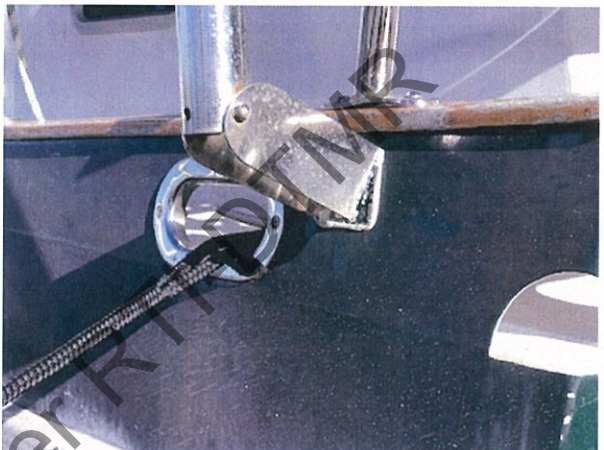
Yamoya had been impacted on the port side of the stern, suffering extensive damage to the pushpit and associated structure incorporating the davits and solar panels. The stern swim platform was extensively damaged and could not be lowered. It appeared to be unsafe to use, if it could be lowered. The stern boarding ladder was jammed in its folded state and could not be easily lowered. The solar panel arch had been pushed onto the mast's back stays. The outboard lifting crane had been damaged and was unsafe to use. The ship's tender was completely destroyed and had spilled most of its contents into the water; except for the outboard and a few items that were thrown onto the aft deck (including the tender's fuel tank). There were no fuel or oil spills. There was no apparent hull damage that was allowing or would allow water ingress. The rudder appeared to be undamaged. There were no obvious crew injuries.

It was observed that the other vessel had his radar on and all navigation lights lit. The other master reported that there was no hull damage to his vessel, and minor damage to the pulpit and bow roller. He reported that his vessel was seaworthy and there were no injuries. After exchanging details, he departed at approx 6:40pm.

The broken tender was secured as much as possible, and any debris that was hanging in the water was raised as much as possible to minimise risk of fouling the rudder and propellor. The water was inspected for any other fouling risk.

At approx 11:00pm, at slack water, Yamoya was deemed seaworthy and able to be relocated to the New Farm River Hub to allow removal of the tender and outboard from the davits and to inspect the transom and rudder.
