Maritime Safety Queensland

Investigation Plan and Running Sheet

Marine Incident Number	MSC2483
Lead Investigator	Anthony Loveridge
Situation/Background of the Investigation:	
<p>Time 19:30 Date 10-4-21 Place Hervey Bay Fairway</p> <p>Ship Watermark collided with Nav aid UC2. Master reported as unlit.</p>	
Legislation	Possible Offence
TOMSA	<p>S43 43 General safety obligation on persons involved with operation of ship</p> <p>(1)A person involved with a ship's operation (including the owner, master and crew members) must not cause the ship to be operated unsafely. Maximum penalty—500 penalty units or imprisonment for 1 year.</p> <p>(2)Without limiting subsection (1), a person causes a ship to be operated unsafely if the person causes the ship to be operated in a way that— (a)causes a marine incident; or (b)contravenes— (i)a condition of the ship's registration under this Act that is about safety; or (ii)a provision of a regulation that is declared by a regulation to be a provision to which this section applies.</p> <p>(3)However, if the contravention of subsection (1) causes the death of, or grievous bodily harm to, a person, the owner, master, crew member or other person commits a

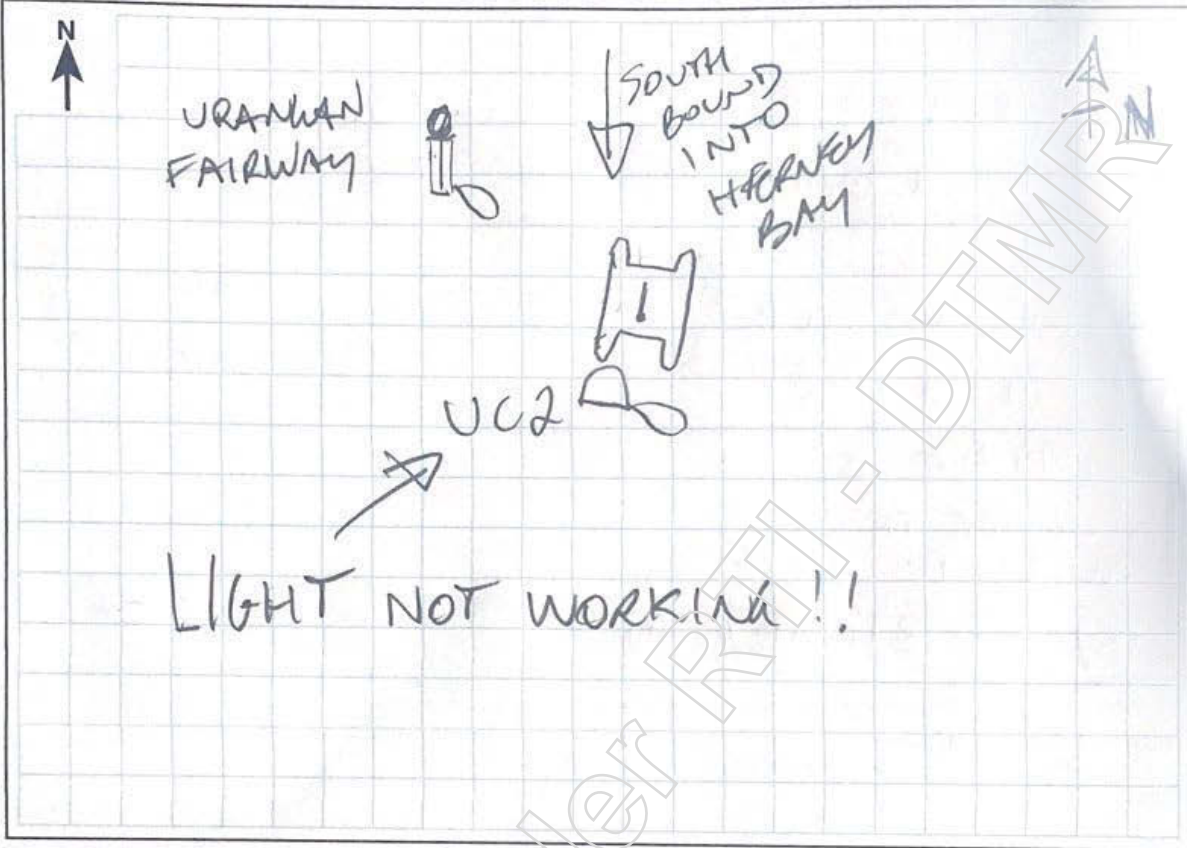
Vessel enroute from Lady Musgrave to Uranman. Master/owner on watch. No moon. Vis good. Fairway buoy light spotted well in advance and entrance to Hervey Bay guided by fairway light.

1930 vessel struck UC2 on starboard bow and buoy made its way under bridge deck and exited at stern. vessel is catamaran. Vessel stopped to identify object and check for damage. Vessel continued to Uranman to make further assessment.

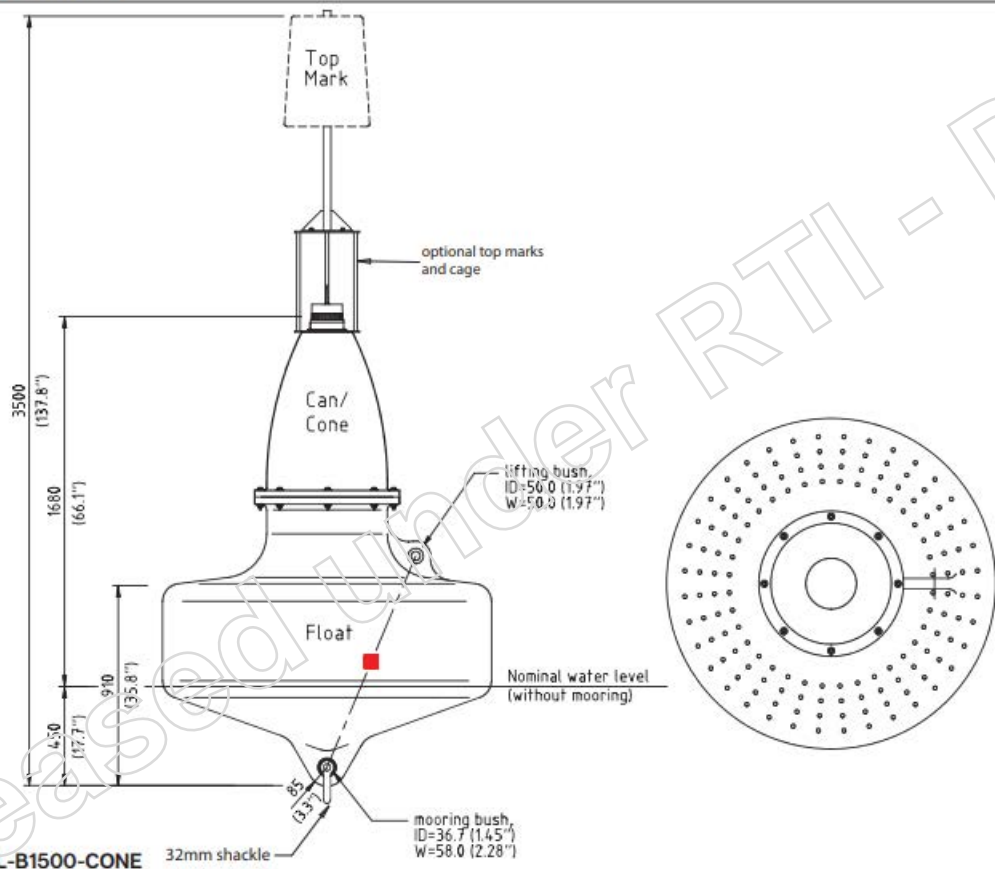
As requested, attached are some photos of the bow and stern damage for your records.

Is it possible to provide the geometry of the buoy (pdf drawing is fine), particularly the freeboard to the broken light fitting? I need to determine if it was possible for buoy to have contacted the underside of the trampoline, potentially causing some damage. I can then make arrangements to replace it.

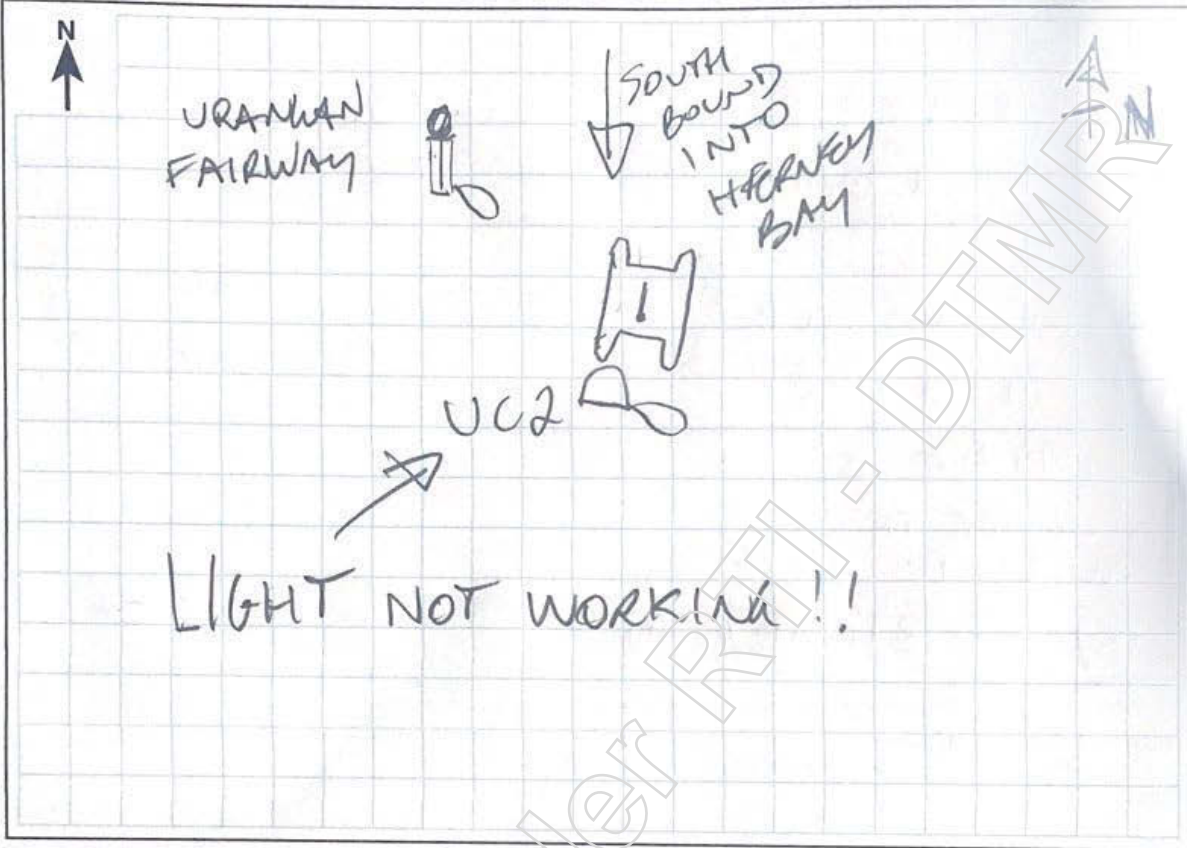
Vessel enroute from Lady Musgrave to Uranian. Master/owner on watch. No moon. Vis good. Fairway buoy light spotted well in advance and entrance to Hervey Bay guided by fairway light.

1930 vessel struck UC2 on starboard bow and buoy made its way under bridge deck and exited at stern. vessel is catamaran. Vessel stopped to identify object and check for damage. Vessel continued to Uranian to make further assessment.

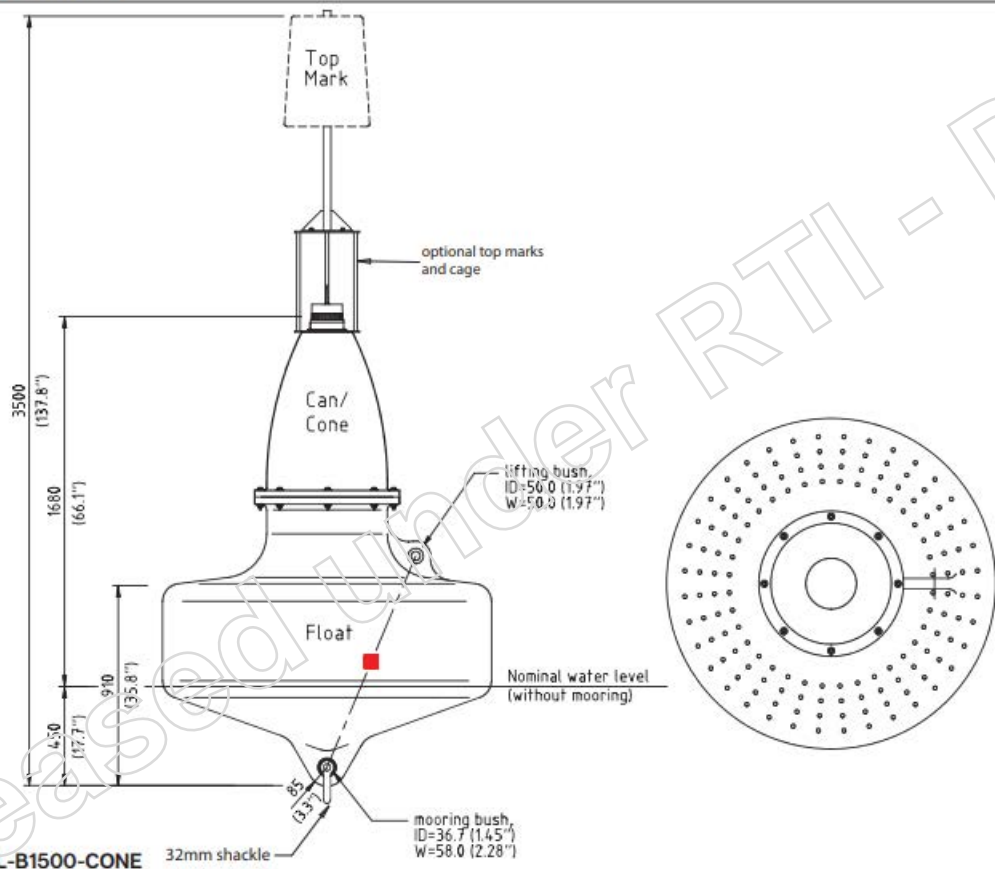
As requested, attached are some photos of the bow and stern damage for your records.

Is it possible to provide the geometry of the buoy (pdf drawing is fine), particularly the freeboard to the broken light fitting? I need to determine if it was possible for buoy to have contacted the underside of the trampoline, potentially causing some damage. I can then make arrangements to replace it.
