Road Safety Performance Review 'Kuranda Range' Kennedy Highway (Road no. 32A)

Prepared for Department of Transport and Main Roads (Far North District)

7 January 2016

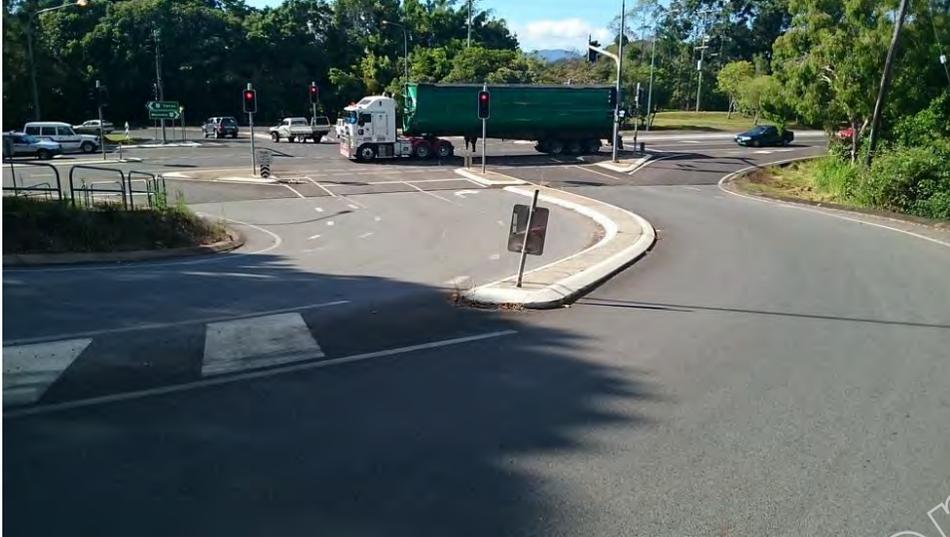
<p>Photograph 1: KEEP LEFT sign facing wrong direction on nose of median island at the Kennedy Highway/Myola Road intersection.</p>

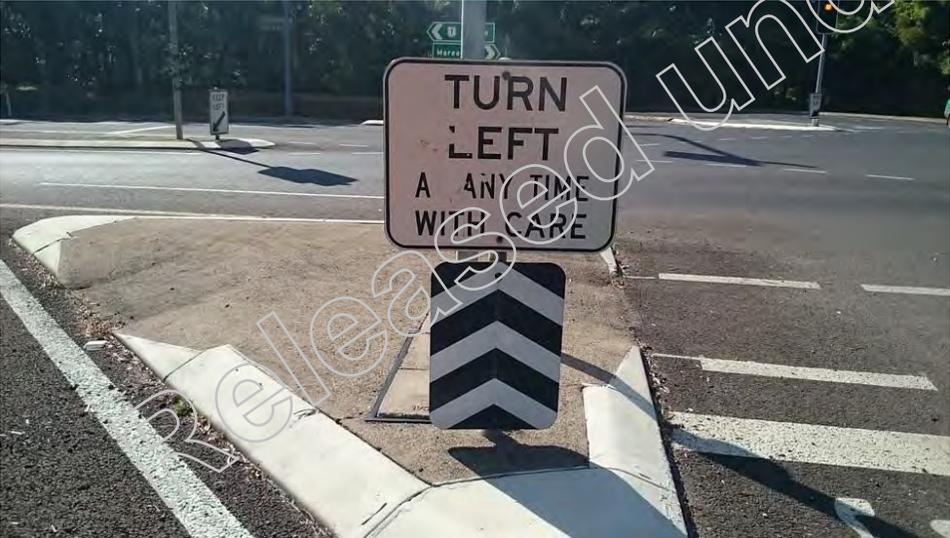
<p>Photograph 2: TURN LEFT AT ANY TIME WITH CARE sign in poor condition on the left-turn slip lane at the Kennedy Highway/Myola Road intersection.</p>	<p>Recommendation 8.1.1.5: Arrange for rotated signs to be realigned to face approaching traffic.</p> <p>Recommendation 8.1.1.6: Arrange for existing TURN LEFT AT ANY TIME WITH CARE (R2-16) signs to be replaced with GIVE WAY (R1-2B) signs, on the left-turn slip lanes at the Canopys Edge Boulevard and Rob Veivers Drive intersections (refer to MUTCD Part 14/6.1(d) for detail).</p>	<p>A</p> <p>C</p>

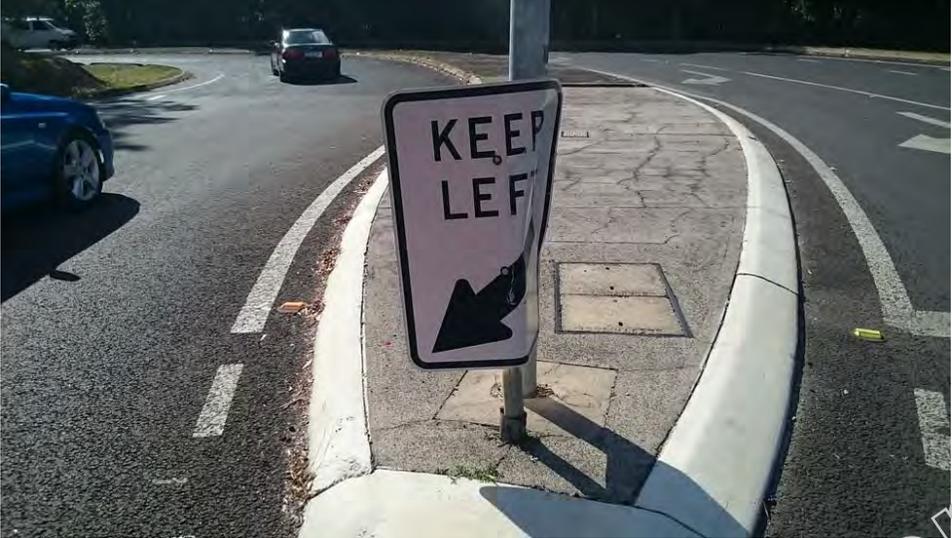
<p>Photograph 3: Damaged KEEP LEFT sign on the nose of the median island at the Kennedy Highway/Rob Veivers Drive intersection.</p>

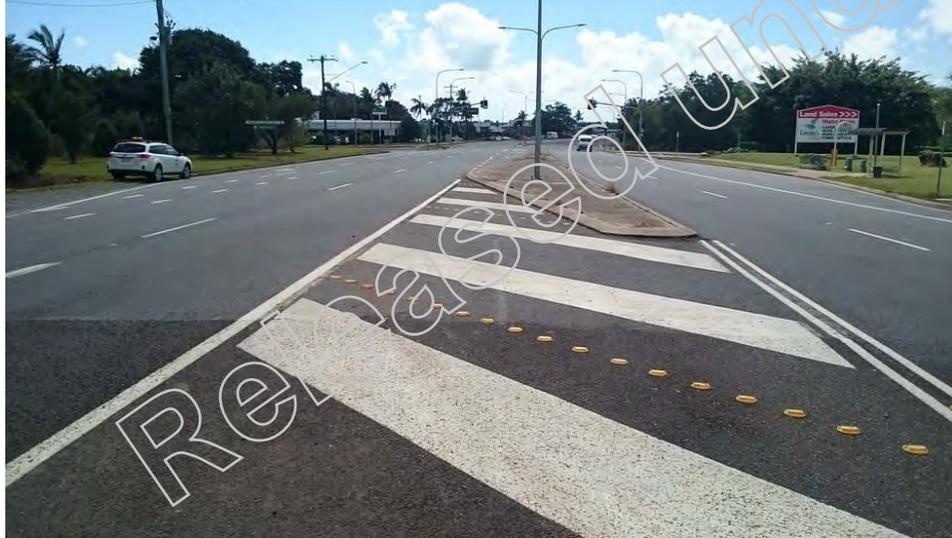
<p>Photograph 4: KEEP LEFT sign missing from the nose of the median island on the eastbound approach to the Kennedy Highway/Canopys Edge Boulevard intersection.</p>

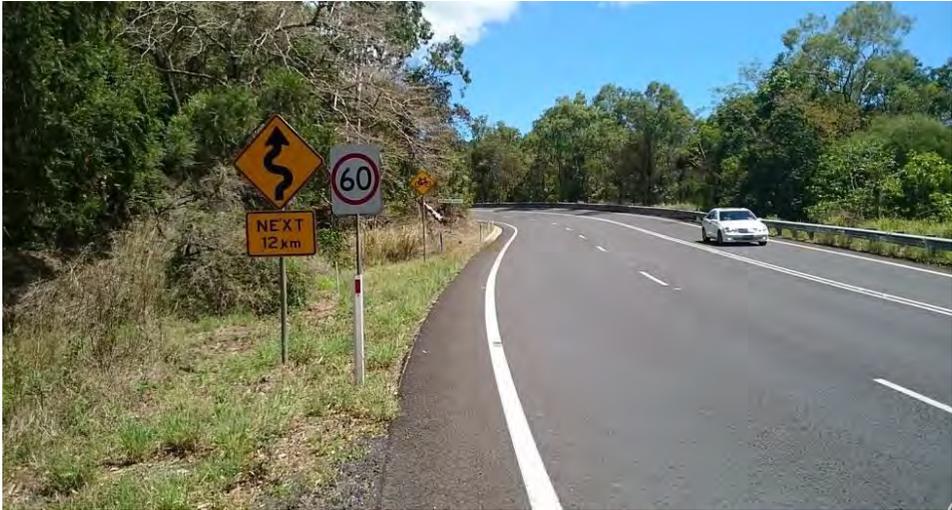
<p>Photograph 5: Example of closely spaced signs near the base of the range on the western side of the RoadTek Depot.</p>

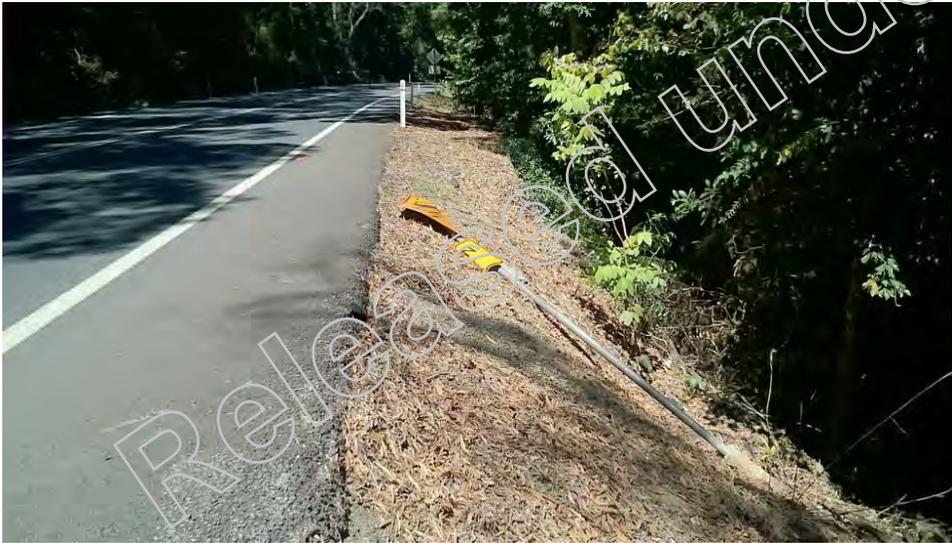
<p>Photograph 6: Damaged Slippery / When Wet sign at chainage 8.77km LHS.</p>

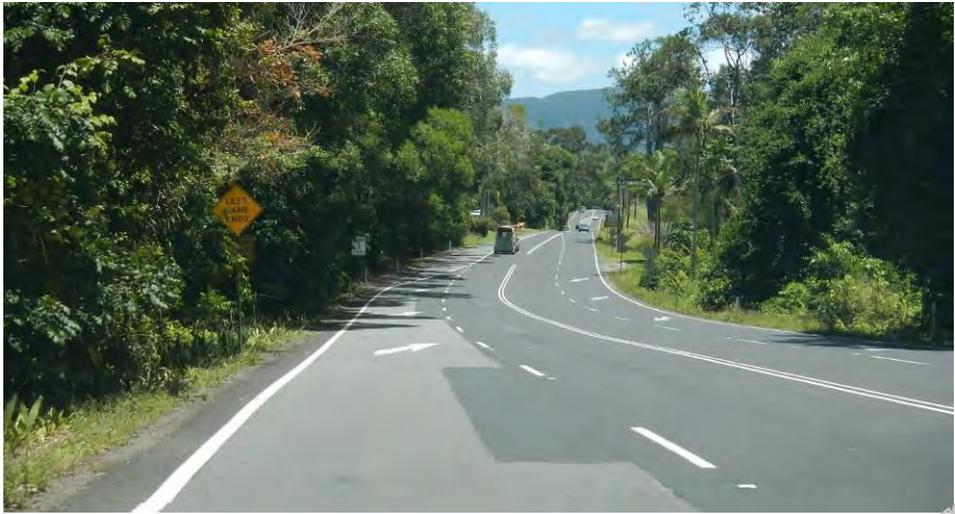
<p>Photograph 7: Example of warning sign (LEFT LANE ENDS) obscured by overgrown vegetation at chainage 11.28km LHS.</p>

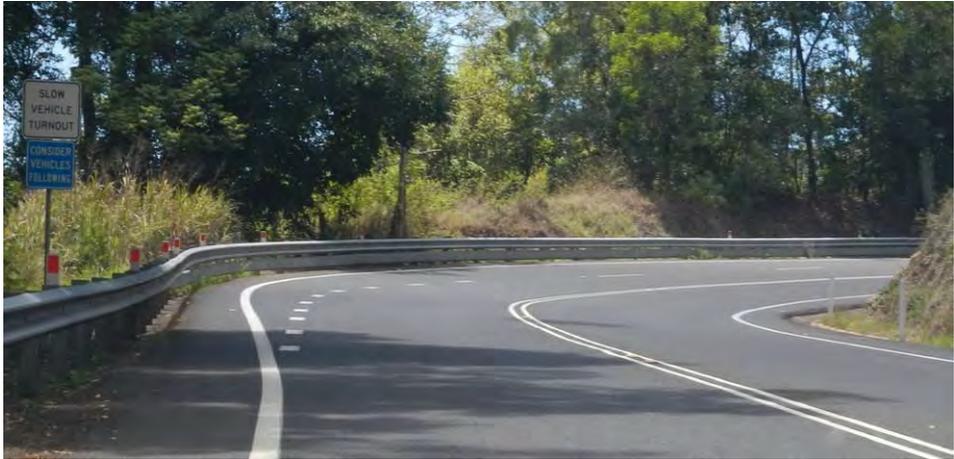
<p>Photograph 11: Example showing a combination of continuity line and broken lane line to separate the through traffic lane from the slow vehicle turnout lane.</p>

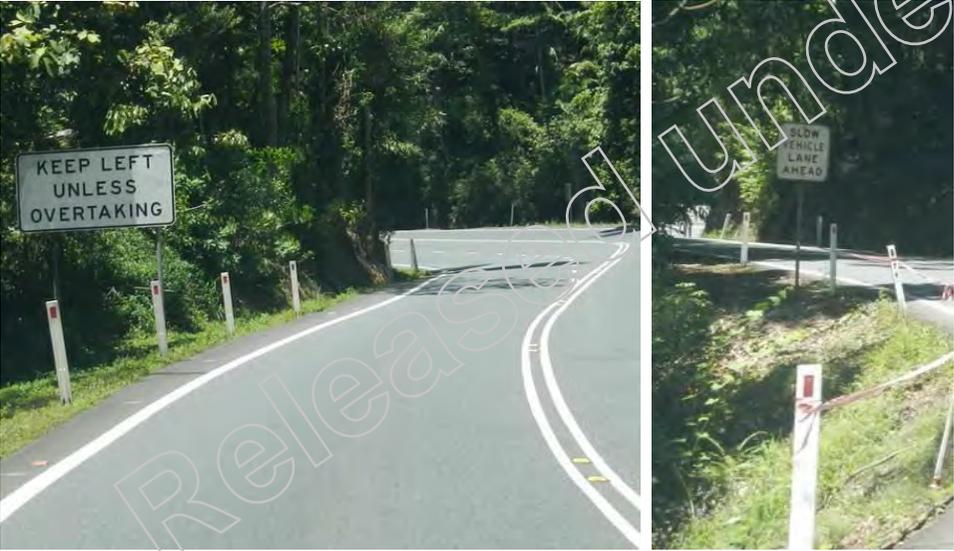
<p>Photograph 12: Examples showing an 'overtaking' sign at the start of an auxiliary lane was superseded by a SLOW VEHICLE LANE AHEAD sign.</p>

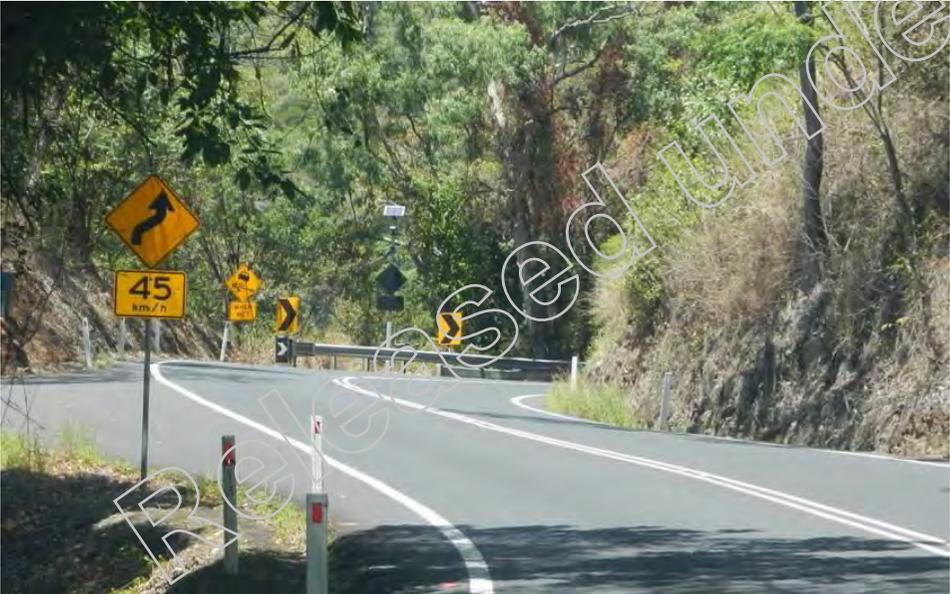
Item no.	Site inspection findings	Suggested action	Priority
<p>8.1.3</p>	<p>There were numerous alignment warning and curve advisory speed signs throughout the range section of the audit site. The values shown on some advisory speed signs were in 5km/h increments, which was inconsistent with current requirements for 10km/h speed value increments specified in Part 2/4.4.7.7 of the MUTCD.</p> <p>As most curve advisory speed signs appeared relatively new, it was unclear if the displayed speed values had been determined using current practice, or if older signs that showed 5km/h increments had simply been replaced. It is critical that posted advisory speeds be determined using accepted traffic engineering procedures.</p>

<p>Photograph 13: Example showing an advisory speed sign with its value in 5km/h increments.</p>	<p>Recommendation 8.1.3.1: Confirm the process used to determine advisory speed values on horizontal curves throughout the audit site. Where an accepted traffic engineering procedure has not been used, or records are not available, consider undertaking a mass review of advisory speeds using the process outlined in Appendix C, Part 2 of the MUTCD. Where discrepancies are identified, arrange for Advisory Speed (W8-2) signs to be replaced as necessary so that posted speed values are in 10km/h increments.</p> <p>Recommendation 8.1.3.2: Where a mass action review of advisory speed values is undertaken in accordance with Recommendation 8.1.3.1, also review the application of associated alignment warning signs to check the type (diagrammatic symbol) and location of the signs are consistent with advisory speed requirements. The appropriate combination of alignment warning and advisory speed signing is outlined in Part 2/4.4.6 of the MUTCD.</p>	<p>A</p> <p>A</p>

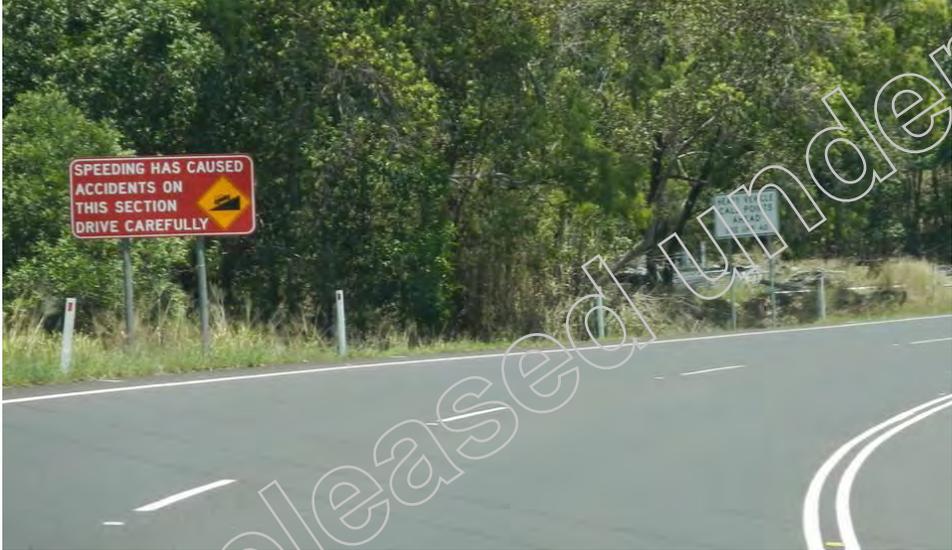
Item no.	Site inspection findings	Suggested action	Priority
<p>8.1.4</p>	<p>A special warning sign that incorporated a Steep Climb (W5-13) sign was installed near the base of the range (immediately west of the RoadTek depot). However, there were no signs installed at the top of the range to warn eastbound motorists of the long steep descent, or the potential need for trucks and buses to use low gears.</p> <p>To assist heavy vehicle drivers to moderate speeds on approach to the steep downgrades, it is important that adequate advance warning is provided.</p>

<p>Photograph 14: Steep Climb sign incorporated into a special target board near the base of the Kuranda Range (immediately west of the RoadTek Depot).</p>	<p>Recommendation 8.1.4.1:</p> <p>In accordance with Part 2/4.9 of the MUTCD, investigate the need for additional steep grade signing throughout the Kuranda Range section of the Kennedy Highway. Where the need for additional signing is identified, ensure the application of signage complies with current MUTCD guidelines.</p>	<p>A</p>

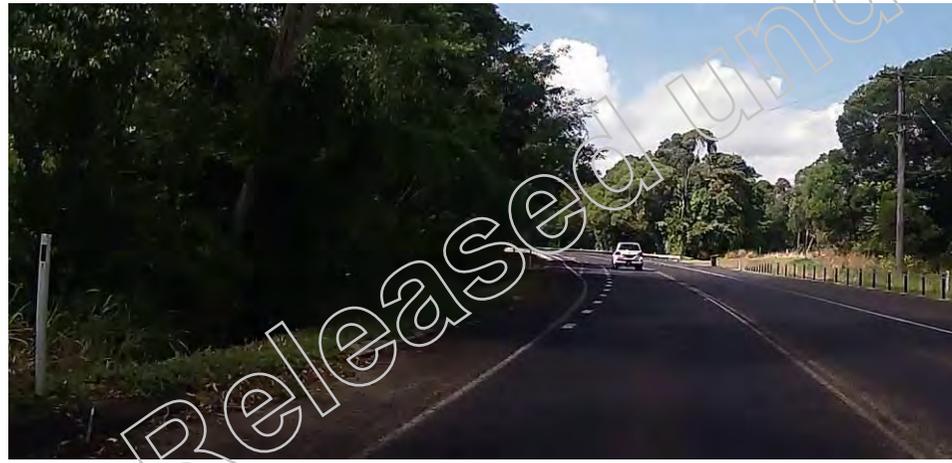
<p>Photograph 20: Westbound view on approach to the Green Hills Road intersection showing the absence of an advance road name sign near the deceleration lane taper.</p>

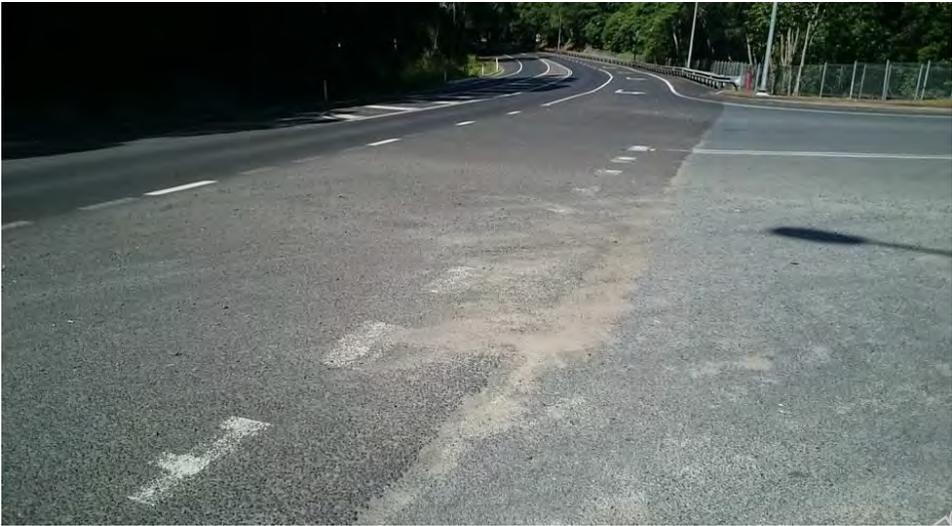
<p>Photograph 21: Example of worn give way line at the Black Mountain Road intersection.</p>

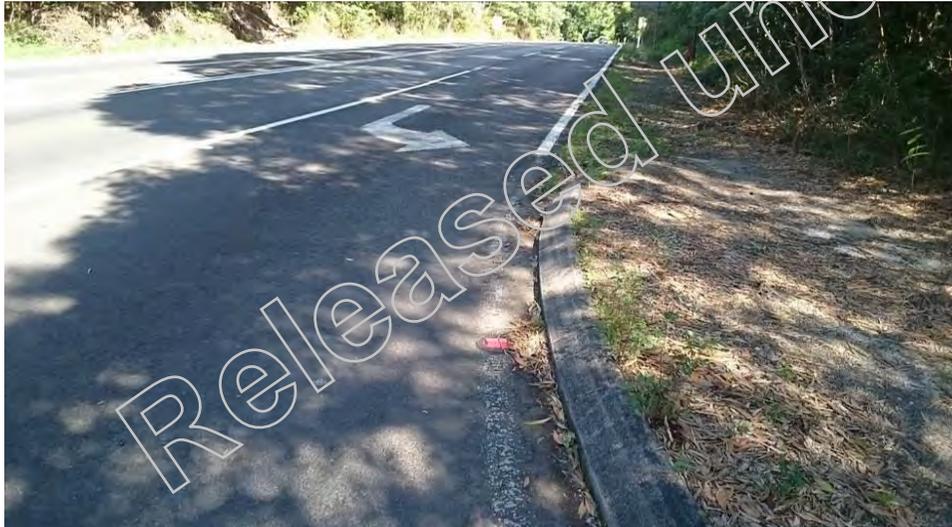
<p>Photograph 22: Example of worn edge line beside the kerb return at the Saddle Mountain Road intersection.</p>

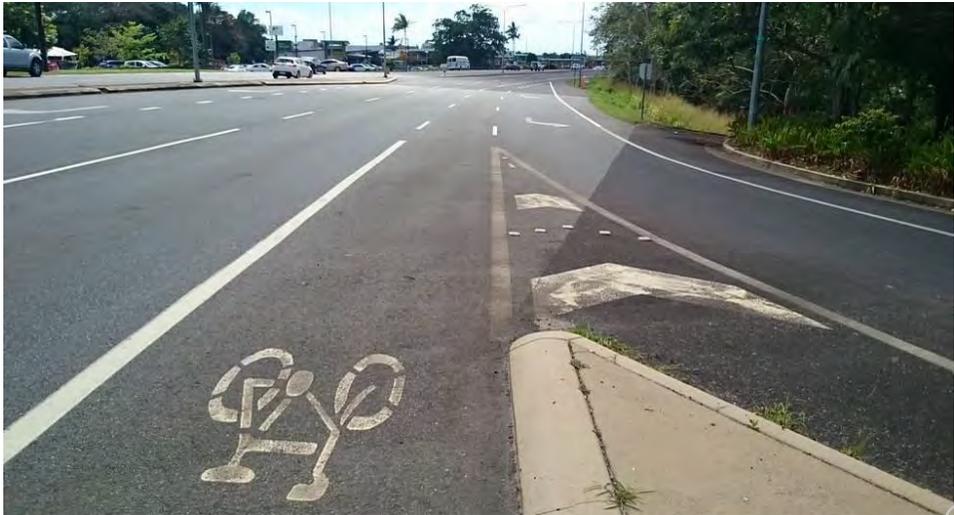
<p>Photograph 23: Example of worn outline markings and chevrons on the splayed island approach at Canopys Edge Boulevard.</p>

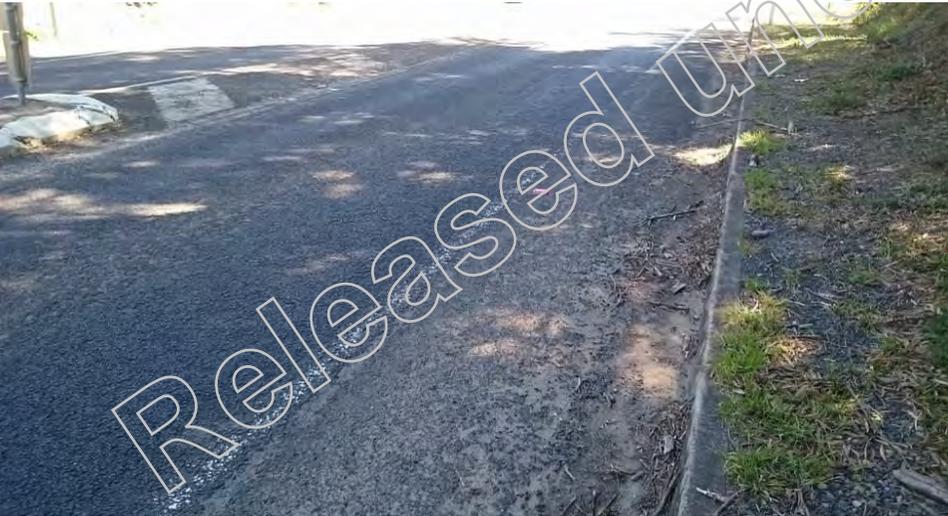
<p>Photograph 24: Example of worn edge lines between Rob Veivers Drive and the Green Hills Road intersection (photograph shows eastbound lane near end of median island).</p>

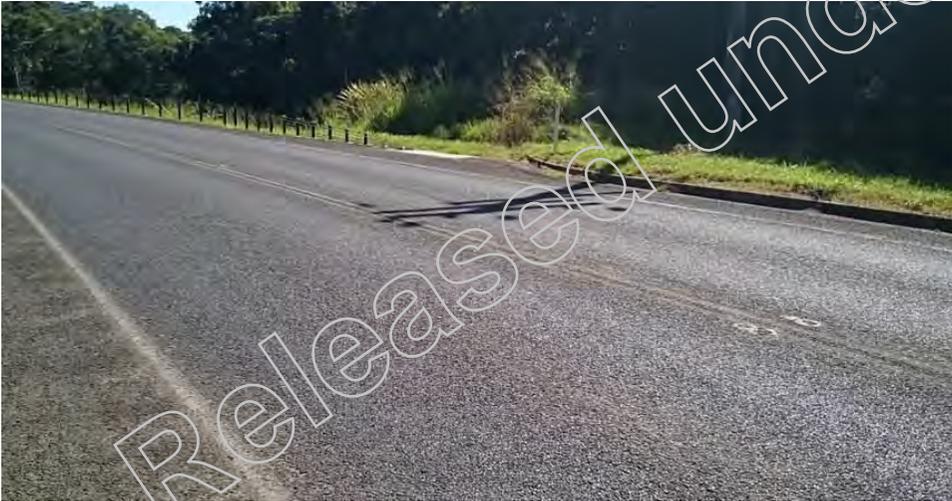
Item no.	Site inspection findings	Suggested action	Priority
8.3 Delineation			
8.3.1	<p>Raised Reflective Pavement Markers (RRPMs) were installed throughout the audit site to supplement edge, centre, and lane lines. Road Edge Guide Posts (REGPs) were also installed near the shoulder/formation edge on unkerbed road sections. The application and condition of RRPMs and REGPs were to a high standard, which provided good night time delineation in both directions. There were isolated locations where REGPs and RRPMs were damaged or missing, however, the small number of absences did not detract from delineation continuity during the night inspection.</p> <p>Given the extent of substandard alignment and hazardous roadside environment throughout the audit site, maintaining a high standard of delineation is a crucial component to maximising safety for road users.</p>

<p>Photograph 27: Example showing missing consecutive centre line RRPMs between Rob Veivers Drive and Green Hills Road.</p>	<p>Recommendation 8.3.1.1: Arrange for the replacement of damaged and missing RRPMs and REGPs throughout the audit site.</p> <p>Recommendation 8.3.1.2: Check the department's current maintenance arrangement with a view to ensuring a high standard of delineation is maintained throughout the audit site through regular inspections and replacement of devices, as required.</p>	<p>B</p> <p>B</p>

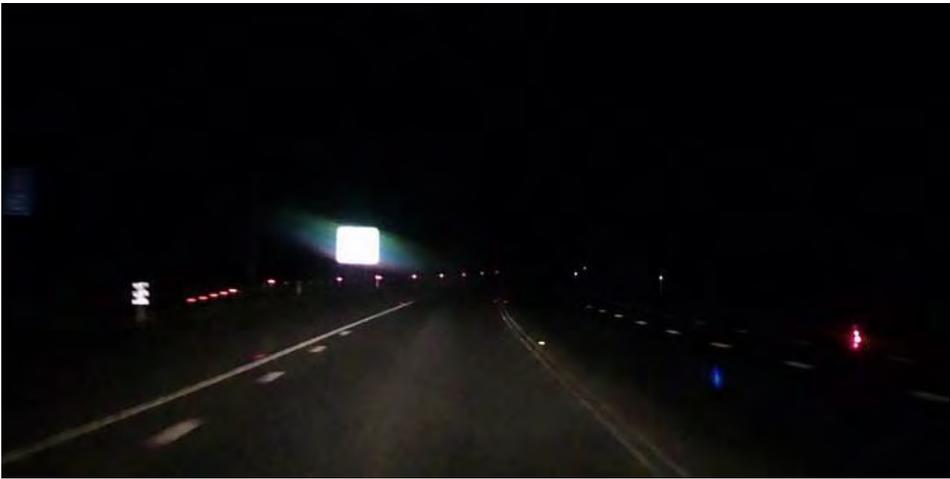
<p>Photograph 28: Example showing missing centre line RRPMS immediately east of the Green Hills Road intersection.</p>

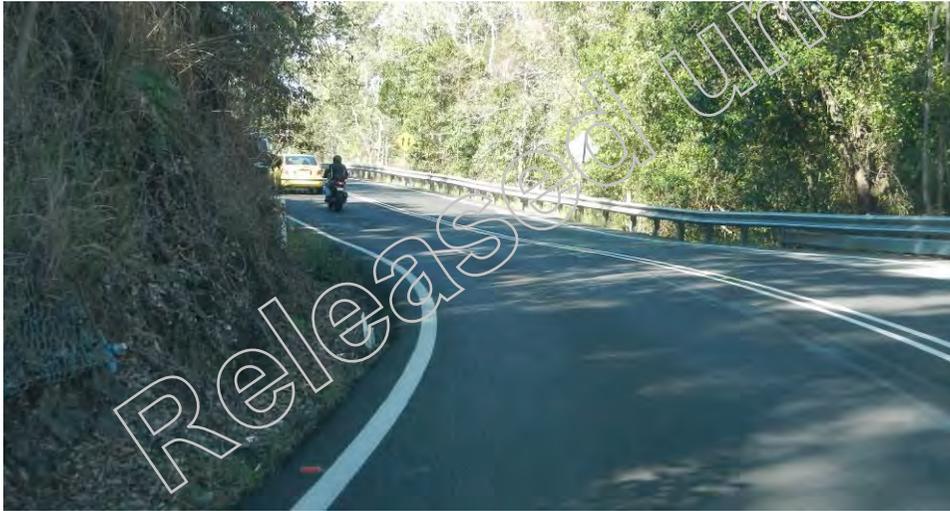
<p>Photograph 29: Example showing damaged REGPs on the range, east of Avondale Creek.</p>

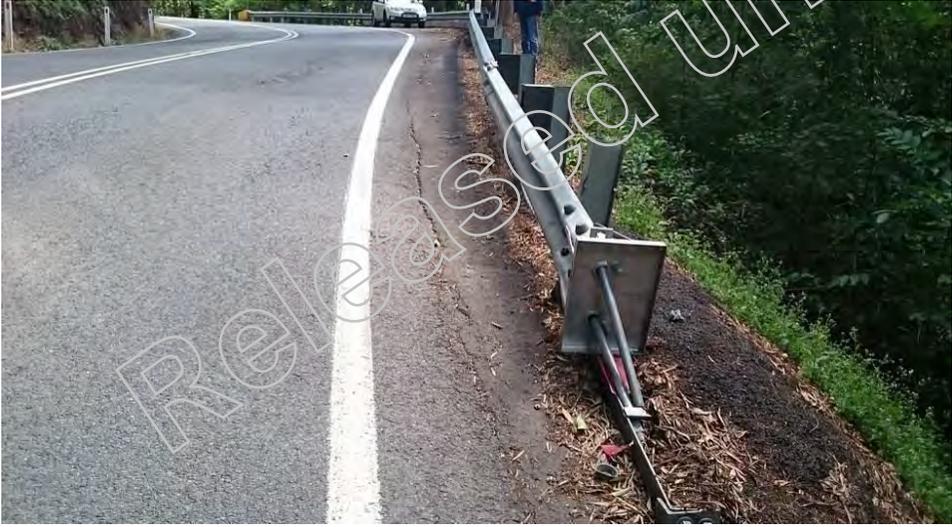
Photograph 30: Damaged X-350 end terminal at chainage 6.55km RHS.

<p>Recommendation 8.4.1.1: Arrange for all safety barrier terminals to be inspected and for any damaged components to be logged for repaired/replaced as necessary. As a minimum practice, conduct assessments in accordance with Section 3.5, Part 1: Road Safety Barrier Systems (AS/NZ 3845.1:2015).</p> <p>Recommendation 8.4.1.2: Arrange for uni-directional hazard stickers (D4-1-2-Q01) to be installed on end terminals where they are missing and for the replacement of existing stickers where they have been damaged. Also ensure that at least one dual-sided delineator is placed close to the end of each terminal head.</p>	<p>A</p> <p>A</p>

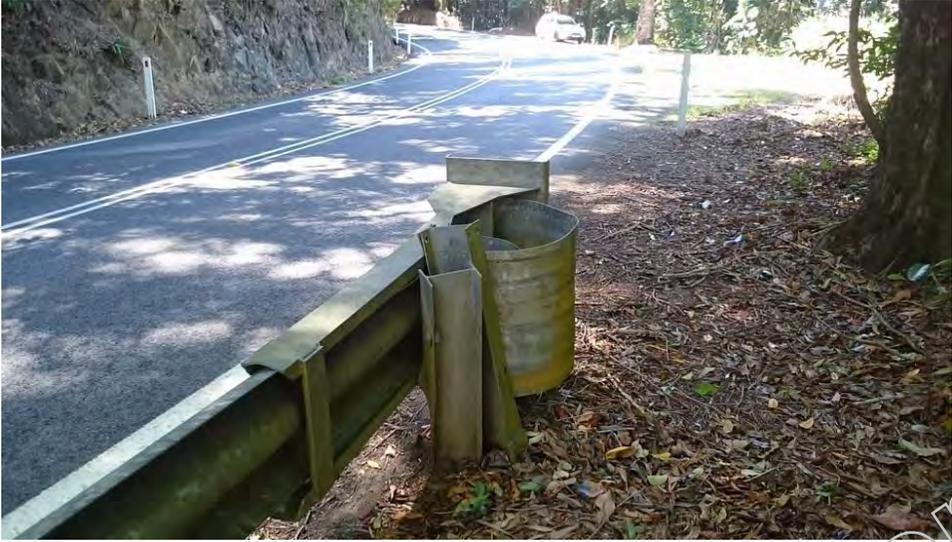
<p>Photograph 31: Damaged ET2000 Plus end terminal at chainage 7.45km RHS.</p>

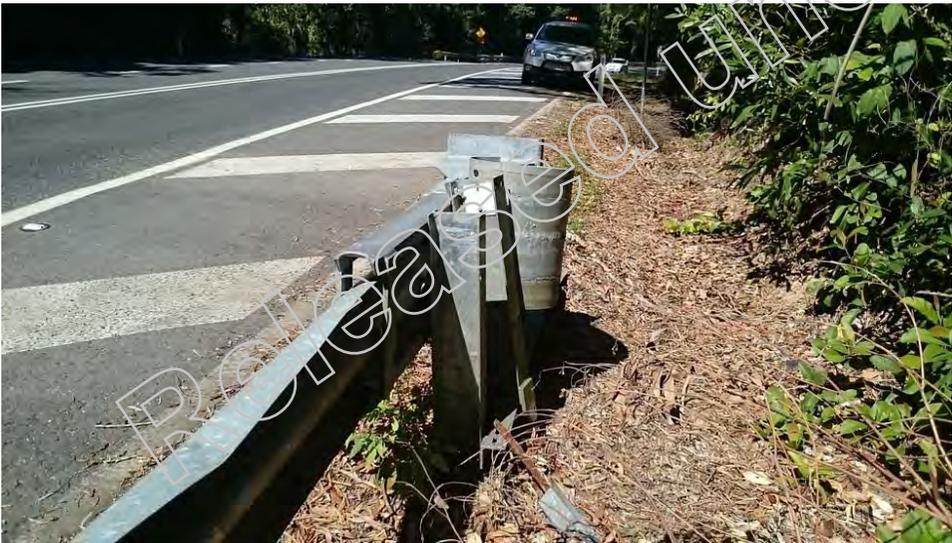
<p>Photograph 32: Damaged ET2000 Plus end terminal at chainage 7.96km LHS.</p>

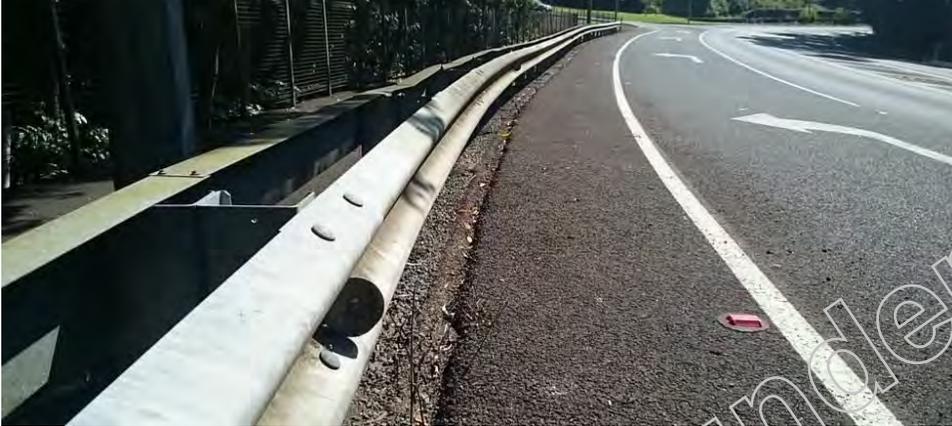
Item no.	Site inspection findings	Suggested action	Priority
8.4.2	<p>There were a significant number of successive delineators either missing or damaged on the section of guardrail that extended between the Barron River Bridge and Black Mountain Road (right side of carriageway). As the barrier is situated close to the traffic lanes, a high standard of delineation is required to alert motorists of the potential hazard during periods of poor light or adverse weather conditions.</p>

<p>Photograph 33: Eastbound view towards the Black Mountain Road intersection showing missing delineators on the W-Beam barrier face.</p>

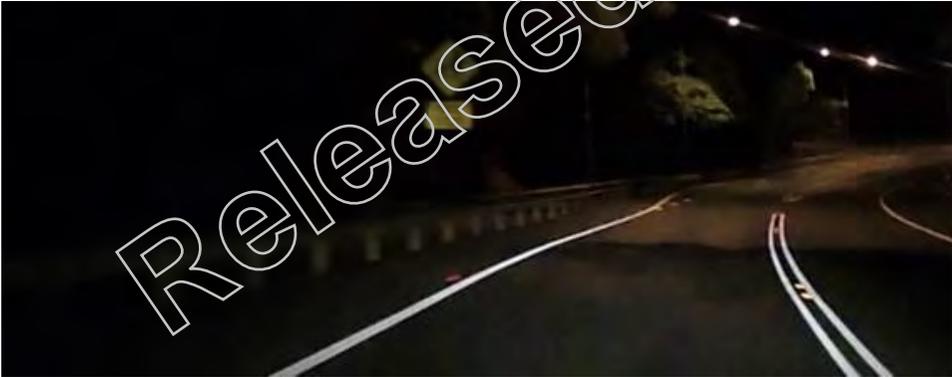
<p>Photograph 34: Eastbound view towards Black Mountain Road intersection during the night inspection showing the absence of reflectorisation from guardrail delineators.</p>	<p>Recommendation 8.4.2.1: Arrange for new delineators to be placed on the section of W-Beam barrier that extends between Barron River Bridge and Black Mountain Road (right side of carriageway).</p>	A

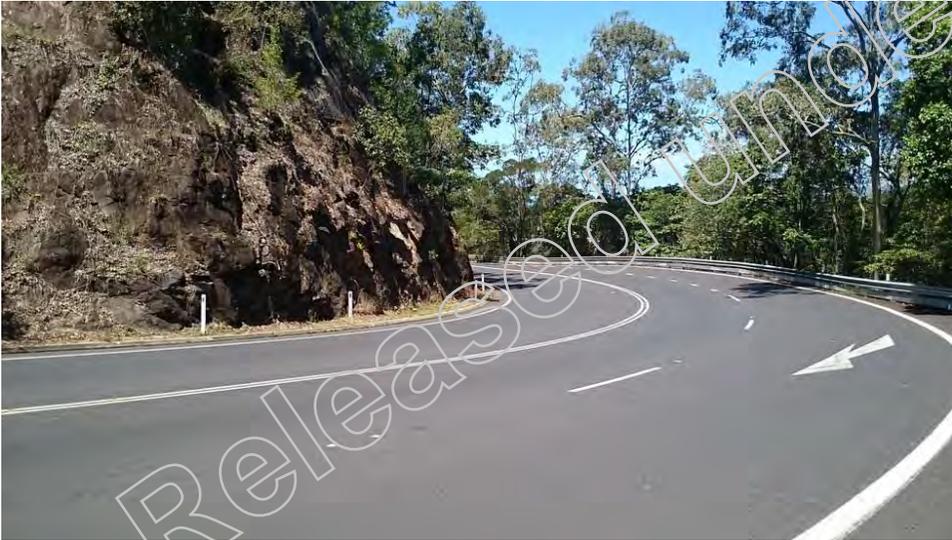
<p>Photograph 35: Example of steep-sided cutting with jagged rocks protruding at chainage 2.06km RHS.</p>

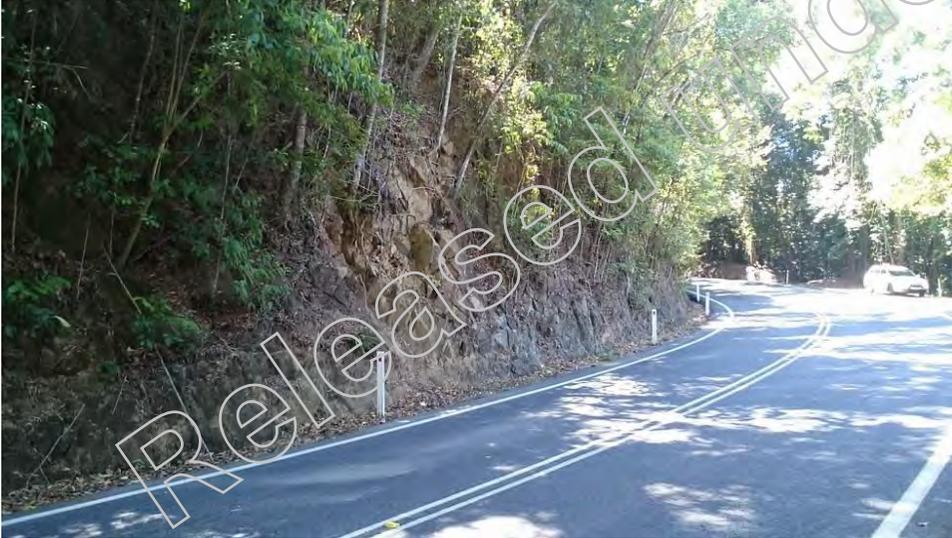
<p>Photograph 41: Example of a steep-sided cut batter where there appeared to be a risk of loose rocks falling onto the road at chainage 7.47km LHS.</p>

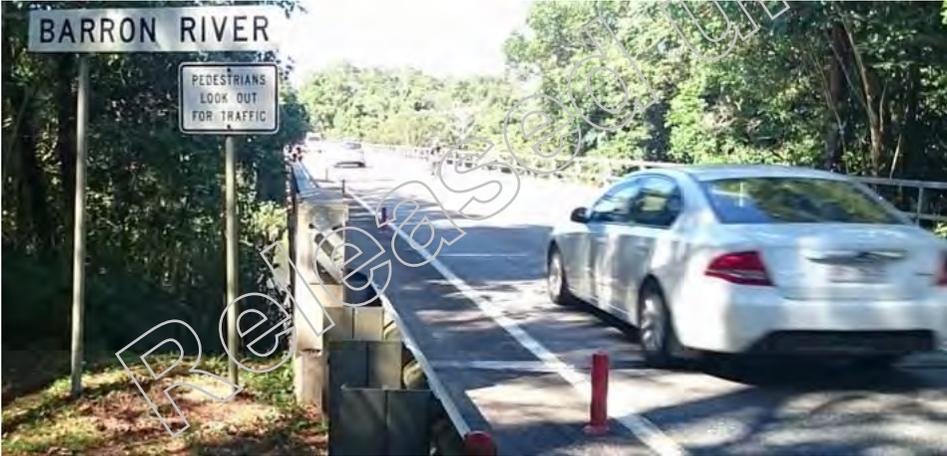
<p>Photograph 44: Eastbound view at the western abutment of the Barron River Bridge showing the raised bollards that separate the traffic lane and pedestrian path.</p>	<p>Recommendation 8.7.1.4: Determine if a suitable treatment can be provided to physically separate cyclists/pedestrians from vehicular traffic crossing the Barron River Bridge.</p> <p>A suggested option would involve constructing barrier kerb across the northern side of the bridge such that it is parallel with, and at the same height, as the existing bridge kerb, with breaks provided for drainage and at deck expansion joints. The new kerb could be offset from the traffic lane at a similar offset to that used between the edge line and bridge kerb on the southern side of the bridge. Chequered steel lintels could be fixed between the two parallel kerbs to create a raised walkway above the existing shoulder. Pedestrian fencing or a suitable barrier system (if sufficient width is available) would need to be provided along the edge of the new kerb.</p> <p>Where an options analysis identifies one or more suitable treatments, develop a business case for the preferred solution and prioritise upgrade works accordingly.</p>	<p>C</p>

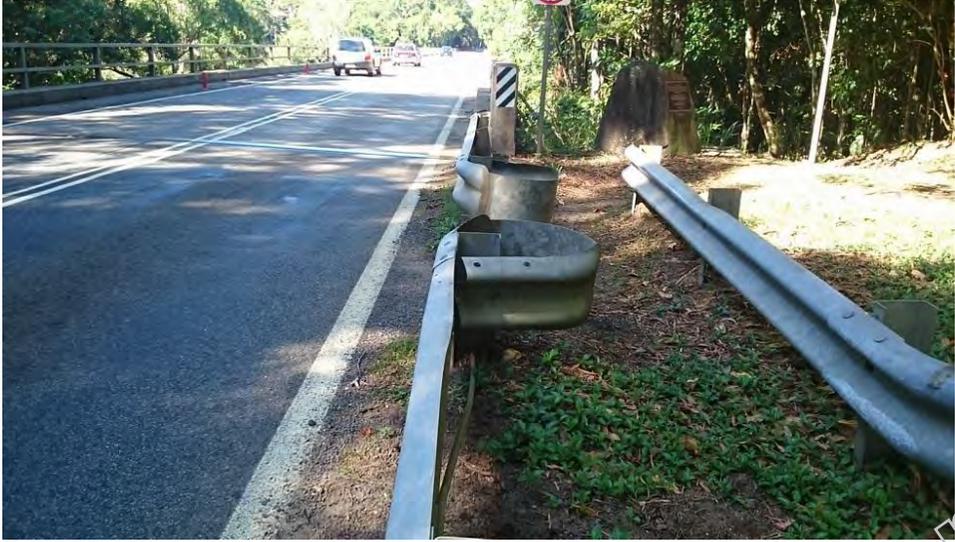
<p>Photograph 45: Eastbound view at the western abutment of the Barron River Bridge showing the break in W-Beam barrier that allows path users to cross the road.</p>

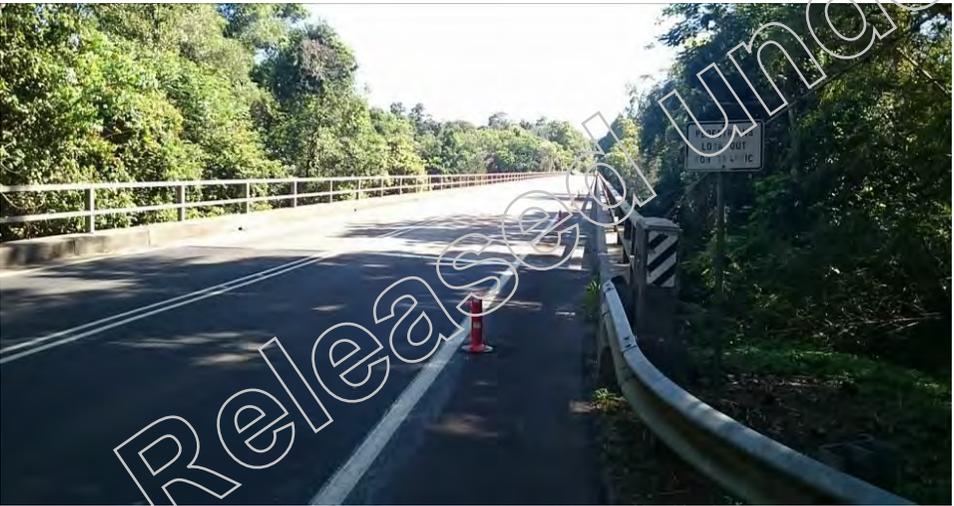
<p>Photograph 48: Westbound view from the eastern abutment of the Barron River Bridge showing the raised bollards that separate the traffic lane and pedestrian path.</p>

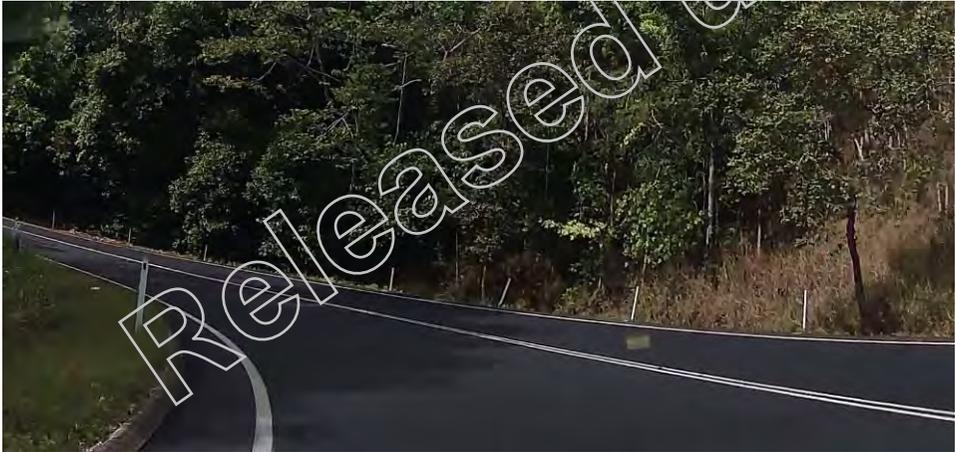
Item no.	Site inspection findings	Suggested action	Priority
<p>8.7.2</p>	<p>During the daytime inspection several cyclists were observed riding eastbound on the Kennedy Highway, near the base of the Kuranda Range. The audit team was advised at the pre-start meeting that an off-road mountain bike trail extends down the side of the range, starting near the Henry Ross Lookout and terminating at chainage 1.13km on the right-hand side. Cyclists re-enter the Kennedy Highway at this point and ride the remaining distance to the base of the range on the road. The road shoulder along this section varied in width between 0.5m to 1m and is typically constrained by the presence of safety barrier or kerb. This required cyclists to travel partially or fully within the eastbound traffic lane.</p> <p>Bicycle warning signs were installed near the top (11.17km RHS) and base of the range (0.67km LHS), which provided a general warning to motorists that they may encounter cyclists on the range. However the sign facing eastbound traffic (chainage 11.17km RHS) failed to highlight the area near the base of the range where potential for cyclist/vehicle conflict was greatest. There was also no specific warning or protection where cyclists re-enter the road unexpectedly at chainage 1.13km.</p>

<p>Photograph 49: Westbound view near chainage 1.13km showing the location where the mountain bike trail re-enters the Kennedy Highway.</p>	<p>Recommendation 8.7.2.1:</p> <p>Arrange for a SHARE THE ROAD warning sign (TC1878) and supplementary plate (TC1864) (as illustrated in Figure 10) to be installed near chainage 1.21km RHS, which is prior to the point where the mountain bike trail terminates and cyclists re-enter the Kennedy Highway.</p> <p>Also arrange for a ROAD AHEAD (W6-8) warning sign to be installed beside the mountain bike trail, prior to its junction with the Kennedy Highway at chainage 1.13km.</p>

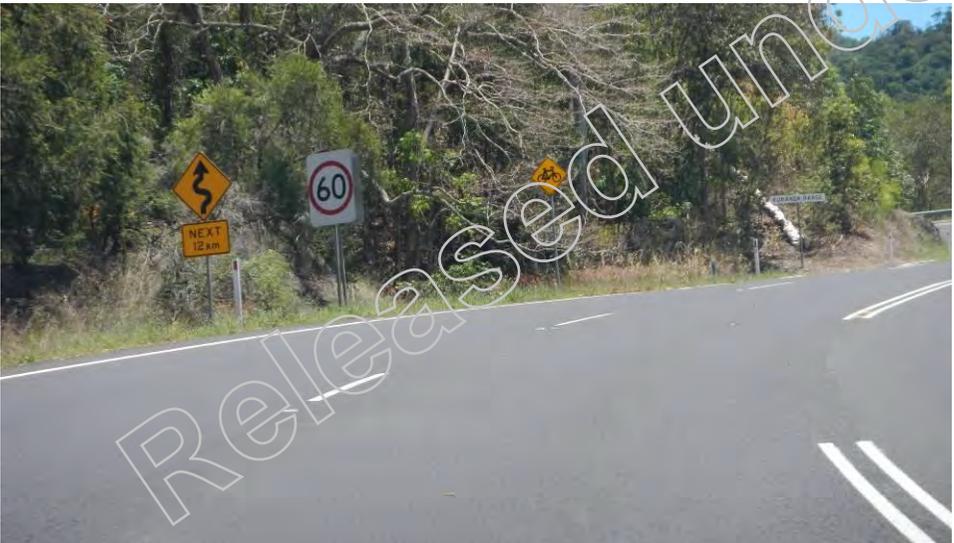
<p>Photograph 51: Westbound view showing the Bicycles warning sign at chainage 0.67km LHS.</p>

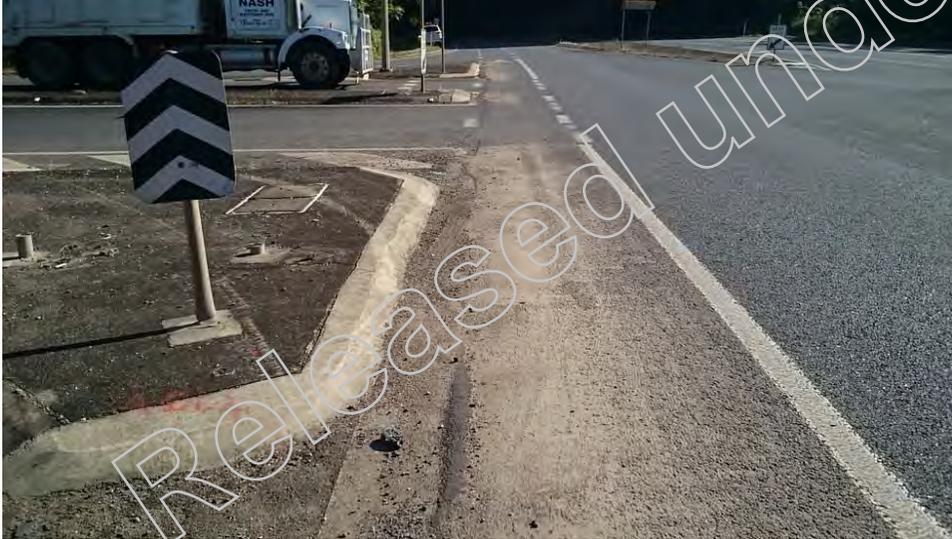
<p>Photograph 52: Example of dirt and loose grit on the road surface within the eastbound bicycle lane at the Warril Drive/Fallon Road intersection.</p>

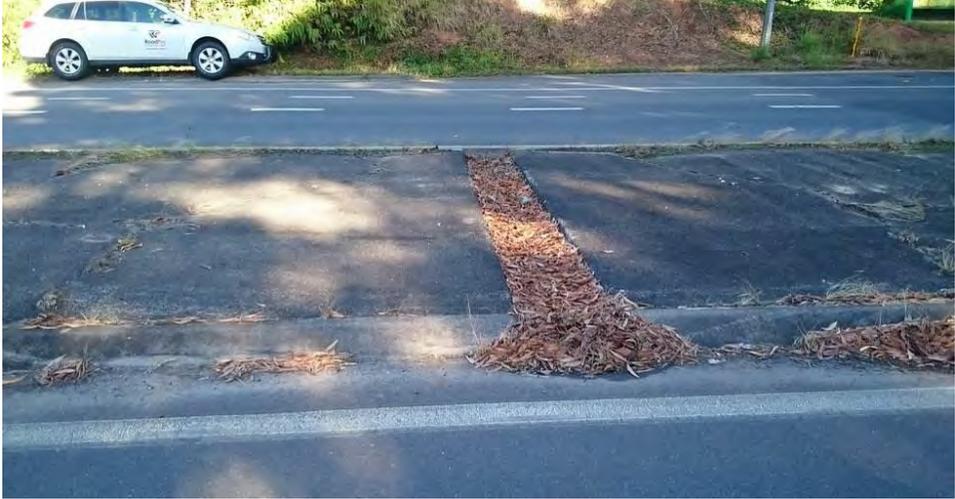
<p>Photograph 53: Example of leaf matter blocking the drains cut through the median island at the Warril Drive/Fallon Road intersection.</p>

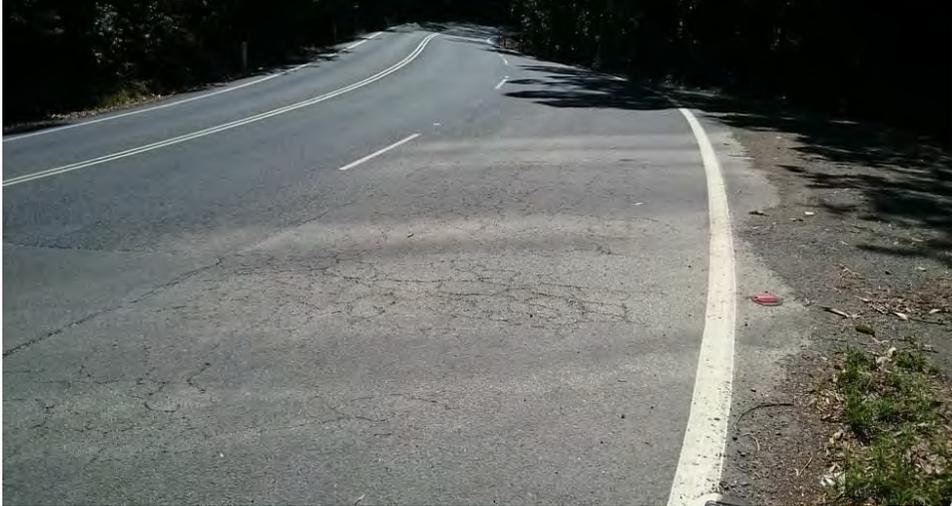
<p>Photograph 55: Example of crocodile cracking on the range section at chainage 6.29km.</p>

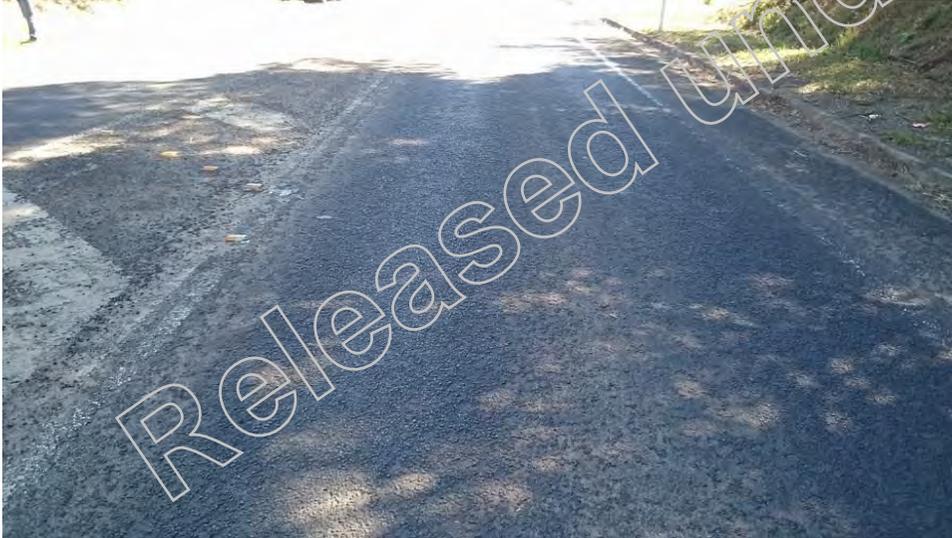
<p>Photograph 56: Aggregate stripping on the eastbound lane near the end of the median island at chainage 14.28km.</p>

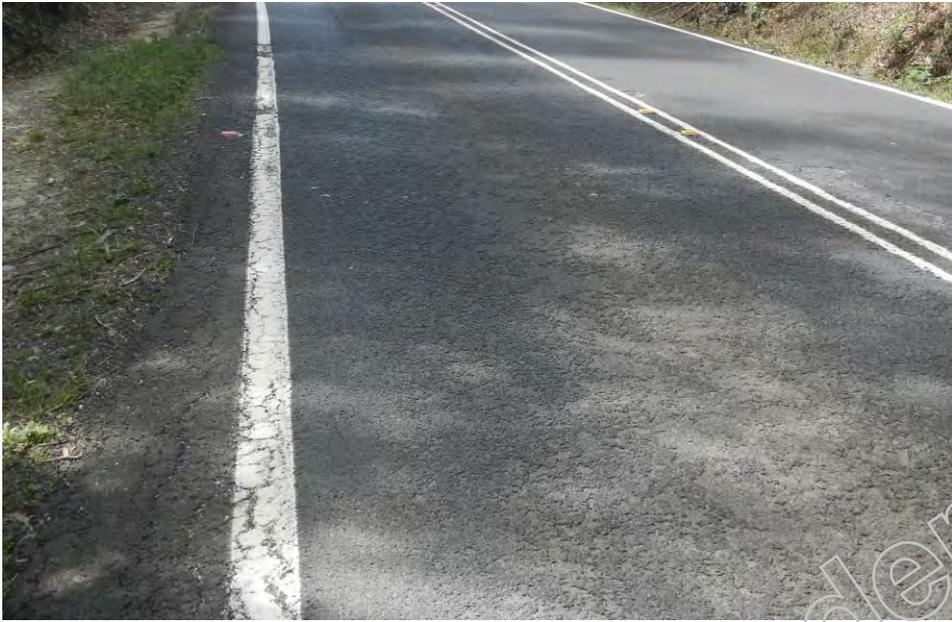
<p>Photograph 57: Aggregate stripping and cracking between the Black Mountain and Saddle Mountain roads intersection (eastbound lane).</p>

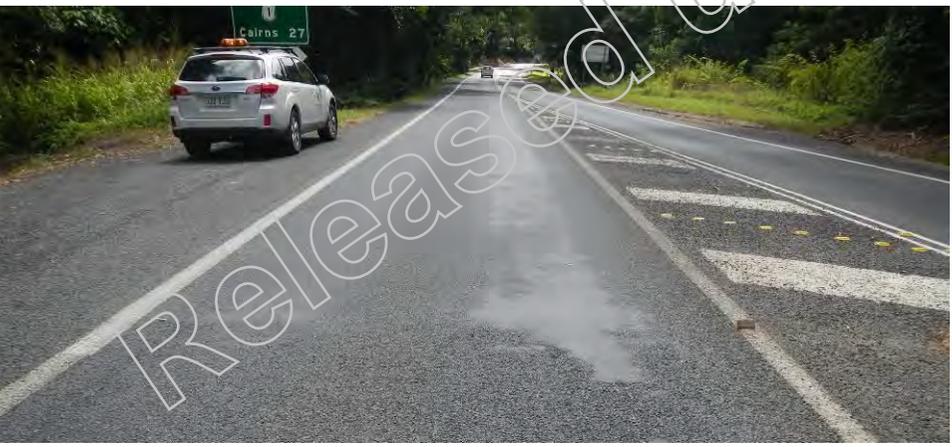
<p>Photograph 58: Flushing in the right-hand wheel path near the nose of the median island on the eastern side of the Myola Road intersection.</p>

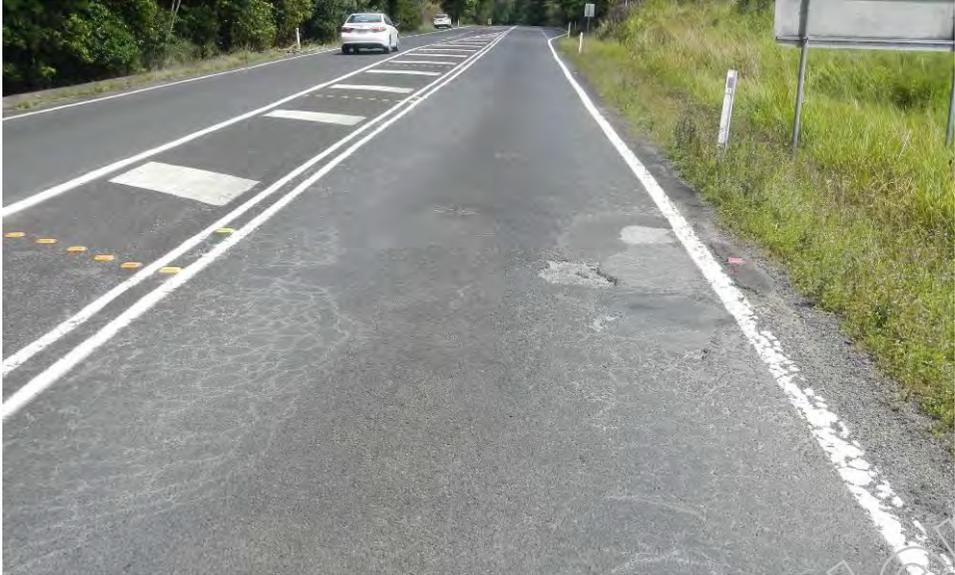
<p>Photograph 59: Extensive crocodile cracking on the road section immediately east of the Saddle Mountain Road intersection.</p>

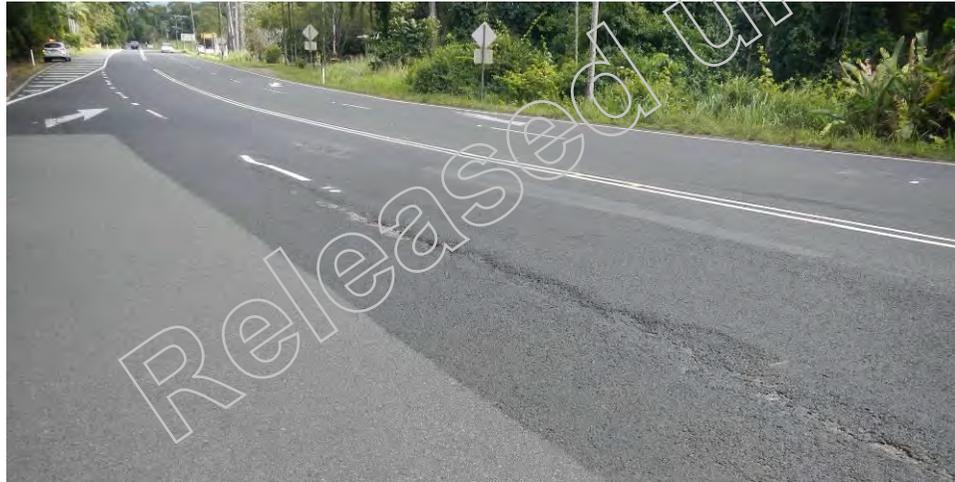
<p>Photograph 60: Longitudinal cracking on the road section immediately east of the Saddle Mountain Road intersection.</p>
