Road Safety Performance Review 'Kuranda Range' Kennedy Highway (Road no. 32A)

Prepared for Department of Transport and Main Roads (Far North District)

7 January 2016

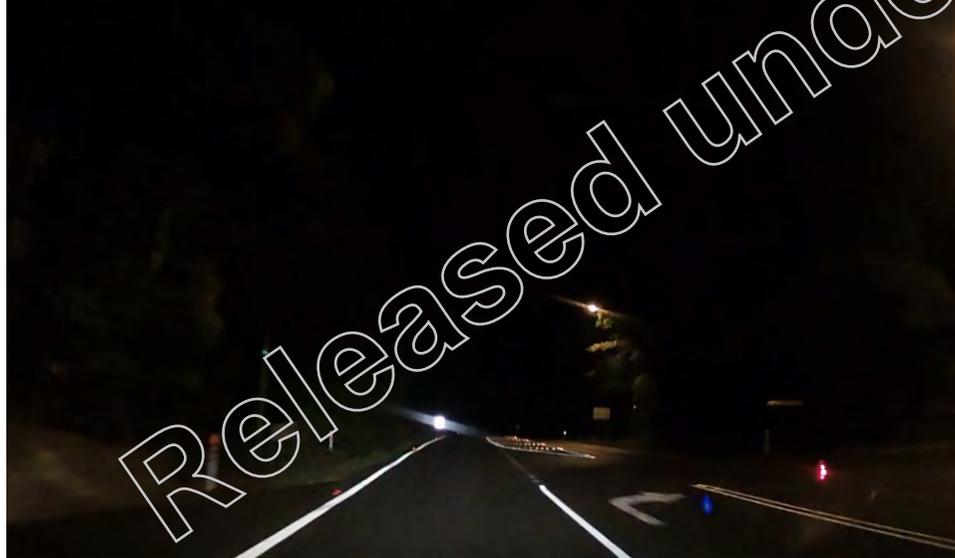
<p>Photograph 62: Westbound view at the Saddle Mountain Road intersection showing a Rate 3 street light that was not functioning (left side of image between the two guide posts).</p>
