Queensland Transport Compliance

Investigation File: CAS 3827 Vehicle Rego:

## Briefing Note

**Subject** CAS 3827  
AIS Complaint- Rego

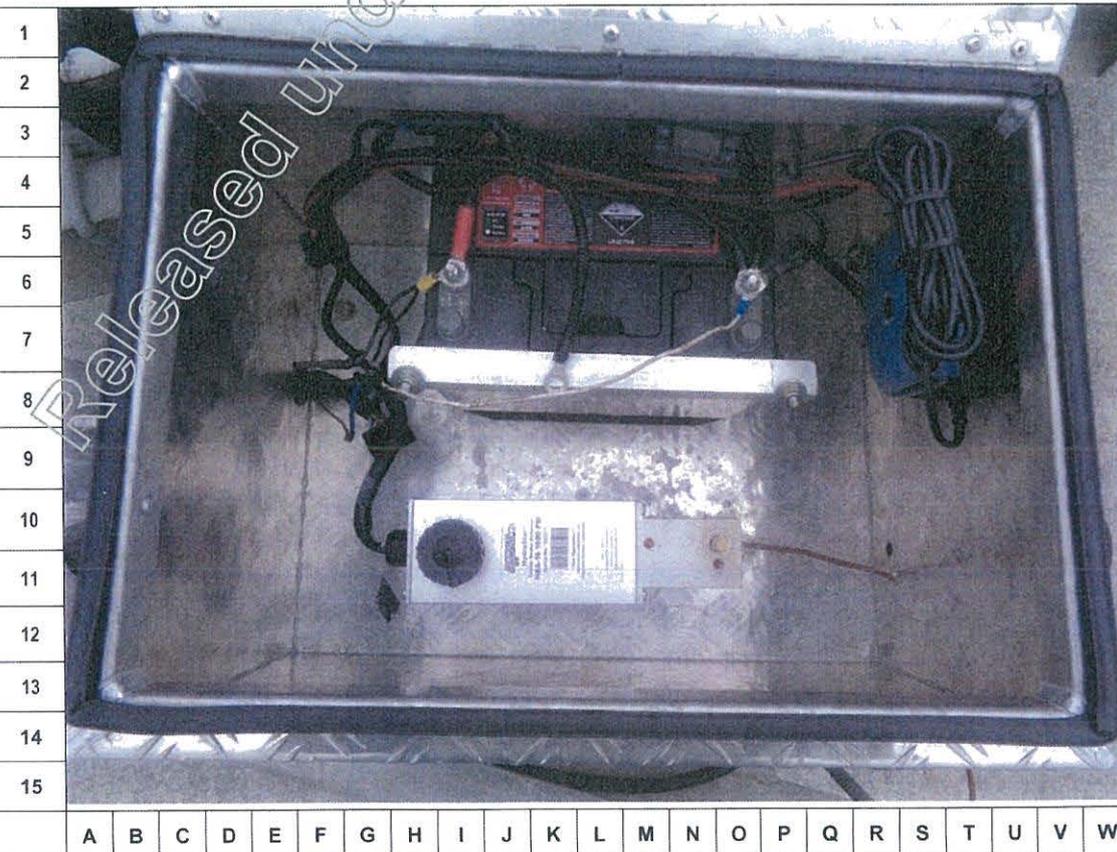
Photograph 2

Photo showing inside of electrical box. M4- battery, 5L unconnected wire, 11K- electro-hydraulic unit, 3N- battery voltage display and 5S- electrical control unit.

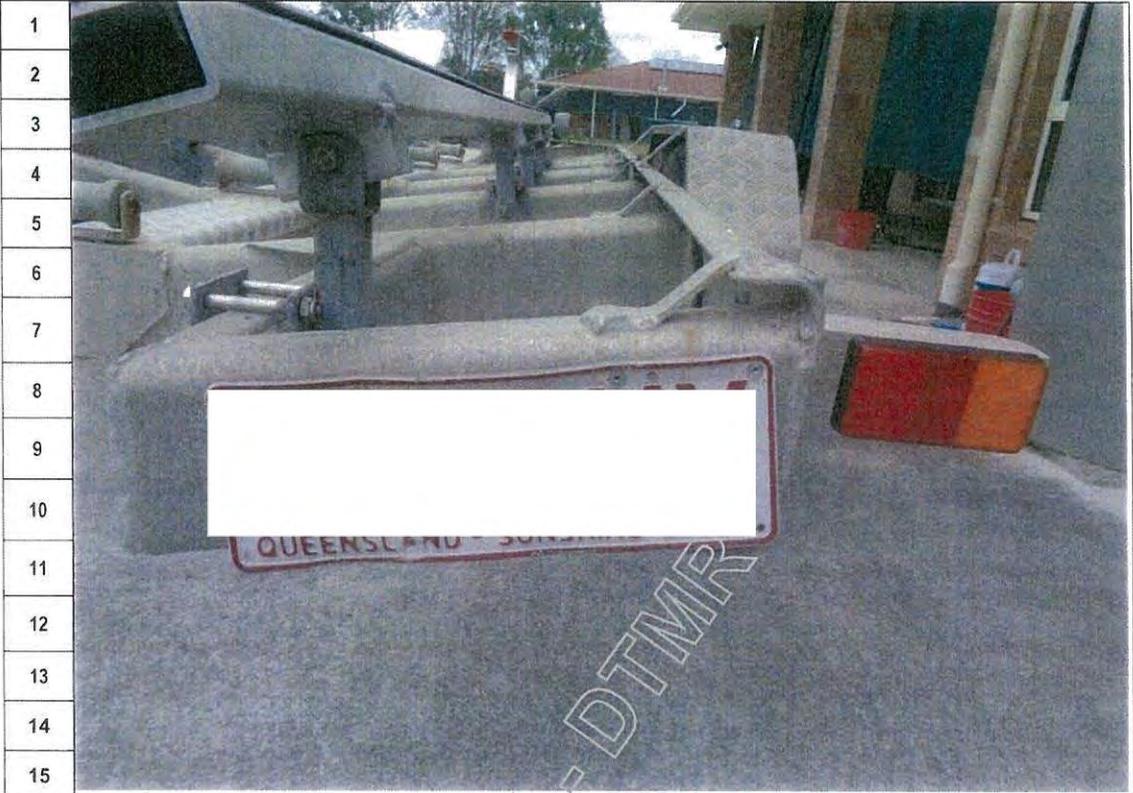
Photograph 3

Photo of number plate and showing no number plate light fitted.

1. Replace broken second axle is fairly easy to follow by the photos.  
Replace as broken.  
**COP. 6.11 Suspension components.** Components are distorted, cracked, corroded, fractured or are worn beyond manufacturer's specifications.
2. Inspect 1<sup>st</sup> axle. If damaged replace – is there an issue with the first axle that the AE may have missed?  
Inspect axle as rusty at the same place where the 2<sup>nd</sup> axle broke. If the axle is weakened by the rust. Replace.  
**COP. 6.11 Suspension components.** Components are distorted, cracked, corroded, fractured or are worn beyond manufacturer's specifications.
3. Fit number plate light – looks like there isn't one fitted at all?  
Not fitted.

### **VS1. 13.5 Rear Registration Plate (Number Plate) Lamp**

. Must be fitted.

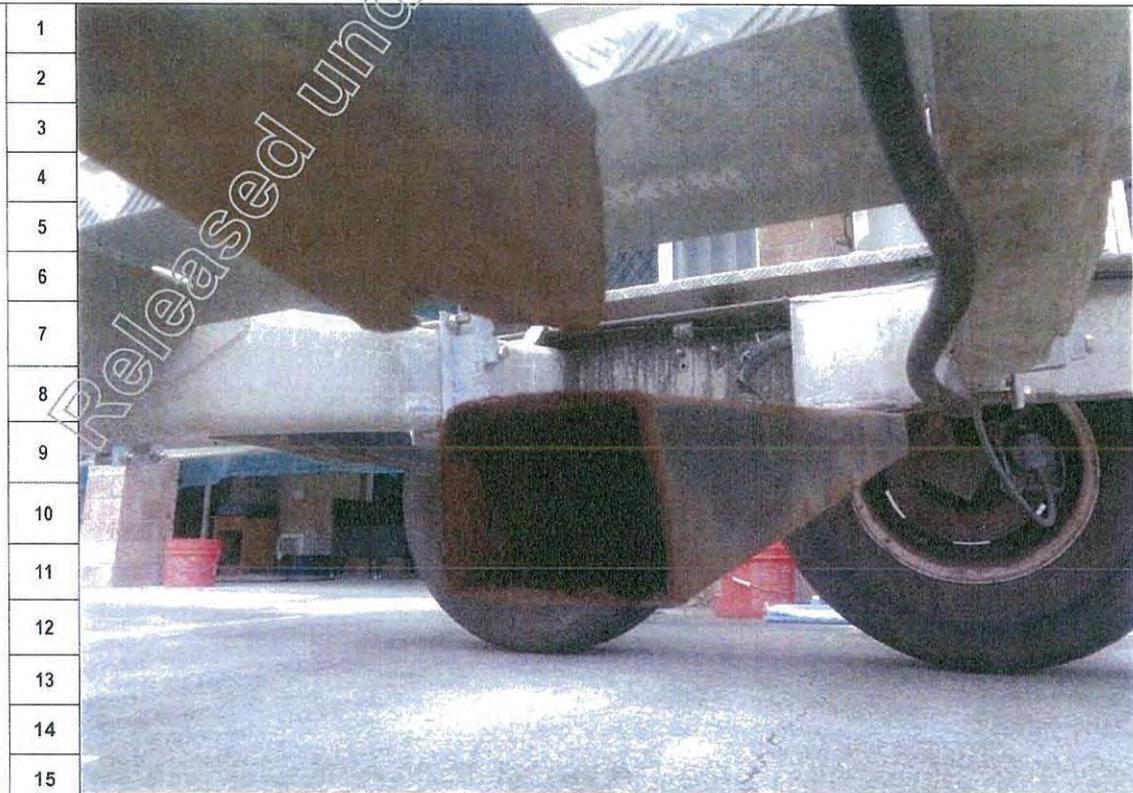
Photograph 4

Photo of broken 2<sup>nd</sup> axle. Looking from left side.

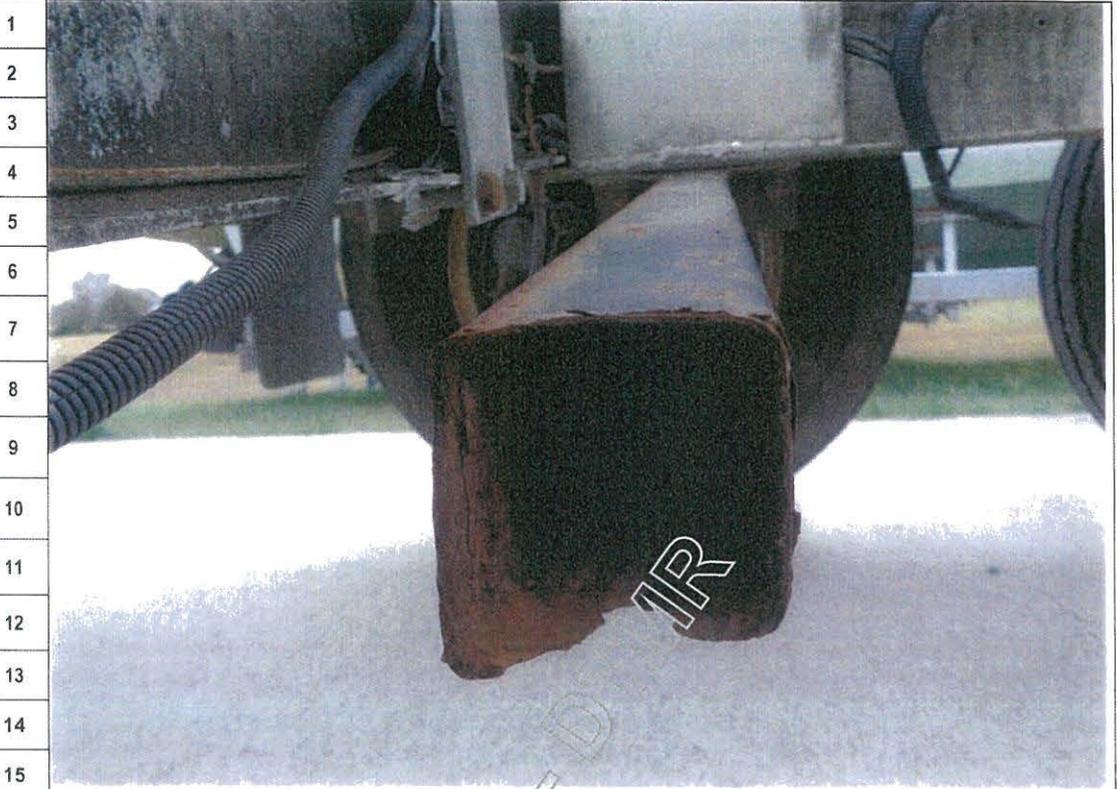
Photograph 5

Photo of broken 2nd axle. Looking from the right side. The water drain hole can just be made out at 12M.

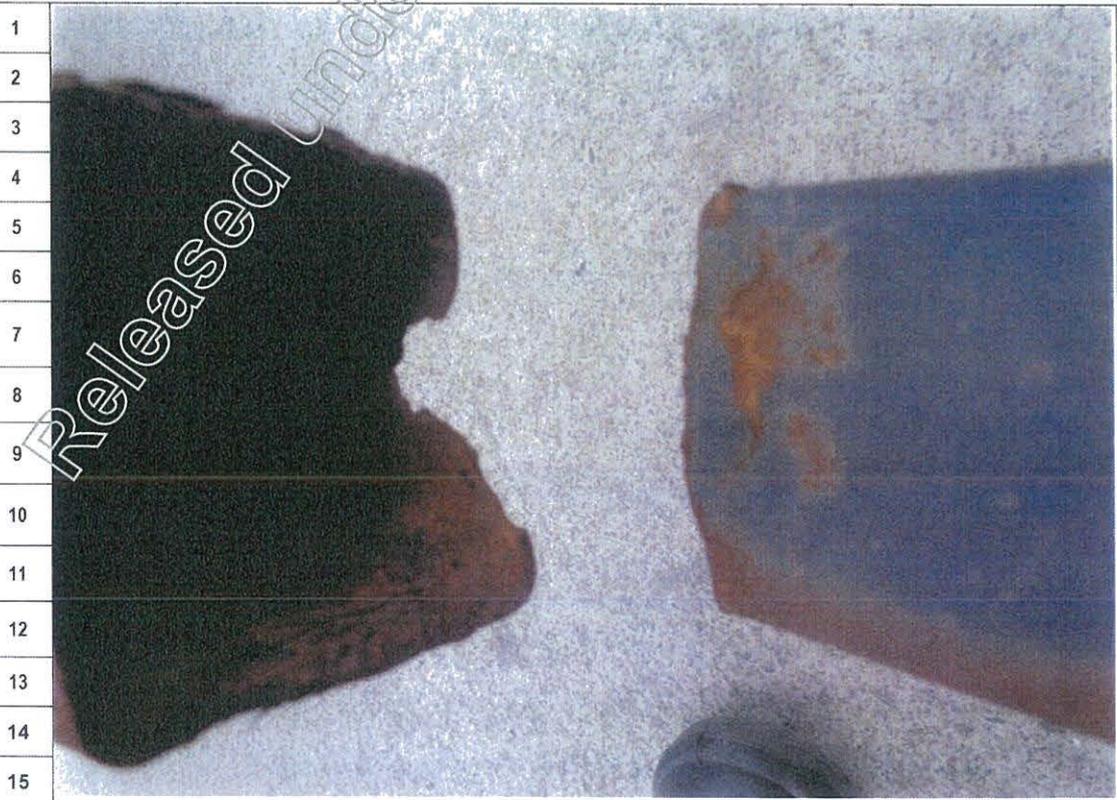
Photograph 6

Photo of 2nd axle. Looking from on top. The water drain hole can just be made out at 8H.

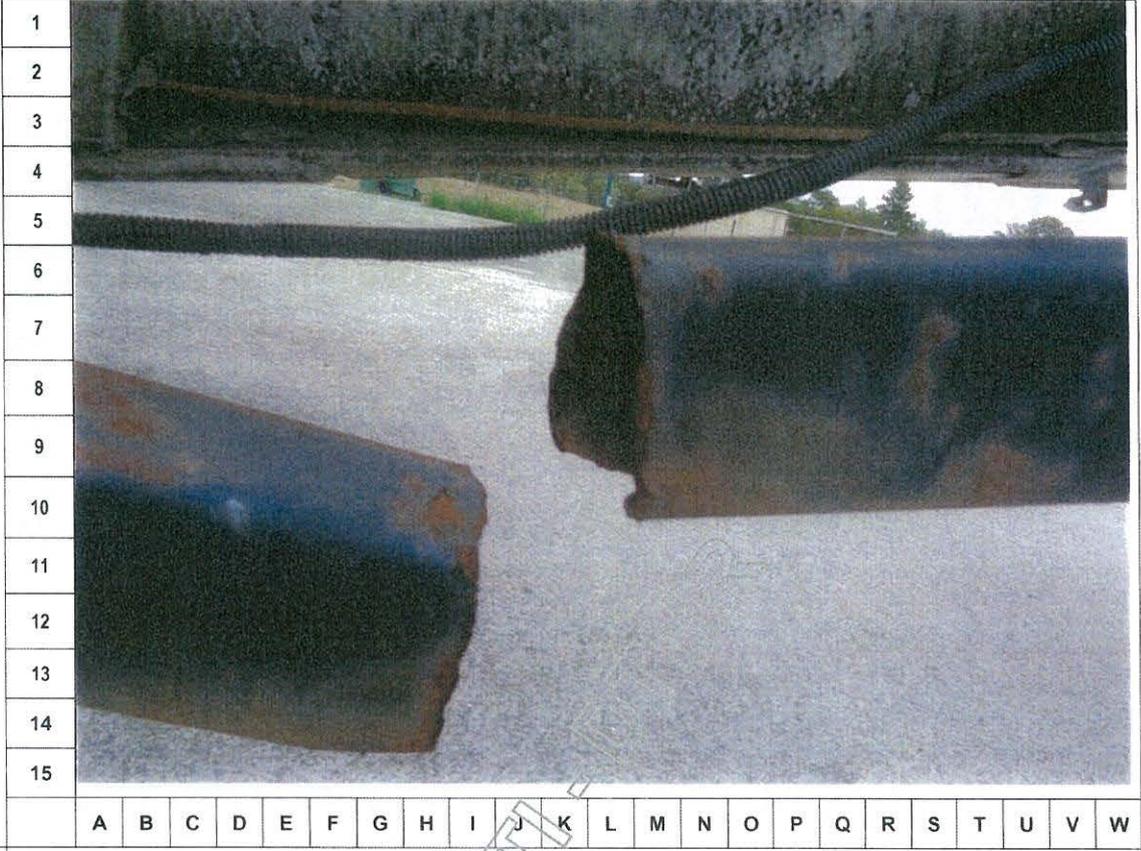
Photograph 7

Photo of broken 2<sup>nd</sup> axle. Looking from the front.

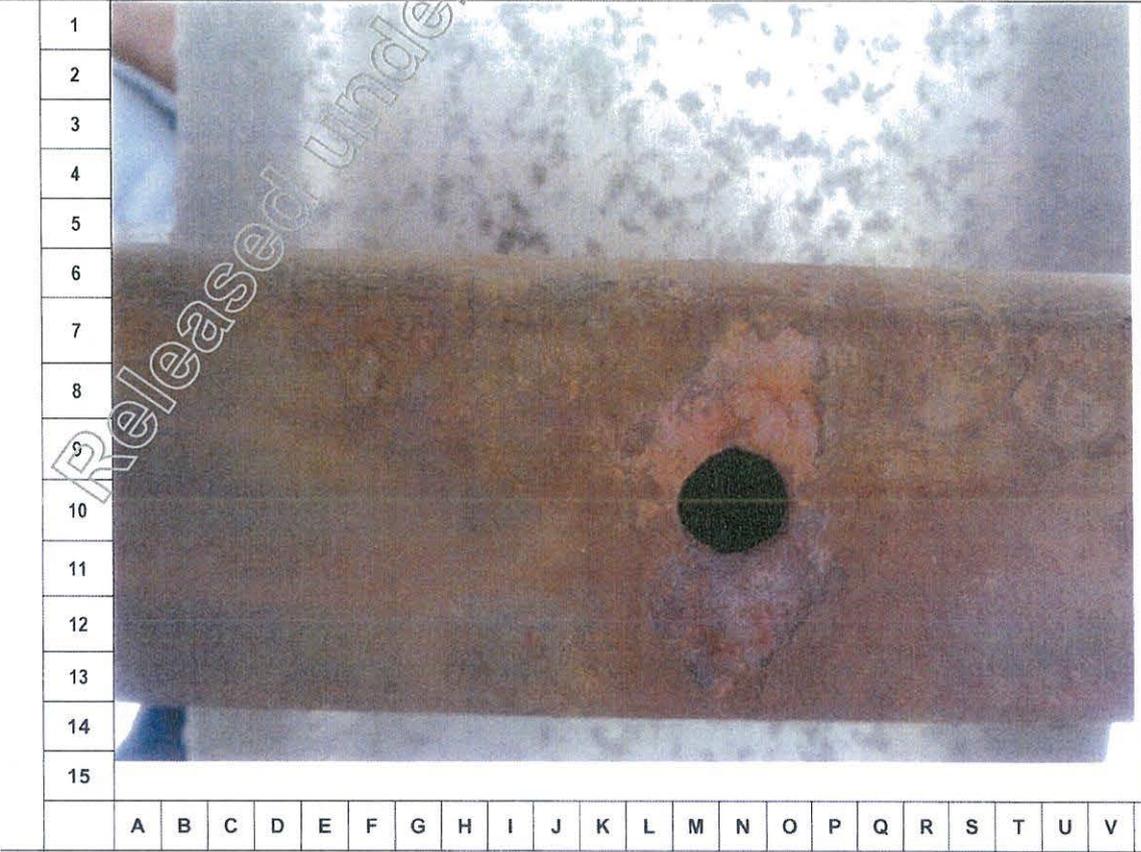
Photograph 8

Photo of 1st axle. Looking from the bottom. Scale rust can be seen at 10N around the water drain hole.

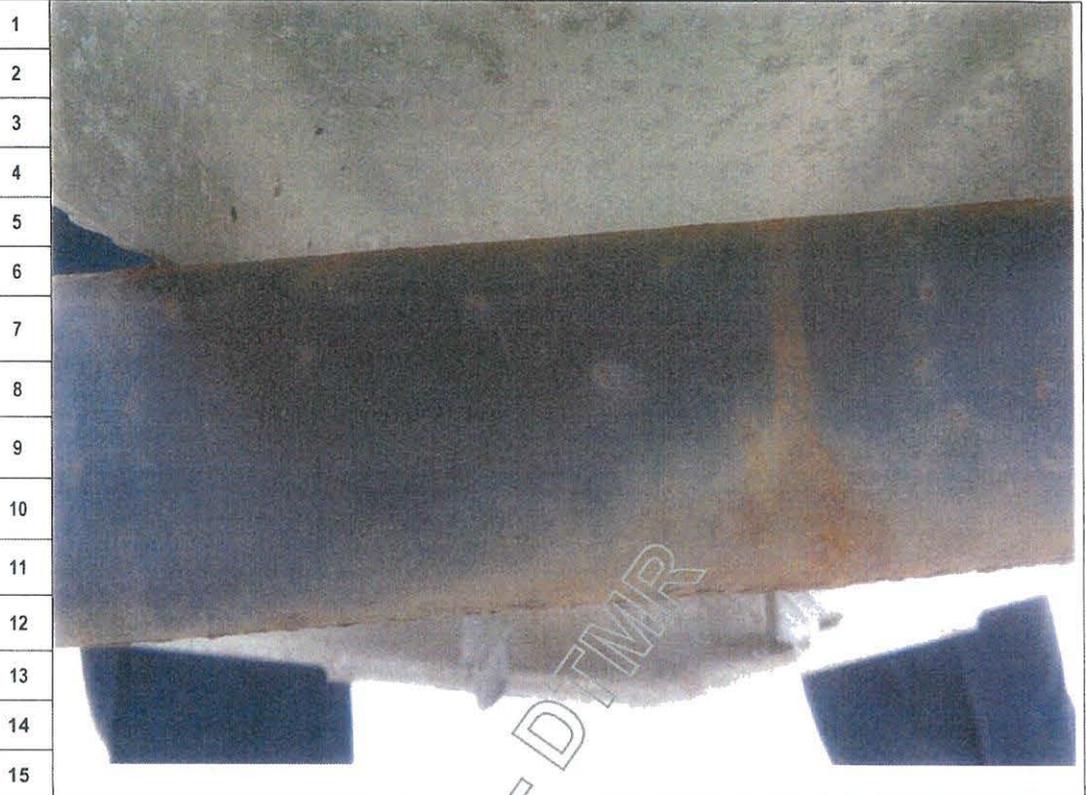
Photograph 9

Photo of 1st axle. Looking from the front. Scale rust can be seen at 11Q around water drain hole.

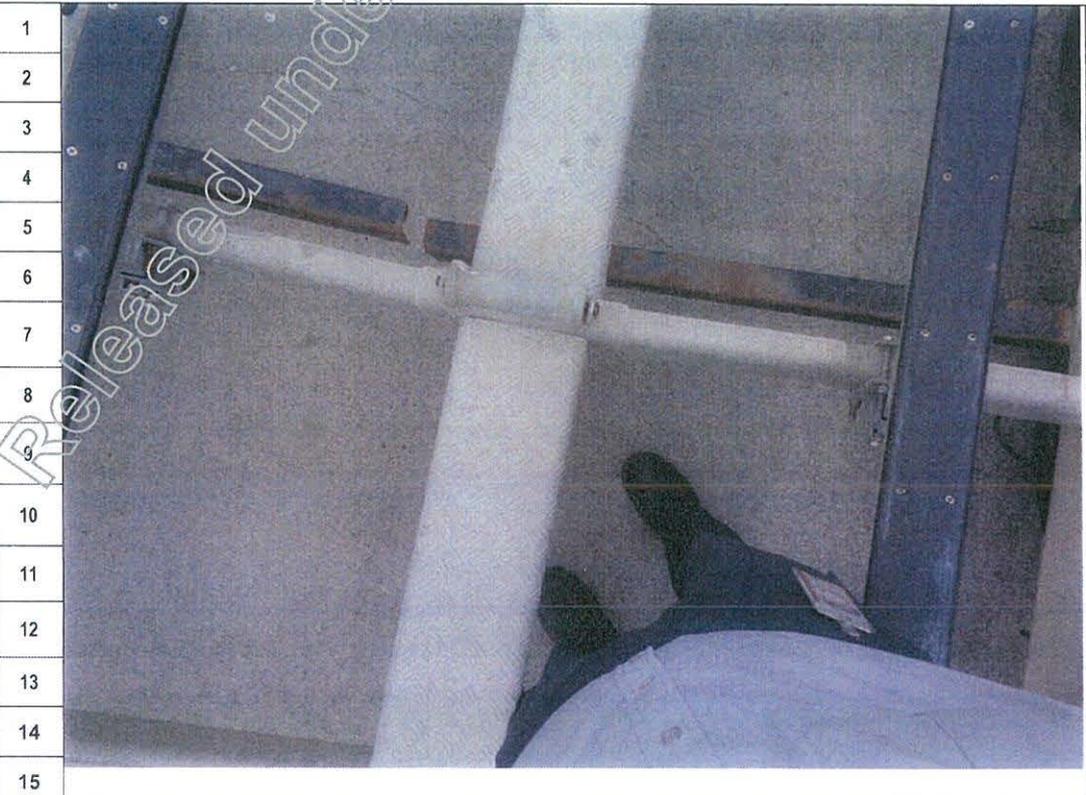
Photograph 10

Photo of 2nd axle. Looking from the top and the front of the trailer is at the top of the photo.

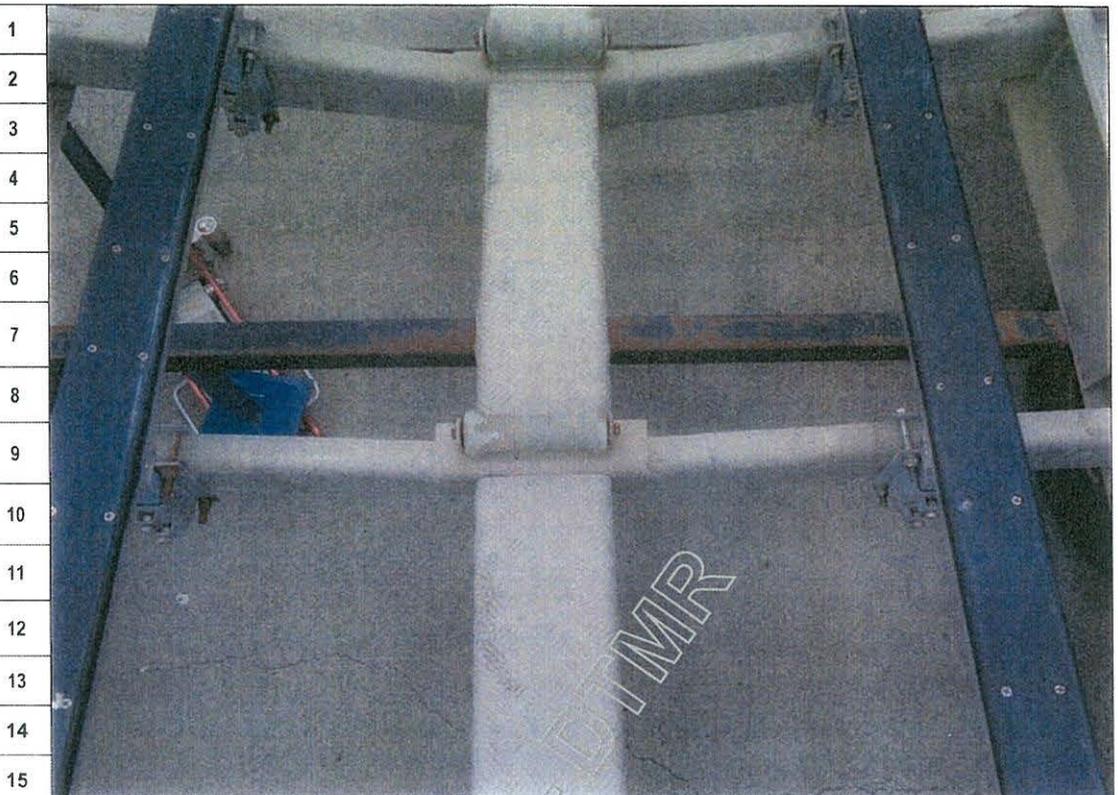
Photograph 11

Photo of 1st axle. Looking from the top and the front of the trailer is at the top of the photo.

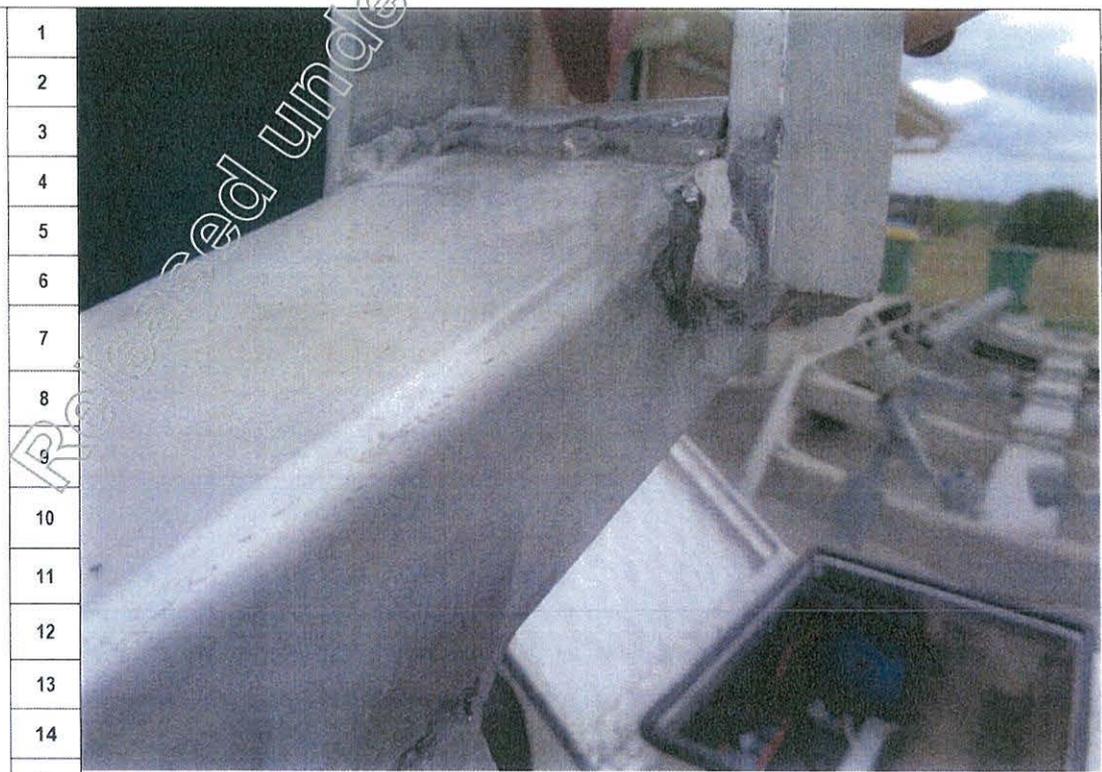
Photograph 12

Photo of broken weld at bow/ winch stop. Looking from left front.

Broken weld.

**COP. 4.2. Body, Chassis and Frame. A frame component is cracked, sagged, broken, distorted, missing or corroded to the point where a component is weakened or failure of a component is likely to occur.**

8. Repair broken weld at bow/winch stop – fairly easy to follow on the photos.

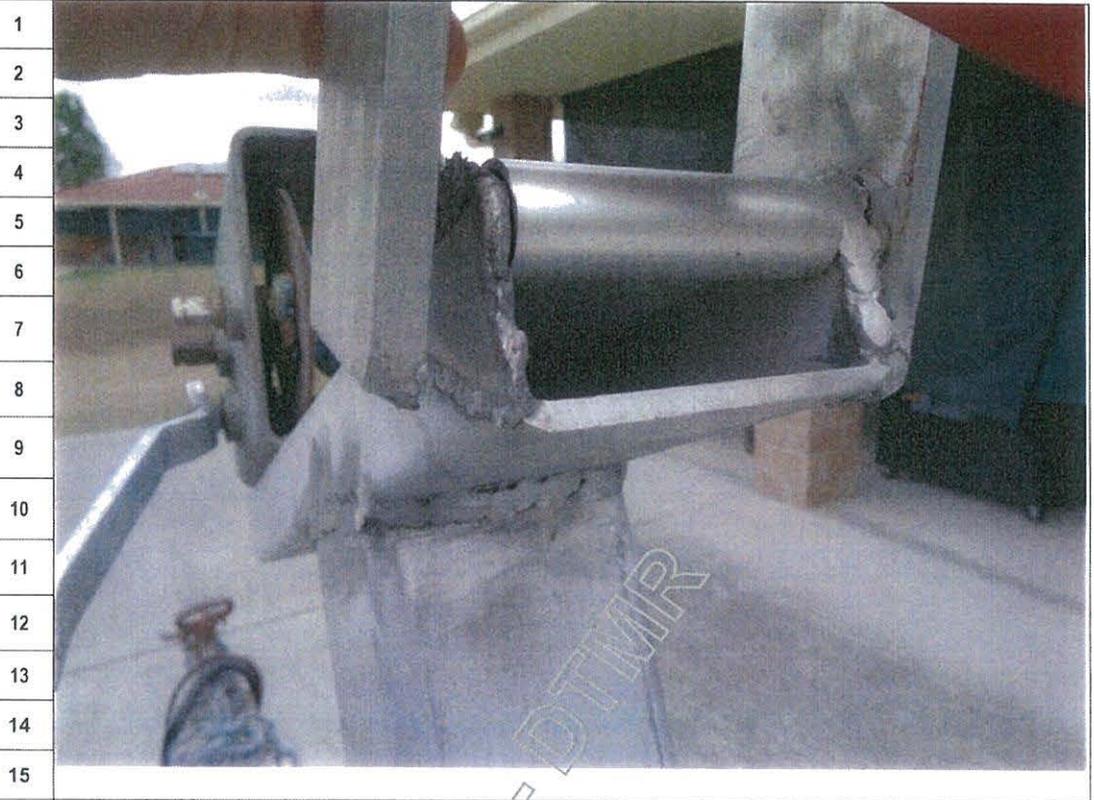
Photograph 13

Photo of broken weld at bow/ winch stop. Looking from left rear.

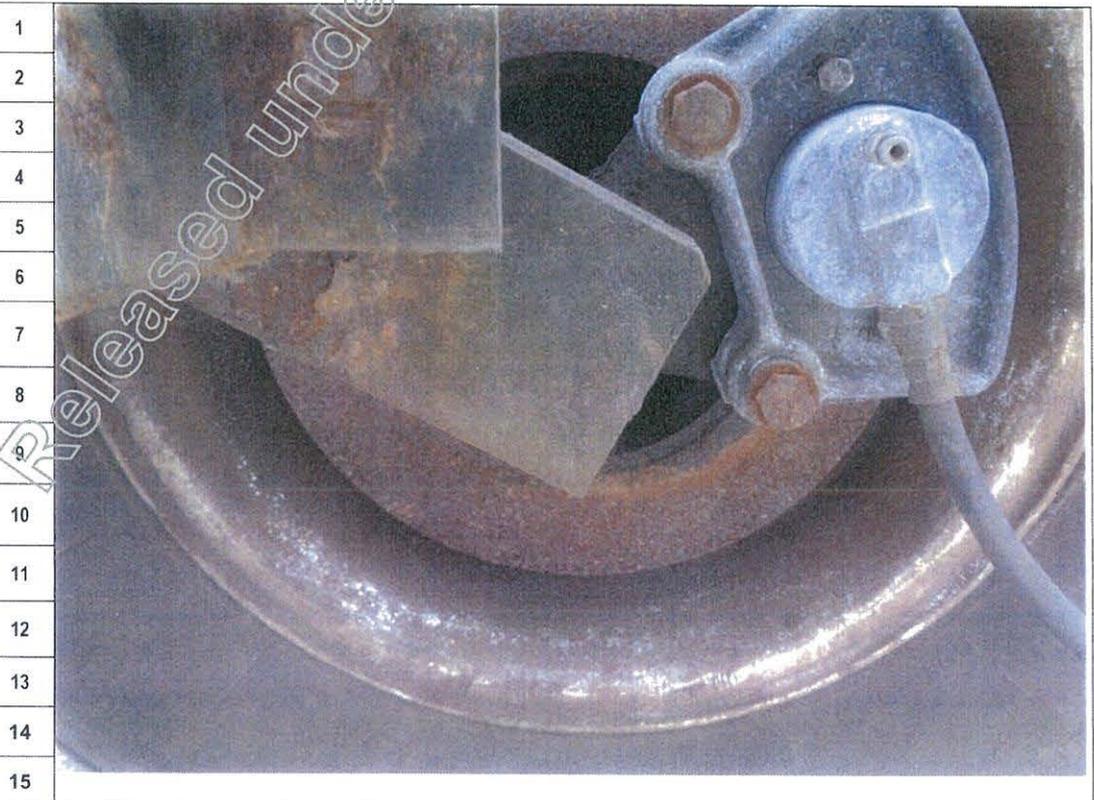
Photograph 14

Photo of rusty 1st axle right brake rotor. Looking from inside.

Brake rotors rusty because of brakes not operating. Check because might be under size and not cleanable/ machinable.

**COP. 8.1 Brake system. Any brake component is seized, severely corroded or inoperative or, where worn, is worn beyond manufacturer's limits.**

9. Check/clean rust from all brake rotors - fairly easy to follow on the photos but which wheel/brake is each of the photos looking at?

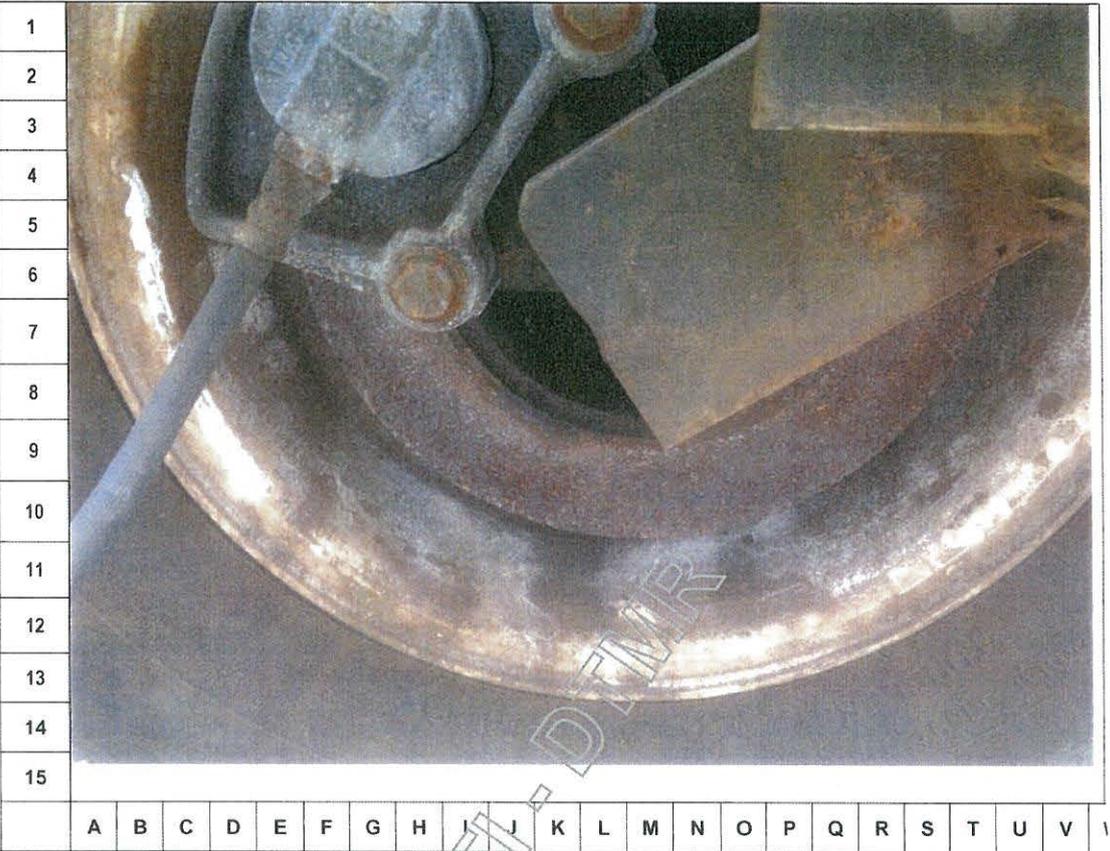
Photograph 15

Photo of rusty 1st axle left brake rotor. Looking from inside.

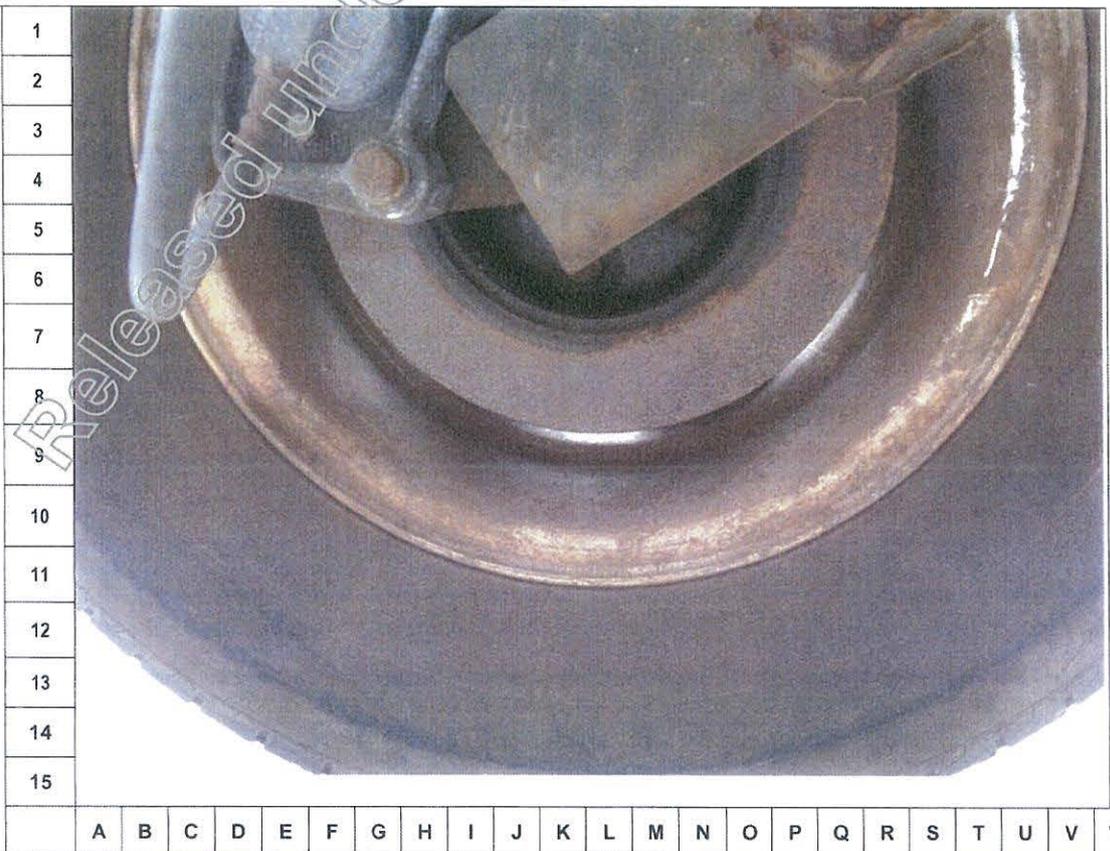
Photograph 16

Photo of rusty 2nd axle left brake rotor. Looking from inside.

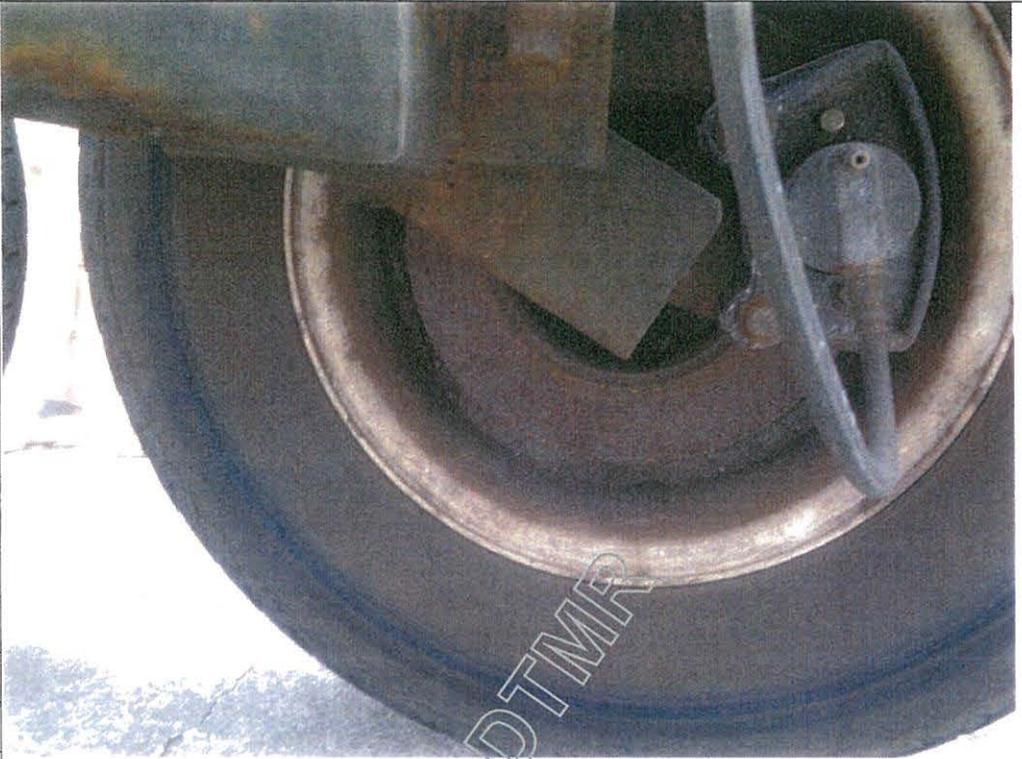
Photograph 17

Photo of rusty 2nd axle right brake rotor. Looking from inside.

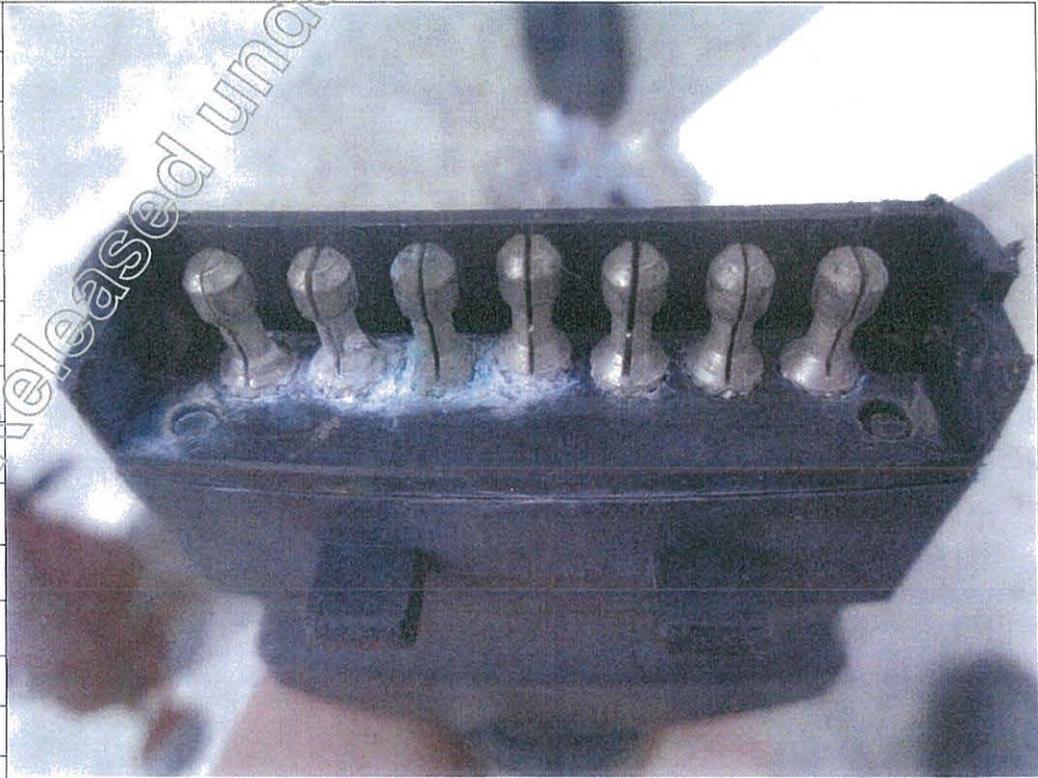
Photograph 18

Photo of corroded trailer wiring plug.
