Memorandum

Our ref MSC 1546 - 2020
Your ref
Date 30 January 2020

Subject Rockhampton Ski Gardens Incident 1 January 2020

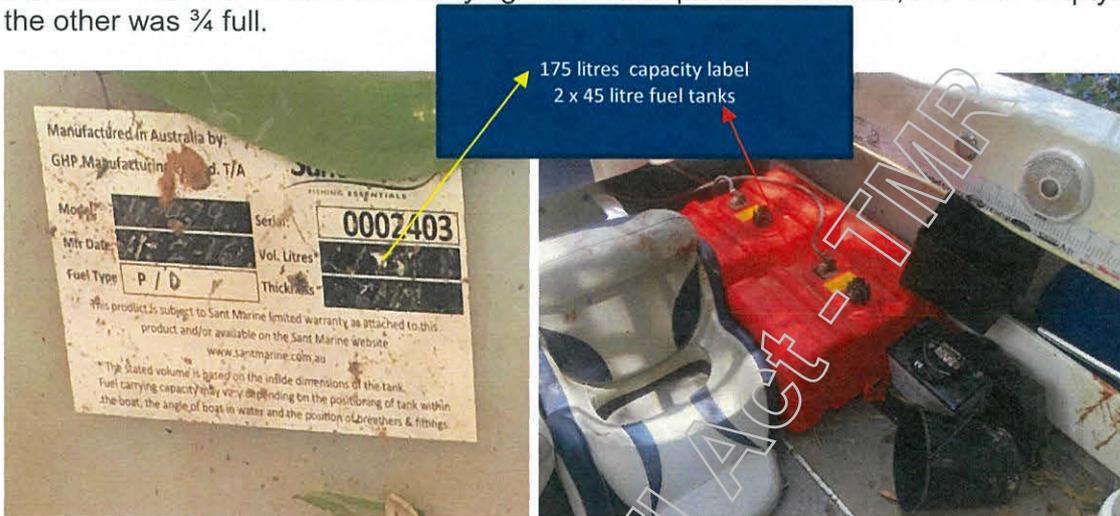
It is believed that both the plastic fuel containers were sitting either side of the vessel at impact, not as seen in this photograph. Officers have been advised that the vessel is used for reef fishing on occasions and the two extra tanks stay on board the vessel.

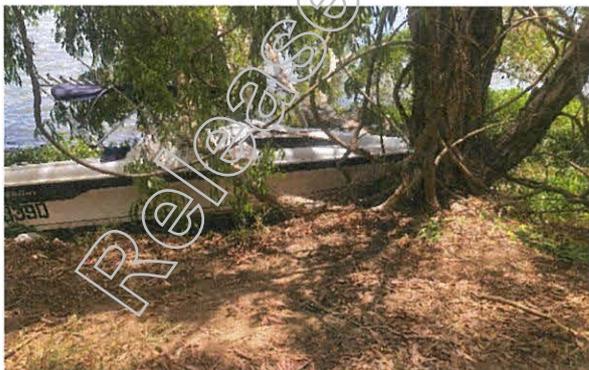
The vessel has sustained substantial damage both to the bow and the interior of the vessel. The force of the vessel hitting the tree trunk has forced all persons to move forward, breaking both passenger seats off their mounts, the steering wheel has been buckled under the weight of A tree limb has bent back the bimini and broken the perspex windscreen with large shards of perspex found up to 12 meters away from the bow of the vessel.

Vessel insitue after incident

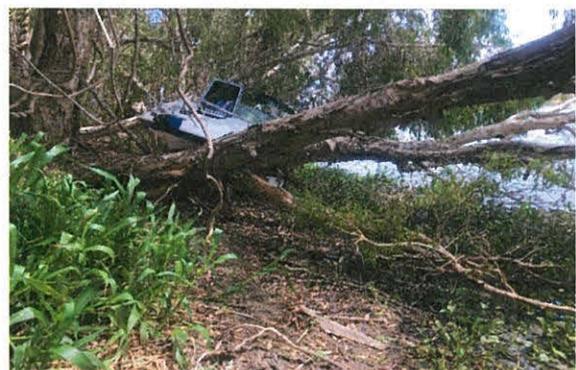
Front on view of vessel

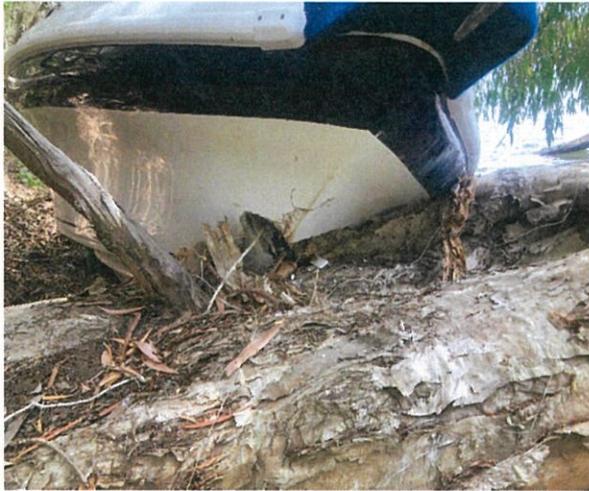
Vessels bow resting on tree trunk

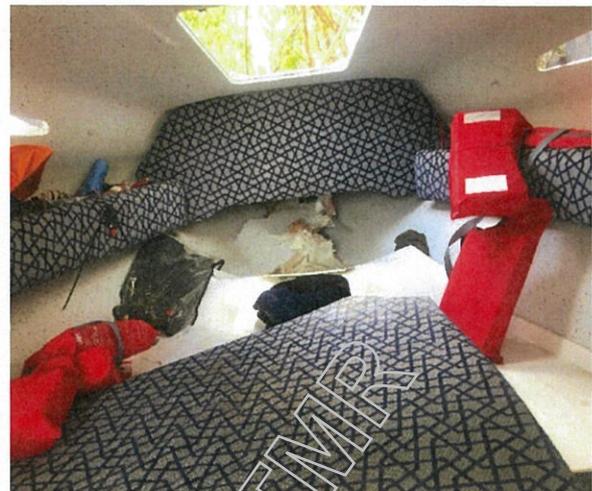
View to inside of cabin

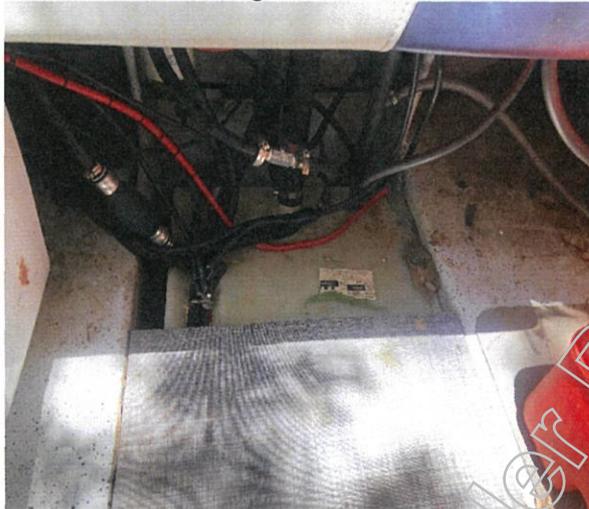
Underfloor fuel tank

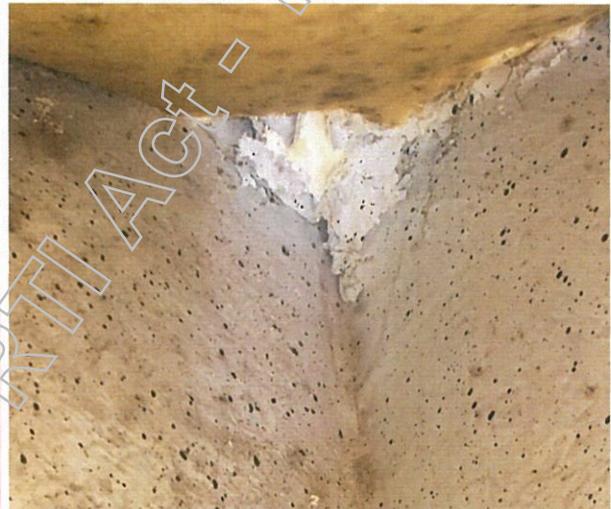
Hole in bow below water line

5. There was extensive damage to the bow of the boat. The damage was a squared off hole to what I expect from being hit or hitting a solid object. The damage was back to the collision bulkhead and had been covered by a piece of vinyl and wooden blocks screwed to the hull, I expect this was to keep the hull from taking water. The dash has been cracked almost off and the windscreen on the drivers side has been smashed. The batteries have come loose from their mounting point and most of the wiring and switch panels have been ripped out.

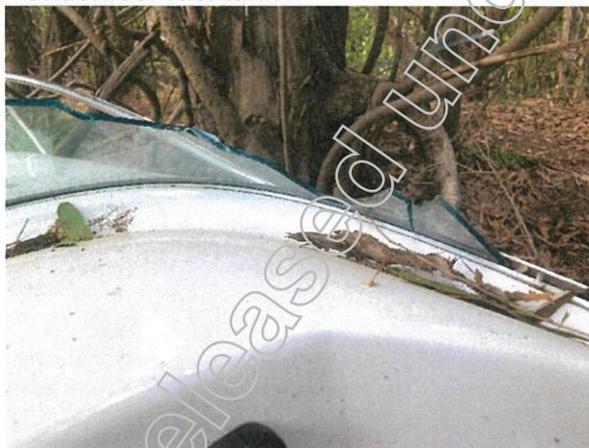
Damage to Perspex

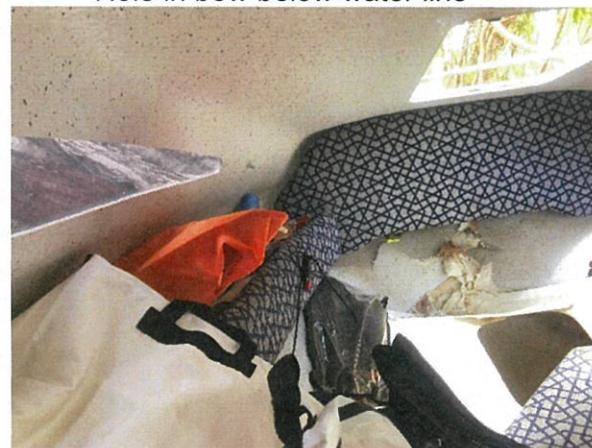
View of bow from inside of cabin

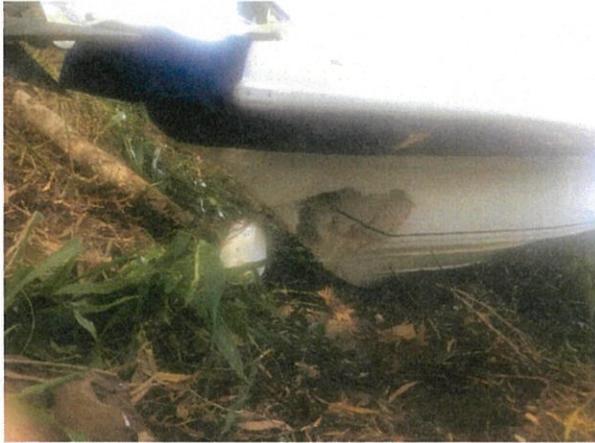
Bow after being removed from tree

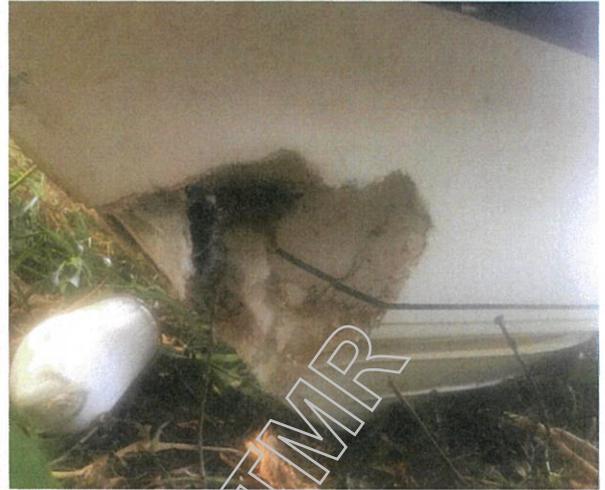
Close up of hole in the bow

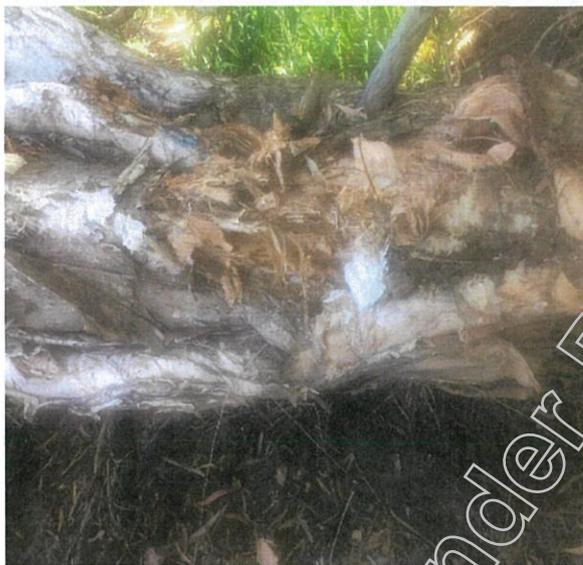
Tree trunk vessel has hit

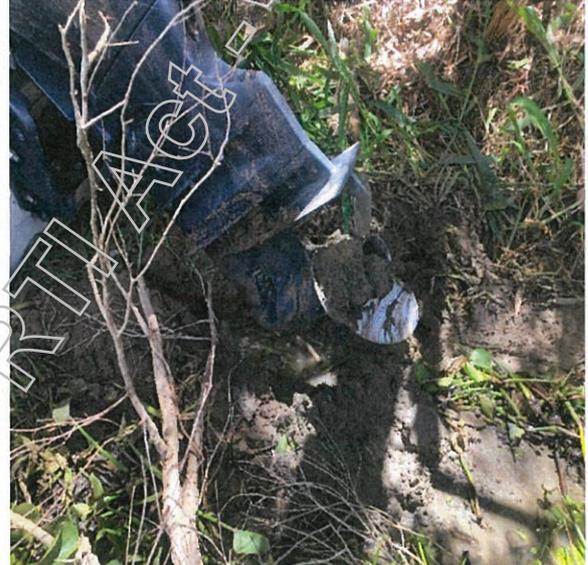
Engine after being trimmed out of mud

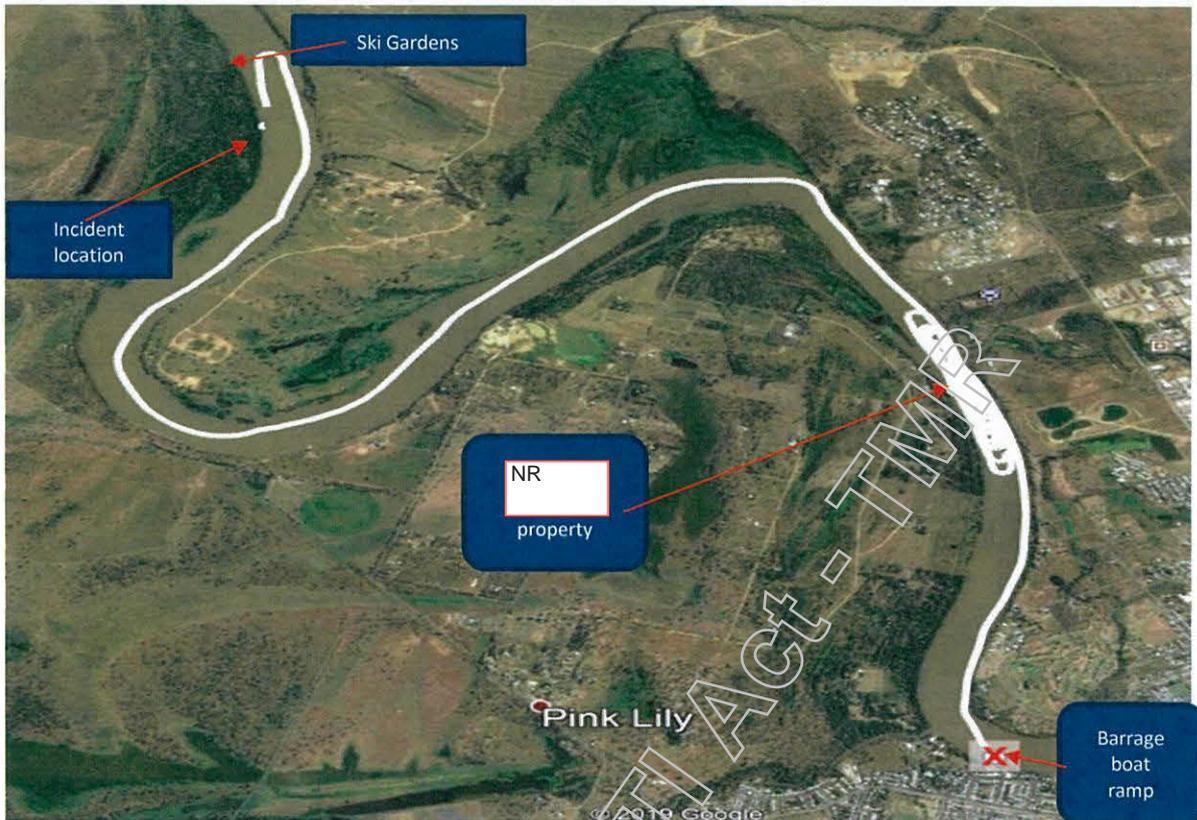
The above image is the actual course taken by the vessel during the afternoon

The white line is the track the vessel took beginning at the barrage boat ramp, heading north west along the Fitzroy River. The area showing the wider white shading is where the vessel has been used by Maguire to tow tubes behind the vessel. The top left of the image shows where the vessel has turned to continue south west along the river back towards the barrage boat ramp. The break between the white lines when the vessel turned, is where the GPS has been turned off, or malfunctioned. The white spot shown where the incident site is, is where MSQ officers turned the GPS unit on, when they attended the site on 2 January 2020. The malfunctioning of the GPS unit will be discussed by [redacted] electronic technician, later in this memo.

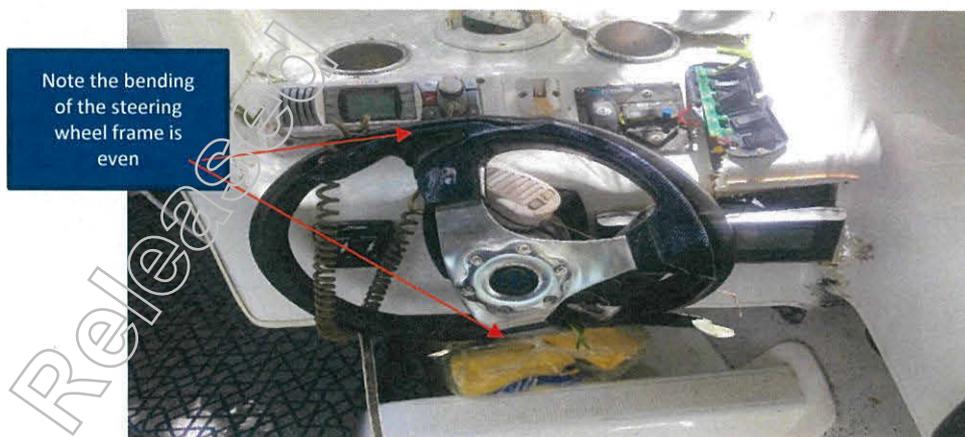
With the forces encountered as the vessel has hit the bank [redacted] could easily think the steering wheel was ripped from his hands. The steering wheel has been bent in such a way, the damage suggests that [redacted] has had hold of the steering wheel with both hands at the time of impact.

[redacted] has stated he hit something that has forced the steering wheel from his hands. The evidence suggests that [redacted] has had both hands on the steering wheel at the time of the incident. The steering wheel damage indicates that [redacted] would have had both hands on the steering wheel at the time. Investigations suggest that the reason [redacted] felt the steering wheel being ripped from his hands was because the vessel had hit the bank and the engine could not be turned as it was pressed against the bank at the time of the incident.

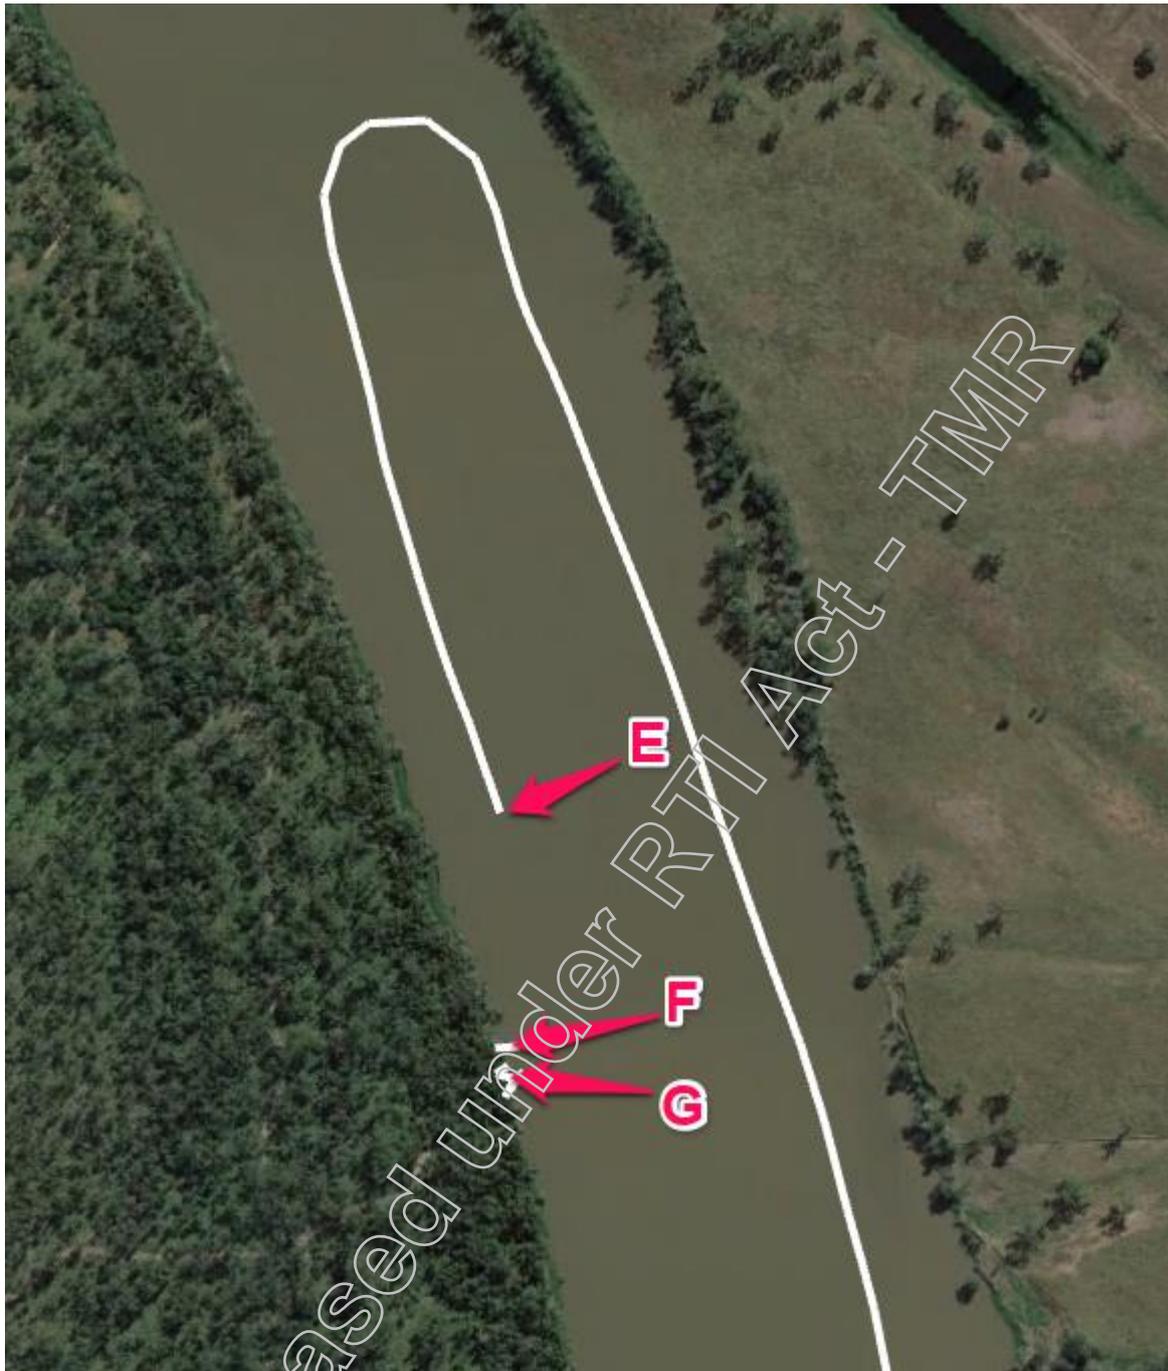
The Garmin GPS unit has recorded the day's travels on the water, however, did not record the last 200 meters of the vessel tracks before the incident occurred. It is unknown why the unit has not captured the last 200 meters of the vessels journey. However, the unit recorded the moment officers switched the unit on, when they attended the scene on 2 January 2020.

Diagram 10 shows the vessel travelling upriver then turning around and proceeding downriver. At Point E the recording stops and there is no further data for 1/1/2020. The time at Point E is 16:23:45 and the position is S23 18.769 E150 26.995.
