Bridge Information System
Structure Level Report

Structures Management Plan SMP1

Structure Id 7799	Name Barron River
Crossing Name 	Alt. Name Post #255
Structure Type Bridge	Owner Transport and main Roads
Construction Type Girder/Beam	District 403 Far North
Construction Material Steel	LGA Id

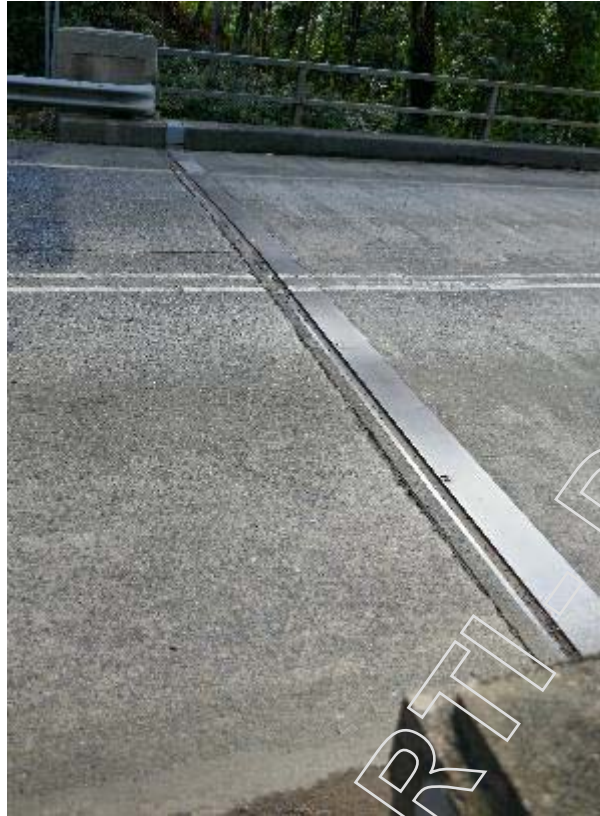
Figure 10 Barron River Bridge: Abutment deck plates are noisy and difficult to maintain (Kuranda abutment 28 May 2018)

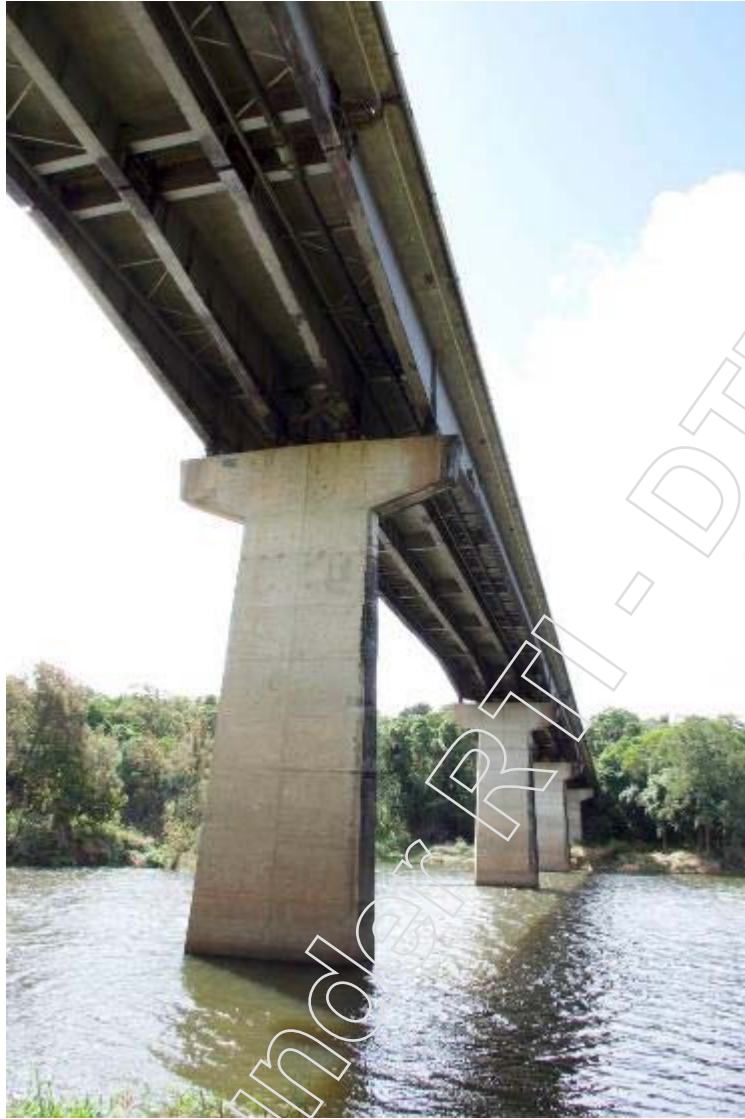
Component	Inspection outcomes	Comments from visual inspection 28/5/2018
Girders	Concern that the protective coatings are beginning to fail – especially near joints (refer Figure 12 and Figure 13). Applies both to girders and post-tensioning bars applied to the bottom flanges. Recommended an options analysis re protective coating	Agree Macalloy bars vibrating against girder stiffeners and brackets causing notches in bars in the Kuranda end span (refer Figure 14) Pitting corrosion observed in Macalloy bars and bottom flange in Kuranda end span.
Bearings	Severe corrosion to bolts restraining bearings – in some locations the nuts and bolts missing to levels below plates (refer Figure 16 and Figure 17) Pitting to base, rocker and sole plates Water from joints increasing the rate of corrosion (refer Figure 12 and Figure 13). Concerns about over rotation of bearings leading to extended road closures / severe damage / collapse (Figure 17).	Agree Red iron oxide deposits evident at Kuranda abutment consistent with fretting of movement joint between the rocker and sole plate (refer Figure 11). Possible wear evident in other bearings (refer Figure 17).

Figure 12 Barron River Bridge. Note: Fabricated steel girders, cross-girders, drop-in span joints, services, rail for inspection gantry, piers (26 May 2018)

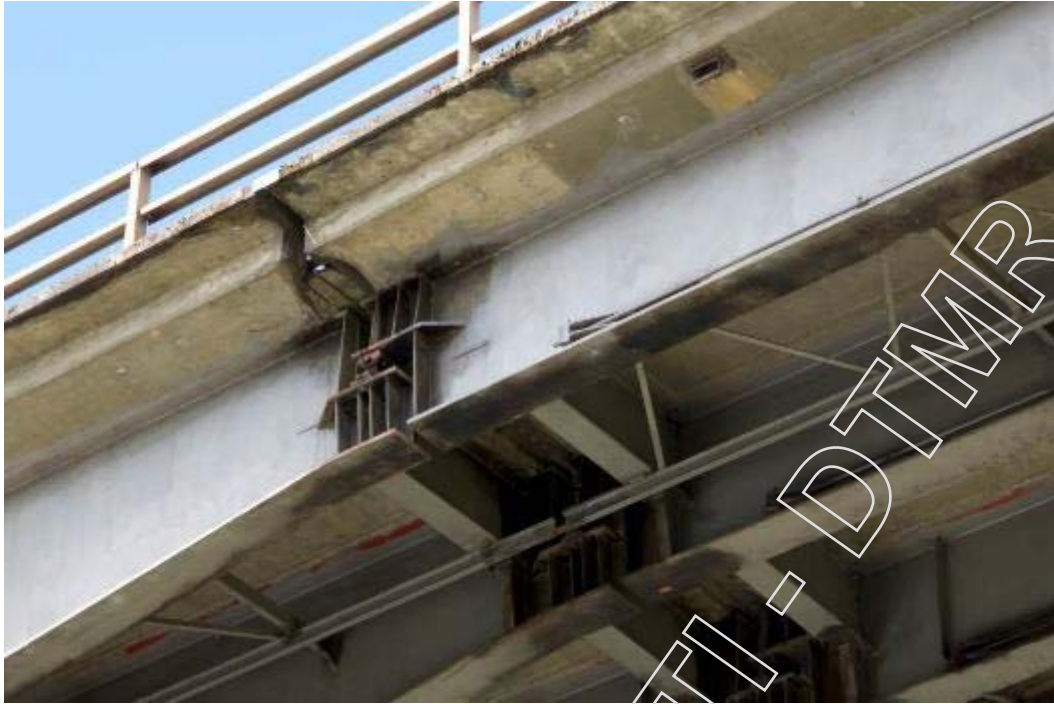
Figure 13 Barron River Bridge at an expansion joint of the drop-in span. Note halving-joint, rocker bearings, opportunity for water to penetrate the deck at joint, discolouration from coating holding coat (26 May 2018)

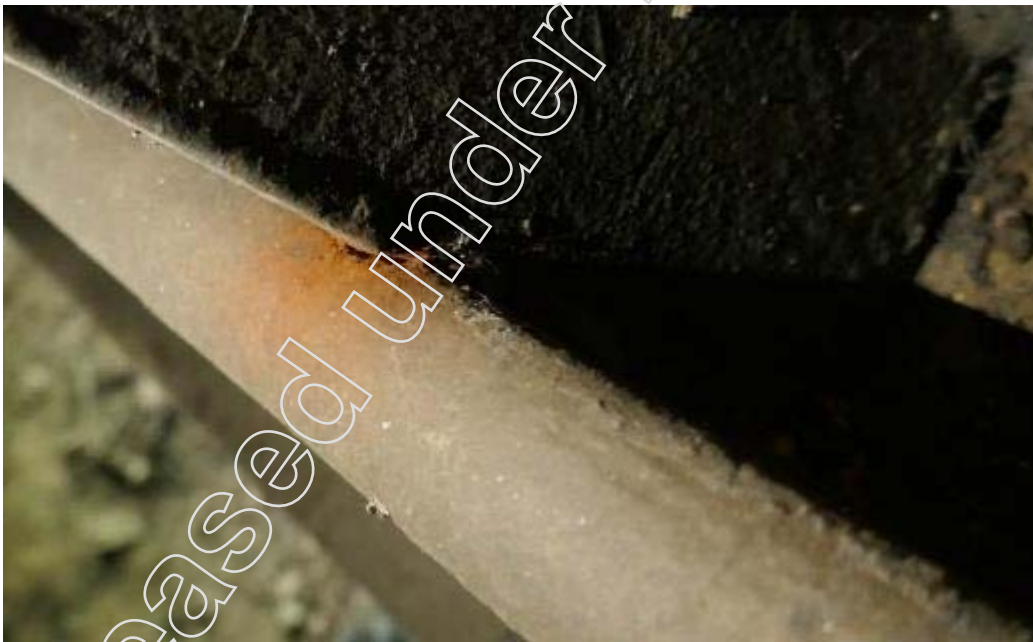
Figure 14 Barron River Bridge: Wear in Macalloy bars vibrating against stiffeners (Kuranda end span, 28 May 2018)

The pitting corrosion of the Macalloy bars and the notches induced by wear of the Macalloy bars due to vibration are of particular concern because of the high levels of stress (620 MPa) in the Macalloy bars may lead to stress corrosion cracking in these bars and an increased risk of sudden failure of the bars. A plan is required for the corrosion protection of the steelwork and corrosion / abrasion of the Macalloy bars. One option is to replace the Macalloy bars.

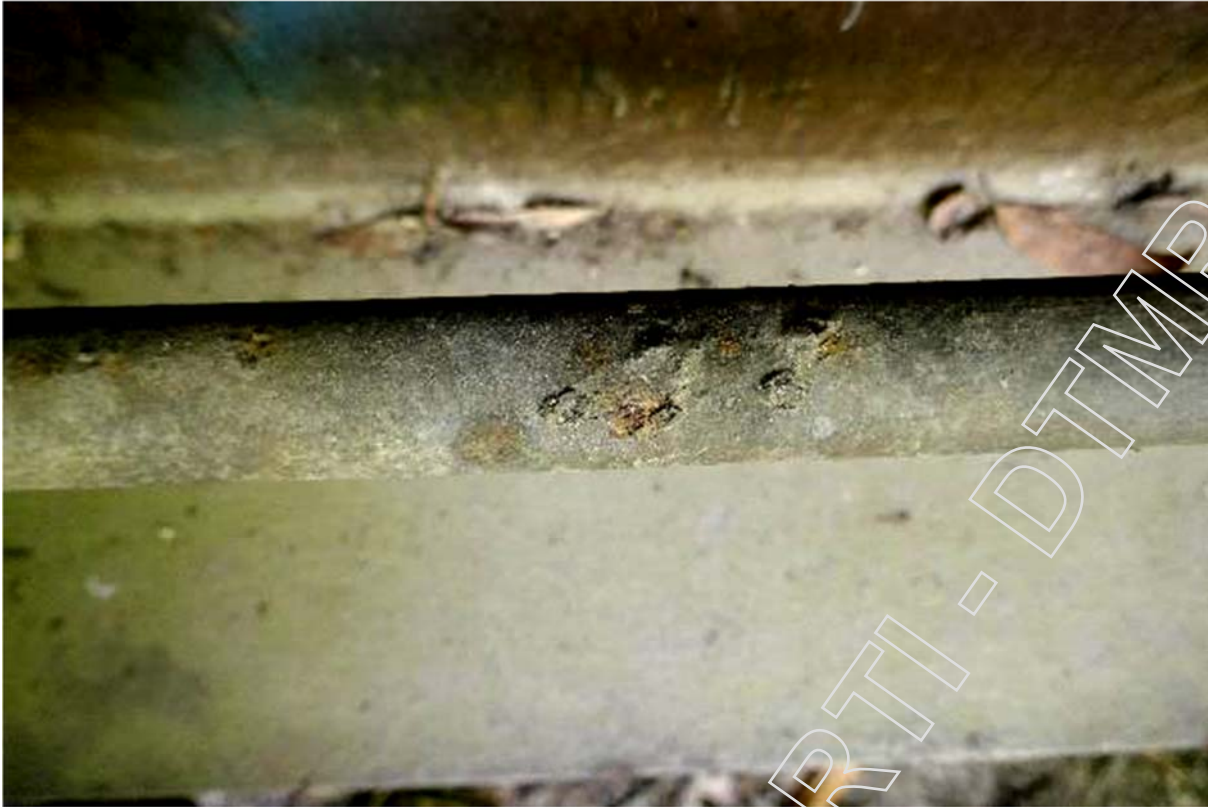
Figure 15 Barron River Bridge: Pitting corrosion in Macalloy bar (Kuranda end span, 28 May 2018)

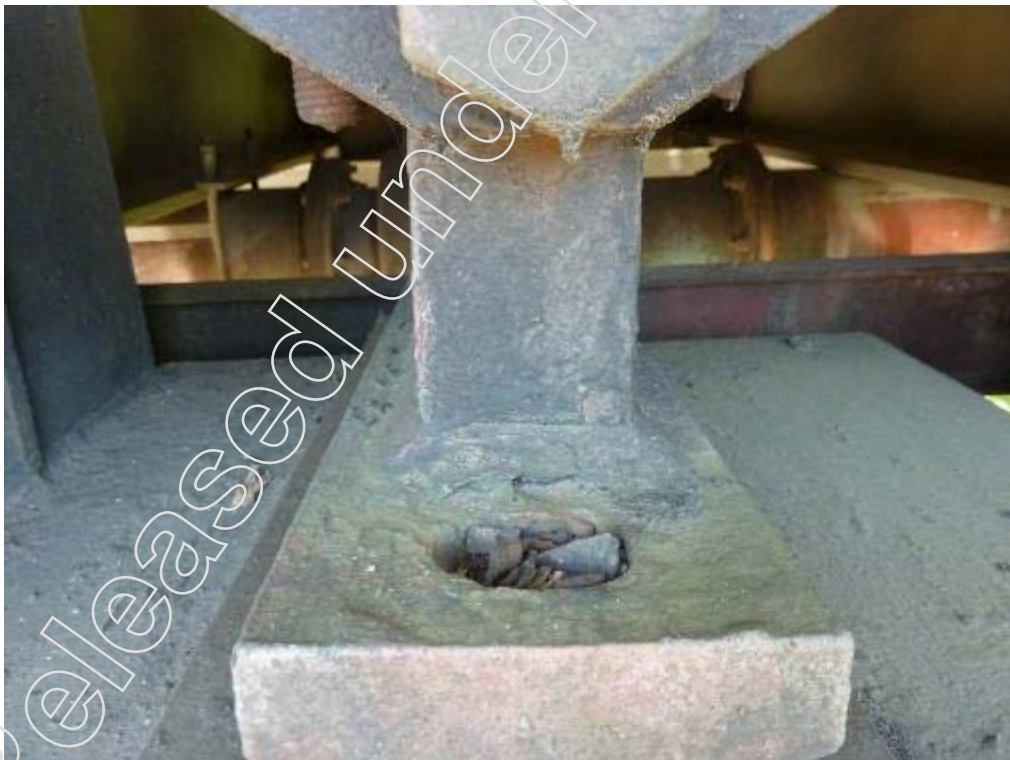
Figure 16 Barron River Bridge: Rocker bearing at a drop-in span expansion joint. Note: Missing nut and bolt to rocker bearing and possible residue 'flakes' from bolt and nut (image supplied by TMR Cairns)

Some of the nuts and parts of the bolts that restrain the rocker bearings have deteriorated severely with some portions missing altogether. Corrosion is a likely cause, but this may have been exacerbated by rotations of the rocker eccentrically loading / stressing the bearing restraint bolts and nuts (refer Figure 21). This raises concerns about the restraint of the bearings. Short-term risk interventions are recommended to manage the associated risks.

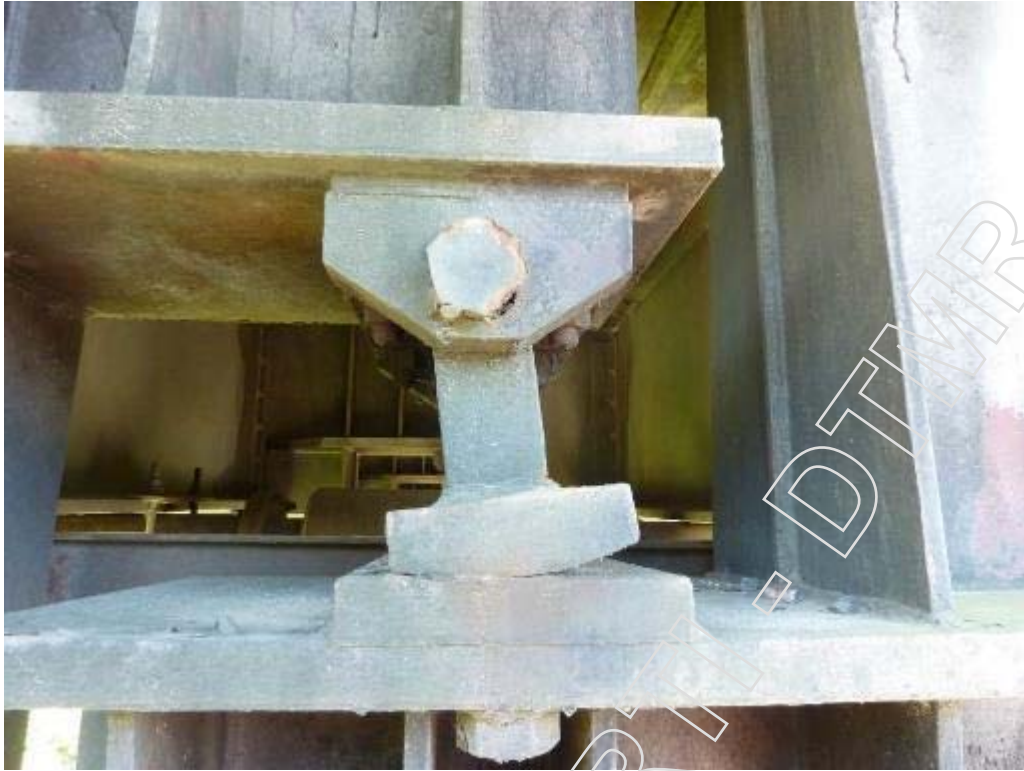
Figure 17 Barron River Bridge: Rocker bearing at a drop-in span expansion joint. Note: Inclination of rocker; missing nut and top half of bolt through rocker although head of the bolt is still in position, partial loss of head to bolt at the top of the rocker, the visible gap between the shank of the bolt and the restraining bracket (image supplied by TMR Cairns).

The fretting corrosion evident at Kuranda abutment rocker bearings suggests the bearings may be suffering significant wear with the rockers 'eating into' the sole plate or vice versa¹¹. There is also some suggestion that the rocker may be wearing into the base plate at some locations. For example, Figure 18 (Figure 14 of Barron River Defect Options Report #1 (Appendix C)) suggests a possible wear depression in the base plate. The Defect Options Report #1 also summarises the measurements between the base plate and the edge of the curved rocker surface (e.g., Figure 17 of Appendix C). A comparison of these field measurements with the

¹¹ One interpretation of Figure 17 is that the bolt through the sole plate to the rocker is closer to the top of the sole plate than shown on the drawings and this is a consequence of wear.

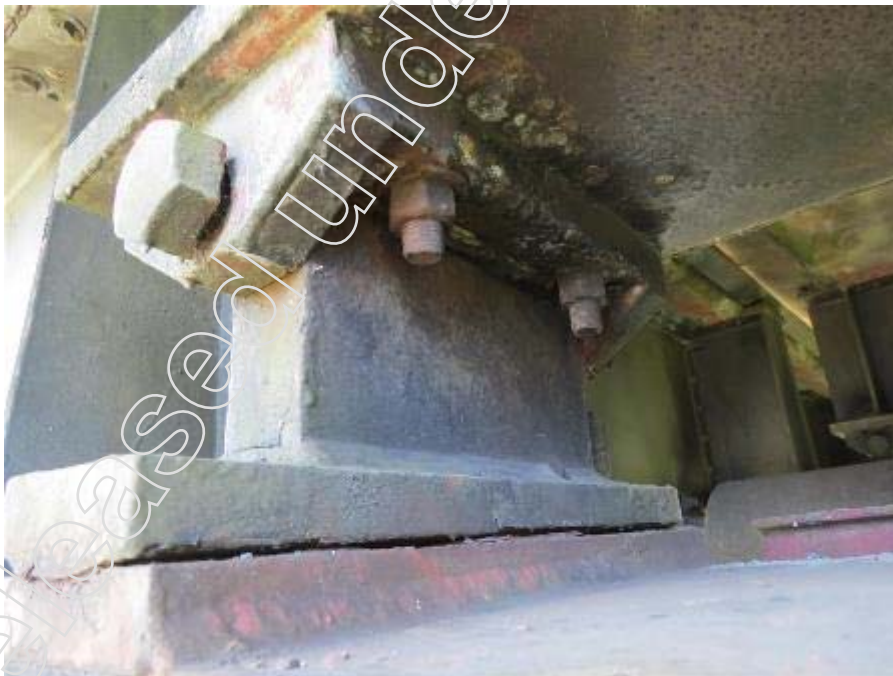
Figure 18 Barron River Bridge: Span 2 expansion rocker bearing at Pier 3. Note 'depression' in left end of base plate where it contacts the rocker (Figure 14 from Defect Repair Options Report #1, 20 May 2017)

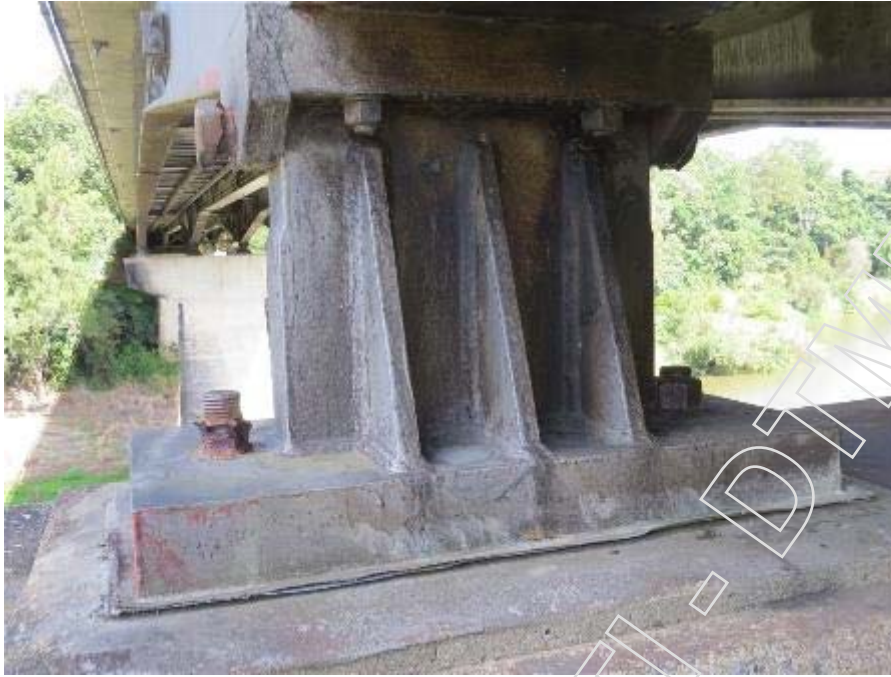
Figure 19 Barron River Bridge: Fixed bearing at Pier 3. Note stiffeners, two bolts, corroded nut (Figure 7 from Defect Repair Options Report #1, 20 May 2017)

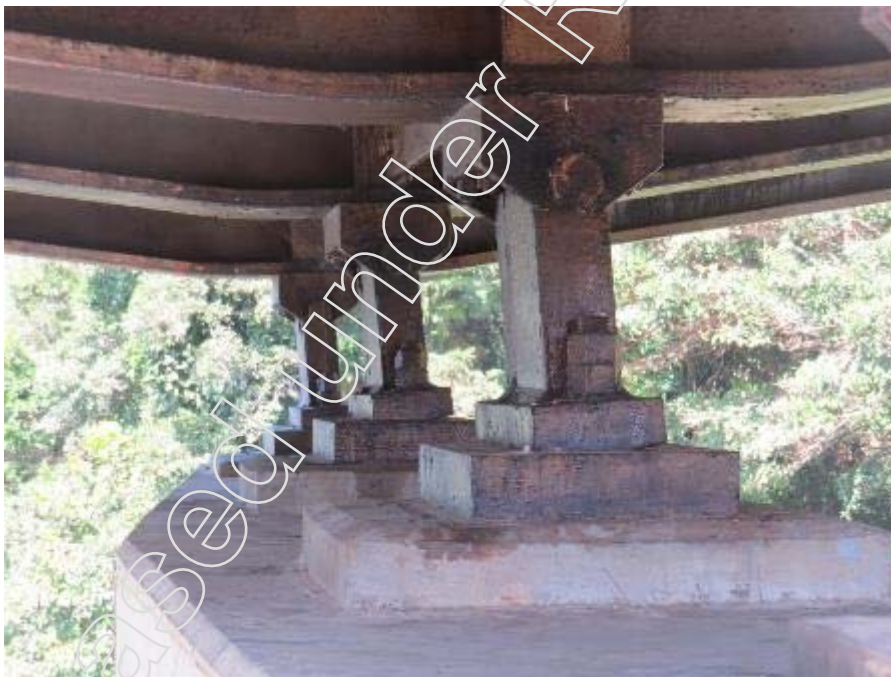
Figure 20 Barron River Bridge: Expansion rocker bearing at Pier 4. Note improved condition away from the deck joints and the unstiffened 'kinks' in the bottom flange of the girders (Figure 22 from Defect Repair Options Report #1, 20 May 2017)

Water penetrating the deck joints has exacerbated the deterioration in the vicinity of the joints, especially around the steel rocker expansion bearings. Away from the leaking deck joints, the rocker bearings are in much better condition. Improving the waterproofing of the deck joints will improve the life / reduce the maintenance costs associated with the bearings and the structural steelwork.

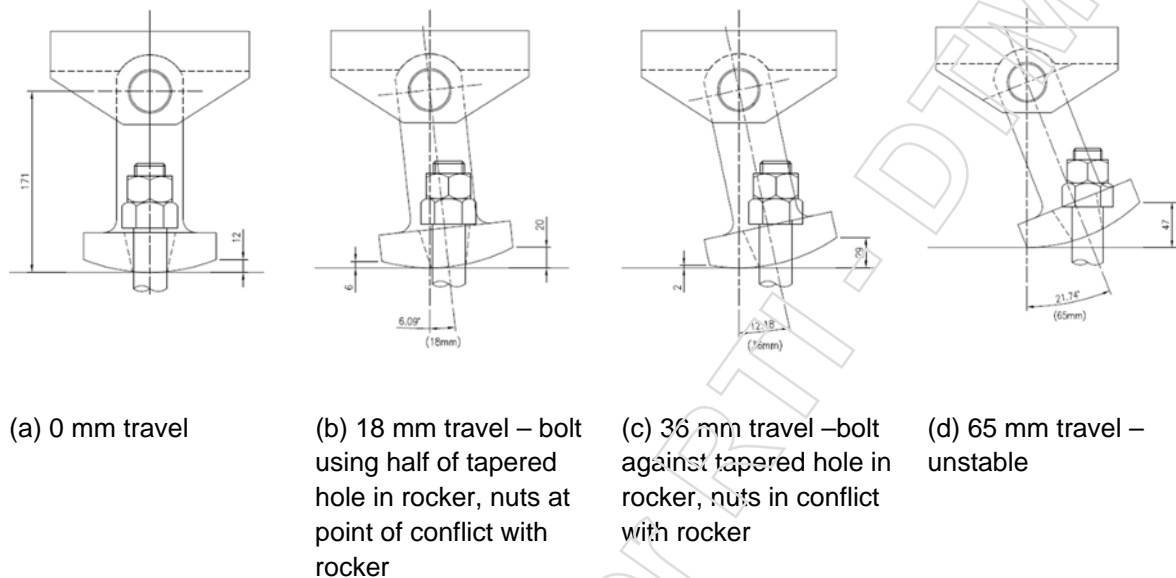
- Either there is a build-up of paint and debris on the base plate or there is some wear of the rocker / base plate interface, or a combination.
- The rotations at the time of the measurement were moderate (approximately equivalent to Figure 21 (b)) and potentially enough to load the bolts.

Figure 21 Barron River Bridge: Drop-in span expansion rocker bearing schematic for various relative travel.

Rocker bearings that exceed their travel have the potential to cause significant disruption as the bridge may drop significantly with the resulting dynamics potentially overloading / damaging / collapsing the bridge. The movement studies undertaken to date have focused on the movements due to thermal effects. However, there will also be substantial movements due to traffic loads / crowd loadings (e.g. a fun run starting from the bridge...) due to the haunched girders and the articulation. An audit of the circumstances required for the bearings to exceed their travel should be part of the management plan for this bridge.

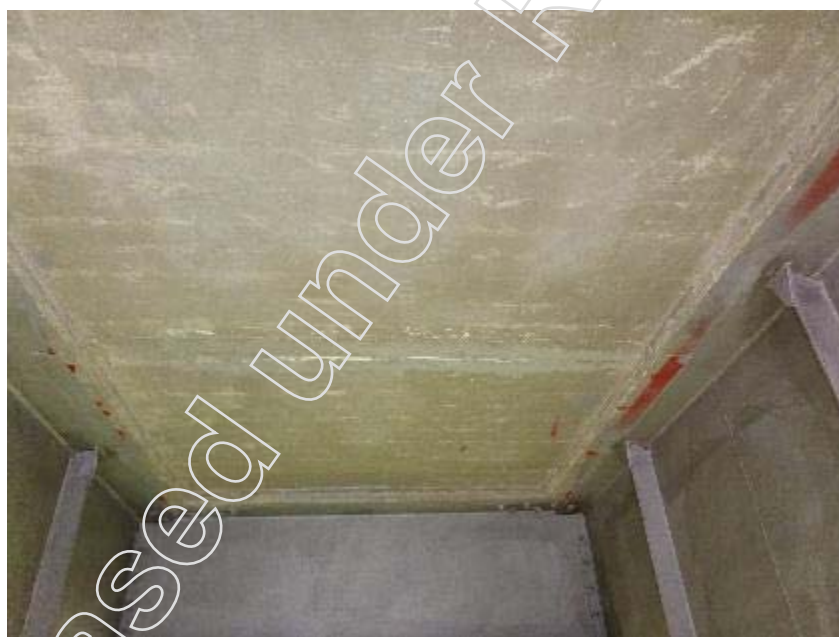
Photo 8: Crack on concrete slab

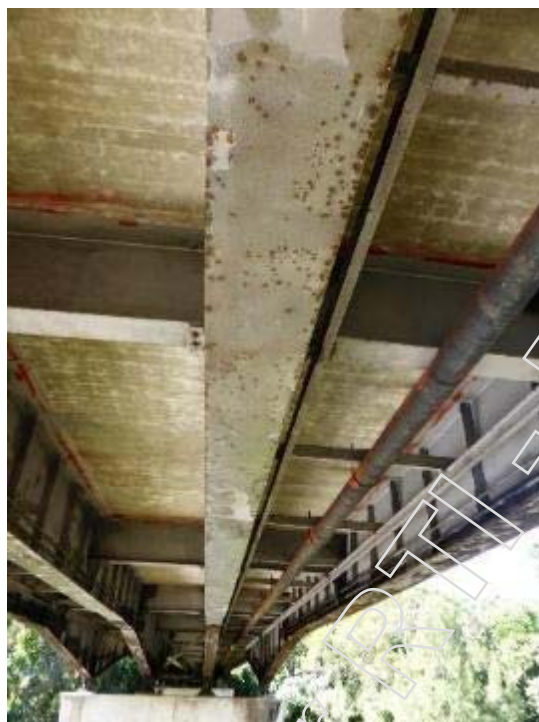
Photo 9: Steel corrosion

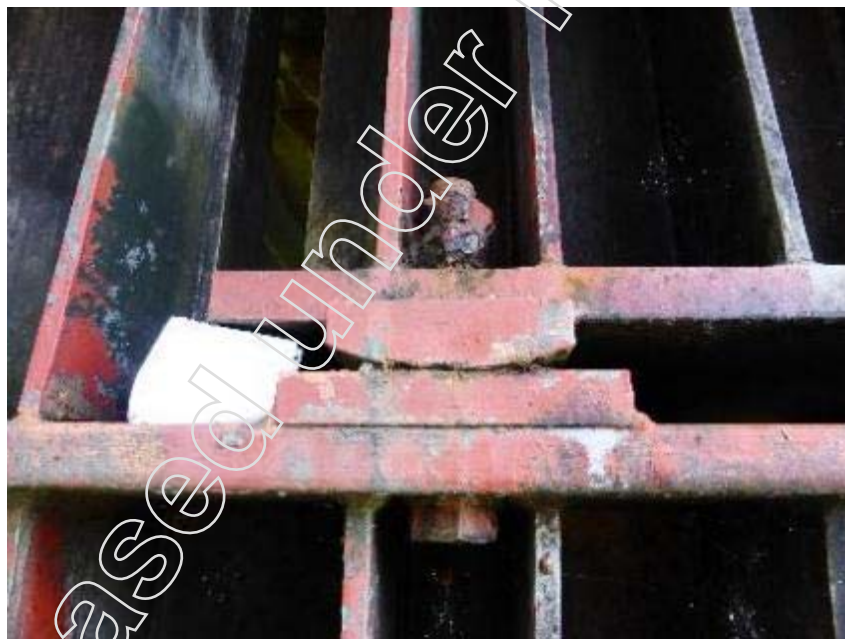
Photo 12: Suspended span (P1-P2) fixed bearing. (Evidence of Red Lead Paint)

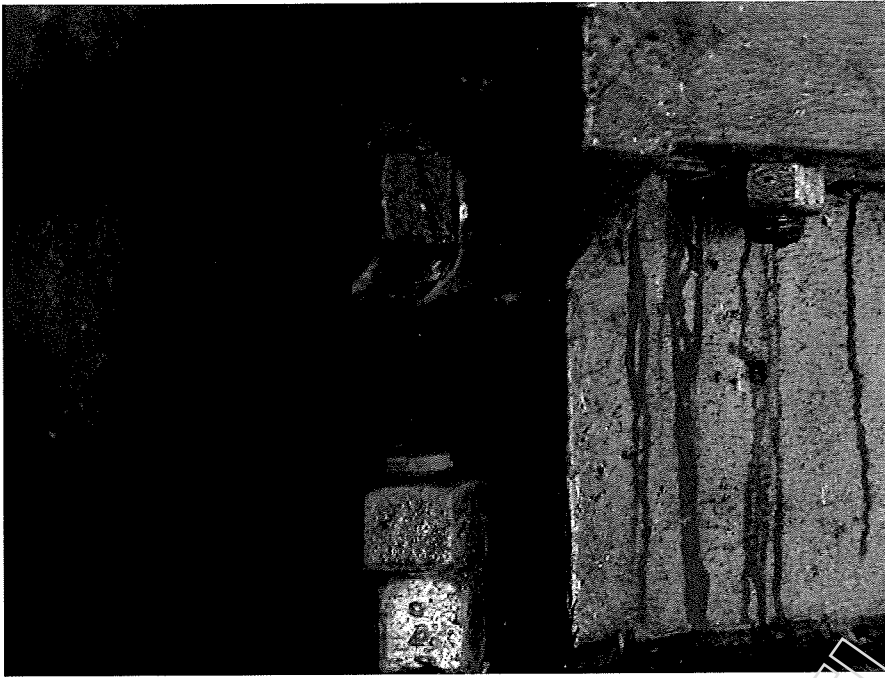
Figure 3 View of the corroded bolt

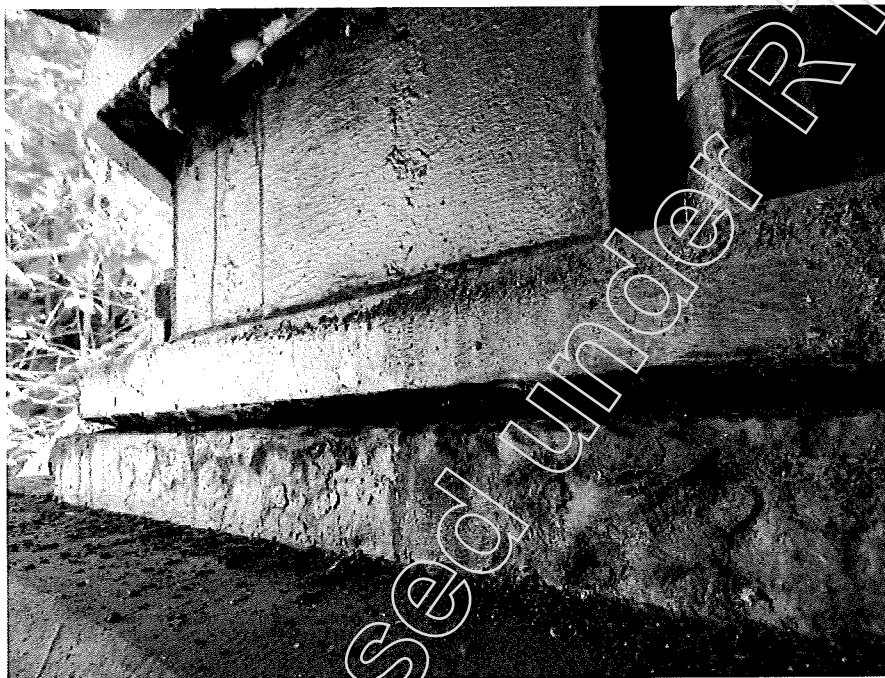
Figure 4 View of the corrosion between the rocker surface and the sole plate

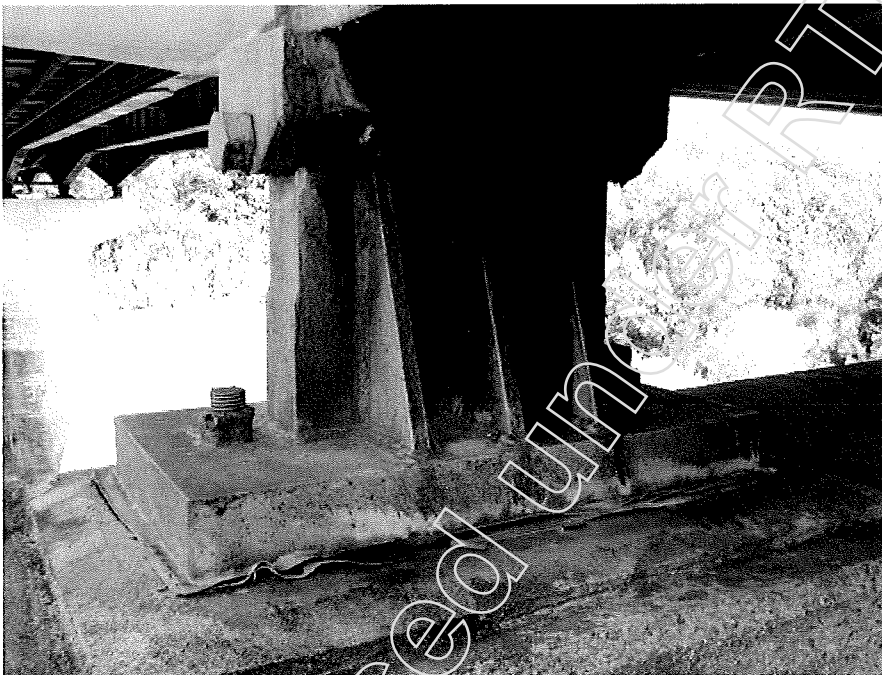
Figure 6 View of the corroded nut on the Pier 2 fixed bearing

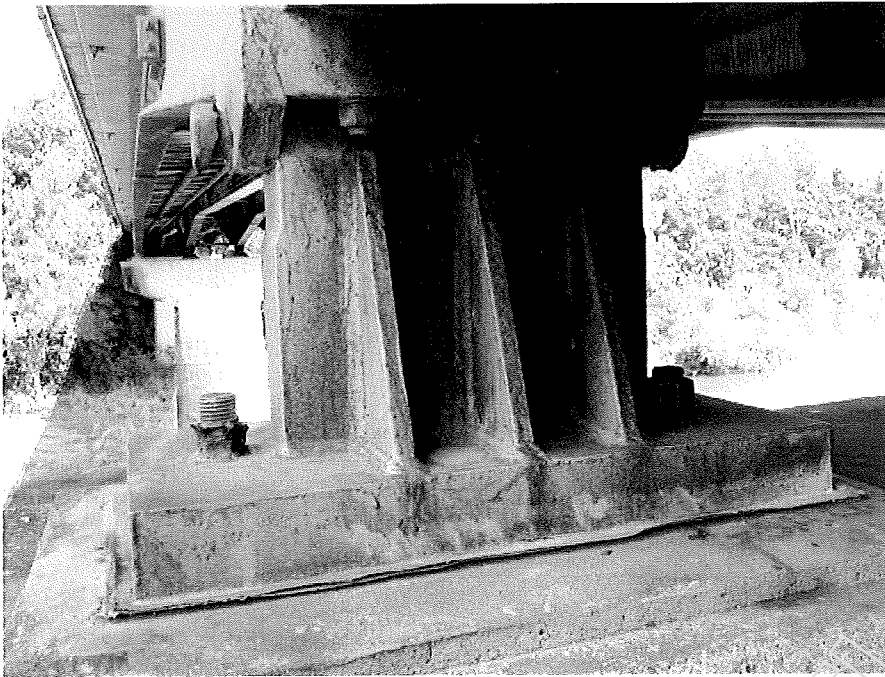
Figure 7 View of the corroded nut on the Pier 3 fixed bearing

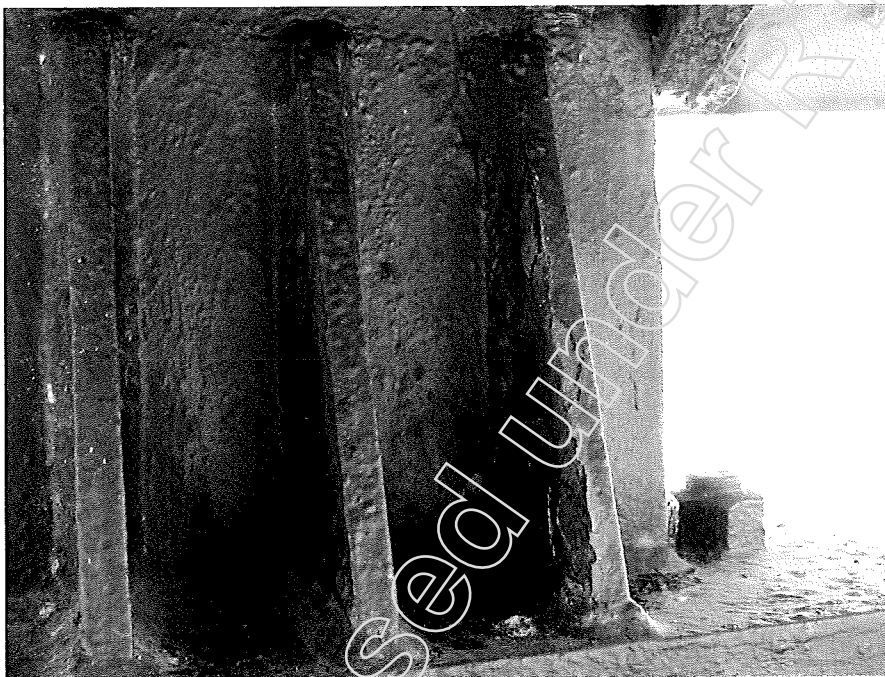
Figure 8 View of the corrosion on the Pier 3 fixed bearing

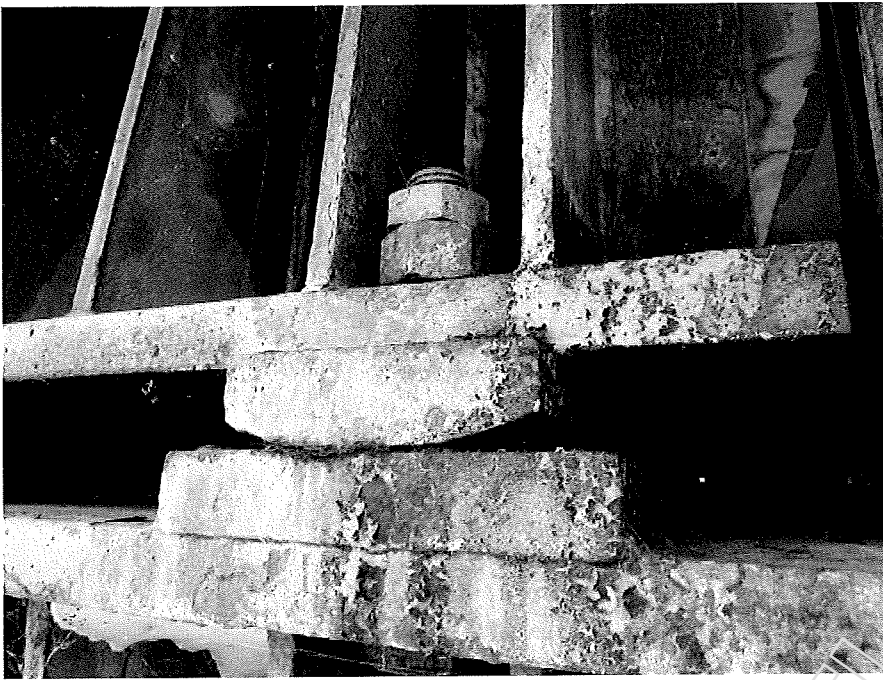
Figure 11 View of the corrosion on the Span 5 Fixed Hinge bearing

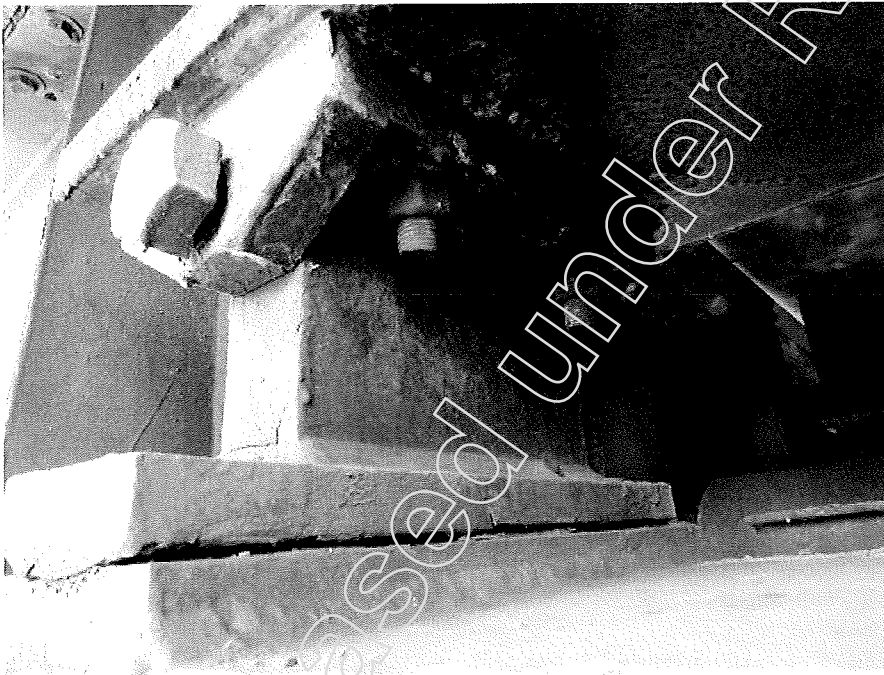
Figure 14 View of the Span 2 expansion hinge (dishing of sole plate ?)

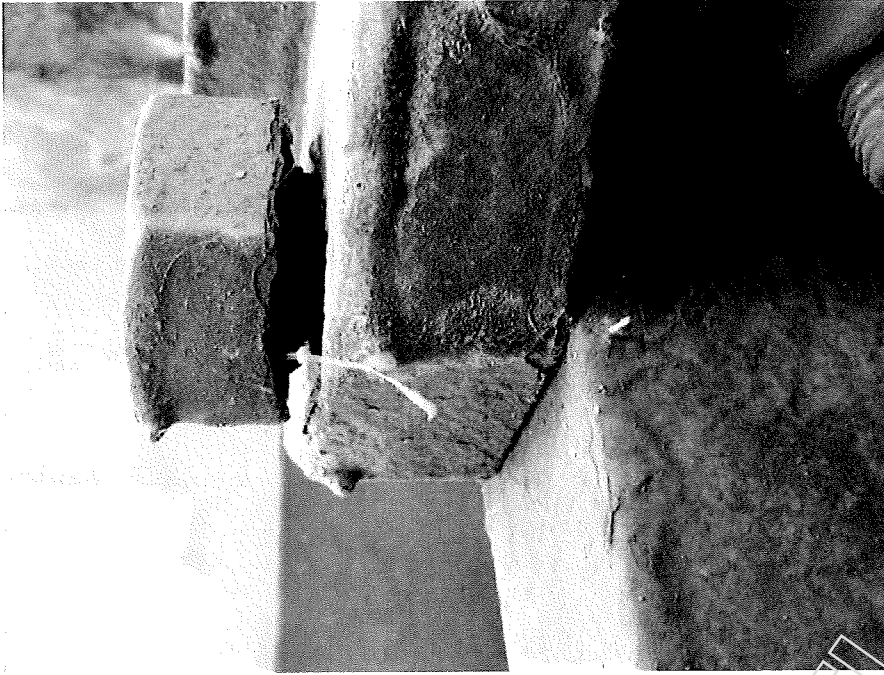
Figure 15 View of the corroded top bolt

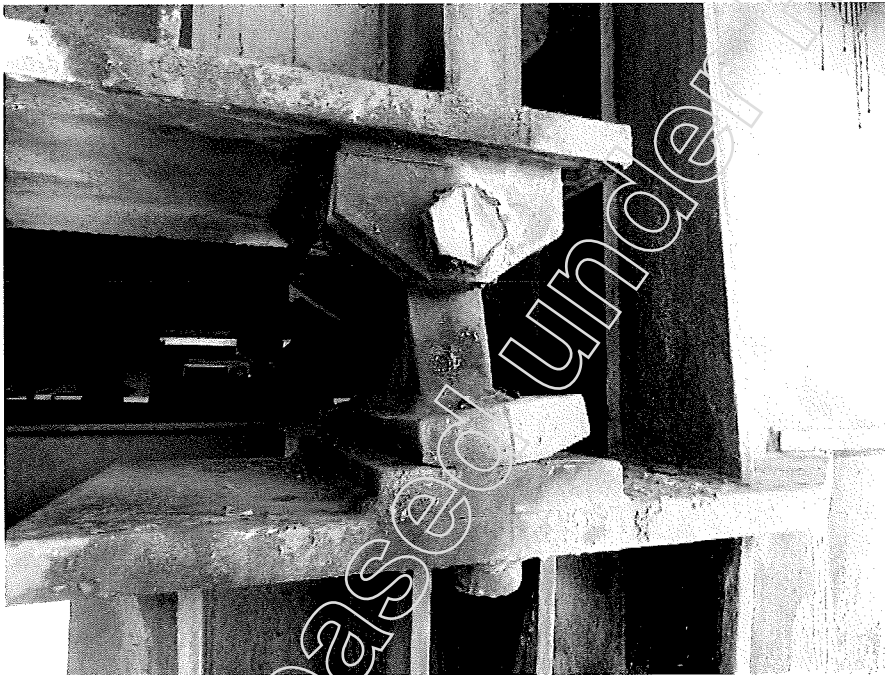
Figure 18 View of the corrosion on the Span 5 expansion bearing

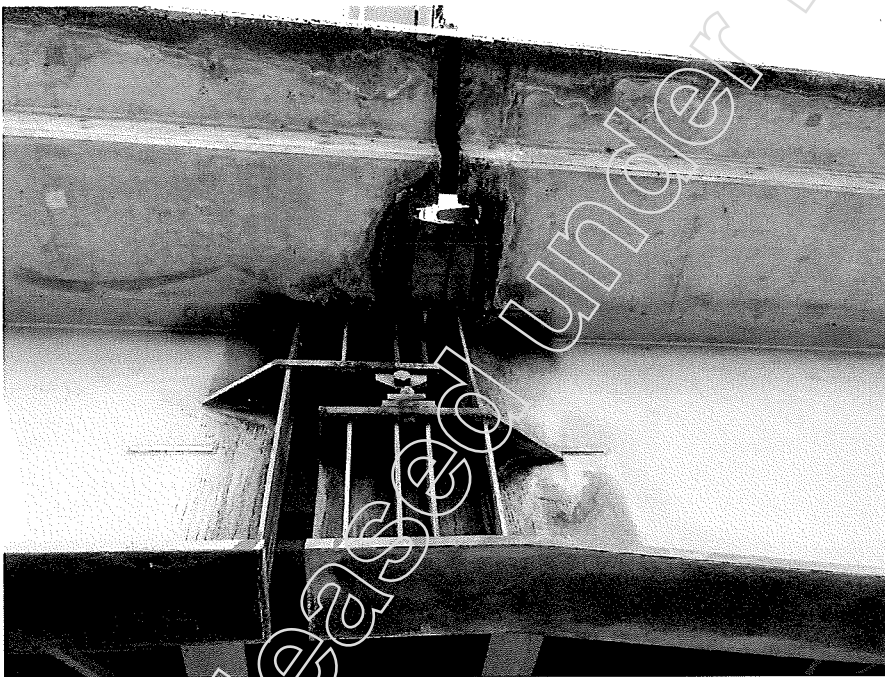
Figure 20 View of drainage which discharges onto the bearings

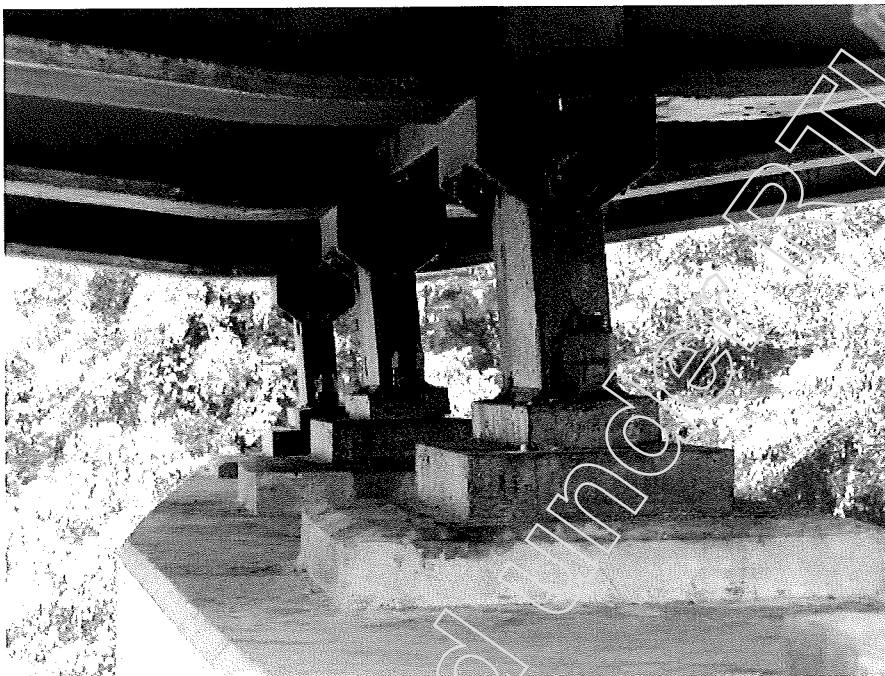
Figure 22 View of the corrosion on the Pier 4 expansion bearing

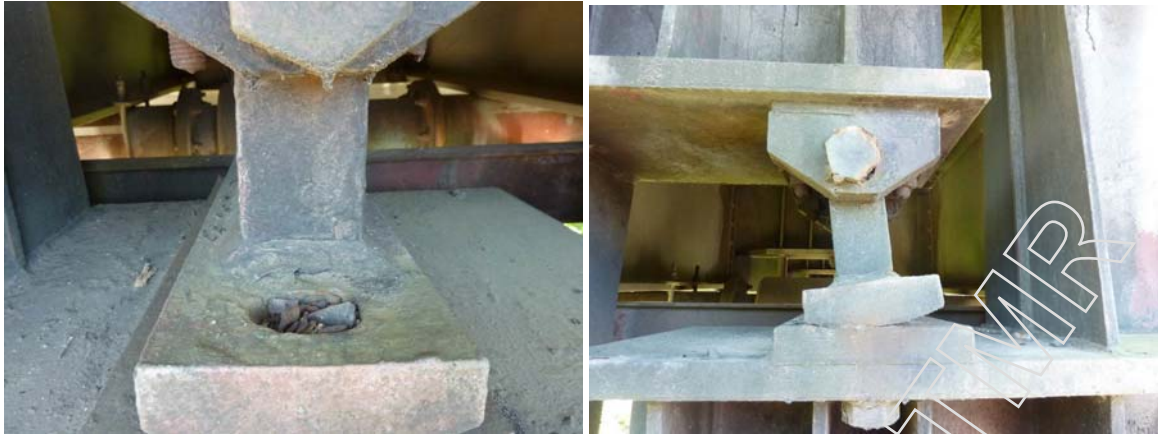
Figure 4 Barron River Bridge: Rocker bearing at a suspended span expansion joint.

- (a) Rocker bearing with top portion of bolt corroded away
- (b) Inclined rocker bearing with missing bolt and possible wear of hole around the bolt that the bearing pivots around

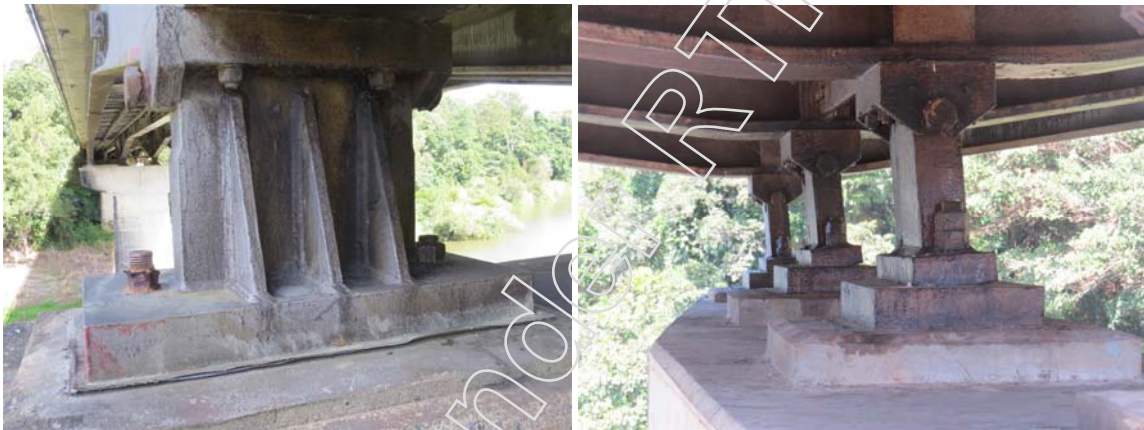
- (a) Fixed bearing at Pier 3 with corroded nuts to hold down bolts
- (b) Expansion rocker bearings at Pier 4

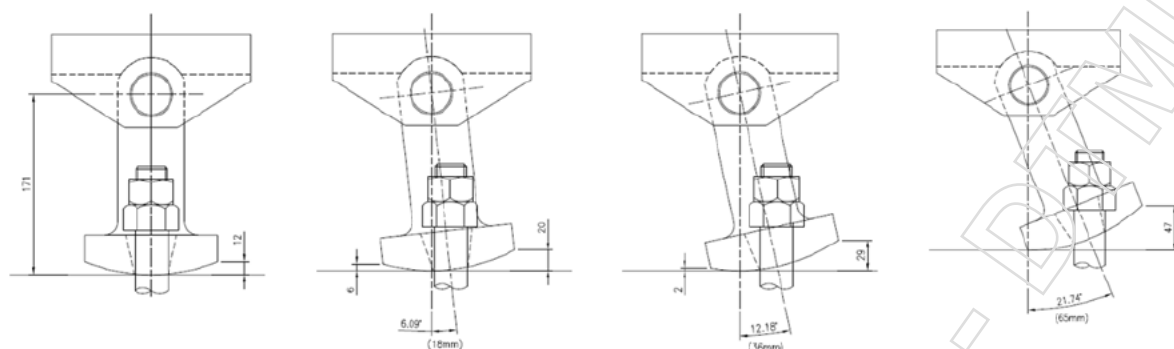
The articulation of the suspended span rocker bearings is illustrated in Figure 11. Note that the through bolts and nuts will contact the bearing shoe at modest travels and hence tend to restrain / redistribute the travel unless the bolts yield or fail or are lost to corrosion.

(a) 0 mm travel (b) 44 mm range (± 22 mm) – bolt using half of tapered hole in rocker, nuts at point of contact with rocker (c) 88 mm range (± 44 mm) – bolt against tapered hole in rocker, holding down bolts distorted (d) 140 mm range (± 71 mm) – unstable
