Marine Incident – Beaver Rock, Mary River – Collision between vessels –

Marine Incident Investigation Report

Case Ref: MSC2715-2021

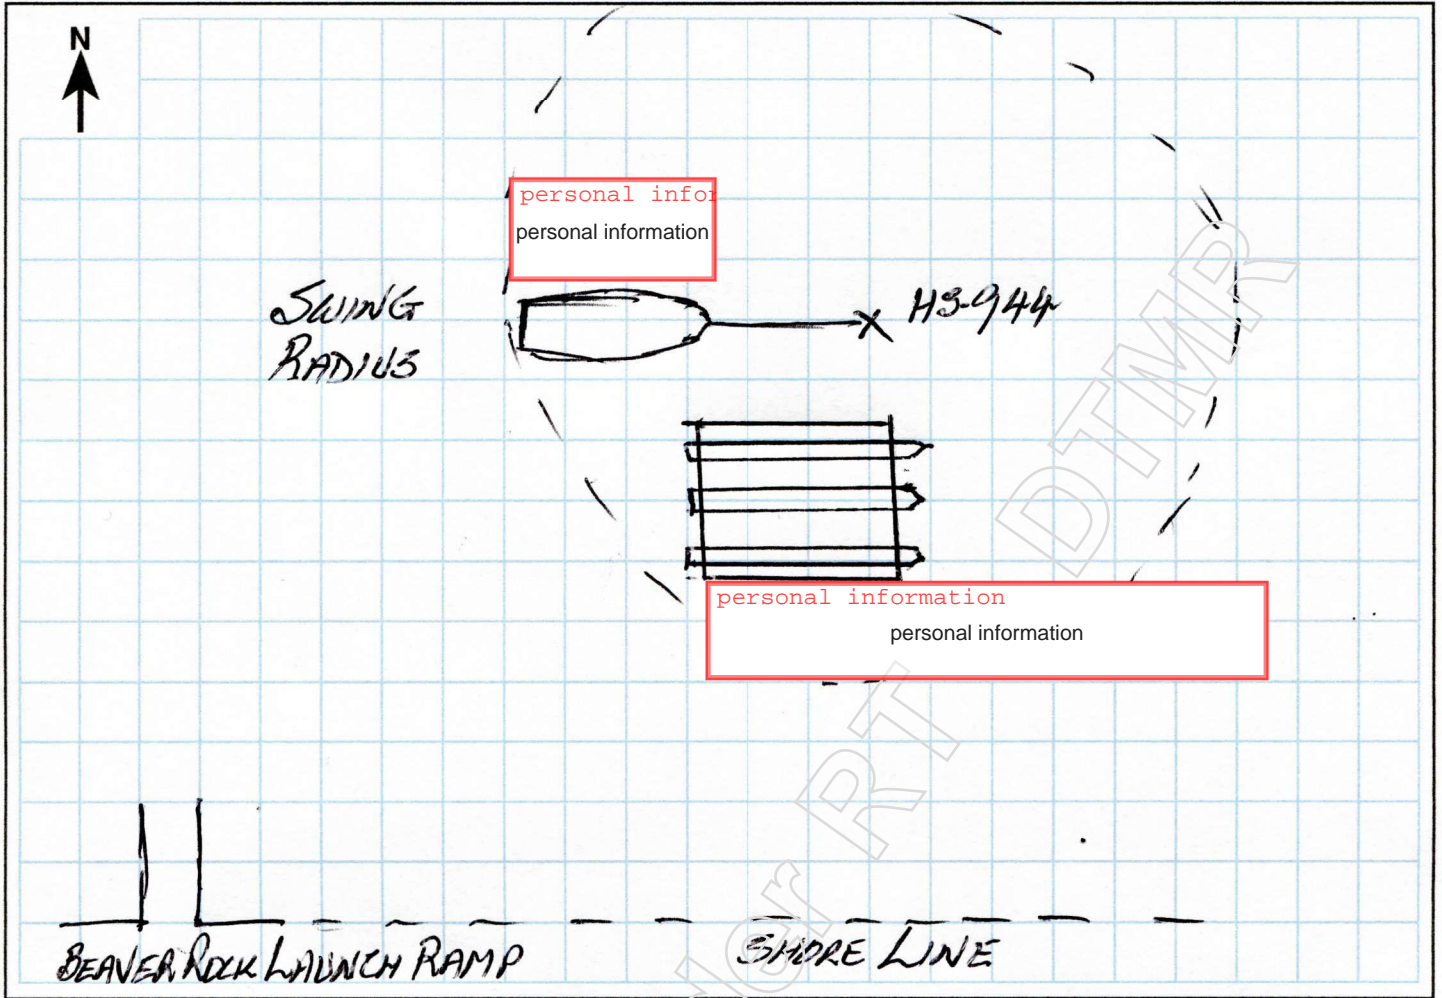
Owner's/Master's report MSD BUNDABERG ADVISED THAT ANOTHER VESSEL HAD DROGGED AND WAS ENTANGLED WITHIN THE LINE FROM TO MOORING H3944.

ON 29 JUL 21 I VISITED THE MOORING SITE APPROX 0830. AT THIS TIME THE VESSELS WERE INDEPENDANT BUT WERE MOORED WITHIN 1/2 A VESSEL LENGTH AND WERE SWINGING FREELY WITH TIDE. IMPACT WAS ALWAYS IMMINENT.

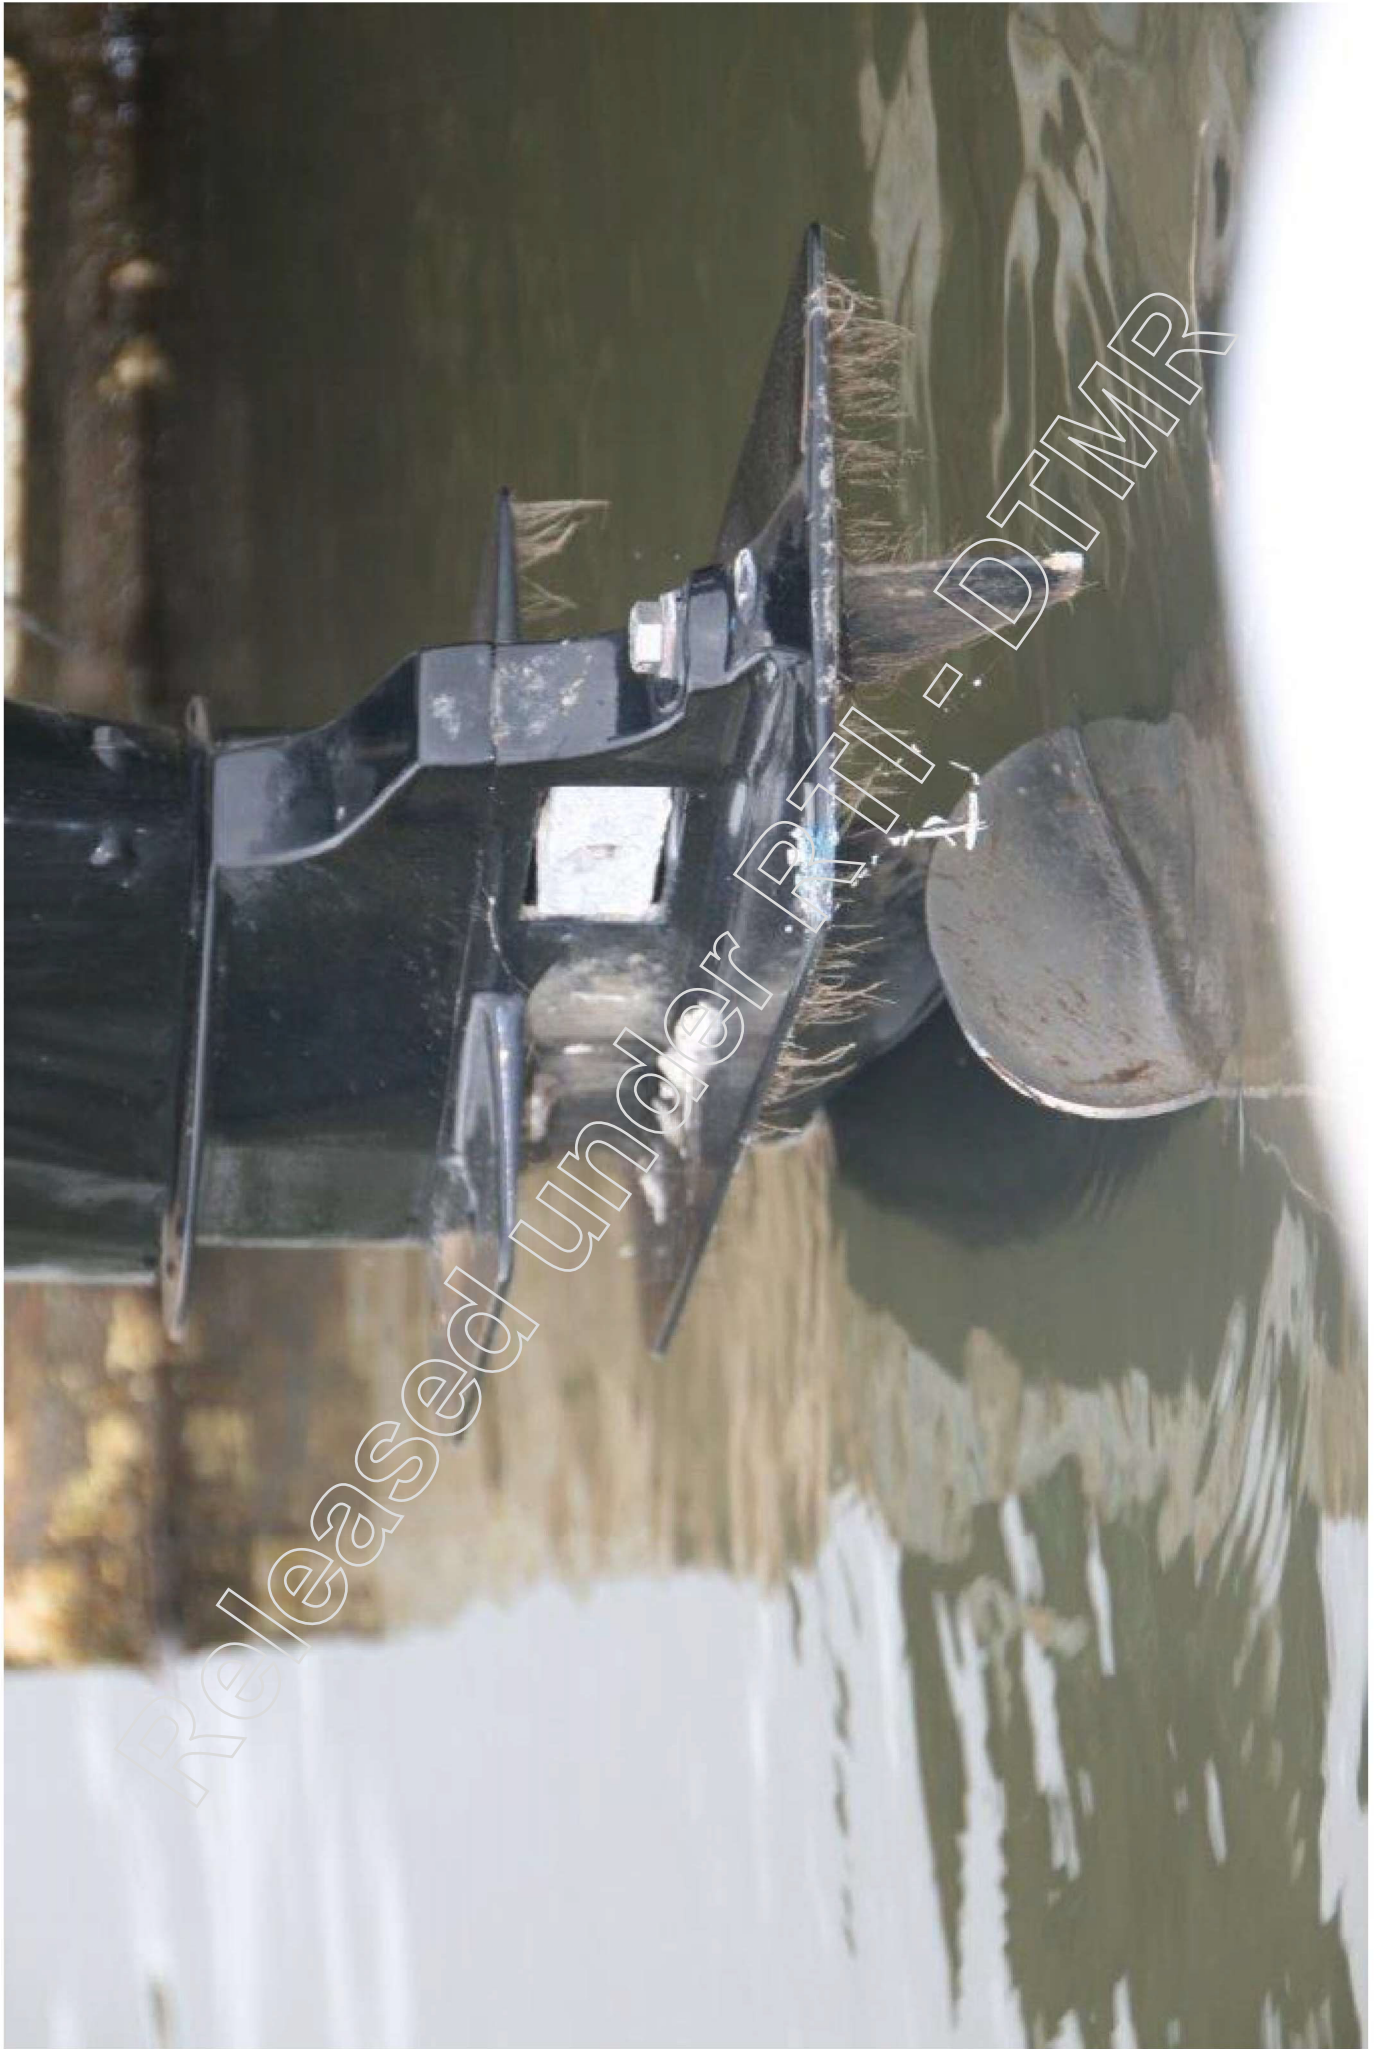
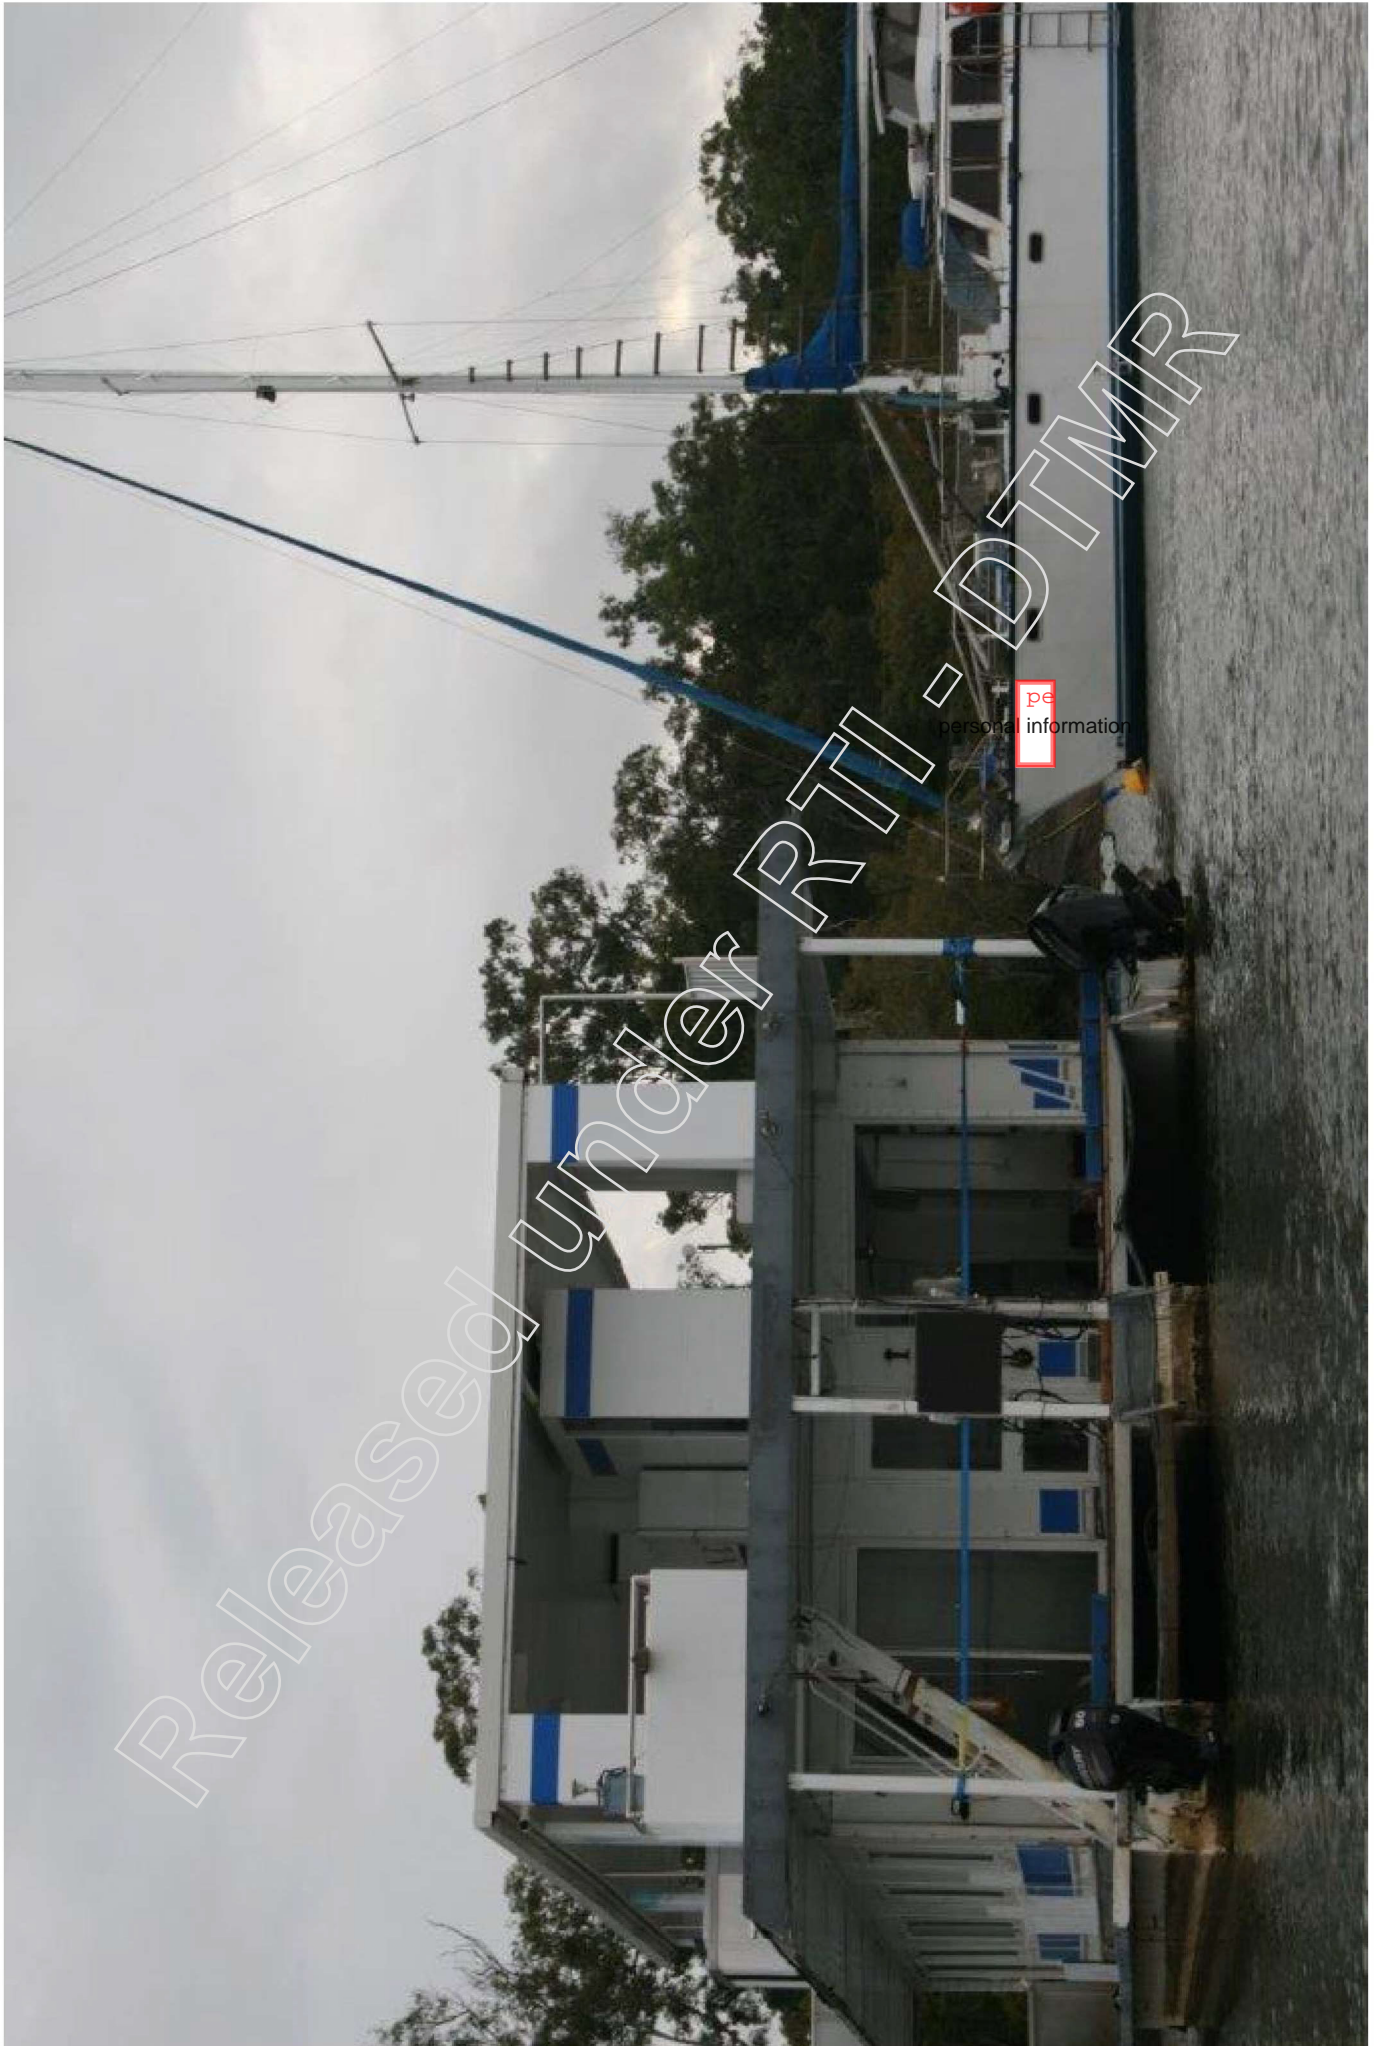
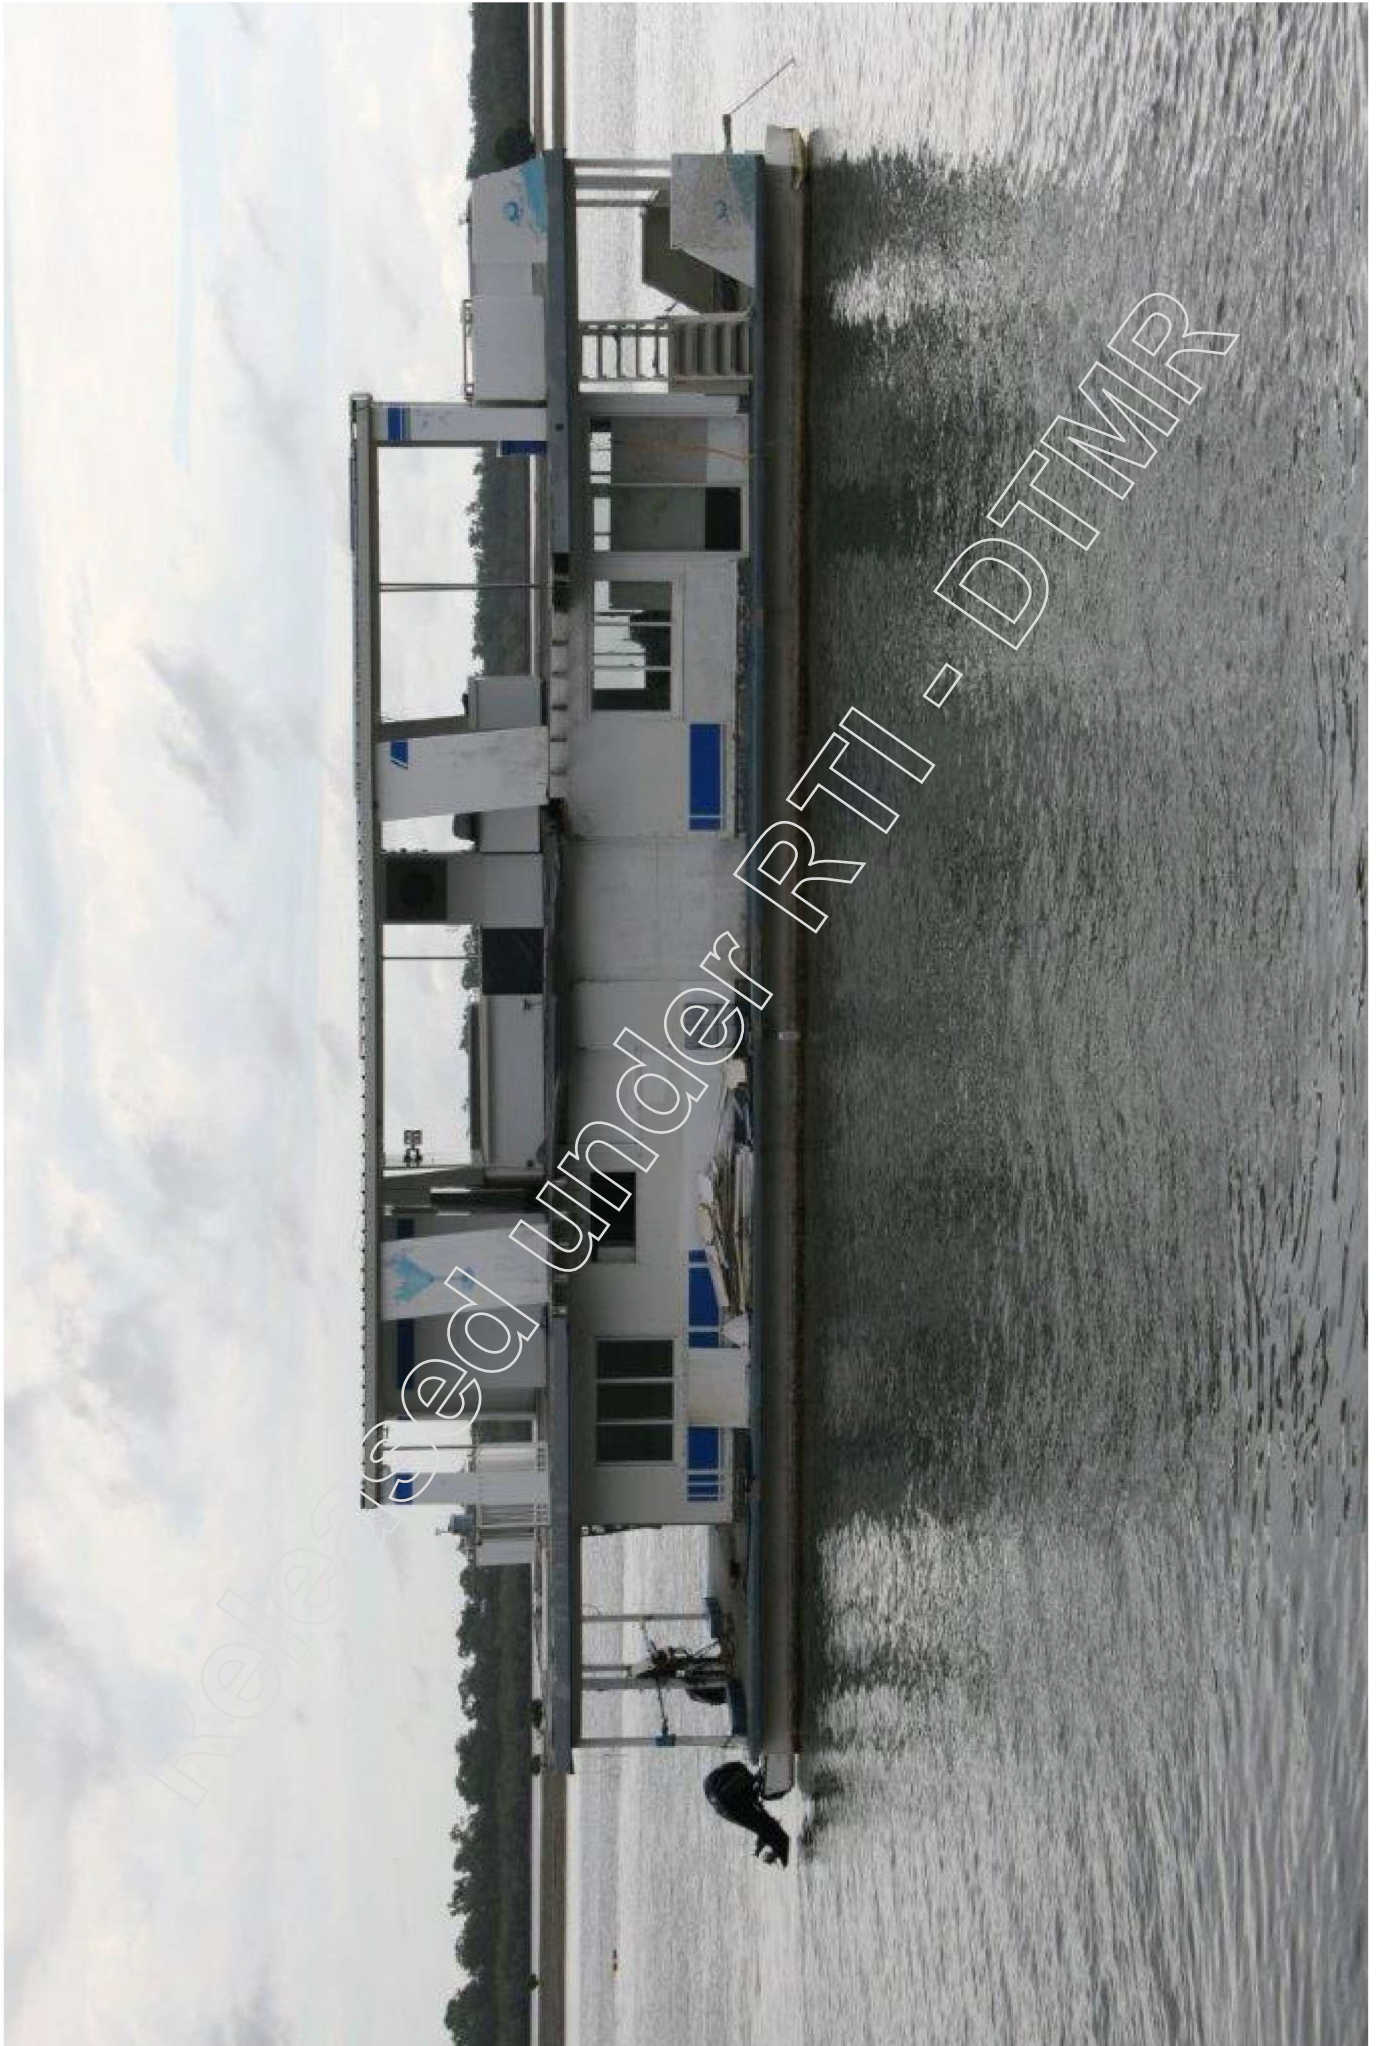
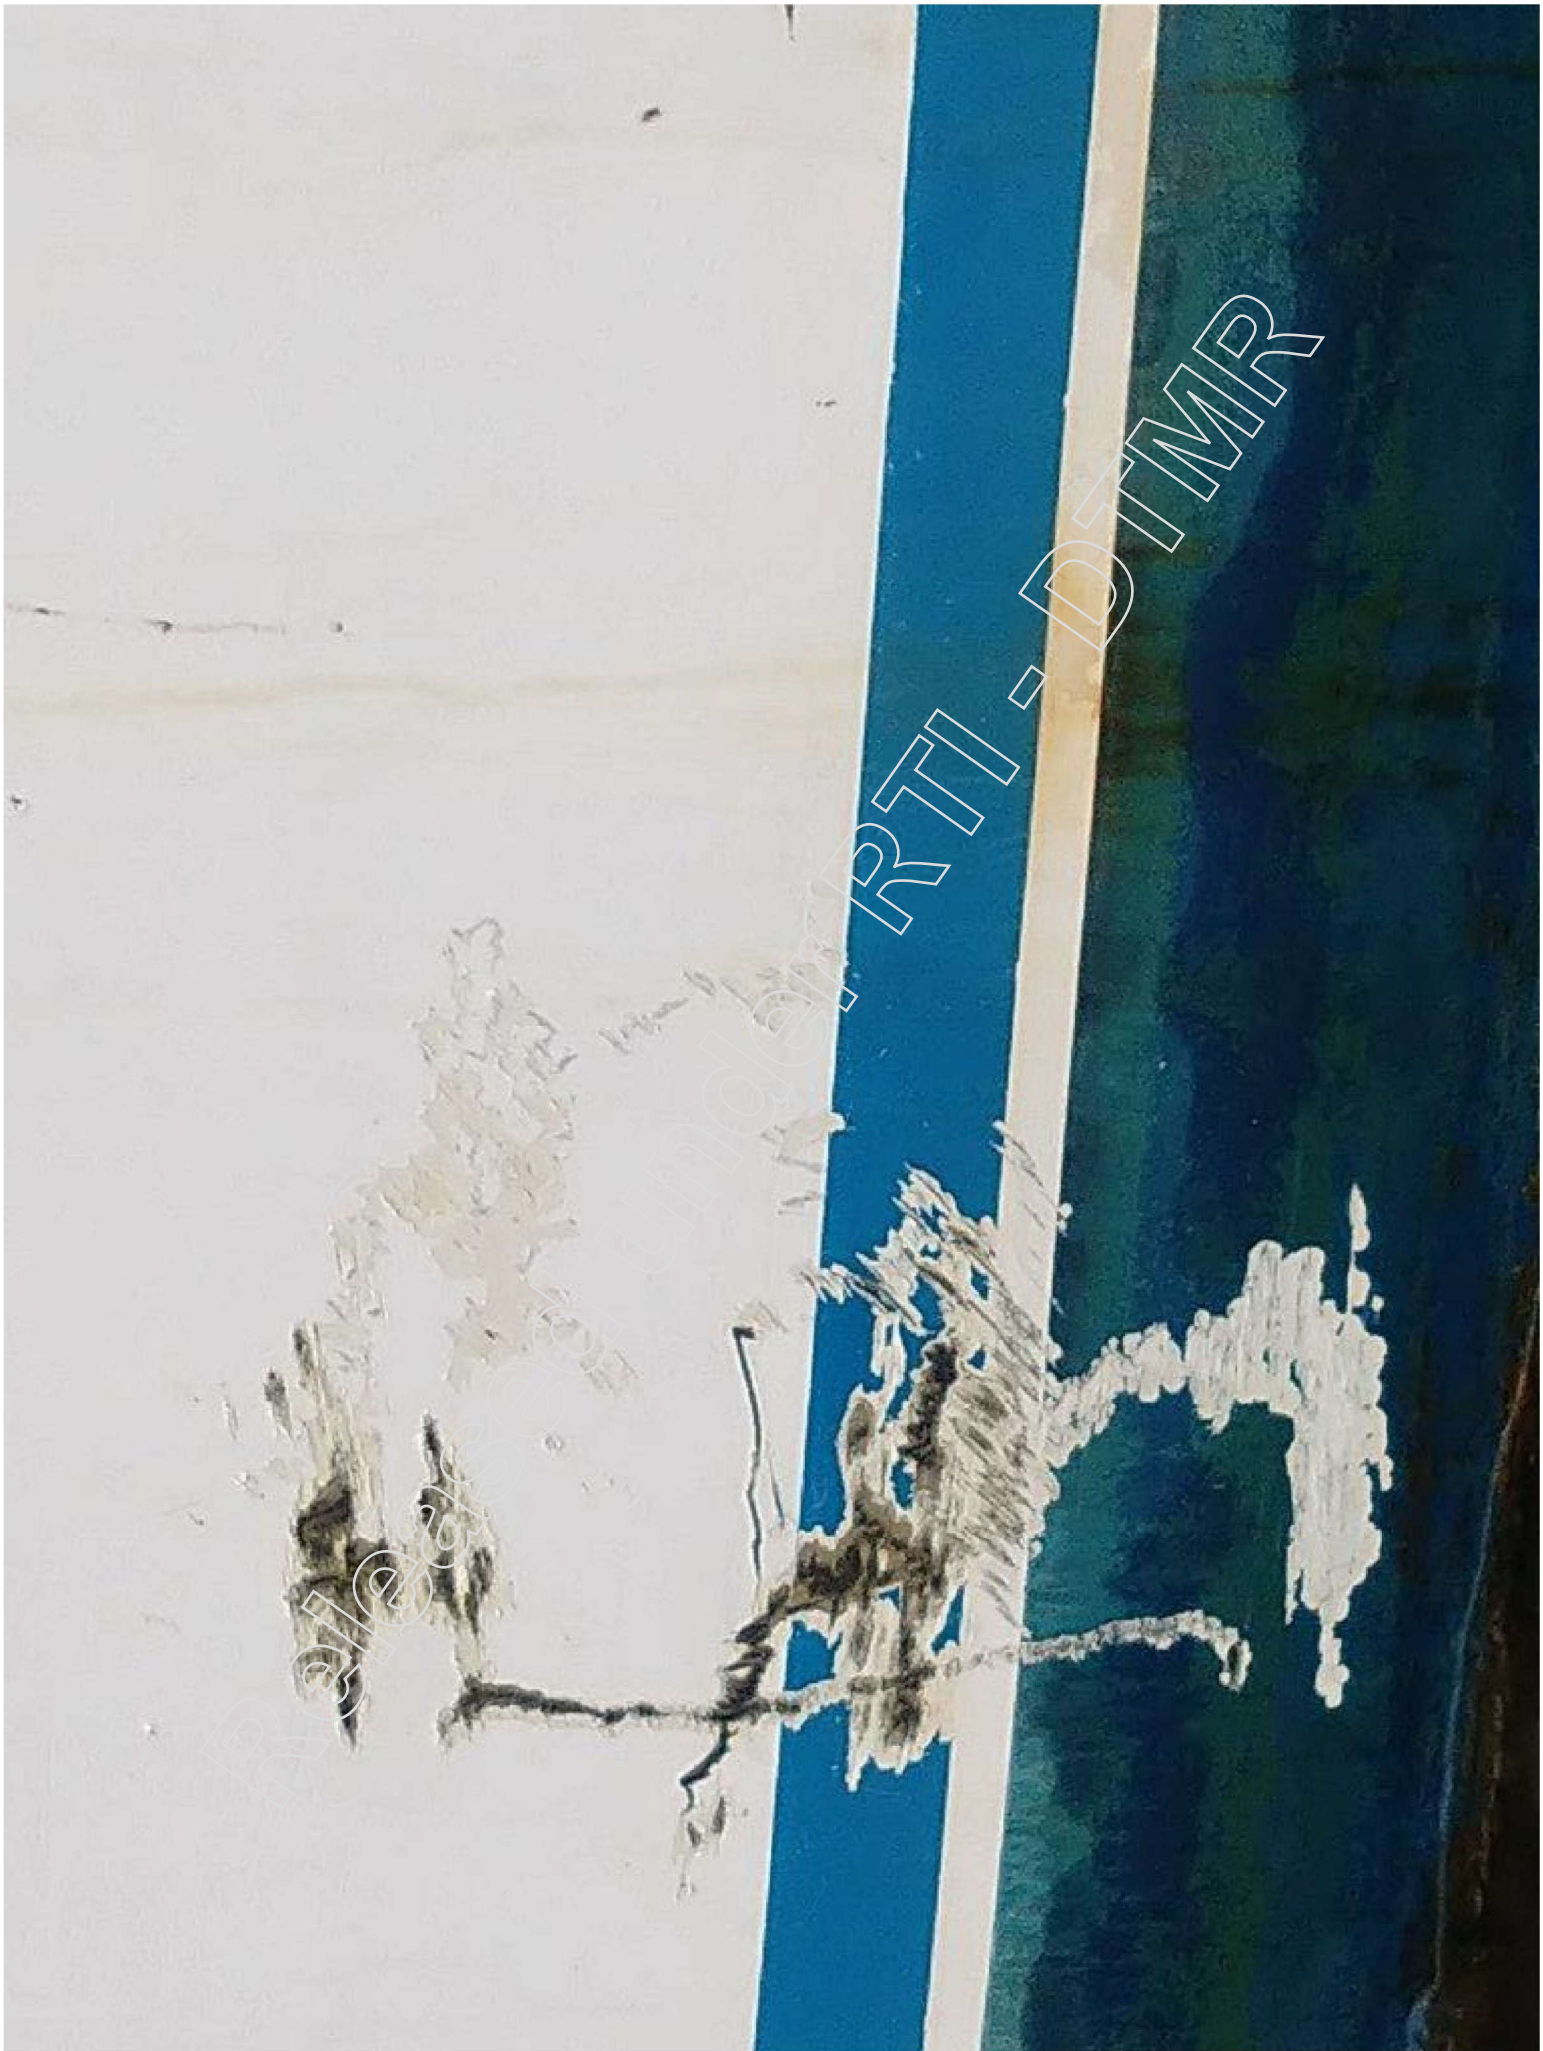
CTPI phoned to advise that there was significant damage to his vessel. He requested that we contact Maritime Police (Water Police) and ask that they move the vessel personal information as it is still currently only about 20m away and on the change of tide it will again collide with personal information. I advised that we are unable to organise anything until we have the Owners details and discuss the moving of the vessel. I also advised that he will need to complete a Marine Incident Report Form – he asked if this could be emailed.

That on 28 July 2021, a marine incident occurred in the smooth waters of The Mary river in the vicinity of Beaver Rock involving a collision between ships. The Incident resulted in damage to the ships. The matter was reported to Maritime Safety Qld (MSQ) on 28 July 2021 by the QPS and the investigation was assigned to Gladstone South to Investigate. As a result, Officers contacted the owner of the ship personal information and identified the owner personal information notified him of the incident. A Marine Incident Report was submitted by owner personal information on 10 August 2021. Officers contacted the owners of the ships to confirm details of the incident. personal information a Buoy Mooring personal information the mooring is in the plotted position. personal information at anchor and dragged onto Ramona causing damage to the forward port side gunwales. There was paint from personal information the outboard motors of personal information owner personal information only recently purchased personal information and was new to the area, he then removed the ship from the vicinity of personal information and secured the ship from dragging. The ship has since been relocated to the personal information

As a result of the investigations into this matter it was determined that the Marine Incident was caused by an operational error in anchoring by the master personal information that allowed for the ship to drag anchor onto personal information ship was removed from the vicinity and later from the region. As a result of the investigations into this matter it was determined that there is insufficient evidence to prove beyond reasonable doubt that an offence has been committed.

As a result of the findings of this investigation, it is recommended that no further action be taken against any individual or organisation in relation to this matter and a closure letter be issued to all parties informing them of the outcome of the investigation.
