# Structure Condition Inspection Report

Structure Id 817

Inspection Date 29-NOV-2020

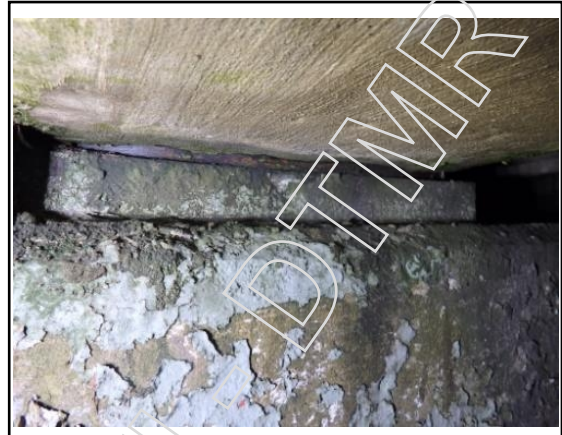
O  A  1  B

Component Location				Exposure Class	Quantity	Unit	Quantity Per Condition State				Maintenance Req'd	Comments
Modification	Group	Component	Standard				1	2	3	4		
O	A1	B	42O	4	3.0	EACH			3.0			
All splitting & bulging insp pic 001, Monitor. Have been like this for many inspections but still performing there job.												
O	A1	PED	44O	4	3.0	EACH		3.0				
O	A1	A	50C	4	1.0	EACH		1.0			X	
Services brackets mild to servere corrosion insp pic 002 & 003, Clean & treat or replace brackets with maintenance.												
O	A1	WW	51C	4	2.0	EACH		2.0				
O	S1	D	20C	4	160.5	M2		160.5				
O	S1	G	22P	4	3.0	EACH		3.0				
O	S1	XG	31C	4	3.0	EACH		3.0				
O	S1	W	71O	4	1.0	EACH		1.0				
O	P1	B	42O	4	6.0	EACH			6.0			
All splitting & bulging insp pic 005, Monitor. Have been like this for many inspections but still performing there job.												
O	P1	PED	44O	4	6.0	EACH		6.0				
O	P1	H	54C	4	1.0	EACH		1.0			X	
Tree growing RHS insp pic 004, Remove tree with maintenance.

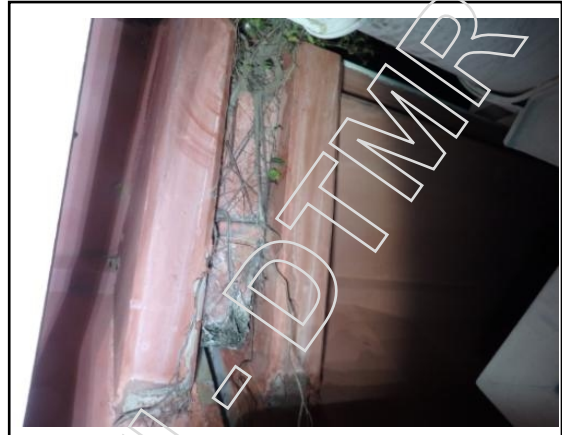
Mod O Category P Number 1 Comp Code H Comp No

Tree growing RHS

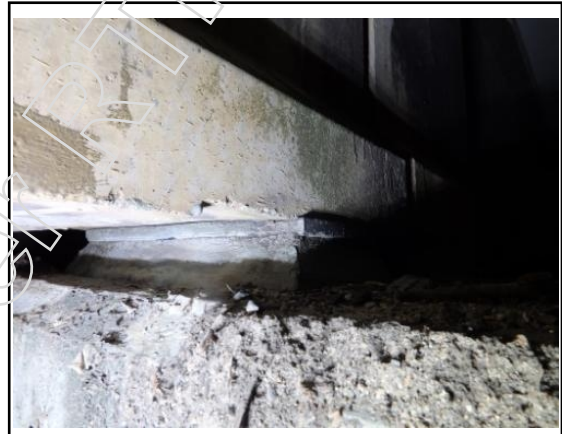
Mod O Category P Number 1 Comp Code B Comp No

Bulging

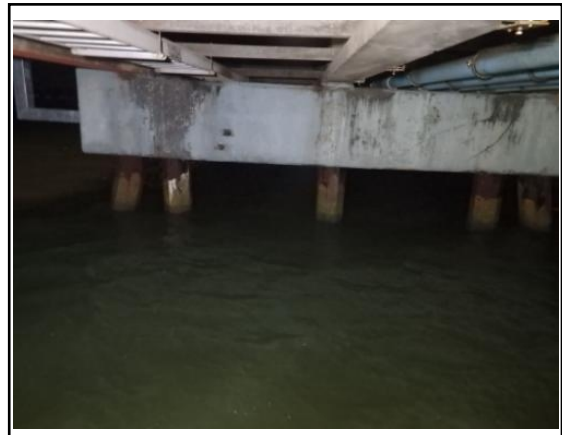
Mod O Category P Number 1 Comp Code P Comp No

Less than 25% inspected

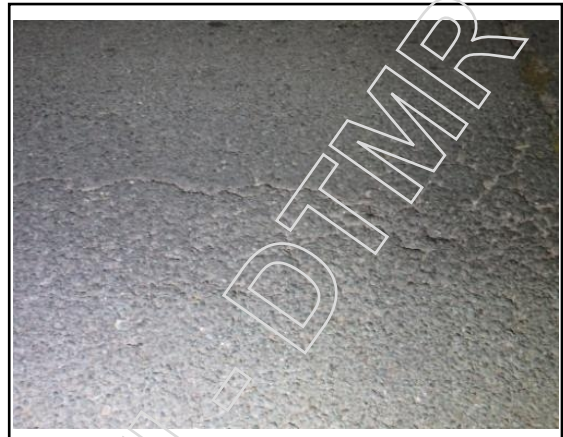
Mod O Category AP Number 1 Comp Code AP Comp No

Component Location				Exposure Class	Quantity	Unit	Quantity Per Condition State				Maintenance Req'd	Comments
Modification	Group	Component	Standard				1	2	3	4		
O	AP1	AP	70O	4	1.0	EACH			1.0			
Cracking at relieving slab & section of craze cracking insp pic 19,20 & 21, Fix- excavate & relay 80m2 section with programmed maintenance prior to next inspection.												
O	AP1	GR	72S	4	1.0	EACH		1.0				LHS only.
O	AP1	GR	72O	4	1.0	EACH		1.0				Wire fence.
O	AP1	FY	4C	4	20.0	LINM		20.0				
O	AP1	PRO	53O	4	80.0	M2	80.0					20m x 2m both sides.
O	A1	K	3C	4	6.2	LINM		6.2				
O	A1	BR	2S	4	3.1	LINM		3.1				
O	A1	J1	13O	4	5.5	LINM		5.5				
Open joint with 3 rubber infills over girders. Infills are splitting & sinking but not affecting the joint. Refer insp pic 22,23 & 24.												
O	S1	BR	2C	4	43.9	LINM		43.9				
O	S1	FY	4C	4	21.9	LINM		21.9				
O	S1	BR	2S	4	21.9	LINM		21.9				Steel fence between footway & roadway insp pic 25.

Cracking

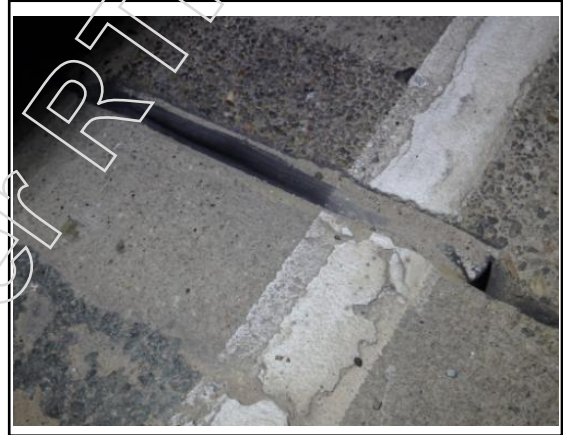
Mod O Category A Number 1 Comp Code J1 Comp No

Rubber infill splitting 3

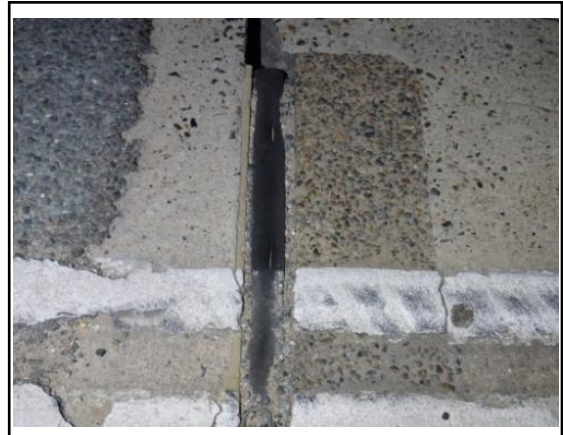
Mod O Category A Number 1 Comp Code J1 Comp No

Rubber infill splitting 2

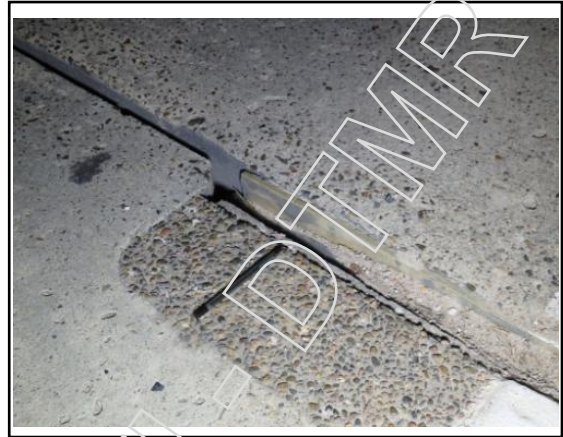
**Mod** O **Category** P **Number** 2 **Comp Code** J1 **Comp No**

**Description**  
Rubber infill sinking 3

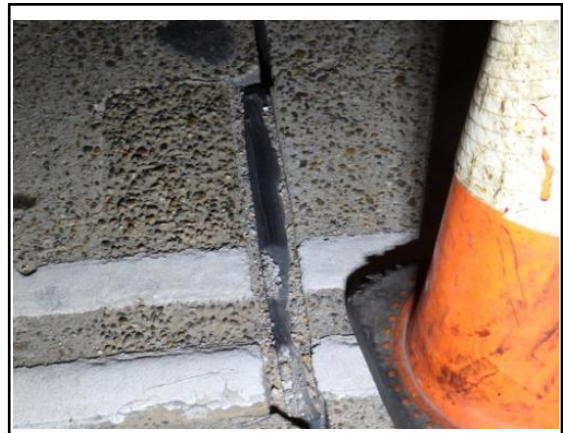
**Mod** O **Category** P **Number** 3 **Comp Code** J1 **Comp No**

**Description**  
Rubber infill splitting 2

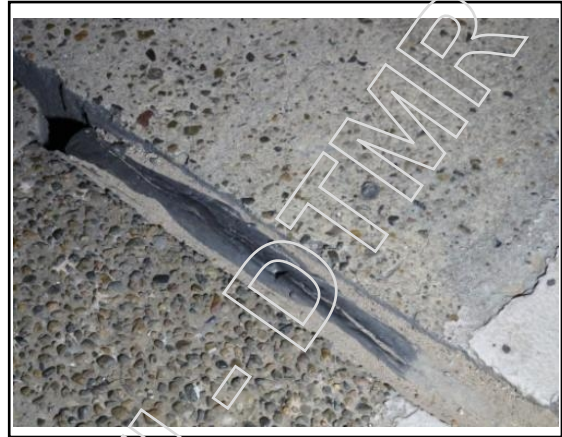
Mod	Category	Number	Comp Code	Comp No
O	P	4	J1

Rubber infill perished 3

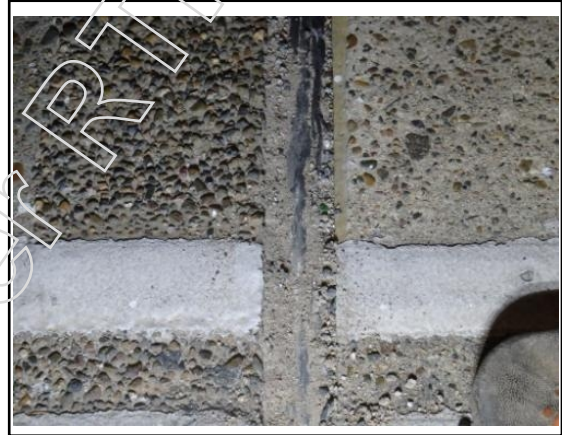
Mod	Category	Number	Comp Code	Comp No
O	P	4	J1

Rubber infill perished 2

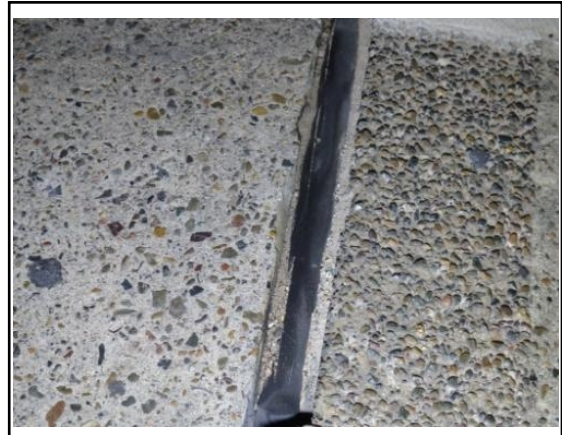
Mod	Category	Number	Comp Code	Comp No
O	P	5	J1

Rubber infill splitting 3

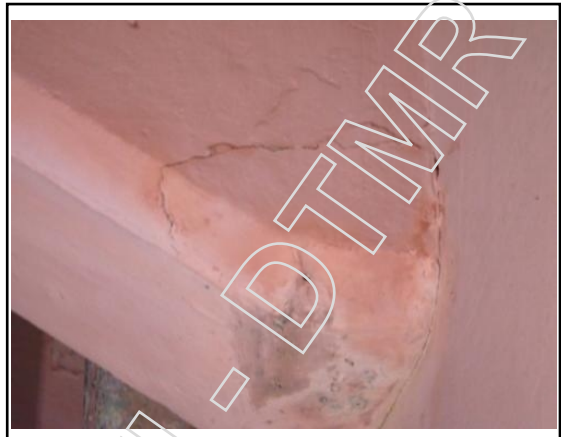
Mod	Category	Number	Comp Code	Comp No
O	S	9	XG	1

Starting to spall

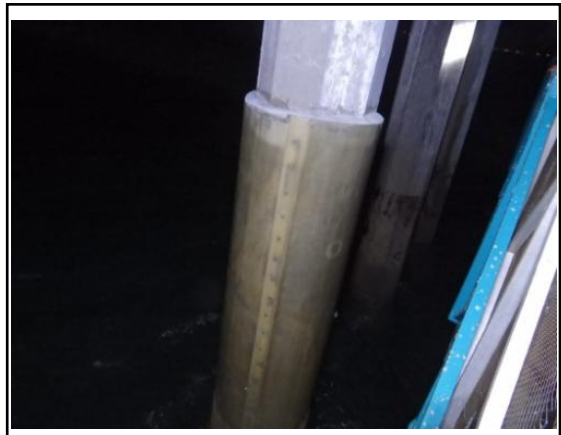
Mod	Category	Number	Comp Code	Comp No
ST	P	9	P

Denso wrap on pile
