# Melbourne Street Automatic Doors Condition Report 2023

Prepared on behalf of Department of Transport and Main Roads  
January 2023

Contract Ref No: TMR-2217

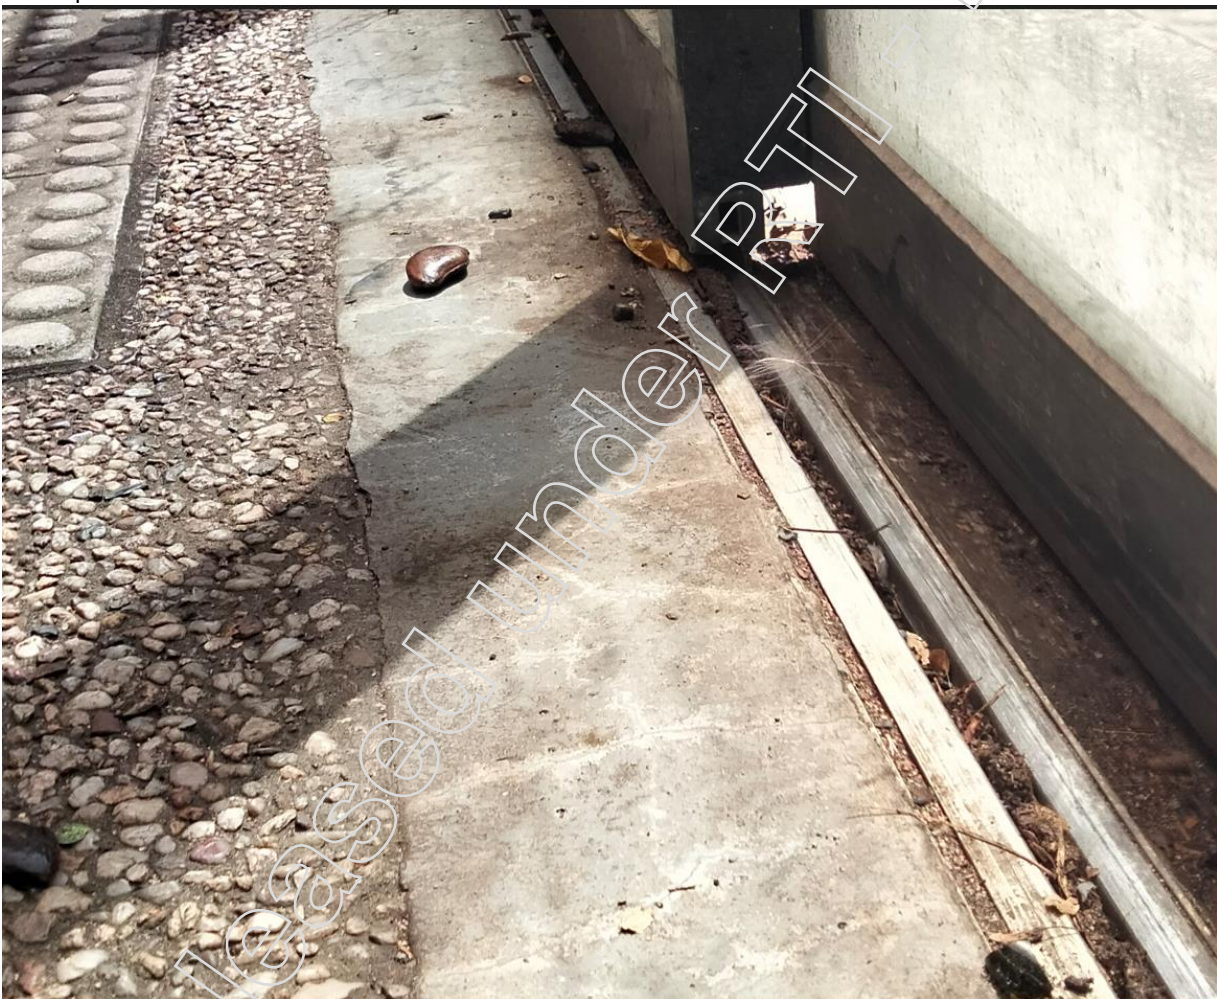
The two door cards slide on rollers mounted inside the door pelmet with the lower part kept in place with a track and glide system. These inground tracks continually fill up with leaves and dirt from the surrounding area. This debris causes the automatic doors to get jammed and trip out on an obstruction error. Once the door is in fault mode it will not move and require the tracks to be cleaned and door reset by the key switch.

Below photo shows the Westend Side Automatic Door tracked full of leaves and dirt.

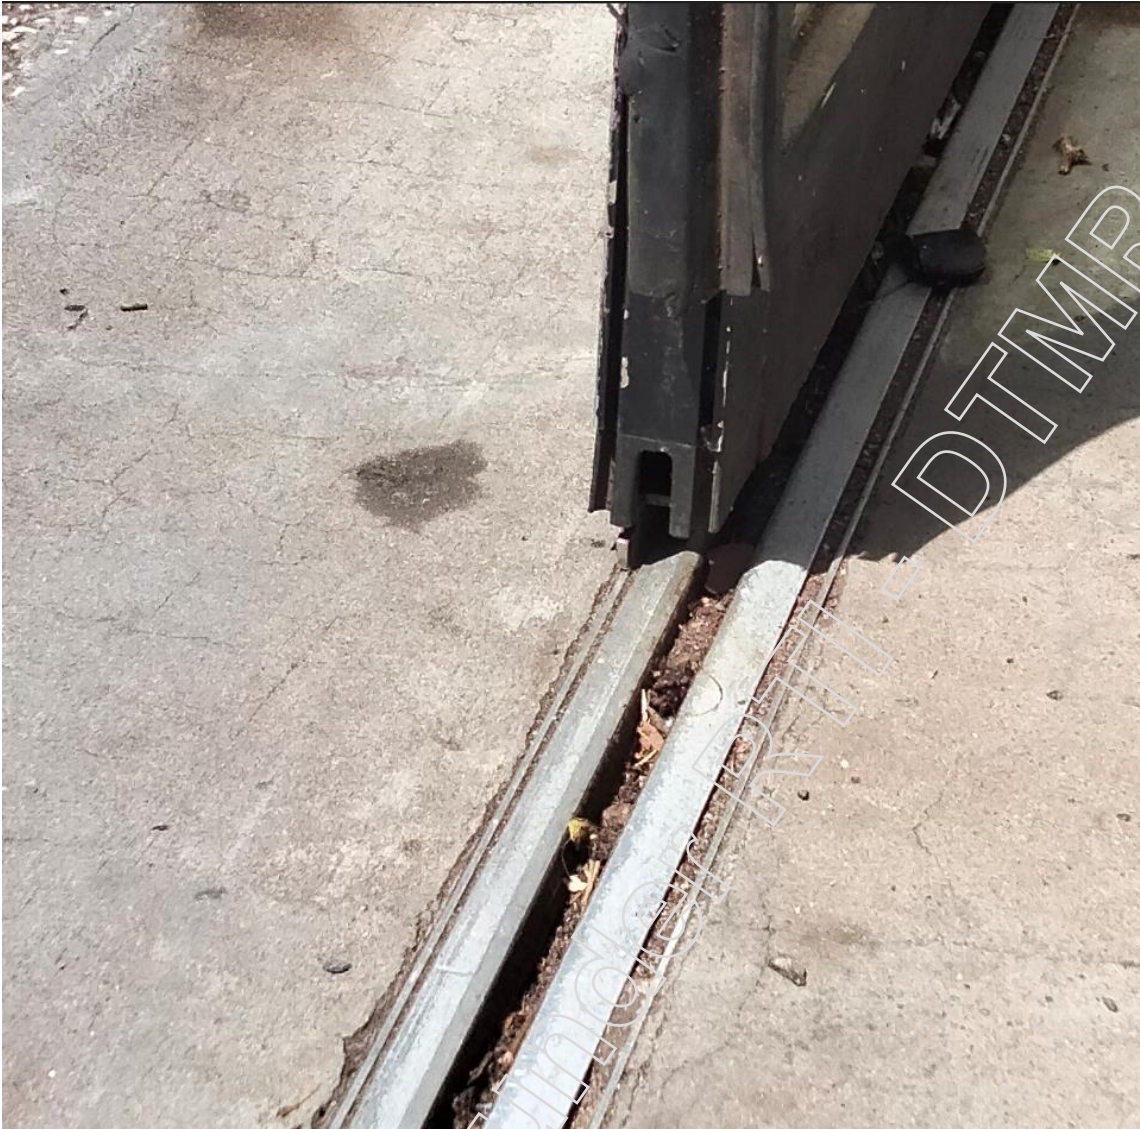
Below image indicates worn floor guide causing door misalignment.

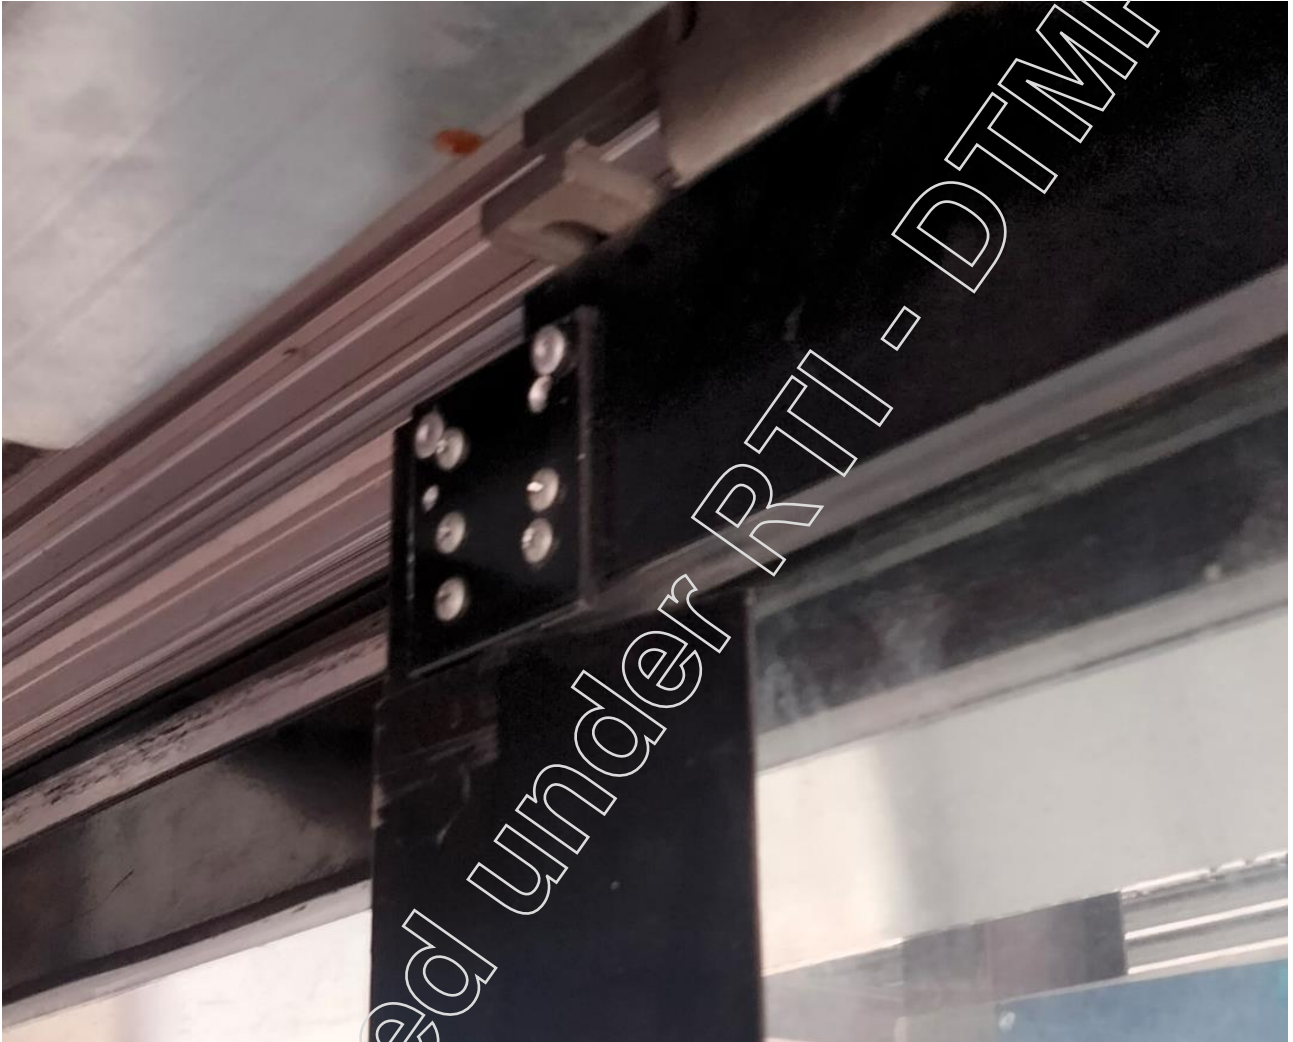
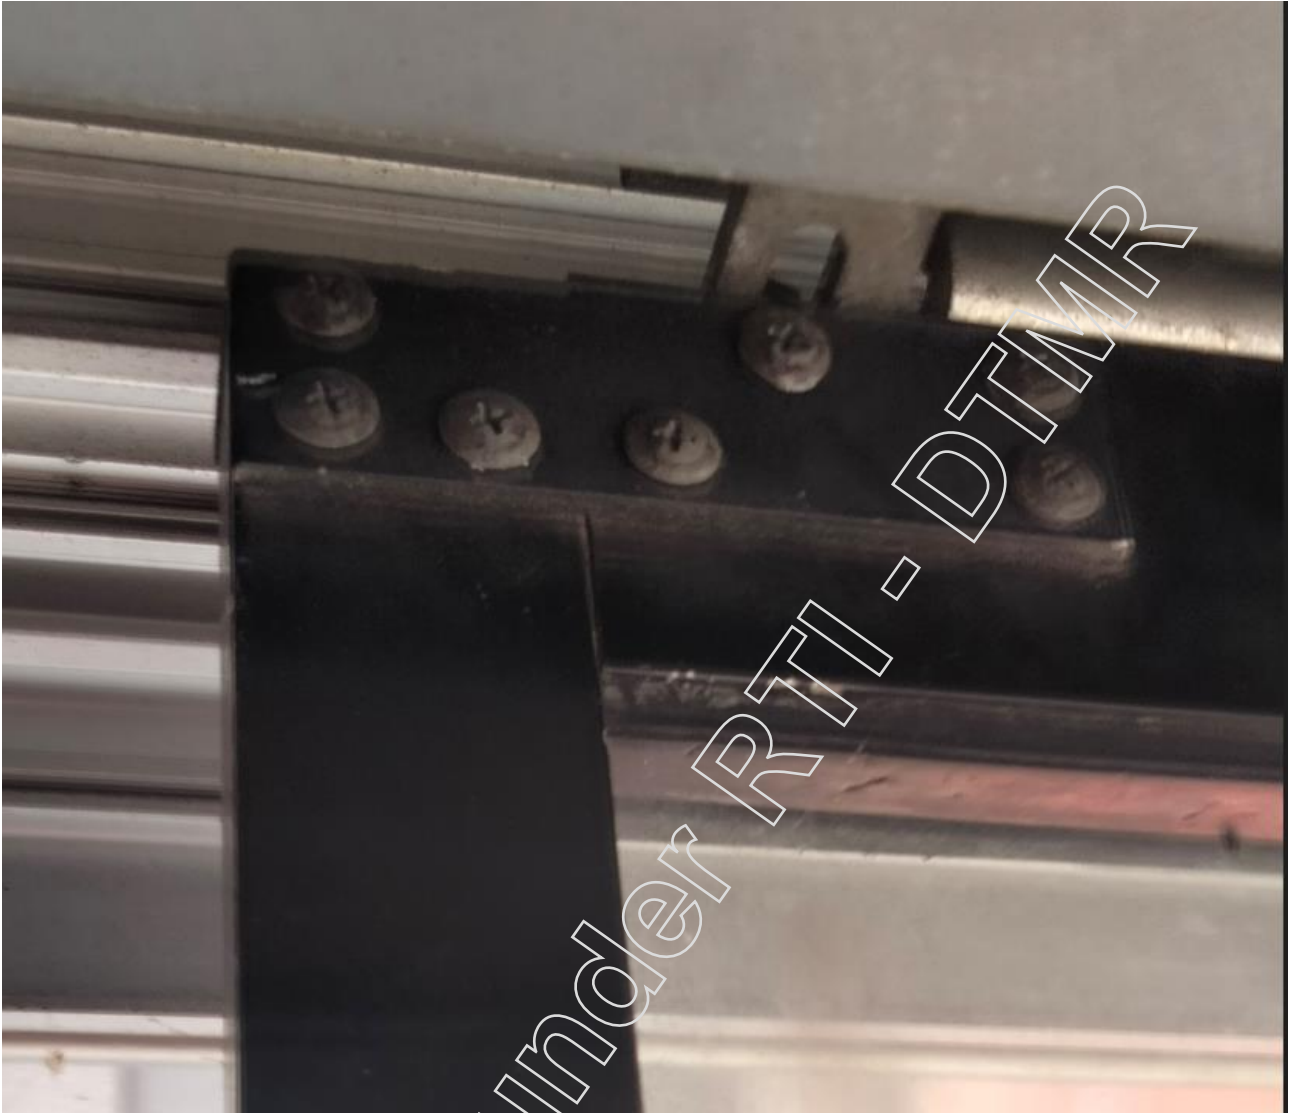
Both doors have broken the cast aluminum corner connectors on the moving door frames. The cause of the fault is unknown and could be related to age. Both East and West side door frames have been repaired using a plate riveted or screwed to the side of the door frames.

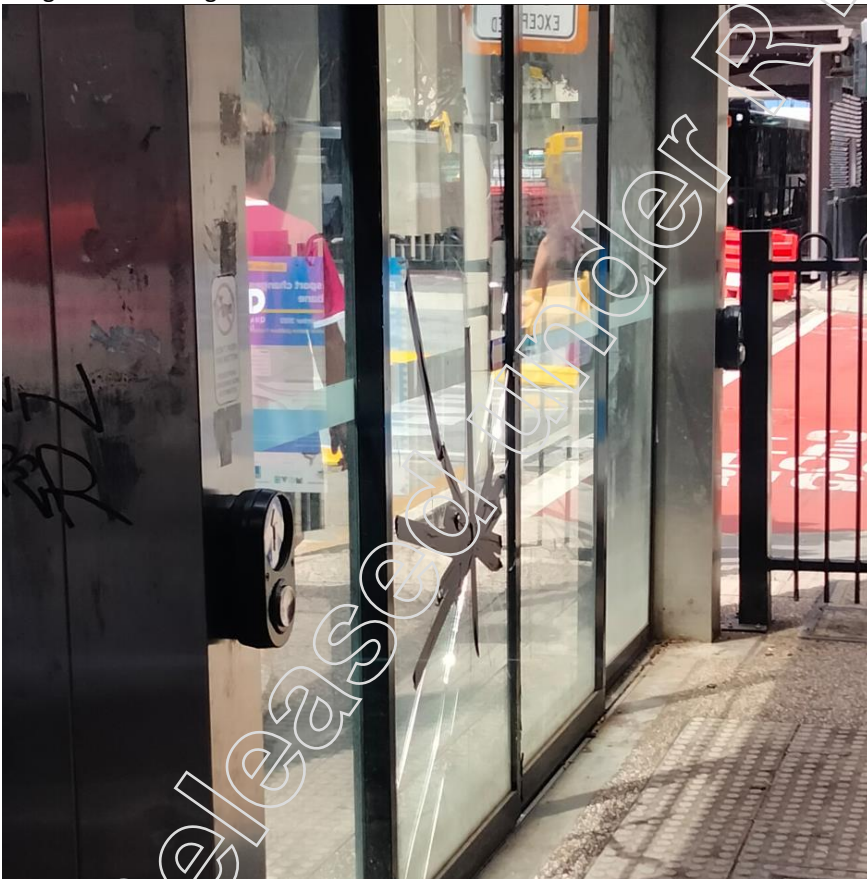
Both automatic doors have had been continually vandalized by the public. The glass panels in the doors have been shattered causing a safety hazard. Installation of temporary tape to the panels is required to prevent further failure, UGL is normally contacted to make safe and to replace the damage glass panel.

Image of smashed glass below:

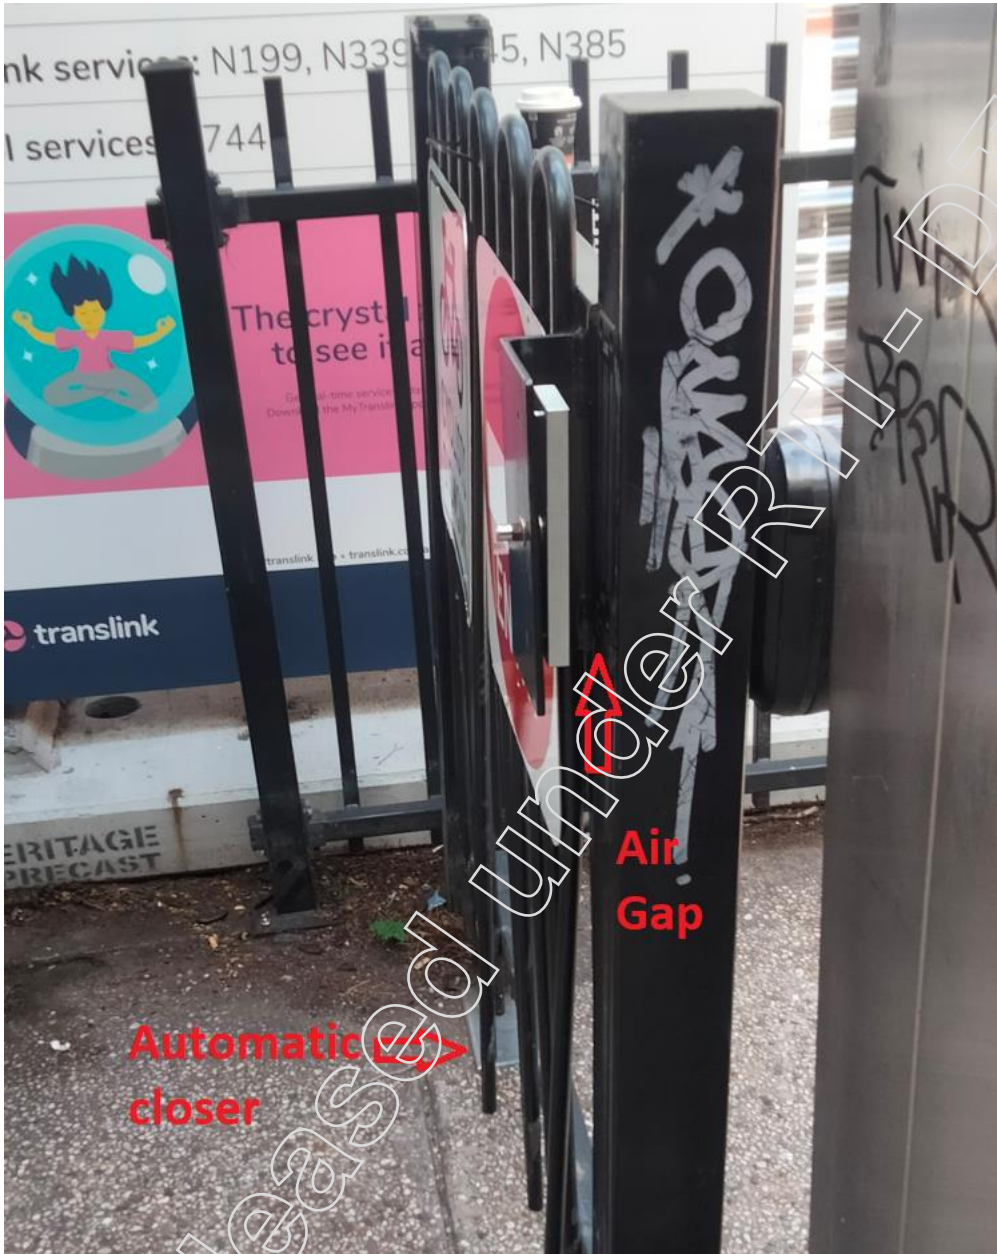
#### 5.4 EMERGENCY EXIT GATES NOT CLOSING/LOCKING

Both automatic doors have an emergency exit gate installed for pedestrians to exit if the door close before they have time to exit the crossing. Pedestrians need to push the exit button to release the magnetic lock on gate. The gate is installed with an automatic closer installed into the ground, these are devices are worn and subject to failure. When the automatic closer fails to operate the magnetic lock will not engage. This leaves the gate to be manually opened, allowing pedestrians to bypass the automatic doors if they desire.
