Road Safety Audit Existing Stage

**Western Arterial Road
(Toowong – Everton Park)
Chainage 1.40km – 2.00km**

Prepared for Department of Transport and Main roads (Metropolitan Region)

Road Safety Audit (Existing Stage): Western Arterial Road U18B (Toowong – Everton Park), Chainage 1.40km – 2.00km

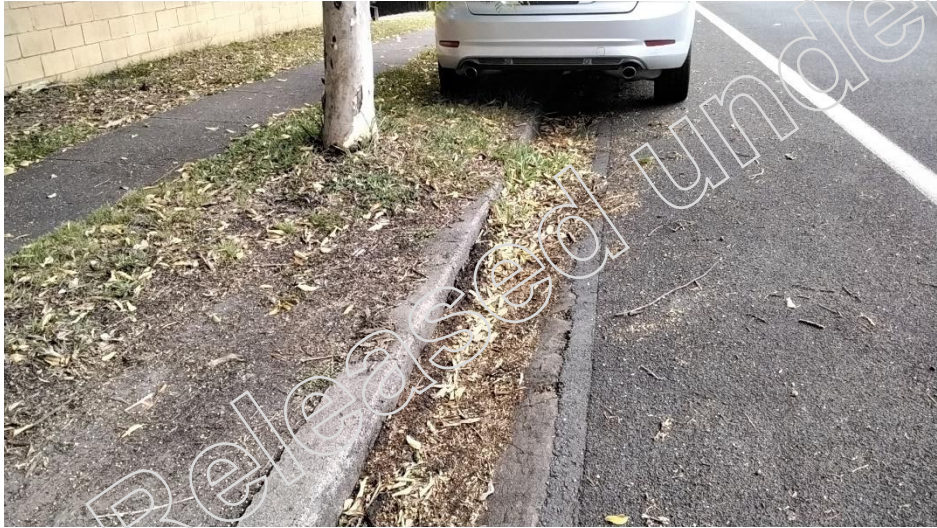
Item no.	Audit findings	Suggested action	Priority
<p>6.1.3</p>	<p>There were a number of locations where a build-up of silt and grass/weeds in kerb and channel inverts was likely to prohibit unrestricted stormwater flow. It was also likely the build-up would cause stormwater to pond and potentially flow into the adjacent traffic lane, creating a safety hazard for cyclists and vehicular traffic.</p> <p>On the northbound approach to the southern roundabout (intersection with Rainworth Road), the issue was exacerbated by a series of steel plates and concrete ramps at property accesses – installed to minimise vehicles bottoming-out as they traversed the changing grade between the road surface and property driveways. In addition to impacting stormwater flow, the steel plates and concrete ramps could present a hazard to cyclists riding along the outer edge of the roadside.</p>

<p>Photograph 1: Example build-up of silt and grass/weeds in kerb and channel invert.</p>	<p>Recommendation 6.1.3.1: Arrange maintenance activities to clear all silt and grass/weed build-ups from drainage inverts throughout the audit site. Also, repair or remove damaged or dislodged pieces of concrete ramps.</p> <p>Recommendation 6.1.3.2: In conjunction with future upgrade works on Western Arterial Road, consider options to regrade surfaces that would allow the permanent removal of all steel plates and concrete ramps at property accesses. Prioritise action accordingly.</p>	<p>L = Rare S = Serious P = Medium (FSI)</p>

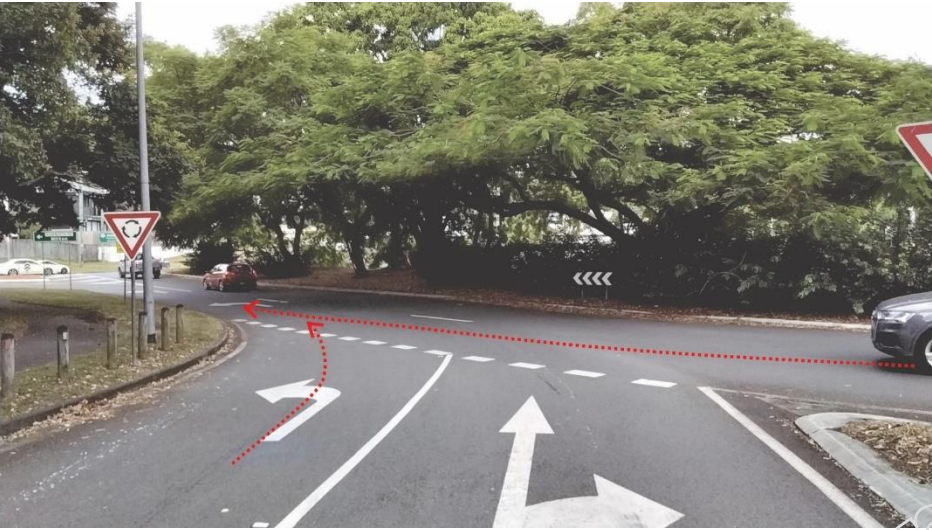
<p>Photograph 14: Southern roundabout - view looking south from Western Arterial Road. Due to a lack of lane line markings, circulating vehicles intending to change lanes and make a left-turn exit conflicted with vehicles entering the roundabout from the left lane.</p>

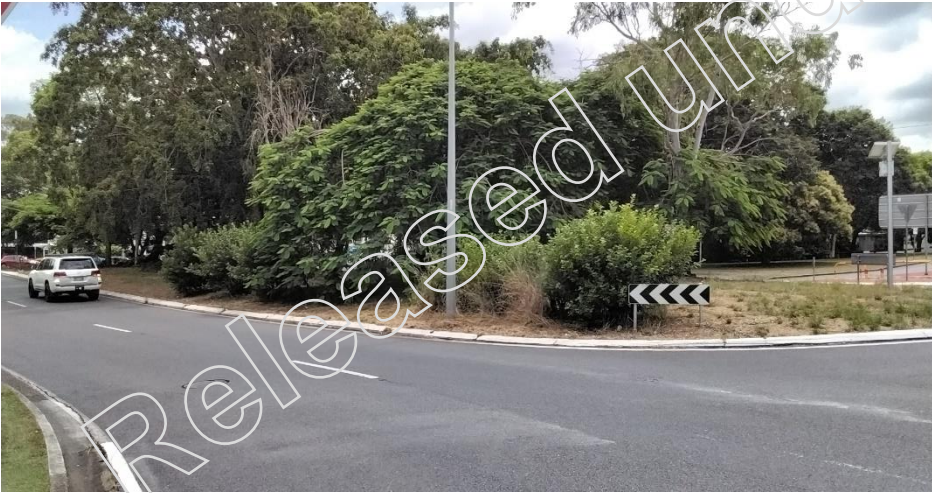
<p>Photograph 15: Northbound view from southern end of roundabout. Thick vegetation in the central island obstructed sight lines to circulating vehicles, impacting decision times for drivers to select safe gaps to enter the roundabout.</p>

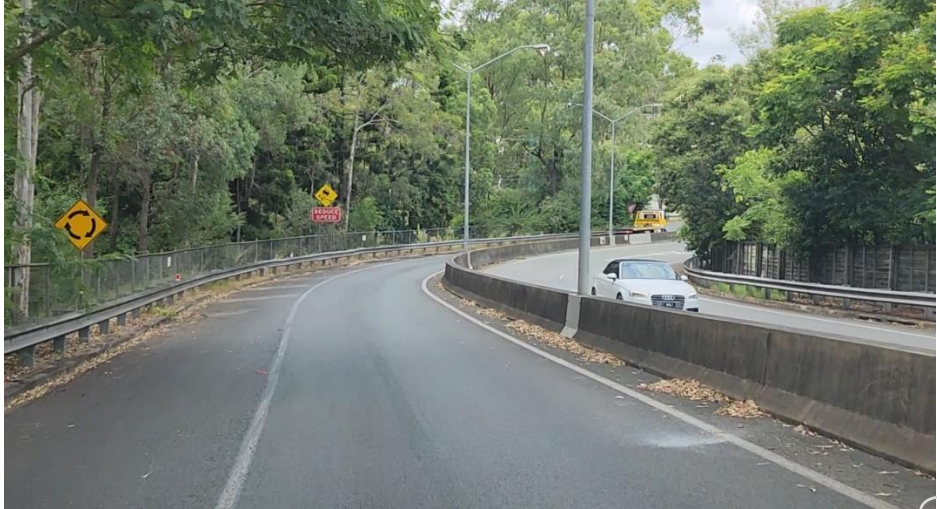
<p>Photograph 21: There was a curve in the horizontal alignment that limited vehicle speeds on the southbound approach to the roundabout on Western Arterial Road.</p>

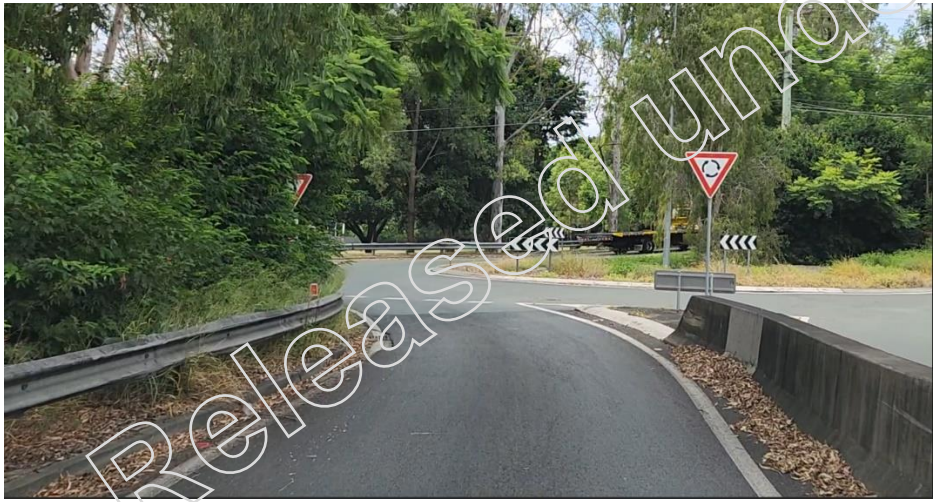
<p>Photograph 22: Southbound entry to northern roundabout from Western Arterial Road. Compared to the northbound entry, there was some deflection in the existing horizontal alignment that restricted vehicles speeds entering roundabout before negotiating the small radius right curve around the end of the central island.</p>

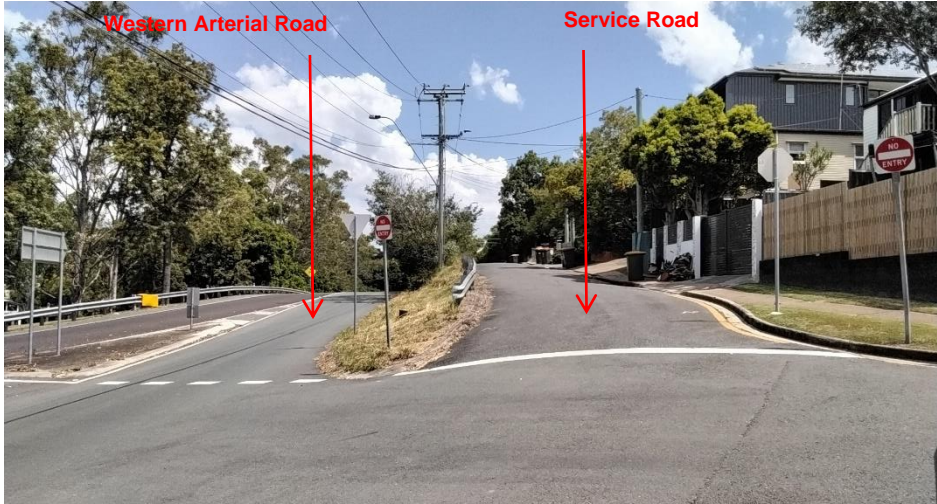
<p>Photograph 25: For traffic entering the intersection from the service road, there was a poor observation angle (looking back over right shoulder) to traffic approaching on the northbound lane on Western Arterial Road.</p>   <p>Photograph 26: Thick vegetation in the centre of the roundabout obstructed sight lines and prevented clear vision to the layout, alignment and other circulating vehicles.</p>

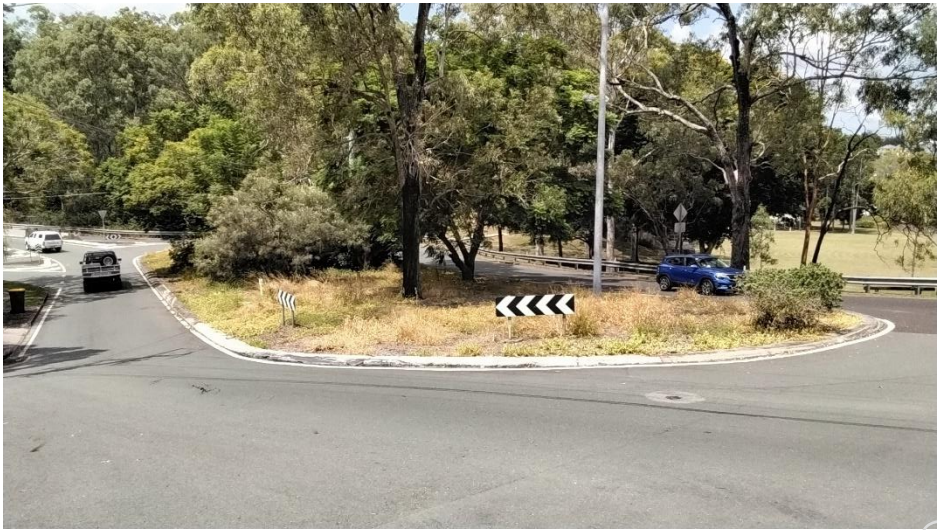
<p>Photograph 27: Thick vegetation in the centre of the roundabout obstructed sight lines and prevented clear vision to the layout, alignment and other circulating vehicles.</p>

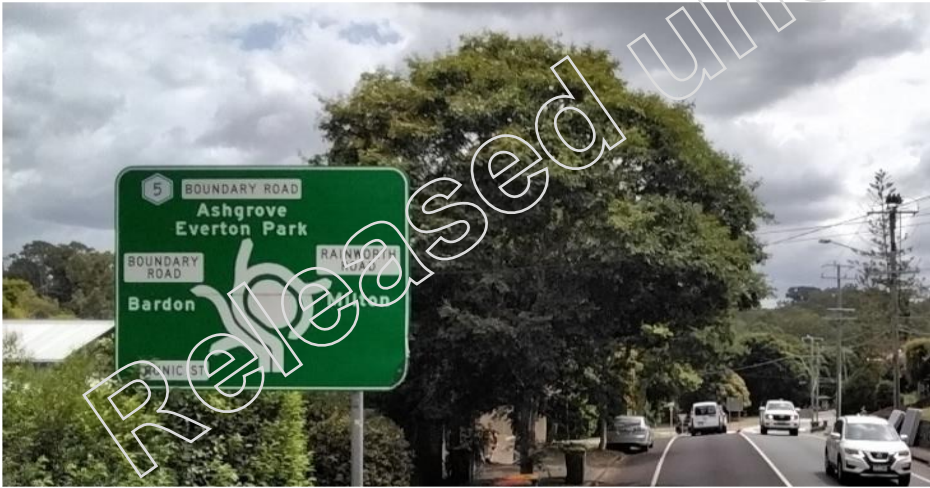
Item no.	Audit findings	Suggested action	Priority
6.4 Signs and lighting			
6.4.1	<p>The application of direction signs varied throughout the audit site. Issues observed included:</p> <ul style="list-style-type: none"> • varying condition, some with minor damage • different design standards – such as roundabout diagrams and illustration of dual circulating lanes • inconsistencies with content – such as between advance and intersection signs on the same approach leg • no advance direction signs on northbound or southbound approaches to northern roundabout, nor northbound departure from northern roundabout • sign faces obscured by vegetation (refer Recommendation 6.4.7.1) <p>Given the complexity of the alignment and number of intersecting legs throughout the audit site, upgrading signage would benefit both safety and efficiency.</p>

<p>Photograph 28: Direction sign facing northbound traffic on approach to the southern roundabout. The roundabout diagram illustrates dual circulating lanes.</p>	<p>Recommendation 6.4.1.1: Instigate a project to review and upgrade all advance and intersection direction signs (and structures as required) throughout the audit site. The scope of works should ensure:</p> <ul style="list-style-type: none"> • an adequate provision of signage is provided at key decision points (including locations not currently signed) to effectively guide traffic through the complex site • signs are designed in accordance with current departmental design standards, including compliance of content with the local focal point plan. Sign content must be consistent throughout, particularly between advance and intersection signs on the same leg • a consistent approach is adopted for roundabout diagrams on advance signs – such as illustrating dual or single circulating lanes. The impact of any proposed changes to lane line markings should also be taken into consideration • sign structures are frangible where required to minimise the risk to occupants of errant vehicles. <p>Consider in conjunction with other approved signing works and prioritise action accordingly.</p>	<p>L = Unlikely S = Moderate P = Medium</p>

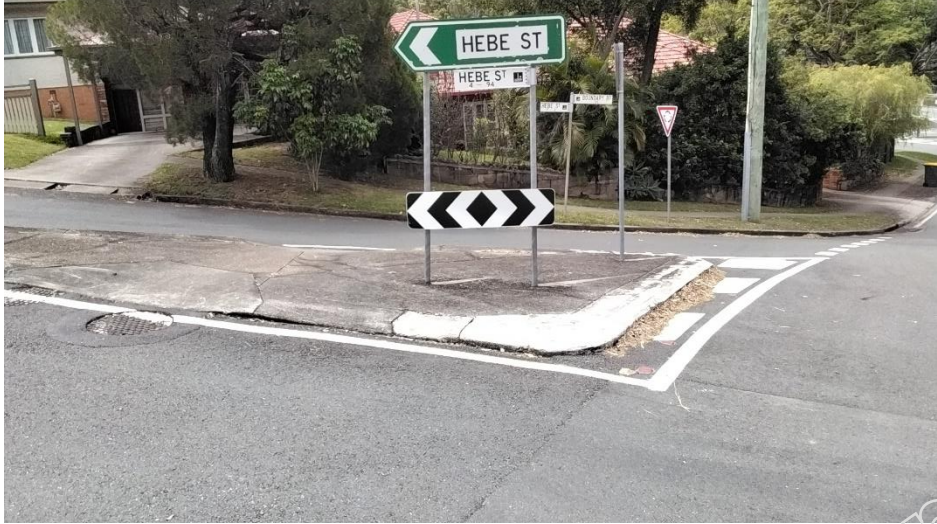
<p>Photograph 39: The existing direction sign at Hebe Street was in a deteriorated condition.</p>

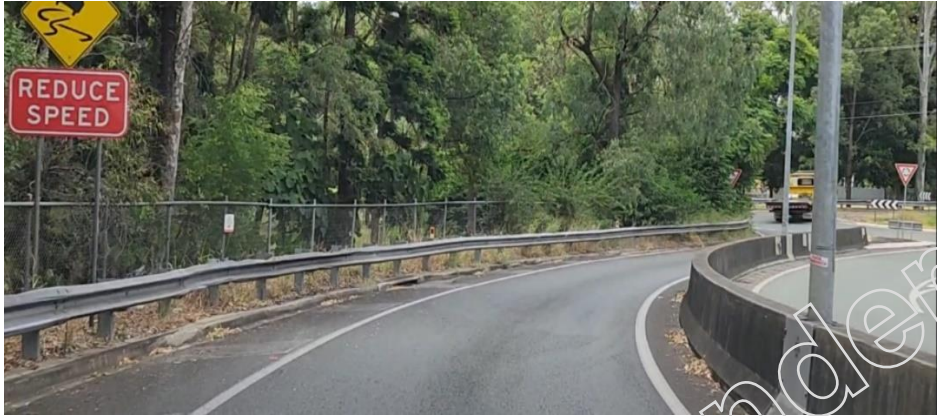
Item no.	Audit findings	Suggested action	Priority
6.4.2	<p>SLIPPERY (W5-20) warning signs were installed facing southbound traffic on Western Arterial Road on the approach and departure from northern roundabout. As a high friction pavement surface treatment had been applied to sections of the road in the vicinity, it was unclear if the signs were still warranted. To maintain credibility, it is essential warning signs, such as SLIPPERY, are restricted to locations where there is a current safety issue.</p>

<p>Photograph 40: Existing signage on southbound approach to northern roundabout.</p>

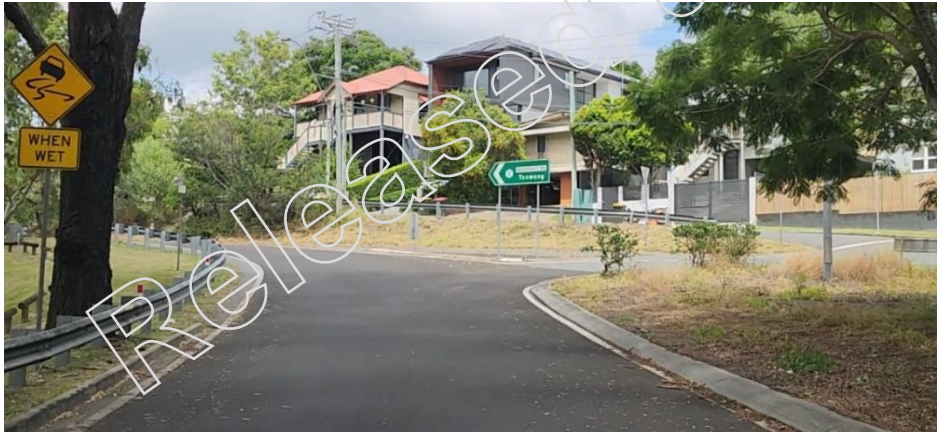
<p>Photograph 41: Existing signage on southbound departure from northern roundabout.</p>	<p>Recommendation 6.4.2.1: Confirm the exact locations of the deficient pavement surface and determine whether the high friction pavement surface treatments have rectified the safety issue. Review the warrants for retaining the existing SLIPPERY (W5-20) warning signs. Where signage is not required arrange removal. Consider in conjunction with Recommendation 6.4.3.1 (with regards to the existing REDUCE SPEED sign) and other approved signing works. Prioritise action accordingly.</p>	<p>L = Rare S = Moderate P = Low</p>

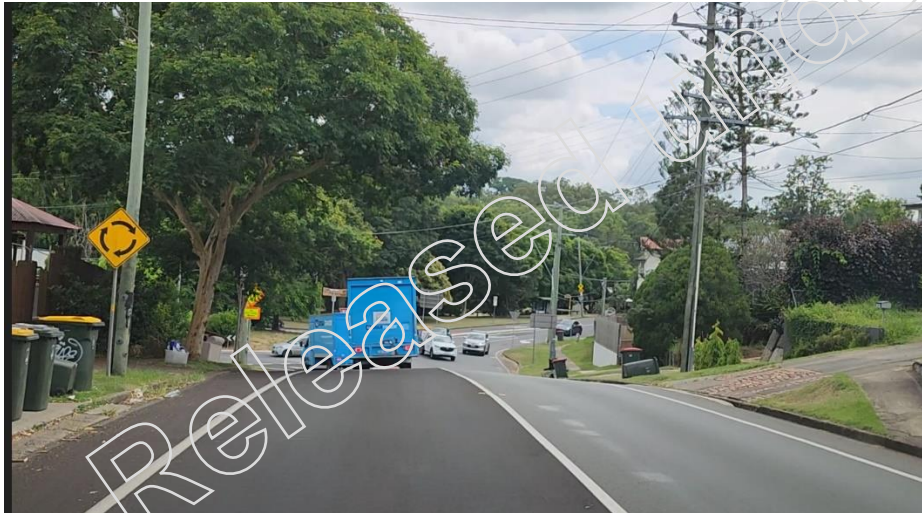
Item no.	Audit findings	Suggested action	Priority
<p>6.4.3</p>	<p>As discussed in Section 6.3, the audit team observed many vehicles appearing to enter, circulate and exit the roundabouts at excessive speed.</p> <p>To reinforce the presence of the roundabouts and the need for drivers to navigate at a safe speed, safety could be improved by installing more conspicuous warning signs on approaches.</p>

<p>Photograph 42: Existing warning sign on northbound approach to southern roundabout.</p>	<p>Recommendation 6.4.3.1: Remove the three existing ROUNDABOUT warning signs and posts. Install four (one on each approach to the northern and southern roundabouts) Target Board (TC1308) with a ROUNDABOUT (W2-7) warning sign. Consider in conjunction with Recommendation 6.4.2.1 (with regards to the existing REDUCE SPEED sign) and other approved signing works. Prioritise action accordingly.</p>

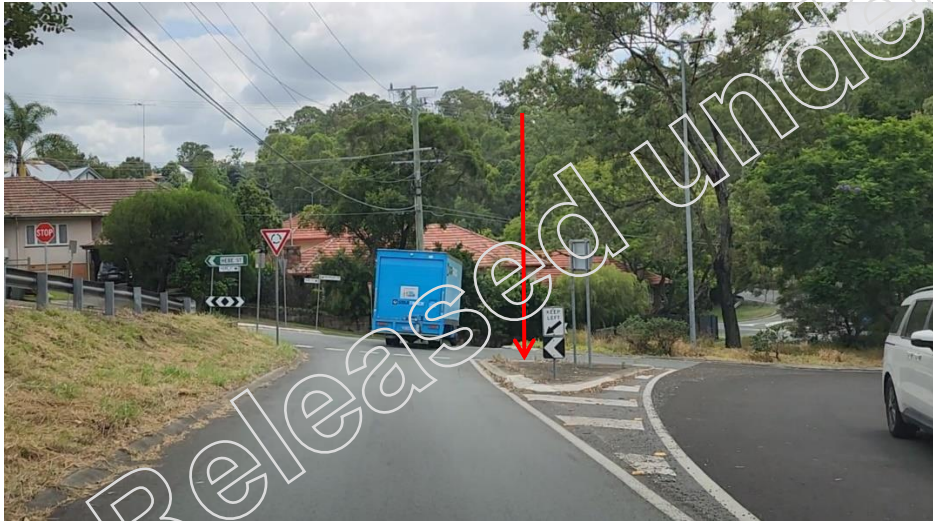
Item no.	Audit findings	Suggested action	Priority
<p>6.4.4</p>	<p>As discussed in Item 6.3.2, there was inadequate ASD on the northbound approach to the northern roundabout.</p> <p>To make the conflict point more conspicuous to approach motorists, safety could be improved by duplicating the regulatory ROUNDABOUT (R1-3) sign on the right side of the carriageway in the existing splitter island.</p>

<p>Photograph 45: To make the location of the conflict point more conspicuous to approaching traffic, installed a duplicate regulatory ROUNDABOUT sign.</p>	<p>Recommendation 6.4.4.1:</p> <p>To make the location of the conflict point at the intersection more conspicuous to approaching traffic, installed a duplicate ROUNDABOUT (R1-3B) sign on the right side of the carriageway in the splitter island. Consider in conjunction with other approved signing works and prioritise action accordingly.</p>	<p>L = Possible S = Serious P = High (FSI)</p>

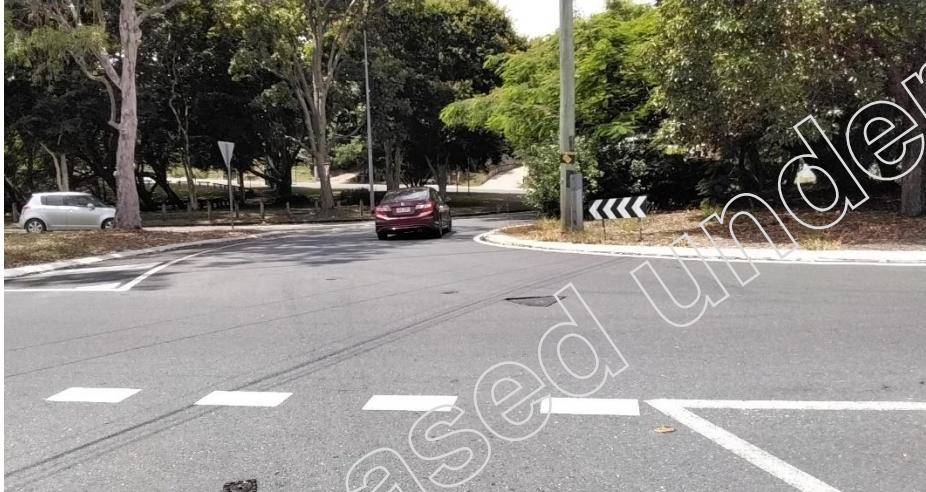
Item no.	Audit findings	Suggested action	Priority
<p>6.4.5</p>	<p>There was a UNIDIRECTIONAL HAZARD MARKER (D4-1-1) installed at the northern end of the southern roundabout central island (facing traffic entering from Boundary Road). The sign was in a deteriorated condition.</p> <p>Also, the sign was offset from an electricity pole that posed a safety hazard for occupants of errant vehicles.</p> <p>Safety could be improved by installing a new hazard marker in front of the electricity pole to maximise warning and guidance passed the roadside hazard.</p>

<p>Photograph 46: The existing hazard marker was in a deteriorated condition and offset from the electricity pole hazard.</p>	<p>Recommendation 6.4.5.1: Remove the existing hazard marker and posts. Install a new UNIDIRECTIONAL HAZARD MARKER (D4-1-1) in front of the electricity pole. Consider in conjunction with other approved signing works and prioritise action accordingly.</p>	<p>L = Rare S = Serious P = Medium (FSI)</p>

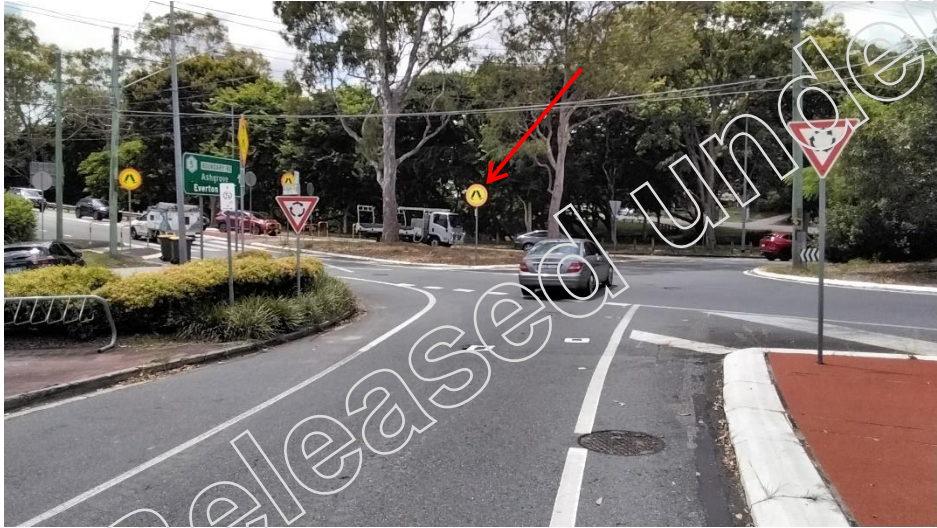
Item no.	Audit findings	Suggested action	Priority
<p>6.4.6</p>	<p>There was a PEDESTRIAN CROSSING warning sign installed facing eastbound traffic approaching the southern roundabout on Boundary Road. The sign referred to the crossing located on the northern departure leg, for left turning traffic. However given its orientation, it could be interpreted as another crossing located ahead for right turning traffic.</p> <p>The existing PEDESTRIAN CROSSING warning signs installed at the zebra crossing appeared to provide adequate warning for left turning traffic out of Boundary Road.</p> <p>To avoid any potential confusion, removal of the subject warning sign is recommended.</p>

<p>Photograph 47: The orientation of the PEDESTRIAN CROSSING warning sign (highlighted above) was potentially misleading.</p>	<p>Recommendation 6.4.6.1: Remove the existing PEDESTRIAN CROSSING (R3-1) warning sign and post.</p>	<p>L = Rare S = Moderate P = Low</p>

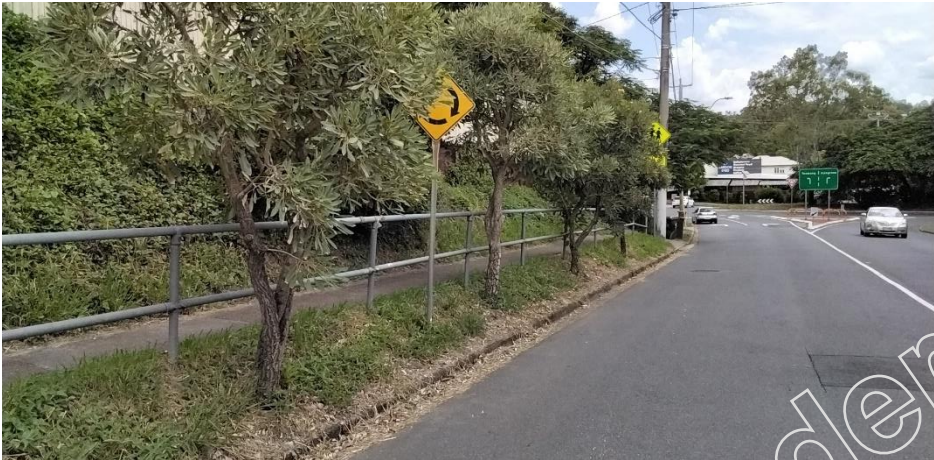
<p>Photograph 48: Westbound approach to southern roundabout on Rainworth Road</p>

Item no.	Audit findings	Suggested action	Priority
<p>6.4.7</p>	<p>Overgrown roadside vegetation obscured several signs throughout the audit site. To maximise safety, particularly with regards to regulatory control and warning messages, it is essential roadside vegetation is regularly inspected and maintained to ensure clear sight lines to signs for approaching road users.</p>

<p>Photograph 49: Northbound at Runic Street intersection.</p>	<p>Recommendation 6.4.7.1: Arrange vegetation trimming as required to ensure all road traffic signs are clearly visible to approaching traffic.</p> <p>Recommendation 6.4.7.2: Review the current maintenance program with a view to ensuring routine inspection and undertaking of vegetation trimming surrounding road traffic signs.</p>	<p>L = Rare S = Serious P = Medium (FSI)</p>

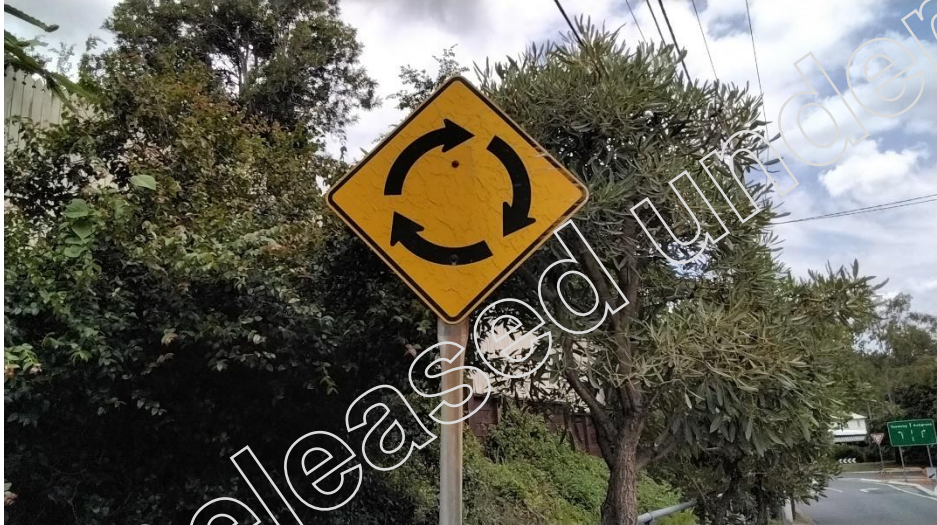
Item no.	Audit findings	Suggested action	Priority
<p>6.4.8</p>	<p>There were a number of signs in poor or a deteriorated condition throughout the audit site.</p> <p>To maximise safe and efficient traffic movement it is essential signs are maintained to a high standard.</p>

<p>Photograph 53: Example warning sign in poor condition. Also, the sign was installed on a flat top post that is no longer approved for use.</p>	<p>Recommendation 6.4.8.1: Instigate a project to replace all damaged and deteriorated signs throughout the audit site. Before replacement, check:</p> <ul style="list-style-type: none"> • the warrants for retaining sign against relevant guidelines and standards • suitability of current location • compliance of current sign face content and design against relevant guidelines and standards • compliance of existing sign structure if re-used <p>Where funding permits, consider a mass action project to incorporate all approved signing recommendations from this report. Prioritise action accordingly.</p>	<p>L = Rare S = Serious P = Medium (FSI)</p>

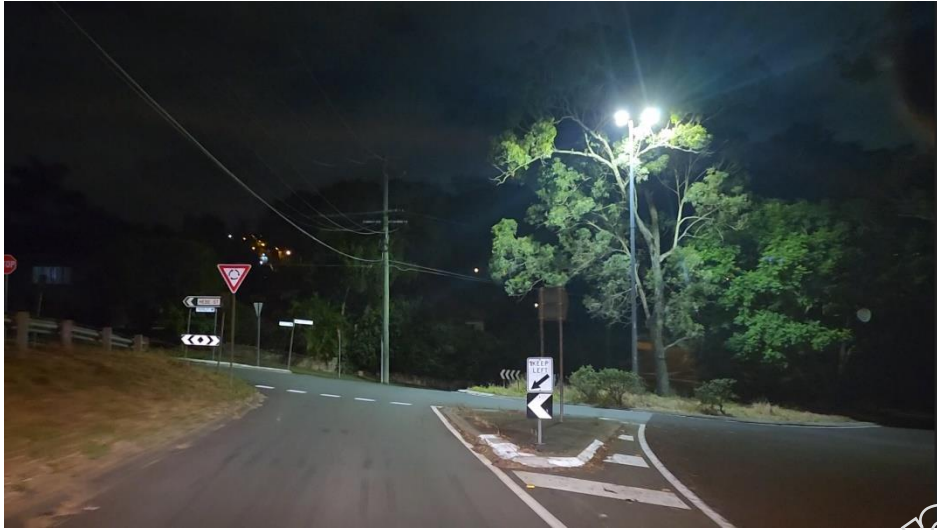
<p>Photograph 55: Southern end of northern roundabout. Tree foliage adjacent to the streetlights severely impact the spread of lighting.</p>   <p>Photograph 56: Northern end of northern roundabout. Tree foliage adjacent to the streetlights severely impact the spread of lighting.</p>

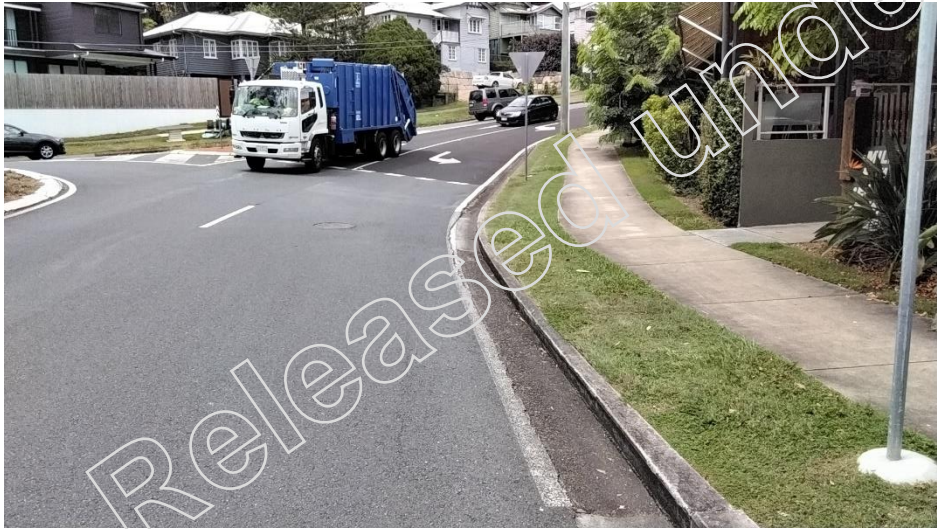
Item no.	Audit findings	Suggested action	Priority
6.5 Markings and delineation			
<p>6.5.1</p>	<p>As a general comment, there appeared to be an adequate provision of line and pavement markings throughout the audit – except on the southern roundabout circulating lanes as discussed in Item 6.3.1.</p> <p>While the overall condition of line and pavement markings was good and visible during daylight and night conditions, there were a few locations where reapplication was required due to dull or worn markings.</p> <p>Also, an edge line was not installed along the northbound lane on Western Arterial Road between the northern and southern roundabouts.</p>

<p>Photograph 57: Worn and dull edge line adjacent to the northbound entrance to the southern roundabout.</p>	<p>Recommendation 6.5.1.1: Undertake a detailed inspection throughout the audit site to identify all locations where dull or worn of line and pavement markings require reapplication. Consider in conjunction with Recommendation 6.3.1.3 and prioritise action accordingly.</p> <p>Recommendation 6.5.1.2: Install an edge line along the northbound lane on Western Arterial Road between the northern and southern roundabouts. Consider in conjunction with Recommendation 6.5.1.1 and prioritise action accordingly.</p>	<p>L = Rare S = Serious P = Medium (FSI)</p>

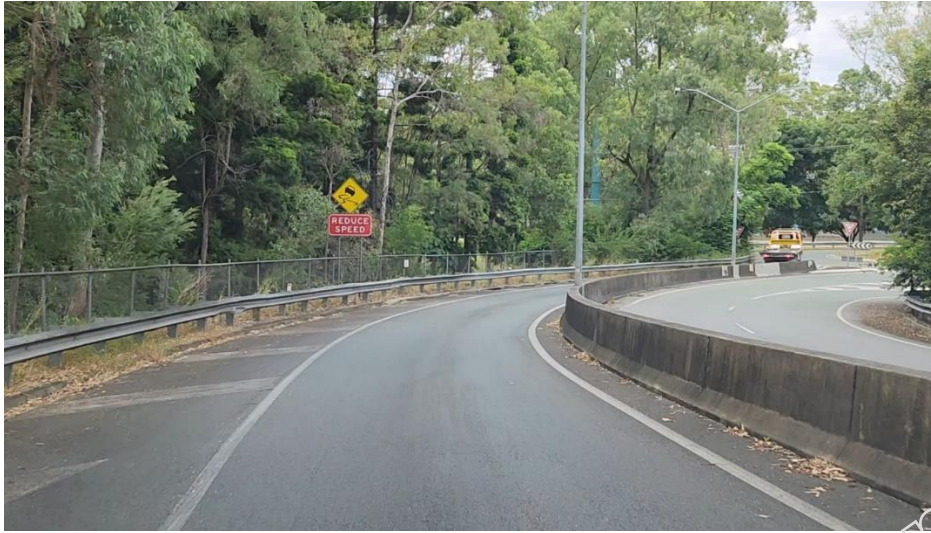
<p>Photograph 60: Southbound approach to the northern roundabout. The edge lines and chevron markings were in poor condition.</p>

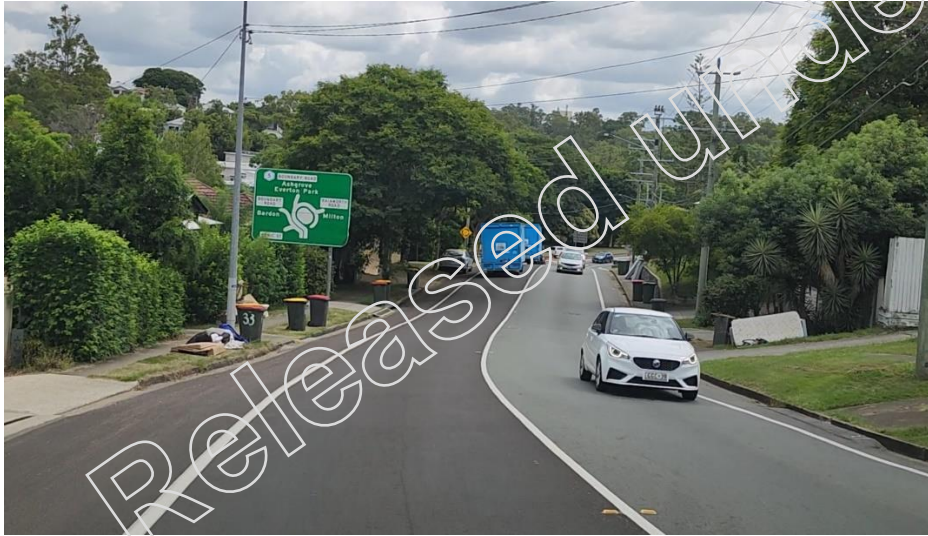
Item no.	Audit findings	Suggested action	Priority
6.5.2	<p>There was an inconsistent application of RRPMS throughout the audit site. While devices were installed along the centre of the road on approaches and between the two roundabouts, their application around intersection splitter islands and roundabout circulating lanes was varied and limited.</p> <p>As RRPMS provide important visual cues, particularly when the road pavement is wet or during foggy/misty weather conditions, it is essential the markings are installed and maintained to a high standard.</p>

<p>Photograph 61: RRPMS installed along the centre of the road on the northbound approach to the southern roundabout.</p>	<p>Recommendation 6.5.2.1: Instigate a project to upgrade RRPMS throughout the audit site to comply with minimum department standards and guidelines. Consider in conjunction with other approved safety works and prioritise action accordingly.</p>	<p>L = Unlikely S = Serious P = High (FSI)</p>

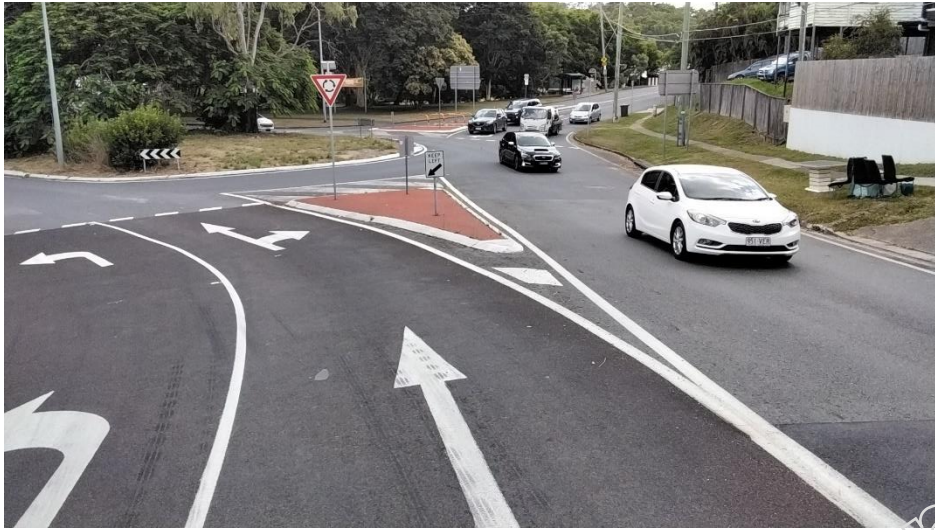
<p>Photograph 62: RRPMs not installed surrounding the splitter island at the southern end of the southern roundabout.</p>

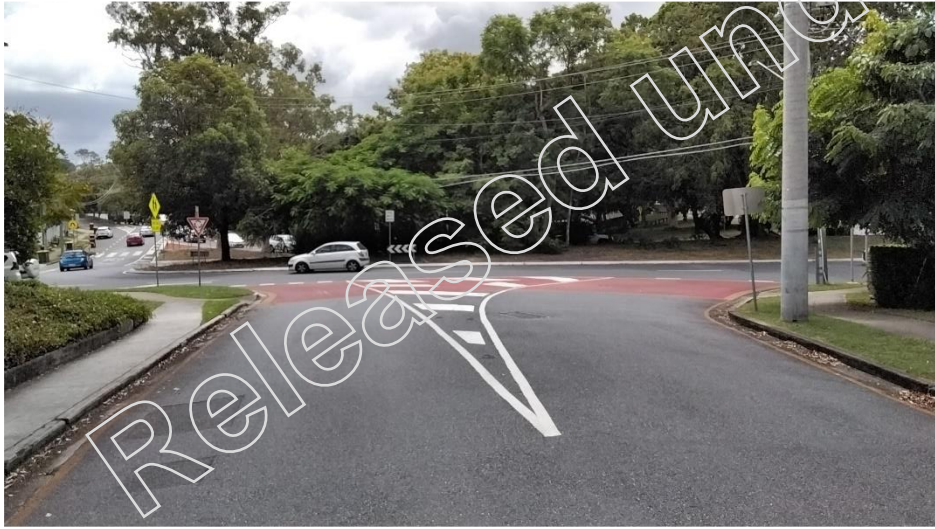
<p>Photograph 63: RRPMs not installed at the painted island at the Runic Street intersection.</p>

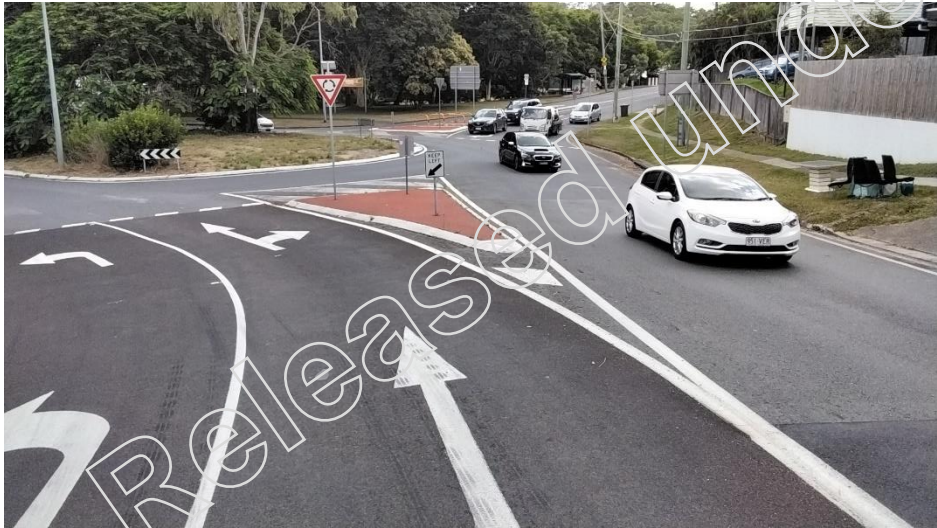
Item no.	Audit findings	Suggested action	Priority
<p>6.5.3</p>	<p>There were a significant number of raised traffic islands located at the two roundabouts within the audit site. Their conspicuousness during daylight and at night varied and was dependant on the condition of their surfaces and the extent and condition of painted concrete kerbing along the perimeters.</p> <p>At the southern roundabout. The surfaces of the traffic islands were painted terracotta colour, and the surrounding kerbs painted white. Some of the white painted on the kerbs was cracked and peeling. At the northern roundabout, surfaces were unpainted, and the nose of islands painted white. The unpainted concrete surfaces were typically dull and dirty, and there was poor contrast between the traffic island and the adjacent road surface. Some of the white painted on the kerbs was cracked and peeling.</p> <p>Safety could be improved by cleaning and repainting surfaces to provide a high and consistent level of delineation to traffic islands throughout the audit site.</p>

<p>Photograph 67: Northbound entry to southern roundabout. The coloured surface and white painted kerbs on the splitter island provided a high level of contrast to the adjacent road surface.</p>	<p>Recommendation 6.5.3.1: Instigate a mass action project to improve the delineation of traffic islands throughout the audit site. The scope of works could include:</p> <ul style="list-style-type: none"> • paint the surfaces of all traffic islands at the ‘zebra crossing’ kerbs and the northern roundabout the same terracotta colour as all islands at the southern roundabout • where surface painting is not supported, (water) pressure clean the exposed concrete surfaces to improve contrast to the adjacent pavement • repaint all the concrete kerbs surrounding the splitter islands and large central circulating islands with white reflectorised paint (to ensure a consistent standard and condition) <p>Consider in conjunction with other approved safety works and prioritise action accordingly.</p>	<p>L = Rare S = Serious P = Medium (FSI)</p>

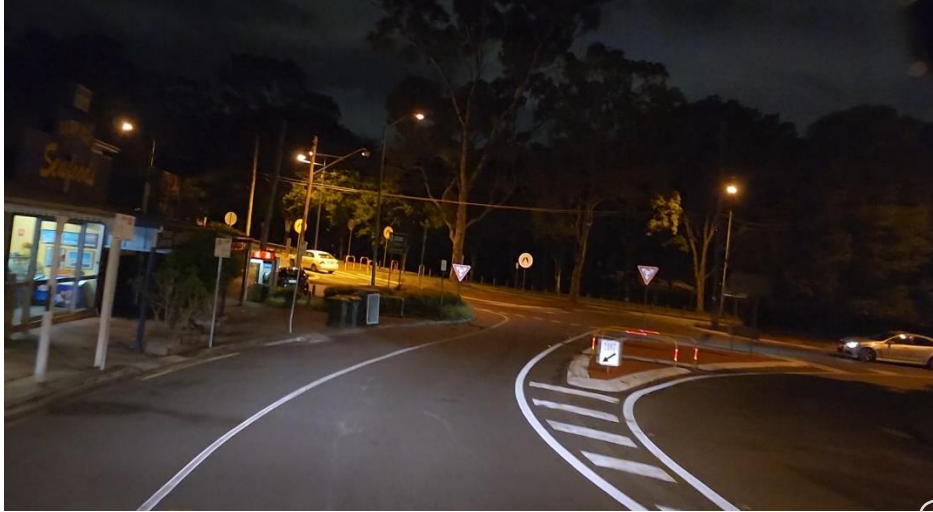
<p>Photograph 68: Boundary Road approach to southern roundabout. The coloured surface and white painted kerbs on the splitter island provided a high level of contrast to the adjacent road surface.</p>

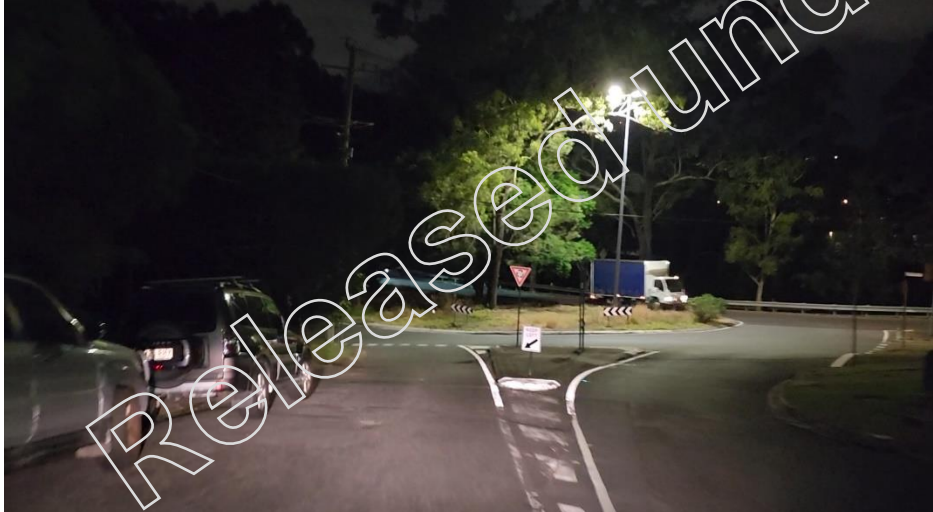
<p>Photograph 69: Hebe Street approach to northern roundabout. There was limited contrast between the traffic island surface and the adjacent road pavement.</p>

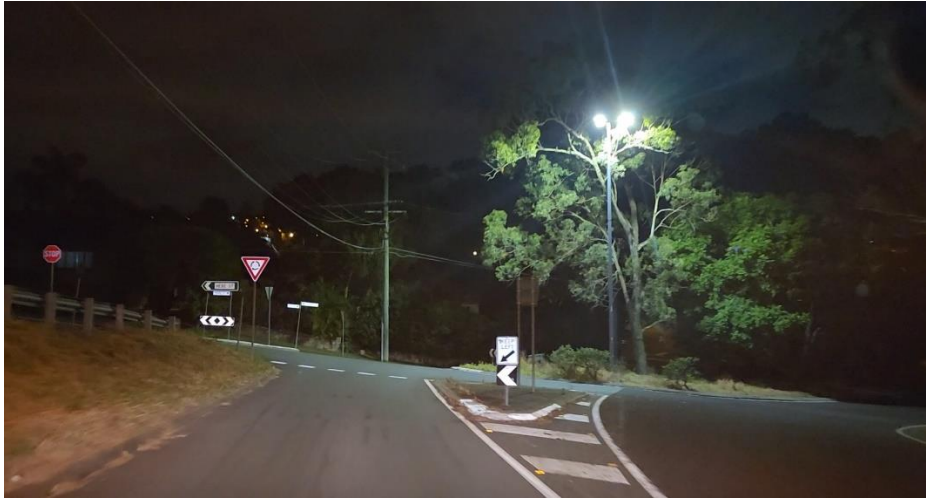
<p>Photograph 70: Northbound approach to northern roundabout. There was limited contrast between the traffic island surface and the adjacent road pavement.</p>

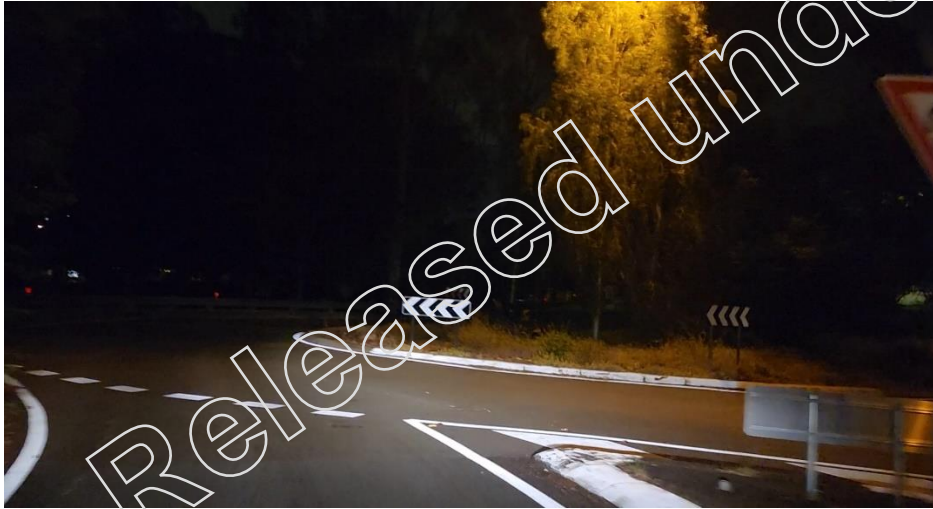
<p>Photograph 71: Southbound approach to northern roundabout. The painted kerb on the central island did not extend far enough around the perimeter to delineate the hazard.</p>

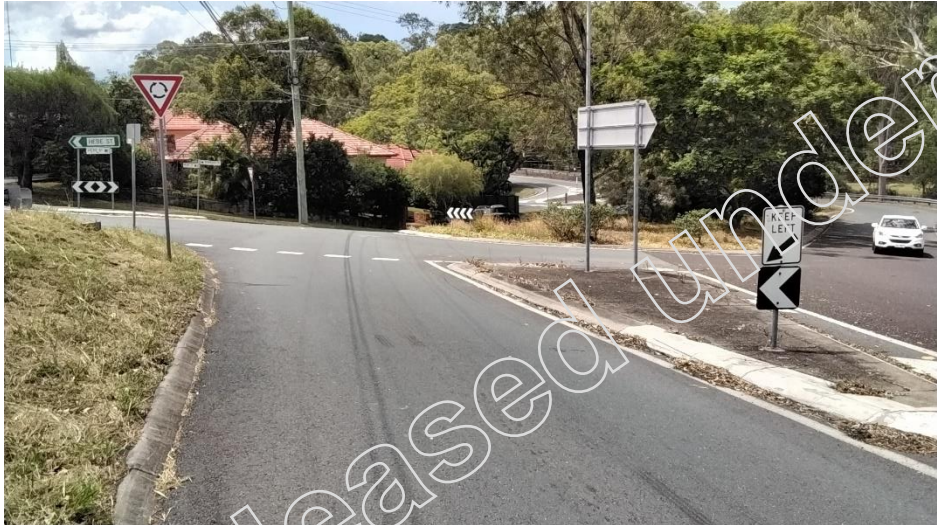
<p>Photograph 72: Northbound approach to the northern roundabout. The severity of the right curve passing the end of the central island, and the subsequent alignment further to the north, was not evident.</p>	<p>Recommendation 6.5.4.1 At the south-west corner of the central island, remove the small bush and grass surface to maximise forward sight distance across the roundabout for northbound traffic entering the intersection. Seal the surface with concrete or fake turf to prevent re-growth and maintain the sight line. Prioritise action accordingly.</p> <p>Recommendation 6.5.4.2 Commencing adjacent to the right end of the existing UNIDIRECTIONAL HAZARD MARKER in the central island, install short flexible bollards (or similar) along the top of the concrete kerb at regular intervals (for approximately 25m) to delineate the severity of the curve and subsequent alignment. Where supported, ensure the proposed delineation device is approved for use on the state-controlled road network. Prioritise action accordingly.</p>

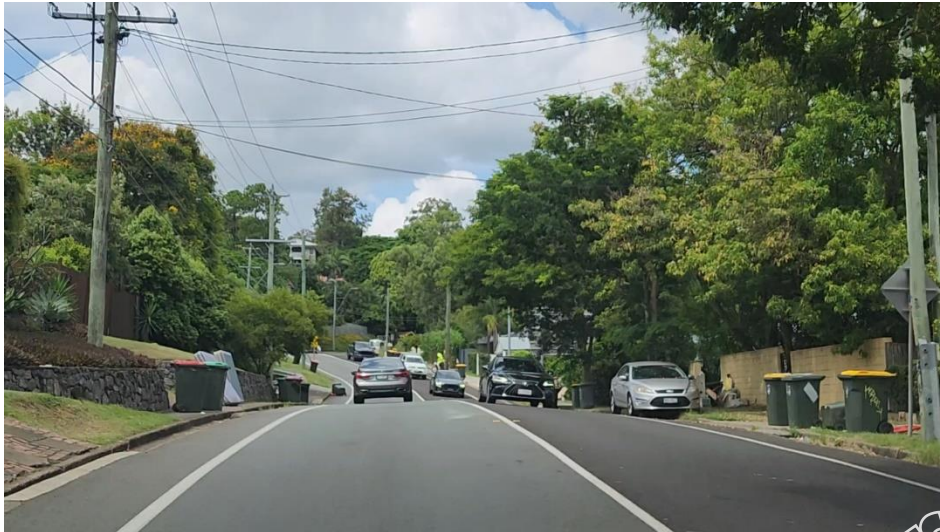
Item no.	Audit findings	Suggested action	Priority
6.6 Crash barriers and clear zones			
<p>6.6.1</p>	<p>There were a significant number of non-frangible hazards located close to the edge of the traffic lanes throughout the audit site, including:</p> <ul style="list-style-type: none"> • electricity and street light poles • trees with large diameter trunks • safety barriers • tree lined embankments • retaining walls. <p>A noticeable reduction in roadside hazards would require the undertaking of significant works to relocate electricity and street light poles and remove trees. In addition to extensive costs, it is highly likely environmental constraints and community expectation would prevent (or severely limit) tree removal. Installation of additional safety barriers may be an alternative solution to hazard removal where further investigation identifies an economic benefit.</p> <p>Safety could be improved, at the very least, by implementing better guidance, clearer delineation, and enhanced visual cues as outlined in the signing, linemarking, and delineation recommendations.</p>	<p>Recommendation 6.6.1.1 Instigate a project to identify and evaluate treatment options for high-risk hazards located within the audit site in accordance with the process detailed in Section 3 of AGRD, Part 6.</p> <p>If the evaluation finds that roadside risk intervention thresholds are met or exceeded, determine the relative priority of identified remedial works and, if appropriate, develop a hazard mitigation project.</p> <p>Recommendation 6.6.1.2 Where the evaluation suggested in Recommendation 6.6.1.1 determines that safety treatments cannot be justified, ensure a high standard of signing, linemarking, and delineation is implemented.</p>	<p>L = Possible S = Serious P = High (FSI)</p>

<p>Photograph 75: Retaining wall adjacent to southbound lane at southern end of audit site.</p>

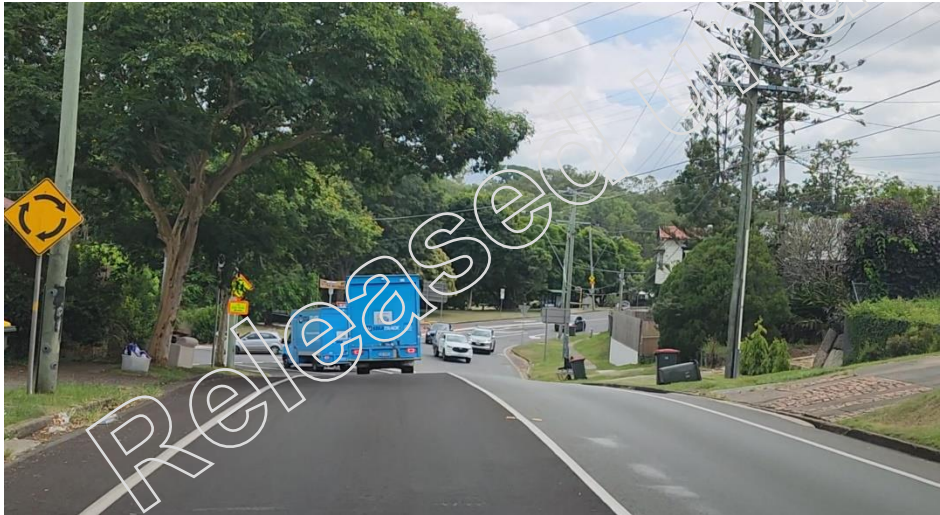
<p>Photograph 76: Large diameter tree trunks and electricity poles on both sides of the road on approach to the southern roundabout.</p>

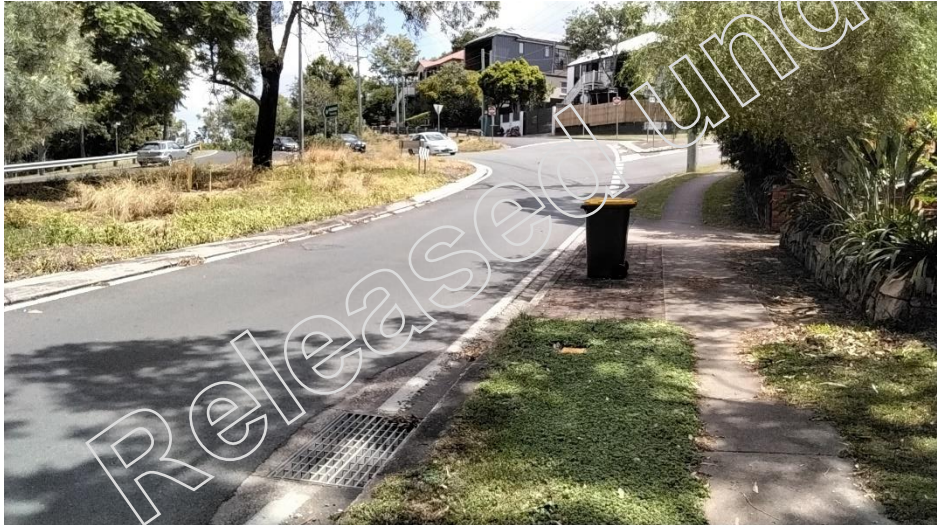
<p>Photograph 103: Narrow 1m wide path along the western side of the northern roundabout, between Hebe Street and Warburton Street. Partially overgrown with grass.</p>

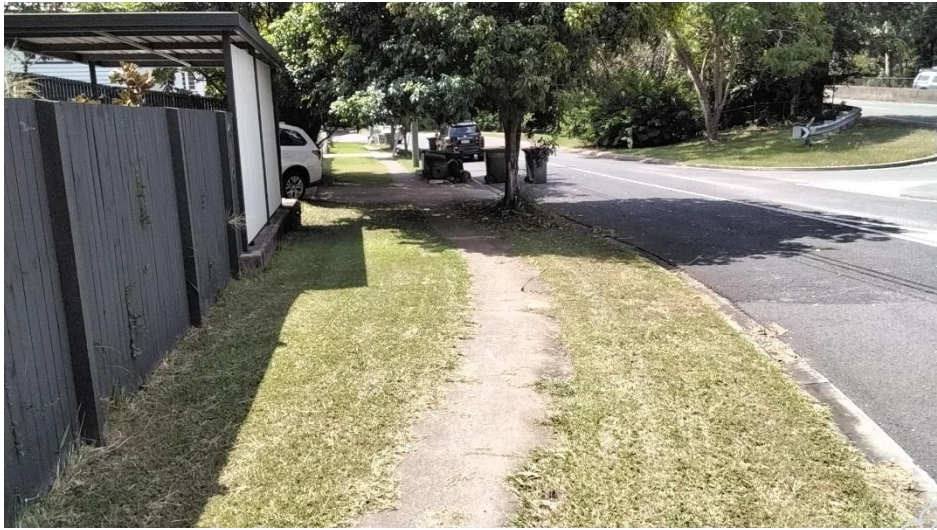
<p data-bbox="259 762 1193 815">Photograph 104: Narrow 1m path along southern side of Warburton Street. Partially overgrown with grass.</p>

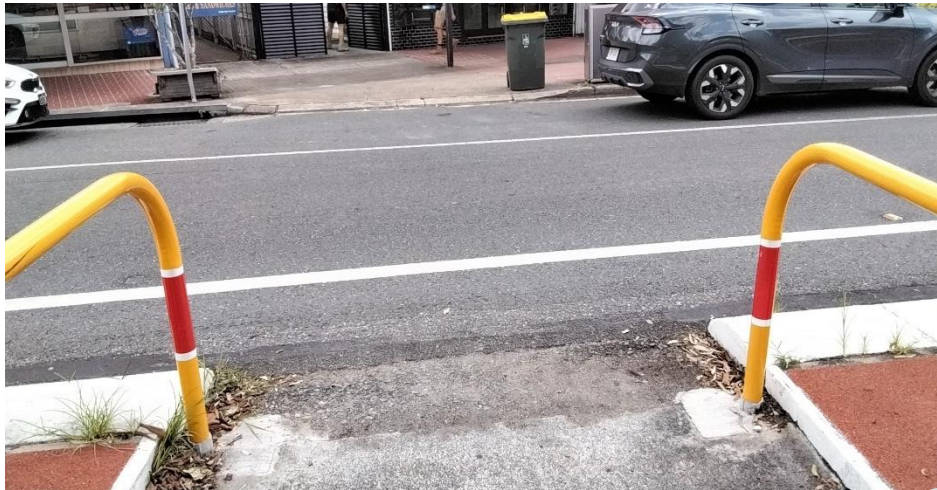
<p>Photograph 117: Northern corner of intersection with Boundary Road. Pedestrian access on the northern side of the road was via a property access and not a dedicated kerb ramp.</p>   <p>Photograph 118: Property access on the northern side of Boundary Road that provide access to the pedestrian refuge.</p>
