Road Safety Audit Existing Stage

**Western Arterial Road
(Toowong – Everton Park)
Chainage 1.40km – 2.00km**

Prepared for Department of Transport and Main roads (Metropolitan Region)

Road Safety Audit (Existing Stage): Western Arterial Road U18B (Toowong – Everton Park), Chainage 1.40km – 2.00km

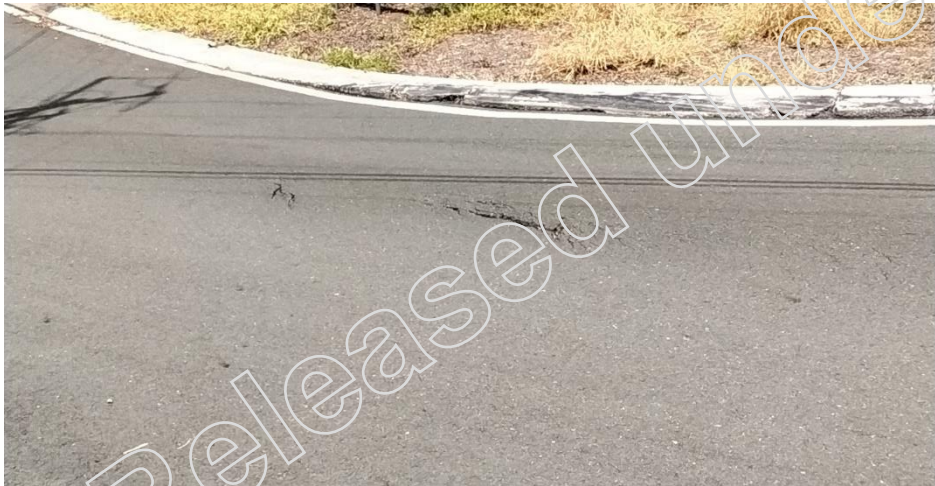
<p>Photograph 129: Failure in the northbound lane of the northern roundabout, adjacent to the intersection with Hebe Street.</p>	<p>Recommendation 6.10.1.1 Conduct a detailed inspection of the road pavement throughout the audit site to locate and assess pavement failures, and to determine an appropriate course of action to rectify. Prioritise accordingly. Consider in conjunction with other planned maintenance activities and prioritise action accordingly.</p>	<p>L = Unlikely S = Minor P = Low</p>
