**Transport and Main Roads**

**Serious Injury Collision, St Vincents Road, Banyo  
14 September 2012**

**Final report, rail incident investigation TMR 4617**

**Publication date**  
April 2013

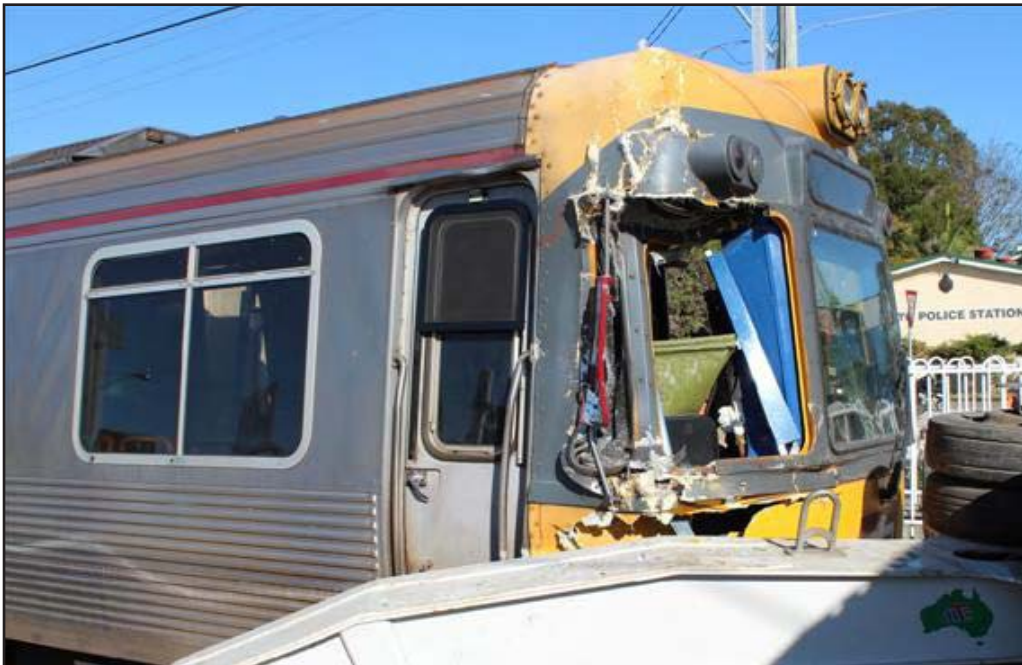
Figure 5: Damage to northbound train

The stationary southbound train sustained minor damage to the front of the cab. The northbound train derailed on impact and sustained significant damage to the drivers cab and along the right hand side of the lead unit, as depicted in Figure 5.

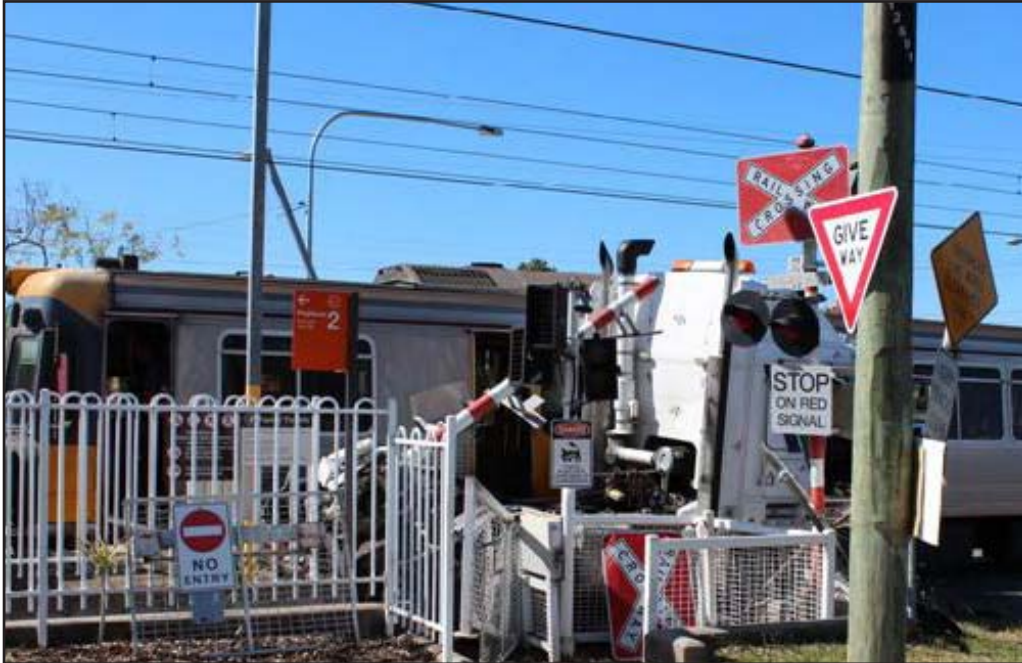
Figure 6: Damage to rail infrastructure

The pedestrian and level crossing protection equipment sustained extensive damage, as shown in Figure 6. The rail infrastructure including tracks and support structures and the overhead electrical lines sustained minor damage.

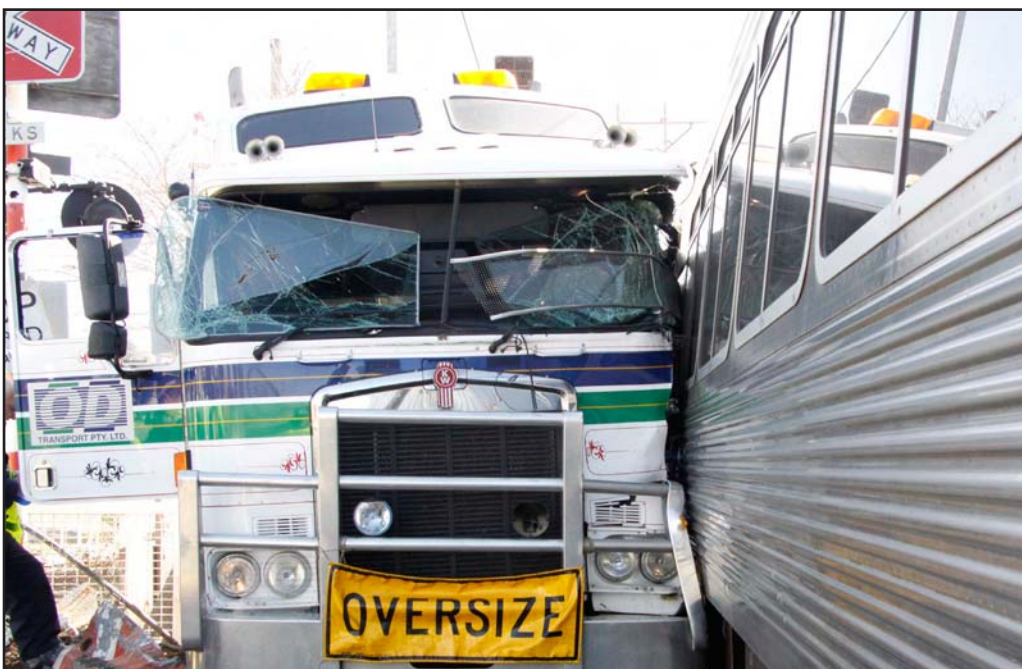
Figure 7: Damage to heavy vehicle

The heavy vehicle sustained extensive damage, as shown in Figure 7.

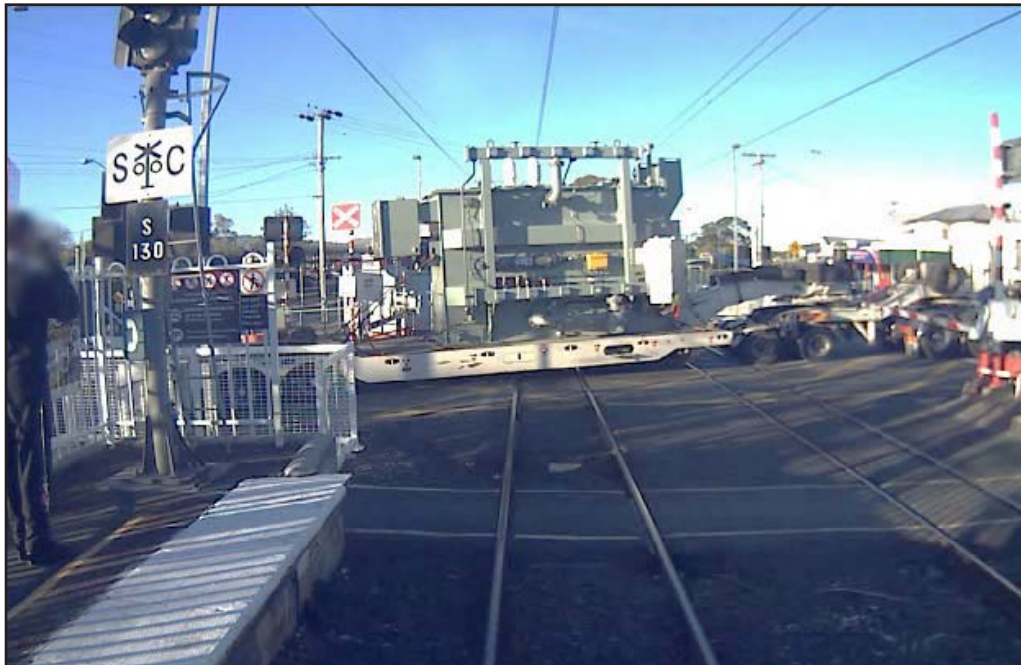
Figure 8: Heavy vehicle grounded on the level crossing, the CSA to the left on the radio

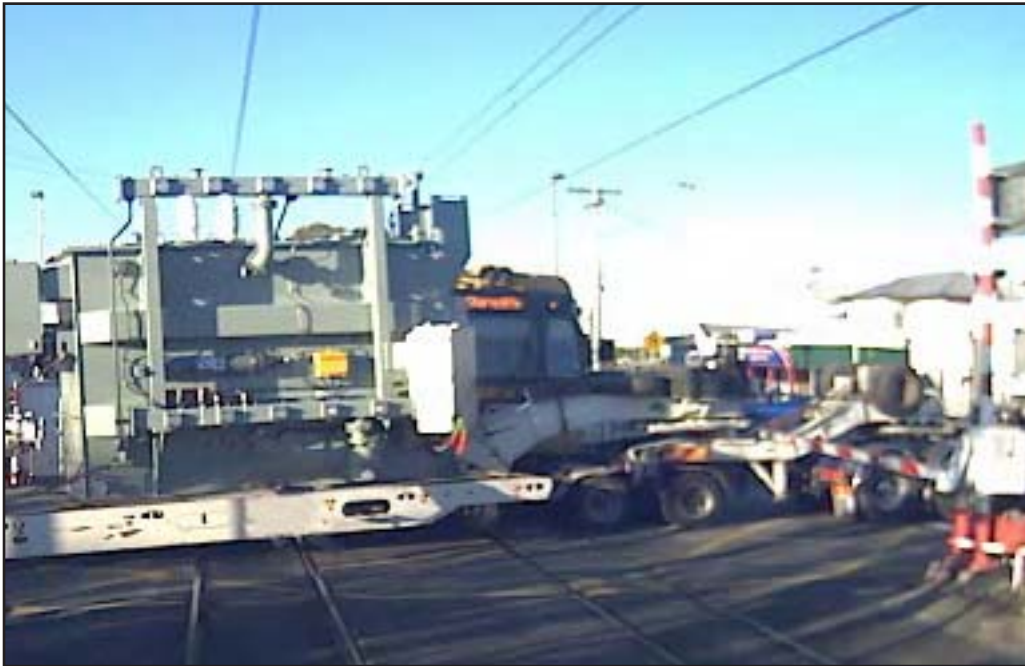
Figure 9: Moment of impact

At 6:32:35am, the northbound train collided with the heavy vehicle in the vicinity of the articulation point between the prime mover and dolly trailer (refer Figure 9). The member of the public escaped uninjured however the driver was struck by the low loader trailer and pushed into the eastern side rail corridor fence.

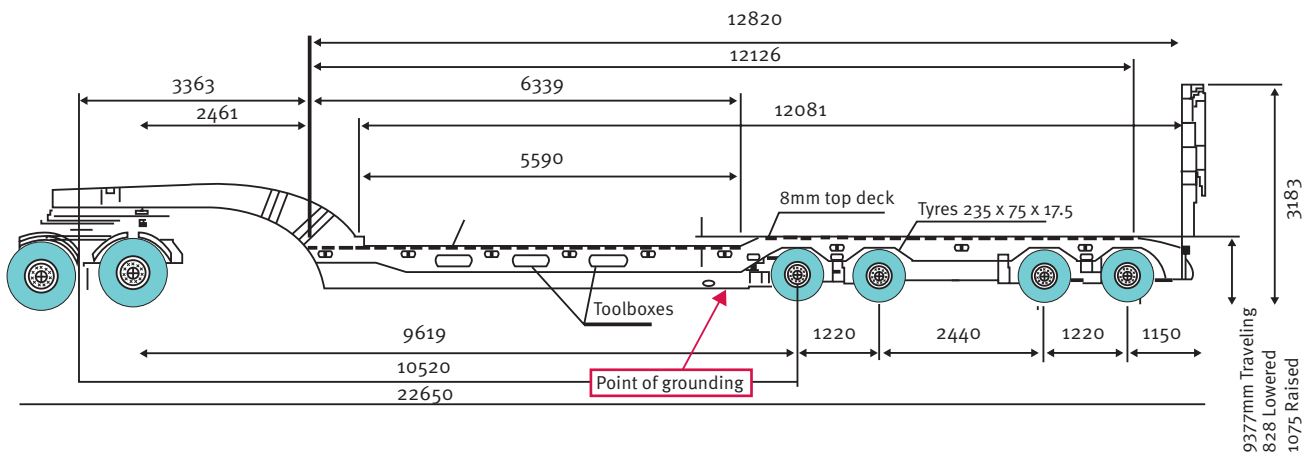
Figure 12: Schematic of low loader

Tufnell and St Vincents Roads are managed and maintained by the road manager. The roads are classified as suburban routes which connect arterial routes in and around suburbs and form important links in the public transport and inter-suburban freight network. The chassis of the low loader of the heavy vehicle combination became grounded on the road pavement in the vicinity of the third axle, which is depicted in Figure 12.

The grounding of the heavy vehicle is considered to be a contributing factor to the incident. Following the incident, the RTO undertook an assessment of the road geometry to determine its potential contribution to the incident. The RTO has created engineering drawings<sup>22</sup> that specify details of public road grading and sign posting for level crossings.

The assessment surveyed the geometry with vertical alignment cross sections at the centreline and both shoulders. The assessment found that the vertical geometry of St Vincents Road across the level crossing does not comply with the drawings, in that all three cross sections fall away more steeply on the approach side of the crossing.

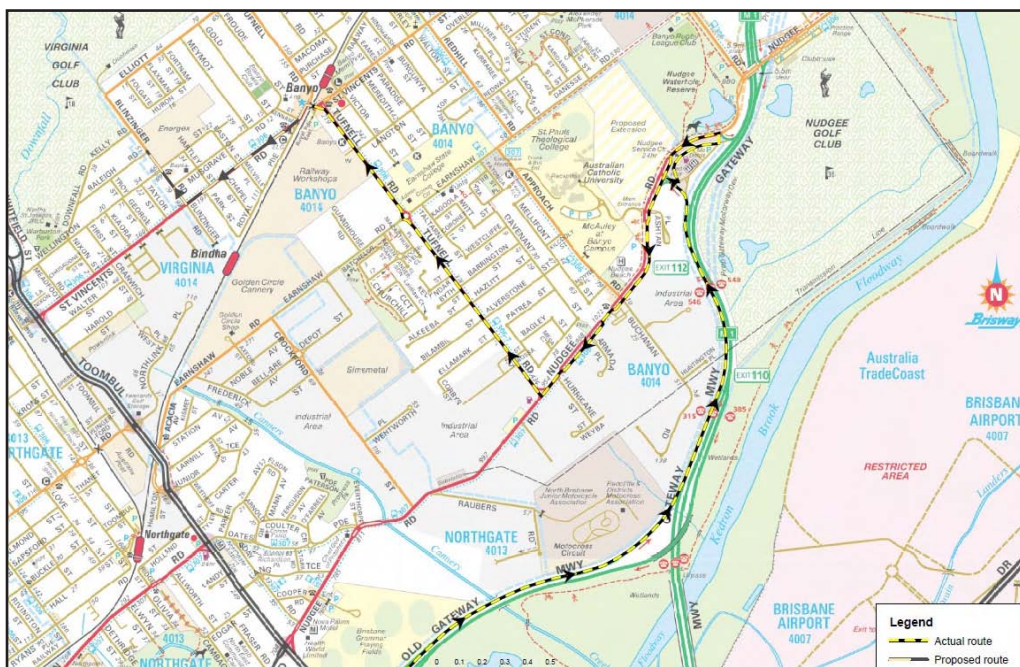
Figure 13: Route taken by the heavy vehicle

The onus to seek approval from the local road manager for operations on local government roads is a condition of travel under the current process. At the time of the incident, the heavy vehicle operator, and therefore the heavy vehicle driver did not have authority to travel on the local government roads.

The investigation team identified that there is no process in place whereby Transport and Main Roads notifies the relevant road manager that a permit application had been received or that an approval had been granted that interacts with the local roads. As a result, a coordinated response did not occur to address the risks of public safety and damage to infrastructure.

- Establish a process for the coordination of permit approvals and notifications between Transport and Main Roads and other road authorities until the introduction of the Heavy Vehicle (Mass, Dimension & Loading) National Regulations.
