Eton Range Realignment Project – Fauna Underpass Monitoring Final Report

State Route 70, Eton QLD, 4741

NCA21R133212

7 February 2022

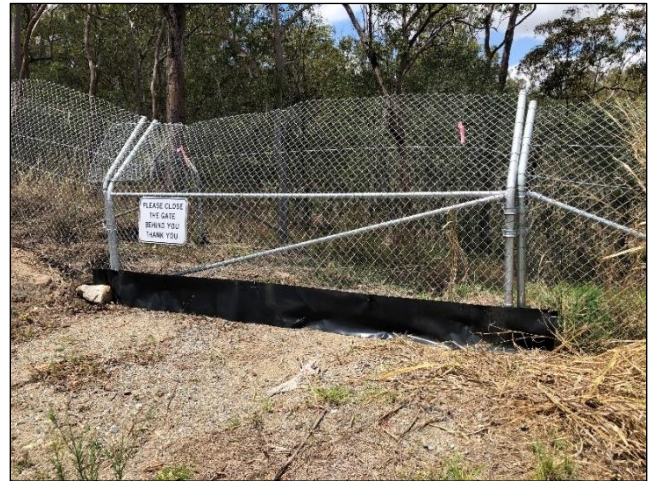
Plate 4: Gate Modifications

During construction of monitoring sites, Kleinfelder also made modifications to access gates and drainage lines where fauna was likely to breach the exclusion fencing. This involved lowering gate hinges and realignment with the fence to reduce the gap. Additionally, installation of a rigid block out screen on the bottom of the gates and sections of the fence was used to prevent under passing (**Plate 4 & Appendix B Site Photos**). The barbed wire fencing leading into Culverts 1 and 2 was removed to encourage fauna to funnel towards the culverts after traversing the fence lines. Fences were reinstated upon completion of monitoring. Removal and brush cutting of thick Guinea Grass and other vegetation at the funnel points was also completed.

Additional measures implemented during monitoring plot construction to prevent fauna from eluding culverts and entering the carriageways have seemingly reduced fauna strikes within the exclusion fenced system (anecdotal evidence supplied by project personnel). Only one record during the 2021 monitoring period, a Brushtail Possum, breached the fencing; these animals are capable of climbing over the exclusion fences. Although no fauna was found to be struck in the 2020 monitoring period, leading up to the 2021 monitoring period it was reported that two Koalas and other fauna had been struck on the range. Other fauna that was recorded as road strikes were at the outer extents of the fence system. *Koala Mapping Mackay & Whitsundays Areas Project* BioCollect data showed a 5/2 comparison of Koala death records from Vehicle strike on the Eton range prior to and post installation of exclusion fencing. This shows that the fencing is working however reason for the two post records may be due to gate operational error. Consideration of extension and / or diversion wings on the outer limits of the exclusion fencing is also recommended to encourage fauna traversing the fence to be redirected back into the bushland rather than around and onto the road. Permanent improved gate fixtures constructed with a concrete base should also be considered to prevent animals crawling underneath.

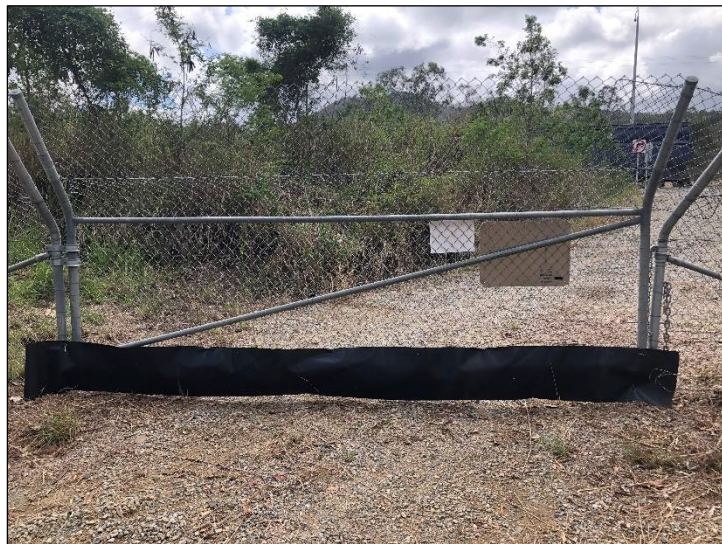
Photo 5: Modified Gate

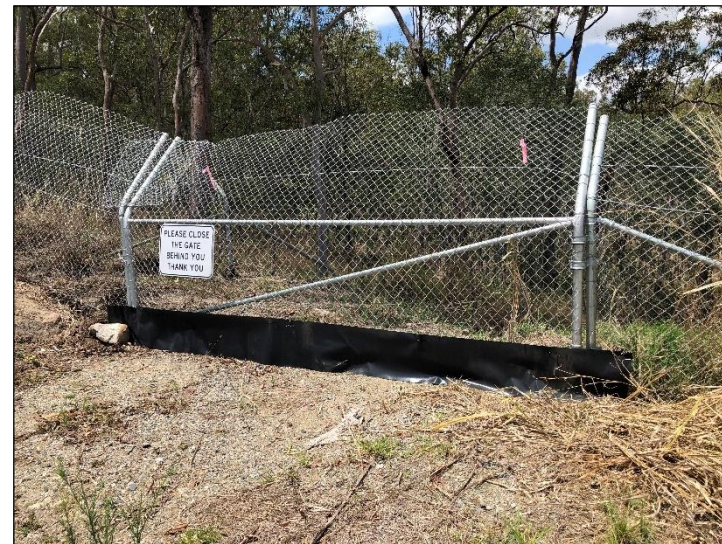
Photo 6: Modified Gate

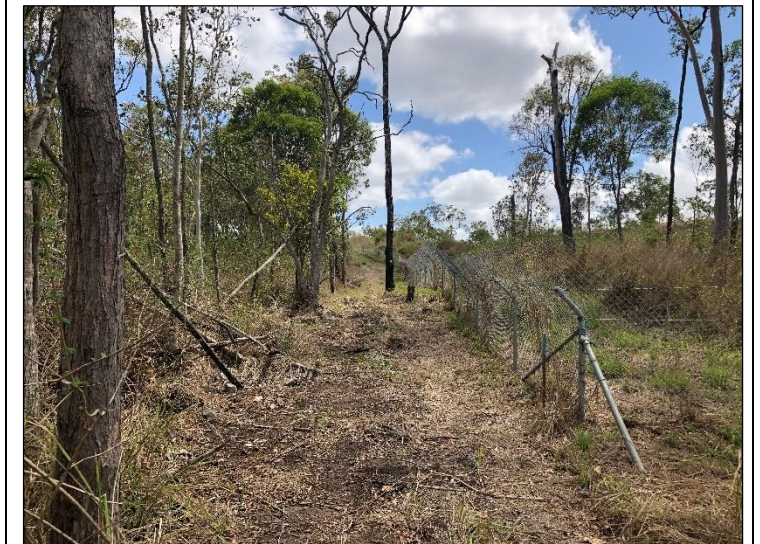
Photo 8: Cleared Fence Line Vegetation

Prior to the 2021 season monitoring, TMR had engaged a contractor to remove and mulch five metres of vegetation on the outer perimeter fences. It was evident that a number of sections observed in the previous monitoring were inaccessible to fauna due to vegetation thickness. Also, trees that were either overhanging or in contact with the fence would have allowed fauna to climb and cross over the fence. This allowed for improved access and encouraged funnelling towards to culverts. This resulted in an increase in fauna records on the Sand Plots and Camera Traps along the fence lines. The addition of infill rock (**Appendix B** Site photos example) leading up to the fauna Culvert 1 (Plot 2) on the outer eastbound carriageway has shown improved fauna interaction and promoted fauna entry and crossing for that culvert. This was particularly evident with macropod species. Allowing fauna to easily traverse the rock scour systems will overtime increase confidence in funnelling and entering the culverts. Revegetation and management of weeds on the westbound route on the outside aprons to provide overhead ground cover and protection for terrestrial species will also support and encouraging funnelling.

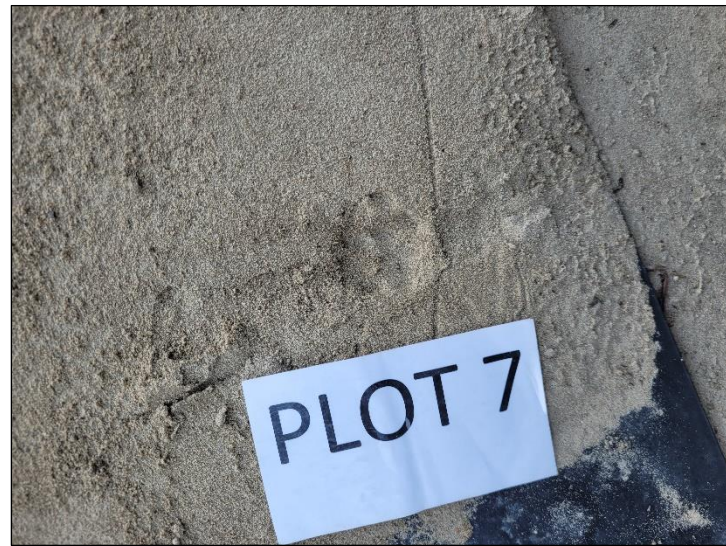
Photo 9: Cat Tracks

- *Implement a Feral Cat removal program, this could involve trapping, baiting, and or shooting.*
- *Installation of permanent improved gate fixtures, constructed with a concrete base to prevent fauna crawling underneath.*

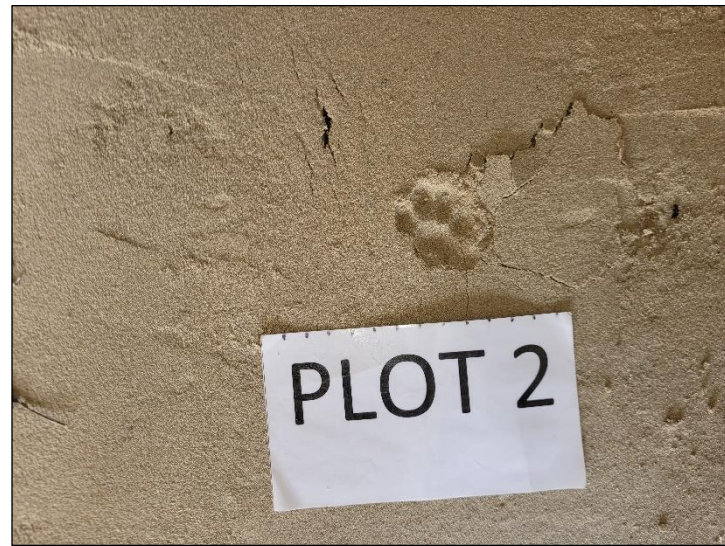
Photo 10: Cat Tracks

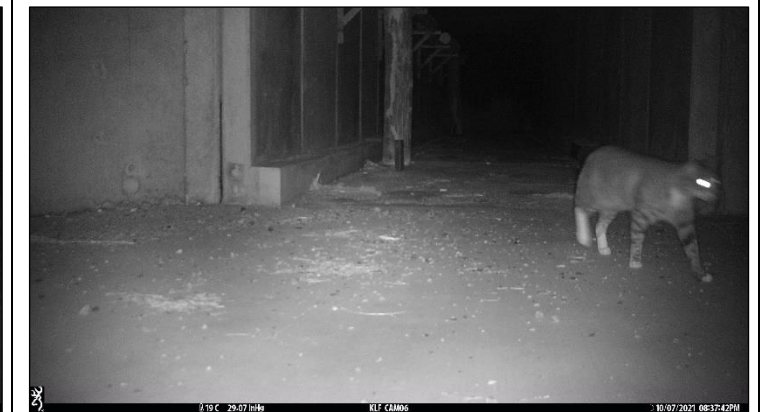
Species diversity was greater in 2021 with 18 species recorded in comparison to 13 the previous year. A Feral Cat was captured on three of the eight cameras in the 2021 monitoring period. It was determined to be the same animal in all images.

Photo 24: Cat – Using Culvert 3

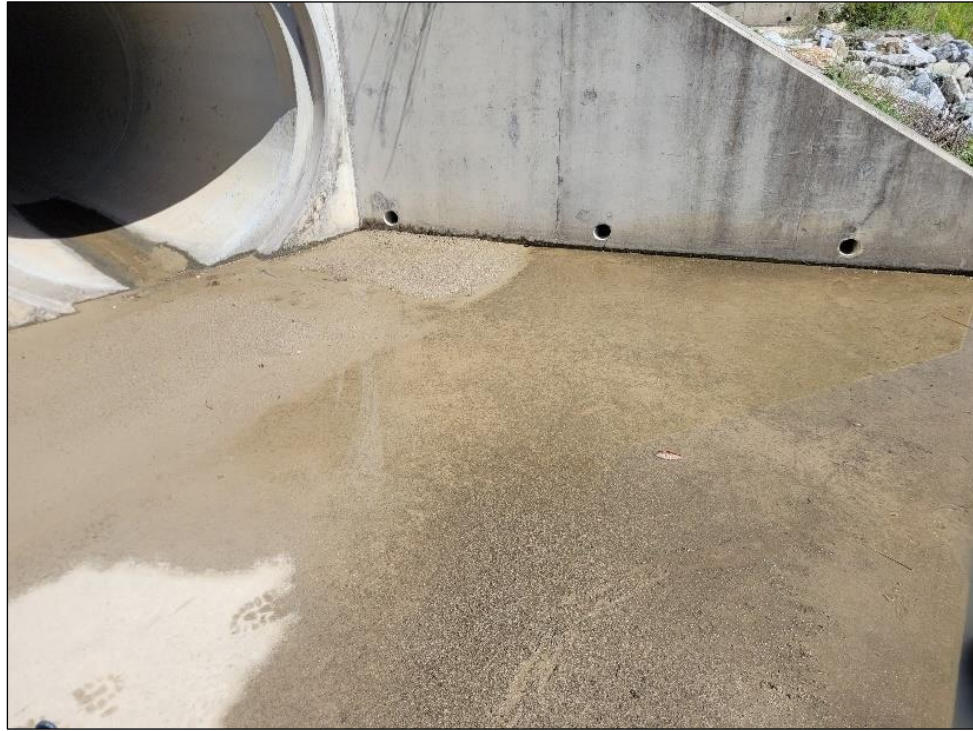
Both the 2020 and 2021 monitoring periods were affected by rain with several plots displaying “no records” due to be rained or out. Overall, fauna species diversity was equal across both years with 13 species recorded in each period. Feral Cat tracks were identified in 2021, they were recorded in five of the eight Sand Plots.

Photo 33: Rain Effected Plot

- *Any future monitoring is suggested to be conducted between September and October to reduce likelihood of weather impacts and capture Koala breeding season movements.*
