# Townsville Ring Road Section 4

**Annual Environmental Compliance Report for 2015/16**  
**EPBC Referral No: 2012/6562**

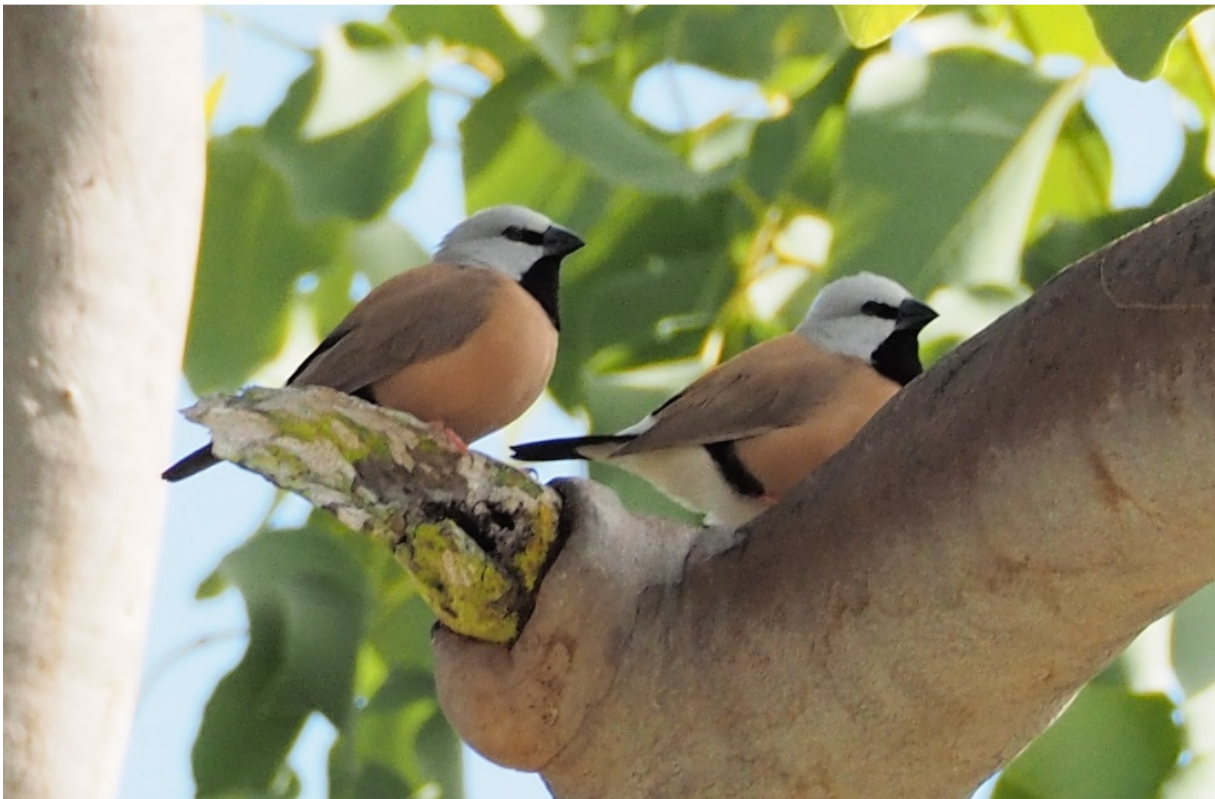
Pair of Black Throated Finches on the construction site (19 Jan 2016)

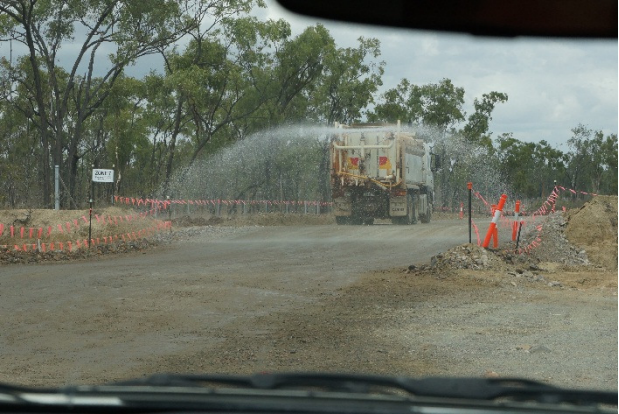
Monitoring Plan Reference No.	Issue	Annual Monitoring or Reporting Outcome (Incl. Dates)	TMR File or Web Site Reference
<b>Dust</b>			
39	Fugitive dust.	<p><b>Veg Clearing:</b> Water truck serviced site every second day in first week, increasing to daily as project works grew in size. No sensitive receptors located in close proximity to site. Ground disturbance minimised to reduce exposure. Ground cover largely undisturbed. Mulch spread over most bare soils especially in proximity to gullies.</p> <p><b>Construction:</b> Numerous water trucks on site. Haul roads of rock construction to minimise dust generation. Dust monitoring undertaken. Results collated. 1x exceedance immediately adjacent to residences. Exceedance not replicated in following month. Location of exceedance not in proximity to wildlife habitat.</p>	<p><a href="G:\TOWD\PROGRAM\DELIVERY\TCC\268-10M-5\8.0 Environment\Photos General">G:\TOWD\PROGRAM\DELIVERY\TCC\268-10M-5\8.0 Environment\Photos General</a></p>

<p>Water Truck in use Jan 2016</p>

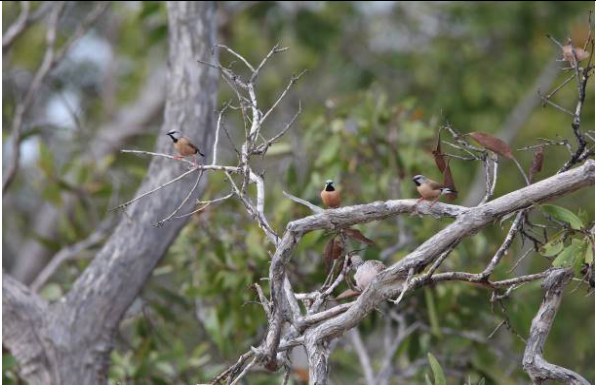
<p>Black Throated Finches within 10m of finished Hwy, 4 Nov 2016</p>

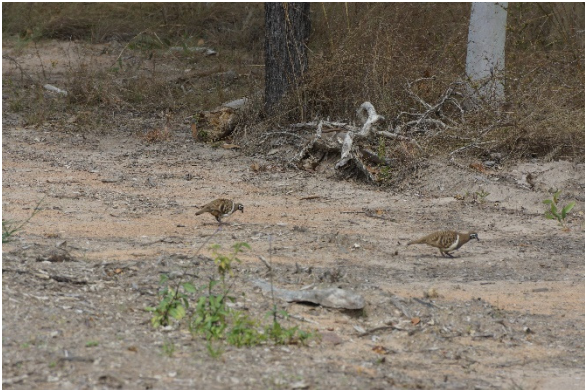
<p>Squatter Pigeon pair in table drain within 10m of finished Hwy, 4 Nov 2016</p> <p><a href="G:\TOWD\PROGRAMDELIVERY\TCC\268-10M-5\8.0 Environment\Black throated Finch">G:\TOWD\PROGRAMDELIVERY\TCC\268-10M-5\8.0 Environment\Black throated Finch</a></p>

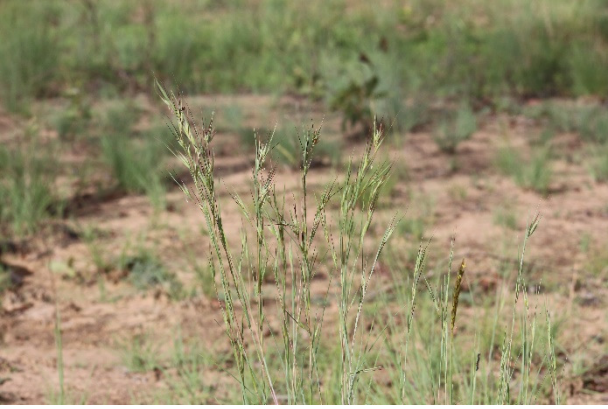
Monitoring Plan Reference No.	Issue	Annual Monitoring or Reporting Outcome (Incl. Dates)	TMR File or Web Site Reference
			<p data-bbox="1258 336 1877 427"><b>Photo above:</b> Golden Beard Grass (<i>Chrysopogon fallax</i>) and Kangaroo Grass (<i>Themeda triandra</i>) regenerating on firebreaks (Jan 2016)</p>

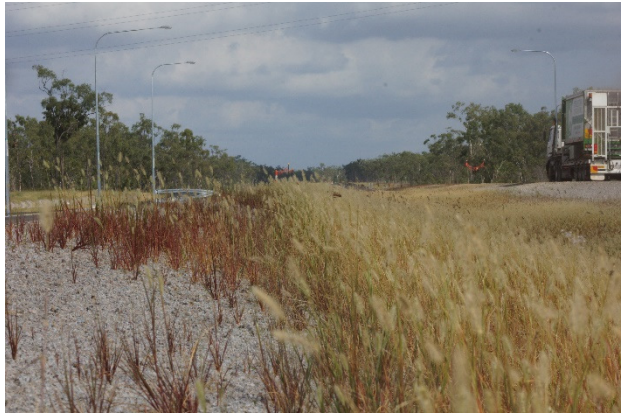
<p data-bbox="1258 869 1877 960"><b>Photo above:</b> Pigeon Grass (<i>Setaria surgens</i>) naturally regenerating from stripped topsoil in revegetation areas (October 2016).</p>

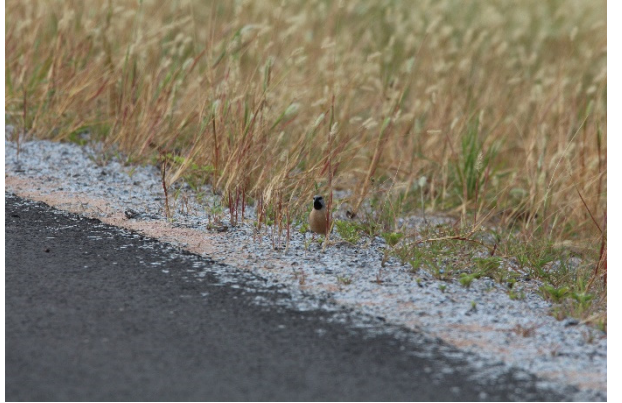
Monitoring Plan Reference No.	Issue	Annual Monitoring or Reporting Outcome (Incl. Dates)	TMR File or Web Site Reference
			<p><b>Photo above:</b> Black Throated Finch feeding on Pigeon Grass regenerating in roadside batter hydromulch adjacent to asphalt. (October 2016)</p>
<b>Other – Construction Generally</b>			
49	Public access will be restricted and discouraged by appropriate signage.	Public access has been restricted by fencing and piles of mulch across tracks to inhibit unauthorised access as part of a staged exit from site after vegetation removal works. Gates to adjoining lands are locked to prevent unauthorised access. Signage states that the area is a construction site and is closed to public access.

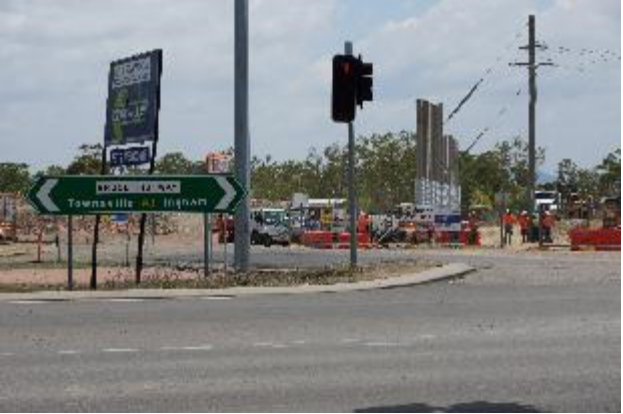
<p>Restricted Access at Mt Low Parkway (Jan 2016)</p>

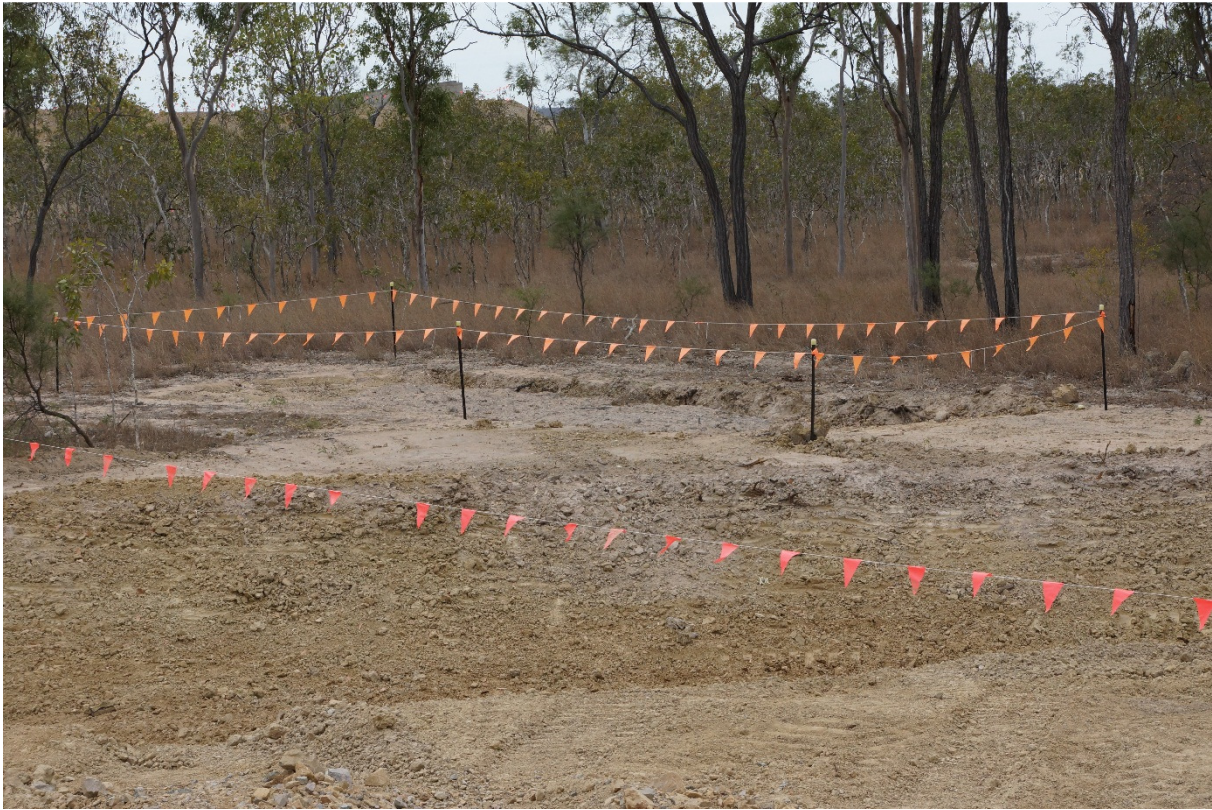
Soil containing Bog Figwort was stripped from an area of what will become Dalrymple Road. The soil has been stockpiled and segregated by bunting adjacent to what will become Kalynda Chase. As works reach localised completion, the stockpiled soil containing Bog Figwort propagules will be placed as a topsoil over small depressions that will hold water after rains, providing suitable conditions for germination.

**2015-16:** No Bog Figwort have been sighted, however there has been insufficient rainfall to produce persistent standing water required to saturate the soil profile for long enough to trigger a germination event.

Figure X: Stripped Topsoil containing Bog Figwort propagules.

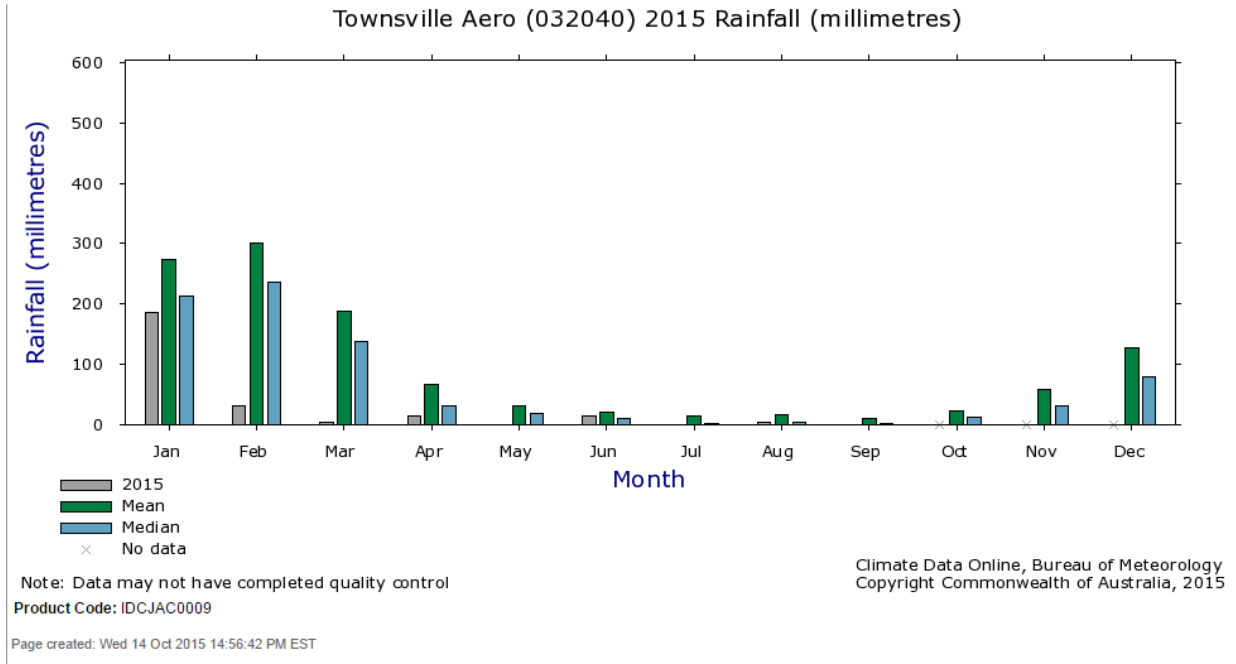
Figure Y: Rainfall deficit compared to long term average for Townsville Airport. (Bureau of Meteorology)

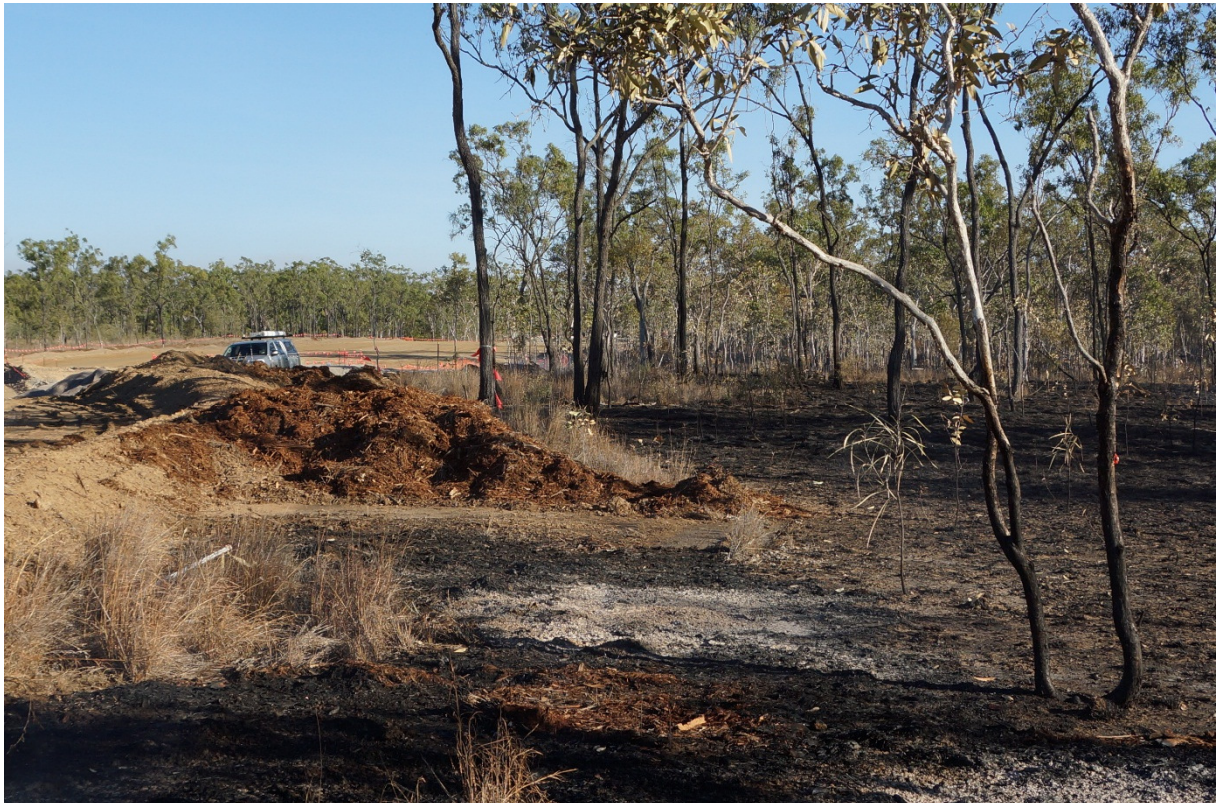
No Fire Monitoring occurred in 2014/15, however fence lines were cleared and constructed. A wildfire occurred on adjacent land and burned up to and over the boundary. Approximately 5.4 hectares of road reserve was burned. The fire was a low intensity burn that consumed ground layers, with minimal scorch of other vegetation.

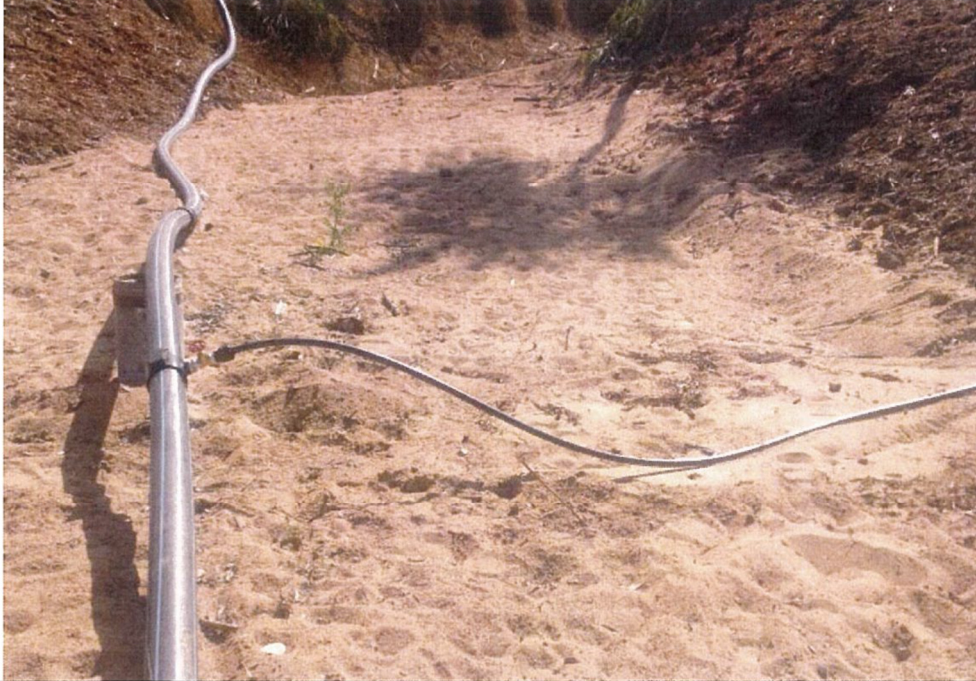
Photo 1 – poly line tapped into main water line (running to quick fills)

- Provision of additional water trucks to suppress dust;
- Installation of sprinklers on embankments adjacent to sensitive receptors (residential areas) as seen in photographs included in the monthly report.

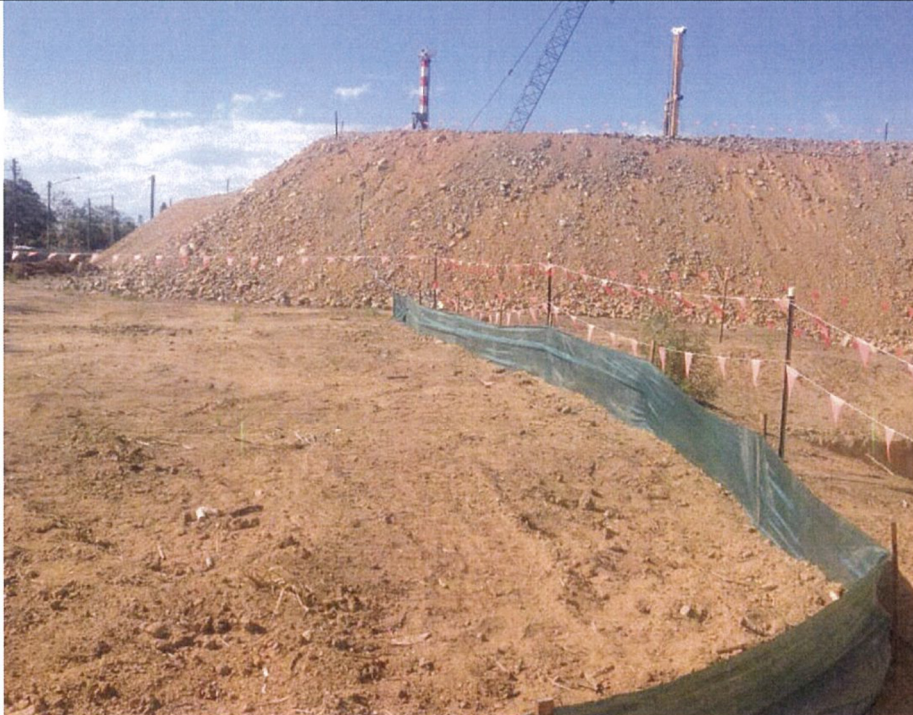
Photo 2 – Poly line running from stony creek to BR40 Abutment B

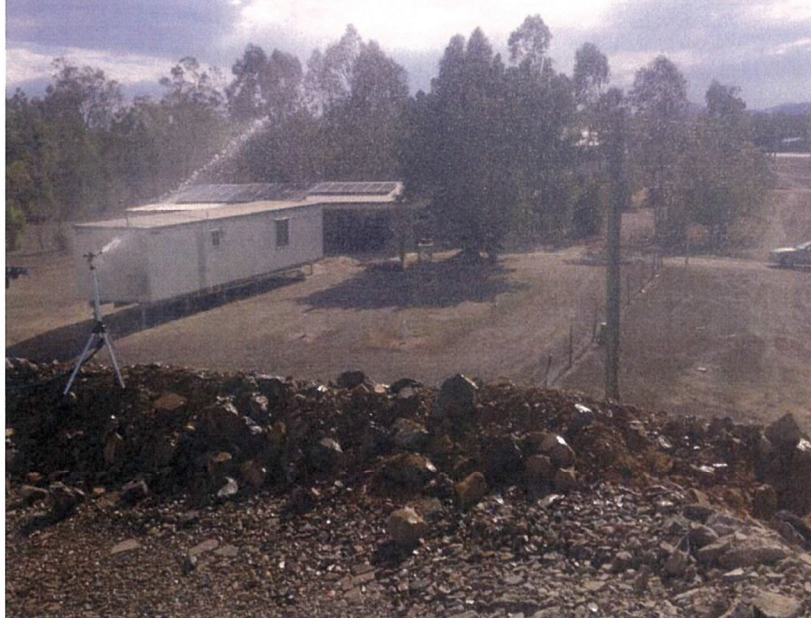
Photo 3 – Sprinkler at top of batter on BR40 abutment B

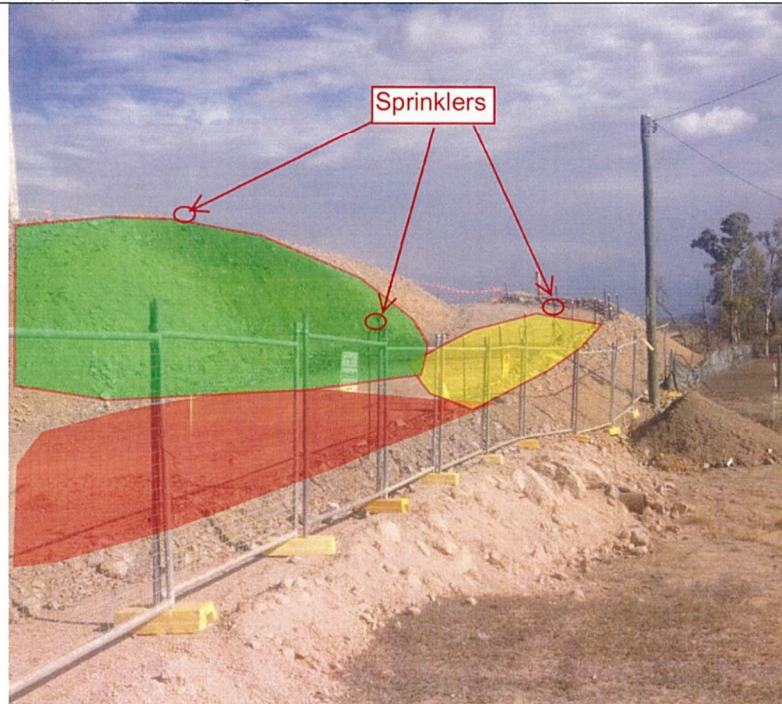
Photo 4 – Sprinkler positions and coverage
