Townsville Ring Road Section 4

Annual Environmental Compliance Report For 2014/15

EPBC Referral No: 2012/6562

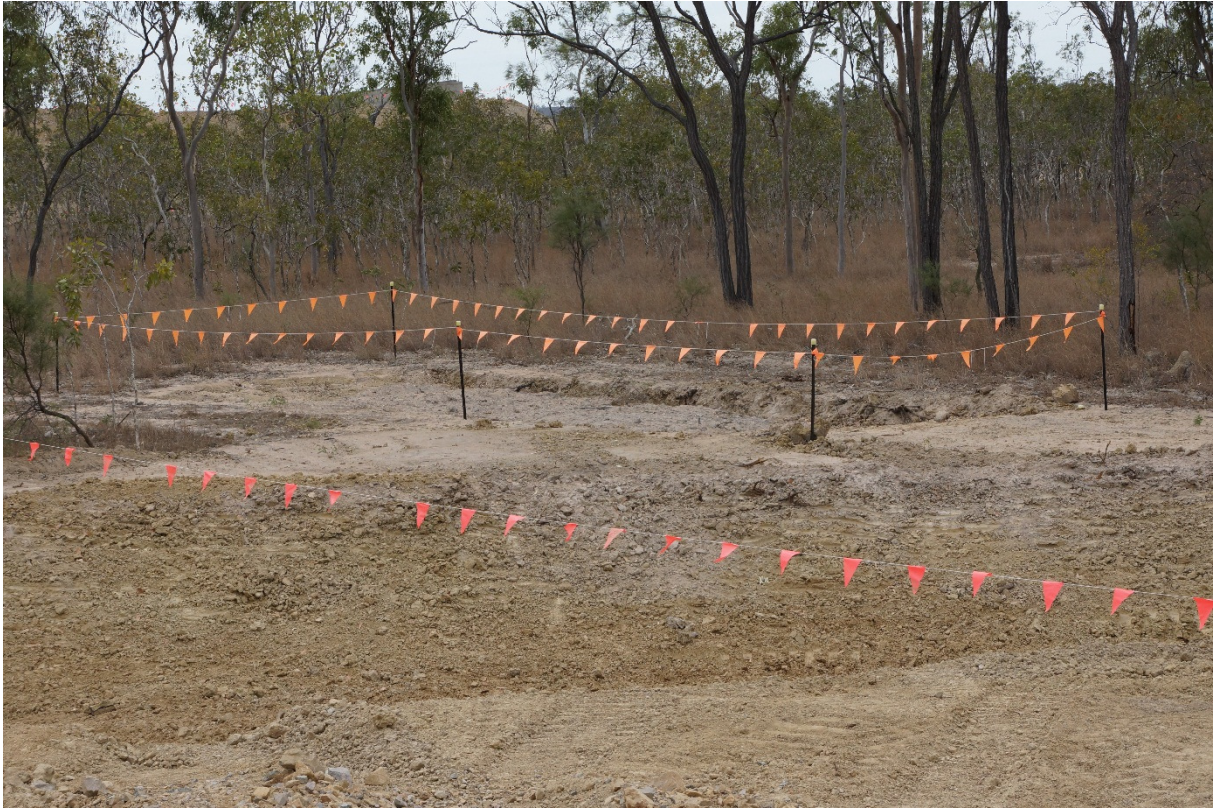
Figure X: Stripped Topsoil containing Bog Figwort propagules.

Soil containing Bog Figwort was stripped from an area of what will become Dalrymple Road. The soil has been stockpiled and segregated by bunting adjacent to what will become Kalynda Chase. As works reach localised completion, the stockpiled soil containing Bog Figwort propagules will be placed as a topsoil over small depressions that will hold water after rains, providing suitable conditions for germination.

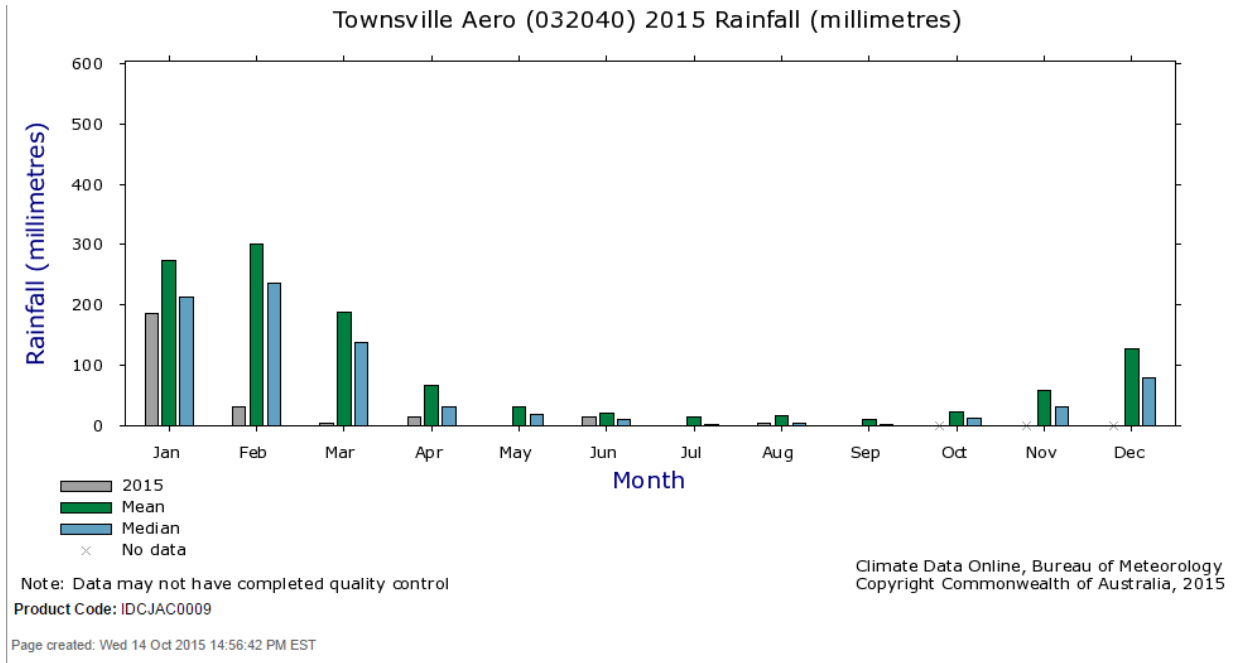
Figure Y: Rainfall deficit compared to long term average for Townsville Airport.

No weed monitoring due to extended dry. Figure Y below shows the rainfall deficit compared to the long term average.

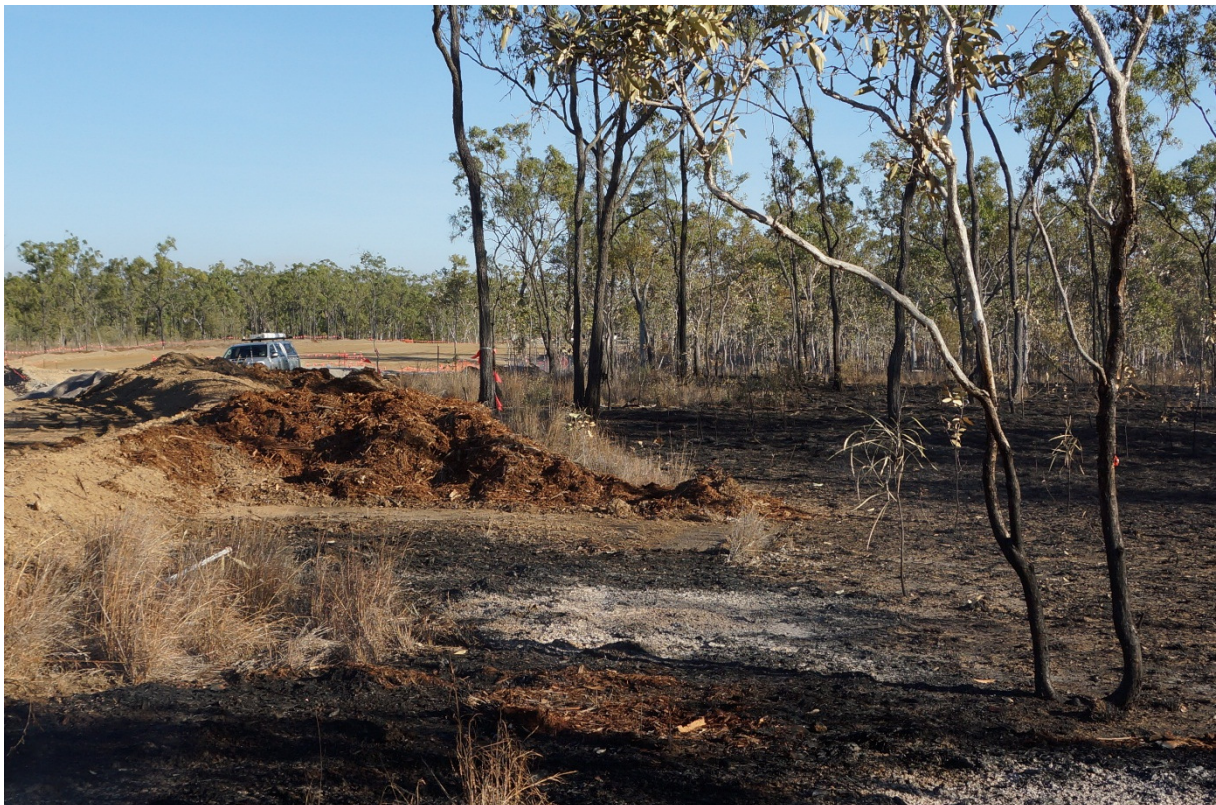
No Fire Monitoring occurred in 2014/15, however fence lines were cleared and constructed. A wildfire occurred on adjacent land and burned up to and over the boundary. Approximately 5.4 hectares of road reserve was burned. The fire was a low intensity burn that consumed ground layers, with minimal scorch of other vegetation.

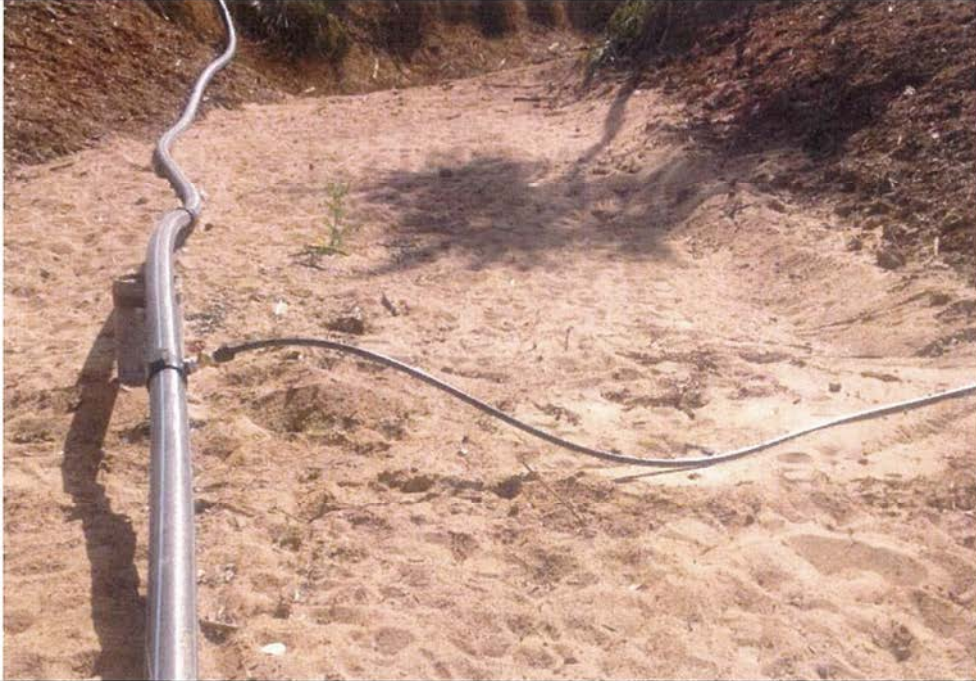
Photo 1 – poly line tapped into main water line (running to quick fills)

- Provision of additional water trucks to suppress dust;
- Installation of sprinklers on embankments adjacent to sensitive receptors (residential areas) as seen in photographs included in the monthly report.

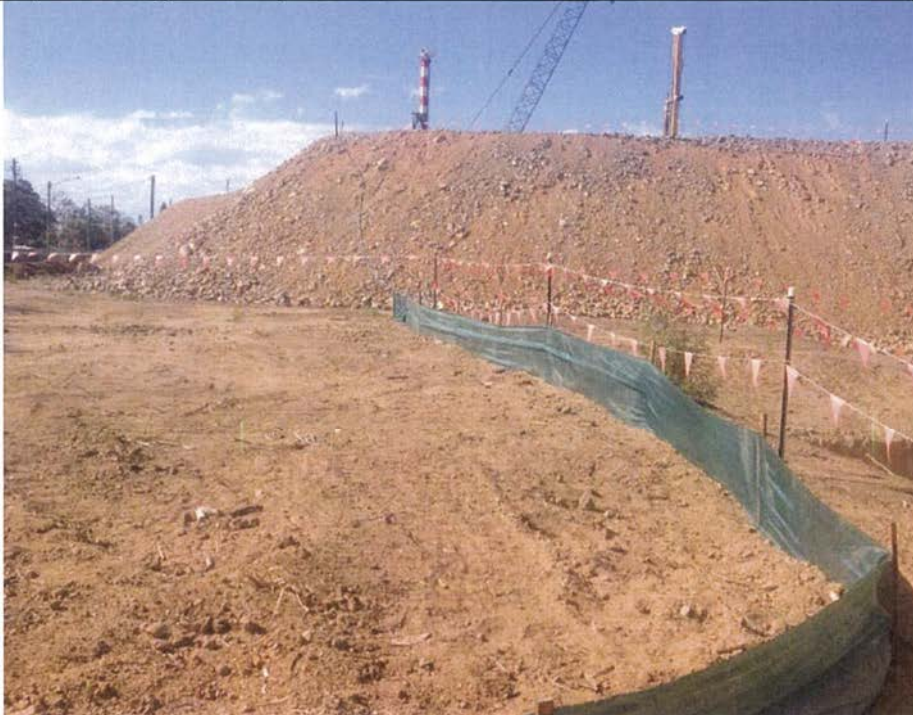
Photo 2 – Poly line running from stony creek to BR40 Abutment B

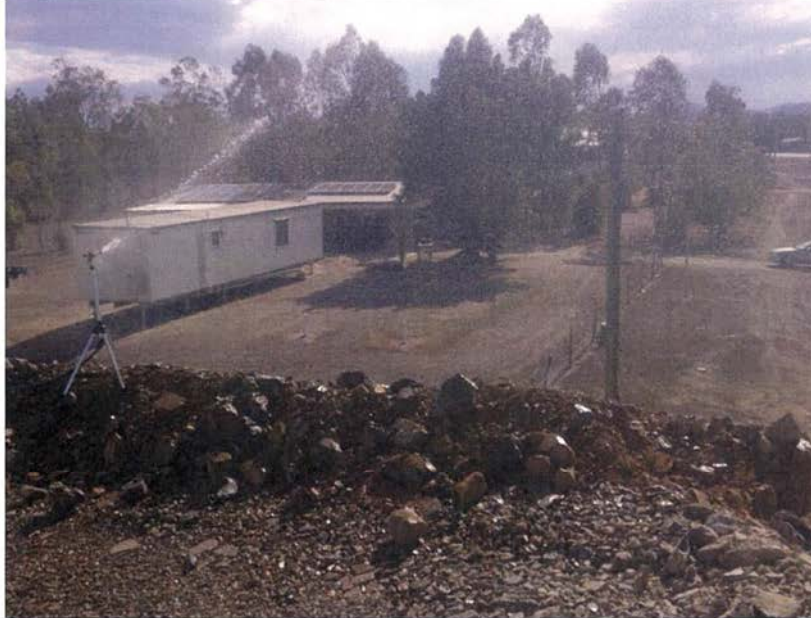
Photo 3 – Sprinkler at top of batter on BR40 abutment B

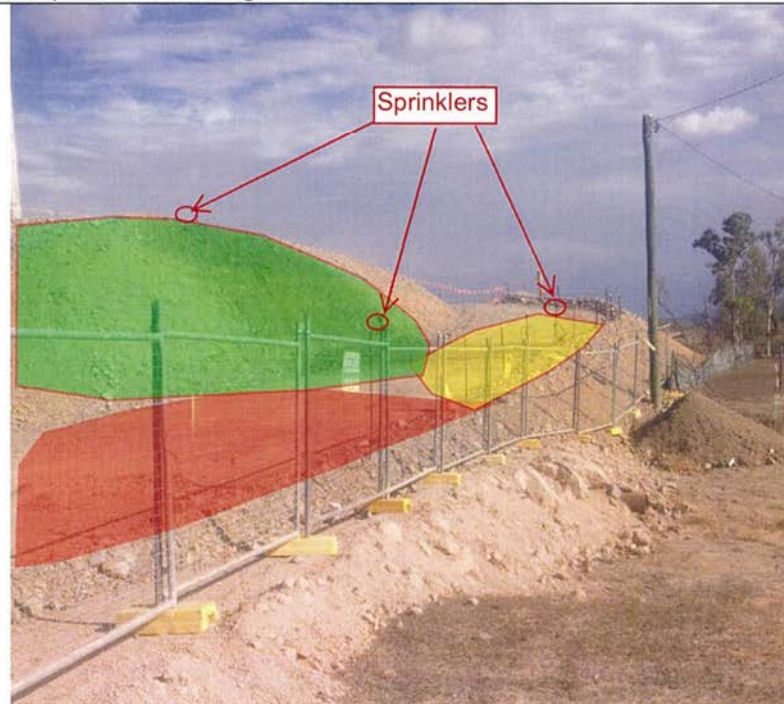
Photo 4 – Sprinkler positions and coverage
