# Eton Range Realignment Project

**ATTACHMENT 1 to EPBC Ref: 2015/7552 Preliminary Documentation  
Fauna Management Plan – Koala**

December 2015

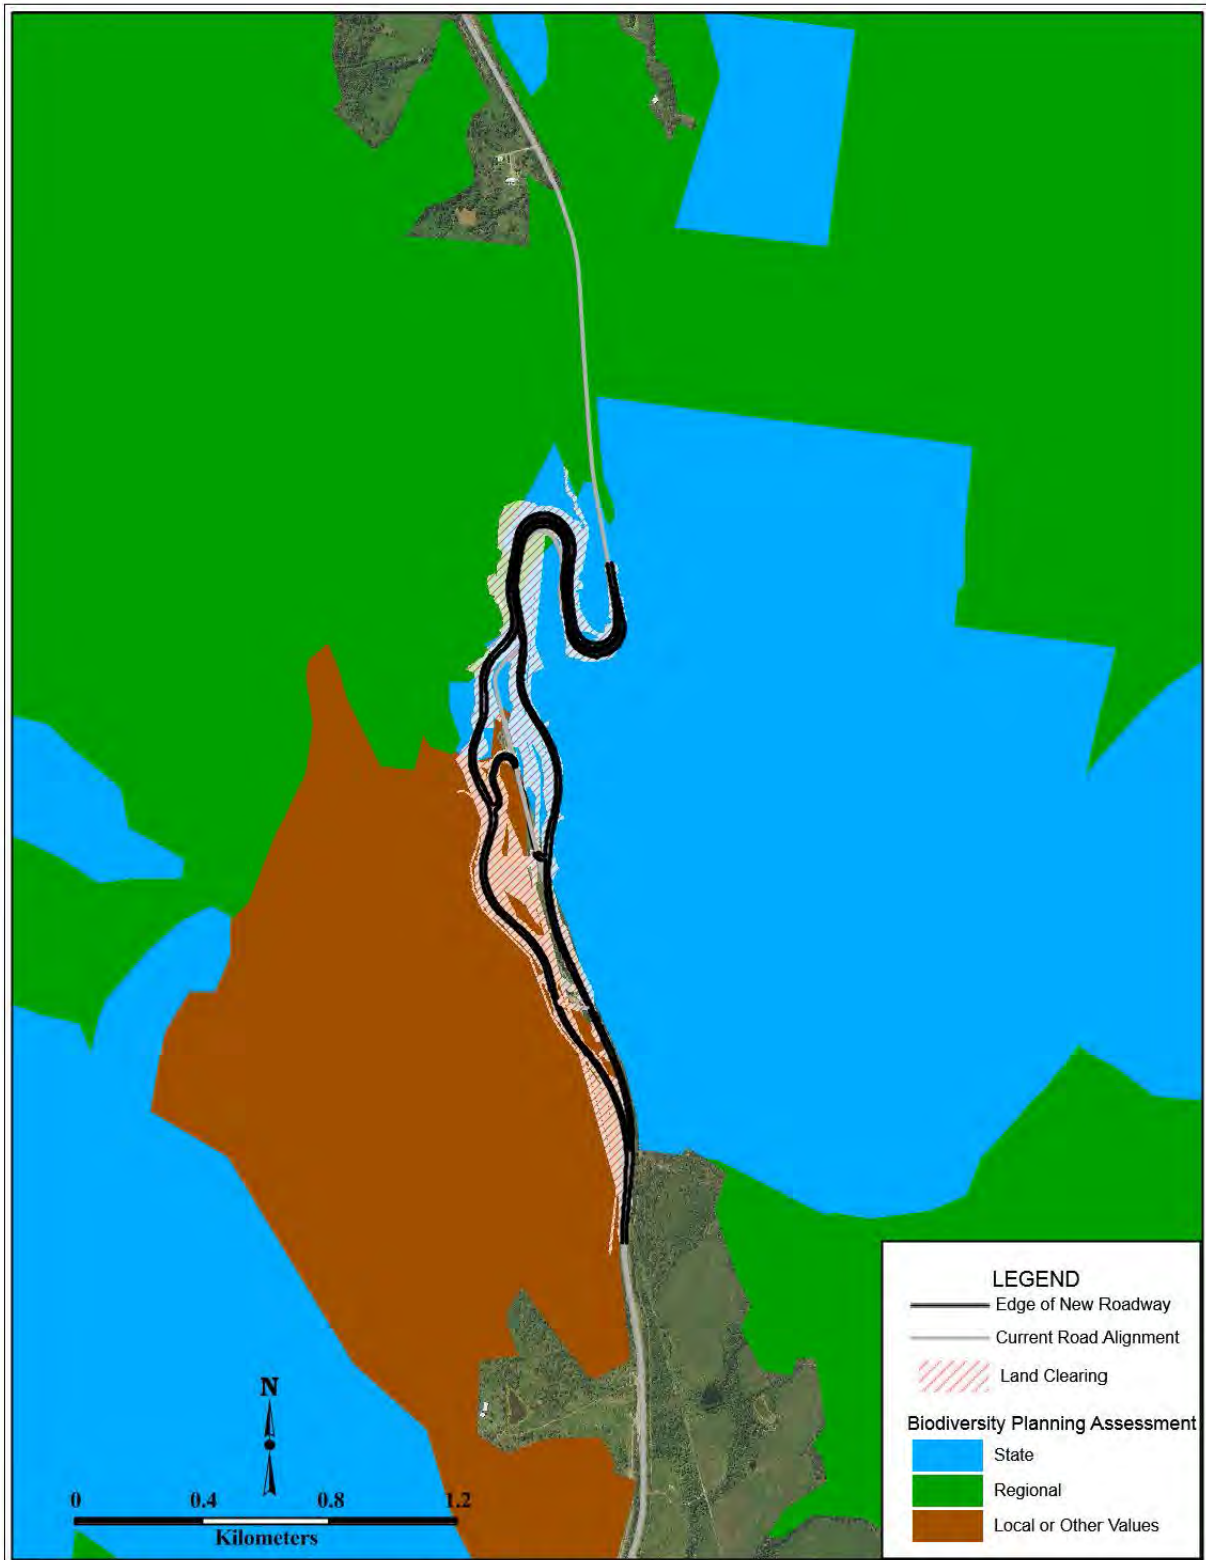
Figure 4: Ecological Corridors in the Project Area

While these ecological corridors have the potential to provide connectivity between areas of Koala habitat at a local, regional and state scale, existing barriers may impede movement at a local scale. An existing barrier for the Project area is the existing Peak Downs Highway, which already traverses the Eton Range. A specific scoring of the Project area's connectivity was determined by EcoSM (2013) utilising this data.

The Field Survey Report for Matters of National Environmental Significance (SMEC, 2015), identified that it is likely that Koalas cross the existing Peak Downs Highway, given that scats were observed on both sides of the highway. There is a known Koala movement corridor 10 km south-west of the Project area where a significant number of Koala fatalities have been recorded on a stretch of the Peak Downs Highway. However, based on Koala home range size (White 1999, Ellis et al. 2009, Mitchell 1990), it is unlikely that the Koala population in the Project area would be crossing at that location. The important crossing points are expected to be in the flatter section of the highway at the top of the range (CH 49,800 – 51,200 m), where Koala activity levels were highest.

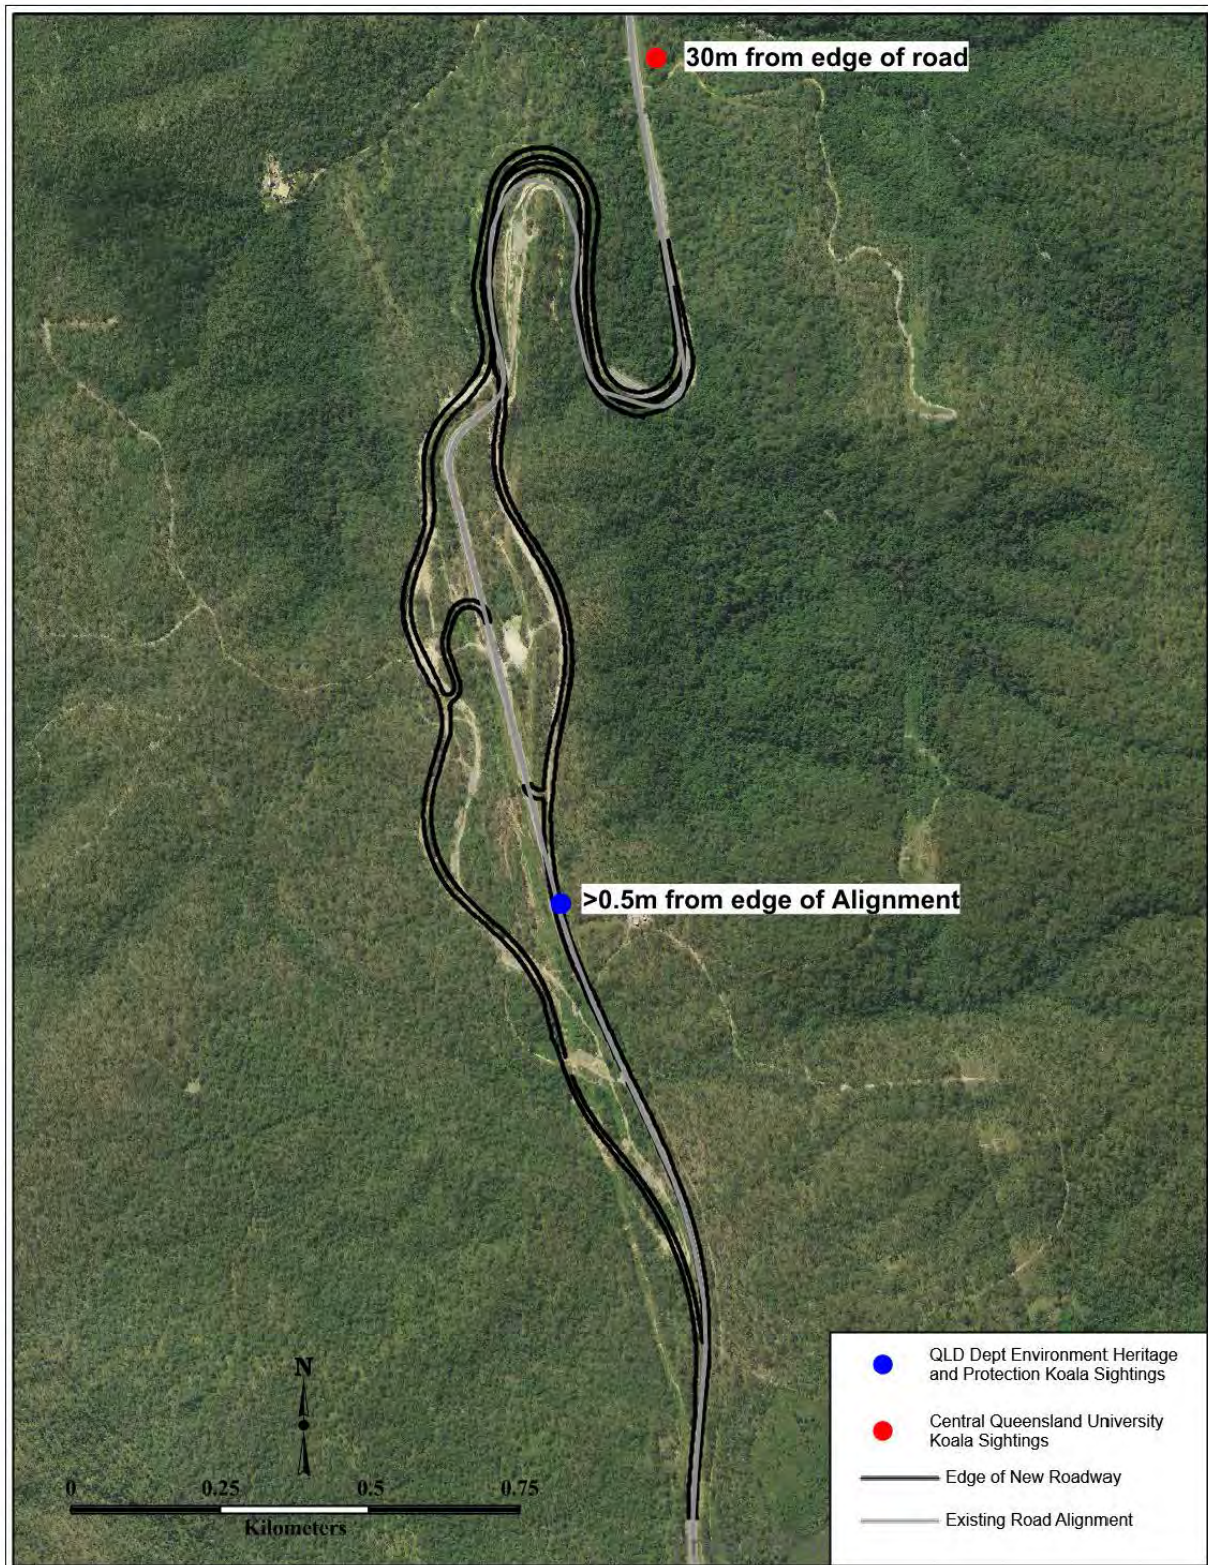
The Koala records obtained from DEHP and CQU within the project extent are provided in Figure 6. The recorded presence of Koalas on either side of the Project alignment indicates that a Koala population exists, or has previously existed, and that vegetation communities within the general Project area are likely to be utilised as habitat.

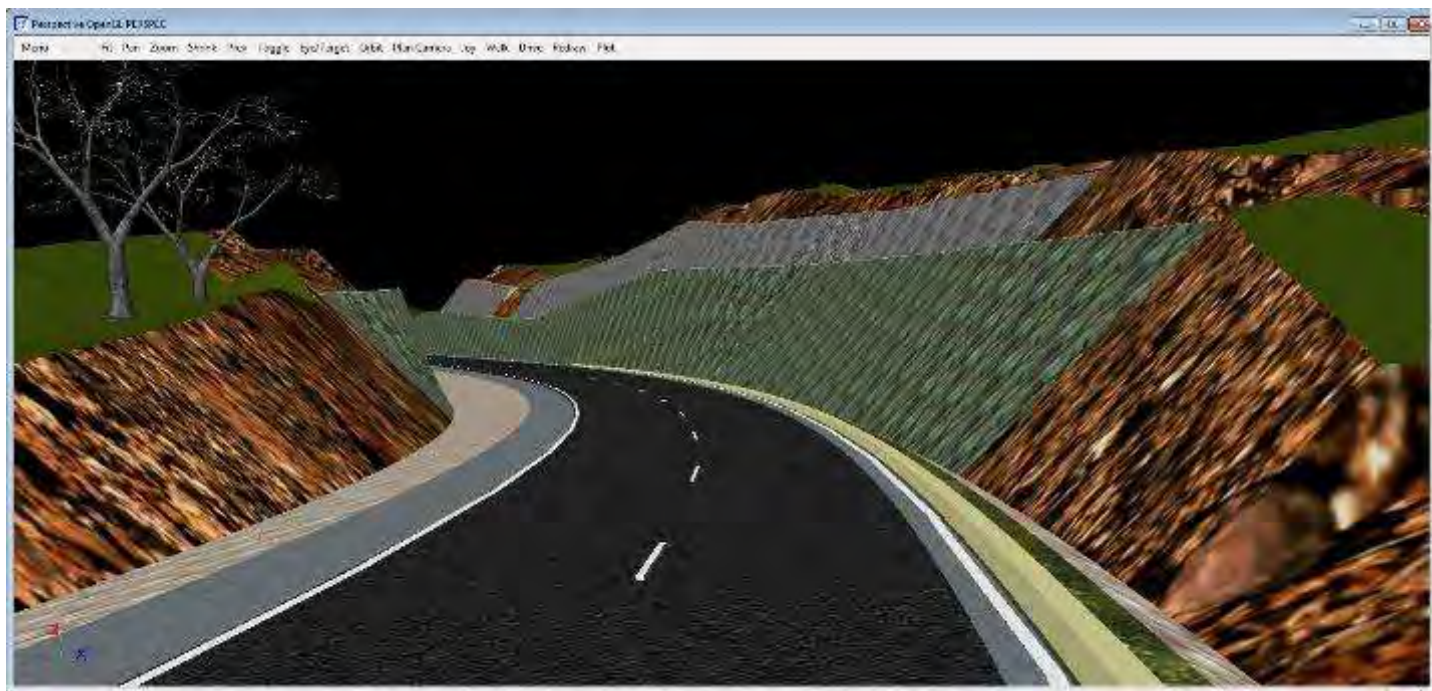
Figure 7: Indicative 3D image of Project road alignment and steep cuts

Figure 7 displays an example 3D image of the road realignment and steep cuts, where the fauna exclusion fencing will not be present.

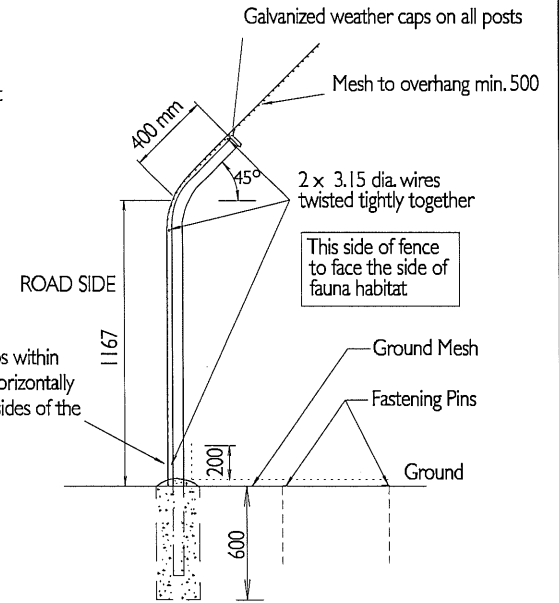
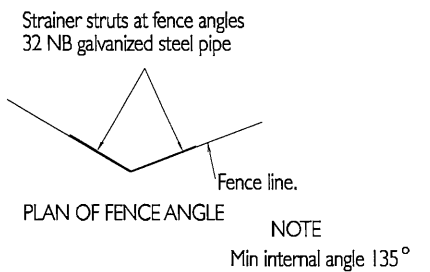
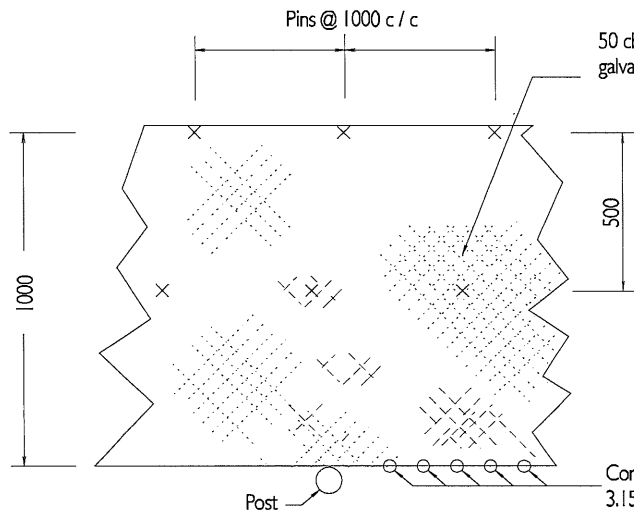
GROUND MESH FIXING DETAIL

For loose or sandy soils 350 (min.) galvanised fastening pins must be used

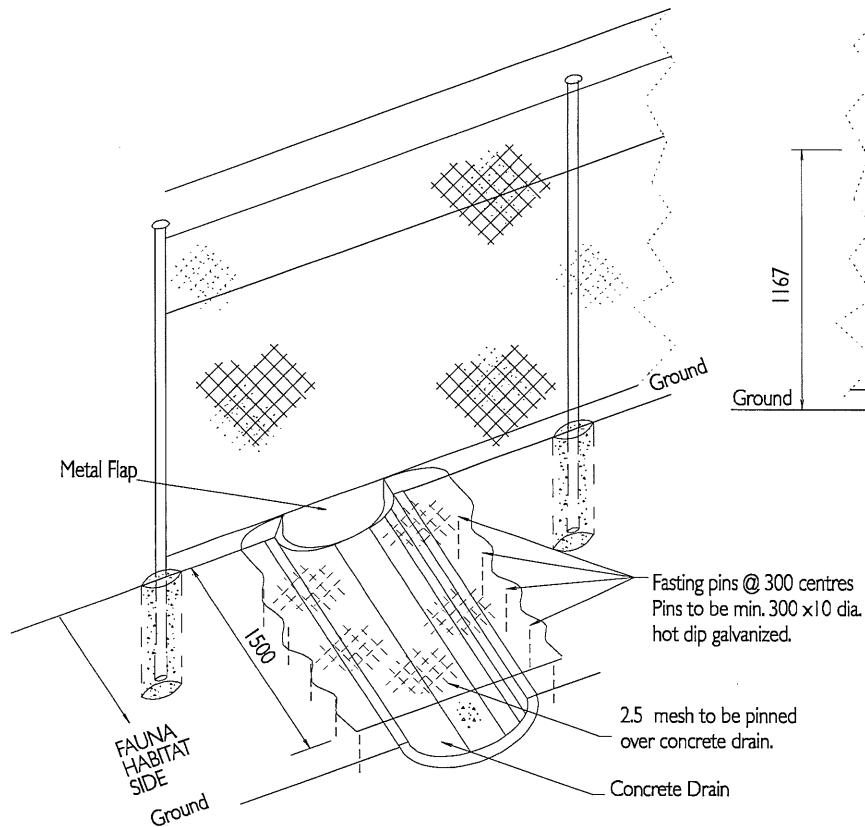
**FAUNA PROTECTION DRAINAGE DETAILS**

At drainage lines and gates light corrosion - resistant metal flap to be installed with less than 50 gap.  
 Flap to be designed to suit hydraulic flows and drain shape in stormwater flow paths.  
 Metal flap to be connected to fence on downstream side of fence.

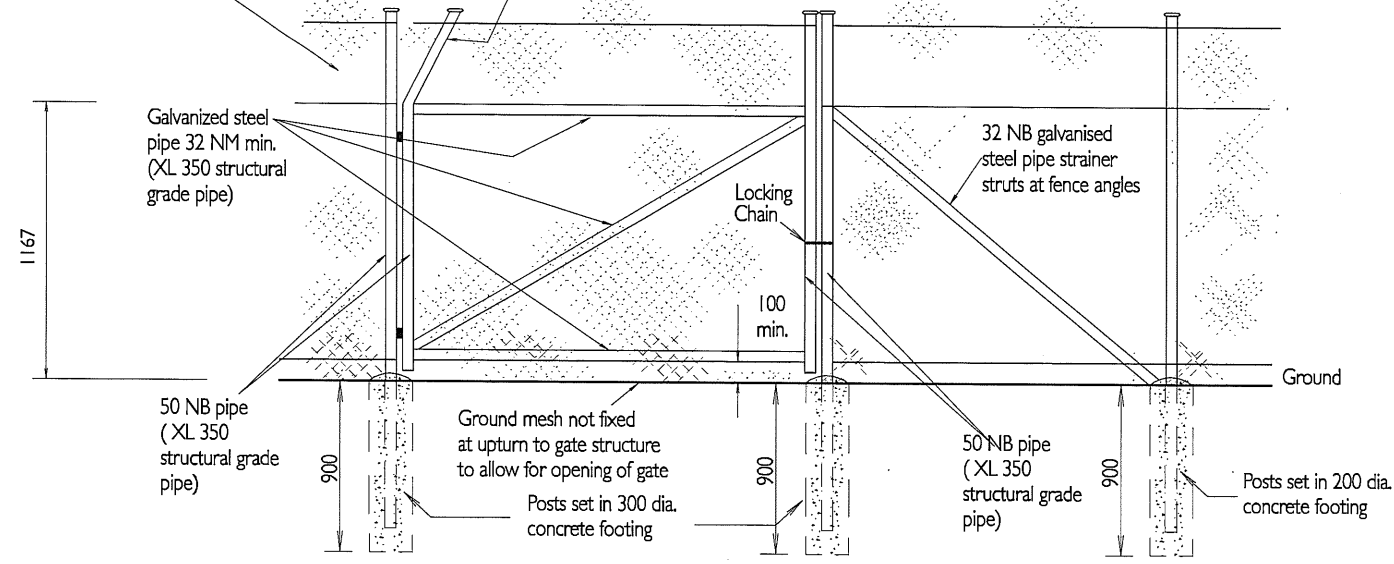
MAINTENANCE GATE DETAILS

4000  
Crank to be angled to allow  
for opening of gate  
(hinge side only)

3000  
Hinges to be installed on either  
side to allow for correct  
opening

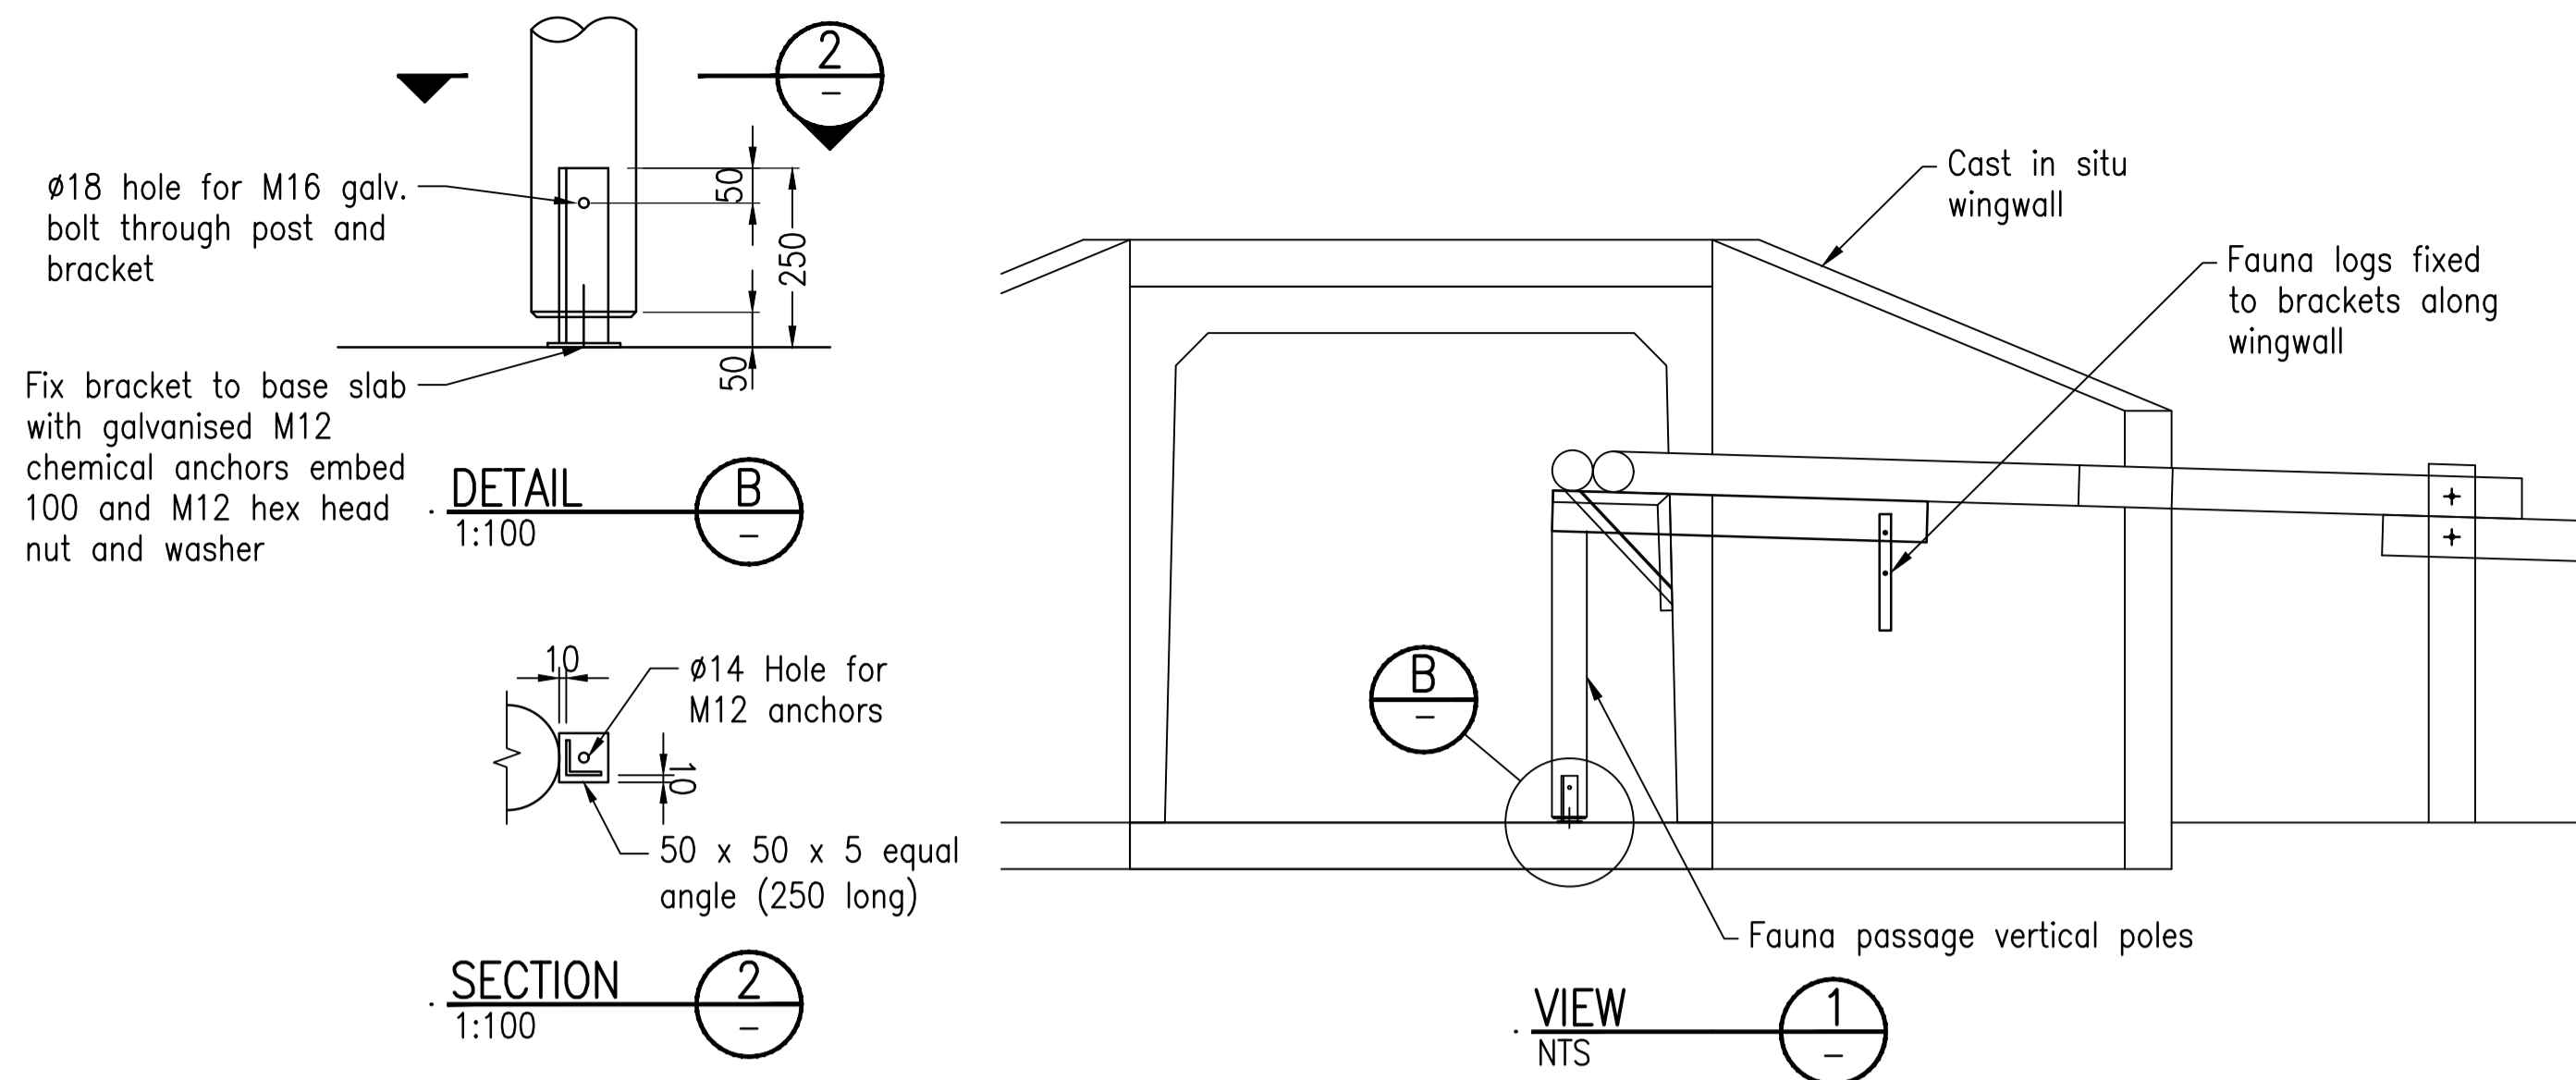
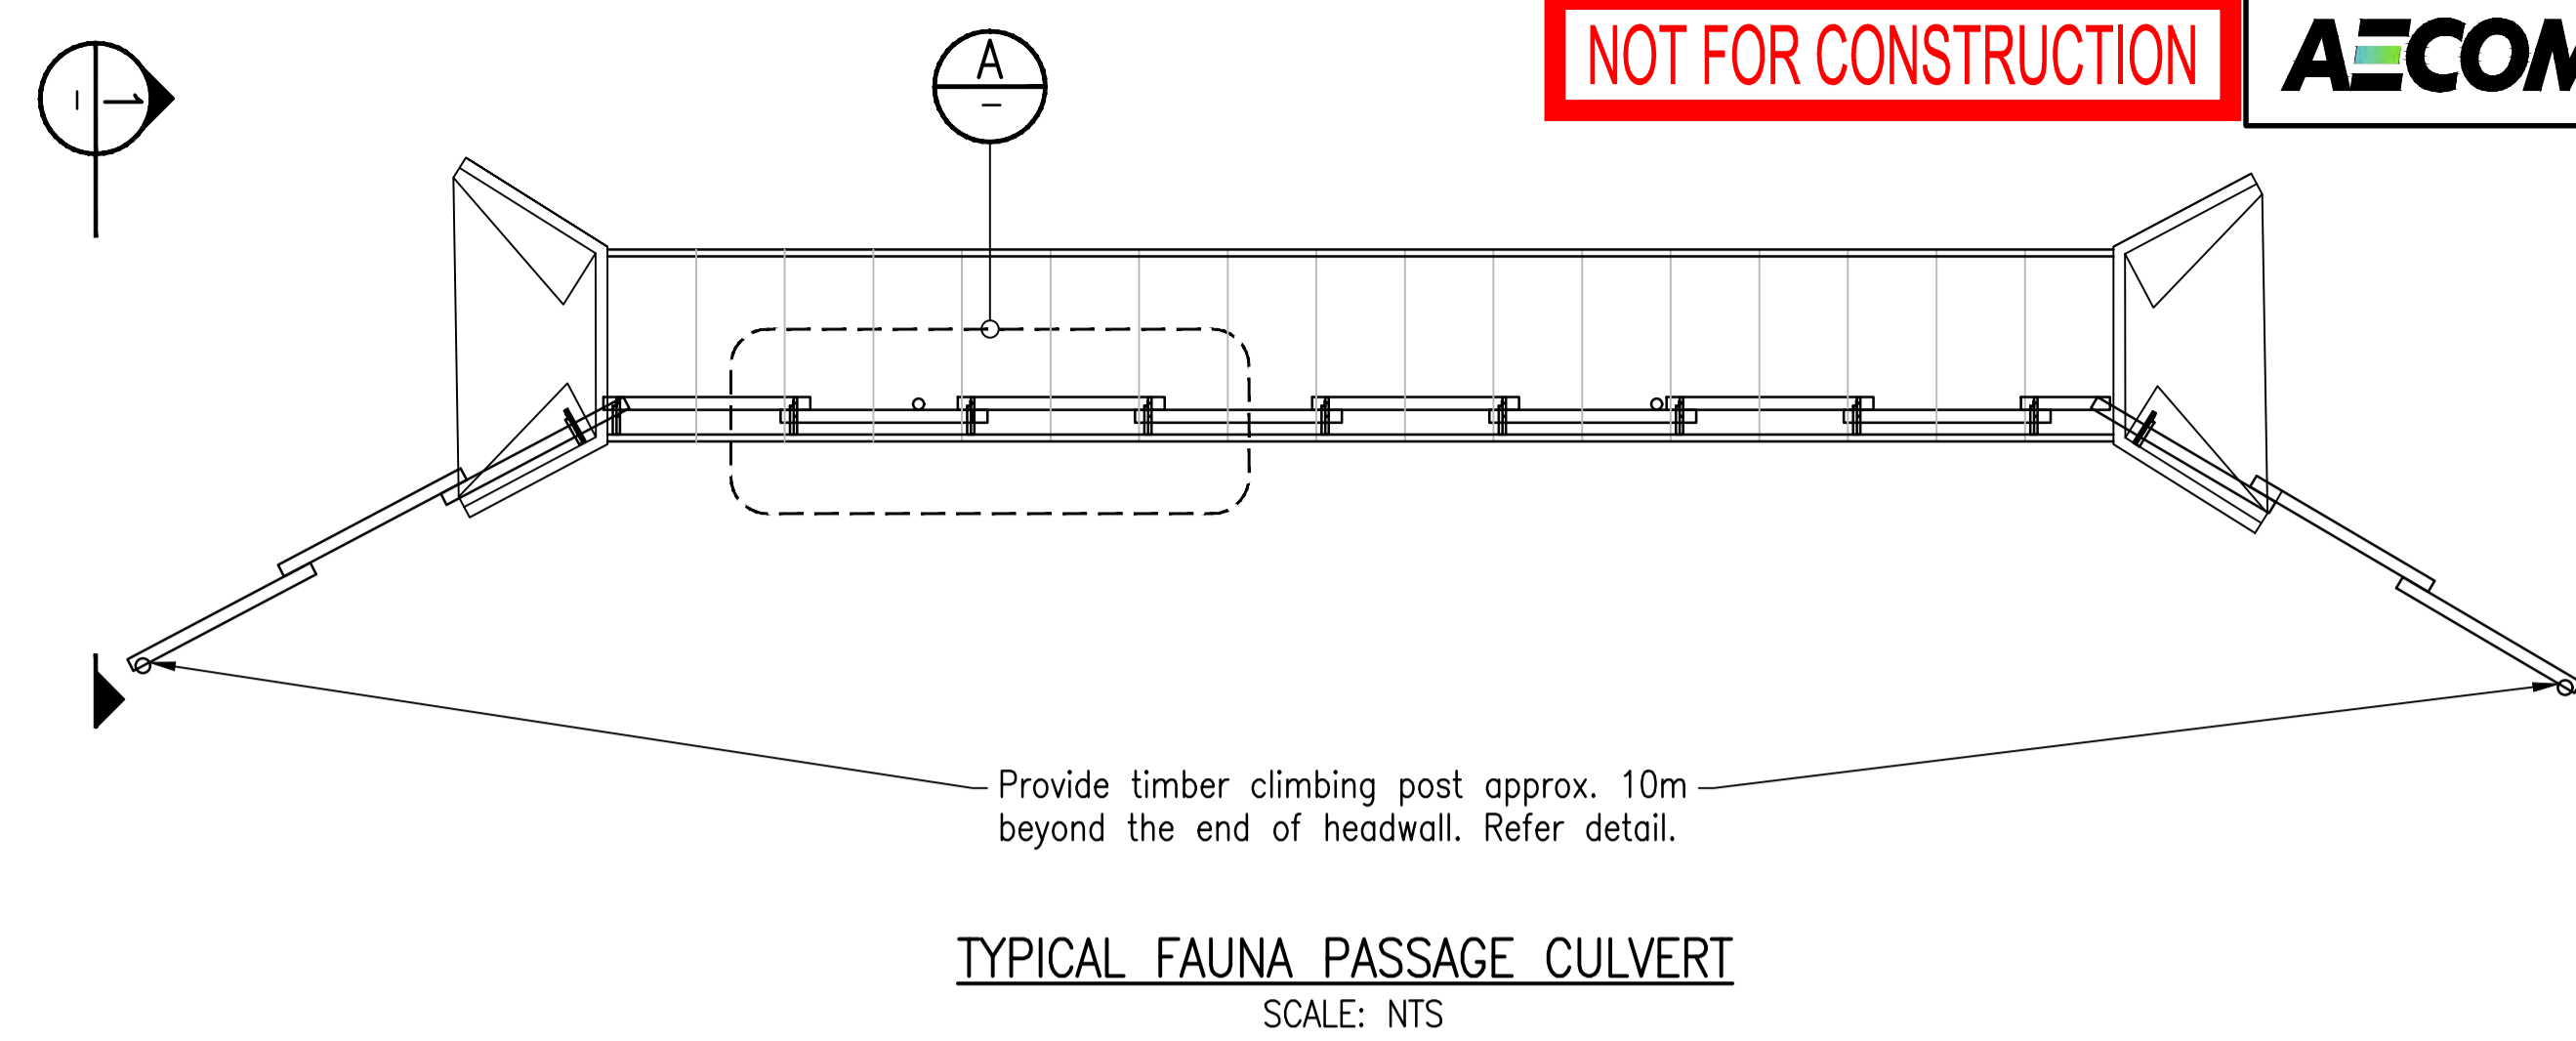
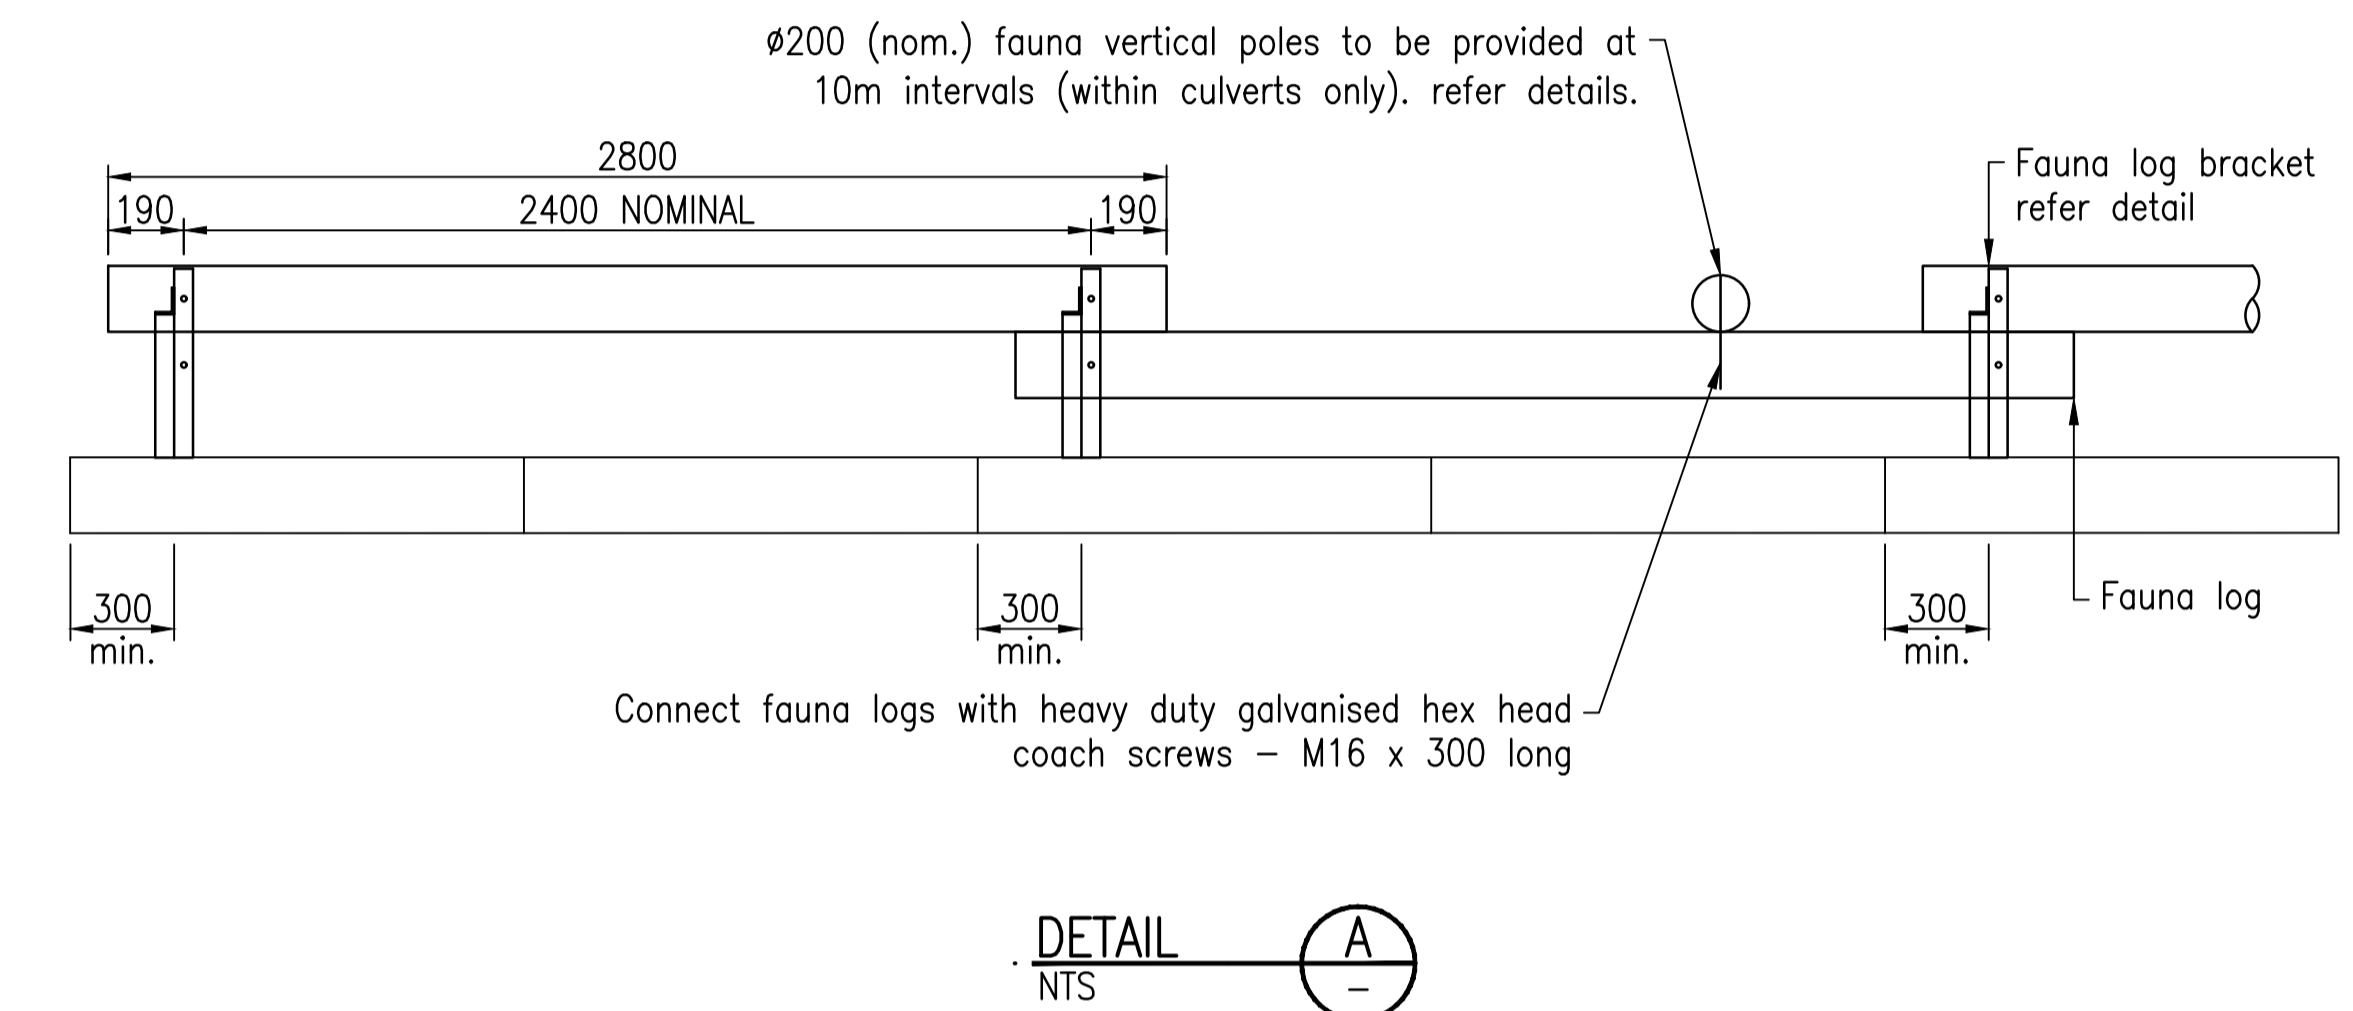
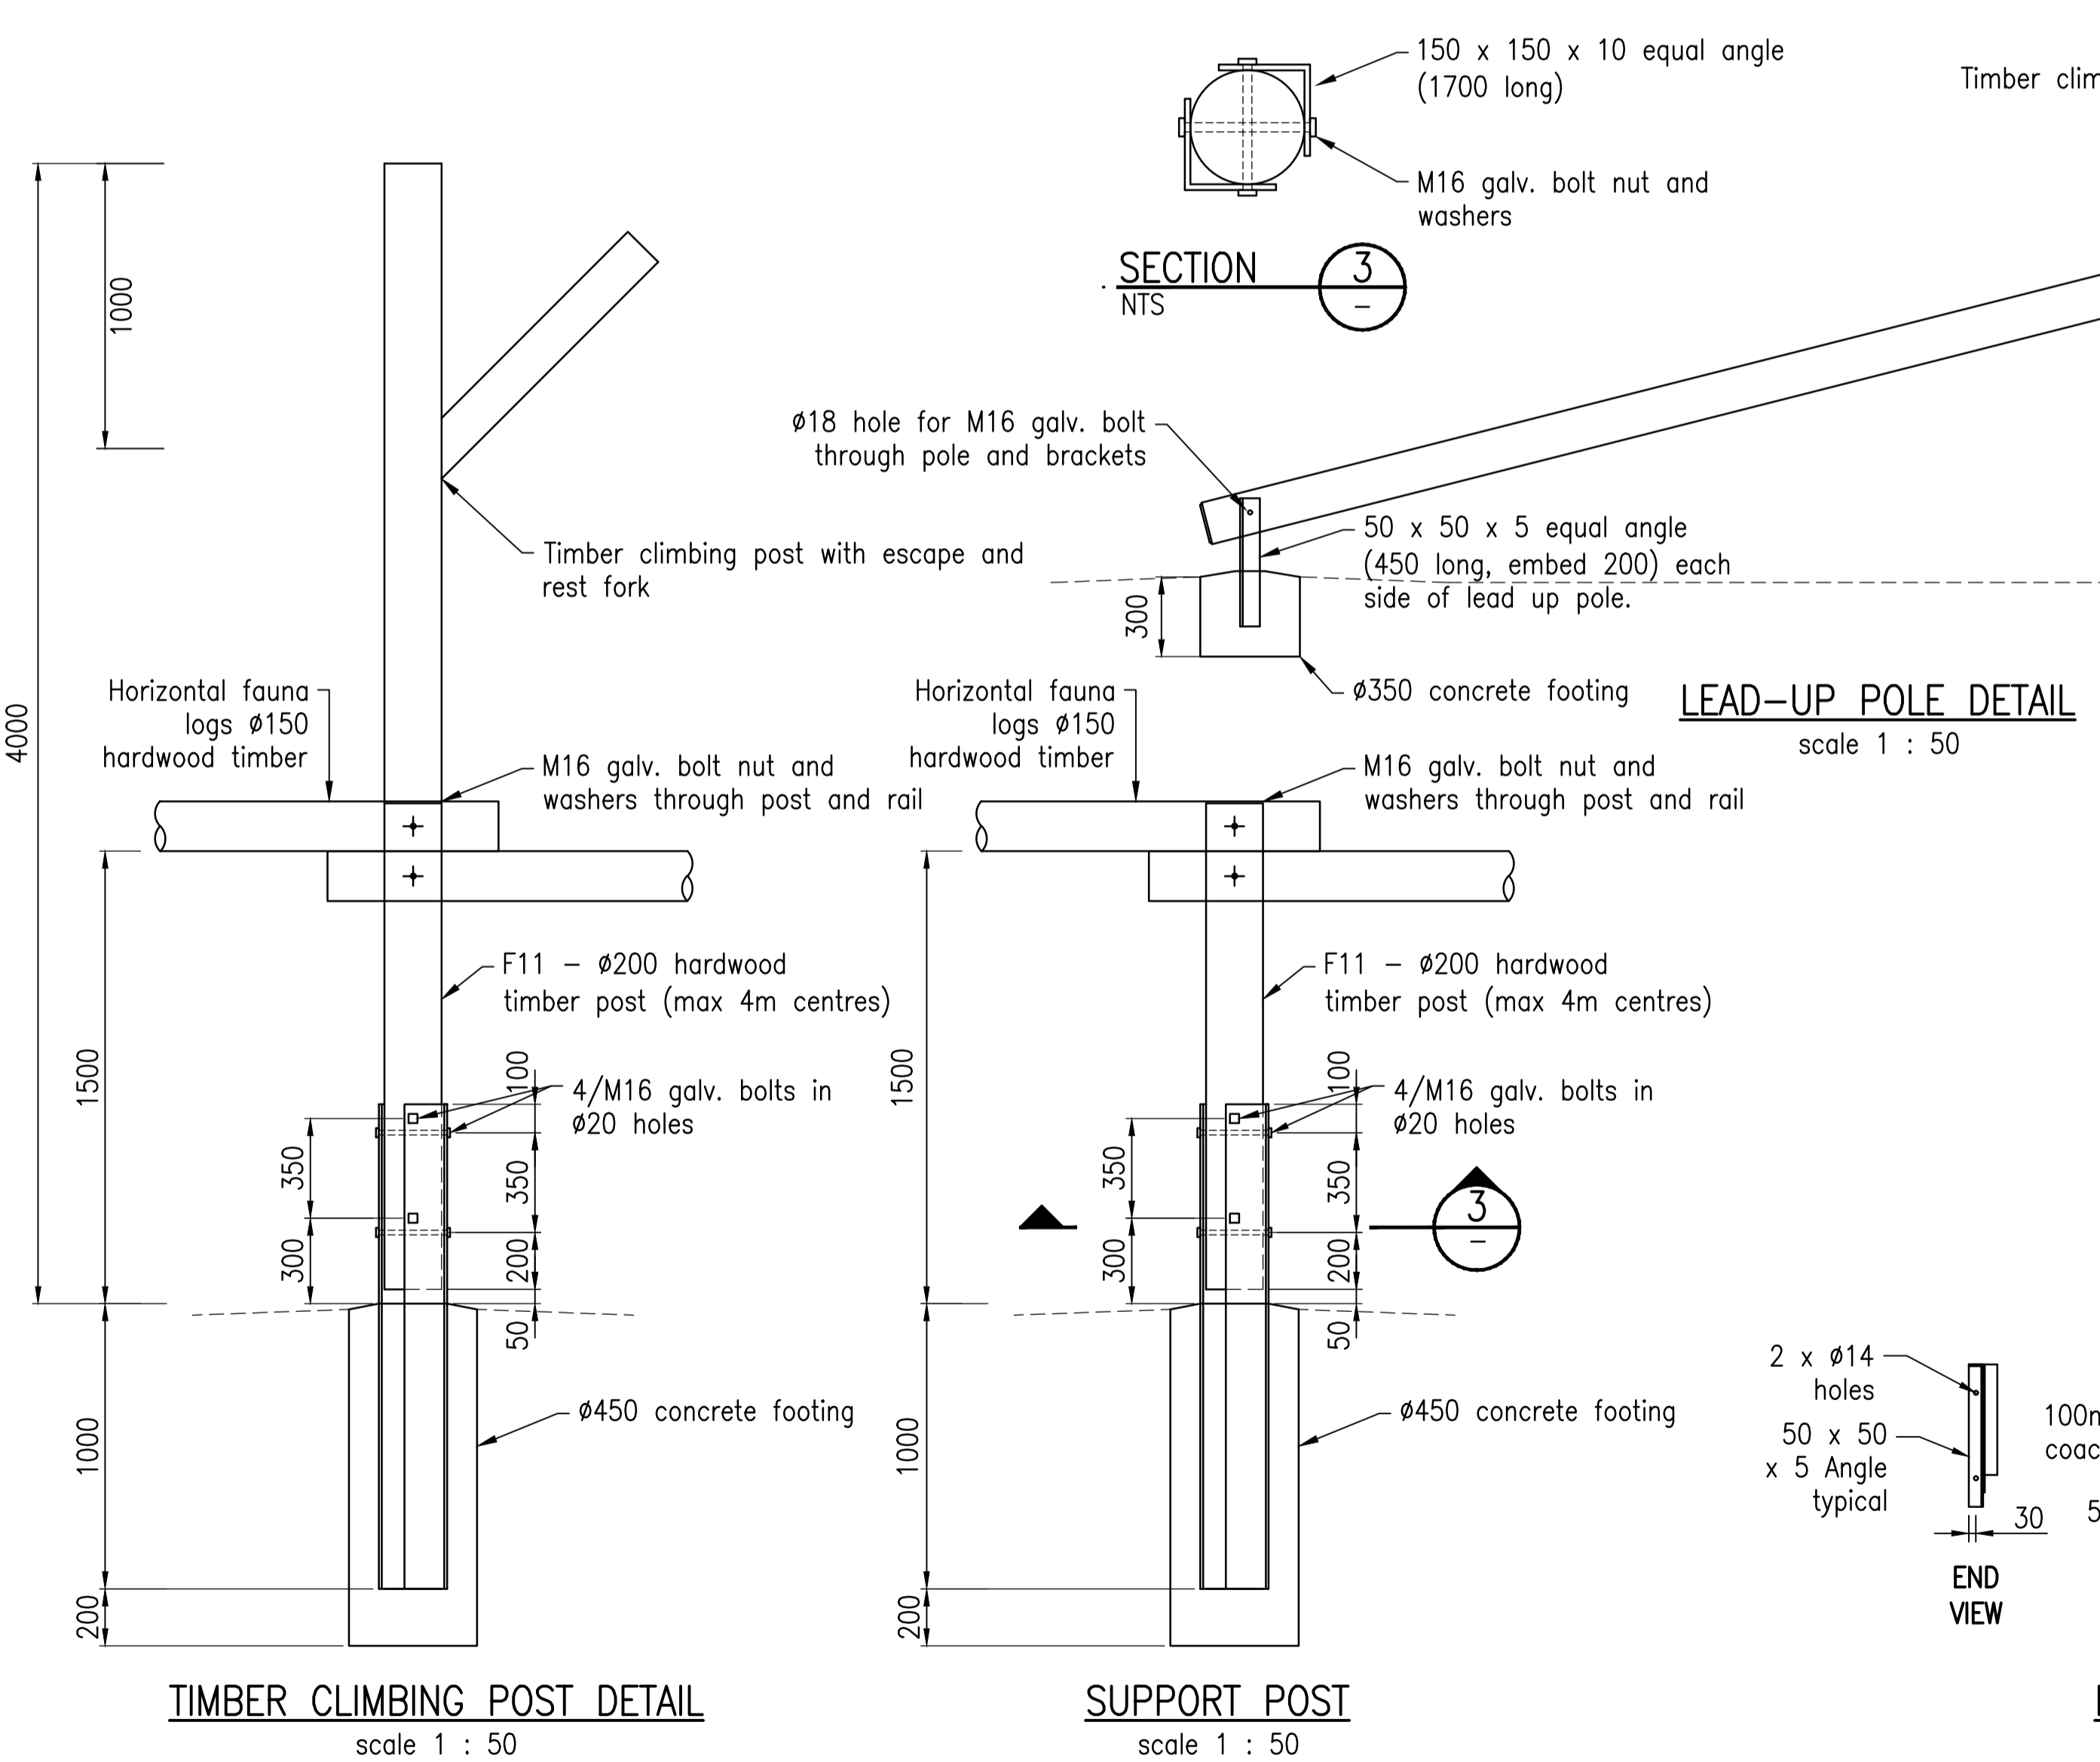
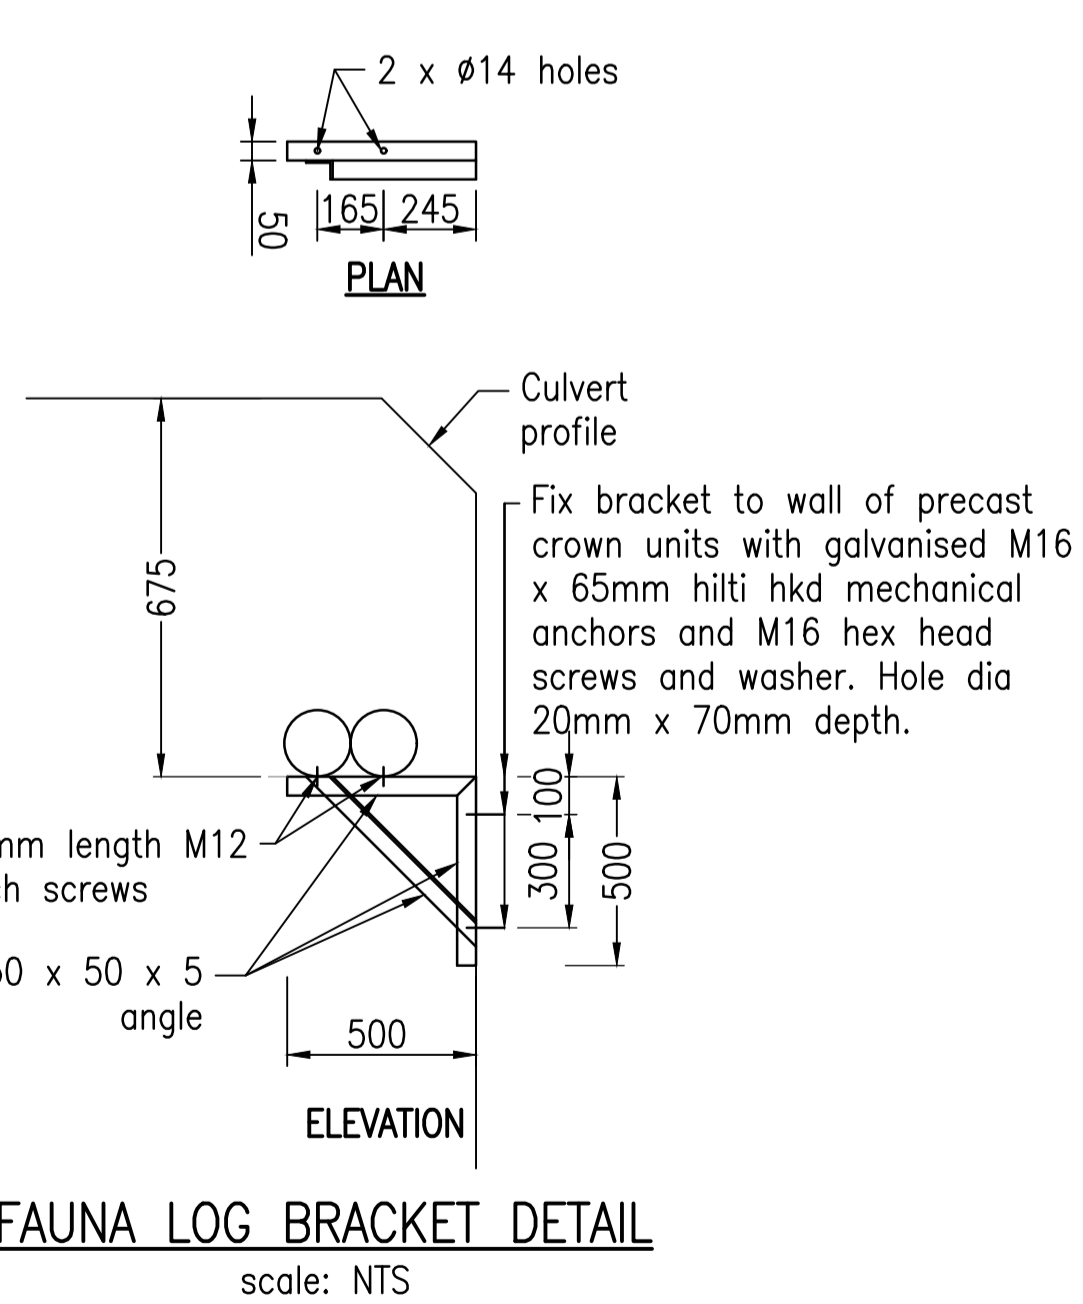
- REFER TO TMR STD DRAWINGS 1303, 1316, 1318 & 1359 FOR BOX CULVERT AND BASE SLAB INSTALLATION DETAILS.
- VERTICAL POLE INSIDE THE BOX CULVERT TO BE INSTALLED AT 10m MAX.

- EDGES TO BE PROTECTIVE TREATED SHALL BE ROUNDED TO A RADIUS OF 1.5mm UNO.
- ALL COMPONENTS EXCEPT STAINLESS STEEL ITEMS SHALL BE HOT-DIP GALVANISED AFTER FABRICATION.
