Technical Note 107

Steelwork Inspection Requirements

Bridge Construction Materials Inspection Report Steel Components

On 8 September 2011, an inspection of the bridge rail for the Wieambilla Creek Bridge on the Korgan Condamine Road was undertaken at Fabricator (Fabricator).

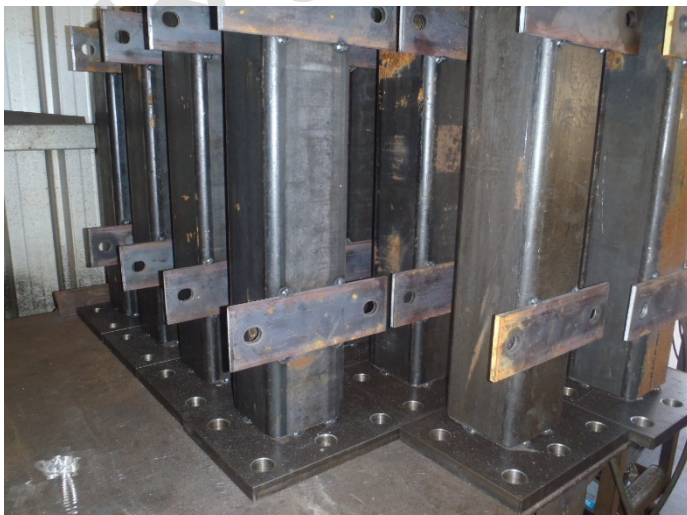
The first items to be inspected were the intermediate posts at the tack up stage, Refer to Figure 1. Figure 2 shows that the butt weld preparation at the base plate to post interface has been prepared in accordance with the weld procedure sheet. Figure 3 shows that the correct root gap has been used between the base plate and the post.

Figure 1 – View of the intermediate posts at the tack up stage

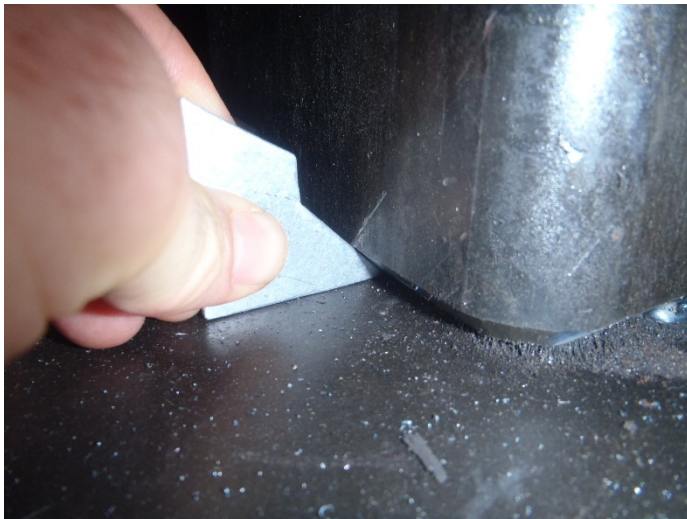
Figure 2 – View of the butt weld preparation on the intermediate posts

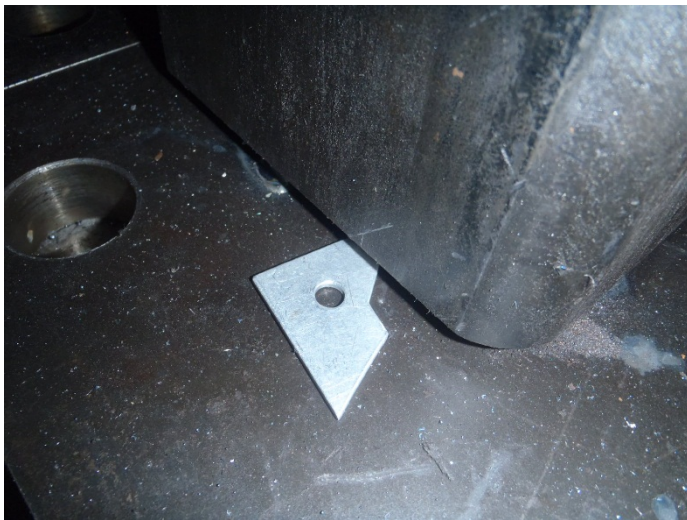
Figure 3 – View of the correct root gap between the base plate and post interface

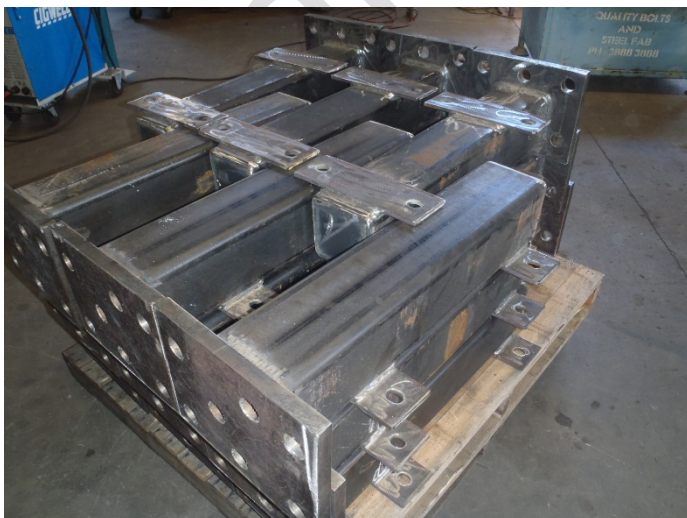
Some of the intermediate posts have been welded out, refer to Figure 4. Figure 5 and Figure 6 show that the fillet weld over the butt weld is the correct size in terms of leg length and throat thickness and are free of weld defects.

Figure 4 – View of the complete posts

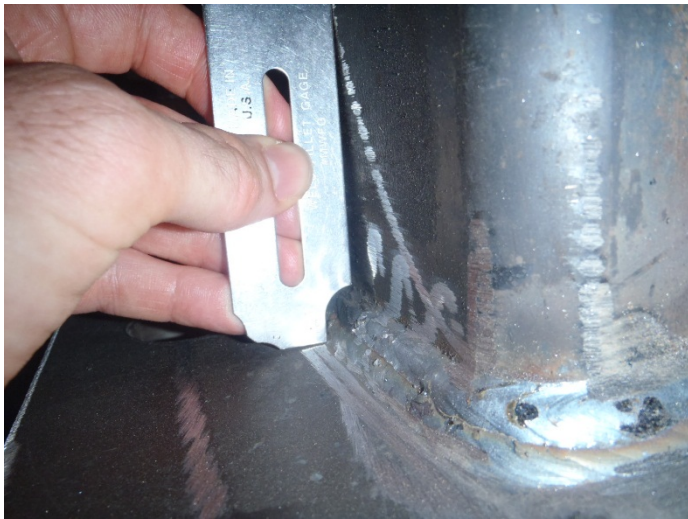
Figure 5 – Fillet weld leg length is the correct size

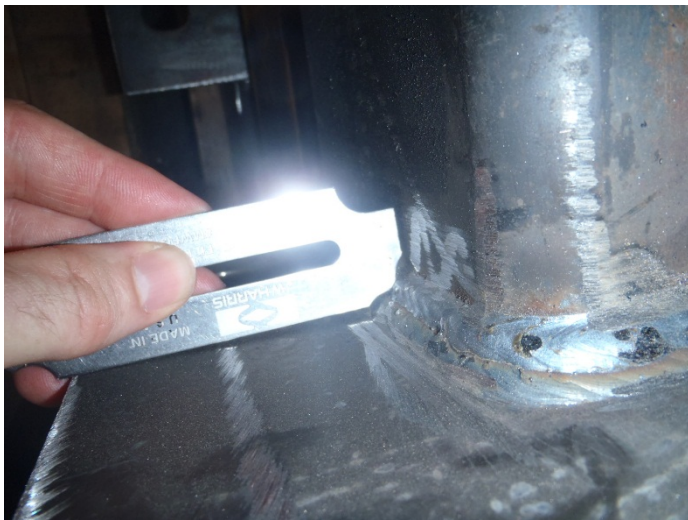
Figure 6 – Fillet weld throat thickness is the correct size

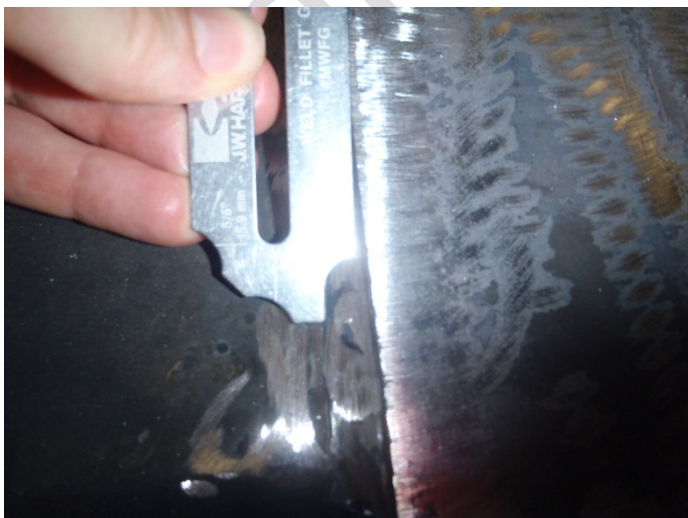
We also inspected the fillet weld around the rail anchor plate. Figure 7 show that the fillet weld is the correct size.

Figure 7 – Fillet weld leg length is the correct size

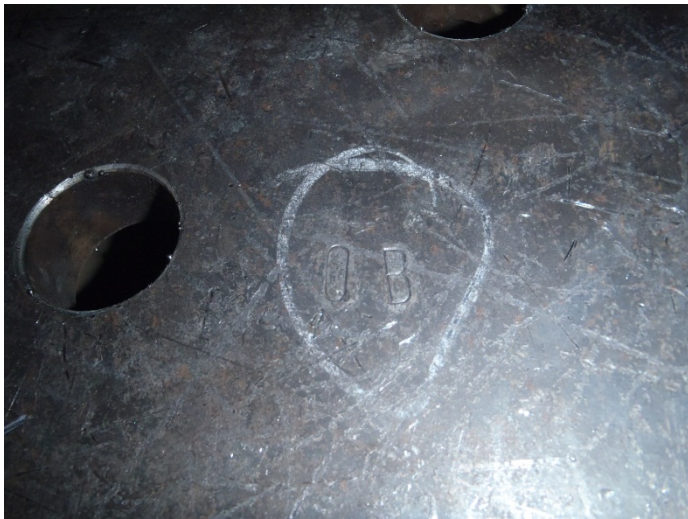
Fabricator has stamped the base plate with a QB symbol, refer to Figure 8. This identification mark will be used for future reference at identifying who supplied the posts.

Figure 8 – View of the post identification mark on the base plate

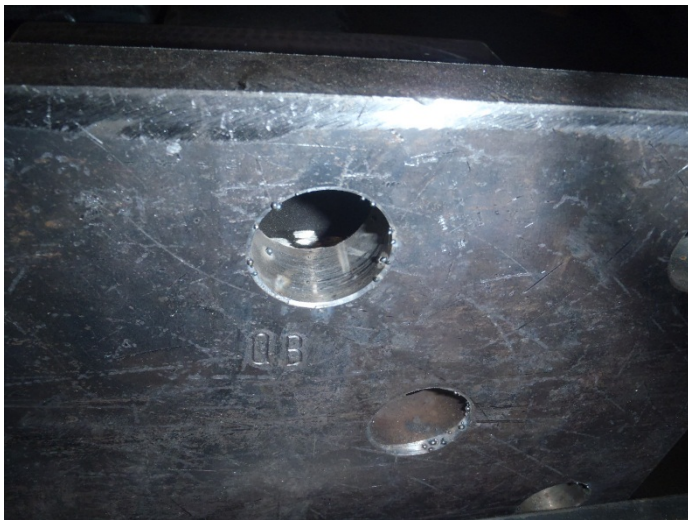
During the inspection we noticed that the hold down bolt holes were filled with weld splatter, refer to Figure 9. Fabricator advised that they would remove the weld splatter before the posts are dispatched for galvanising.

The butt weld preparations have been prepared in accordance with the weld procedures. The completed welds are the correct size and free of weld defects. We did notice that the latest batch of posts has weld splatter in the hold down bolt holes. Fabricator advised that they would remove the weld splatter.

Figure 9 – View of the weld splatter in the base plate holes
