412 Forest Hill Fernvale Rd
Chainage: 9.77km
(Lake Clarendon Way intersection)
23 April 2018

CRASH SITE ASSESSMENT
Stage 1 Report

DMS505/00158

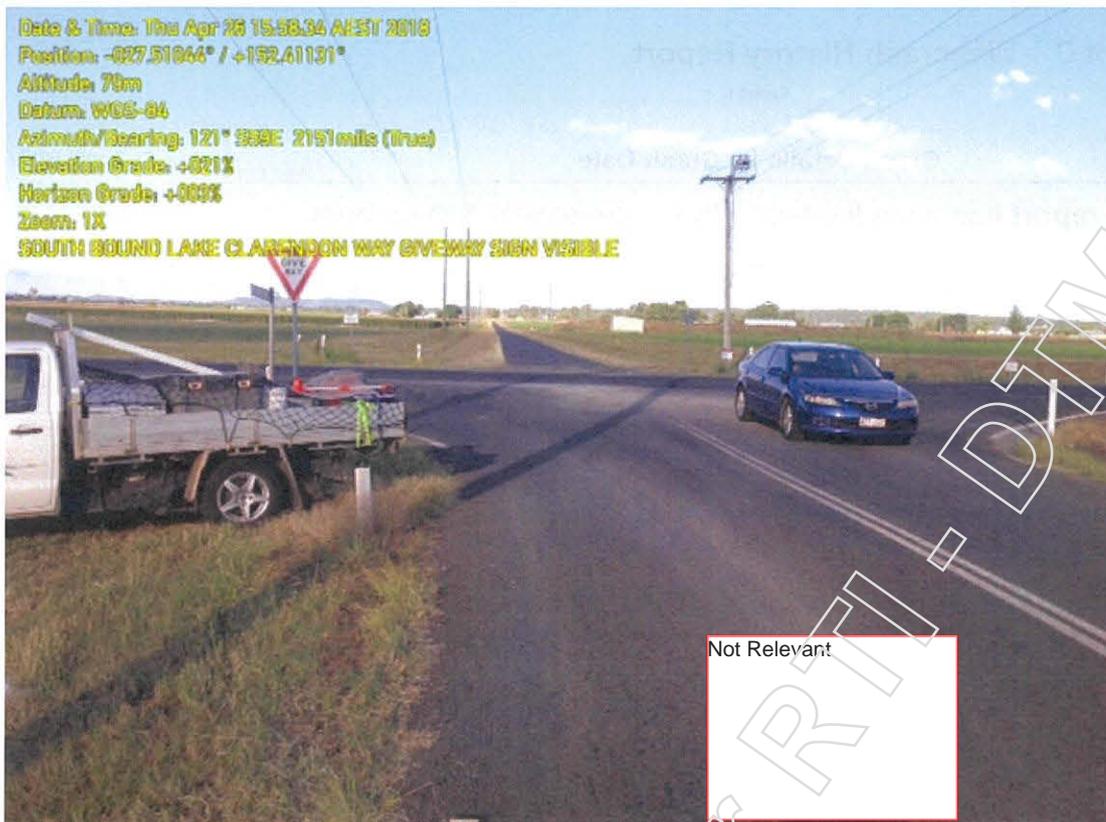
The intersection is controlled by a give way sign. The give way sign is appropriate at this location. Stop signs are used where there is restricted vision in either direction of the major or uncontrolled leg of the intersection (MUTCD Part 2 Cl. 2.5.4). There are no sight obstructions at this intersection.

Photo 5: Giveaway sign at intersection

To improve the conspicuity of the give way sign it could be enhanced with a fluorescent orange border or target board.

To further reinforce the give way sign it could be duplicated in the centre of the road. This would require a splitter island and likely also require associated pavement works to cater for the swept path of heavy vehicles. A reinforced concrete box culvert under Lake Clarendon Way would likely need extending to accommodate additional pavement works.

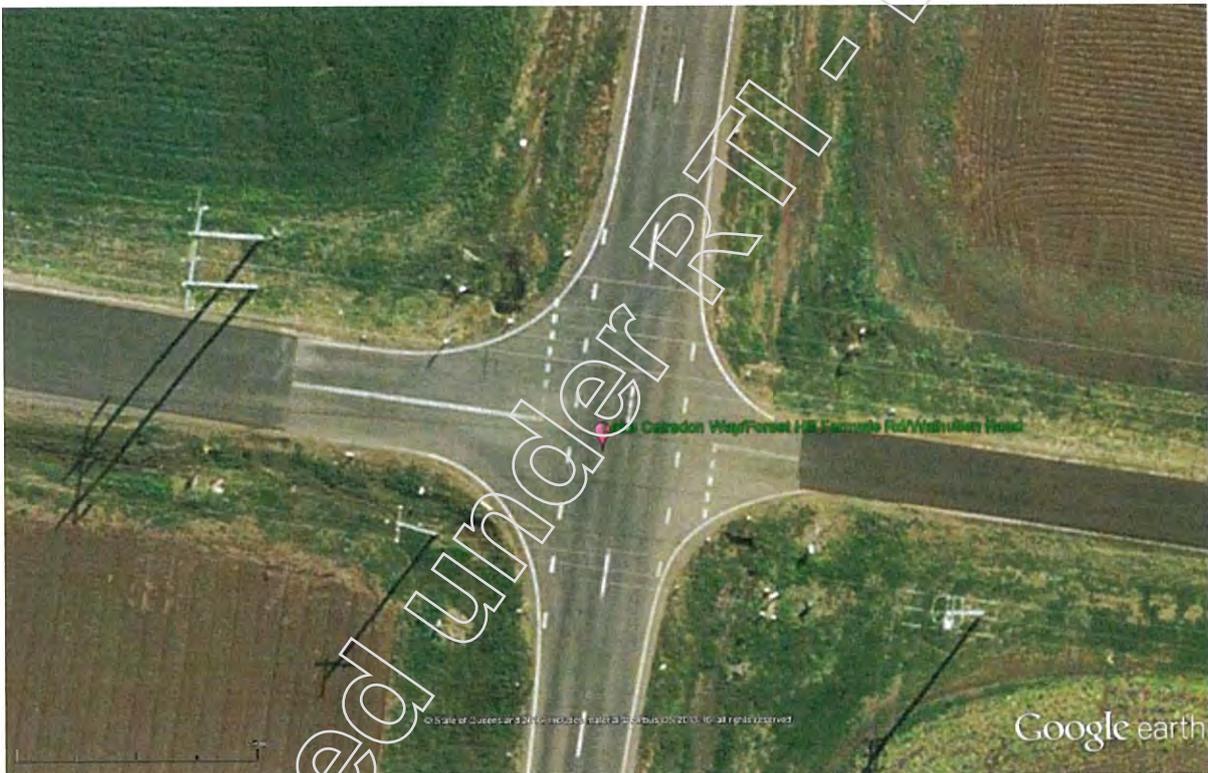
Figure 1: Aerial photograph of the site – Sourced from Google Earth.

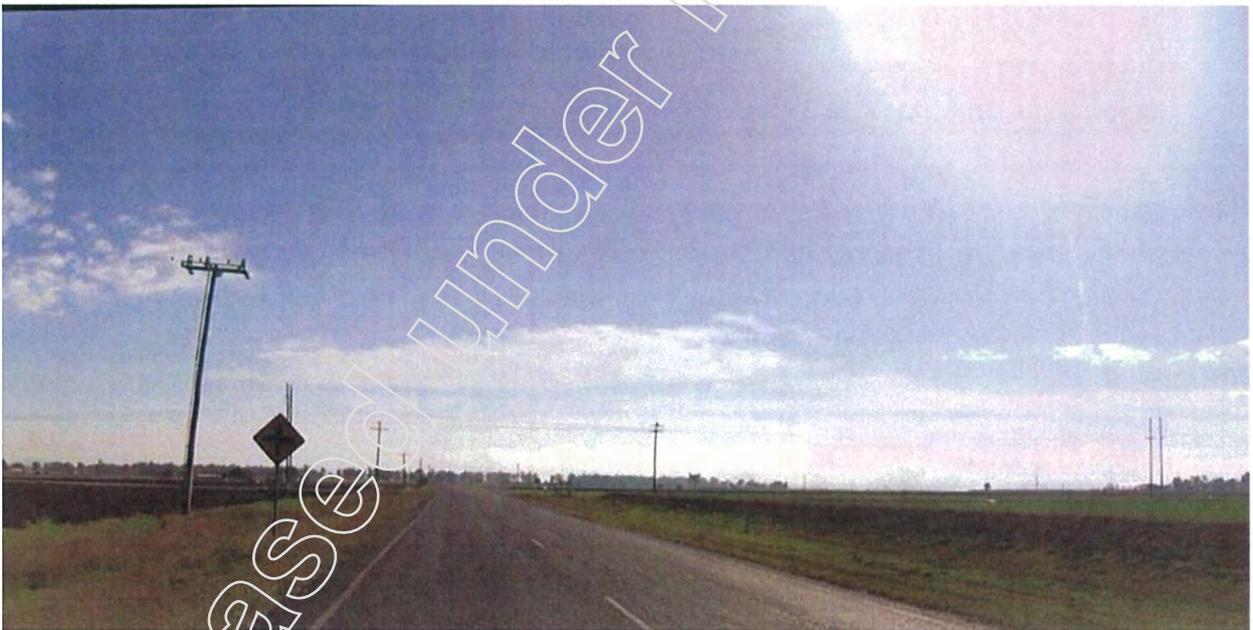
Figure 3 – Forest Hill Fernvale Road – Northbound Approach - Faded Intersection Warning Sign

The road marking on the main through portion of the intersection is in fair to moderate condition. The Signage on the primary road is in fair condition. The advanced warning signage on Lake Clarendon Way is not to current standard and should be reviewed. Walhuben Road has no advanced warning signage and should be reviewed.

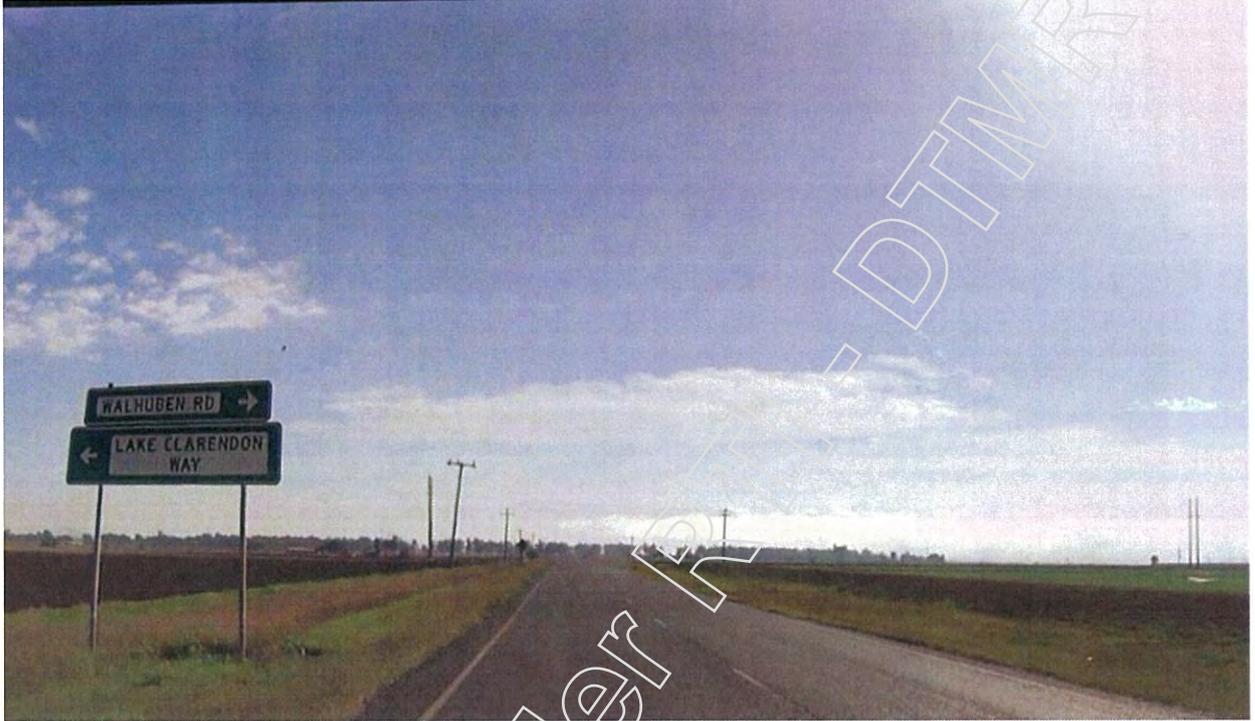
Figure 4 – Forest Hill Fernvale Road – Northbound Approach – Advanced Directional Signage

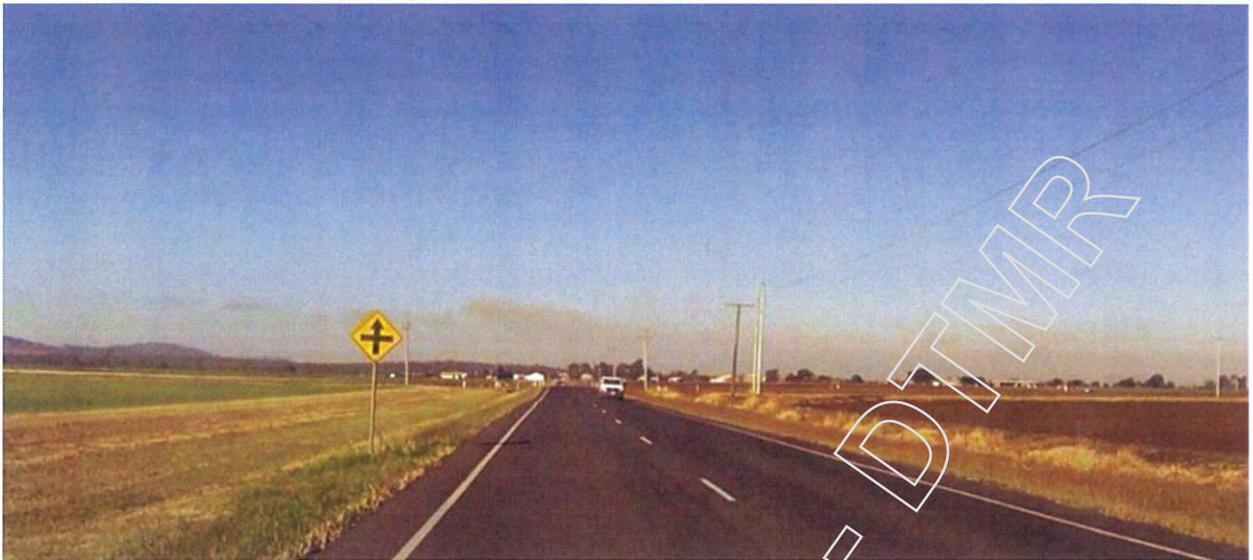
Figure 6 – Forest Hill Fernvale Road – Southbound Approach - Intersection Warning Sign

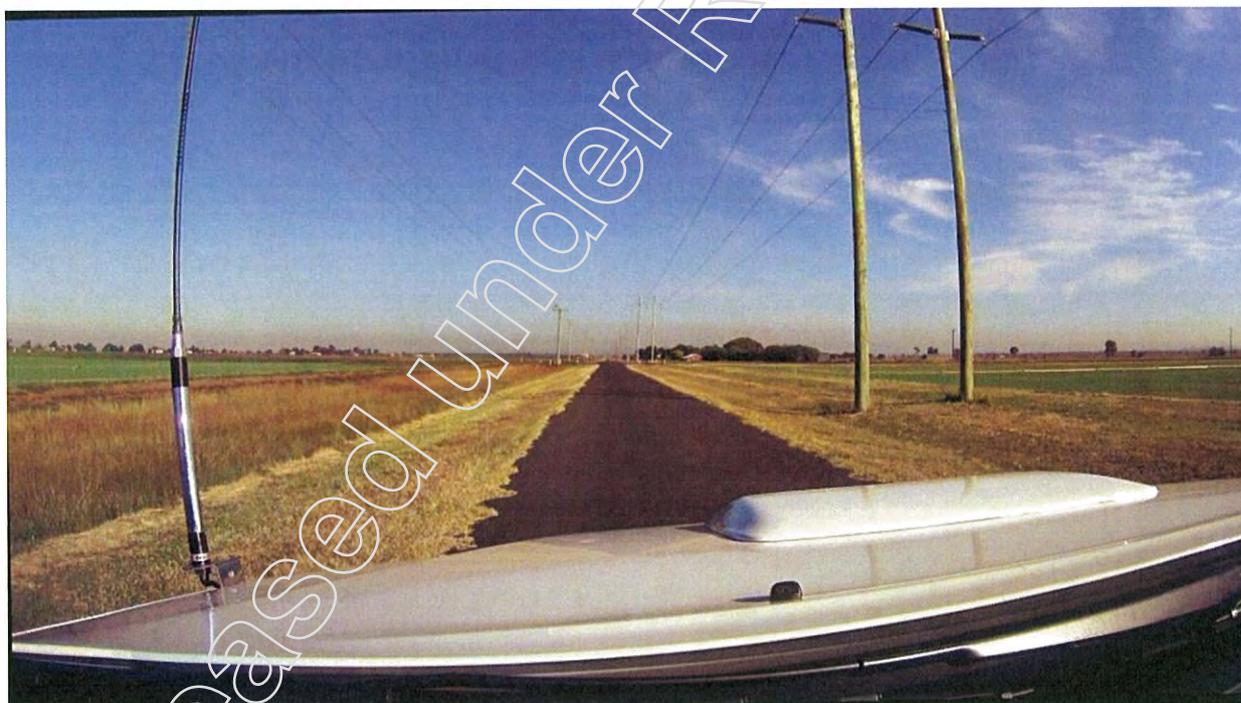
Figure 10 – Walhuben Road – Distant Eastbound Approach – No Advance Intersection Warning Signage

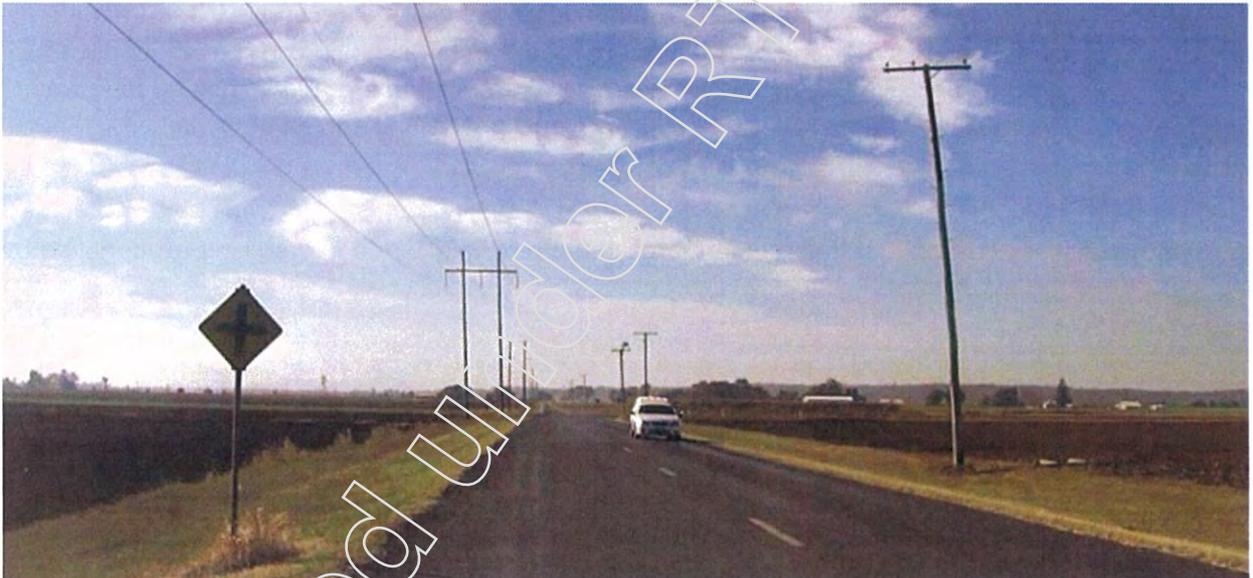
Figure 12 – Lake Clarendon Way – Westbound Approach – Faded Advance Intersection Warning Sign

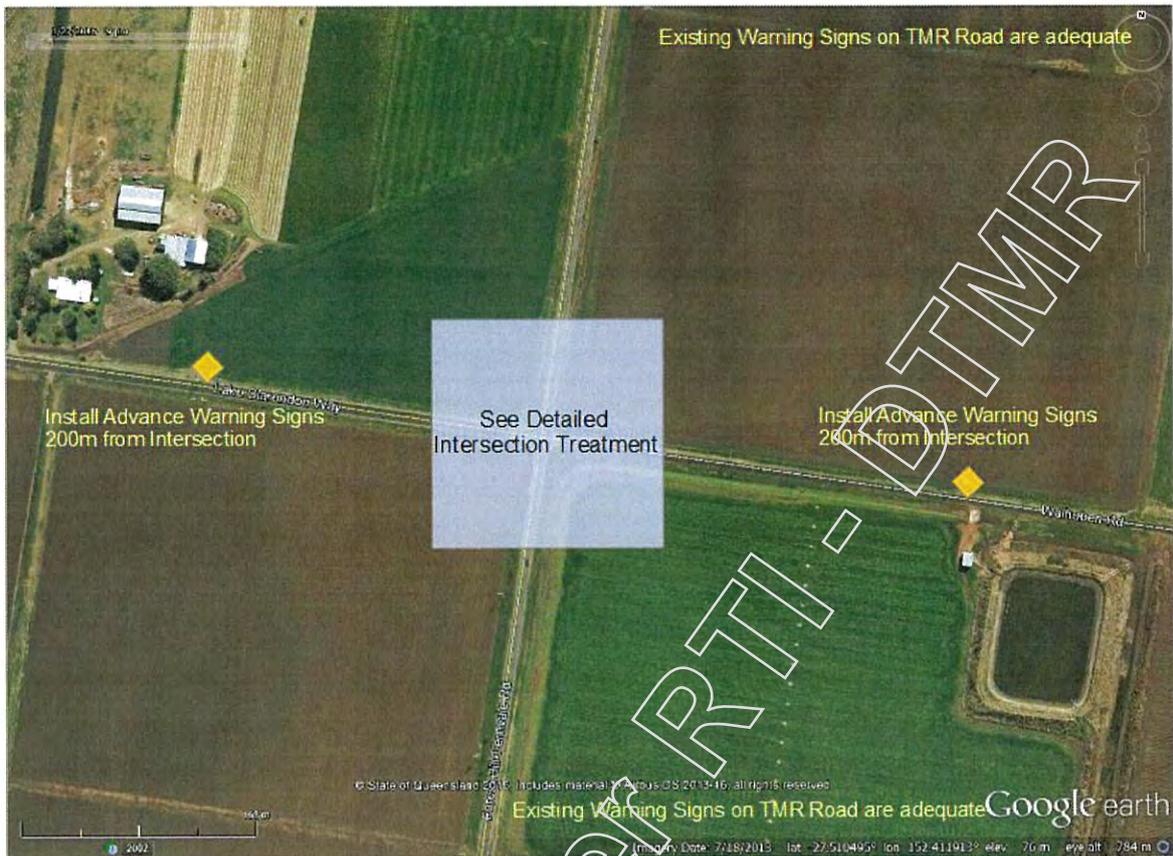
The following diagram is a schematic representation of a possible rectification treatment and if considered feasible would require a detailed site survey and intersection design.

Figure 12 – Possible Treatment Option

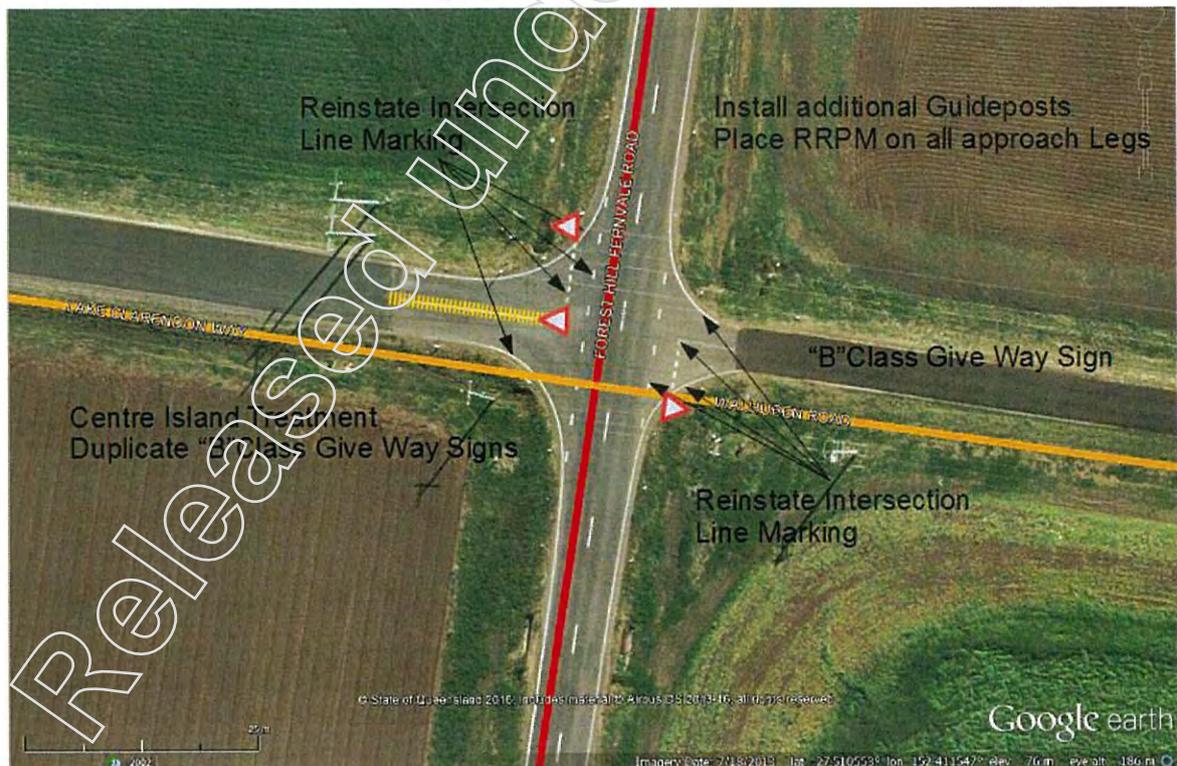
Figure 12a – Possible Treatment Option

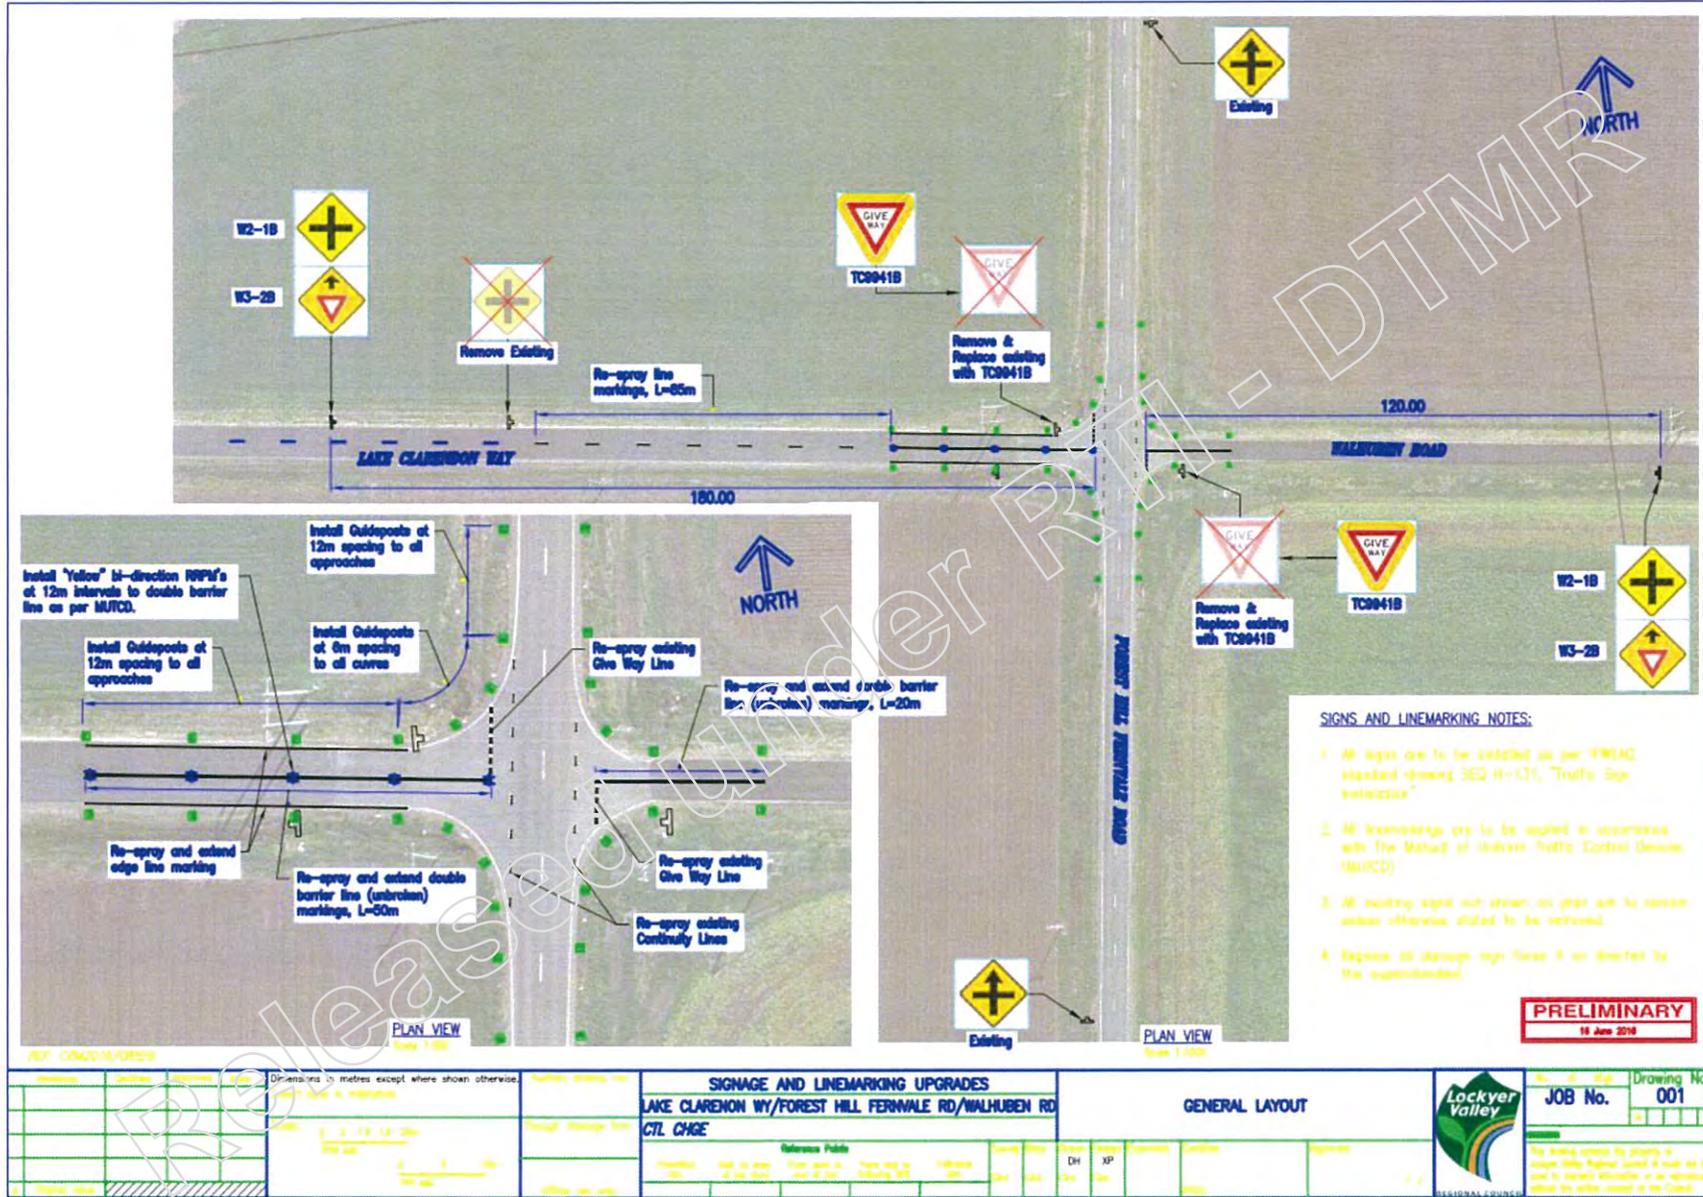
Figure 13 – Possible Treatment Option
