Subject **Hydraulic assessment - Bulimba Creek overflow drain, Tingalpa**

Subject **Drainage Issues - Bulimba Creek Overflow Drain, Tingalpa**

Bulimba Creek Overflow Drain Flood Assessment

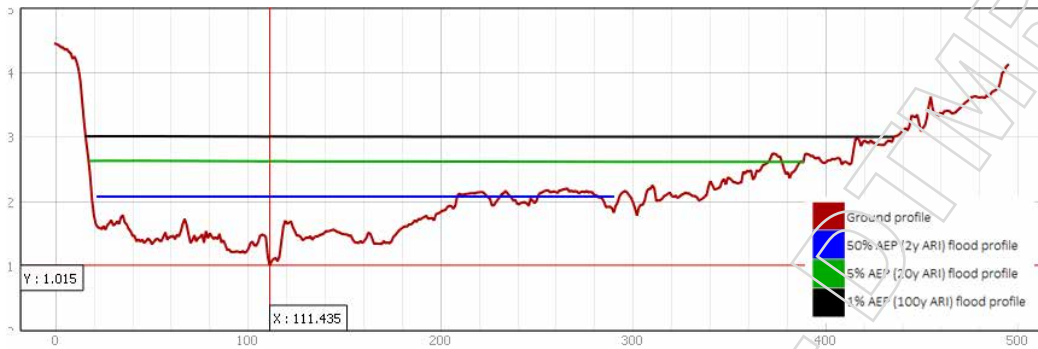
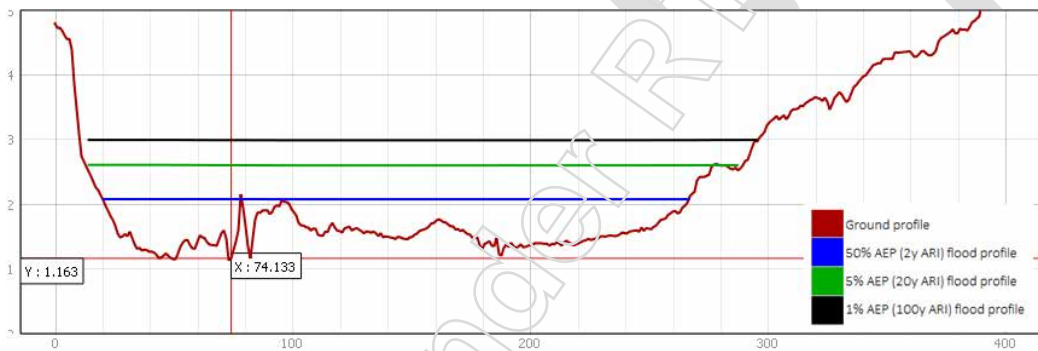
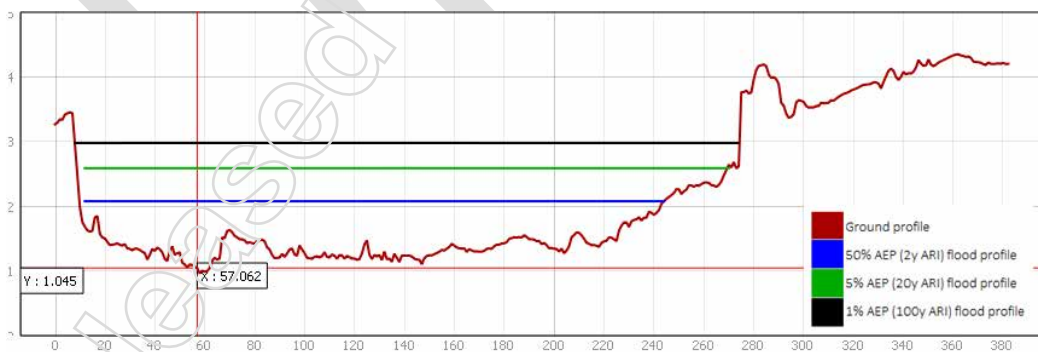
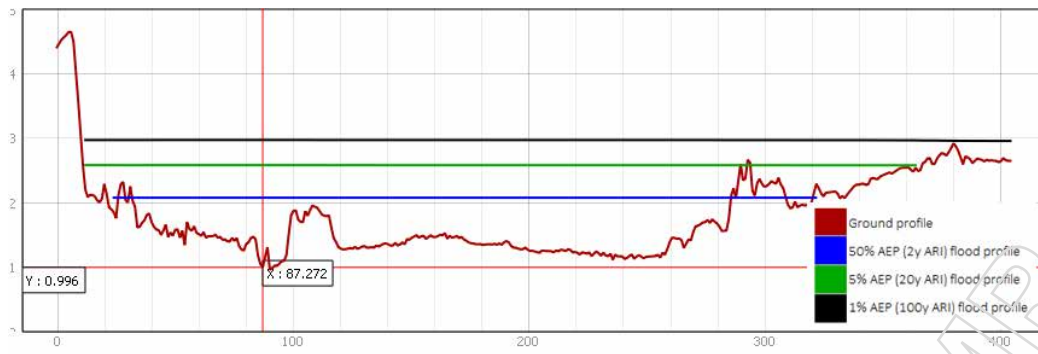
The figure below depicts four cross sections illustrating the ground profiles of the drainage corridor along with maximum water surface profiles for 50%, 5%, and 1% AEP events. For the cross-section locations, please refer to the attached maps (Map 1 to 3). The crosshairs on the cross-sections pinpoint the drain's position within the drainage corridor, providing a visual comparison of its relative cross-sectional area to that of the broader drainage corridor. These sections also highlight the anticipated high water depths across the profiles at the aforementioned events.

Therefore, considering the modelling results and the relative cross-sectional areas of the drain and drainage corridor, it appears that clearing and dredging this drain would yield minimal improvements to its conveyance capacity. Additionally, the current vegetation within the drainage corridor, similar to wetlands, poses significant environmental concerns should the removal of established mangrove-type vegetation become necessary.

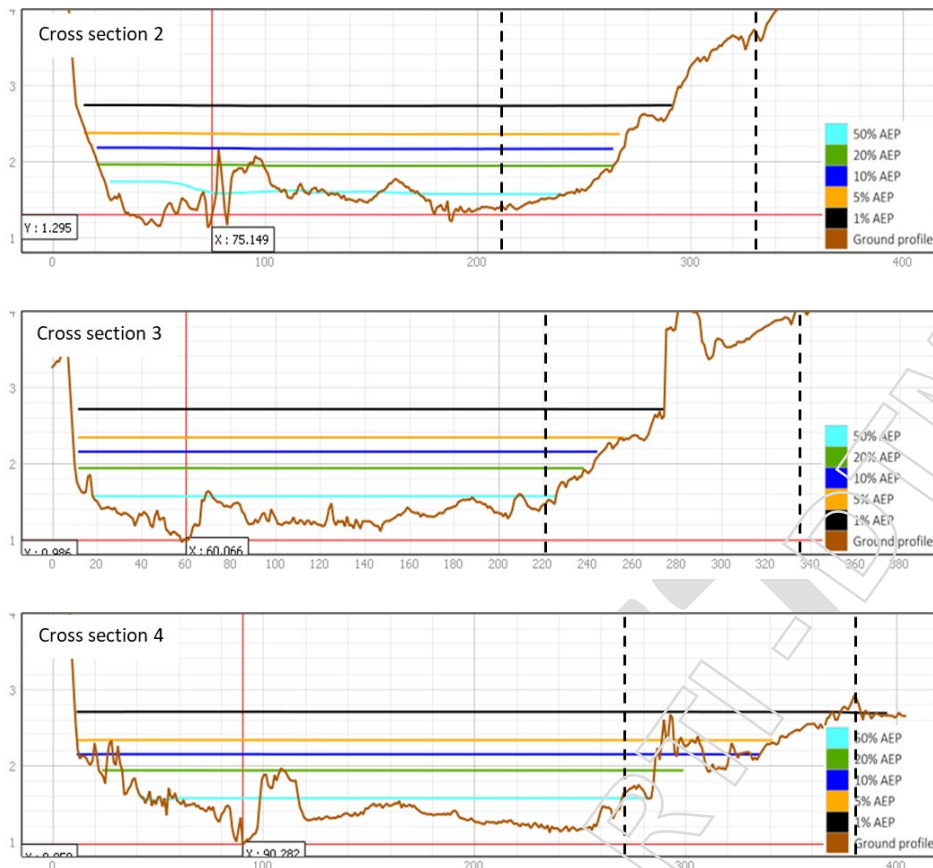
Figure 2 Flood profiles

The figures below depict four cross sections illustrating the ground profiles of the drainage corridor along with maximum water surface profiles for 50%, 20%, 10%, 5%, and 1% AEP events. For the cross-section locations, refer to Maps 1.2 - 1.6. The crosshairs on the cross-sections pinpoint the drain's position within the drainage corridor, providing a visual comparison of its relative cross-sectional area to that of the broader drainage corridor. Additionally, the location of the eastern boundary of the drainage corridor where the allotments boundary start, and the location of Boundary Street are also indicated for information (dashed lines). These sections illustrate the anticipated flood depths across the profiles at the aforementioned events.

Considering the modelling results and the relative cross-sectional areas of the drain and drainage corridor, it appears that in general, clearing and dredging this drain would yield only a minor improvement to its conveyance capacity. Its effectiveness appears to be minimal for the events 20% AEP and above as the flood encroaches the allotments in such events. Additionally, the current vegetation within the drainage corridor, similar to wetlands, poses significant environmental concerns should the removal of established mangrove-type vegetation become necessary.
