Bruce Highway

(Cooroy - Curra)

Strategic Planning Study

Recommended Corridor Report

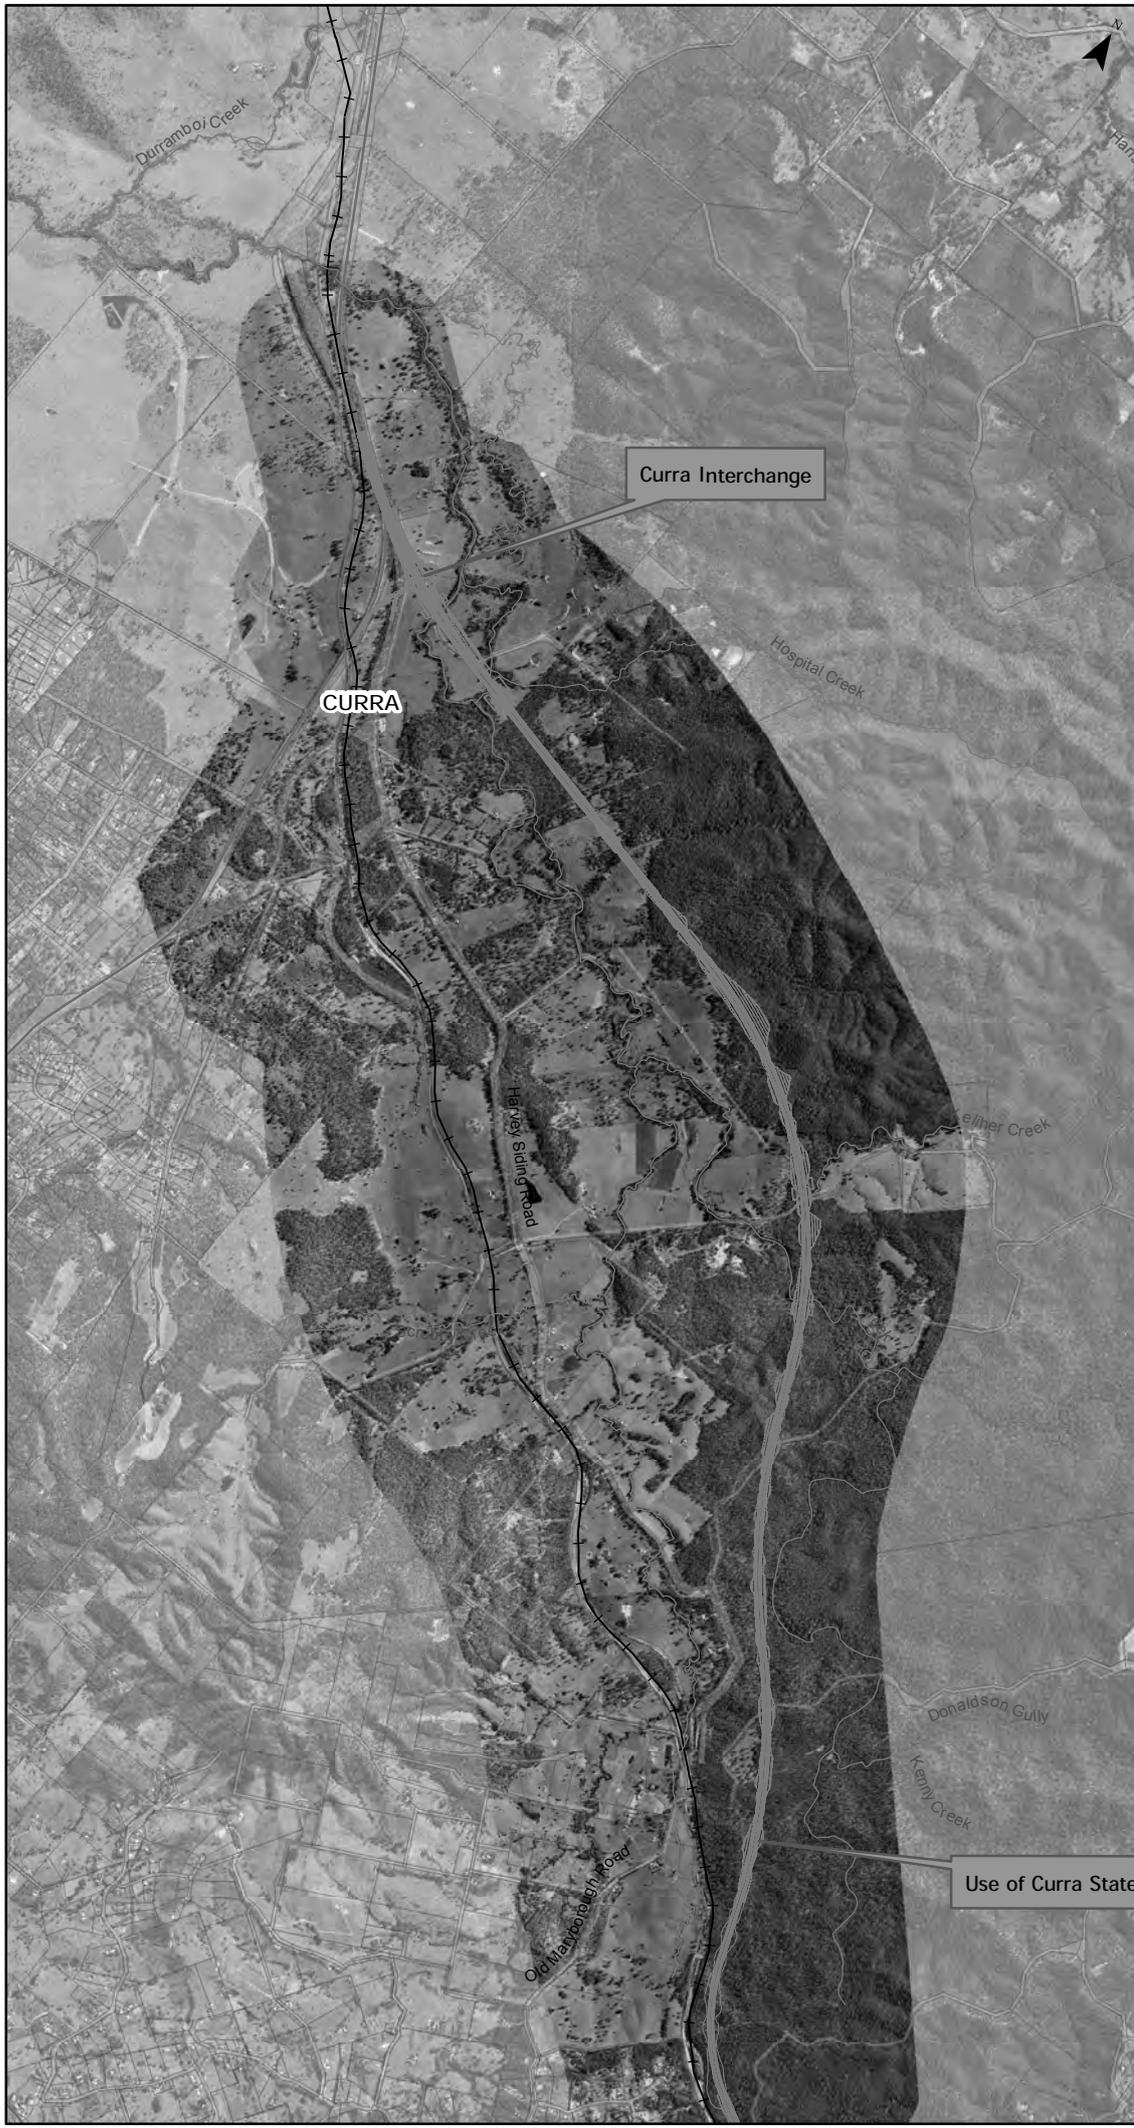
Map 5

Recommended Corridor

The recommended corridor duplicates the existing Bruce Highway between the Cooroy Bypass Interchange and Cooroy Connection Road. The duplication is to the western side of the existing carriageway and is generally within the existing highway reserve.

North of Cooroy Connection Road the corridor aligns to the southern side of the existing highway reserve with significantly improved horizontal and vertical geometry. The recommended corridor crosses the existing highway near the Federal State School.

Within the area of the proposed Traveston Crossing dam the recommended corridor follows the dam's eastern buffer area. Should the dam not proceed then the location of the corridor may change to an alignment close to the existing Bruce Highway as originally favoured by the community. The existing highway will be inundated by the proposed dam; however a two lane service road aligning to the eastern side of the recommended corridor will continue to connect the local traffic which would otherwise have used the existing highway.

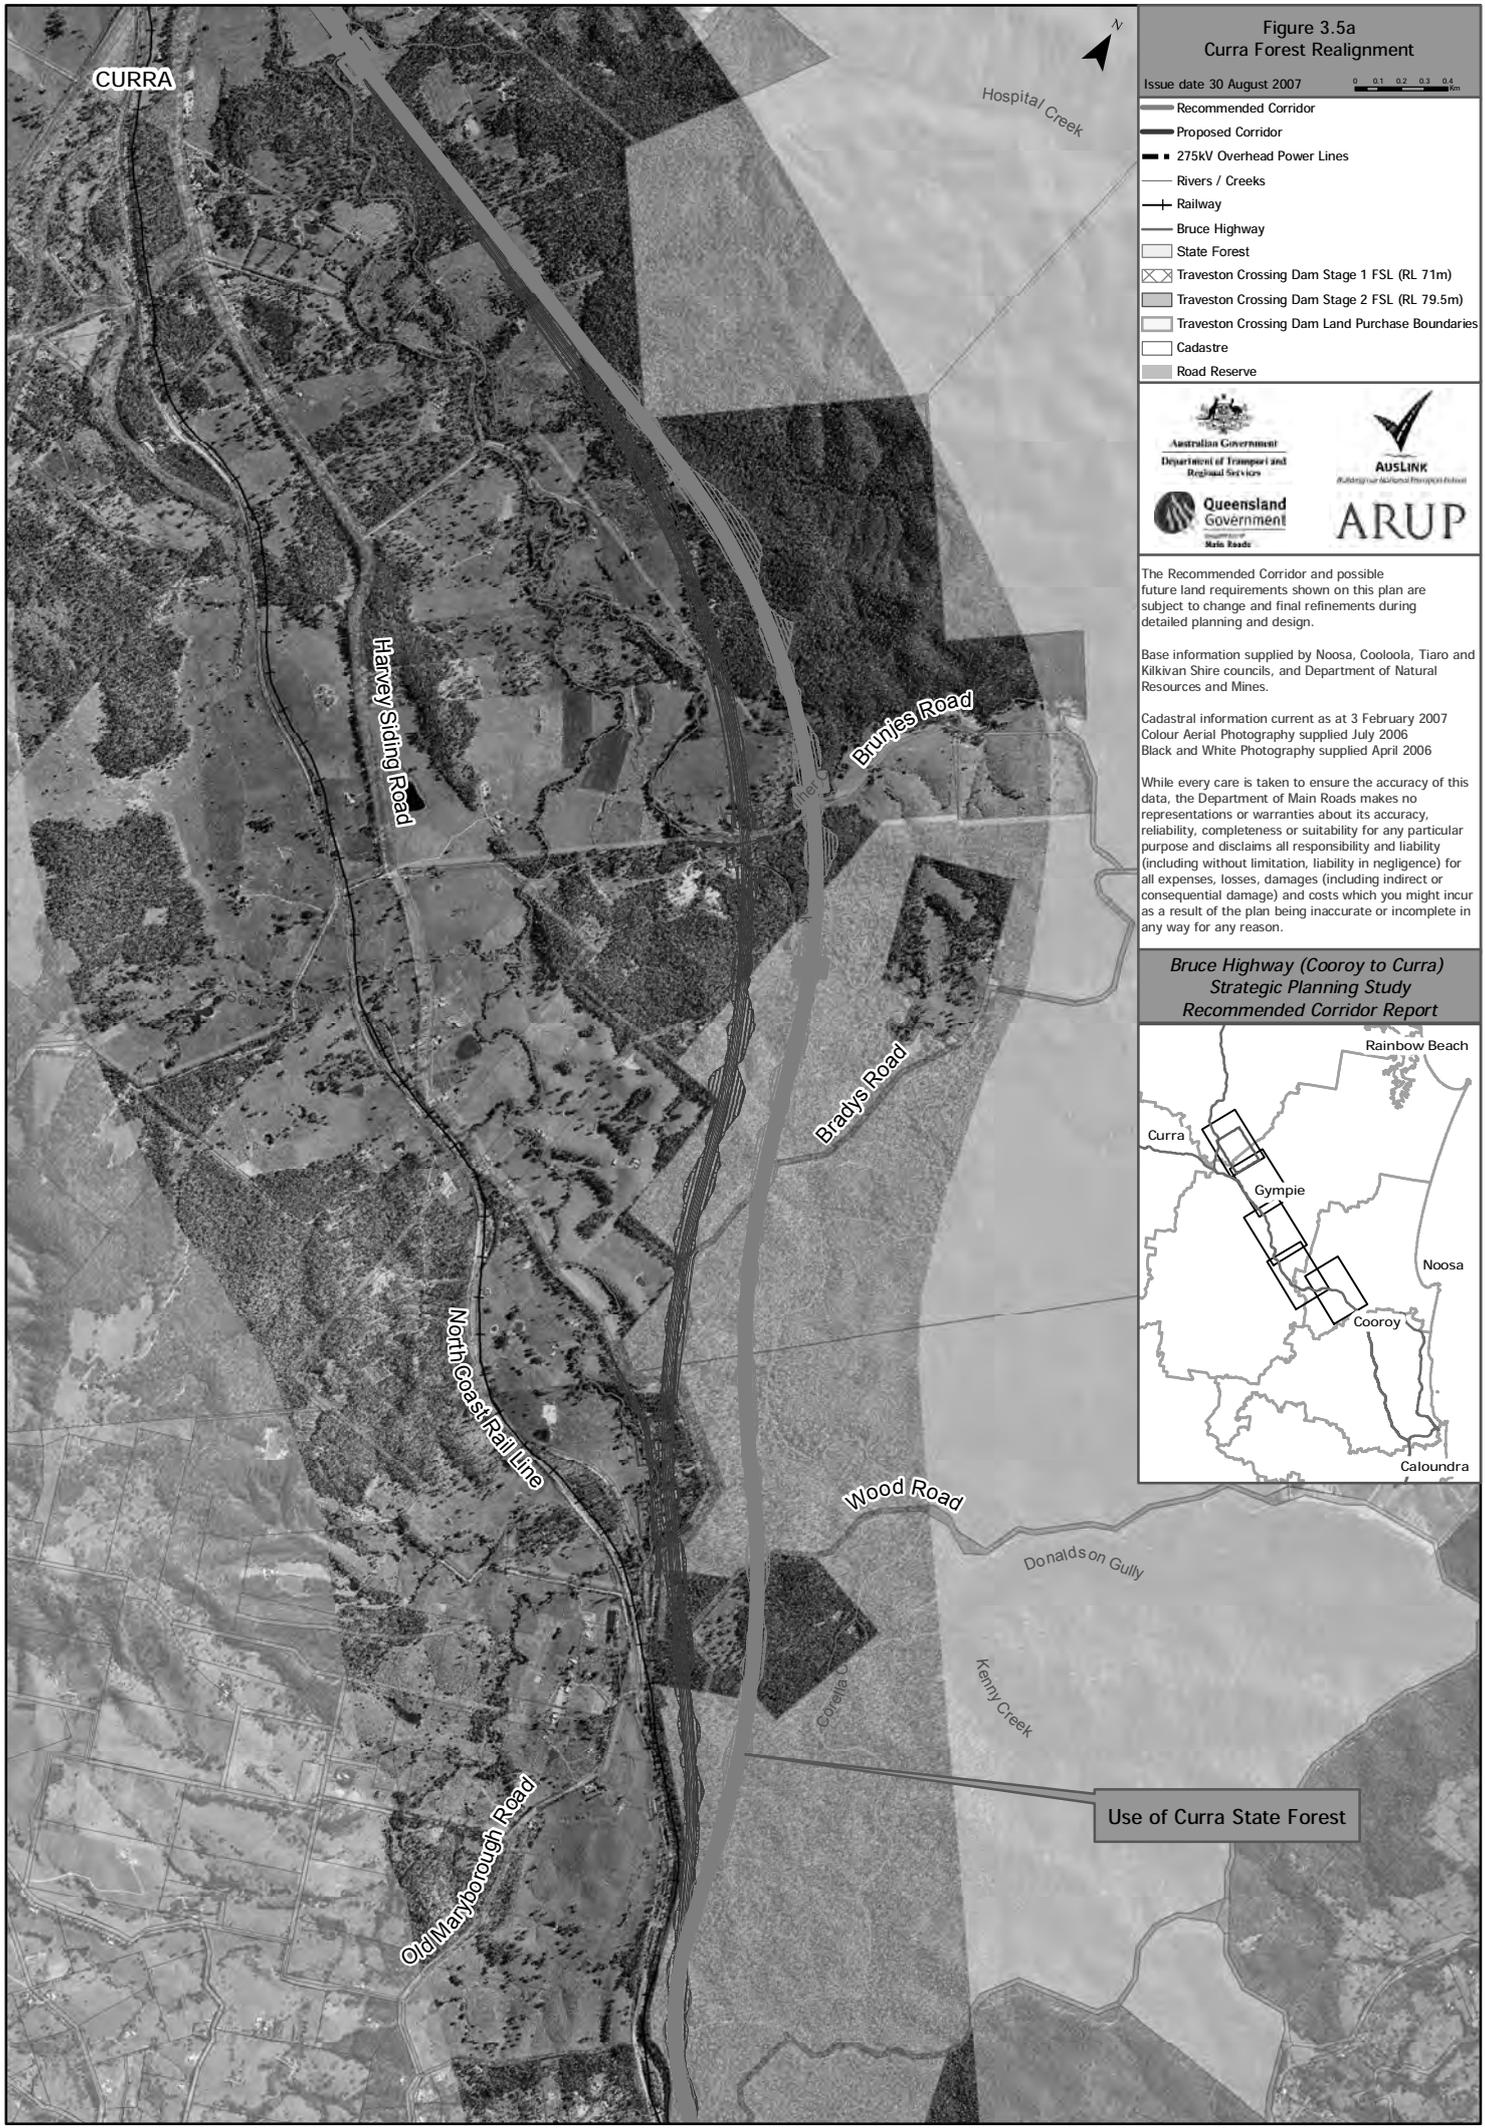
Figure 3.5a
Curra Forest Realignment

Fauna crossing provisions and landscaping elements and roadside maintenance issues will also need to be considered carefully.

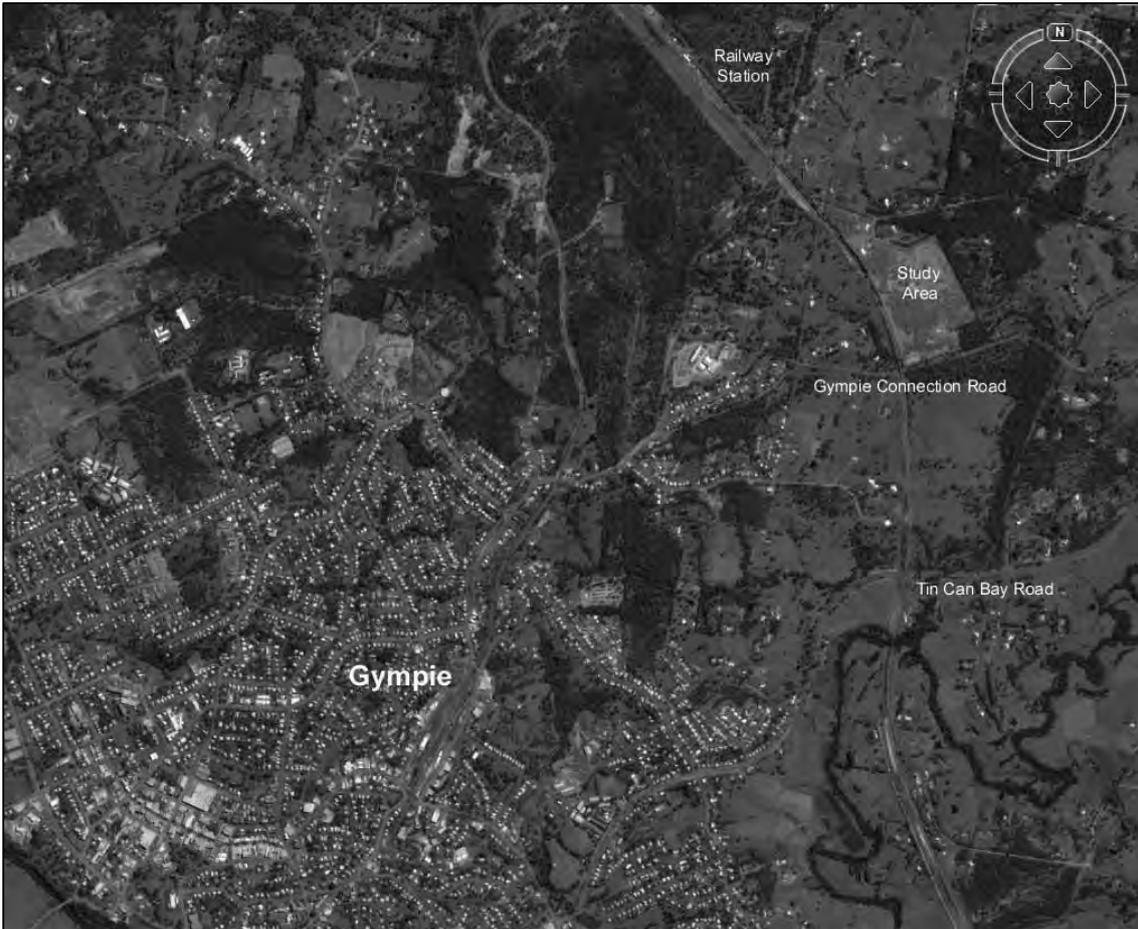
Map 2: Location of the study area in relation to the local area

That section of the study area incorporating features, both natural and historic, sometimes referred to as the "Gympie Pyramid" is restricted to the steeper, southern side of this ridge. Apart from various small outcrops of sandstone (or exposed faces of floating boulders) near the crest, the majority of this slope is not rocky. North of the sandstone cap, the ridge has a gentle slope, covered with sandy material, presumably derived from *in situ* weathering of the sandstone. The southernmost section of the study area below the ridge and adjacent to the Gympie Connection Road is comparatively flat and contains a small creek gully incorporating several deeper waterholes (This area is noted as a reliable water source in early survey maps). Please refer to Map 2 on the following page for further detail.

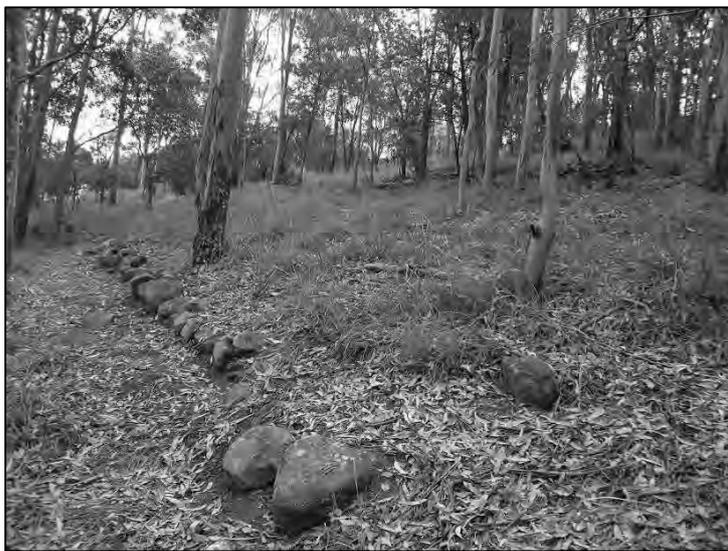
It was decided to refer to these finds collectively as Site Complex 1 (SC1), which includes what can best be described as a series of shallow 'terrace-like' features (F1, F3-6, F8-10) comprised of linear sections of low, loosely stacked local sandstone in combination with low earth banks or cutaway sections that vary considerably in height, length, and the number of courses of stones in their construction (generally no more than 40 - 50 cm or 3-4 courses). Stone utilised in these features was of varying size and most would appear to have been of a scale that would have been moveable a short distance by one or two people. Similarly these features appear to utilise readily-available stones from the adjacent soil surface, with no stones showing any evidence of splitting, dressing, or other attempts at working to improve their flatness.

Figure 1: Looking northwest across Feature F1 from its easternmost point at F1A. Sections of Feature F3 are also visible in the background. These features are separated by approximately 15 metres.

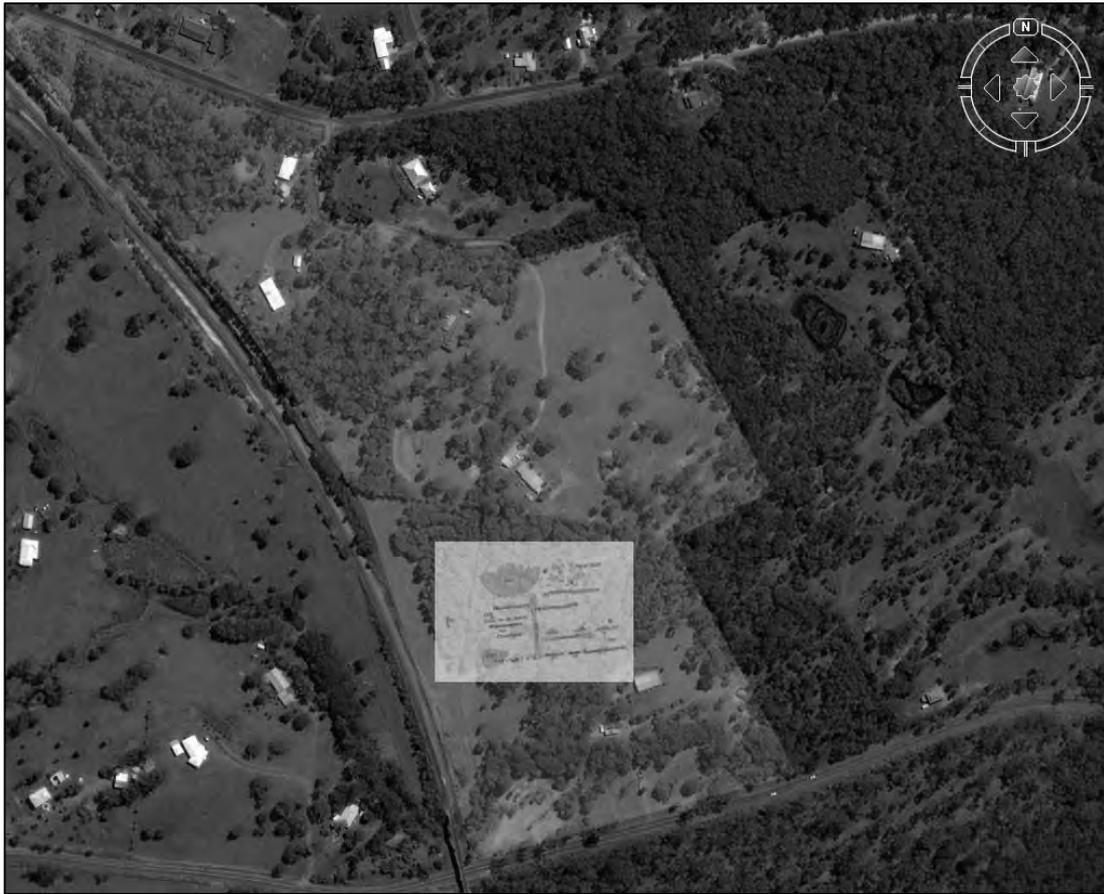
Figure 3: Aerial photograph of the general study area showing areas examined highlighted in yellow overlaid with the mud map demonstrating the general location of SC1 located during the survey.

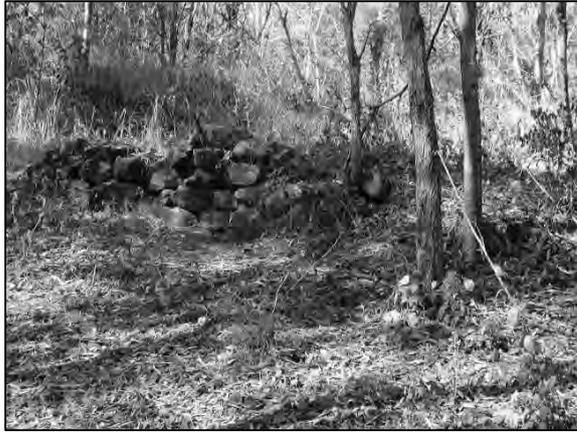
Figure 4 - Western face of Feature F2 shows the dry-stone wall of the structure

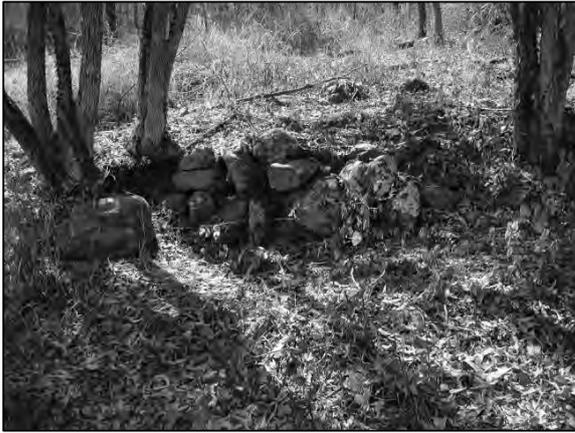
Figure 5 - View looking uphill of Feature F4 showing irregular construction, low height, and partial collapse with block on left rolling down the slope. Camphor Laurel trees on left and right are planted on the line of the "terrace".

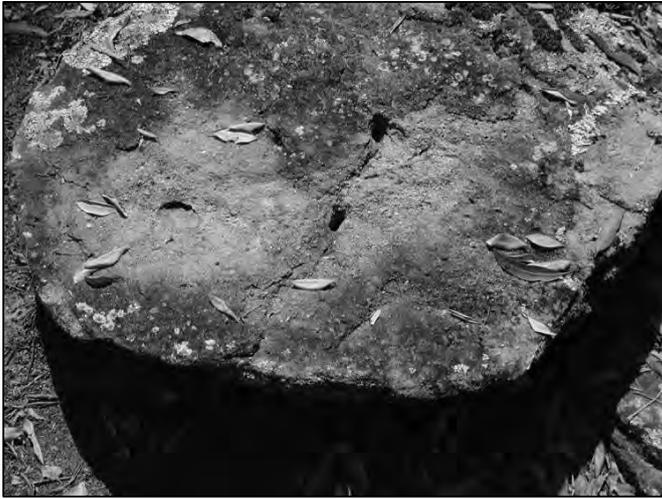
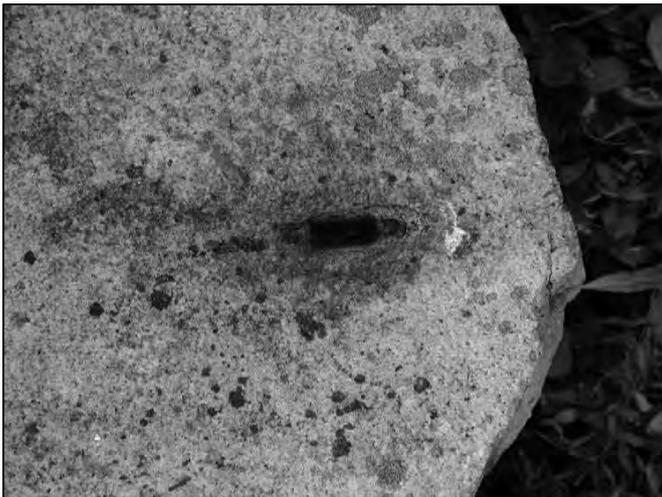
Figure 7. Sandstone block with rectangular holes possibly the result of attempts to split the blocks with gads.

Figure 8. Sandstone block with rectangular hole possibly the result of attempts to split the block with gads. This hole is cratered at its upper edges, typical of the damage done when using gads.

Two separate blocks have elongate blind holes that appear to be the result of attempts to split the blocks with gads (Figure 7). A very old technique for splitting rock involves scratching the desired line across the rock, chipping an interrupted series of shallow holes along the line with a pick or similar tool, and then hammering gads into the holes. Each gad is progressively hammered into the rock, setting up a stress concentration, causing the rock to fracture along the line of gads. Typically such holes are narrow rectangular with a cratered top, such as shown in the two images.

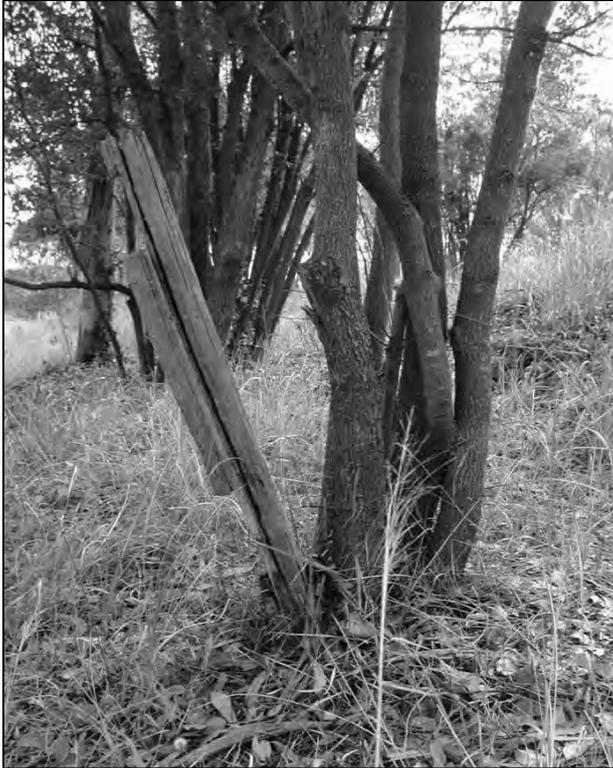
Figure 9. Westerly view along the line of Feature F1D showing remains of fence. The sawn square post has two distinct rebates cut into it on the downhill face. The obvious black line down the post is a crack, not evidence of construction by nailing several pieces together.

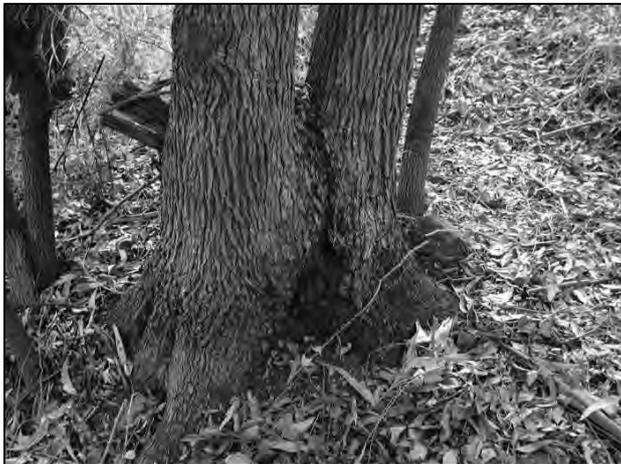
Figure 10. At some time, this fence post fell into the crutch of two trunks of a Camphor Laurel. Subsequent growth has fully enclosed the post.

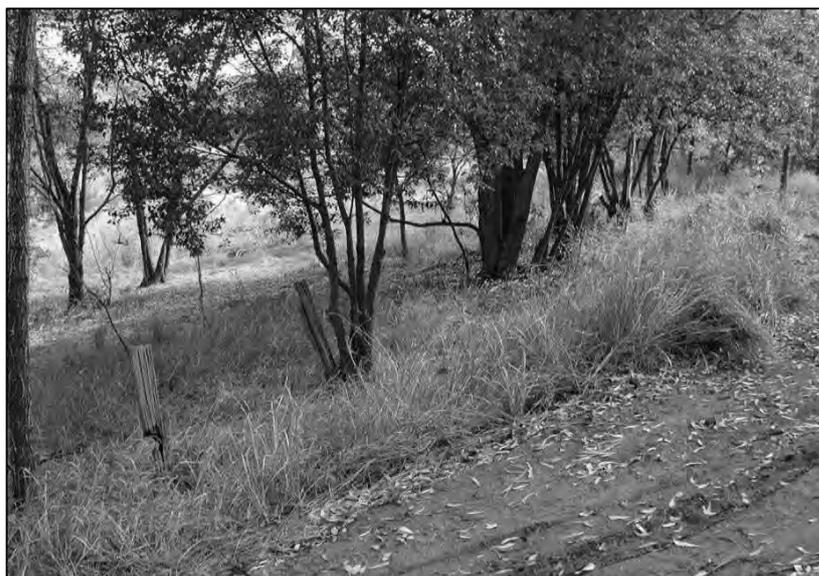
Figure 11. Interrupted line of Camphor Laurel along F1D. The image is an oblique westerly view from above the line, and shows posts from a derelict fence.

Irregular lines of multi-stemmed Camphor Laurel trees occur on or adjacent to two of the historic stone features (F1D and F4). The trees are fairly widely spaced, and are restricted to the south-western side of the slope. The linear arrangement of the trees suggests two origins. The first is that the trees were deliberately planted along the line. Alternatively, they could have grown from seeds voided by birds sitting on the fence. Given that the trees are essentially restricted to these lines, this latter explanation is unlikely. Why the trees were planted is unknown. They are too widely-spaced to serve as hedges designed to retain or exclude stock and therefore may have been intended as shelter-belts or windbreaks for some crop, however this latter explanation is purely speculation.

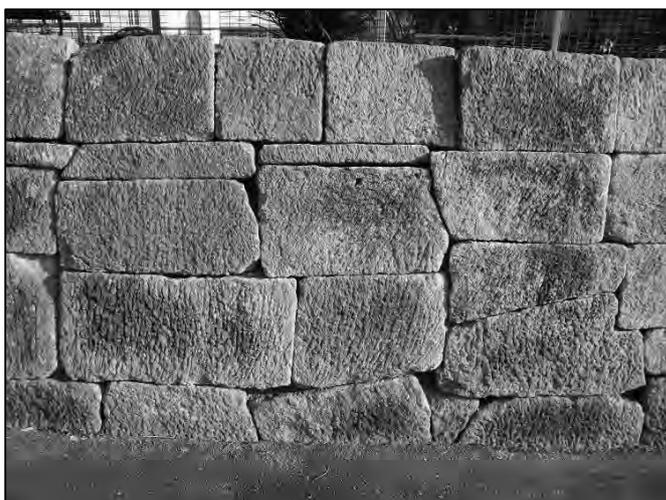
Figure 12. Boundary wall at Surface Hill Uniting Church, Gympie.

The site boundary for part of Barter Street and all of Channon and Reef Streets is finished with a squared but uncoursed rubble retaining wall. This is a suitable example of a dressed and well constructed stone feature and a relevant point of difference to the quality and workmanship involved in the stone elements identified in the study area (Qld Heritage Register Citation: 601529).

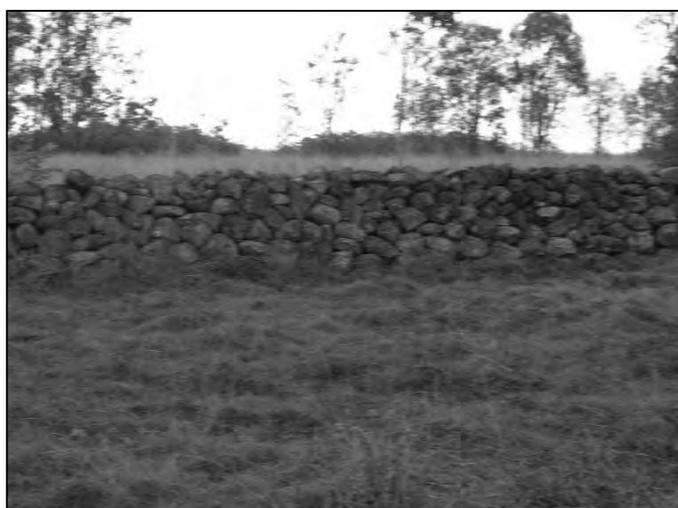
Figure 13. Significant stone wall at Mon Repose near Bundaberg (ARCHAEO 2007).

The dry-rubble boundary walls such as those at Mon Repose and Sunnyside Plantation in the Bundaberg were recently inspected by ARCHAEO staff. These walls were more than likely constructed in the 1880s by indentured South Sea Islanders working to clear the land for sugar cane cultivation.

In the case of the boundary wall at Sunnyside Plantation, which is approximately 200 metres in length, it remains as one of the more intact examples of its type in the Bundaberg district, which around the turn-of-the-century was chequered with such structures. Large scale stone walls from this era, such as those at Sunnyside and Mon Repose are now considered rare to Queensland. Comparatively, the stone elements featured in the study area are of similar construction method and purpose to those at Bundaberg, however those at Gympie clearly do not display the same degree of scale or use of comparable labour force in their construction to those structures abovementioned in the Bundaberg region (Qld Heritage Register Citation: 601700).

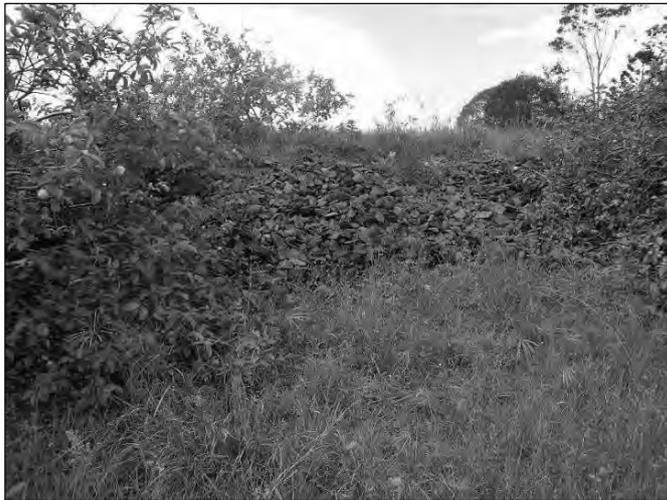
Figure 14. Significant stone terracing and walls on hill slopes near Maryborough (ARCHAEO 2007).

The 'terraces' are of impressive dimensions measuring as much as 200 metres long (maybe more), 1 – 1.5 metres in height and as much as 3 – 4 metres in width at their widest point, indicating the involvement of a significant labour force (possible South Sea Islander labour as large numbers of whom came through the Port of Maryborough in the second half of the 19th century). Other features include several stone and earthen 'mounds' of varying shapes and dimensions, the most notable being roughly circular and measuring approximately 6.5 metres in diameter and 1.5 metres at its highest point.

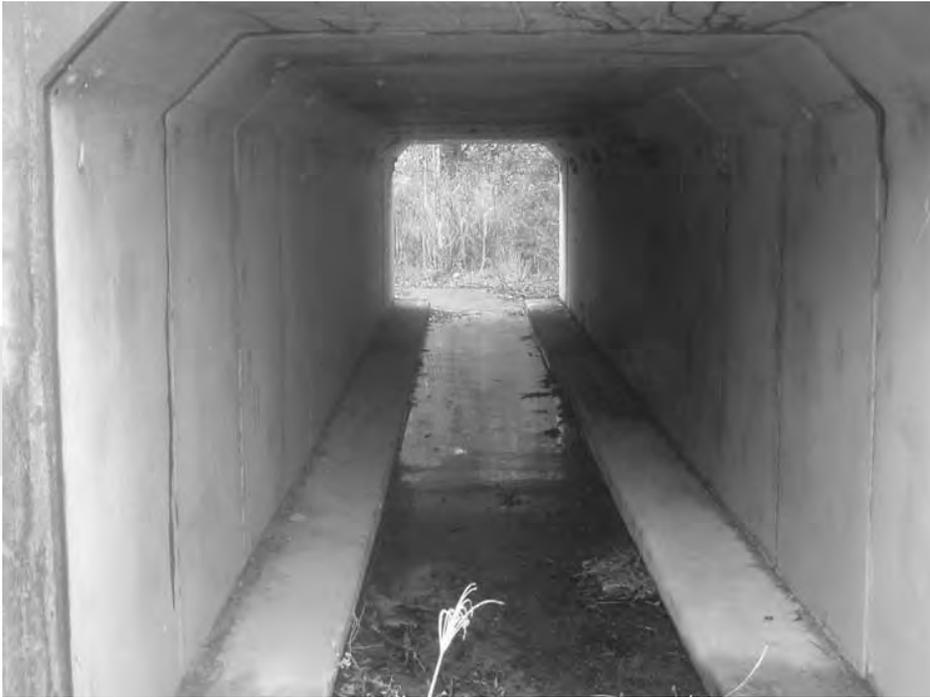
Plate 1. Culvert with dry ledges

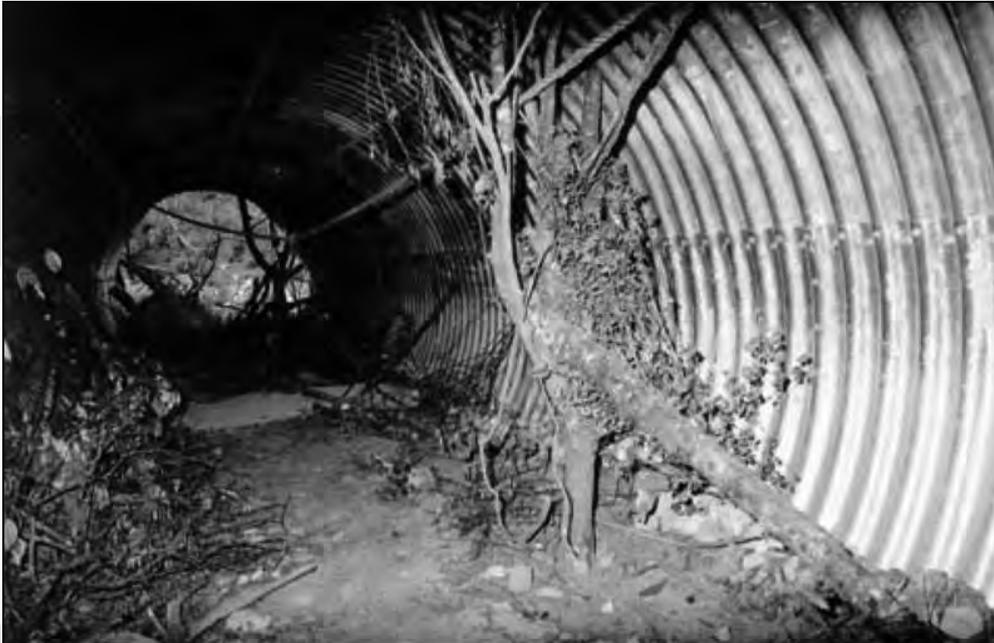
Plate 2. ‘Furniture’ such as ropes and debris may encourage underpass usage (Goosem 2006).

Where possible, underpasses should include ‘furniture’ such as ropes, hollow logs, rocks and poles (Plate 2). These provide shelter opportunities for passing fauna and may alleviate the threat of predation. The inclusion of these features and mass plantings leading into the culvert from nearby forest was found to be highly effective in northern Queensland (Goosem 2003).

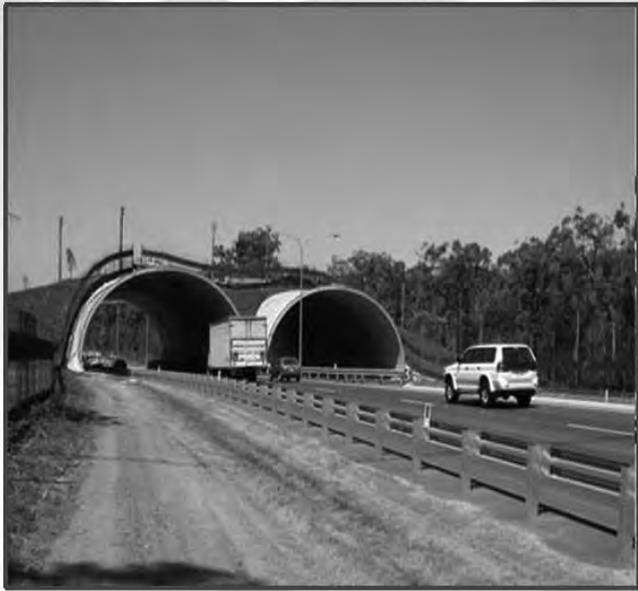
Plate 3. Compton Road Land Bridge, Brisbane.

Similar to underpasses, land bridges are most effective if vegetation connects the bridge to nearby habitat. They are increasingly recognised as the preferred and most versatile fauna passage option and many recent road projects have included these structures in their design. Such examples include Crompton Road in Brisbane (Plate 3) and the Yelgun to Chinderah section of the Pacific Highway in NSW.

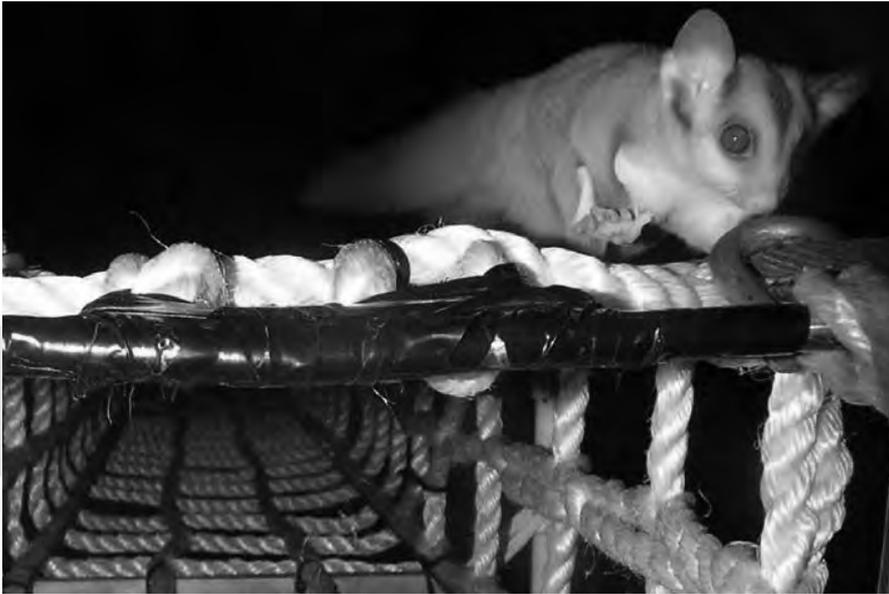
Plate 4. Squirrel Glider using a rope bridge over the Karuah Bypass (Bax 2006)

Rope bridges provide a successful connection for arboreal mammal species such as possums and gliders.
