Rocky Ridge, Gympie

ARCHAEO Cultural Heritage Services was commissioned by Arup to undertake a Historic Cultural Heritage Survey of a section of the Bruce Highway Project, Cooroy to Curra, approximately 7km east of Gympie, Southern Queensland.

**Fauna Movement and
Road Impact Mitigation
(Biodiversity
Assessment and
Management)**

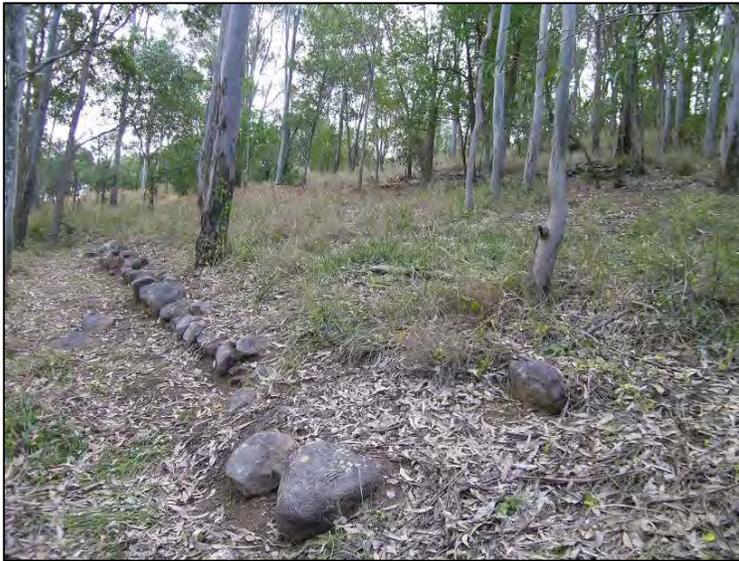
Figure 1: Looking northwest across Feature F1 from its easternmost point at F1A. Sections of Feature F3 are also visible in the background. These features are separated by approximately 15 metres.

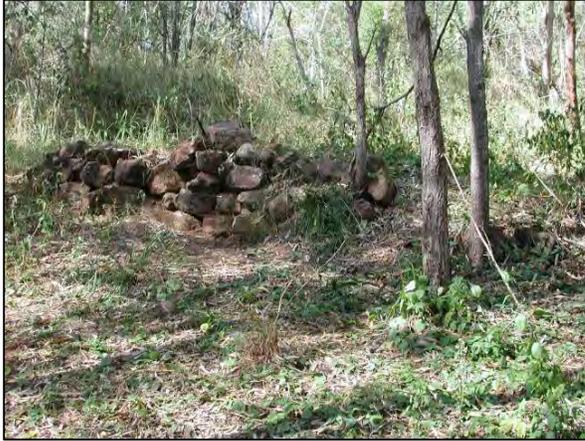
Figure 4 - Western face of Feature F2 shows the dry-stone wall of the structure

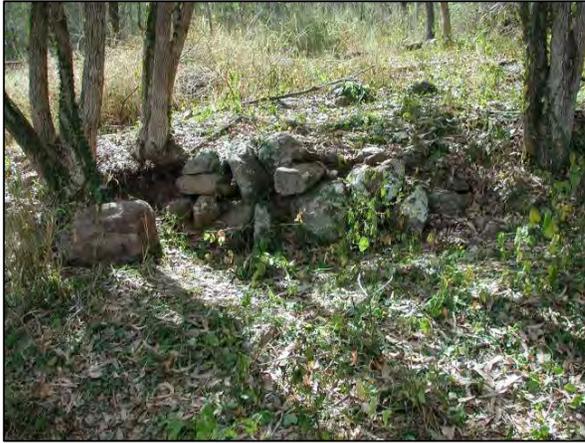
Figure 5 - View looking uphill of Feature F4 showing irregular construction, low height, and partial collapse with block on left rolling down the slope. Camphor Laurel trees on left and right are planted on the line of the "terrace".

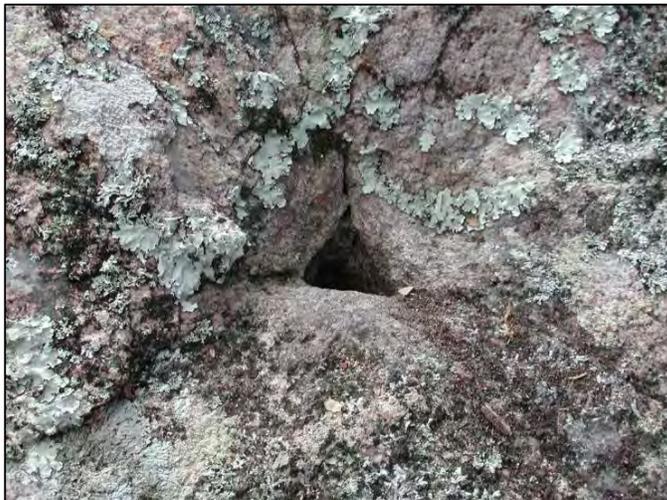
Figure 6. Sandstone block with triangular hole. The upper section of the hole is cratered, but the obvious triangular section has semi-vertical flat sides about 3 cm wide. Note the cracks leading out from each apex of the hole.

In one block, a blind triangular hole (Figure 6) appears to be man-made, but a more likely explanation is that the hole is a weathering feature on the junction of three cracks in the sandstone. Although it is unusual to see triangular weathering holes, such a shape is not unexpected under such circumstances.

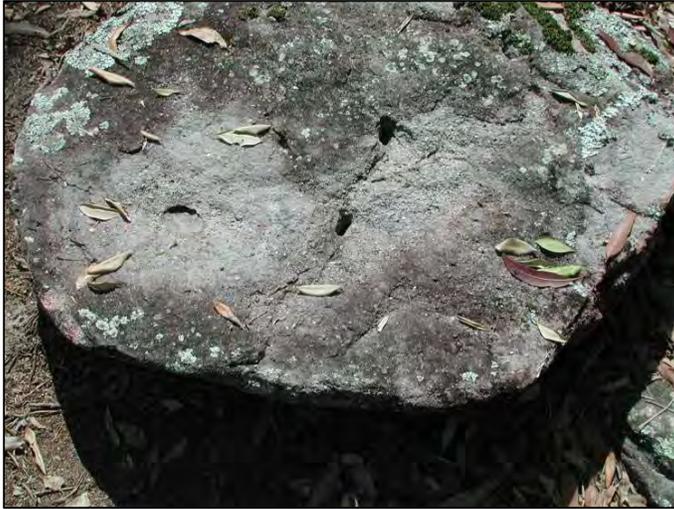
Figure 7. Sandstone block with rectangular holes possibly the result of attempts to split the blocks with gads.

Two separate blocks have elongate blind holes that appear to be the result of attempts to split the blocks with gads (Figure 7). A very old technique for splitting rock involves scratching the desired line across the rock, chipping an interrupted series of shallow holes along the line with a pick or similar tool, and then hammering gads into the holes. Each gad is progressively hammered into the rock, setting up a stress concentration, causing the rock to fracture along the line of gads. Typically such holes are narrow rectangular with a cratered top, such as shown in the two images.

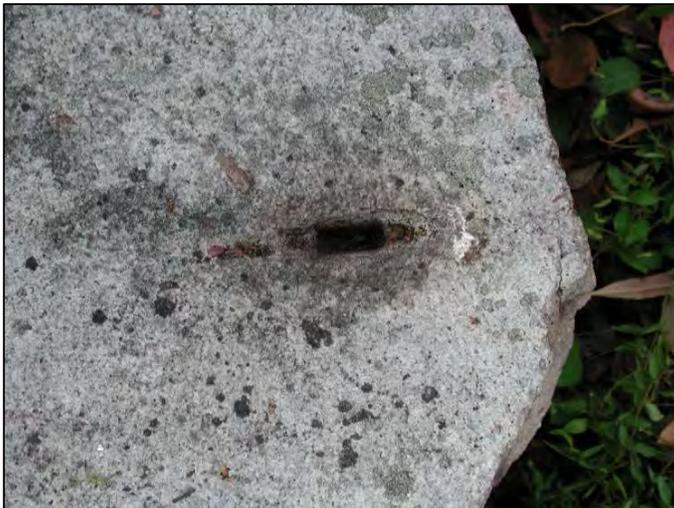
Figure 8. Sandstone block with rectangular hole possibly the result of attempts to split the block with gads. This hole is cratered at its upper edges, typical of the damage done when using gads.

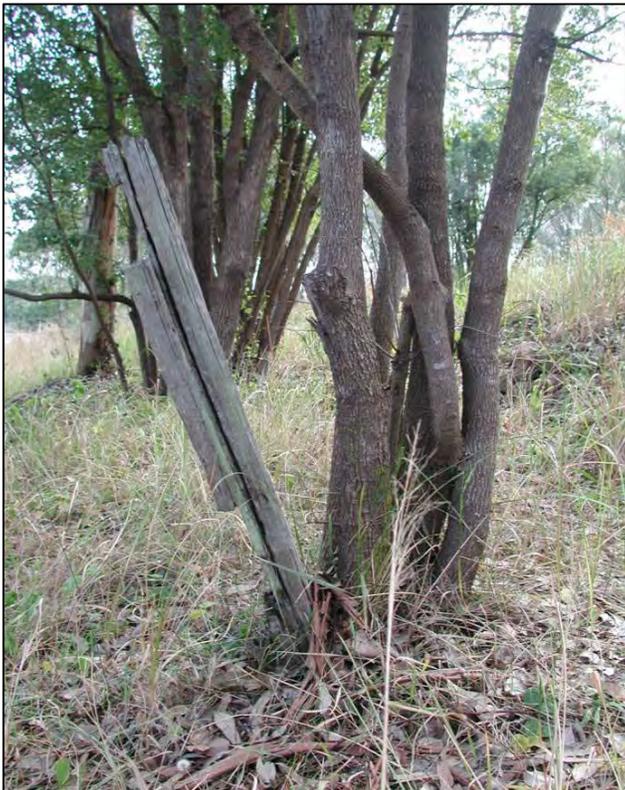
Figure 9. Westerly view along the line of Feature F1D showing remains of fence. The sawn square post has two distinct rebates cut into it on the downhill face. The obvious black line down the post is a crack, not evidence of construction by nailing several pieces together.

The easiest and least labour-intensive is to simply bolt or wire boards to posts. The absence of holes shows that the boards were not bolted onto the posts. Using rebates to locate boards on posts is more labour-intensive and thus expensive. Generally this form is found close to houses, or lining driveways or other areas mostly for aesthetic reasons. However, the rebates on the posts are not consistent from one post to another suggesting that the posts may be re-used from another site. Adjacent posts may not have either or both rebates for retaining the boards.

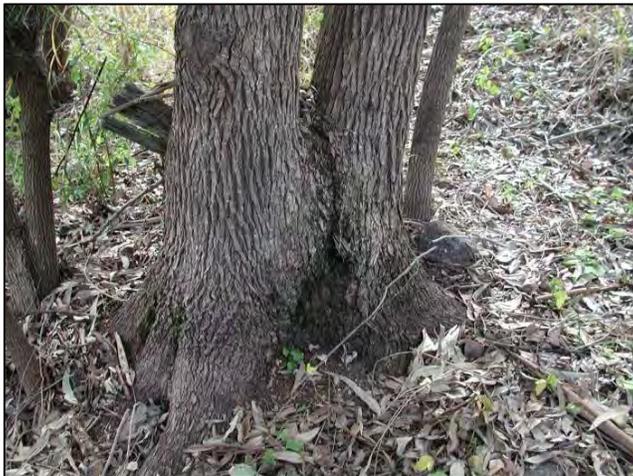
Figure 10. At some time, this fence post fell into the crutch of two trunks of a Camphor Laurel. Subsequent growth has fully enclosed the post.

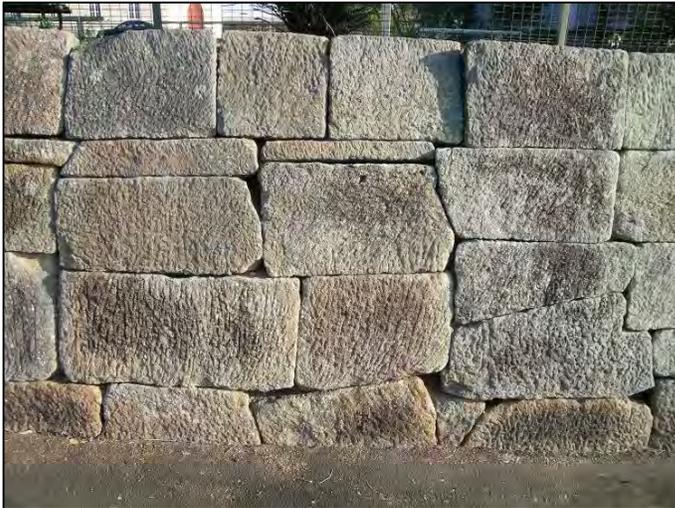
Figure 12. Boundary wall at Surface Hill Uniting Church, Gympie.

The site boundary for part of Barter Street and all of Channon and Reef Streets is finished with a squared but uncoursed rubble retaining wall. This is a suitable example of a dressed and well constructed stone feature and a relevant point of difference to the quality and workmanship involved in the stone elements identified in the study area (Qld Heritage Register Citation: 601529).

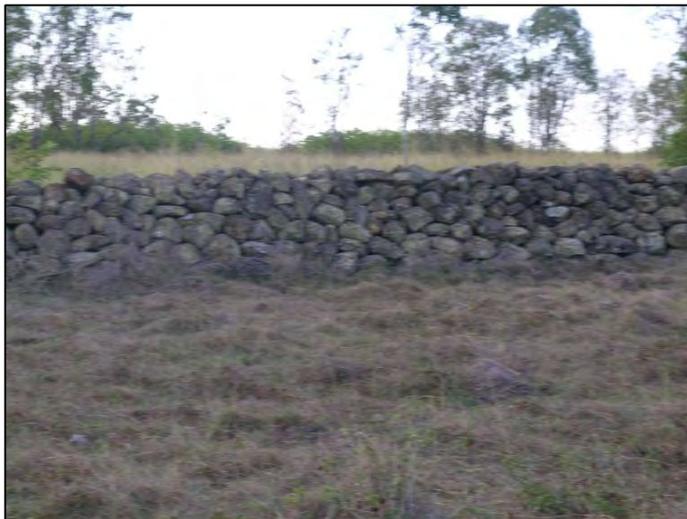
Figure 13. Significant stone wall at Mon Repose near Bundaberg (ARCHAEO 2007).

The dry-rubble boundary walls such as those at Mon Repose and Sunnyside Plantation in the Bundaberg were recently inspected by ARCHAEO staff. These walls were more than likely constructed in the 1880s by indentured South Sea Islanders working to clear the land for sugar cane cultivation.

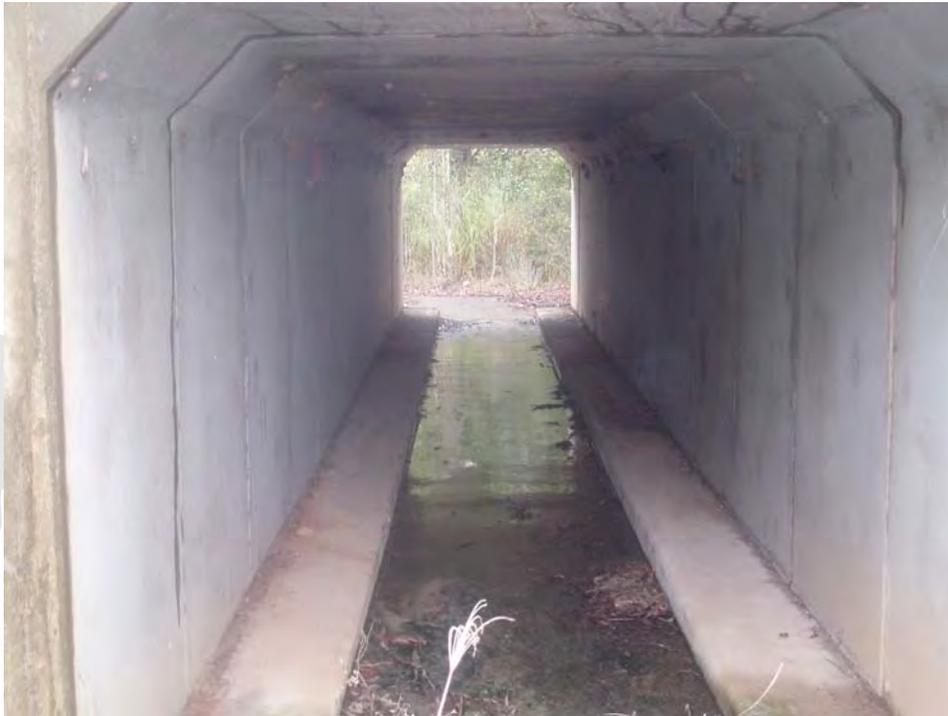
Plate 1. Culvert with dry ledges

Many culverts employed in modern roadways have one or two raised edges (Plate 1).

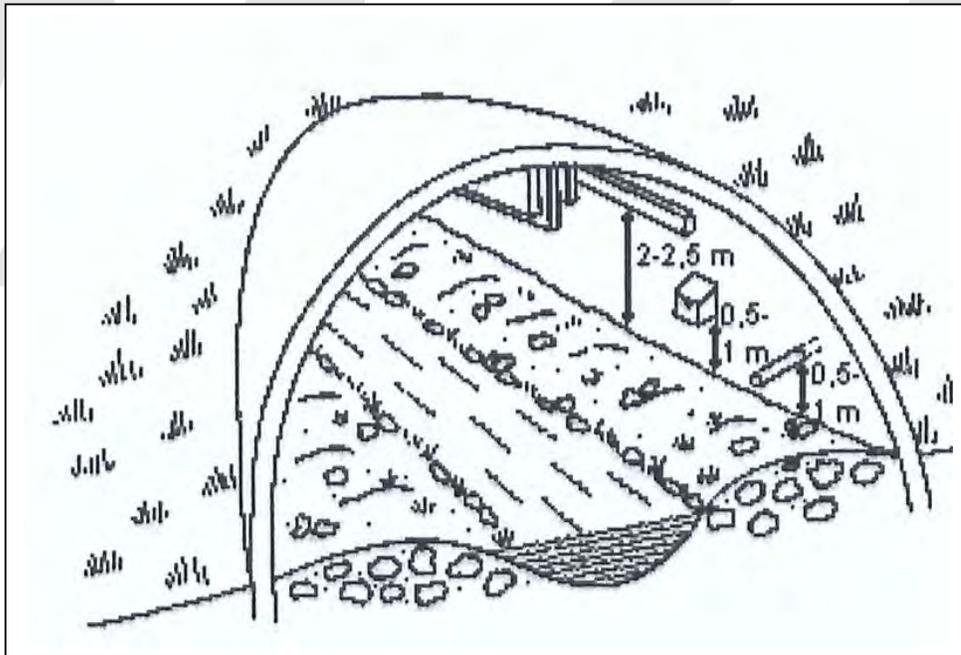
Figure 1. An oversized arch underpasses (Chenoweth 2003)

An extension of this idea is an over-sized culvert such as a pre-cast arch that includes the creation of artificial riverbanks (Figure 1).

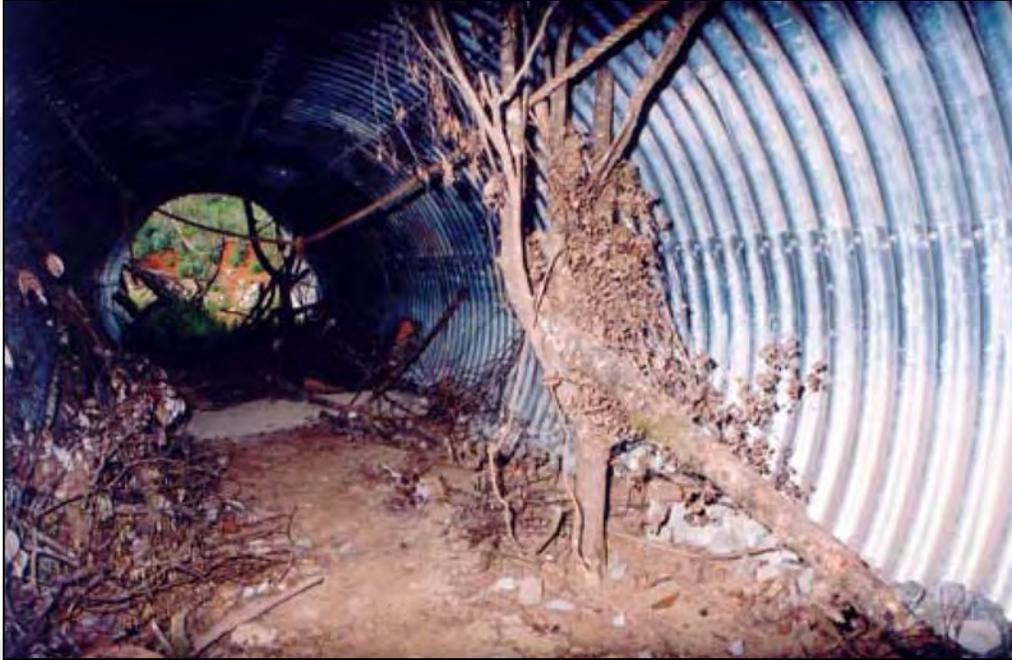
Plate 2. ‘Furniture’ such as ropes and debris may encourage underpass usage (Goosem 2006).

Where possible, underpasses should include ‘furniture’ such as ropes, hollow logs, rocks and poles (Plate 2). These provide shelter opportunities for passing fauna and may alleviate the threat of predation. The inclusion of these features and mass plantings leading into the culvert from nearby forest was found to be highly effective in northern Queensland (Goosem 2003).

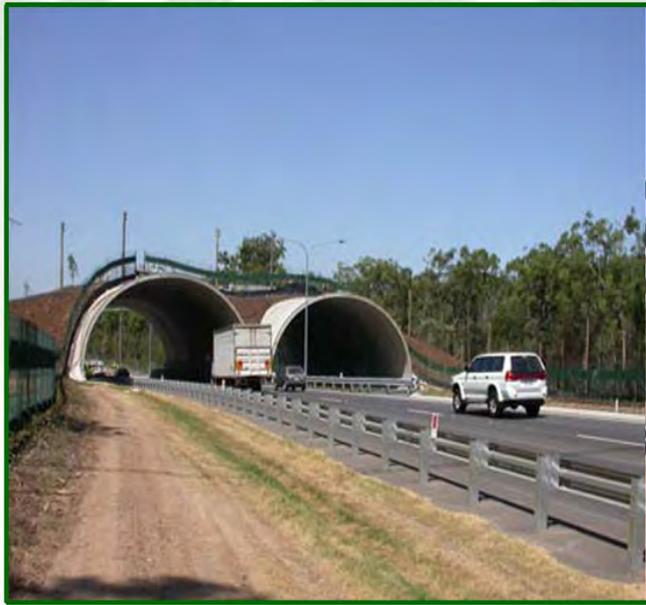
Plate 3. Compton Road Land Bridge, Brisbane.

Similar to underpasses, land bridges are most effective if vegetation connects the bridge to nearby habitat. They are increasingly recognised as the preferred and most versatile fauna passage option and many recent road projects have included these structures in their design. Such examples include Crompton Road in Brisbane (Plate 3) and the Yelgun to Chinderah section of the Pacific Highway in NSW.

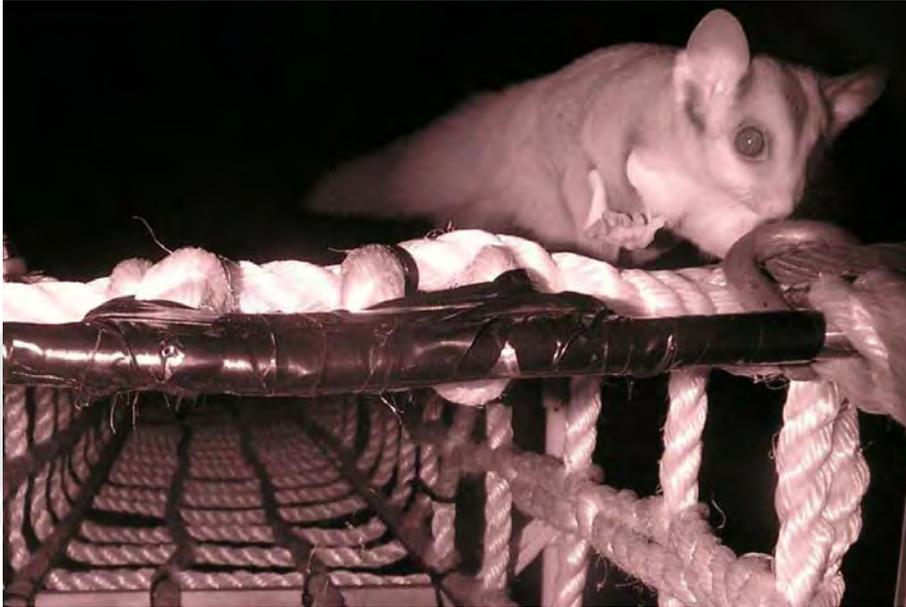
Plate 4. Squirrel Glider using a rope bridge over the Karuah Bypass (Bax 2006)

The effectiveness of rope bridges has been increased by positioning them such that the support base (usually a large pole) is set within vegetation, or connected by thick braided rope. This allows easy access to and from the rope bridge.

Rope bridges provide a successful connection for arboreal mammal species such as possums and gliders.
