Bruce Highway – Cooroy to Curra (Section D: Woondum to Curra)

Macrozamia pauli-guilielmi Translocation Final Report

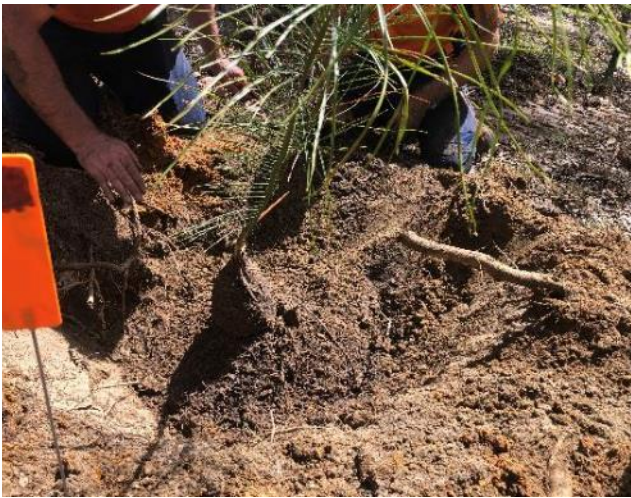
Plate 1. Shows the underground trunk on an adult *M. pauli-guilielmi* where soil fell away.

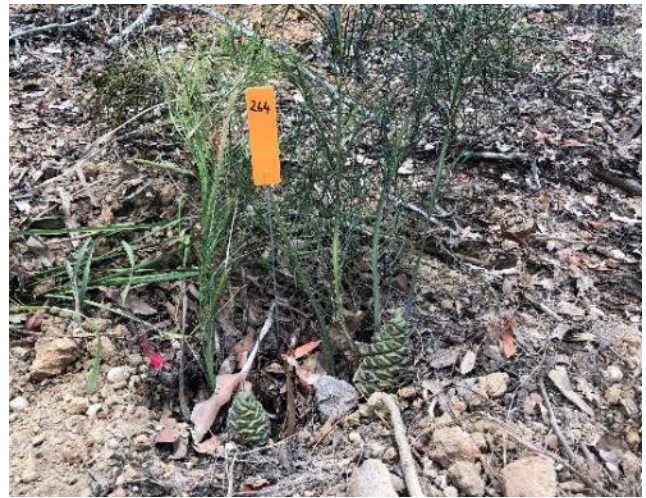
Plate 2. Shows fronds and female cones on an adult *M. pauli-guilielmi* that was translocated.

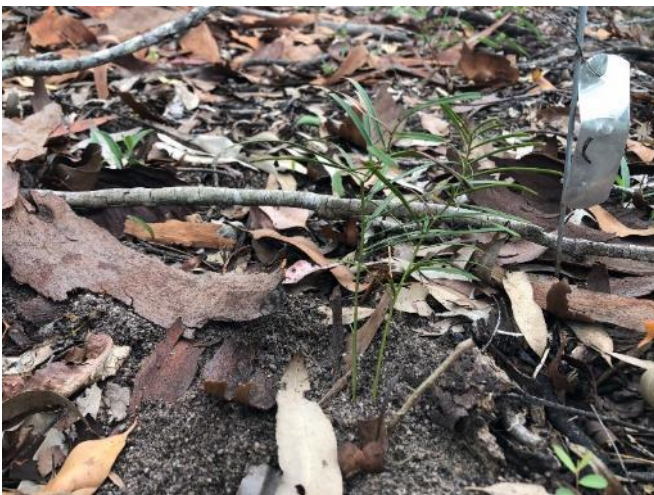
Plate 3. Shows a seedling of the *Macrozamia* which stood at about 20cm tall.

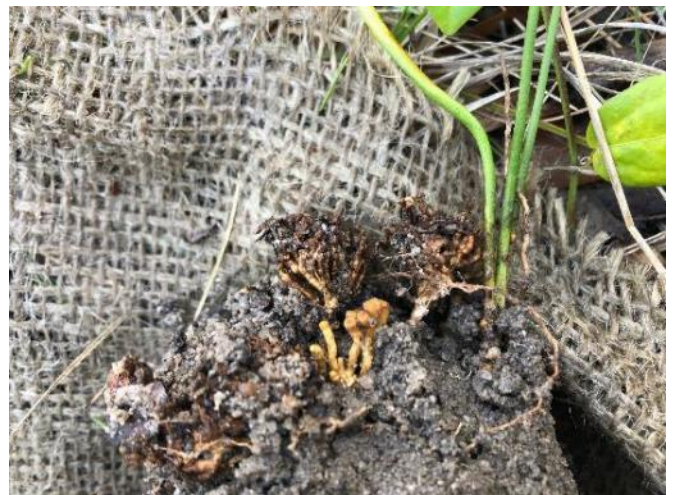
Plate 4. An example of the coralloid root found on both seedlings and adults.

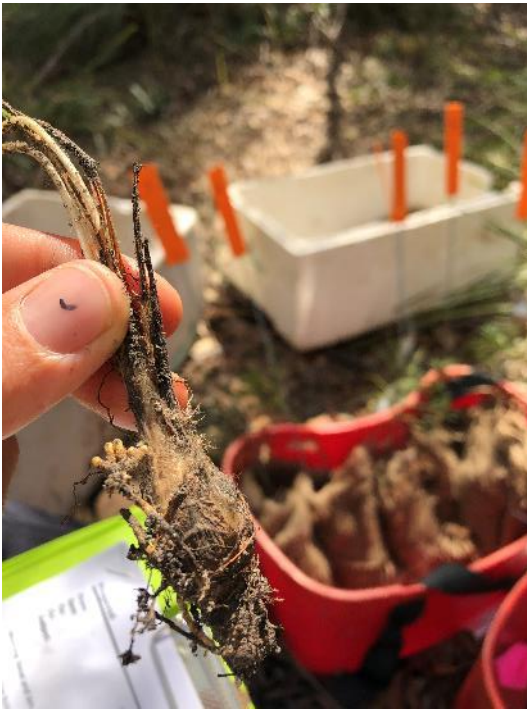
Plate 5. Shows an example of a seedling which was dug out and soil fell away. Displays swollen stem and the coralloid root.

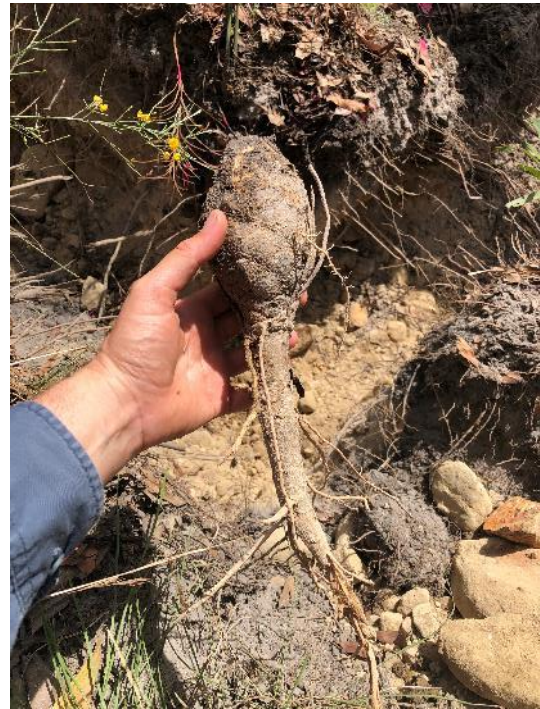
Plate 6. Shows the swollen trunk and tap root of an MPG base which came off of a large clump of adults plants. Note the indentation.

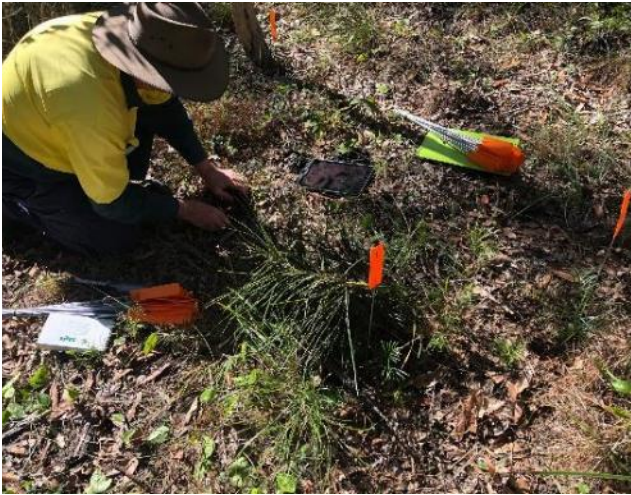
Taken August 2020

Plate 7. Pre works survey was undertaken using Avenza mapping program and maps of surveyed MPG. This photo shows team identifying and recording.

Survey works were undertaken in July 2020 by two suitably qualified Noosa Landcare staff – Steve Husband and Jennifer Coleman. The survey involved finding and recording the location of *M. pauli-guilielmi* using previous flora survey data provided by TMR. Locations were recorded on the AVENZA mapping program and individuals demarcated by placing an orange flag next to the plant for easy identification. Both seedlings and adults were identified and recorded in this manner. Plates 7 and 8 show the method and orange flags used in this project.

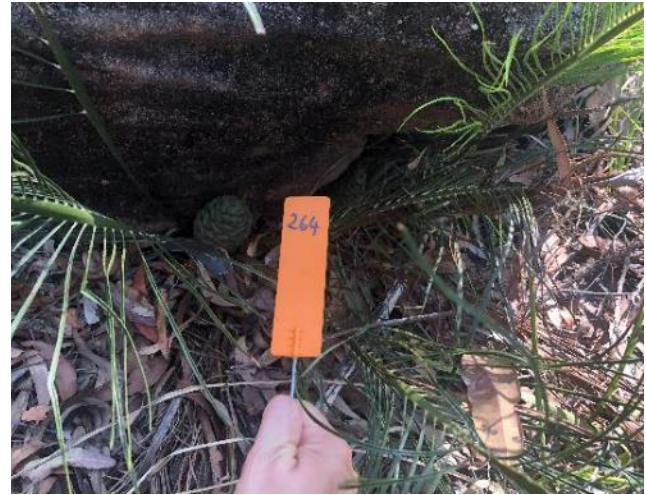
Taken August 2020

Plate 8. An example of the orange flags used to mark the location of the MPG with the addition of a number.

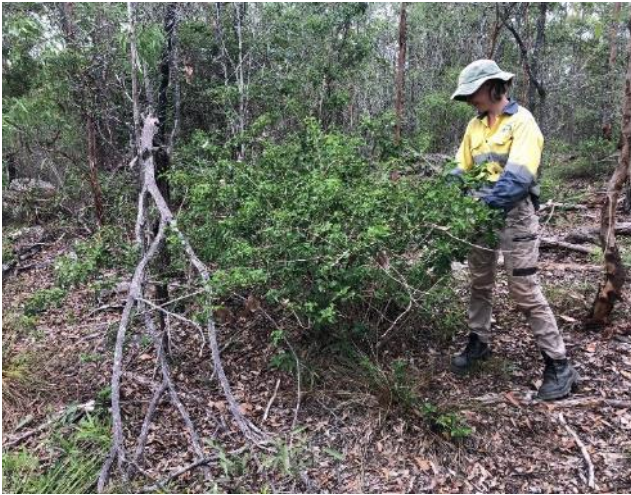
Taken August 2020

Plate 9. Site preparation works were undertaken throughout receiving site removing weeds and identifying suitable areas for planting.

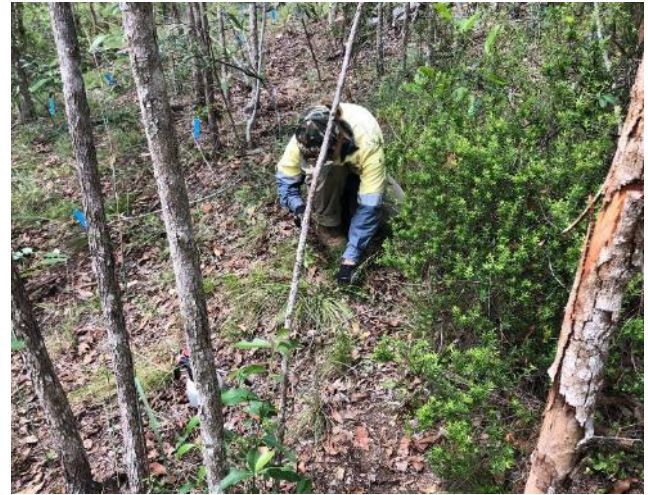
Taken August 2020

Plate 10. Site preparation works were undertaken throughout receiving site removing weeds and identifying suitable areas for planting.

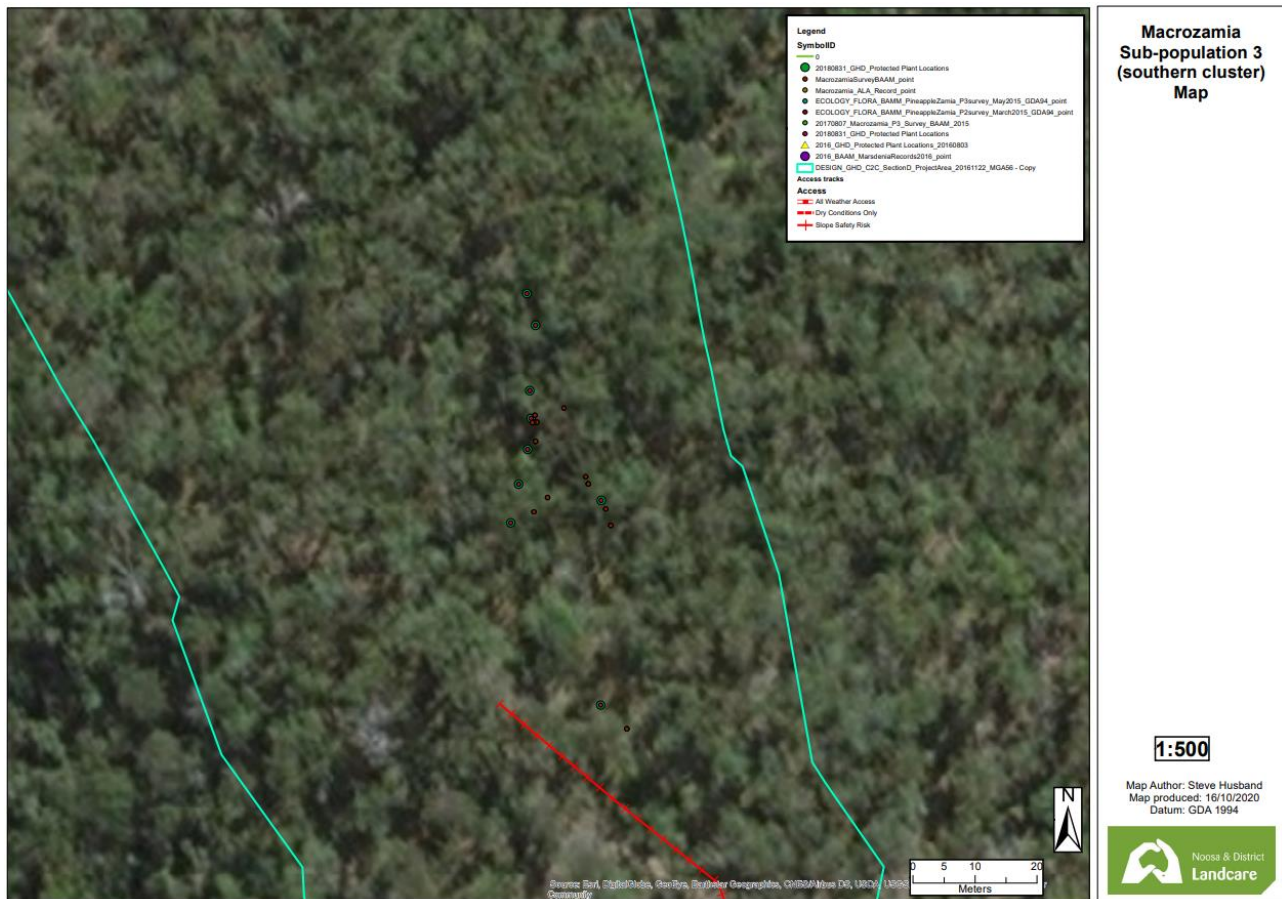
Figure 4. Macrozamia Sub – population 3 (southern cluster).

The two sub populations of *M.pauli-guilielmi* requiring translocation are shown in Figures 3 and 4. Majority of plants were in clusters due to the nature of the seed dispersal being close to the parent plant. This meant that careful planning and strategy had to be used to reduce the risk of trampling and damage to the *M.pauli-guilielmi*. For this report works have been separated below into *M.pauli-guilielmi* seedling salvage works and *M.pauli-guilielmi* Adult salvage works.

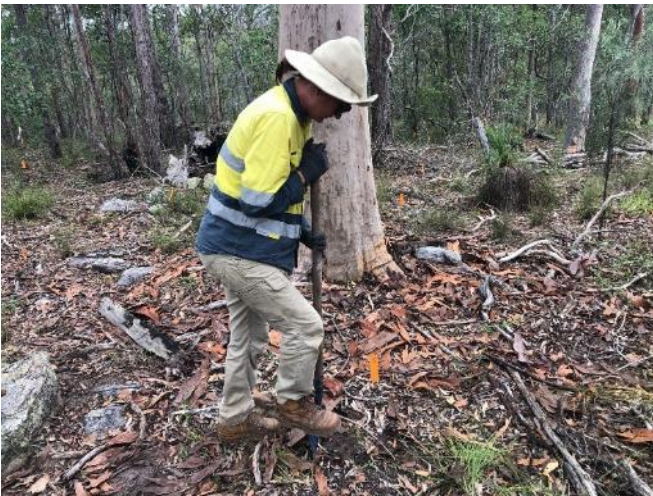
Plate 11. Shows team member digging out a seedling using a shovel, special care was taken to not disturb the root ball and to keep the root ball intact.

- Seedling was identified, if there was a cluster of seedlings example 2+ plants within 10cm of each other they were dug out as one root ball.
- Area approximately 20cm radius around seedling was cut into with shovel (shown in Plate 11) and then water poured over area to drench root ball. This was done to keep root ball intact when moved.

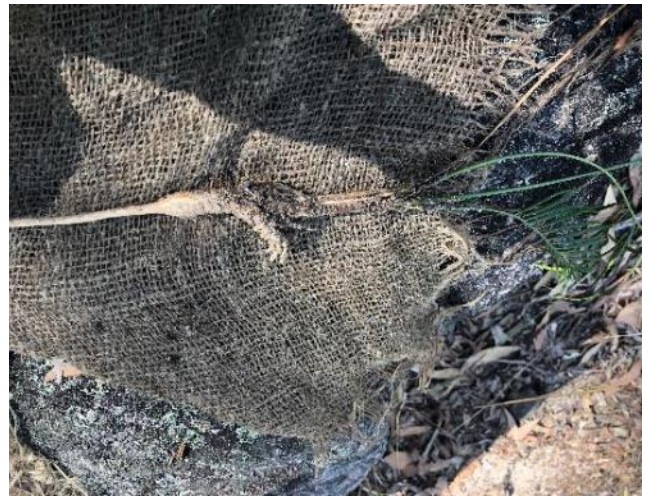
Plate 12. Shows a complete plant that was dug out at the beginning before we started to use water to keep the soil intact.

This methodology worked well, at the beginning we were not using enough water and plants were losing their soil (Plate 12) but with the addition of water and careful work majority of root balls remained intact.

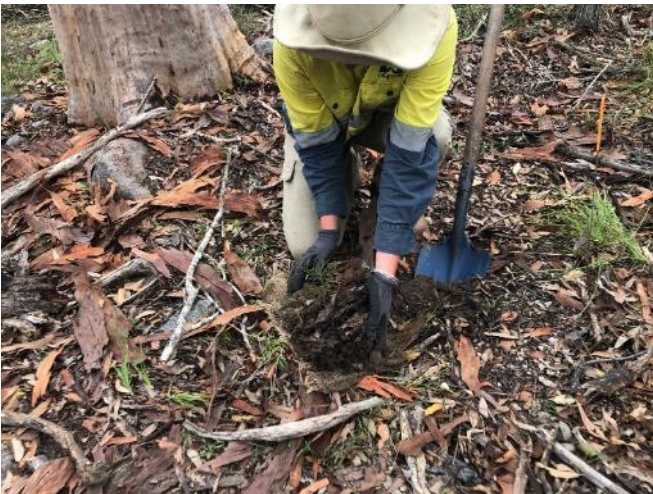
Plate 13. Shows team moving root ball of seedling with soil intact, next steps wrapping in moist hessian to keep it all together.

- Once radius around plant was cut and loosened shovel was used to lever root ball up. Hands were then used to tease and lift the root ball making sure not to damage tap root (shown in Plate 13). Root ball was carefully placed on pre - cut hessian moistened and wrapped making sure to hold bottom.

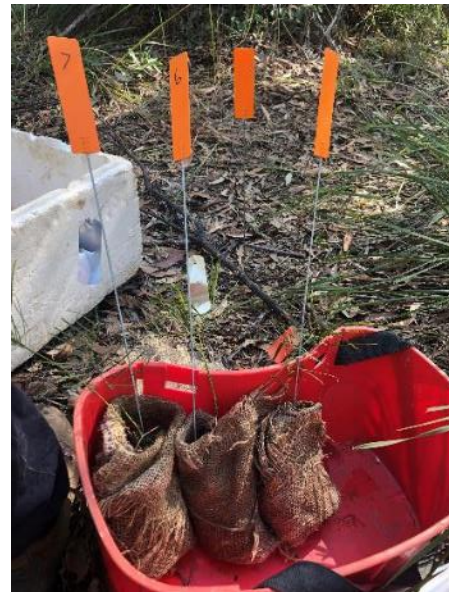
Plate 14. Shows how the seedlings were wrapped in hessian with soil intact and transported to recipient site.

- All seedlings were sprayed with an anti – transparent once dug out.
- Plants were then carefully placed in buckets or pots for transportation (plate 14).

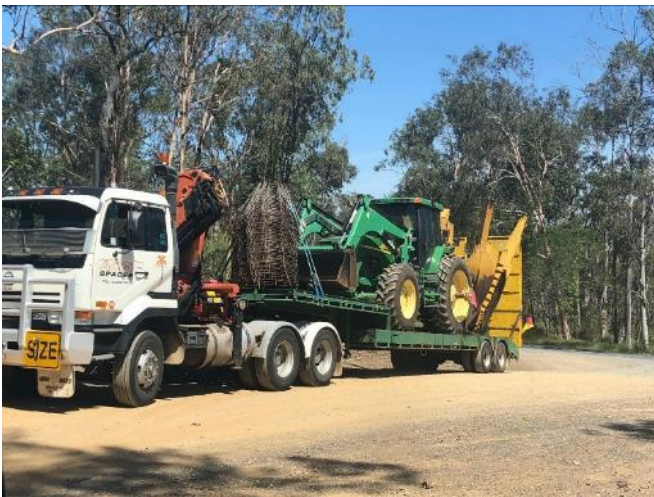
Plate 16. Shows the semi – trailer carrying the John Deere tractor and spade.

Equipment for the translocation of adult *M.pauli-guilielmi* included 5t tilt head excavator, bogie tipper, 4WD ute with water tanks and fire - fighting pump, John Deere 8410 w/62" Big John tree Spade and custom made tree cages 1140 x 650mm.

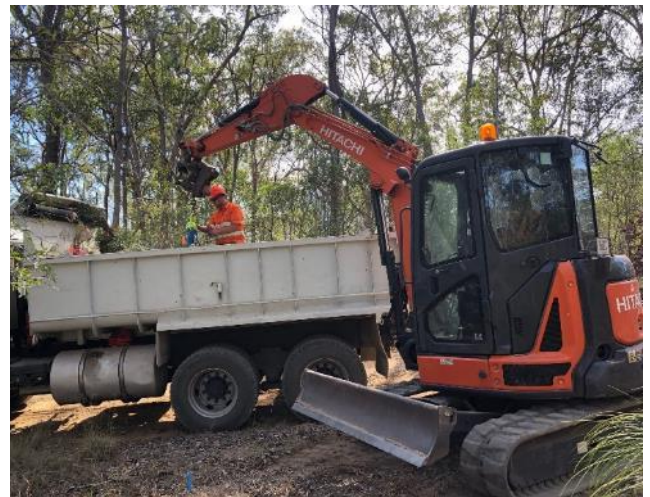
Plate 17. Shows bogie tipper and 5t excavator from Ace of Spades.

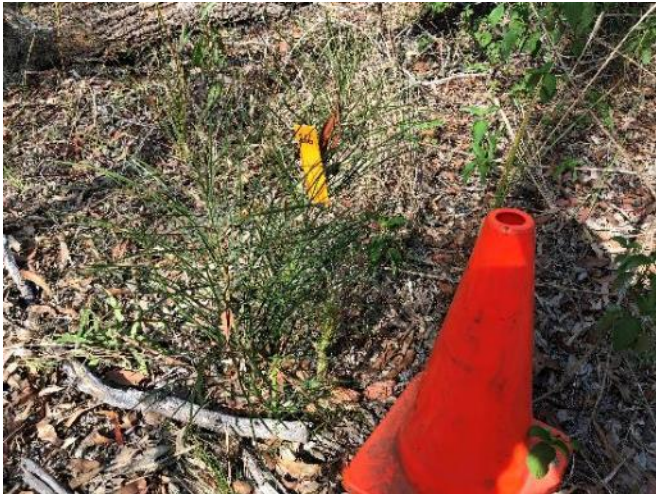
Taken December 2020

Plate 18. Shows the identified adult MPG ready to be dug out.

- Adult *M.pauli-guilielmi* were identified and witches hats placed next to plants for clearer visibility shown in Plate 18.
- In majority of instances the excavator had to be used to dig out around the diameter of the root ball (shown in Plate 19) which was made to fit the 1100mm tree cage. This had to be done on majority of plants first due to the large rocks around the area and under the plants which meant the spade couldn't get through the soil/rock. An example of the root ball is shown in Plate 20.
- The next step was to manoeuvre the tree spade over the plant, Ace of Spades took special care to make sure the plant would be in the middle of the root ball (shown in Plate 21).

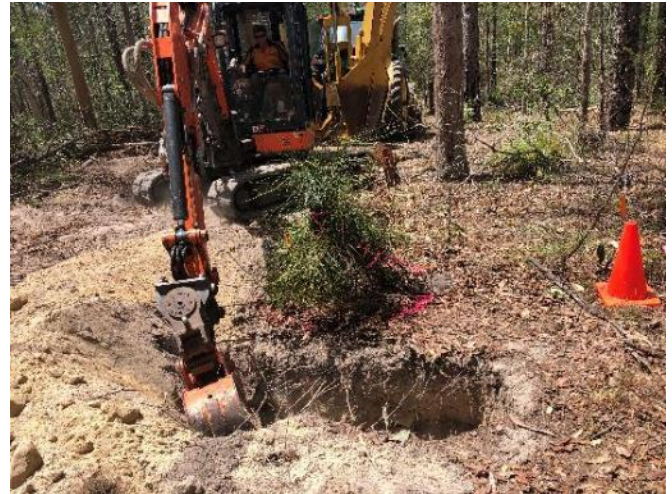
Plate 19. Shows how the majority of plants had to be dug out due to large rocks in the area. The excavator was used to dig around root ball so that the spade could get into the ground.

- The addition of the excavator was necessary to dig around the root balls first, due to the terrain being very rocky the excavator was very good in moving rocks and breaking up the sandstone.

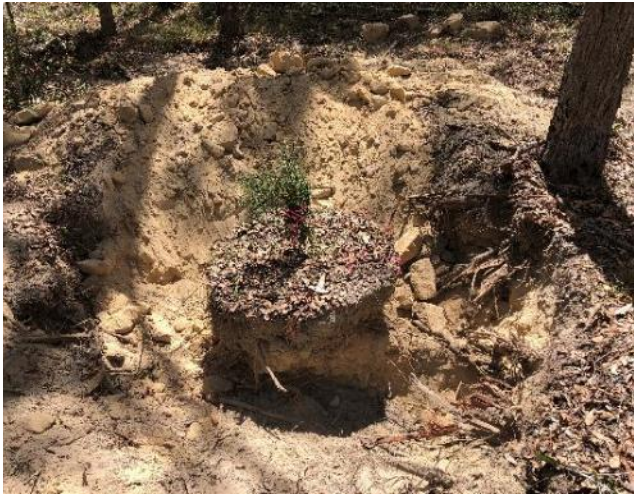
Plate 20. Shows the root ball still intact after the excavator dug around ready for spade.

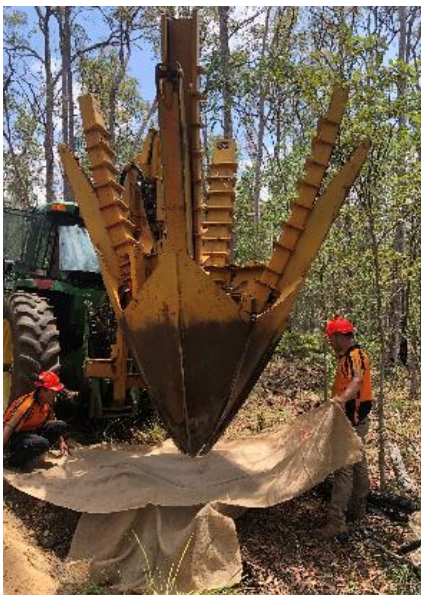
Plate 22. Shows the spade with root ball and plant inside lowering plant into cage lined with hessian.

- The tree spade then moved the blades down and enclosed the root ball, while this was happening the root ball was watered to keep it intact and lubricate the blades.
- The root ball was then lifted up and a pre made tree cage placed in the hole and lined with pre-cut hessian shown in Plate 22.
- The plant was then released into cage undisturbed as you can see in Plate 23.
- All plants were sprayed with an anti – transparent once dug out.
- Once the plant is in the cage hessian was wrapped around and then left in the hole to retain moisture until it is ready to be loaded onto the tipper for transportation shown in Plate 24.

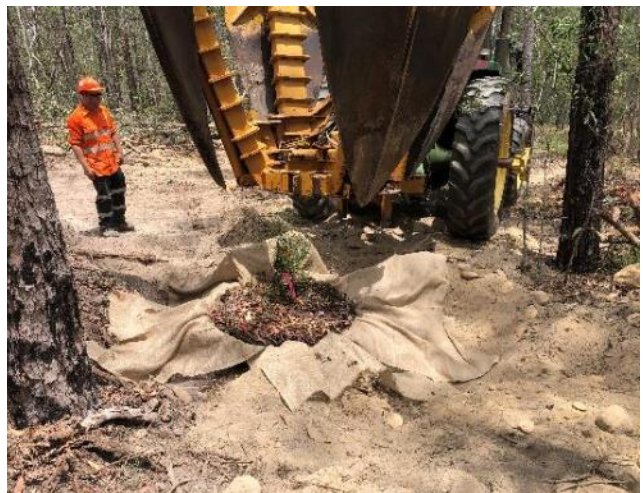
Plate 23. Shows the plant sitting in the cage still intact and then ready for lifting into truck for transportation.

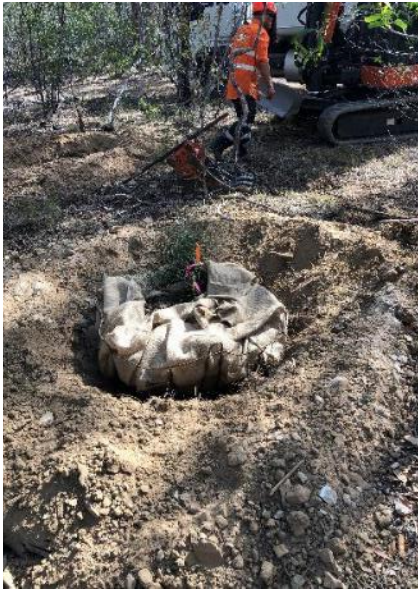
Plate 24. Shows plant in cage ready for transportation.

- The tree cage was a great innovation, it held the plant up during transportation and contained the root ball.
- Watering the root ball worked really well to hold the soil together this was good for both seedlings and adult *Macrozamia*.

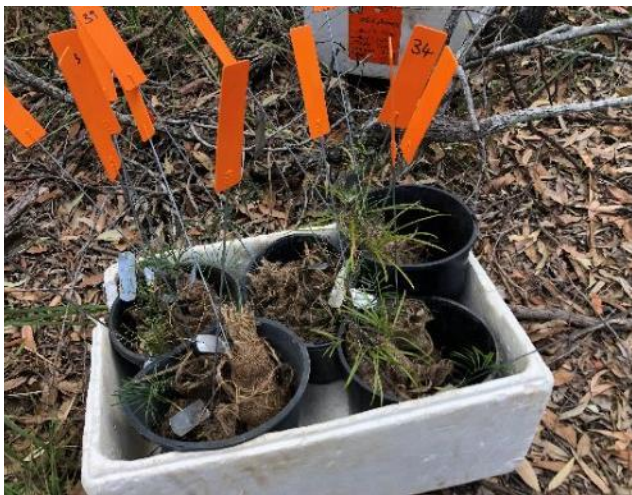
Plate 25. This shows how the seedlings were transported from the salvage sites to the receiving sites.
Taken October 2020

The *M.pauli-guilielmi* seedlings were transported in a covered canopy Ute. They were packed in moist hessian and then placed in pots which then sat in Styrofoam boxes to prevent plants from tipping (shown in Plate 25). Due to only digging out approx. 30-40 seedlings on a day all plants could be transported to receiving site and planted on the day.

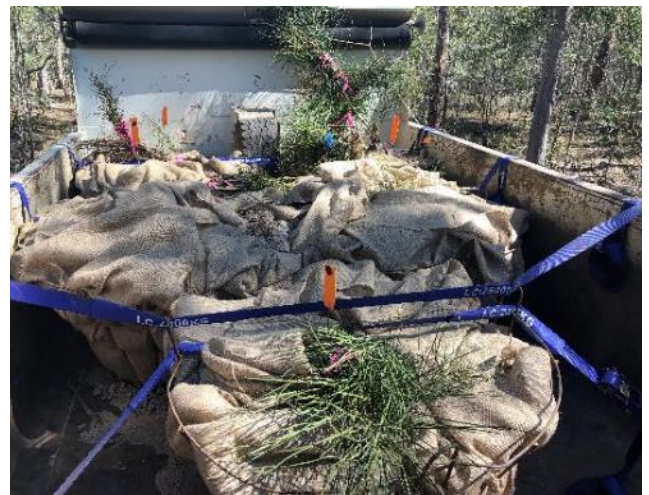
Plate 26. Shows the adult MPG being secured in the back of a bogie tipper (8 baskets per trip). These were lifted on and off by the excavator.
Taken December 2020

The adult *Macrozamia* were transported by the sub – contractors Ace of Spades. Russel and the team had the right equipment to transport the large plants safely and securely. With the addition of the wire cages that held the root ball in place it meant that 8 root balls could be transported at a time in the truck. As shown in Plate 26 the plants were secure and then tied down. Once on the truck plants were taken to receiving site for planting. The excavator was used to lift the root balls carefully in and out of truck. The cage and hessian allowed retention of soil around the rootball and was a successful method to transport these plants safely.

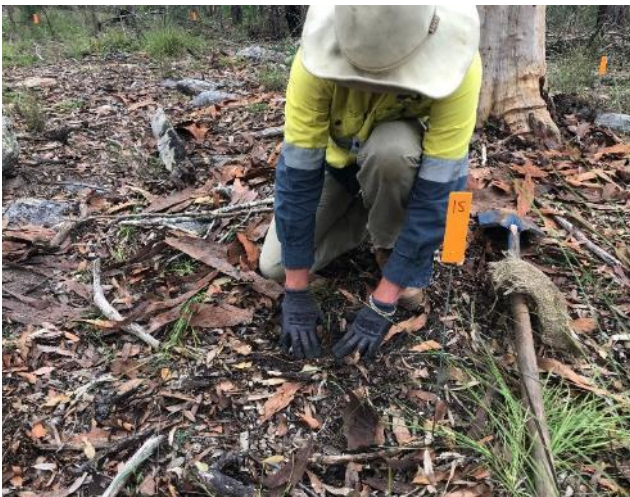
Plate 27. Shows team planting a seedling by pre digging hole about 30cm x 30cm with a mattock and then placing the entire root ball with plant into hole. Special care was taken not to compact too much to protect coralloid roots.

- Holes were dug roughly 2m apart and 30cm deep using mattock.
- The holes were kept in rows for ease of maintenance and monitoring.
- Seedlings were planted in holes making sure to keep them at the correct depth and to not damage any coralloid roots.
- Each plant was planted with its ID number and tag (shown in Plate 27). Special care was taken to plant at the correct depth and to keep as much of the original soil around the plant.
- A raised edge was built on the lower side to keep water in.
- All seedlings were watered in with 10L of water using quickspray unit.
- Each seedling was again sprayed with an anti –transparent.

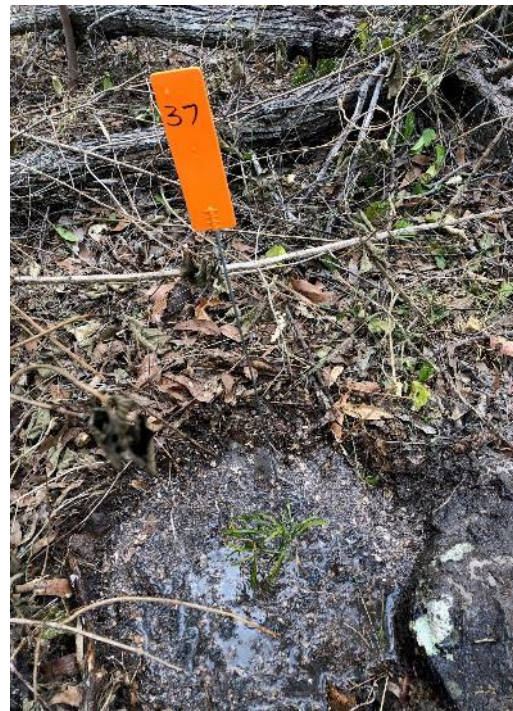
Plate 28. Shows the MPG seedling after it was planted and then watered in.

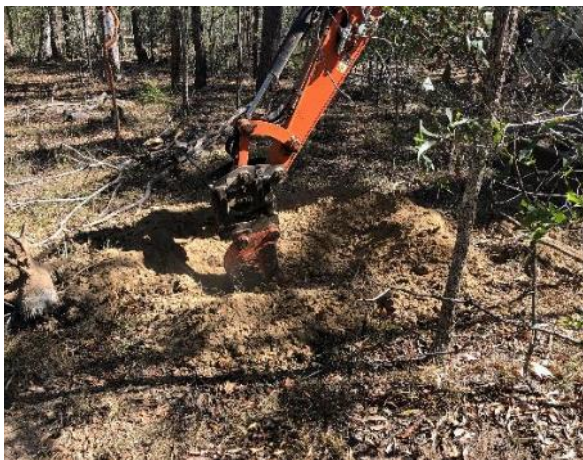
Plate 29. Shows the excavator digging the large holes for the adult plants at the recipient site in their designated areas, suitable locations were decided on by ecologist Peter Moonie.

- Suitable areas for adult *M.pauli-guilielmi* adults were identified and marked by Peter Moonie from Red Ash Consulting.
- Once suitable area identified a 5t excavator was used to dig a hole approx. 1.5 m diameter (shown in Plate 29). Holes further into bush land were dug first to prevent any trampling.

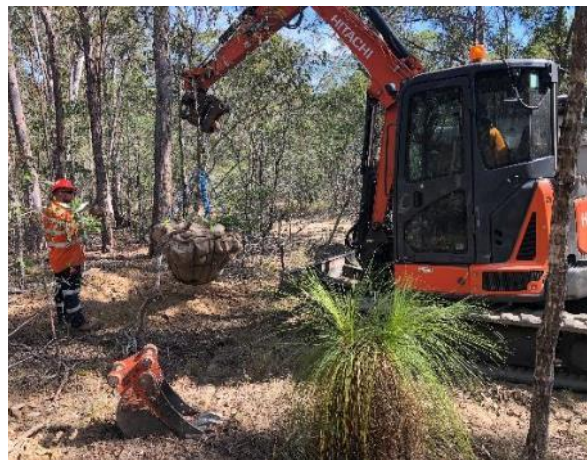
Plate 30. Shows an adult plant being lifted by the excavator out of the back of the truck and into the pre dug holes.

- Once hole was dug the plant was then lifted out of truck using a lifting hook and hoist chains shown in Plate 30 and carried over to pre-dug hole which is shown in Plate 31.

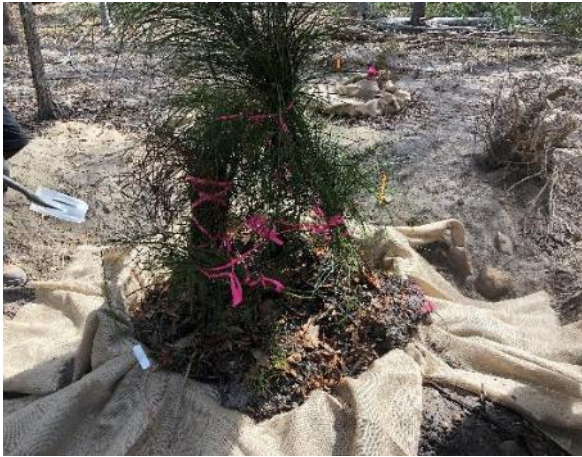
Plate 31. Shows adult plant after it has been; lowered into hole, excess hessian was then trimmed and basket cut to sit flush with the ground.

- Once basket was placed in hole it was infilled if necessary and then the wire basket and hessian cut to soil level.
- Mulch from surrounding area was scattered over planted areas to retain soil moisture and reduce risk of weeds.

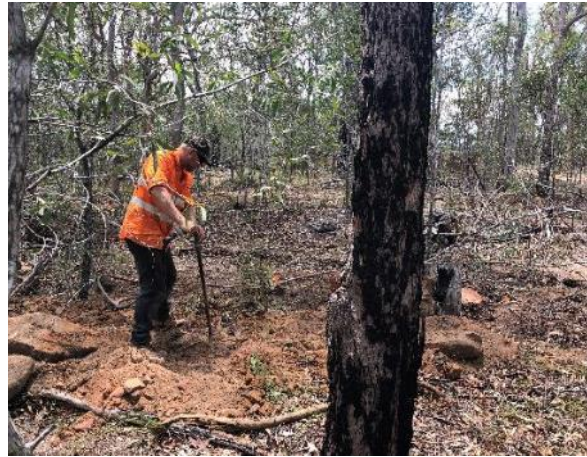
Plate 32. Shows the adult plant being watered in using a water spear, each adult plant was watered in making sure that the soil had well and truly settled around the root ball.

- All adult plants were watered in using aqua spear shown in Plate 32 with approx. 15L of water making sure to water in entire root ball.
- All plants and fronds were then sprayed with an anti – transparent.

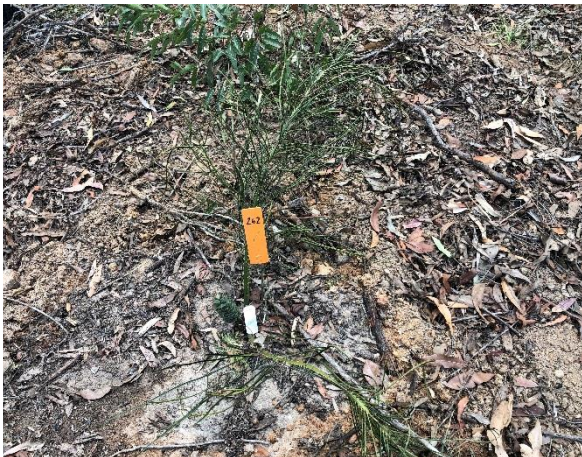
Plate 33. Shows adult plant after being watered in and leaf mulch spread around disturbed areas.

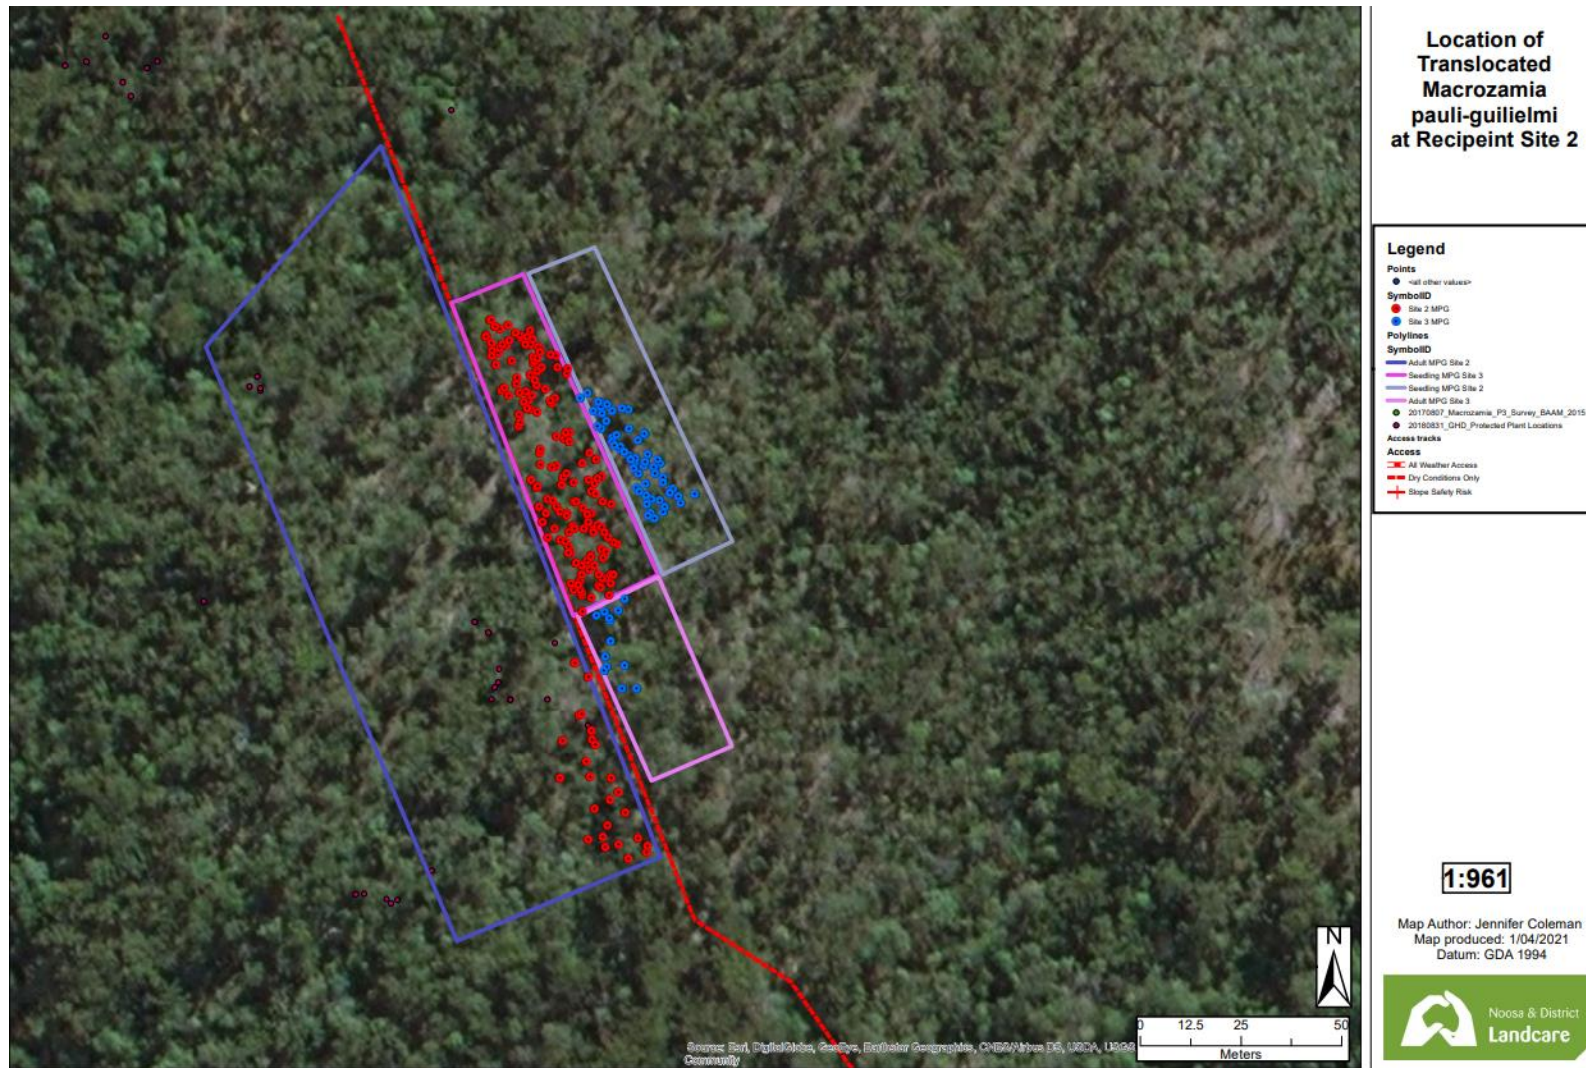
Figure 5. *Macrozamia pauli-guilielmi* final DGPS locations of translocated plants.

Using a DGPS unit the accurate location of each translocated *M.pauli-guilielmi* was recorded on a digital map and the coordinates for each individual plant recorded on the data sheet (Appendix 1). The ID number was written on the flag with permanent marker and then a photo taken of the number and the plant and added to the records.
