DTMR M1 UPGRADE

FLOOD EVENTS OF FEBRUARY AND MARCH 2022 IMPACT ANALYSIS AND RISK ASSESSMENT

SLR Ref: 620.31045-R01
Version No: -v0.1
October 2022

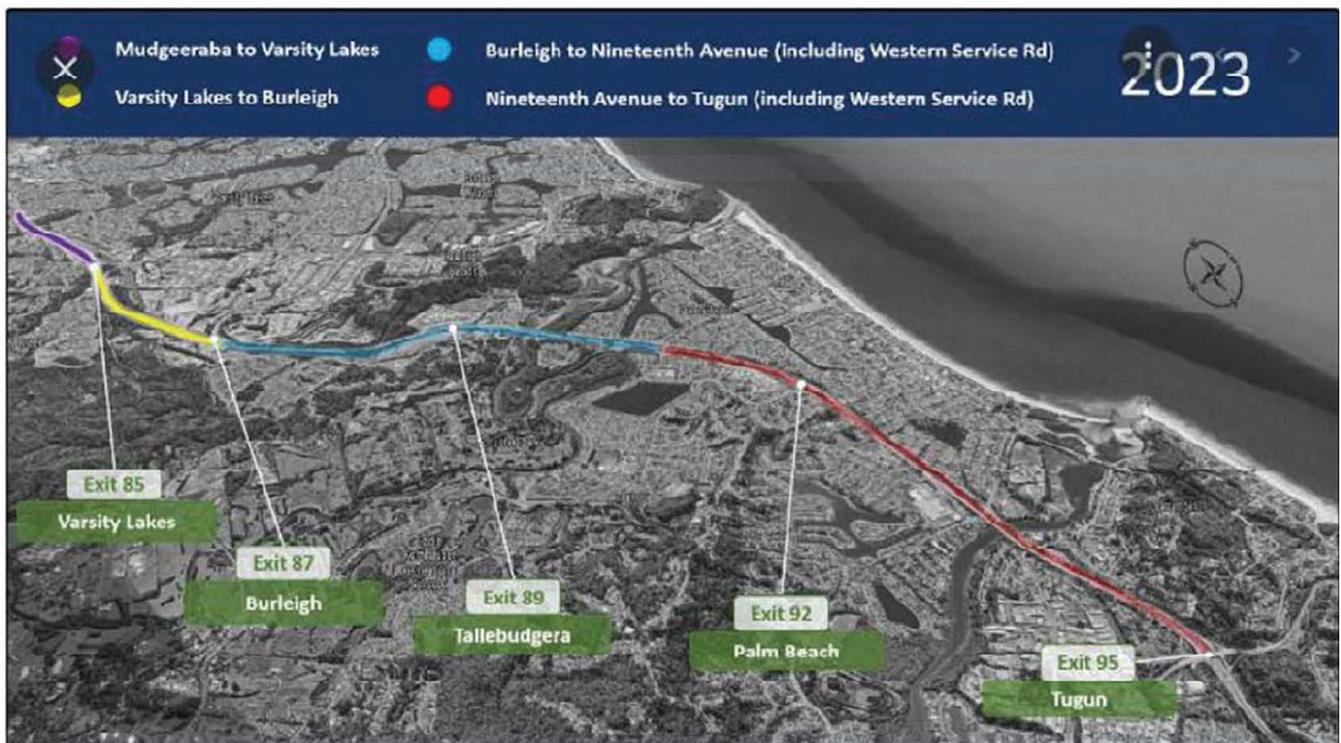
- 3 For completeness sake, I note that DTMR is currently constructing the M1 Pacific Motorway upgrade for the Varsity Lakes to Tugun (VL2T) project. The project comprises three packages, being Package A (VL2B), Package B (B2PB) and Package C (VL2T) as per the coloured sections on the plan on the next page.

- 4 The upgrading of the Motorway involves extensive construction works within the floodplains of several local creeks. In this case, the focus is on Tallebudgera Creek and a minor tributary of that system known as Oyster Creek. The major structures in the floodplain which could have impact on flood levels are the new bridges under construction in Tallebudgera Creek itself, as well as the culvert installation a few hundred metres south of the Creek.

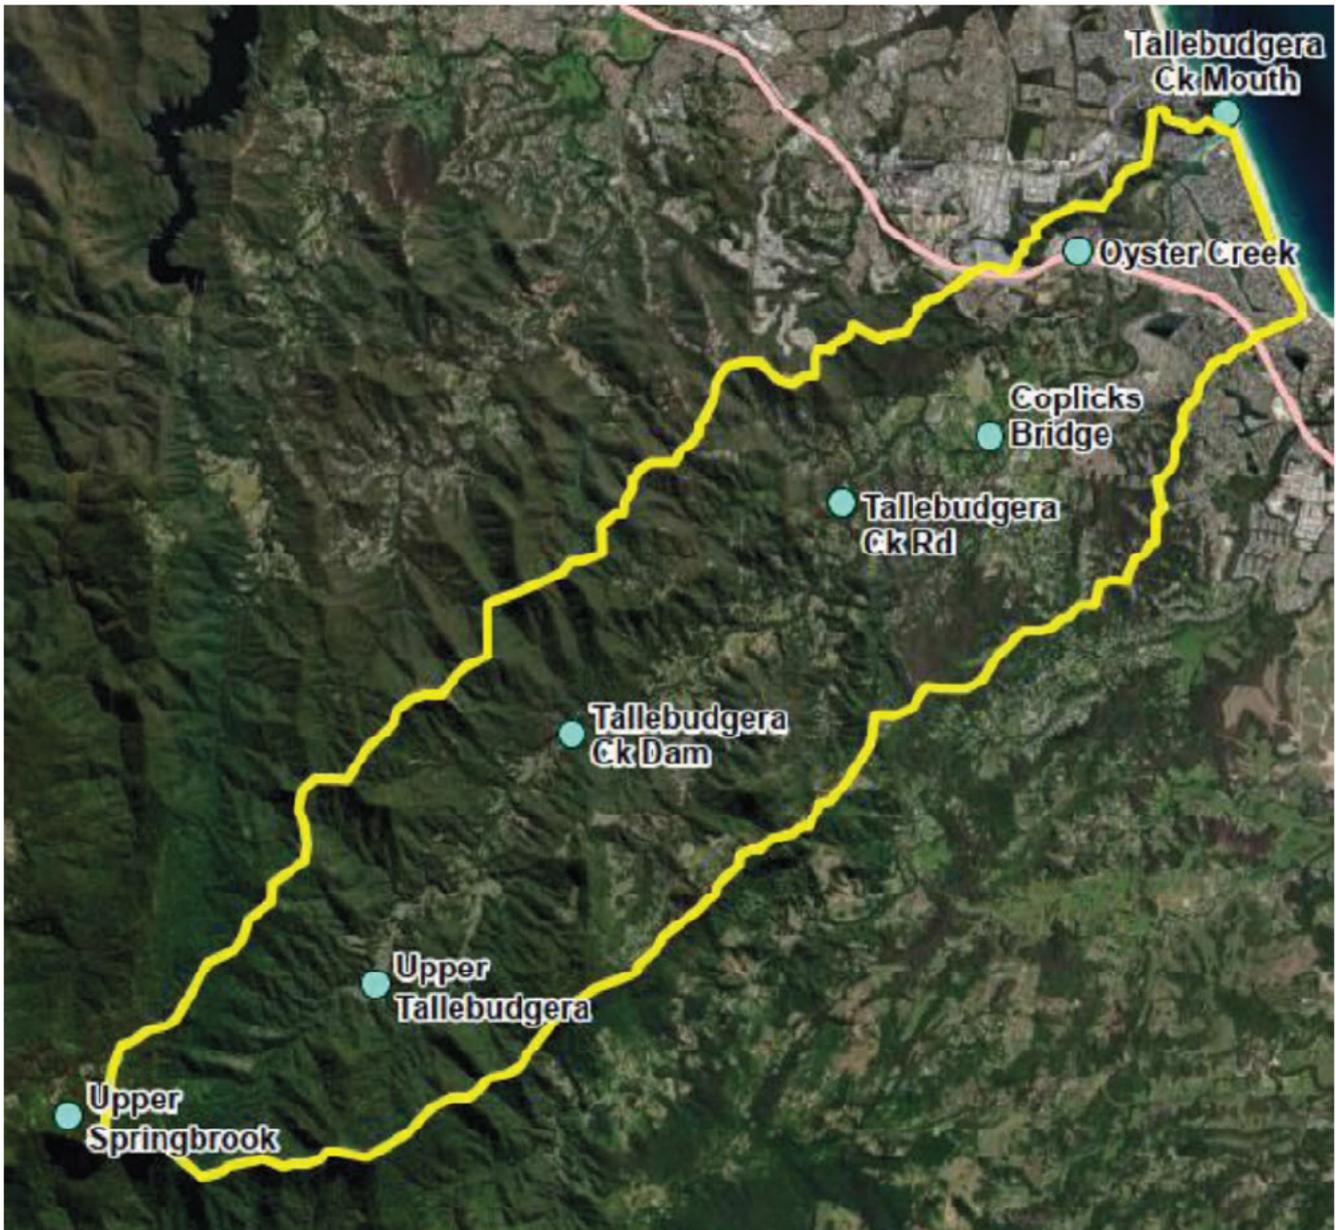
- 5 Pluviograph and ALERT rainfall stations record rainfall totals against time, allowing accurate determination of actual rainfall intensities occurring on site. In this case, the Bureau of Meteorology maintains digital records of seven rainfall stations within the catchment as per the following plan:

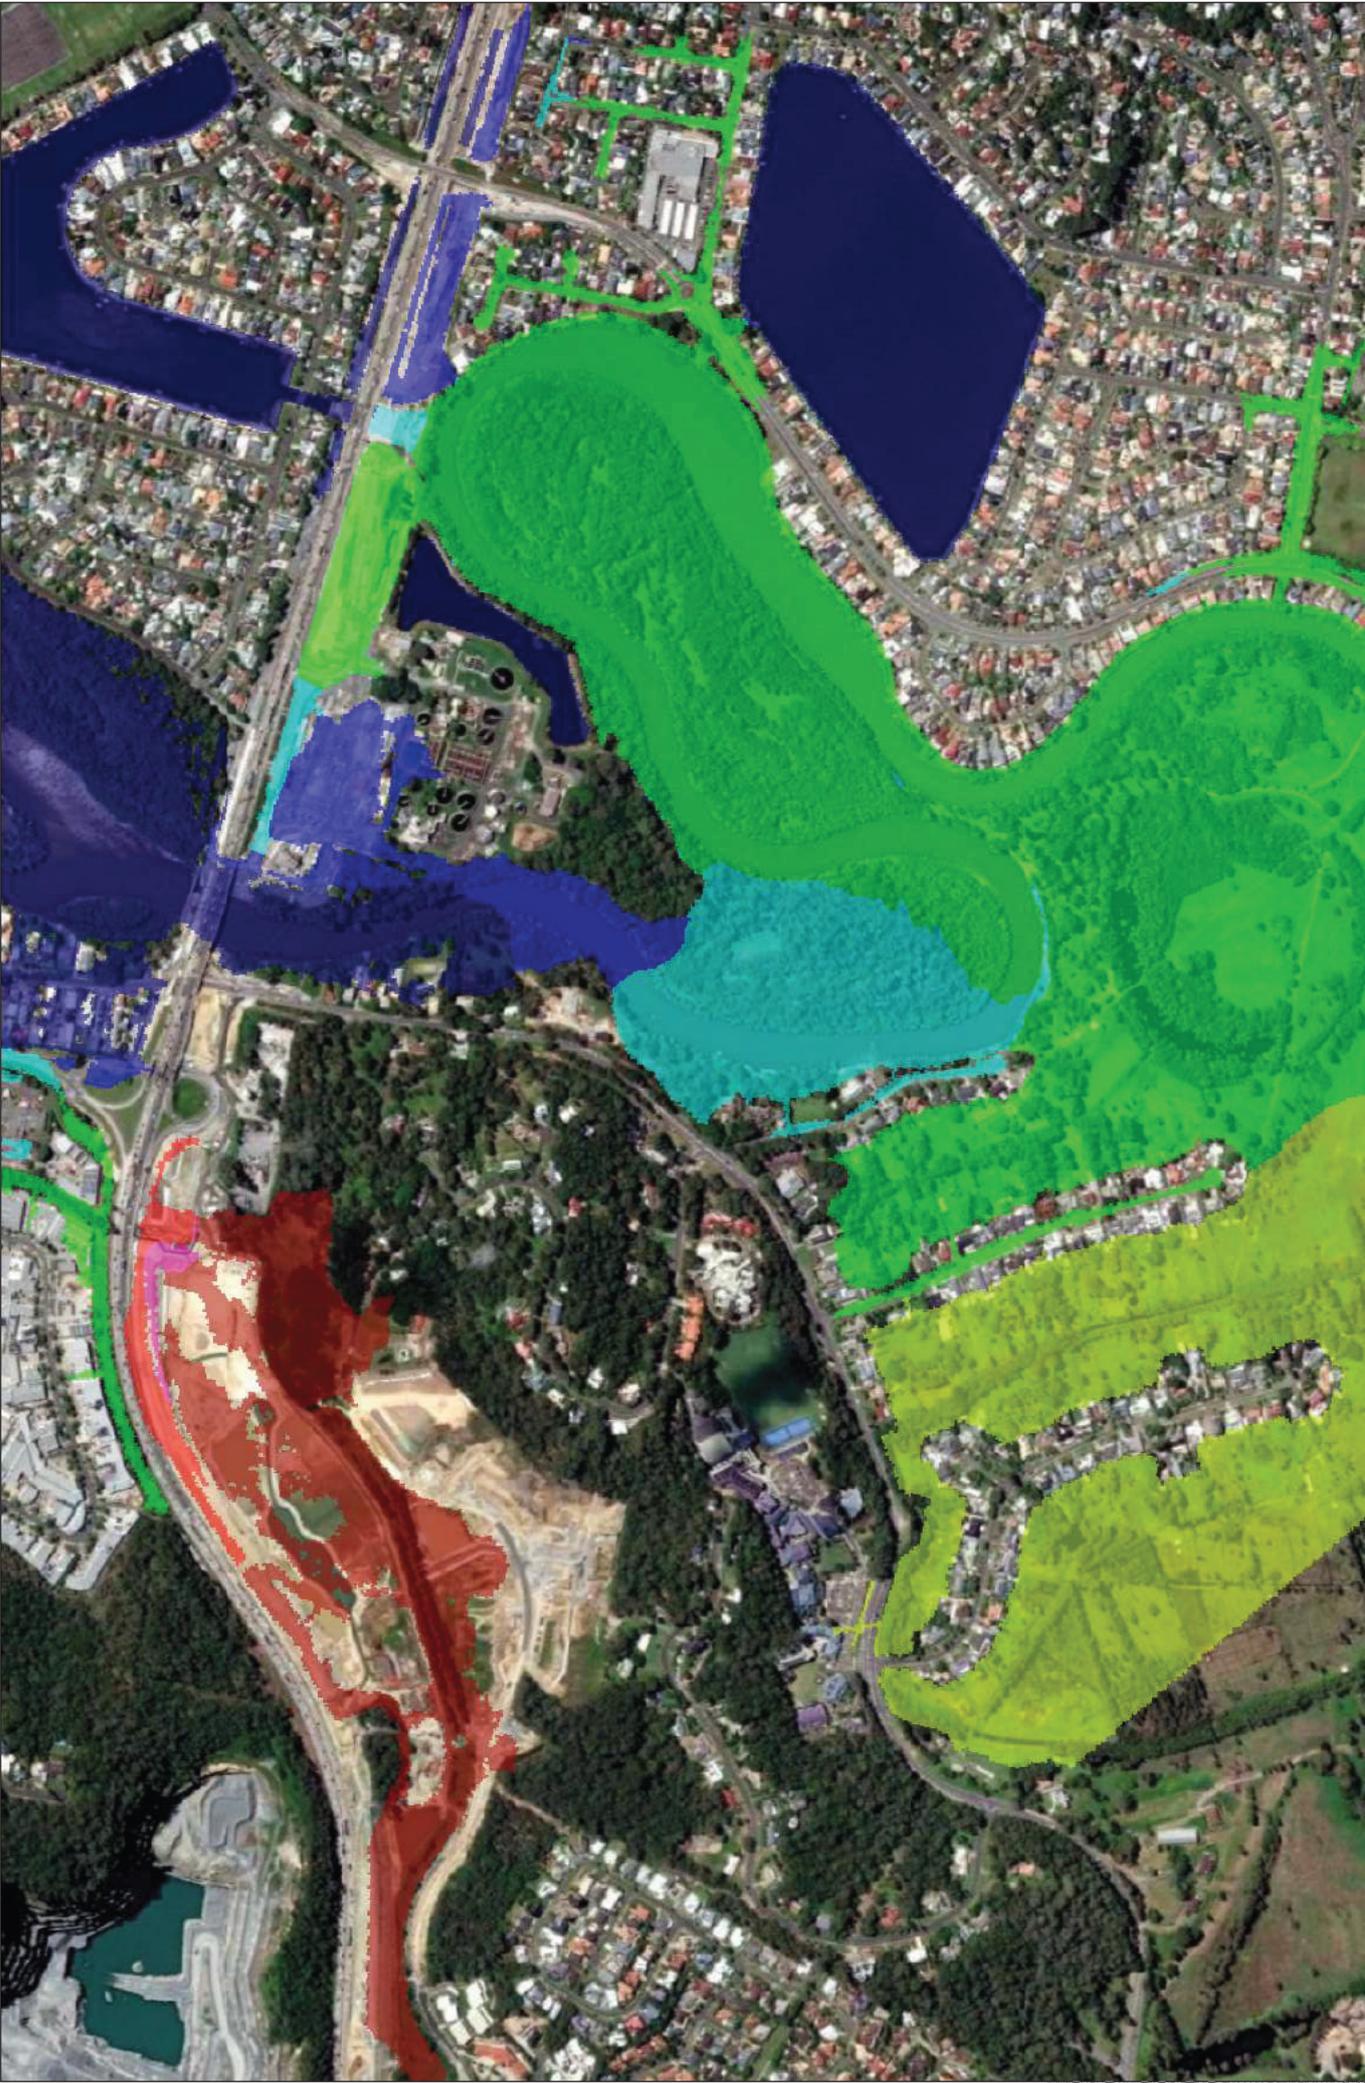
M1 B2PB - Tallebudgera Creek
 Construction Flood Impact Assessment
 Pre-Construction Conditions (E027)
 Peak Flood Levels - 5% AEP

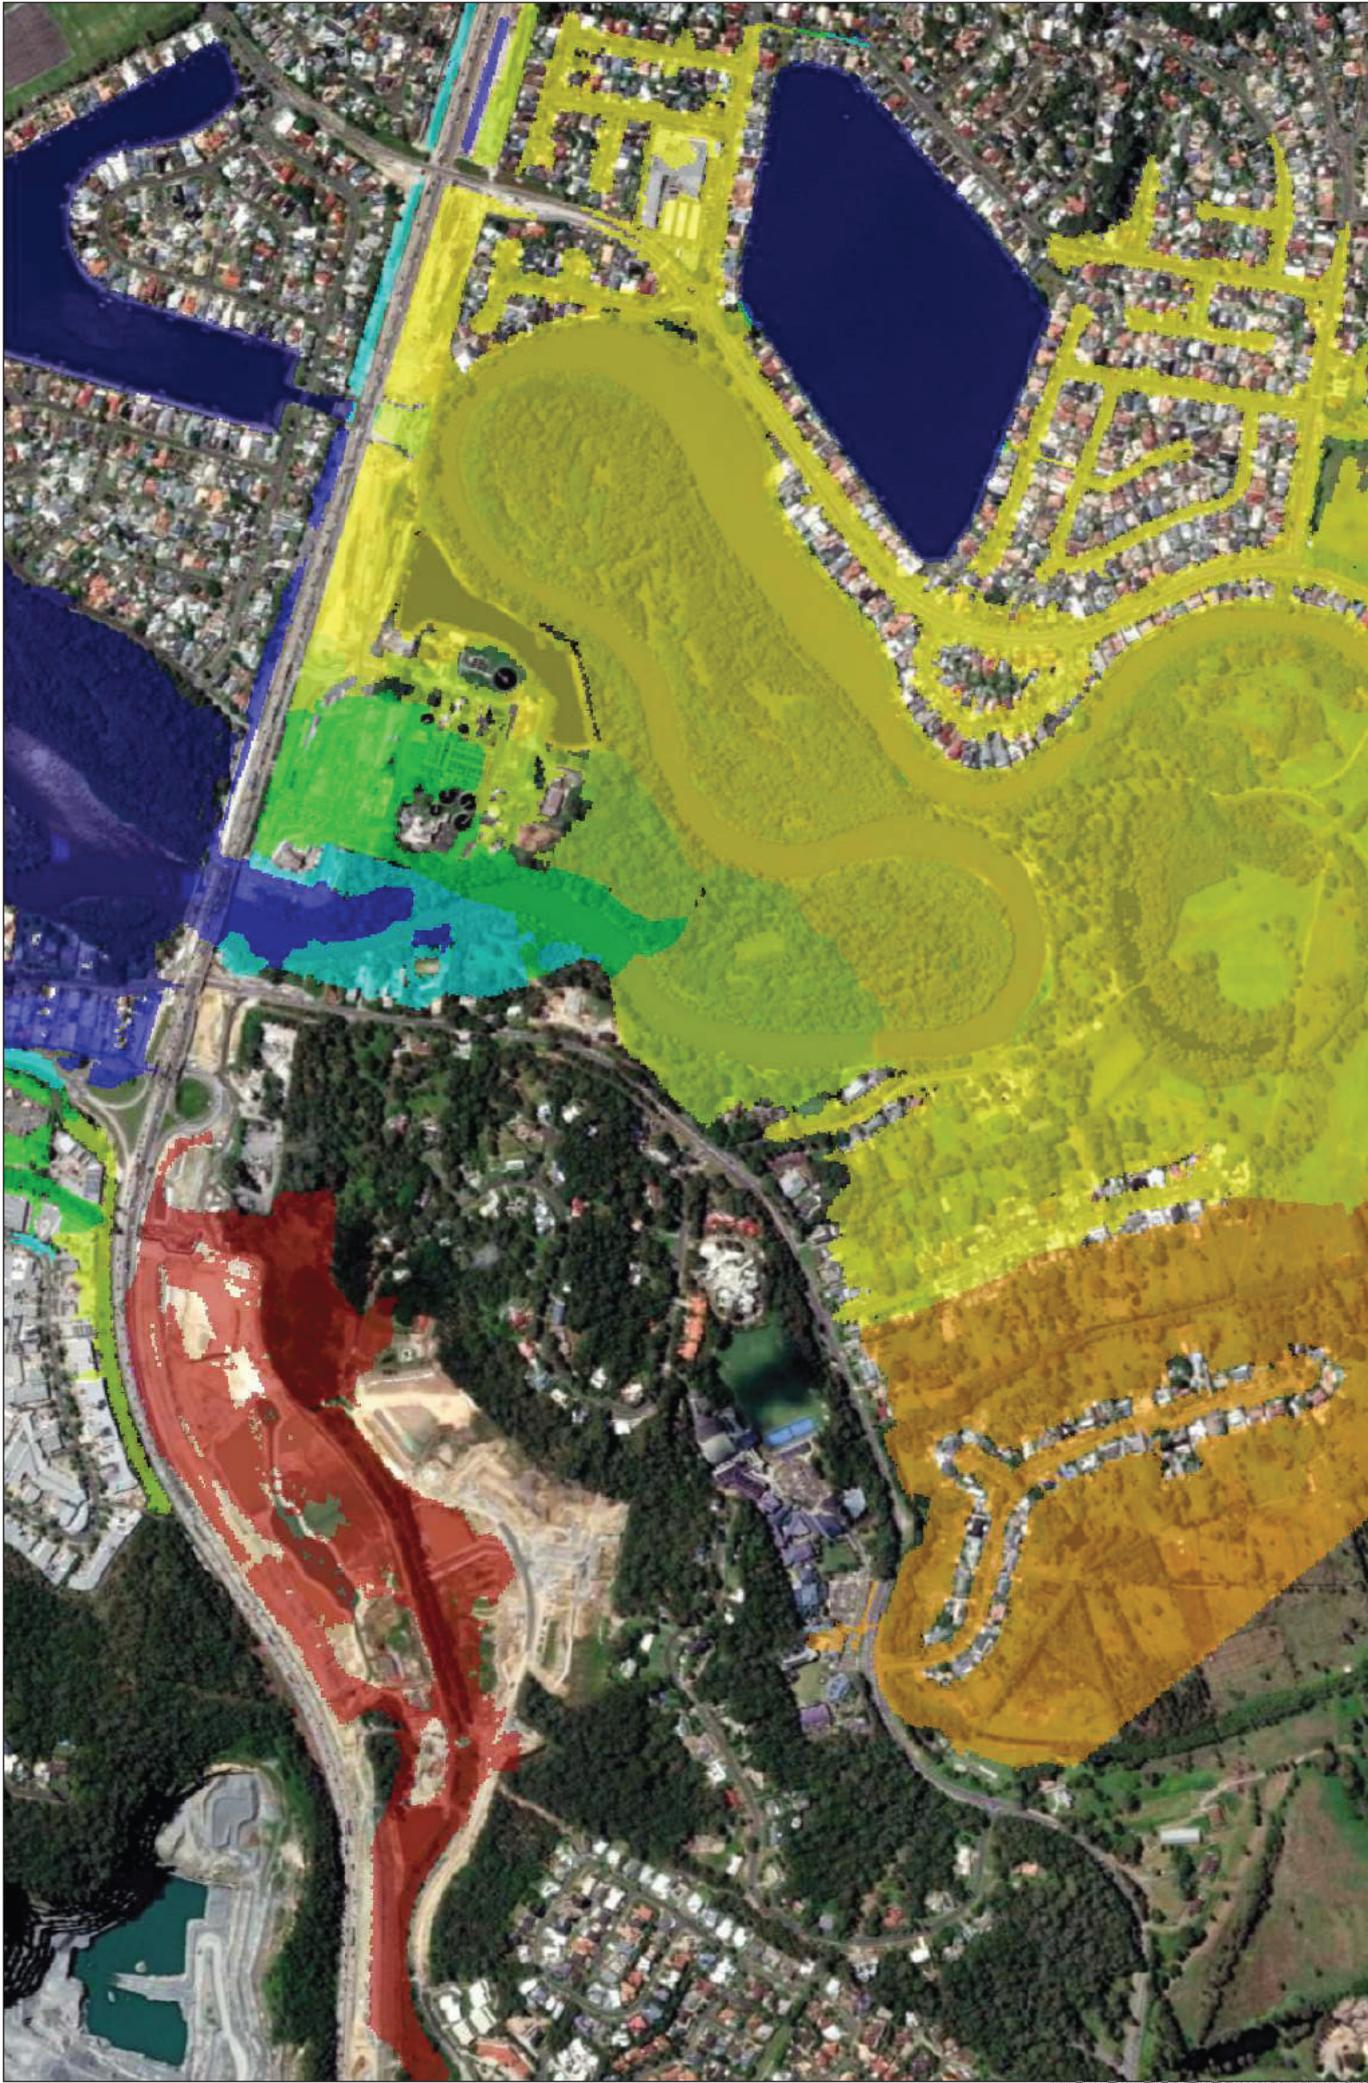
M1 B2PB - Tallebudgera Creek
 Construction Flood Impact Assessment
 Pre-Construction Conditions (E027)
 Peak Flood Levels - 2% AEP

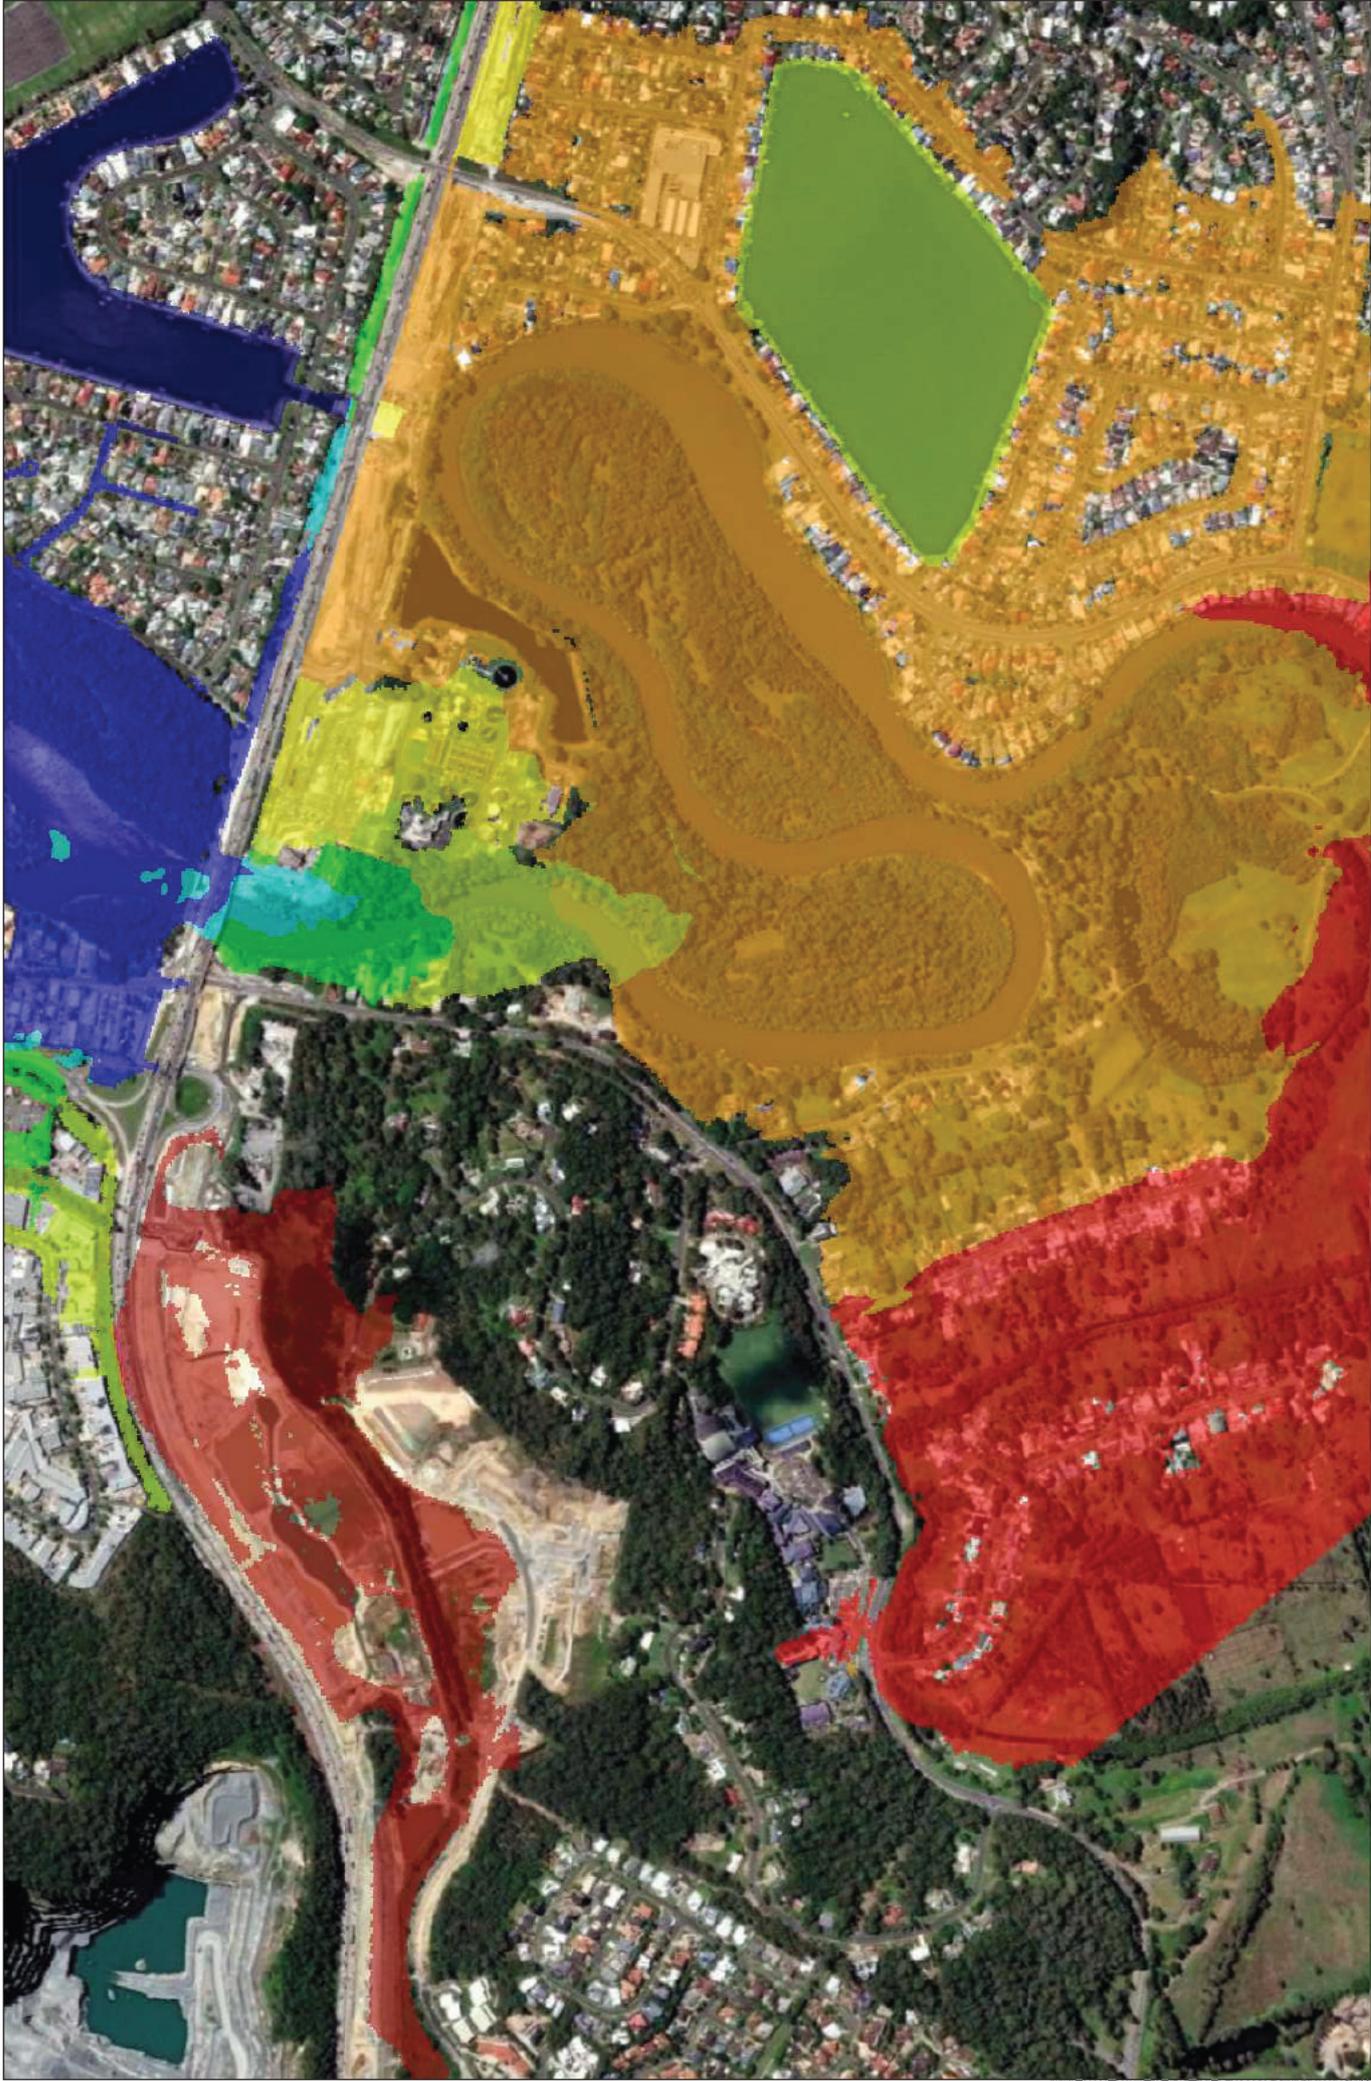
M1 B2PB - Tallebudgera Creek
 Construction Flood Impact Assessment
 Pre-Construction Conditions (E027)
 Peak Flood Levels - 1% AEP

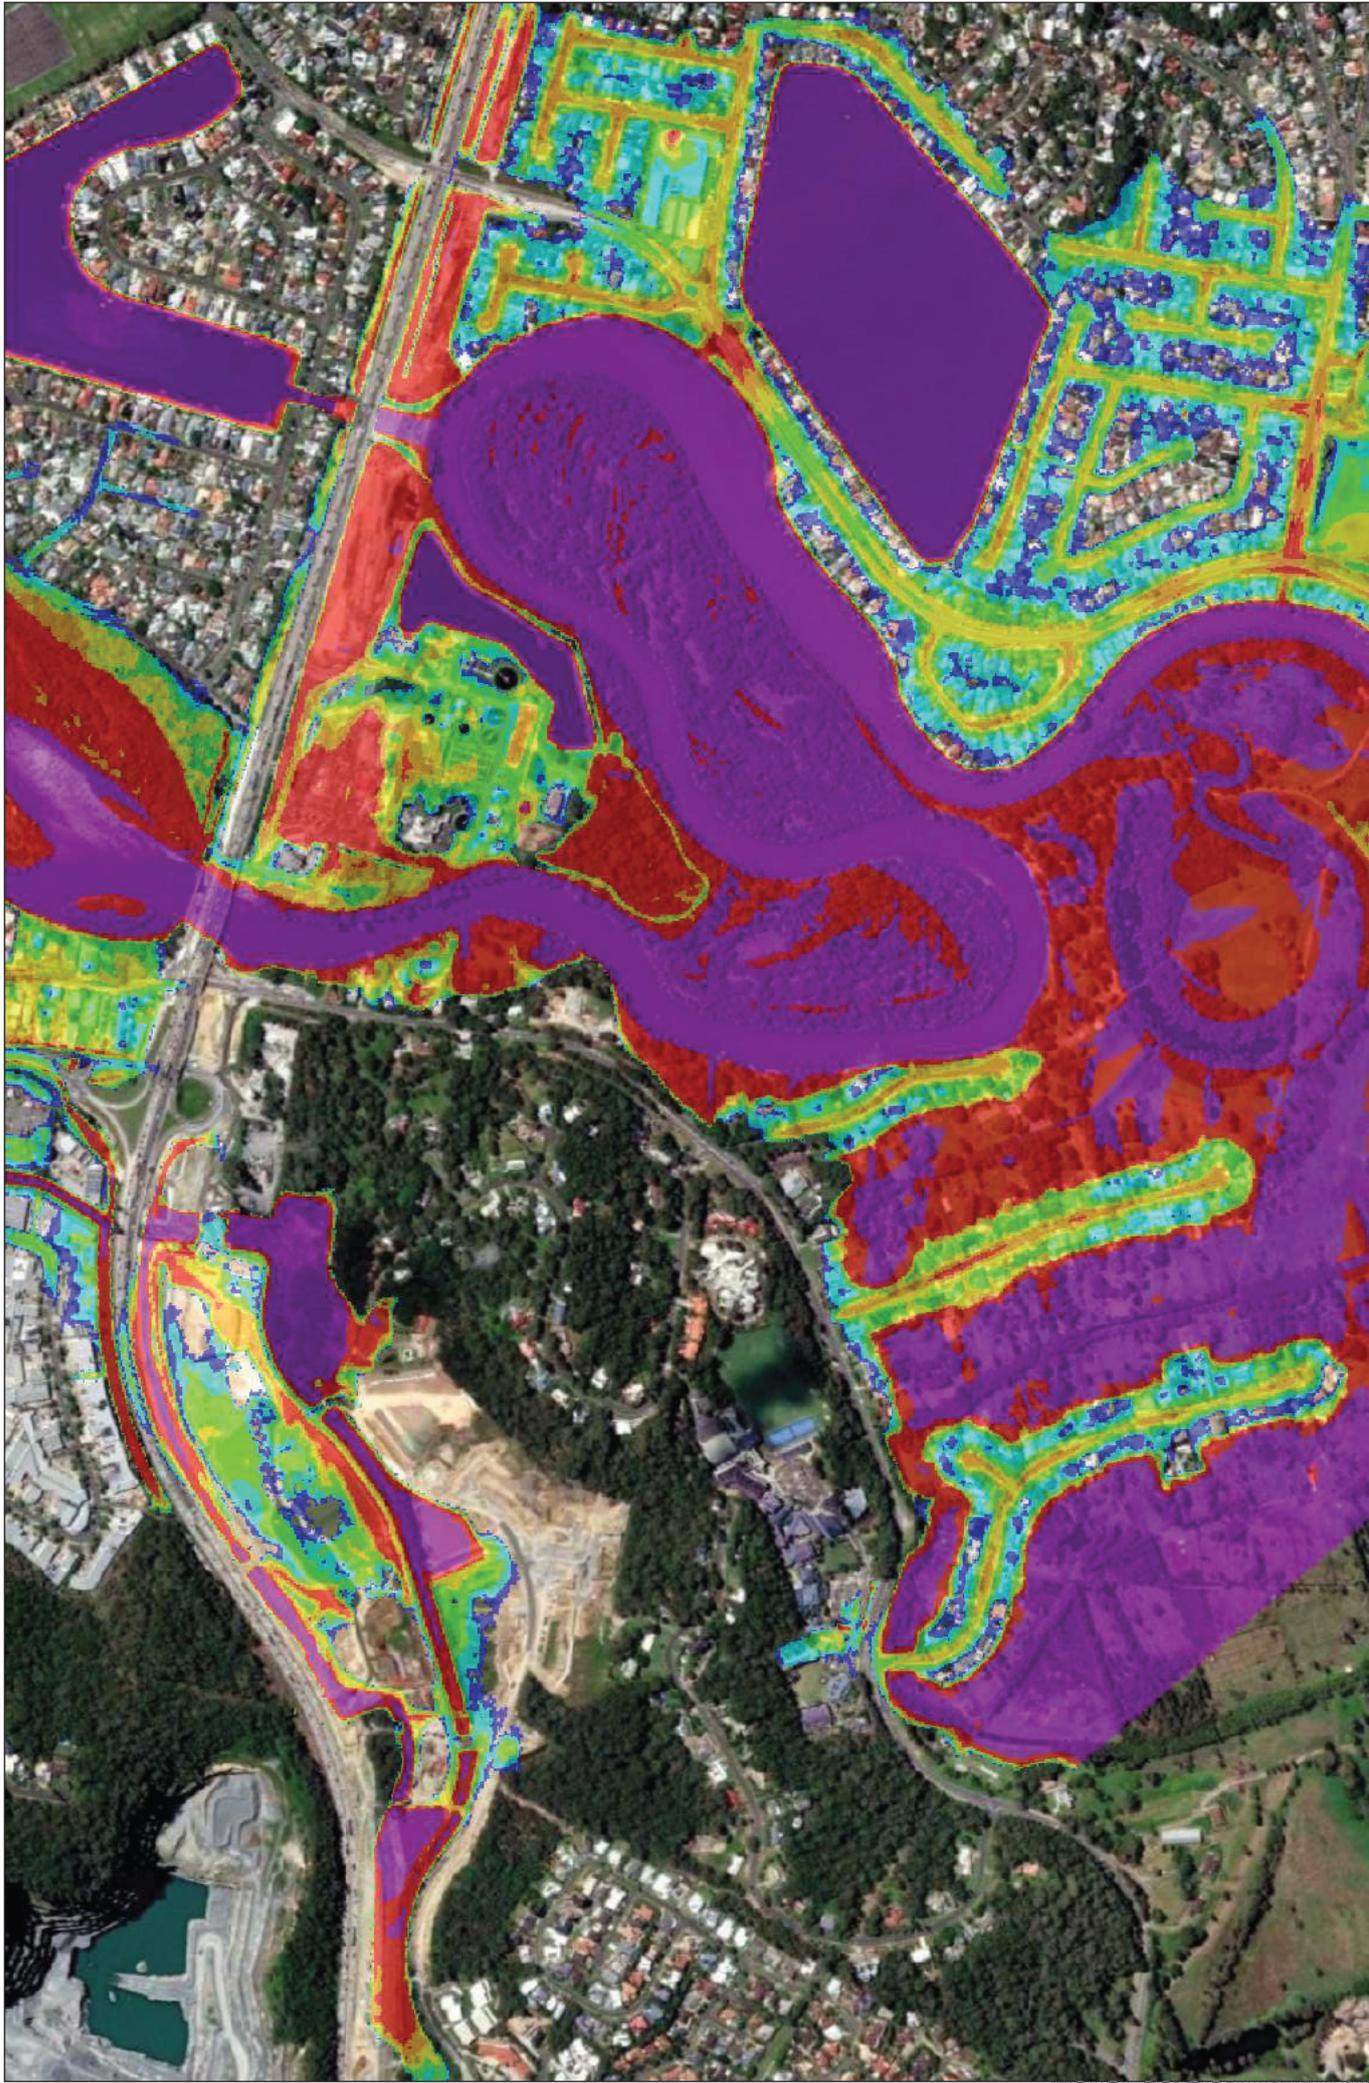
M1 B2PB - Tallebudgera Creek
 Construction Flood Impact Assessment
 Pre-Construction Conditions (E027)
 Peak Flood Depths - 1% AEP

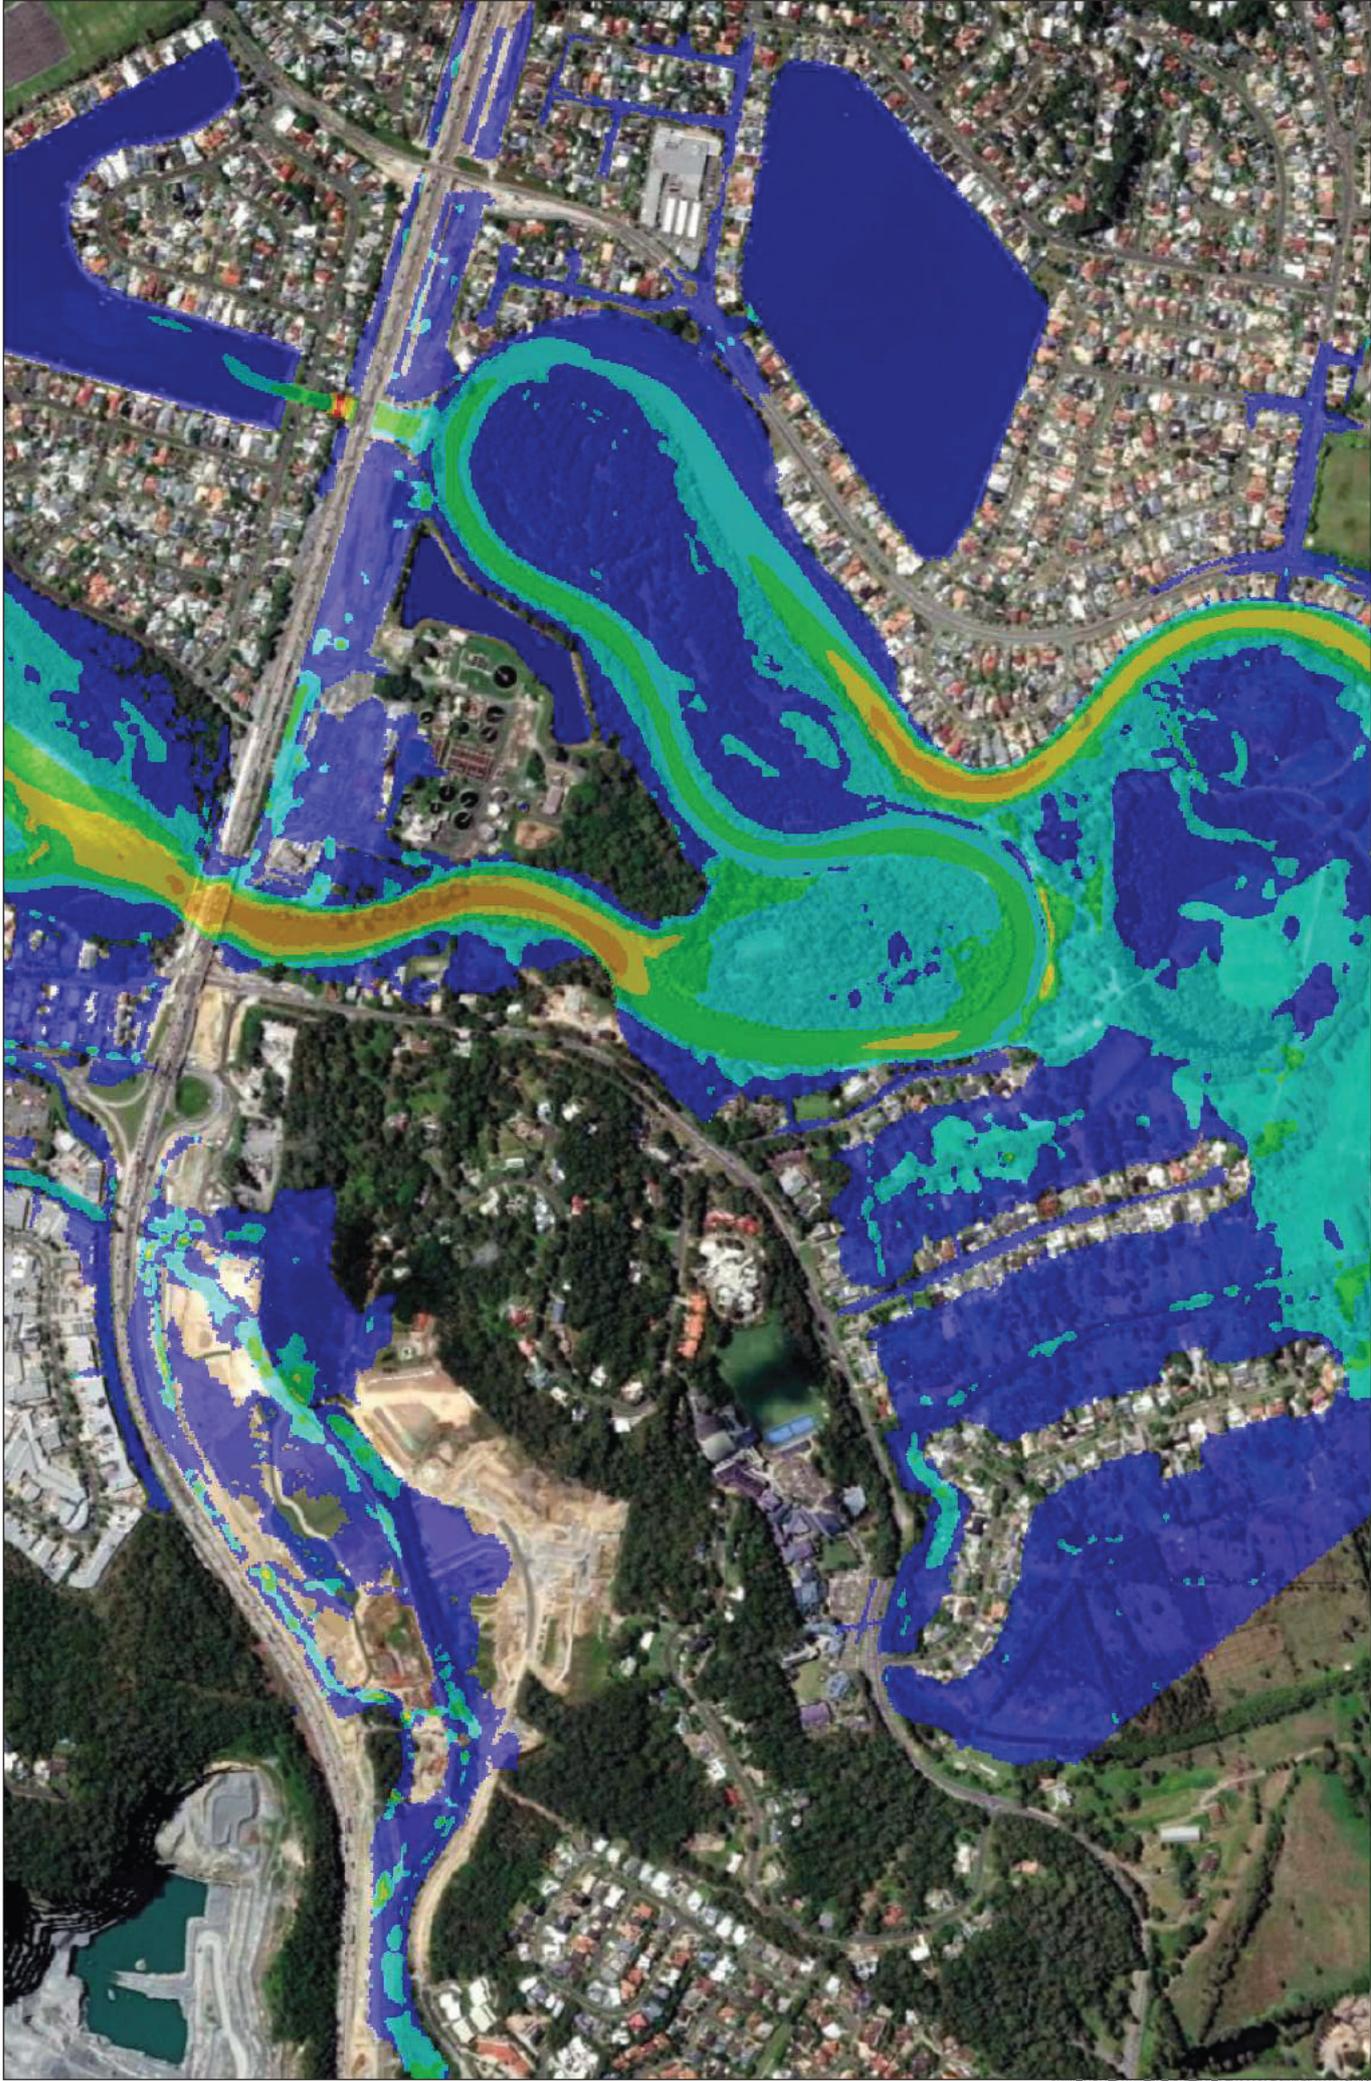
M1 B2PB - Tallebudgera Creek
 Construction Flood Impact Assessment
 Pre-Construction Conditions (E027)
 Peak Flood Velocities - 5% AEP

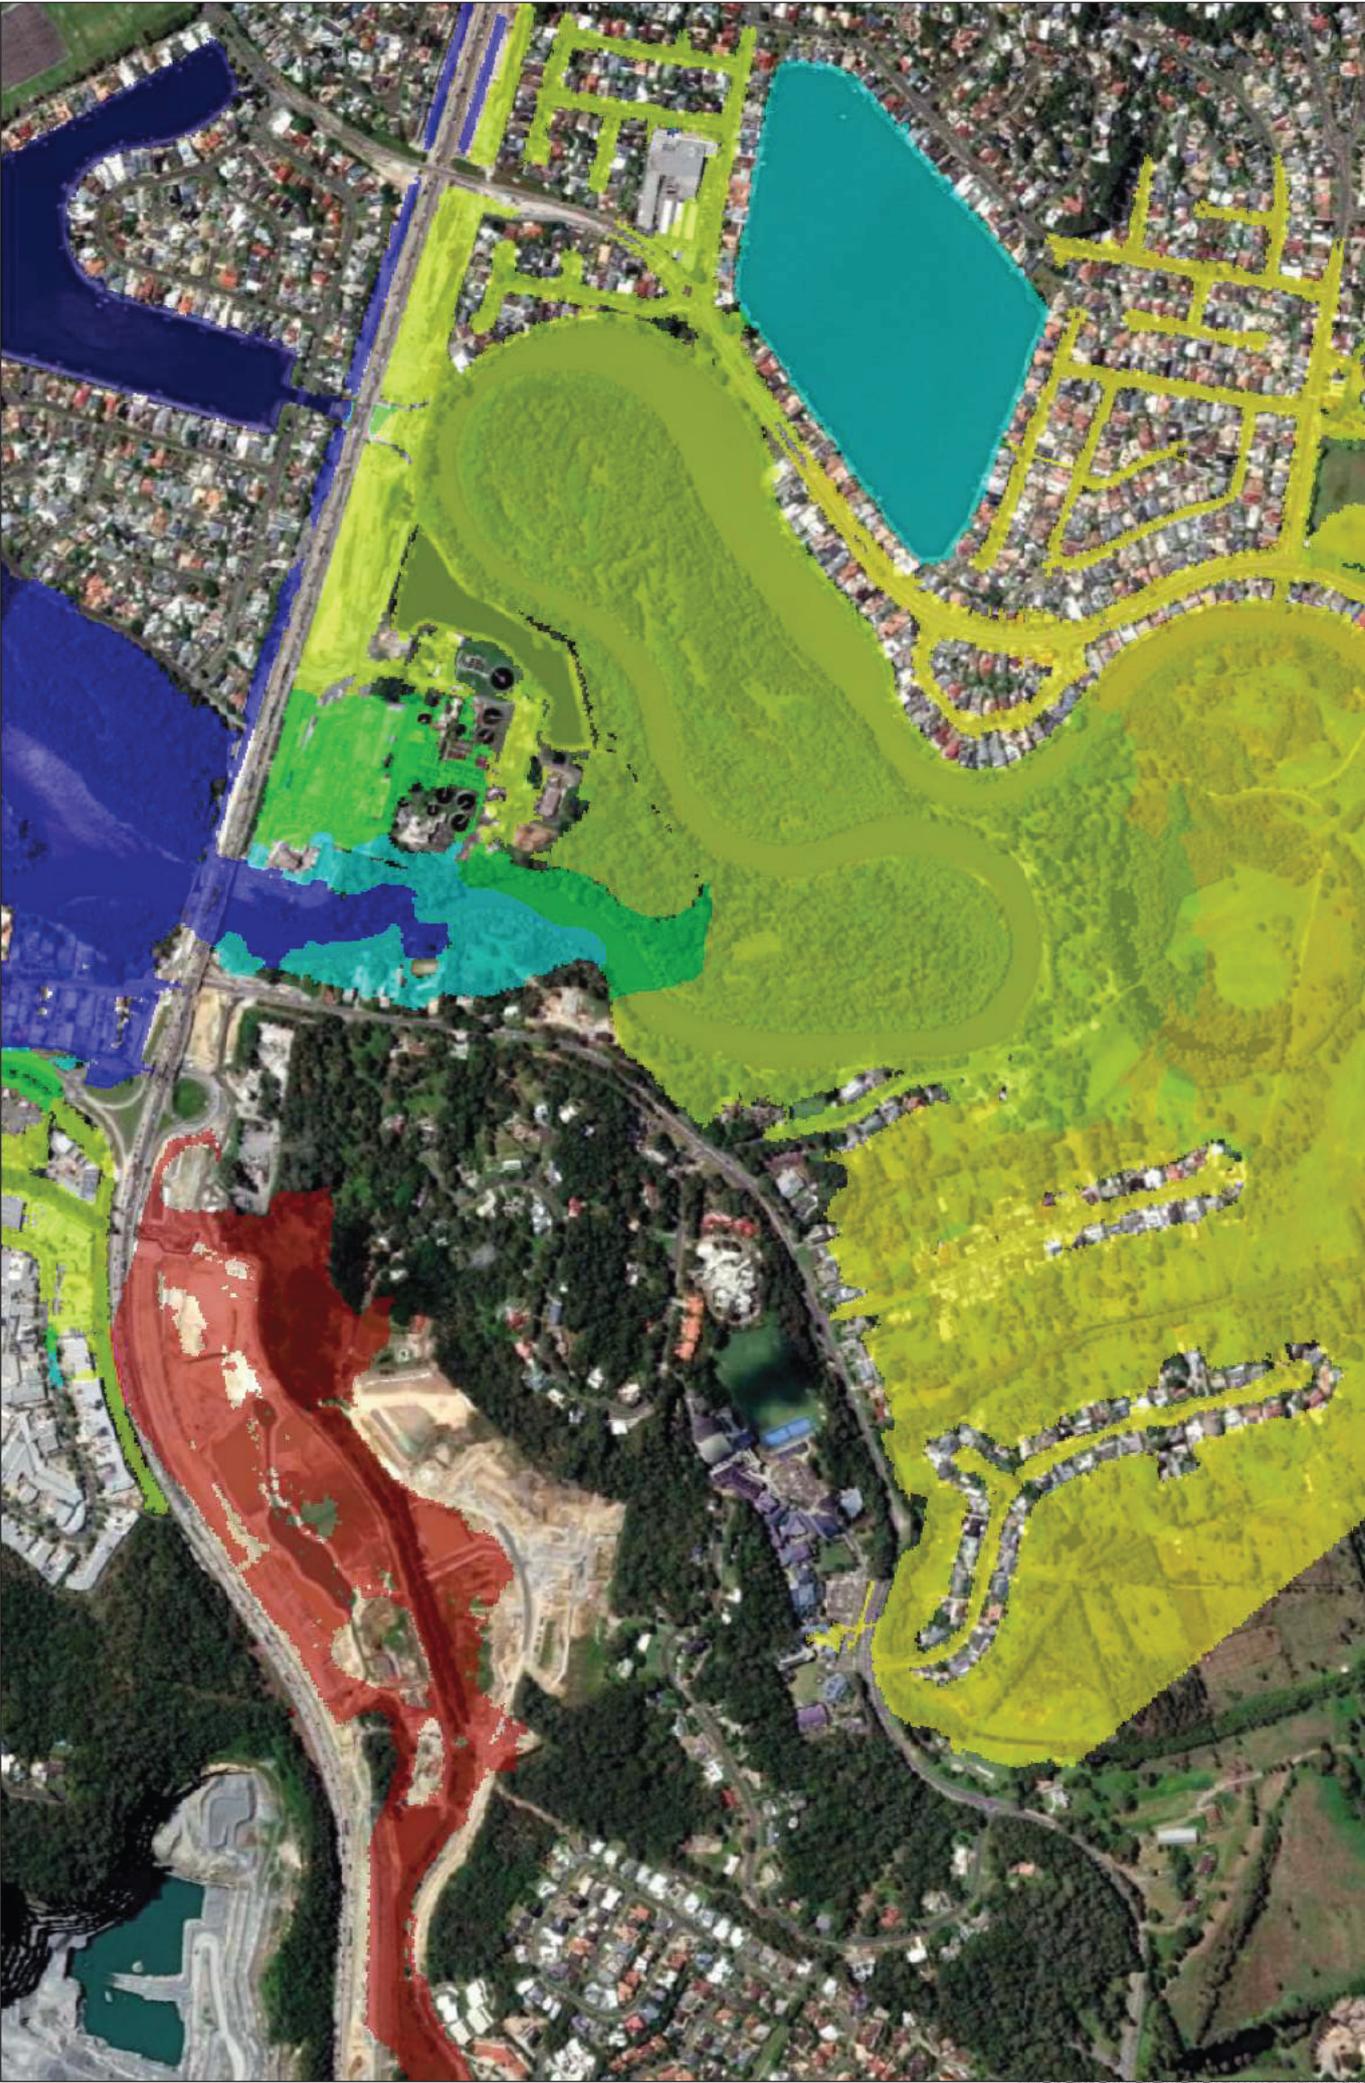
M1 B2PB - Tallebudgera Creek
 Construction Flood Impact Assessment
 Pre-Construction Conditions (E027)
 Peak Flood Levels - February 2022 Event

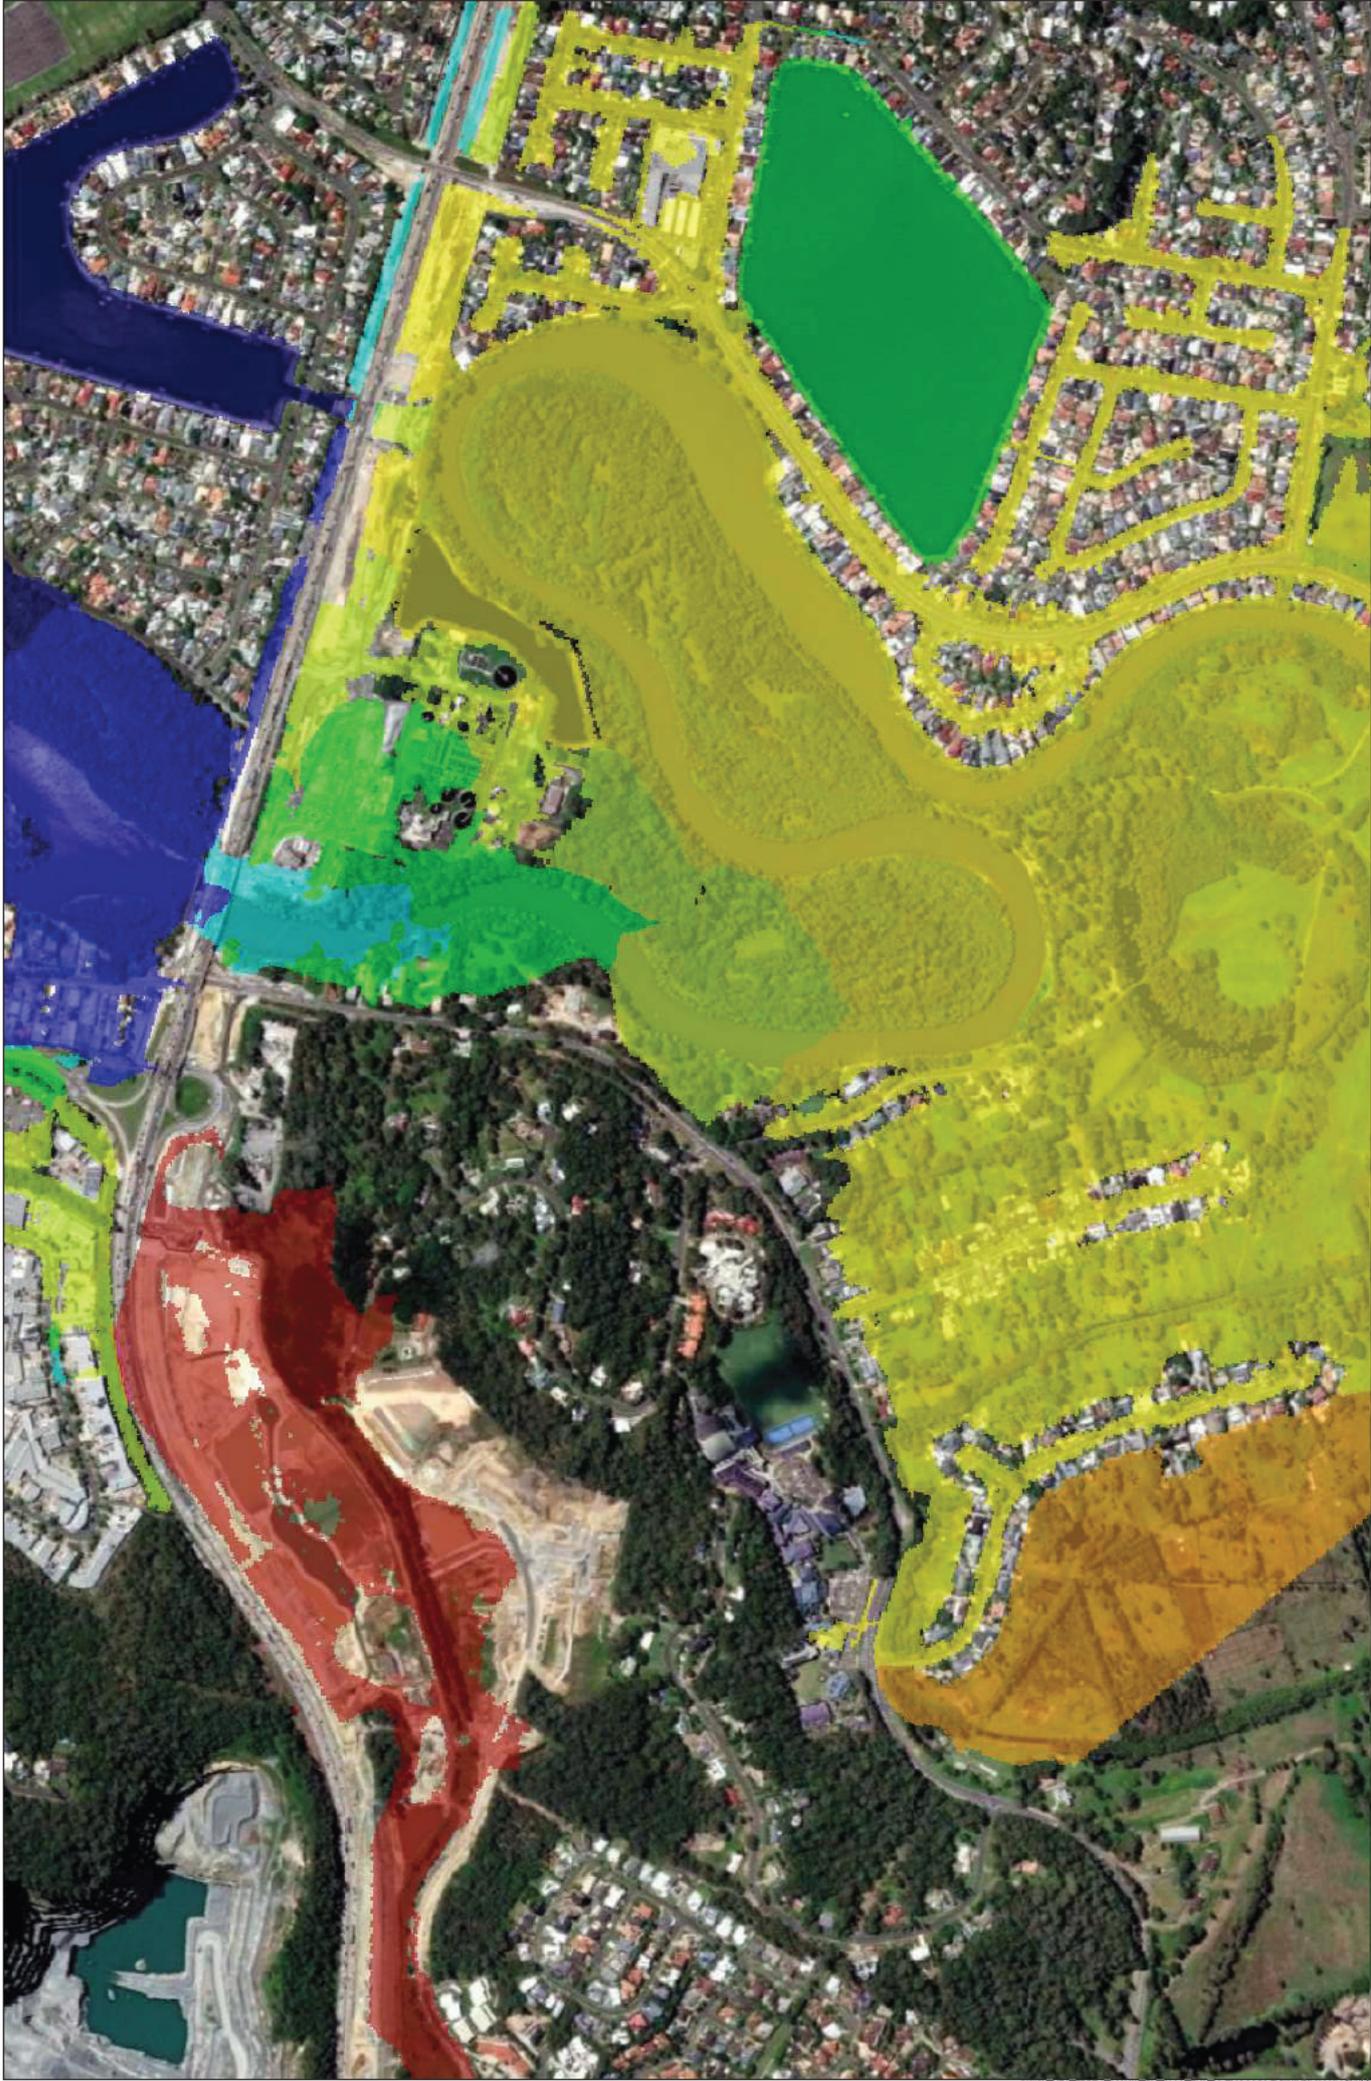
M1 B2PB - Tallebudgera Creek
 Construction Flood Impact Assessment
 February 2022 Construction Conditions (C007)
 Peak Flood Levels - February 2022 Event
