DTMR M1 UPGRADE

FLOOD EVENTS OF FEBRUARY AND MARCH 2022 IMPACT ANALYSIS AND RISK ASSESSMENT

SLR Ref: 620.31045-R01
Version No: -v0.1
October 2022

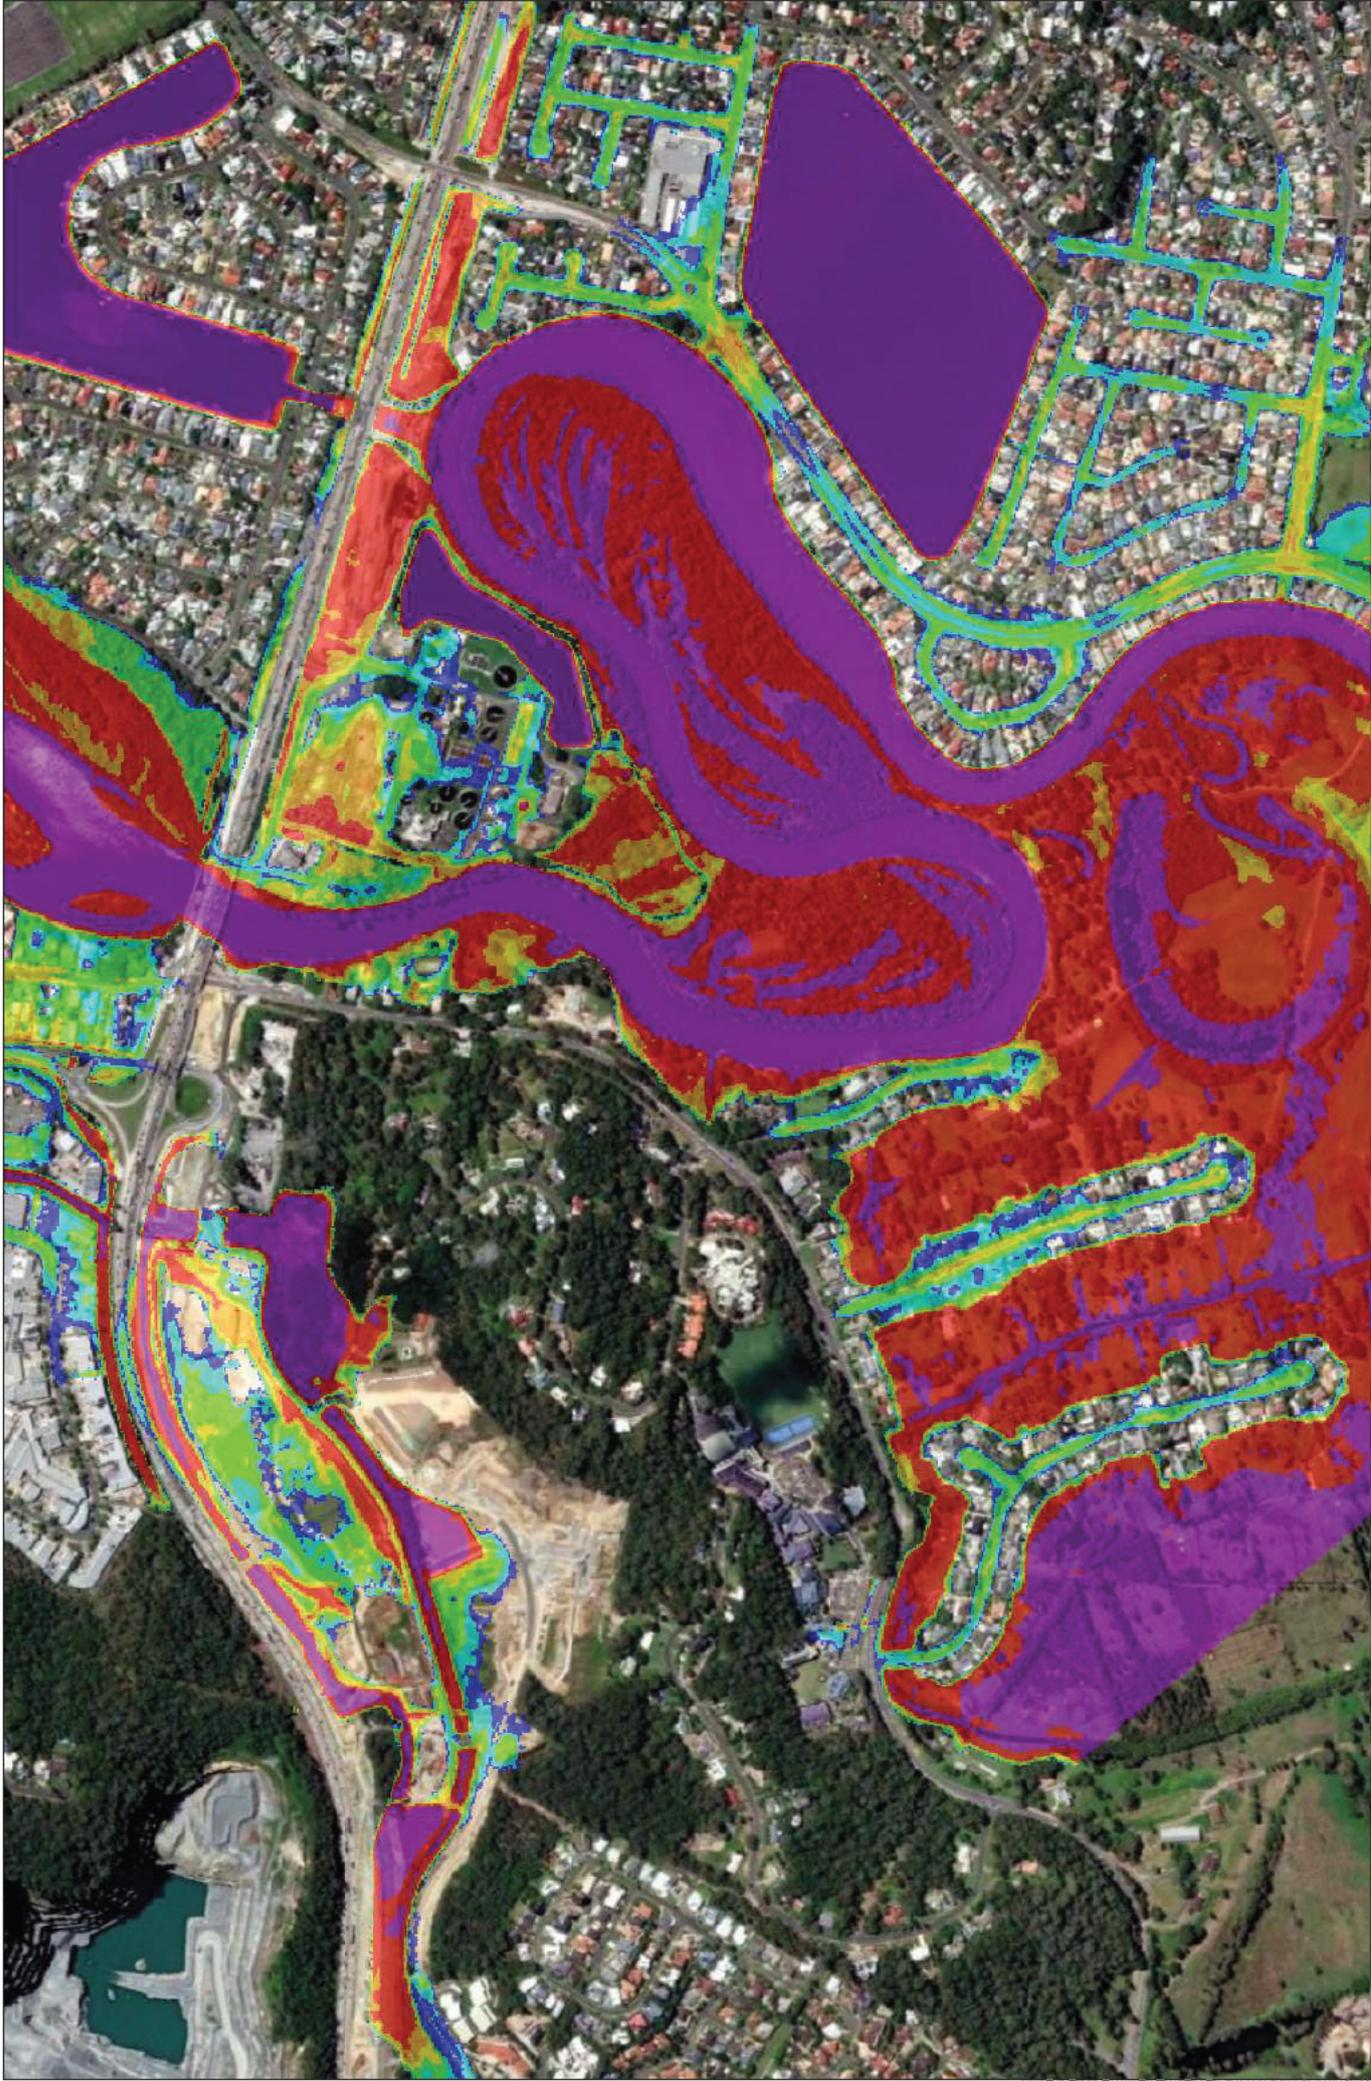
M1 B2PB - Tallebudgera Creek
 Construction Flood Impact Assessment
 Pre-Construction Conditions (E027)
 Peak Flood Depths - February 2022 Event

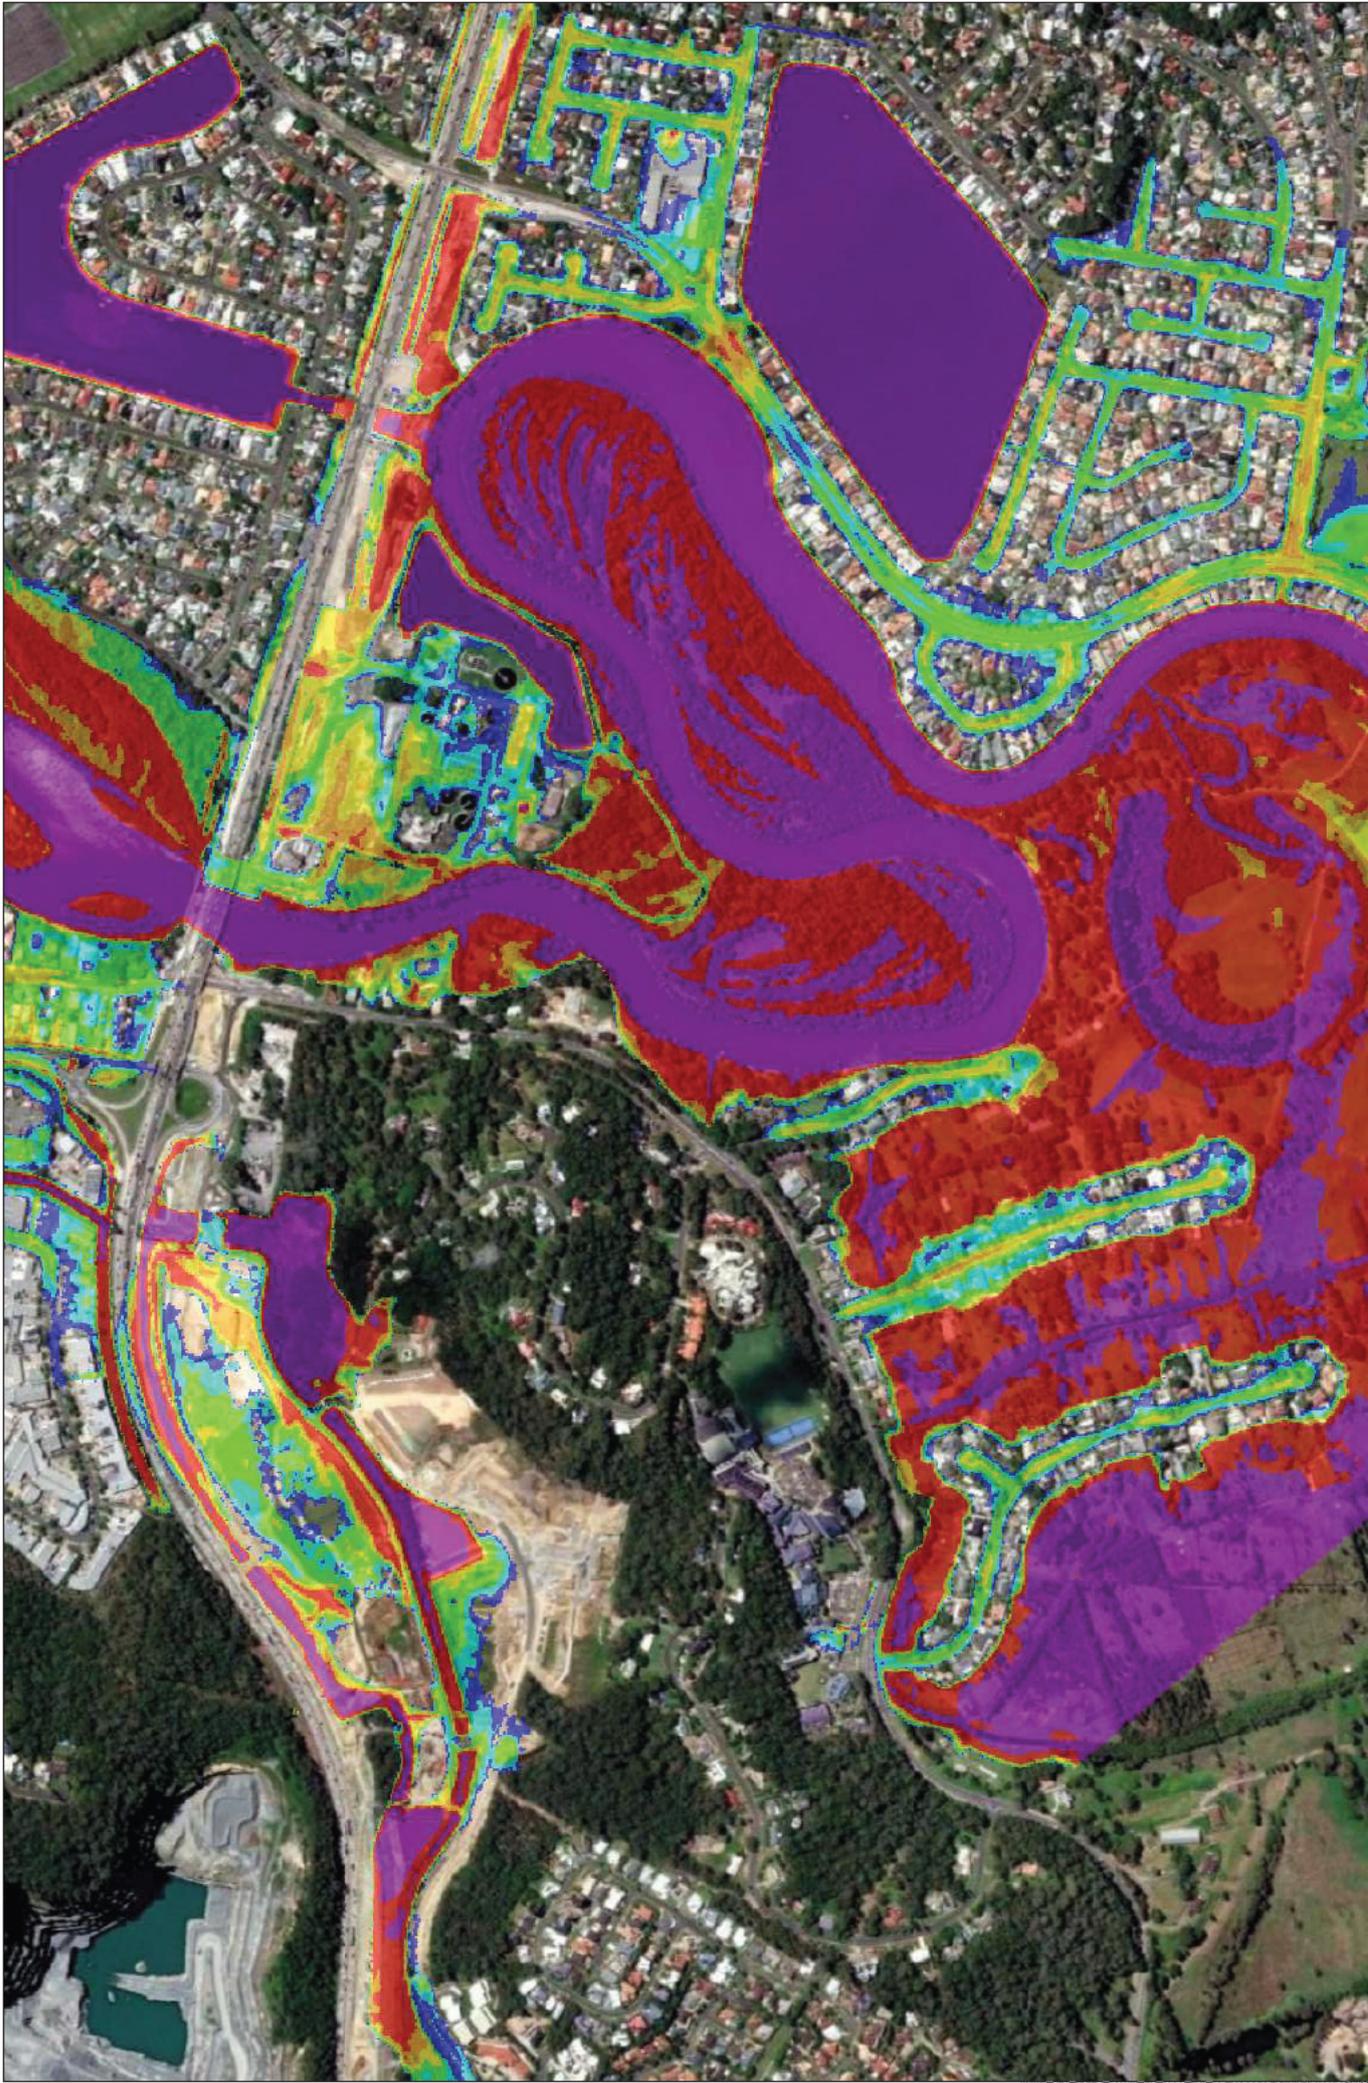
M1 B2PB - Tallebudgera Creek
 Construction Flood Impact Assessment
 February 2022 Construction Conditions (C007)
 Peak Flood Depths - February 2022 Event

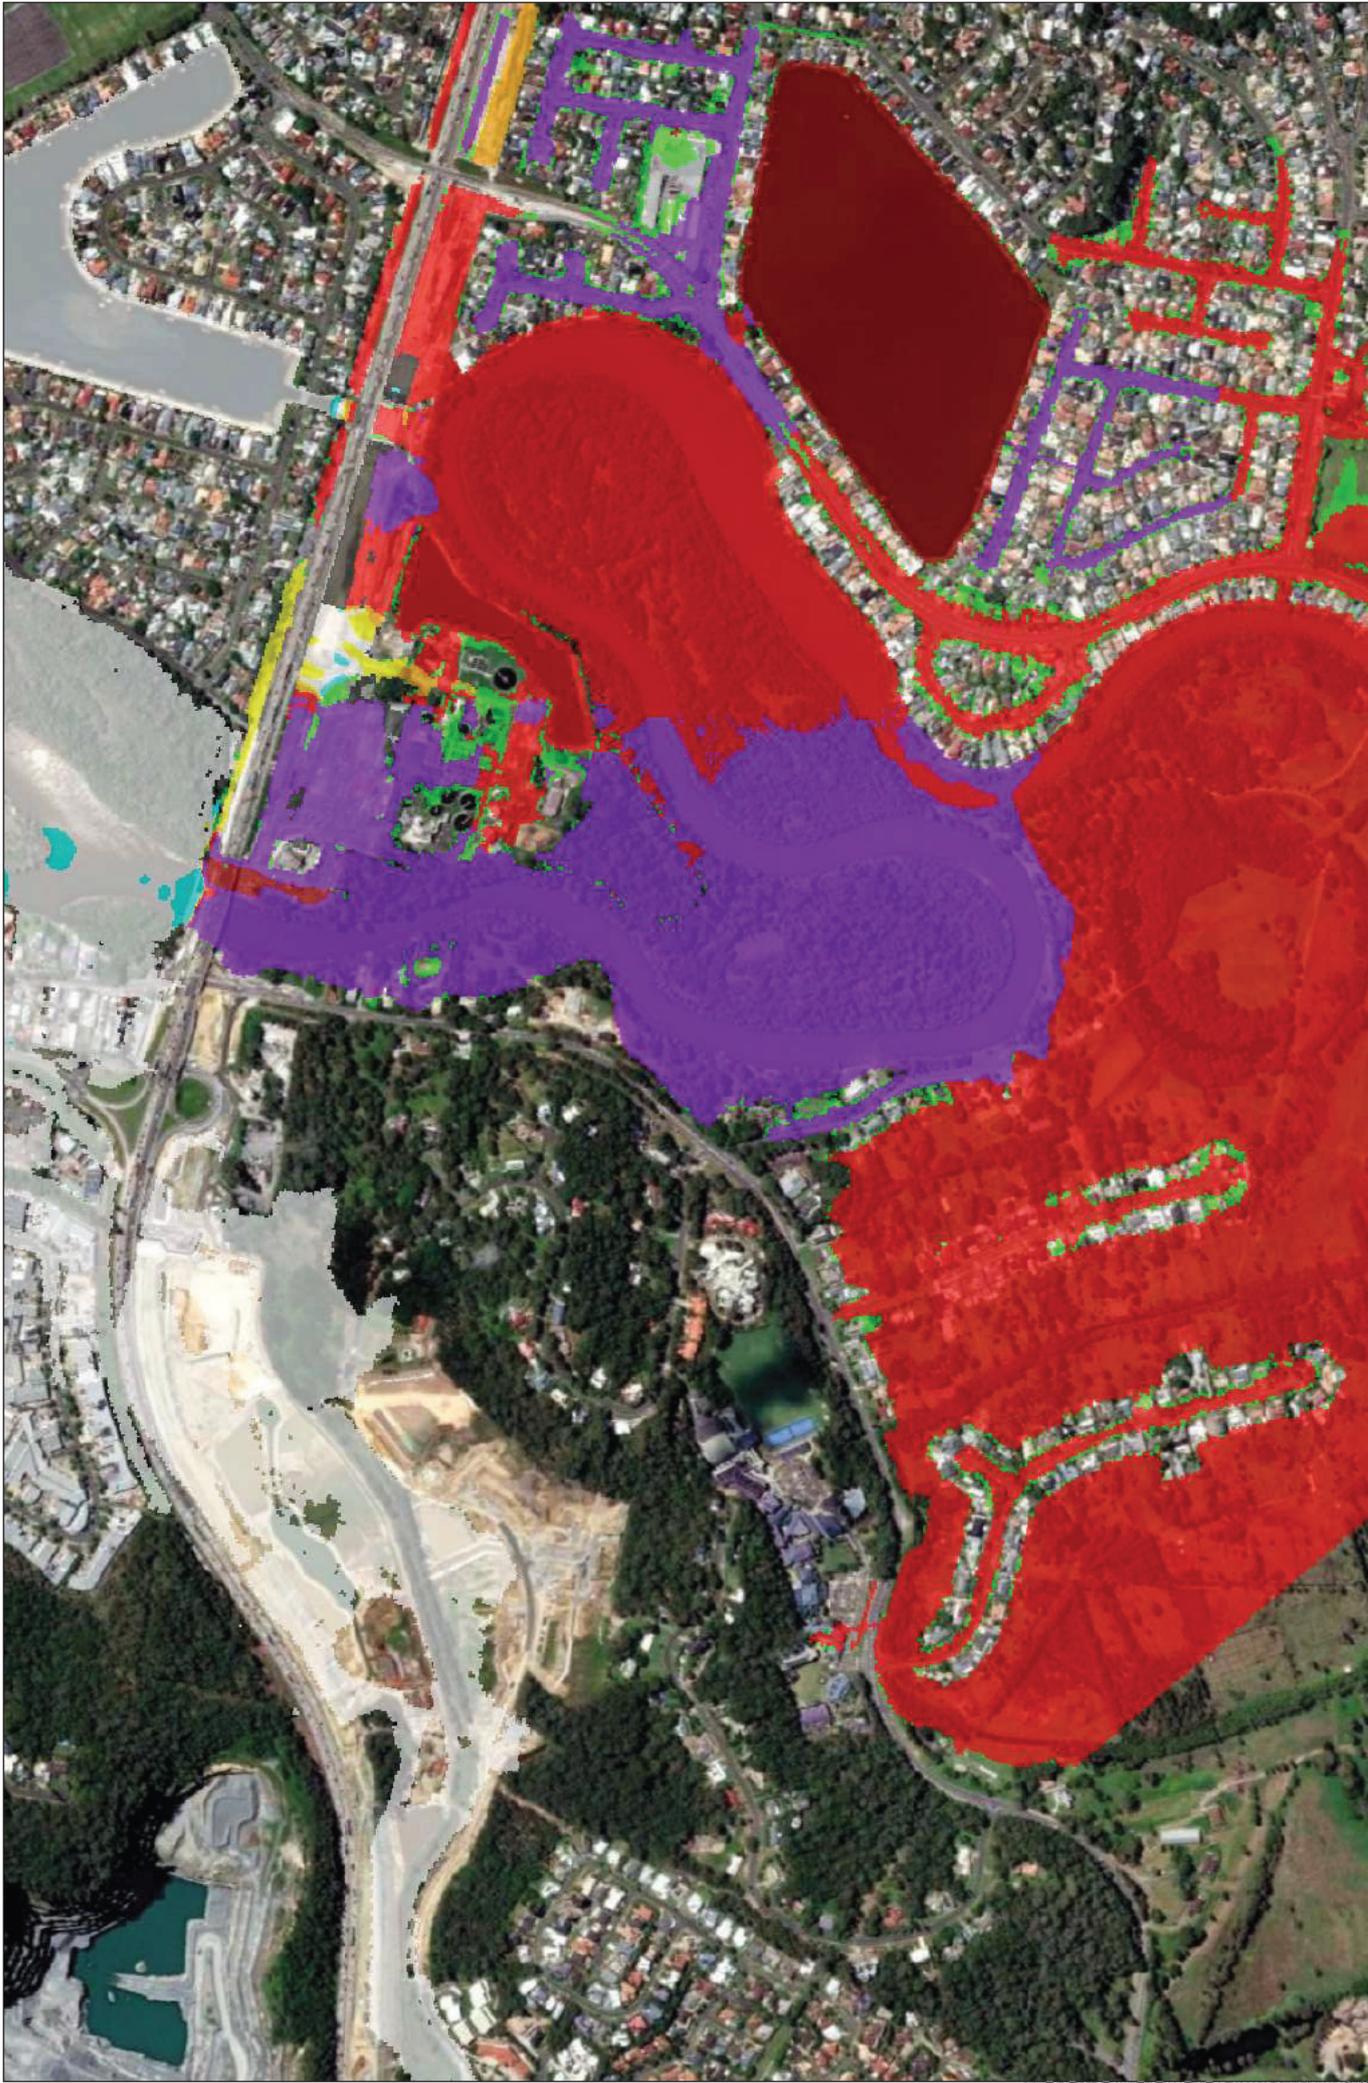
M1 B2PB - Tallebudgera Creek
 Construction Flood Impact Assessment
 February 2022 Construction Conditions (C007)
 Peak Flood Afflux - February 2022 Event

- 41 Figure 14 shows relative widespread low-level impacts (increases in peak flood level of between 50 and 100 mm) in the catchment upstream of the M1, extending to the upstream extent of the model. However, it is noted that there appear to be few impacts on existing residential development. It is noted that the Lidar survey data used in the modelling generally only reflects the average ground and road levels in the model. In particular, it does not pick up floor levels.

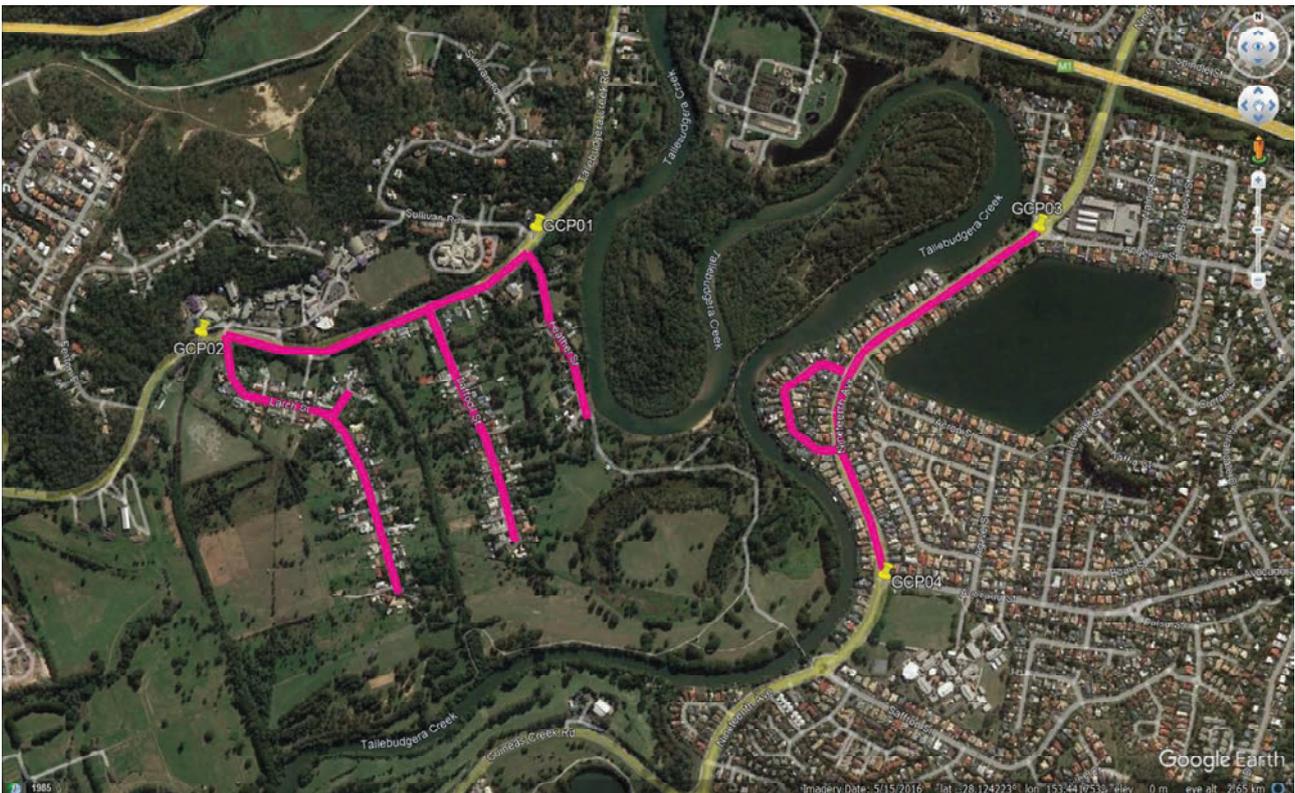
Figure 1 – MLS Capture Area and GCP Locations

MLS control has been placed at a few of locations spread out over the project area to ensure the accuracy of the resultant point cloud data. These have been placed along Tallebudgera Creek Road and Nineteenth Avenue as indicated in Figure 1 and are per Photos 1 and 2 below.

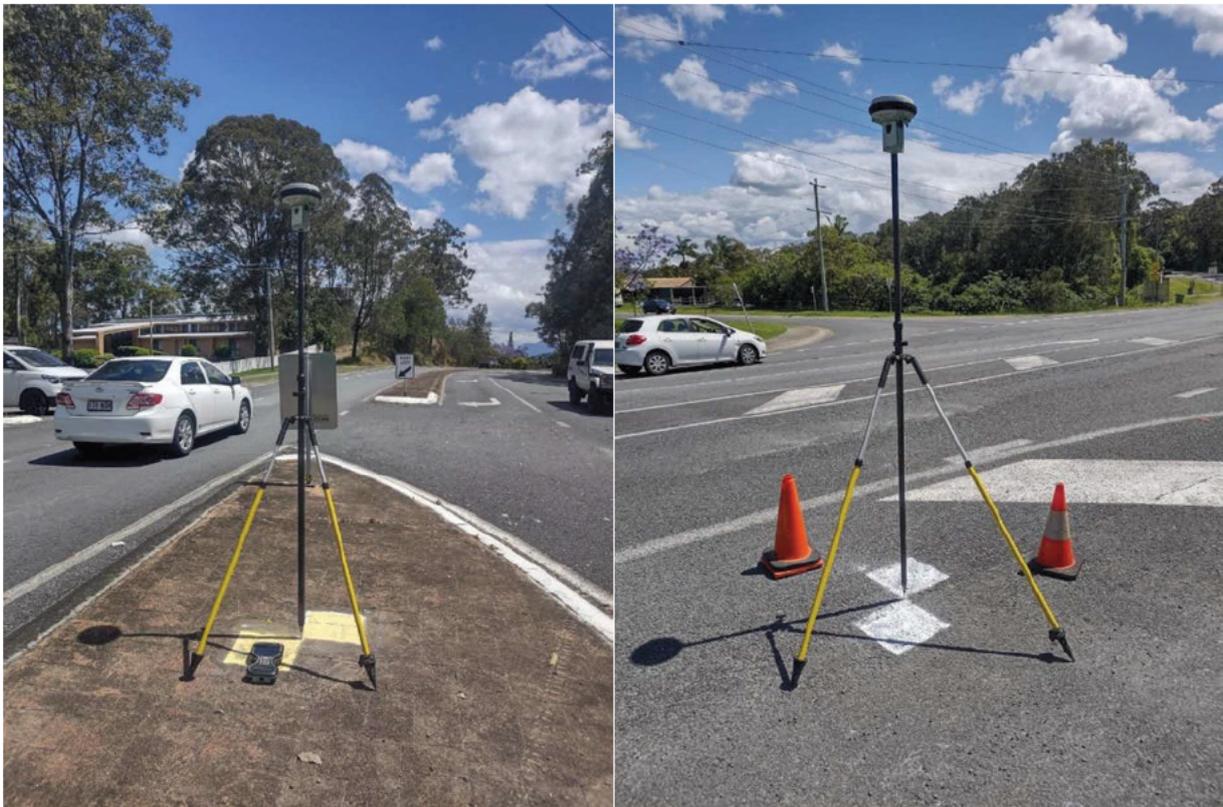
Picture 1 – Examples of Ground Control GCP01 & GCP02 as placed and observed
