# Threatened Turtle & Fish Habitat Assessment

Rockhampton Ring Road - Business Case

Client: Department of Transport and Main Roads

20-Feb-2020

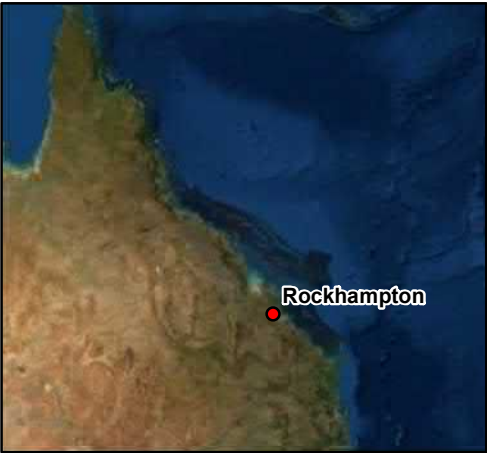
The design of the Project includes the provision for 14 bridges, as detailed in Table 1 below. Proposed bridges are also displayed in Figure 1. The bridges mainly consist of floodplain bridges, road or rail overpasses, creek crossings and the Fitzroy River crossing. Apart from the Lion Creek Bridge (B14), there is no interface with existing structures. At Lion Creek, there is an existing bridge which is being replaced off line and therefore the impacts of the existing structure are considered to be minimal.

The design shown in Figure 1 and described below was current at the time of the PE phase of the Project.

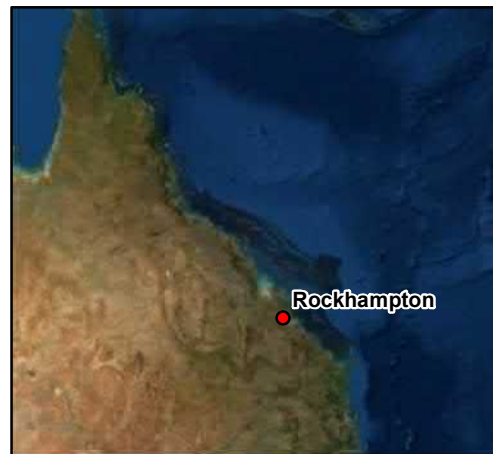
Figure  
3

As part of the technical investigations for the Project, an aquatic assessment was undertaken at all water course crossings within the Project Area in order to determine aquatic habitat values relevant for waterway barrier works and fish passage. The location of these assessments is provided in Figure 3.

The Project Area is mapped as containing five waterways under the *Fisheries Act 1994* (refer to Figure 3). Mapped waterways are categorised based on the level of risk of adverse impact on fish movement that is likely from barrier works. The data layer uses a traffic light colour scheme to indicate risk, with green being least risk and red being highest risk, for self-assessable works. Two other colours are used—purple for higher order waterways and grey for tidal areas. These generally require approval assessment. However, where the barriers are bed-level, works on purple waterways may be self-assessable. Where the works are temporary, works on purple or grey waterways may be self-assessable. The waterways intersected by the alignment and their risk rating are outlined below:

The primary aquatic environments sensitive to impacts from the Project include the Fitzroy River, Lion Creek at Ridgeland Road and Limestone Creek. At the time of survey, two waterways were dry (Lion Creek at Nine Mile Road and Scrubby Creek) and fish passage was highly restricted at the tributary of the Fitzroy River. A brief description of the habitat available at each waterway is provided below and locations of each site are shown on Figure 3. Representative habitat at each site is shown in Plate 2 to Plate 7.

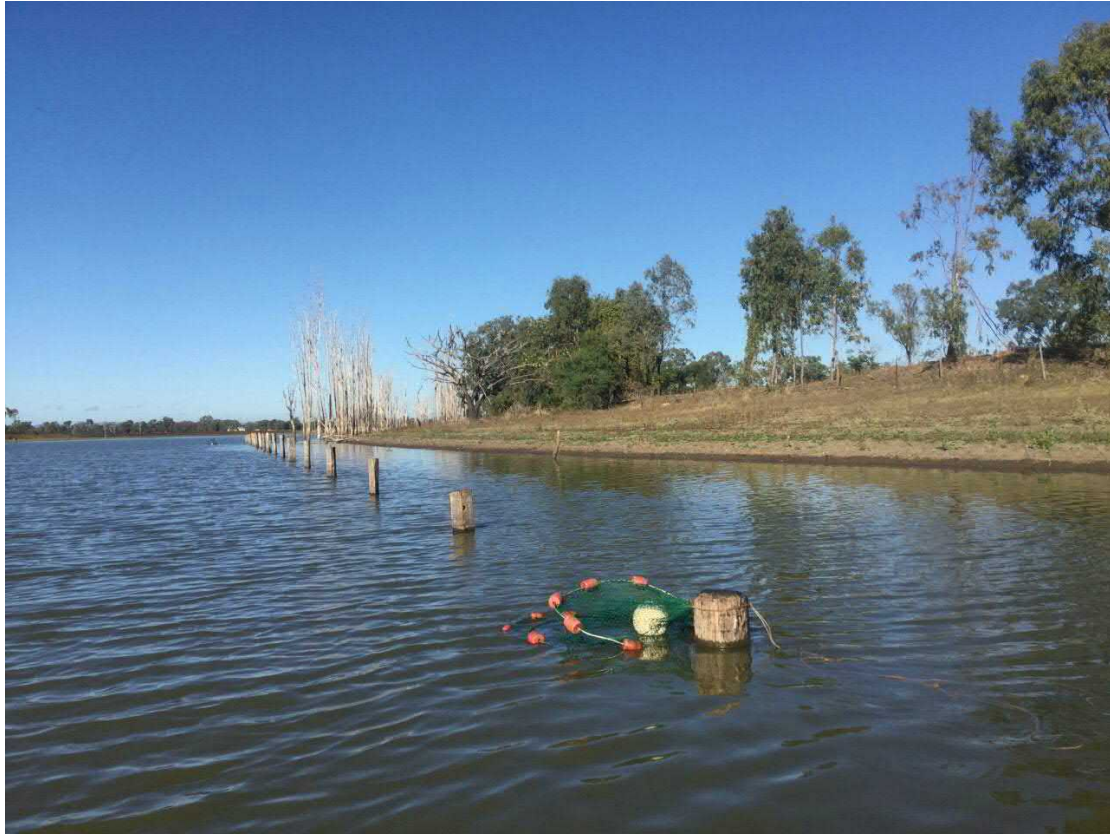
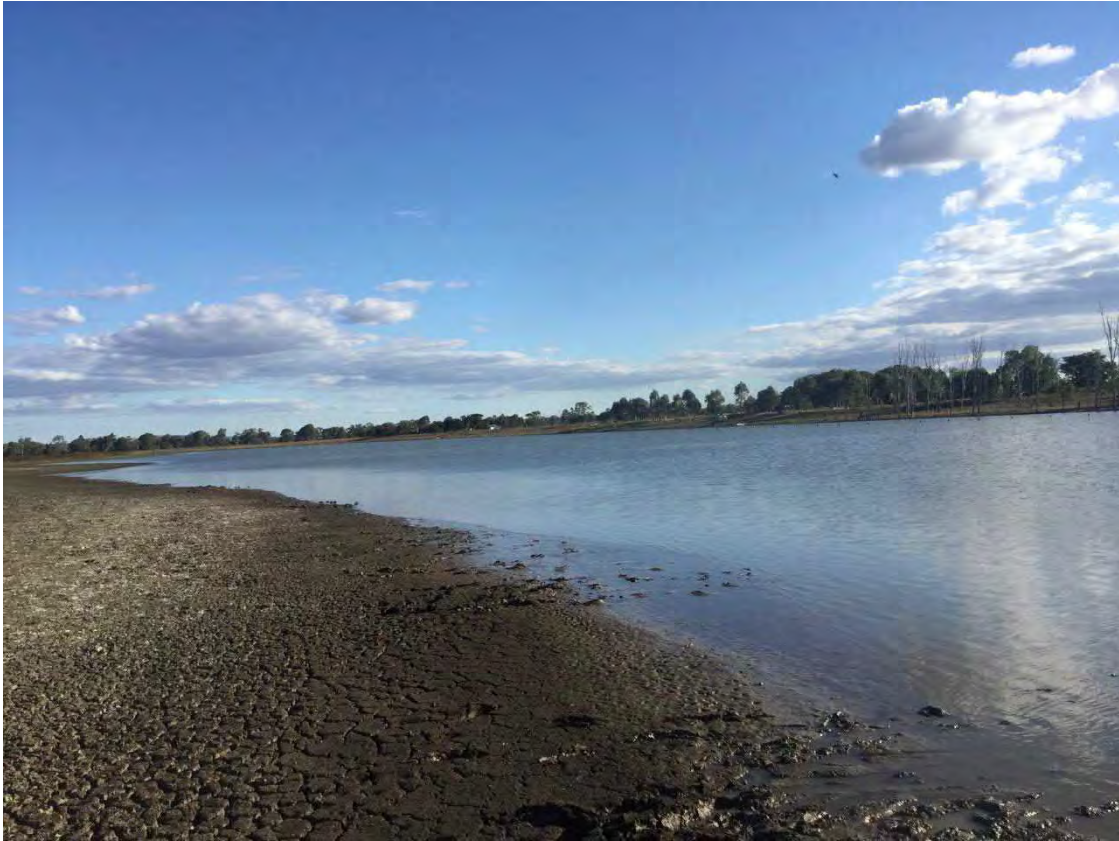
Due to the isolated nature of the lagoon, lack of accessibility to riffle zones and lack of sandy banks and complex feeding habitat, this species is unlikely to occur within Pink Lily Lagoon.

<b>Pink Lily Lagoon</b>
<b>Habitat Description</b>
<p>Pink Lily Lagoon is a permanent, isolated water body in the north of the Project Area, which lies within the floodplain of the Fitzroy River. The adjacent land uses within the Project Area are predominantly suburban housing and cattle grazing. At the time of survey, the lagoon was separated into two distinct pools (which are connected when sufficient water is present). Both pools were characterised by shallow sloping, black cracking clay banks with depths reaching up to 1.6 m in the centre of the large pool and only 0.4 m in the small pool.</p> <p>Riparian vegetation was limited to vegetated margins dominated by <i>Persicaria orientalis</i> and <i>Urochloa mutica</i> which retreat and encroach dependent on the water level. No submerged, floating or emergent macrophytes were recorded and no undercut banks were available. Snags and woody debris were limited to occasional inundated stags and fence posts on the western edge of the lagoon. Periphyton was observed in the water column however no filamentous algae was present. The substrate consisted of 100% silts and clay.</p>

<b>Habitat Suitability for White-throated Snapping Turtle</b>
<p><b>Unsuitable for foraging, nesting or dispersal</b></p> <p>The habitat in Pink Lily Lagoon represented poor quality habitat for this species. The white-throated snapping turtle is a habitat specialist which prefers clear, flowing, well-oxygenated water with complex subsurface structure. Pink Lily Lagoon provides a highly turbid, lacustrine environment with no undercut banks, log tangles or irregular rocky substrata recorded. The banks of the lagoon consisted of black cracking clacks, unsuitable for nesting. Although some food sources are likely present including insect larvae and cane toads, primary food sources for adult turtles (i.e. riparian vegetation, filamentous algae, freshwater sponges and instream macrophytes) were not recorded.</p> <p>The species has limited capacity to cross dry paddocks or streambeds and as such would only be present if stranded after a major flood event which connected the lagoon to the Fitzroy River.</p> <p>Due to the lagoon's isolation from suitable habitat, limited foraging resources and unsuitable nesting habitat, the white-throated snapping turtle is considered unlikely to occur.</p>

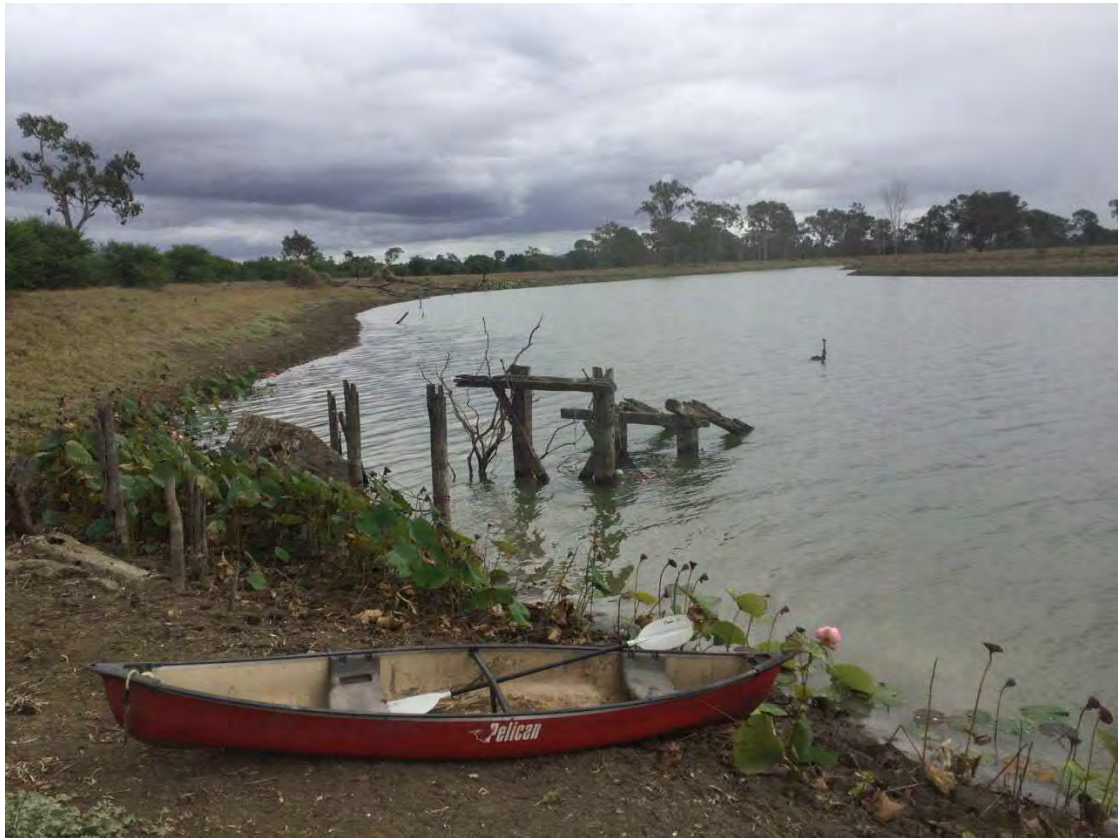
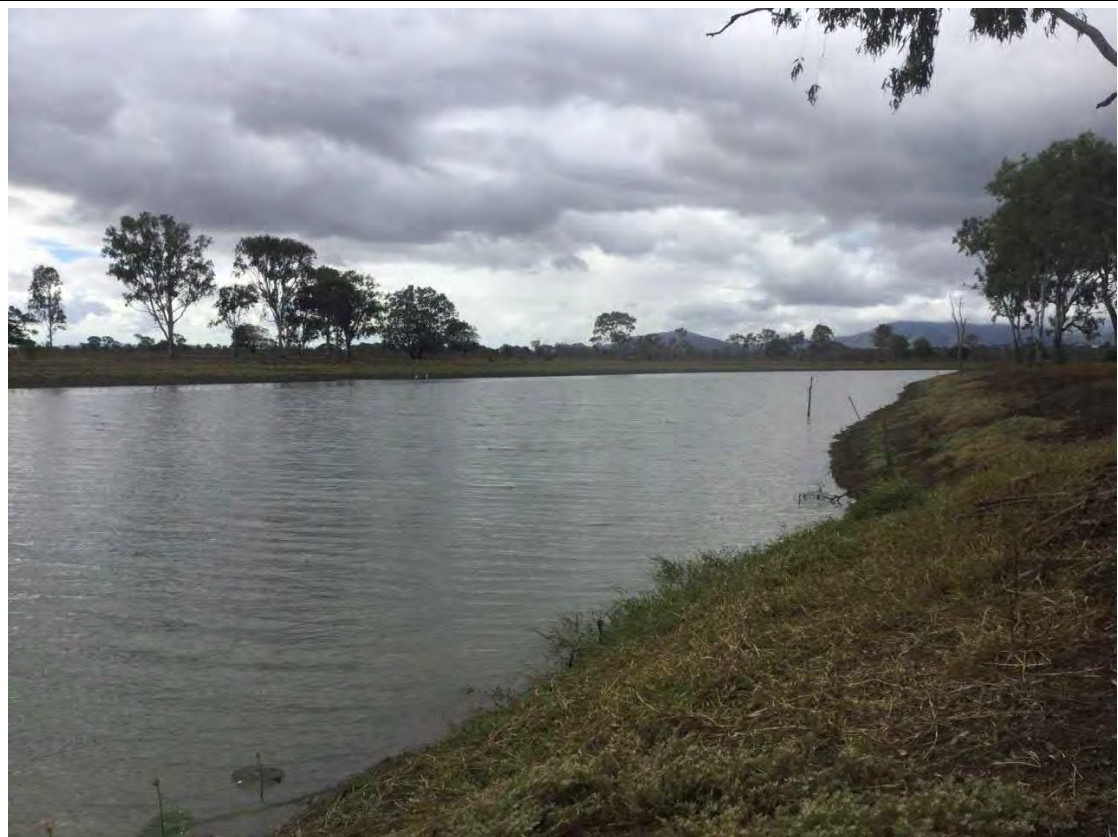
**Dunganweate Lagoon**

Habitat Suitability for Fitzroy River Turtle
<p><b>Unsuitable for nesting or dispersal. Marginal foraging habitat</b></p> <p>Marginal foraging habitat values were available for the Fitzroy River turtle however the lagoon was lacking flowing water, riffle zones, suitable sandy banks for nesting and had minimal complex sheltering habitat. The species requires river sandbanks to nest showing preference for relatively steep slopes and low density of ground vegetation and partial shade. Suitable nesting habitat was absent at this lagoon. Some substrate and complex surfaces suitable for scrape feeding were present with occasional rocks and woody debris associated with the disused timber ramp. Log tangles and sponges were absent. The lagoon is disconnected from potential habitat in the Fitzroy River and is not within overland migration distance.</p> <p>Due to the isolated nature of the lagoon, lack of accessibility to riffle zones and lack of nesting habitat and complex feeding habitat, this species is unlikely to occur within Dunganweate Lagoon.</p>

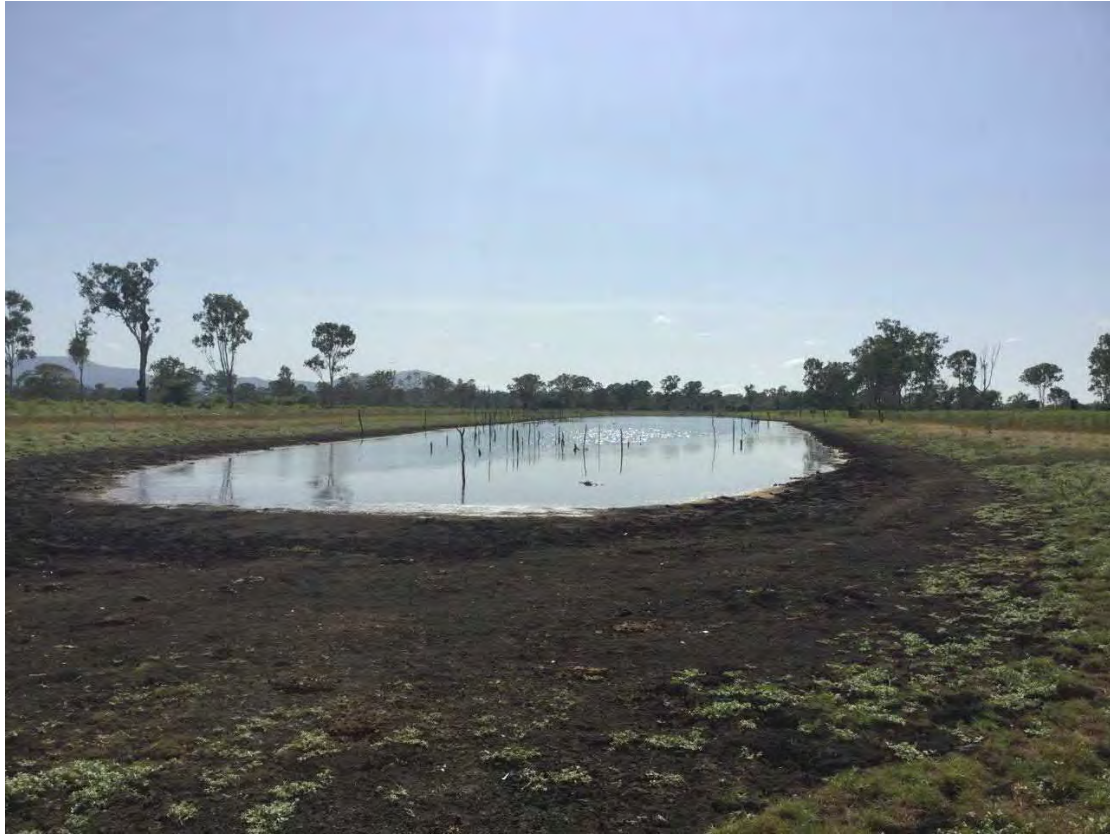
**Nelson Lagoon**

Nelson Lagoon
Habitat Description
<p>Nelson Lagoon is a small permanent waterbody located directly south of Dunganweate Lagoon. The wetland is within heavily disturbed grazing habitat where vegetation is dominated by open <i>Eucalyptus tereticornis</i> woodland. The lagoon is recharged by the Neerkol catchment system and is likely connected to Dunganweate Lagoon during flood events. The geology was characterised by black cracking clays in shallow sloping banks and substrate composed of 100% clay.</p> <p>At the time of survey the lagoon reached depths of up to 1 m. The water had high oxygen levels (100.3% saturation) and was moderately turbid (43.5 NTU). No aquatic macrophytes or complex structure was recorded. Some woody debris is present in the form of narrow, inundated stags.</p>
Habitat Suitability for White-throated Snapping Turtle
<p><b>Unsuitable for foraging, nesting or dispersal</b></p> <p>Habitat in Nelson Lagoon was not suitable to support a population of white-throated snapping turtle. Foraging resources were very limited with no defined riparian zone, tree roots or filamentous algae. Nesting habitat was absent with heavily pugged clays in the banks.</p> <p>The species has limited capacity to cross dry paddocks or streambeds and as such would only be present if stranded after a major flood event which connected the lagoon to the Fitzroy River.</p> <p>Due to the lagoon's isolation from suitable habitat, limited foraging resources and unsuitable nesting habitat, the white-throated snapping turtle is considered unlikely to occur.</p>

Habitat Suitability for Fitzroy River Turtle
<p><b>Unsuitable for foraging, nesting or dispersal</b></p> <p>Preferred habitat for the Fitzroy River turtle includes high water clarity, flowing water, riffle zones and complex sheltering habitat such as undercut banks, root mats, logs and rocks. None of these habitat features were available in Nelson Lagoon. The species requires river sandbanks to nest showing preference for relatively steep slopes and low density of ground vegetation and partial shade. Banks were composed of cracking black clays with no defined riparian zone, unsuitable for breeding for this species.</p> <p>Substrate and complex surfaces suitable for scrape feeding were limited to rare woody debris, with no rocks, log tangles or sponges recorded. The lagoon is disconnected from potential habitat in the Fitzroy River and is not within overland migration distance.</p> <p>Due to the isolated nature of the lagoon, lack of accessibility to riffle zones and lack of sandy banks and complex feeding habitat, this species is unlikely to occur within Nelson Lagoon.</p>

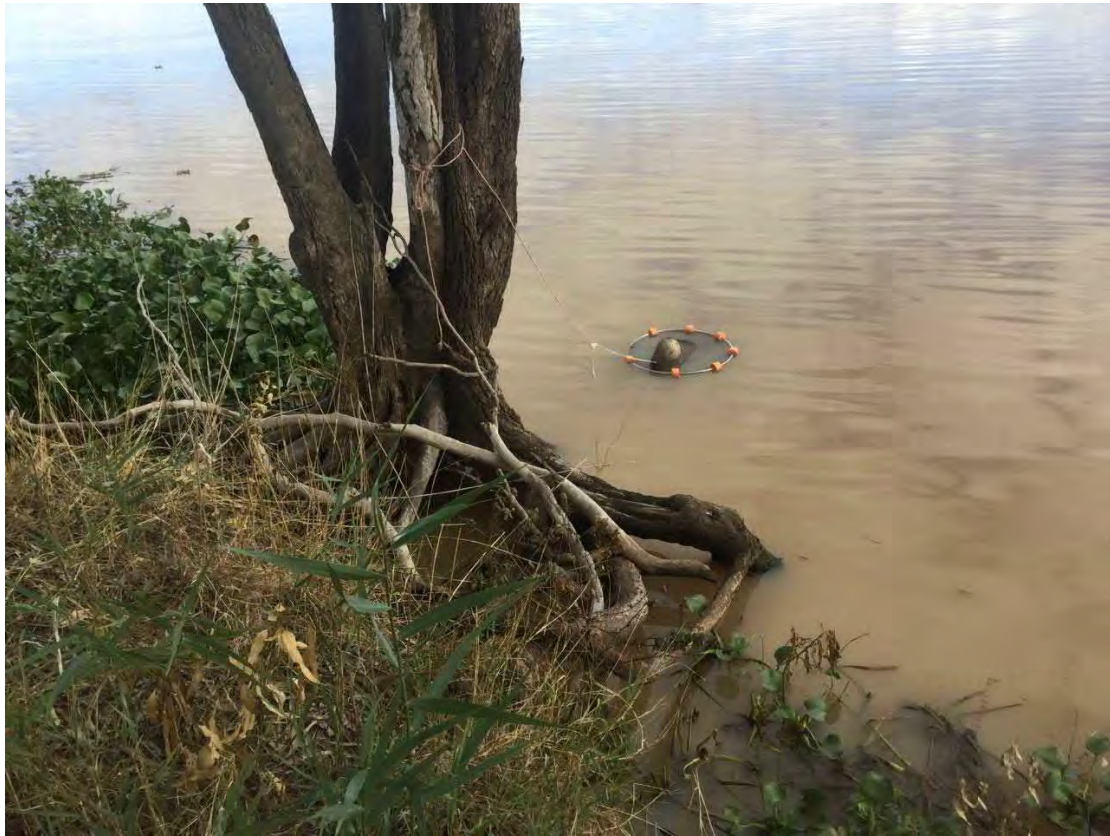
**Fitzroy River**

<p><b>Potential foraging and dispersal habitat</b></p> <p>Undercut banks, root tangles, woody debris, riparian vegetation and macrophytes are all preferred sheltering and foraging habitat features. The species also shows preference for reaches of high water clarity and riffle zones and nests are have all been located on river sandbanks 1 to 4 m above the water level. This habitat was not recorded however the species is known from the Fitzroy River and the Project Area may provide dispersal and foraging opportunities.</p>

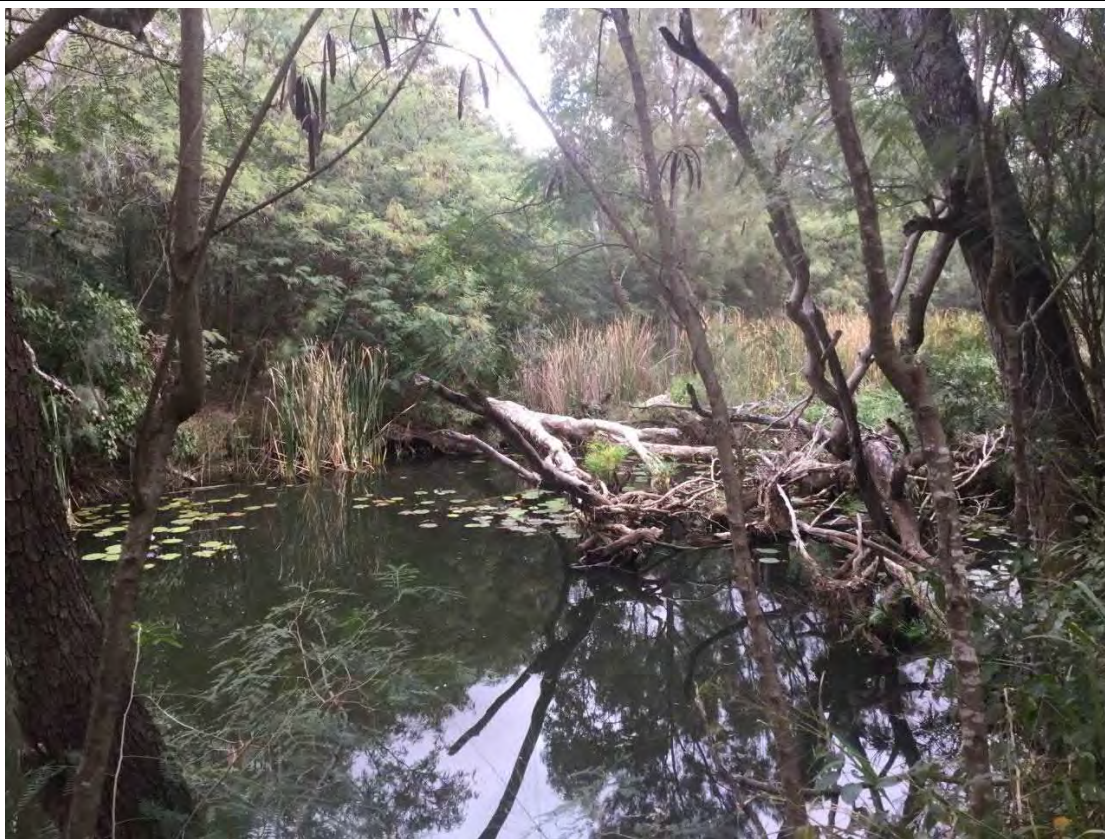
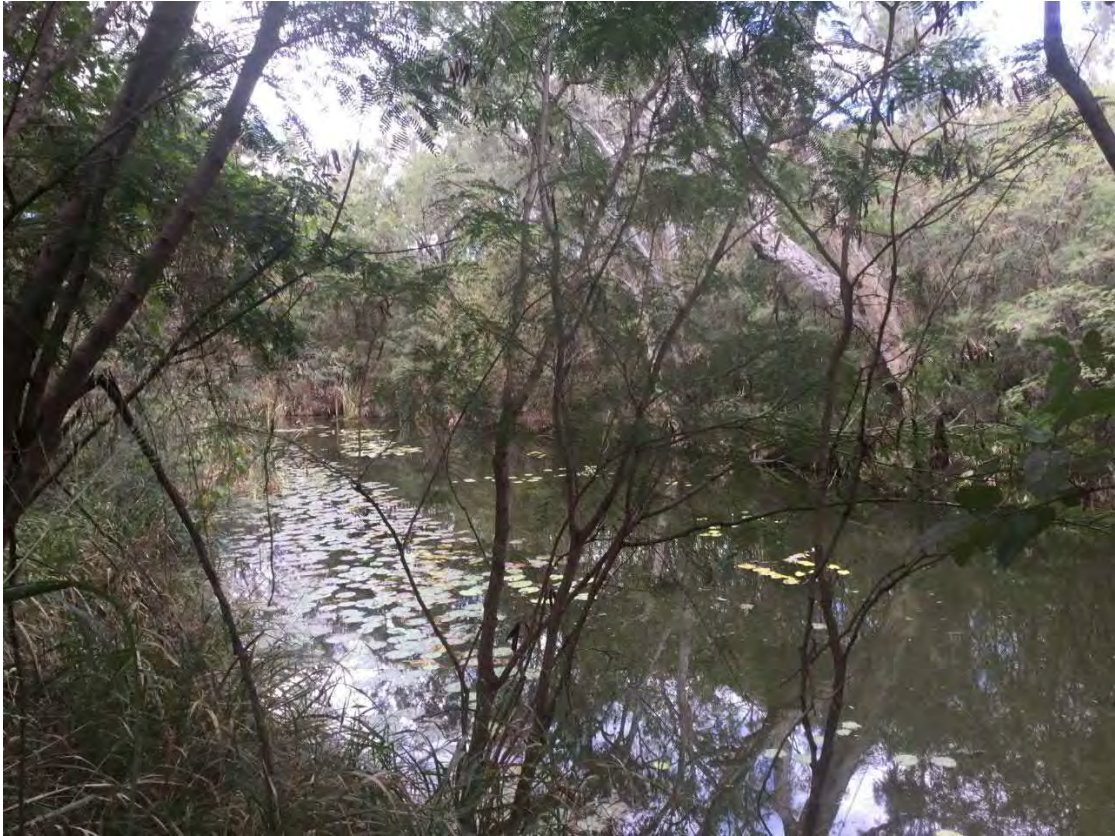
**Limestone Creek**

**Limestone Creek****Habitat Suitability for Fitzroy River Turtle****Marginal foraging habitat. Unsuitable for nesting or dispersal**

Marginal foraging habitat exists for Fitzroy River turtle in the large pool downstream from the Bruce Highway crossing. In this pool water depth reached up to approximately 2.5 m with large stands of floating and submerged macrophytes. Submerged woody debris is abundant in some areas providing potential feeding resources and riparian species associated with Fitzroy River turtle habitat are common in the riparian zone. Several sections of dry, cobbled streambed both upstream and downstream have the potential to form productive riffle zones in periods of high flow, which are favoured habitat for this species. Dissolved oxygen at this location was low and may be limiting for this species. No suitable nesting habitat was identified and upstream habitat is of generally low quality. As such habitat is considered to be marginal for foraging only.

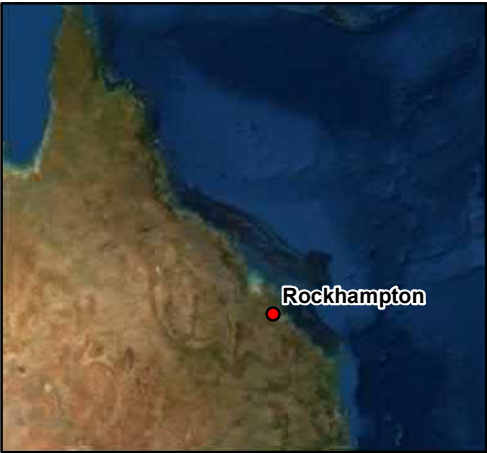
Figure  
4

Habitat descriptions and suitability for each threatened turtle species are detailed below. Potential habitat for these species is displayed in Figure 4.

Habitat Suitability for White-throated Snapping Turtle
<p><b>Marginal foraging habitat. Unsuitable for nesting or dispersal</b></p> <p>Some marginal habitat for white-throated snapping turtle existed in the clear pools downstream from the Bruce Highway crossing (Figure 4). Although no flowing water was recorded in Limestone Creek, the large pool within the Project Area reached depths of 2.5 m and provided complex structure in the form of undercut banks and submerged woody debris. Plant material from dense riparian vegetation and instream macrophytes was abundant and the substrate is favourable for epifaunal colonisation which may provide suitable feeding resources.</p> <p>Gordos, et al. (2007) found that white-throated snapping turtle was generally found in pools &gt;6 m, significantly deeper than any available pools. Further, the species shows preference for clear, flowing, highly oxygenated water. Although clear, no flow was recorded at this location and DO % saturation was significantly below trigger values for moderately disturbed Fitzroy River sub-basin fresh waters. Some cobbled areas upstream may develop into riffle zones during high flow, but no nesting habitat was available adjacent in the stream reach. As such this habitat was considered to be marginal for foraging only.</p>

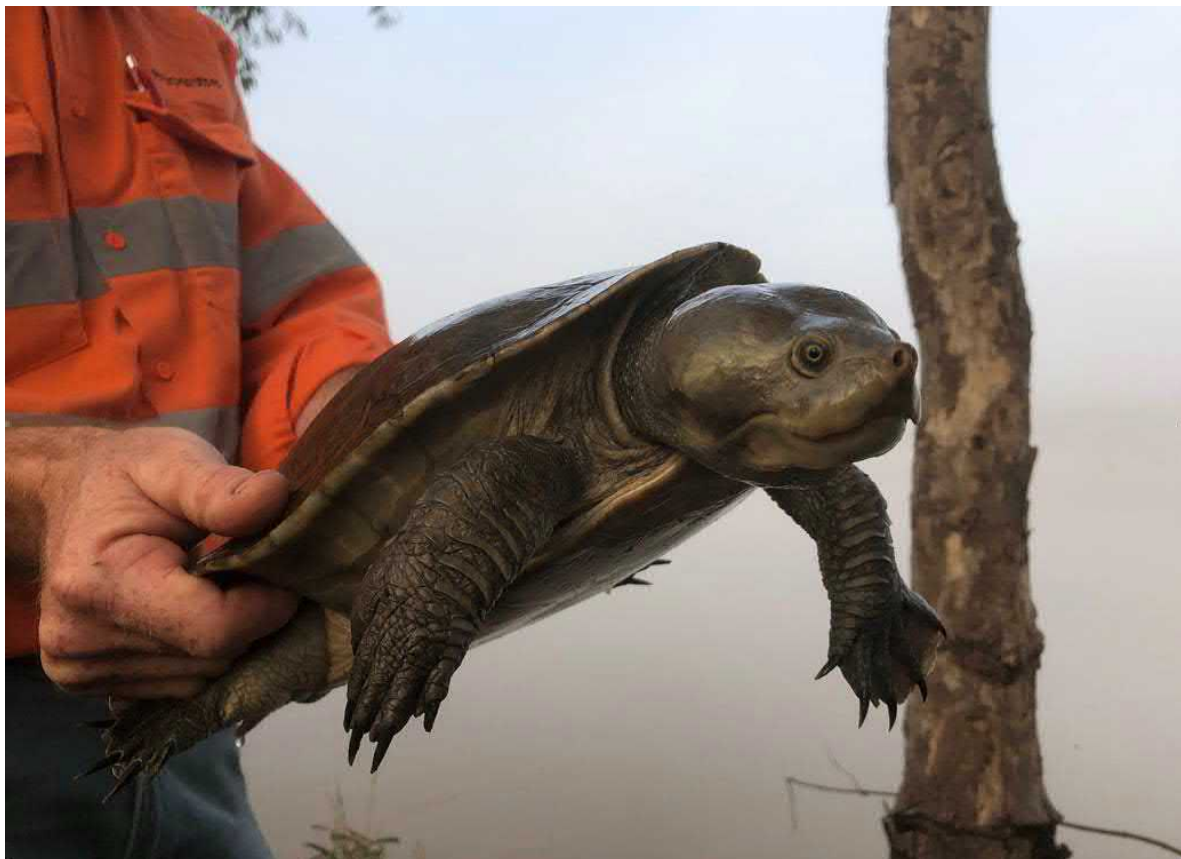
**Plate 1 Large female Krefft's river turtle captured in the Fitzroy River**

During the five day survey a total of 433 individual turtles were captured, positively identified and released without harm. These turtles were all of the same species, Krefft's river turtle (*Emydura macquarii krefftii*) (Plate 1). The species is listed as Least Concern under the NC Act and is not listed as threatened under the EPBC Act.

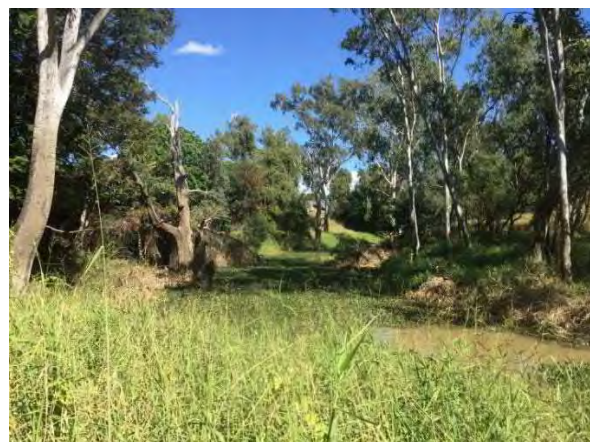
Plate 3 Lion Creek at Ridglands Road (FHA1)

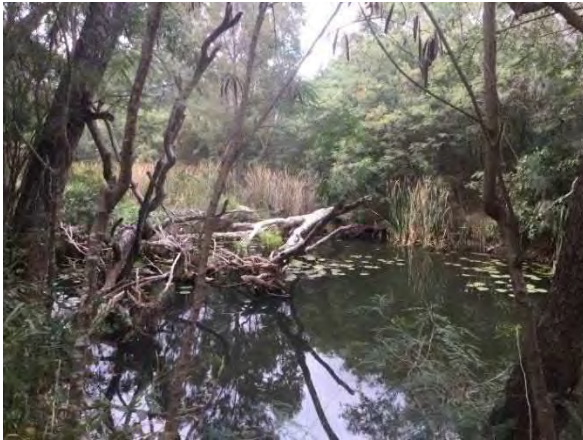
**Plate 4** Limestone Creek at FHA6

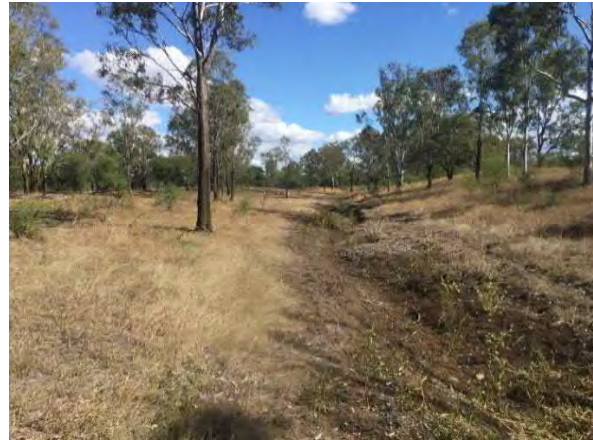
**Plate 5** Lion Creek near Nine Mile Road (FHA2)

At FHA2, Lion Creek is a highly ephemeral system in a landscape which has been severely degraded by historical clearing, thinning and grazing. The riparian habitat consisted of open woodland dominated by *Eucalyptus coolabah* with no defined shrub layer and a grassy understorey. The channel was dry at the time of survey providing no opportunity for fish passage. During summer surveys only a very small, shallow pool was present.

At the time of survey, two waterways were dry (Lion Creek at Nine Mile Road and Scrubby Creek) and fish passage was highly restricted at the tributary of the Fitzroy River. Lion Creek at Nine Mile Road and Scrubby Creek were both highly degraded systems which are unlikely to provide fish passage outside of very large flow events. The channel in both systems is homogenised and would not provide complex in stream habitat during such events. The tributary of the Fitzroy River was reduced to several very small, shallow pools with high electrical conductivity that were found to be disconnected from the main channel. Fish passage is likely to be afforded during flow events and some instream habitat features such as macrophytes, rocky substrate and high riparian vegetation cover were noted at the time of survey.

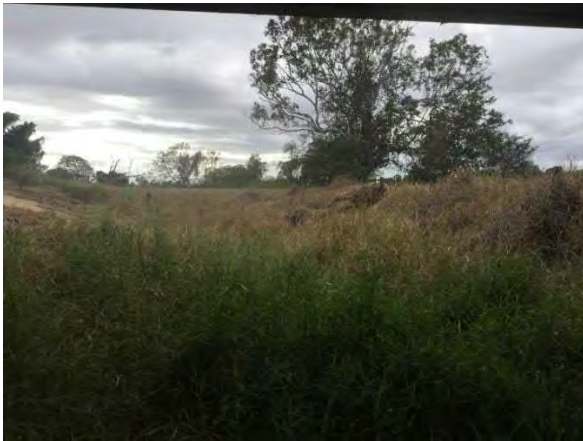
**Plate 6** Scrubby Creek at FHA3

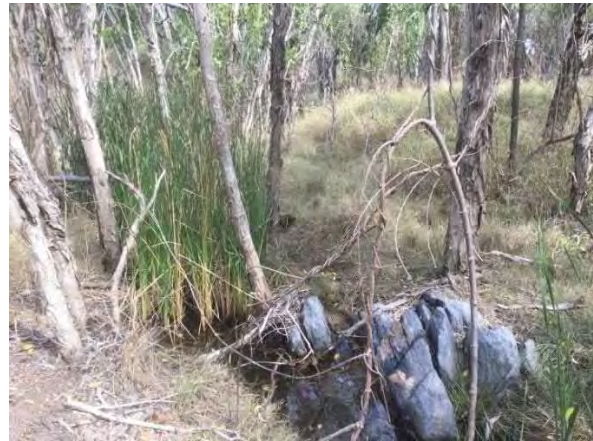
**Plate 7** Tributary of the Fitzroy River at FHA5
