# **Attachment 2: Bruce Highway (Cooroy to Curra) Upgrade Section C (Traveston Road to Keefton Road) Project Job No. 232/10A/2**

**Impact Assessment and Erosion and Sediment Control Plan – Mary River Turtle, Mary River Cod and White-throated Snapping Turtle**

August 2015

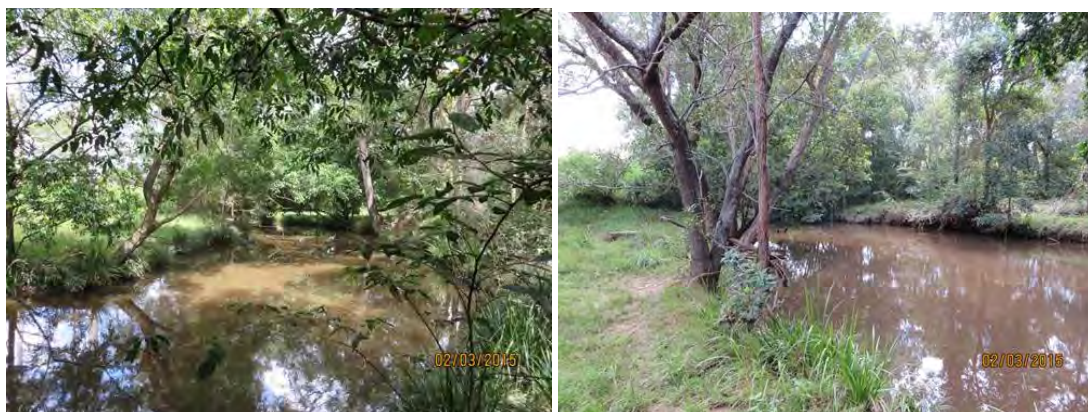
**Plate 1: Downstream (left) and upstream (right) of the crossing point on Traveston Creek**

crossing structure at the time of investigation was 2.2m with a bankfull width of 5.5m (Jacobs SKM, 2014).

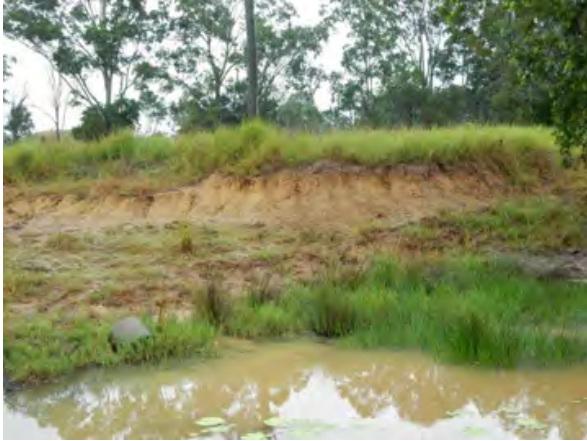
**Plate 2: Erosion occurring upstream of the Project area on Traveston Creek**

The longitudinal aquatic habitat assessment (Jacobs SKM, 2014) found that Traveston Creek had an average rating of 46% which represents a waterway in 'fair to good' condition (100% representing an undisturbed waterway). Bank stability scored in the 'good' range and bank vegetative cover and streamside cover were in the 'fair to good' range. A high degree of siltation was present which resulted in a low score for this assessment criterion.

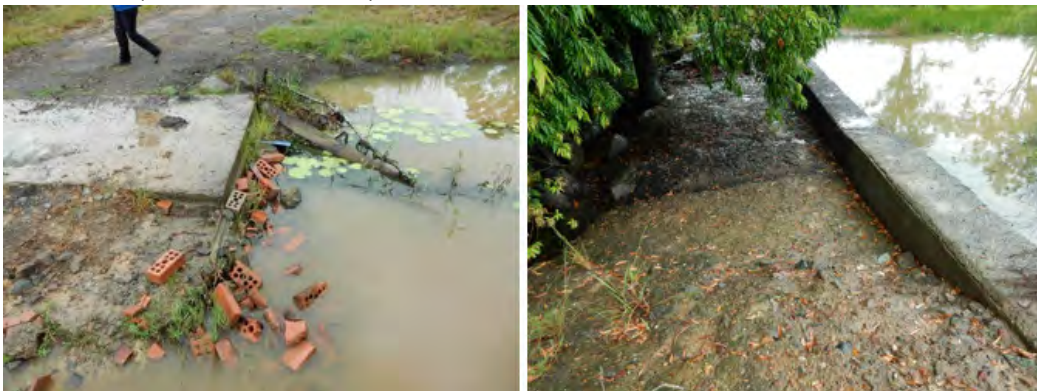
**Plate 3: Collapsed road culvert downstream (left) and concrete weir located downstream (right) of the crossing point on Traveston Creek**

- Road culvert (low flows) on Old Traveston Road (upstream)
- Road culvert on unnamed rural road (downstream) (refer Plate 3)
- Road culvert on the existing Bruce Highway (downstream)
- Concrete weir (approximately 3m high) (downstream) (refer Plate 3)

These barriers inhibit fish migration along this section of Traveston Creek, particularly during periods of low flow (Jacobs SKM, 2014).

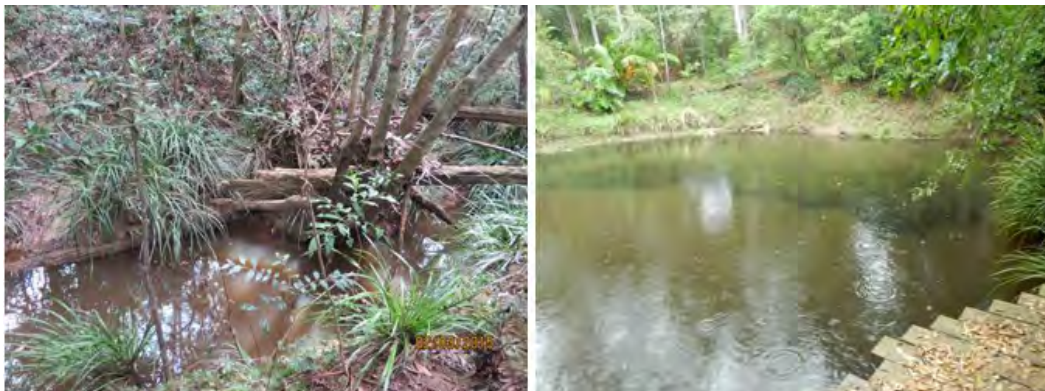
**Plate 4: Upstream (left) and artificial deep pool habitat and decking downstream (right) of the crossing point on Kybong Creek**

Upstream of the site, Kybong Creek and its tributary pass under Tandur Road, approximately 180m and 500m respectively. Downstream, Kybong Creek passes under the existing Bruce Highway approximately 2.4km from the Project area. These culverts present a barrier to fish passage, particularly during periods of low flow. Fish passage is also limited by upstream and downstream dams, located upstream south of Tandur Road, and approximately 100m downstream.

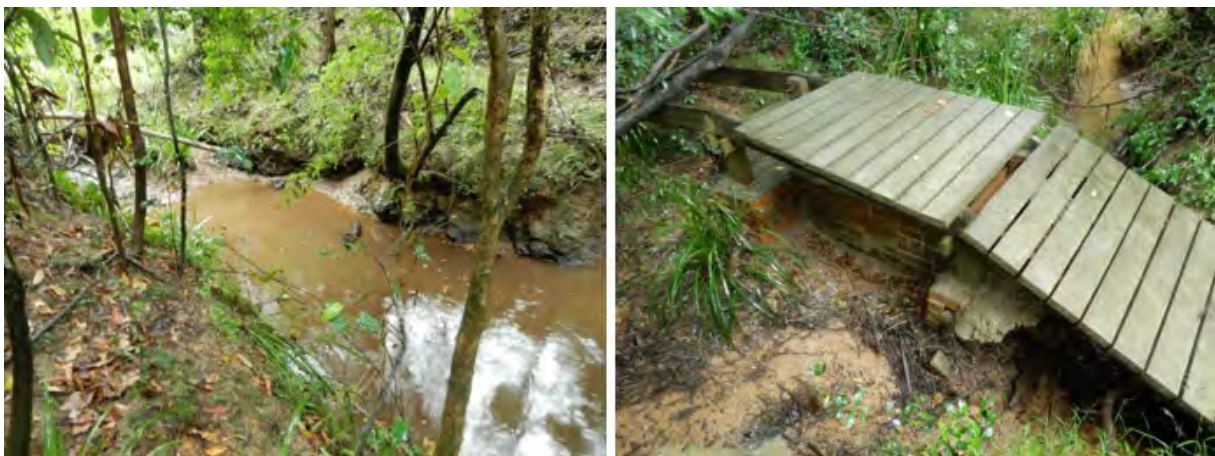
**Plate 5: Fragmented pool habitat (<50cm deep) (left), instream barrier to fish movement (right)**

- Farm dam (upstream)
- Tandur Road culverts (180m and 500m upstream)
- Farm dam (downstream)
- Man-made instream barrier (100m downstream, refer Plate 5)
- Road culvert on the existing Bruce Highway (2.4km downstream)

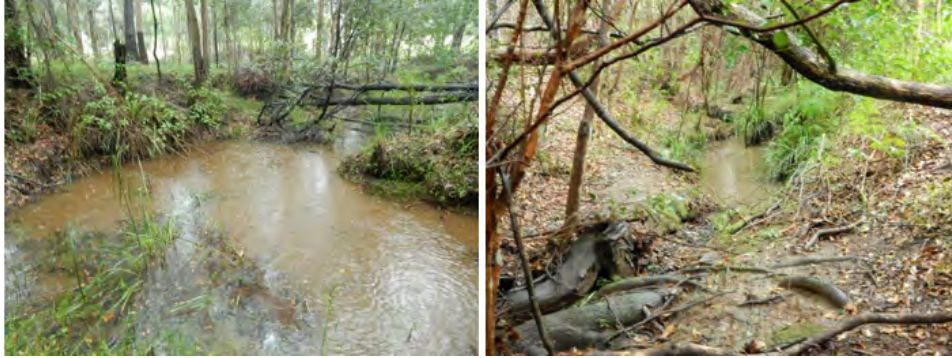
**Plate 6: Woody debris at Cobbs Gully (left) and evidence of disconnected channels (right)**

Cobbs Gully was observed to consist of a series of disconnected sections of channelled pool habitat, each approximately 40m in length and shallow in nature (less than 0.7m deep) (Jacobs SKM, 2014). The disconnected sections of channels, the presence of several downstream barriers and shallow depth of this waterway were considered likely to limit the habitat suitability of this waterway to smaller fish species tolerant of degraded habitats (Jacobs SKM, 2014). Waterway characteristics are shown in Plate 6 and Plate 7.

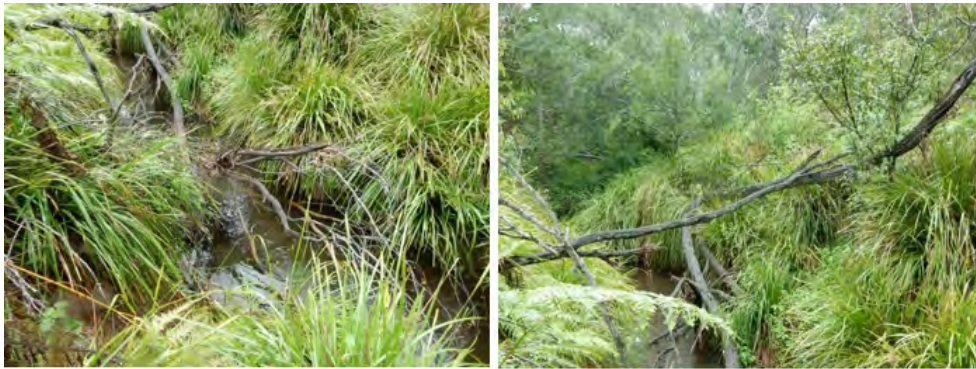
**Plate 8: Riparian vegetation at Jackass Creek (left and right)**

shown in Figure 2 (Jacobs SKM, 2014). Plate 8 provides a representation of the riparian vegetation present at Jackass Creek.

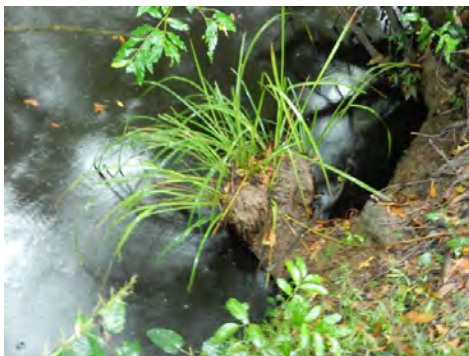
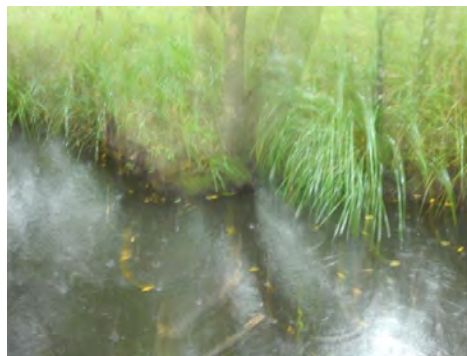
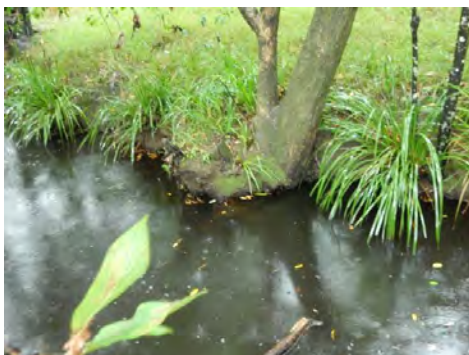
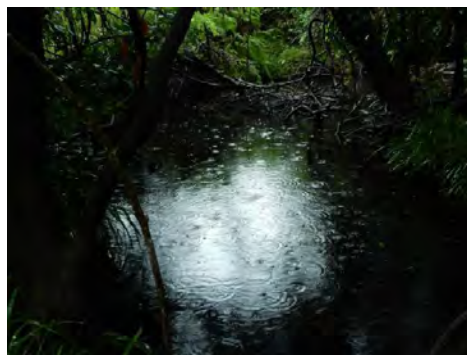
Name of Waterway: Traveston Creek 1		Site ID: Traveston 1	
Stream Order: 3	Lat: -26.328	Long: 152.73255	
DAF Classification: Red			
Location in relation to design:		Centreline of project area	
Channel characteristics		Site Description	
Channel type	Creek	Lomandra, Lantana, forest red gum, native & exotic grasses, weeping lilly pilly	
Channel habitat	Pool/Glide		
Average wetted width	5m		
Average depth	1.5m		
Bank full width	6m		
Bank height	2.5m		
Length of reach	40m		
Flow category	Perennial		
Instream habitat			Platypus and MNES habitat potential
Dominant substrate	Silt	Platypus – deep pool, habitat 1-5m, undercut banks, soft sediment banks, large woody debris Mary River turtle– No sand banks, no riffles, deep pool, with significant barriers downstream Mary River cod– deep pool, large woody debris, roots, however significant barriers downstream	
Substrate complexity	Simple		
Instream cover	12%		
Macrophyte coverage	0%

LWD	15%		
Habitat complexity	Run %		Pool % 50
	Riffle %		Glide % 50
Surrounding environment			
Regional ecosystem status	Not mapped as RE		
Canopy cover	70%		
Upstream barriers	Farm dam, culvert under old Traveston Road		
Downstream barriers	Concrete weir, collapsed culvert 300m downstream, culvert under Bruce Highway 500m downstream		
Adjacent land use	Grazing		
Stream condition (1-10)	8		
Riparian condition (1-10)	6

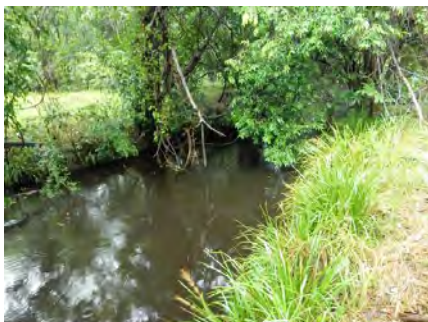
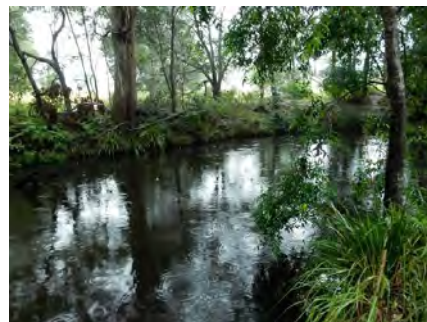
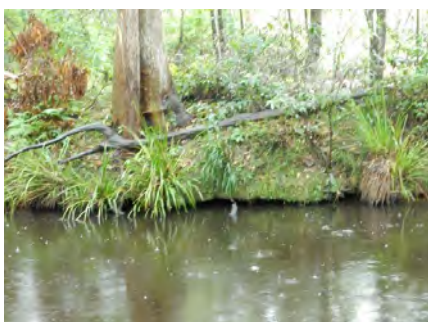
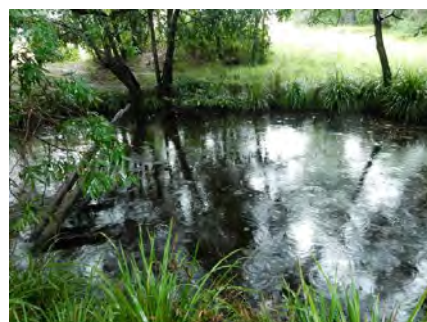
Name of Waterway: Traveston Creek 2		Site ID: Traveston 2	
Stream Order: 3	Lat: -26.32778	Long: 152.73225	
DAF Classification: Red			
Location in relation to design:	100m downstream		
Channel characteristics		Site Description	
Channel type	Creek	Deep pool. Lots of under cut bank Some large woody debris. Tree Roots	
Channel habitat	Pool		
Average wetted width	12m		
Average depth	1.5m		
Bank full width	14m		
Bank height	3.5m		
Length of reach	40m		
Flow category	Perennial		
Instream habitat		Platypus and MNES habitat potential	
Dominant substrate	Silt	Platypus – deep pool Mary River turtle– No sand banks, no riffles, deep pool, with significant barriers downstream Mary River cod– deep pool, large woody debris, roots, however significant barriers downstream	
Substrate complexity	pool		
Instream cover	5%		
Macrophyte coverage	0%		
LWD	5%		
Habitat complexity	Run %		Pool % 100
	Riffle %		Glide % 0
Surrounding environment

Regional ecosystem status	Not mapped as RE		
Canopy cover	50%		
Upstream barriers	Farm dam, culvert under old Traveston Road		
Downstream barriers	Concrete weir, collapsed culvert 200m downstream, culvert under Bruce Highway 400m downstream		
Adjacent land use	Grazing		
Stream condition (1-10)	8		
Riparian condition (1-10)	4

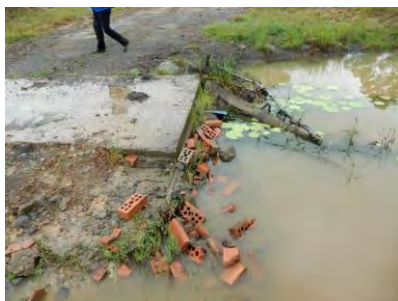
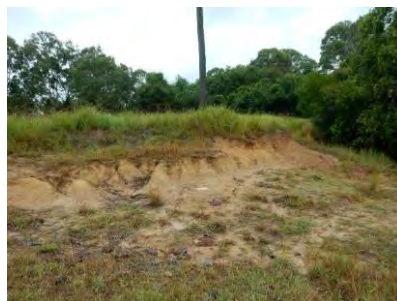
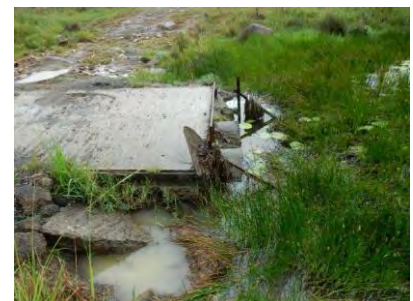
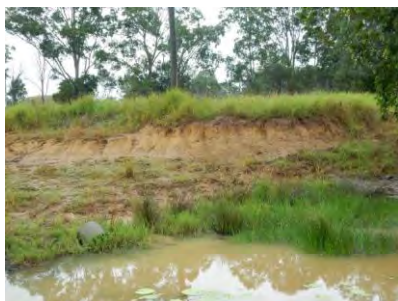
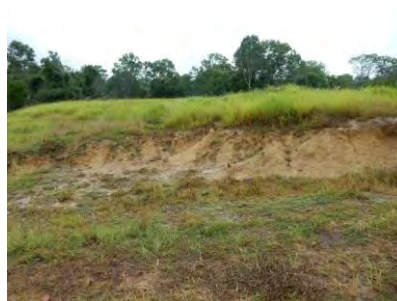
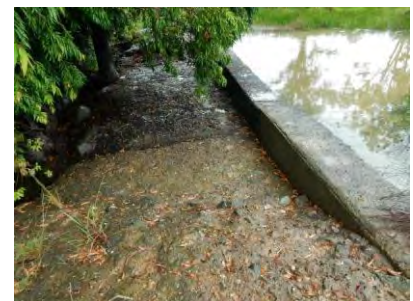
Name of Waterway: Traveston Creek 3		Site ID: Traveston 3
Stream Order: 3	Lat: -26.32775	Long: 152.73256
DAF Classification: Red		
Location in relation to design:	300m downstream	
Channel characteristics		Site Description
Channel type	River/Creek/Drainage	Weir and culvert. Sedimentation from bank Erosion. Culvert, weir, erosion are stresses from D/S of site.
Channel habitat	Run/Riffle/Pool/Glide	
Flow category	Perennial/Ephemeral	
Instream habitat		Platypus and MNES habitat potential
Dominant substrate	Mix of Bedrock/ Cobble/ Gravel/ Sand/ Silt	Barrier to movement and upstream migration.
Substrate complexity	Mix of Complex/ Moderate/Simple	
Surrounding environment		
Regional ecosystem status	NA	
Canopy cover	50%	
Upstream barriers	Barrier at survey site	
Downstream barriers	Concrete weir, collapsed culvert, culvert under Bruce Highway downstream	
Adjacent land use	Grazing	
Stream condition (1-10)	8	
Riparian condition (1-10)	4

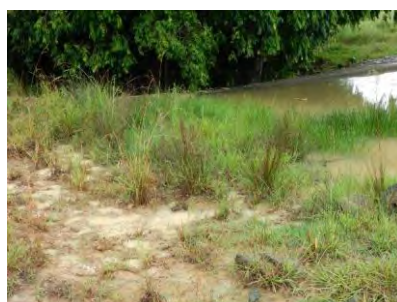
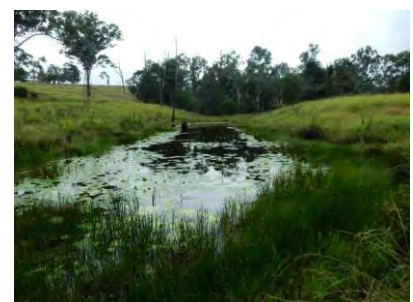
Name of Waterway: Kybong Creek 1		Site ID: Kybong 1
Stream Order: 3	Lat: 26.30288	Long: 152.72807
DAF Classification: Red		
Location in relation to design:	Within Project area	
Channel characteristics		Site Description
Channel type	Creek	Undercut banks LWD Turbid water Well shaded Lomandra, fish tail fern, pink bloodwood, foam bark, iron bark, swamp box, lantana, forest red gum
Channel habitat	Pool	
Average wetted width	3m	
Average depth	<0.5m	
Bank full width	6m	
Bank height	2m	
Length of reach	35m	
Flow category	Perennial	
Instream habitat		Platypus and MNES habitat potential
Dominant substrate	Bedrock/Silt	
Substrate complexity	Moderate/Simple	
Instream cover	15%	
Macrophyte coverage	0%	
LWD	10%	
Habitat complexity	Run %	Pool %50
	Riffle %	Glide %50
Surrounding environment		
Regional ecosystem status	<b>12.3.11</b>	
Canopy cover	70%	
Upstream barriers	Culvert under Tandur Road	
Downstream barriers	Downstream dam

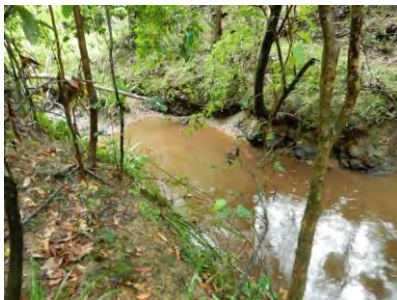
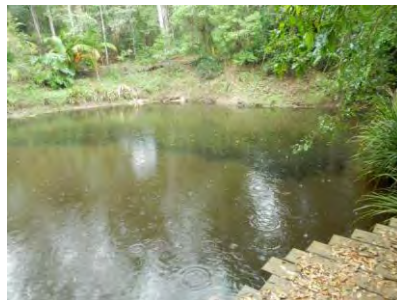
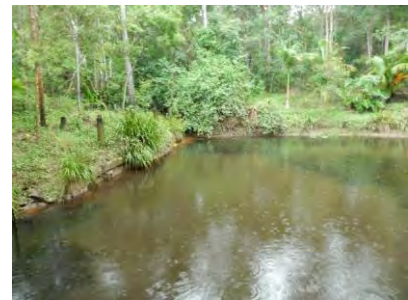
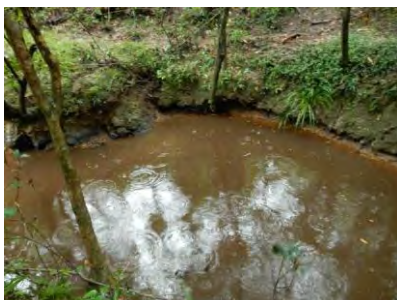
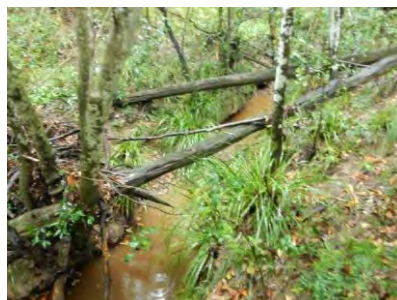
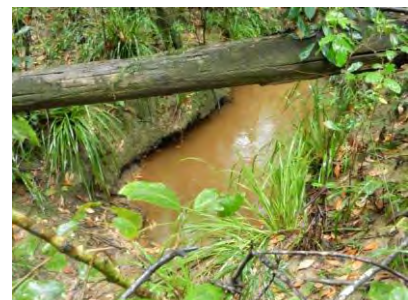
Adjacent land use	Grazing, residential, farming	
Stream condition (1-10)	8	
Riparian condition (1-10)	8

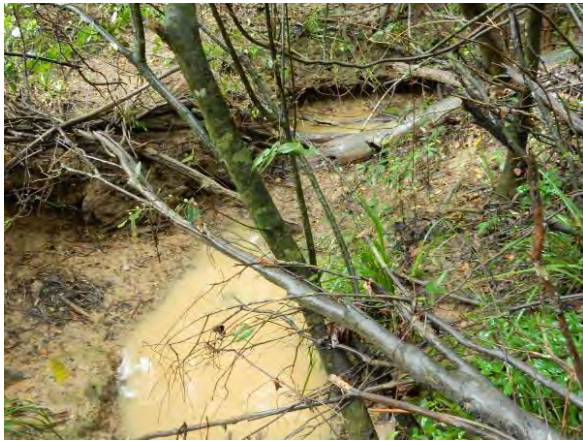
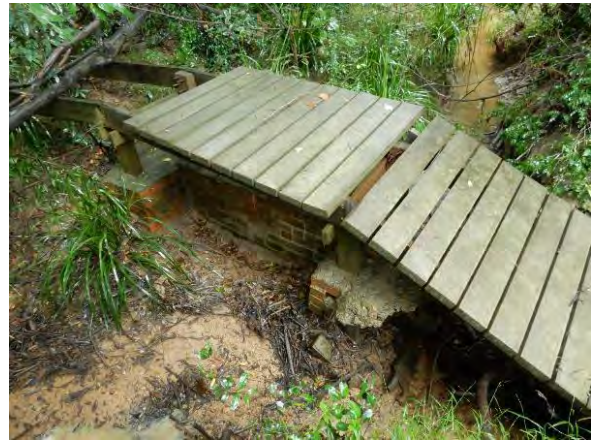
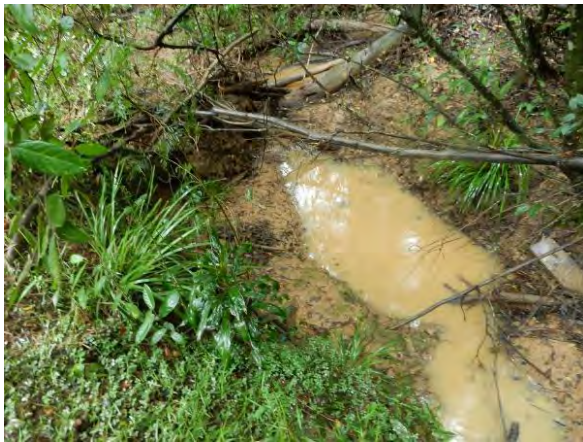
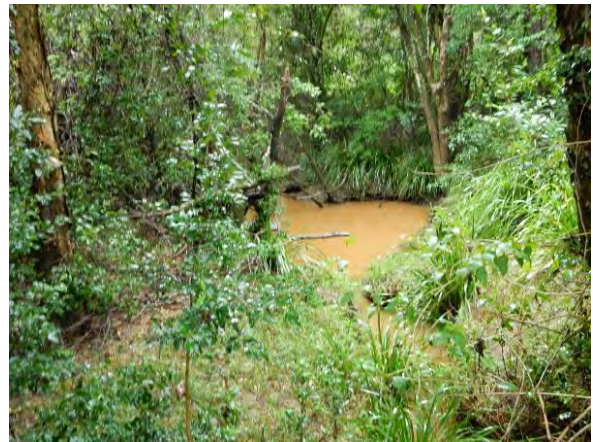
Name of Waterway: Kybong Creek 2		Site ID: Kybong 2
Stream Order: 3	Lat: -26.30284	Long: 152.72743
DAF Classification: Red		
Location in relation to design:		Downstream of Project area
Channel characteristics		Site Description
Channel type	River/Creek/Drainage	Very narrow 2m Incised channel Fragmented pool habitat Lots of large woody debris Bridge/brick barrier in creek
Channel habitat	Run/Riffle/Pool/Glide	
Flow category	Perennial/Ephemeral	
Instream habitat		Platypus and MNES habitat potential
Dominant substrate	Cobble/Sand	Barrier to movement and upstream migration.
Substrate complexity	Complex	
Surrounding environment		
Regional ecosystem status	12.3.11	
Upstream barriers	Culvert under Tandur Road	
Downstream barriers	Downstream dam	
Adjacent land use	Grazing, residential, farming

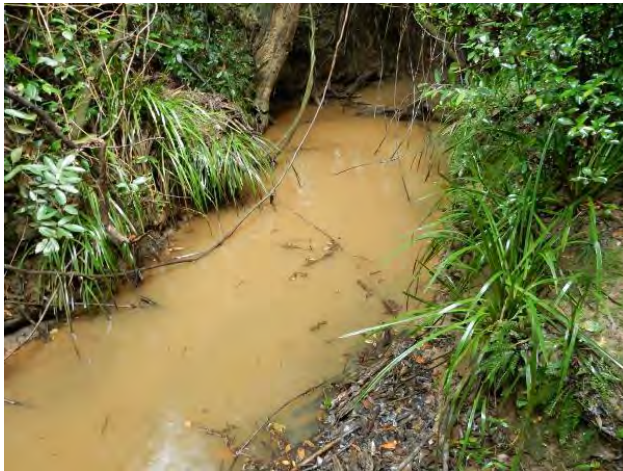
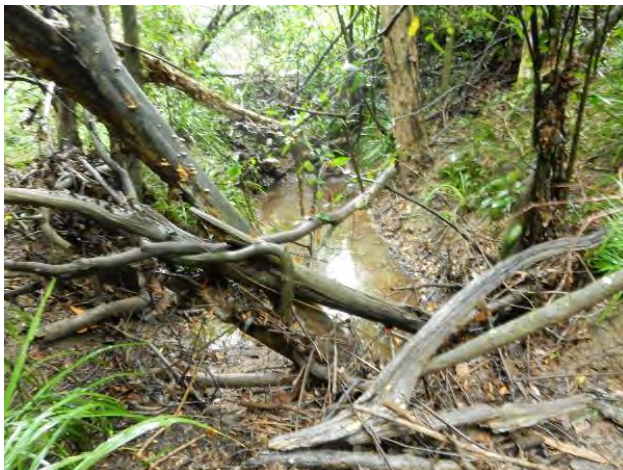
Name of Waterway: Kybong Creek 3		Site ID: Kybong 3
Stream Order: 3	Lat: -26.30288	Long: 152.72807
DAF Classification: Red		
Location in relation to design:	100m downstream	
Channel characteristics		Site Description
Channel type	River/Creek/Drainage	High sediment load in water due to clayey soils Lots of large woody debris Well-developed riparian edge Root wads Fragmented pool habitat Platypus and MNES habitat potential Marginal quality
Channel habitat	Run/Riffle/Pool/Glide	
Average wetted width	2m	
Bank height	3m	
Flow category	Perennial/Ephemeral	
Instream habitat		
Dominant substrate	Bedrock/ Cobble/ Gravel/ Sand/ Silt	
Substrate complexity	Complex	
Surrounding environment		
Regional ecosystem status	12.3.11	
Upstream barriers	Culvert under Tandur Road	
Downstream barriers	Downstream dam	
Adjacent land use	Grazing, residential, farming

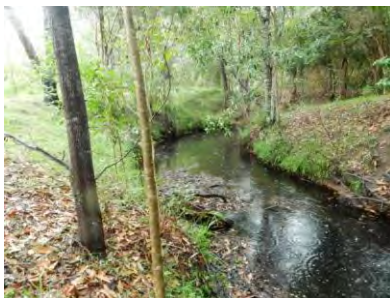
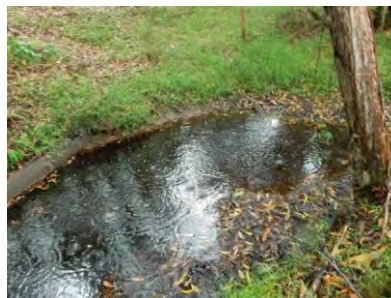
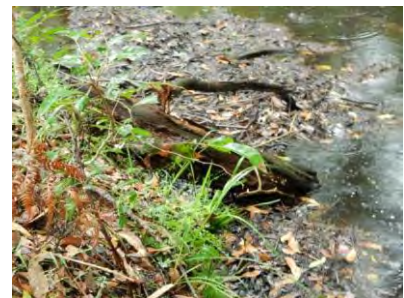
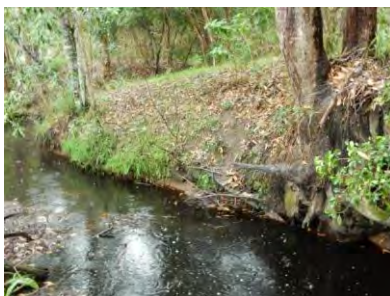
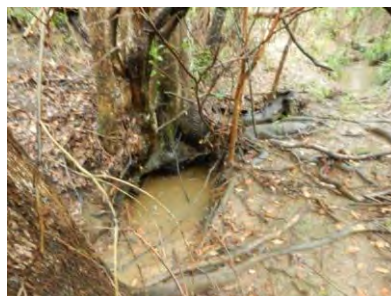
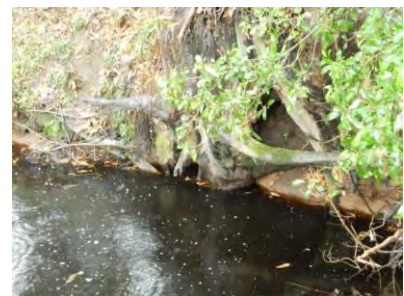
Name of Waterway: Cobbs Gully 1		Site ID: Cobbs 1
Stream Order: 2	Lat: -26.28063	Long: 152.71985
DAF Classification: Amber		
Location in relation to design:		Within Project area
Channel characteristics		Site Description
Channel type	Creek	Swamp box Tree roots Shallow pools Stagnant water
Channel habitat	Pool/Glide	
Average wetted width	4m	
Average depth	0.5m	
Bank full width	8m	
Bank height	3m	
Length of reach	50m	
Flow category	Perennial	
Instream habitat		Platypus and MNES habitat potential
Dominant substrate	Silt	Platypus – Soft banks, tree roots, shallow pools, stagnant water MRF – no sand bank, no riffles, no deep pod, poorly oxygenated water MRT – Shallow pools, some large woody debris, stagnant water, lots of litter in water Marginal habitat for all 3 species
Substrate complexity	Simple	
Instream cover	10%	
Macrophyte coverage	0%	
LWD	10%	
Habitat complexity	Run %	
	Riffle %	Glide % 50
Surrounding environment

Regional ecosystem status	Not mapped as RE	
Canopy cover	60%	
Upstream barriers	Dam	
Downstream barriers	Dam	
Adjacent land use	Disturbed Grazing Land	
Stream condition (1-10)	5	
Riparian condition (1-10)	7

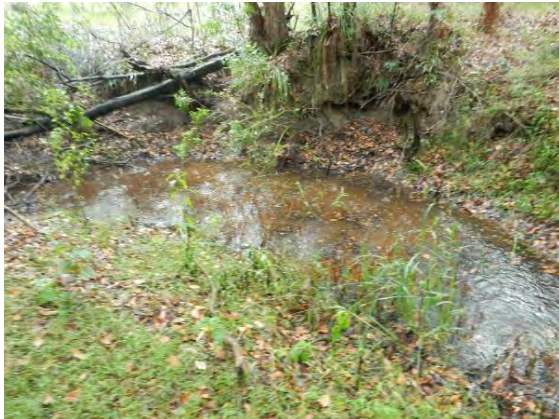
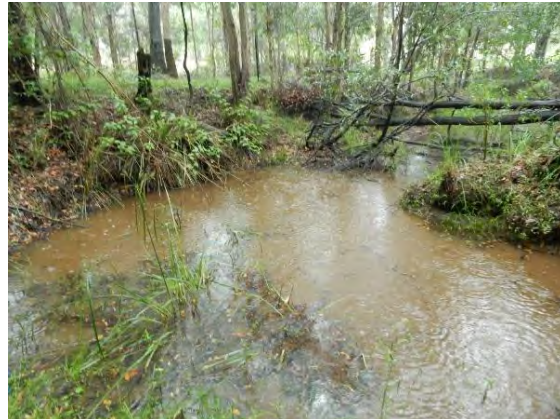
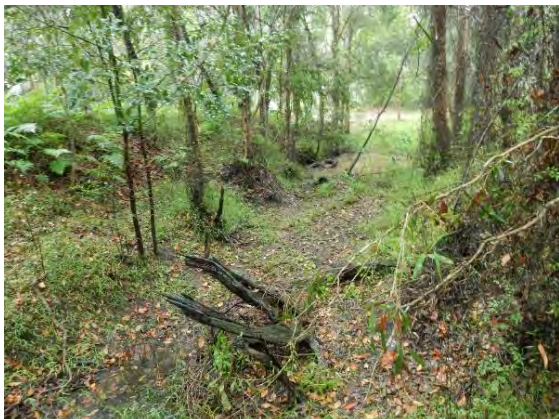
Name of Waterway: Cobbs Gully 3		Site ID: Cobbs 3
Stream Order: 2	Lat: -26.28063	Long: 152.71985
DAF Classification: Amber		
Location in relation to design:	100m downstream of Project area	
Channel characteristics		Site Description
Channel type	Creek	Sediment in water Large woody debris Series of fragmented pools Heavy sediment load in water Water stagnant Impacted by cattle Undercut banks Well shaded Fragmented pools
Channel habitat	Pool/Glide	
Average depth	0.5m	
Flow category	Perennial/Ephemeral	
Instream habitat		Platypus and MNES habitat potential
Dominant substrate	Bedrock/ Cobble/ Gravel/ Sand/ Silt	Marginal habitat for all 3 species
Substrate complexity	Complex/ Moderate/ Simple	
Macrophyte coverage	<5%	
Surrounding environment		
Regional ecosystem status	Not mapped as RE	
Canopy cover	60%	
Upstream barriers	Dam	
Downstream barriers	Dam	
Adjacent land use	Disturbed Grazing Land

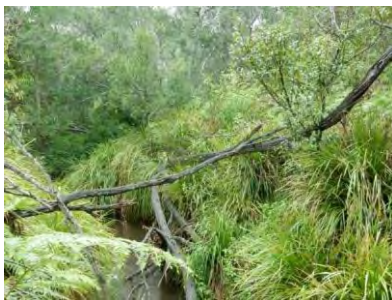
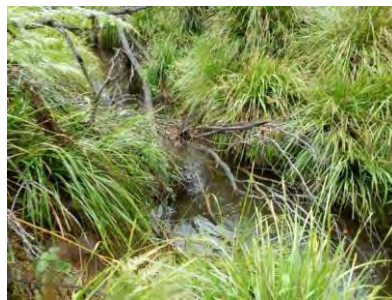
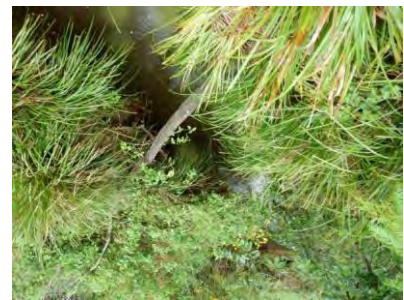
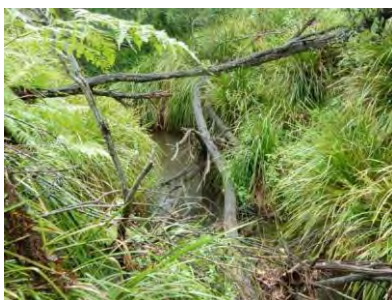
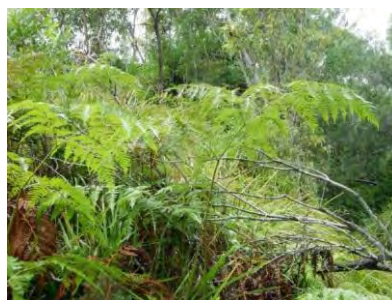
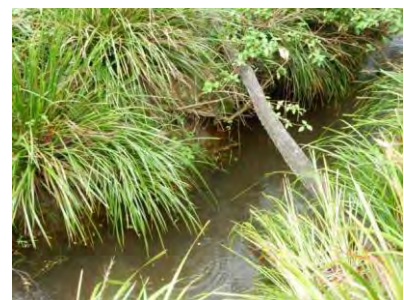
Name of Waterway: Jackass Creek 1		Site ID: Jackass 1	
Stream Order: 2	Lat: -26.270754	Long: 152.715406	
DAF Classification: Amber			
Location in relation to design:		Within Project area	
Channel characteristics		Site Description	
Channel type	Creek	<b>Swamp box</b> Lantana Lomandra sp Bracken fern Blue Billy goat weed acacia	
Channel habitat	Pool/Glide		
Average wetted width	2m		
Average depth	0.5m		
Bank full width	6m		
Bank height	2.5m		
Flow category	Perennial		
Instream habitat		Platypus and MNES habitat potential	
Dominant substrate	Silt	Marginal habitat for all 3 species	
Substrate complexity	Simple		
Instream cover	10%		
Macrophyte coverage	0%		
LWD	10%		
Habitat complexity	Run %		Pool % 50
	Riffle %		Glide % 50
Surrounding environment			
Regional ecosystem status	Not mapped as RE- acacia regrowth		
Canopy cover	25%		
Upstream barriers	Culvert under private access		
Downstream barriers	Dam, culvert under Woondum Road, culvert under Bruce Highway

Adjacent land use	Landscape supply – disturbed riparian
