## Main Roads Investigation into the Fatal Crash on South-bound Ramp from Bruce Highway to Sunshine Motorway at Tanawha

**Date** 6 July 2007

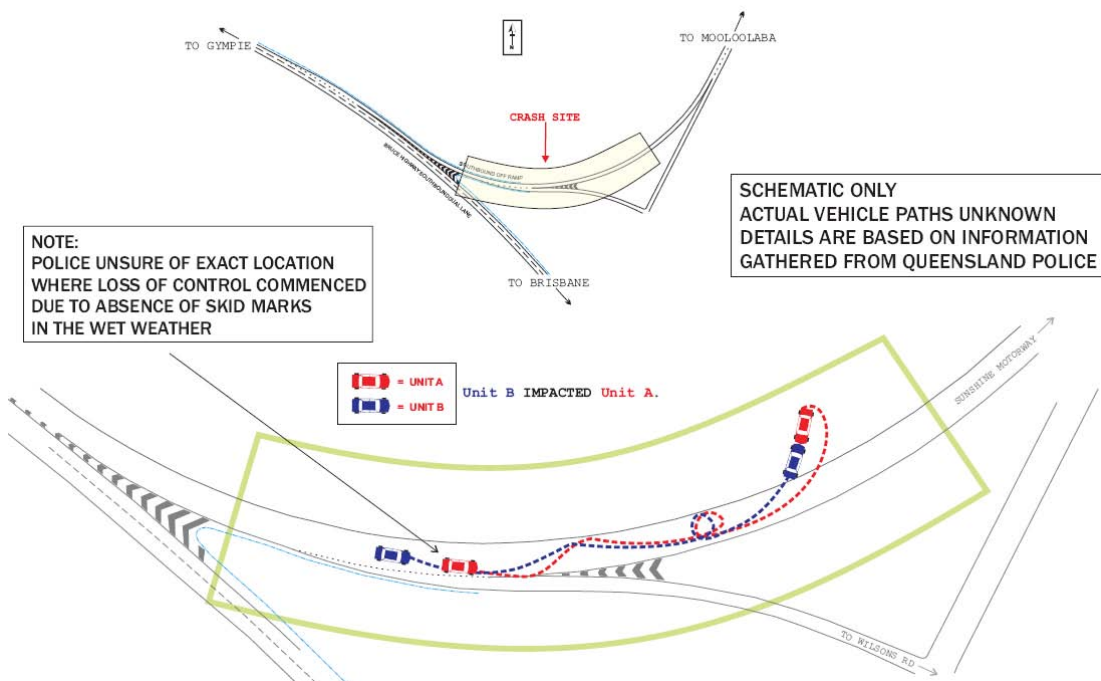
Figure 2 – Crash site location sketch

This report summarises Main Roads' investigations into the fatal crash that occurred on 21 May 2007 on the south-bound ramp from the Bruce Highway to the Sunshine Motorway at Tanawha. The driver of a sedan lost control on the ramp in light rain at approximately 3.00pm and was standing behind her car, making a call for assistance. A four-wheel drive vehicle also lost control and collided with the first car, causing the first car to back over its driver.

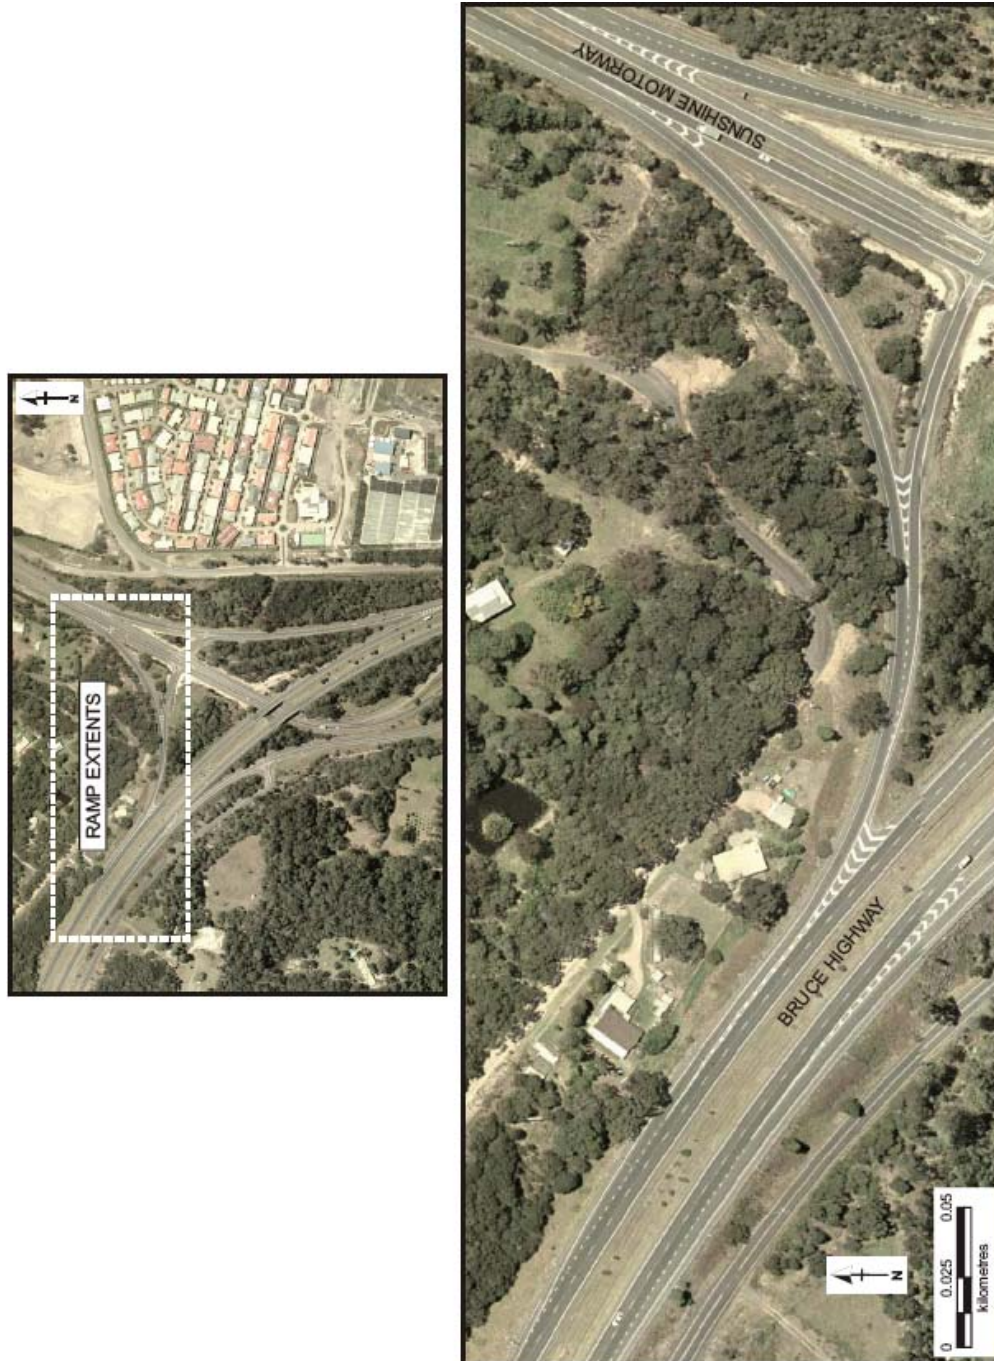
Figure 3 – Aerial view of ramp

When the interchange was constructed in 1989, the posted speed limit on the duplicated Bruce Highway was 100 km/h. The Bruce Highway speed limit was increased to 110 km/h in 1993. The original design provided for a short off-ramp. This was lengthened in May 2000 to provide motorists with a longer distance to decelerate before the start of the ramp linking the Bruce Highway to the Sunshine Motorway.

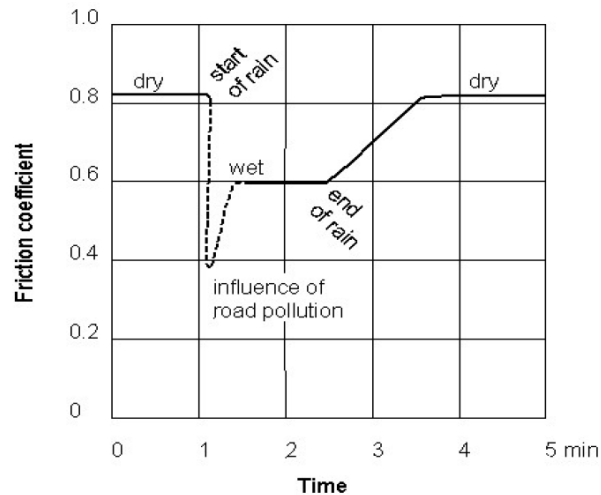
Figure 6 – from Bennis and De Wit, *State of the art on friction and texture measurements*, 2003 as referenced in Austroads Guidelines for the Management of Road Surface Skid Resistance (2005)

- another possible factor affecting skid resistance at the time of the crash is the influence of "road pollution". Research shows that in light rain after a period of dry, road pollution can significantly reduce available friction (refer Figure 6). Based on rainfall information sourced from the Bureau of Meteorology, it appears that this crash did occur in light rain, although given the "patchy" nature of rainfall in the vicinity, it is difficult to establish whether there was a significant preceding dry period<sup>7</sup>.

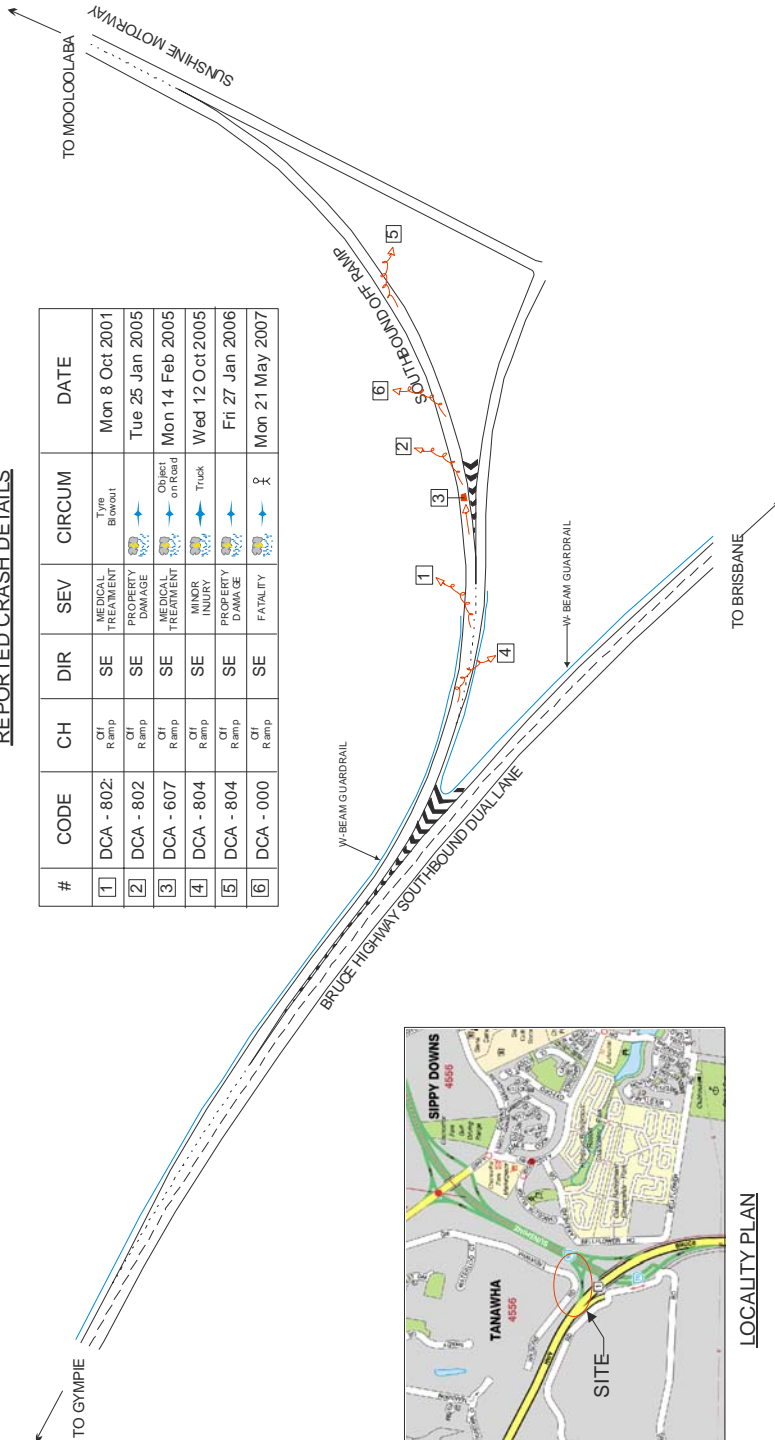
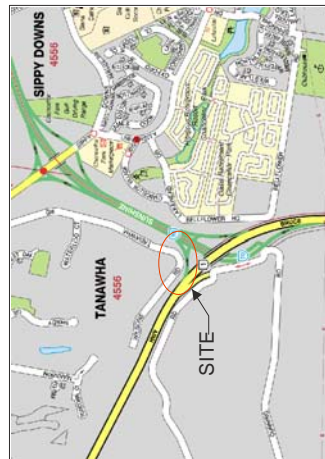
Figure 8 – Collision diagram (1 June 2001 to 24 May 2007)

#	CODE	CH	DIR	SEV	CIRCUM	DATE
1	DCA - 802	OT Ramp	SE	MEDICAL TREATMENT	Type Blowout	Mon 8 Oct 2001
2	DCA - 802	OT Ramp	SE	PROPERTY DAMAGE	Object on Road	Tue 25 Jan 2005
3	DCA - 607	OT Ramp	SE	MEDICAL TREATMENT	Truck	Mon 14 Feb 2005
4	DCA - 804	OT Ramp	SE	MINOR INJURY	Object on Road	Wed 12 Oct 2005
5	DCA - 804	OT Ramp	SE	PROPERTY DAMAGE	Object on Road	Fri 27 Jan 2006
6	DCA - 000	OT Ramp	SE	FATALITY	Object on Road	Mon 21 May 2007

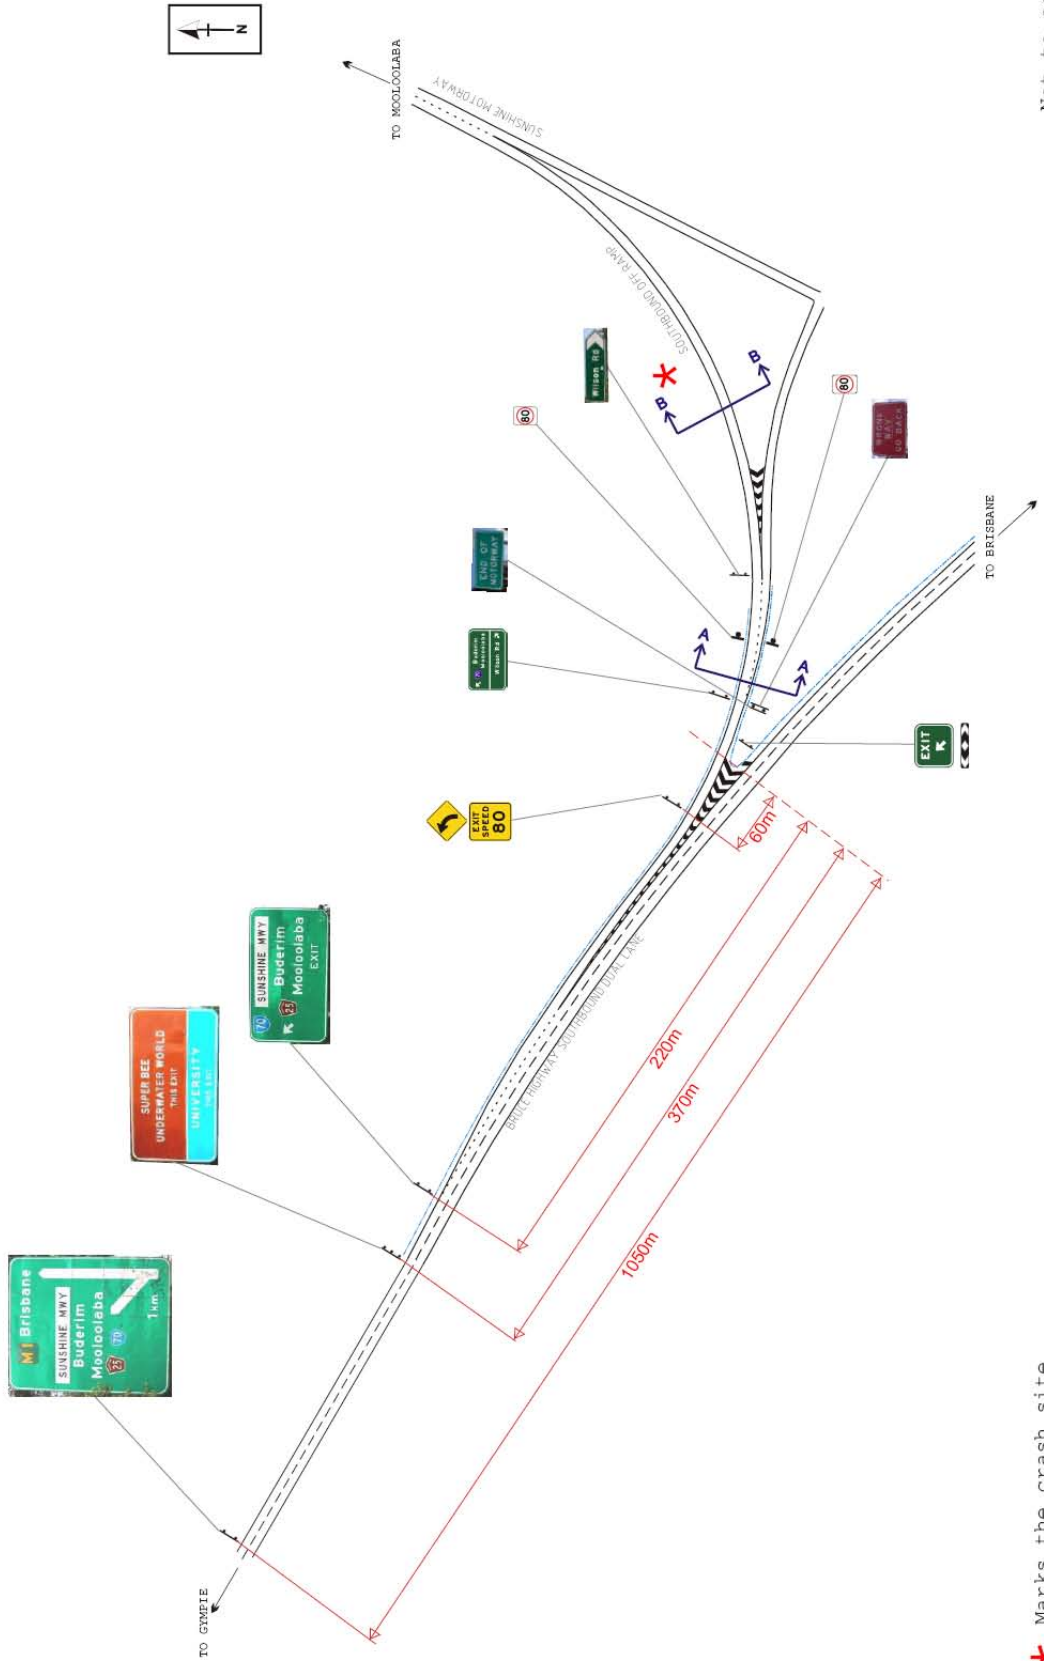
**EXISTING SIGNS DIAGRAM - Fatal Crash Investigation # 20700097149**

**X** Marks the crash site

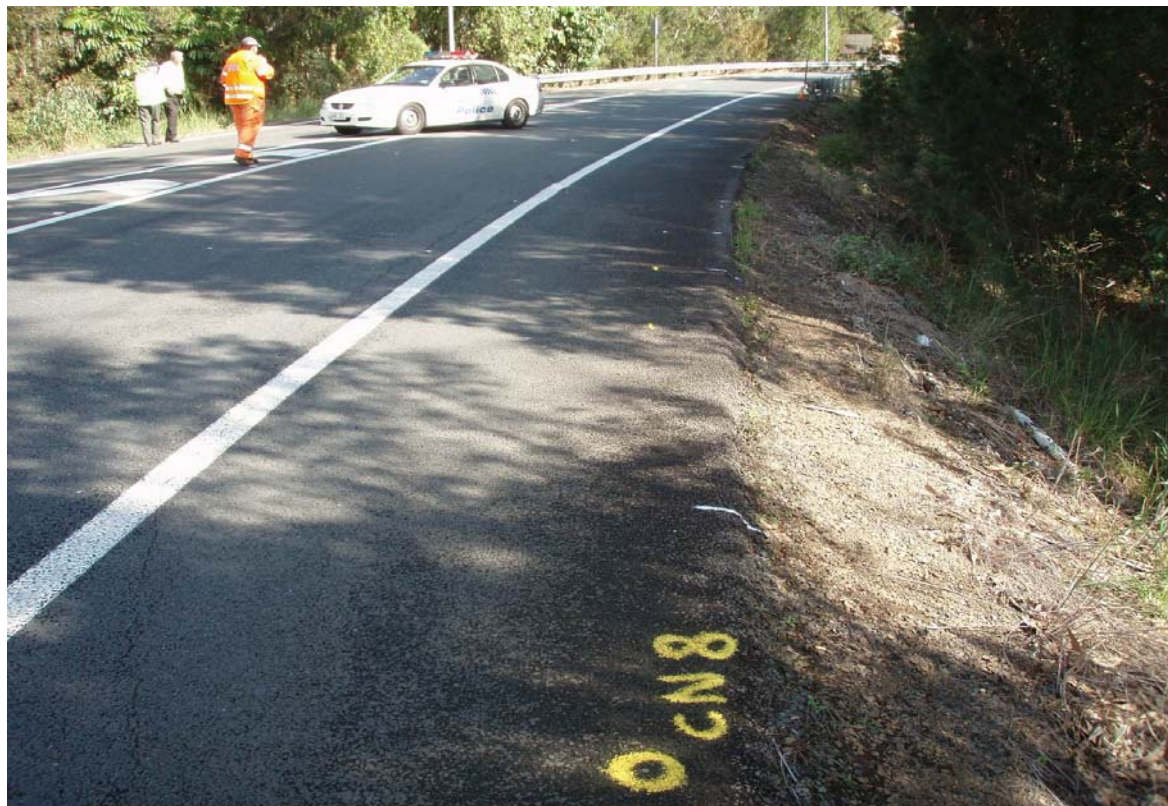
Photo 8 – Reverse view along shoulder

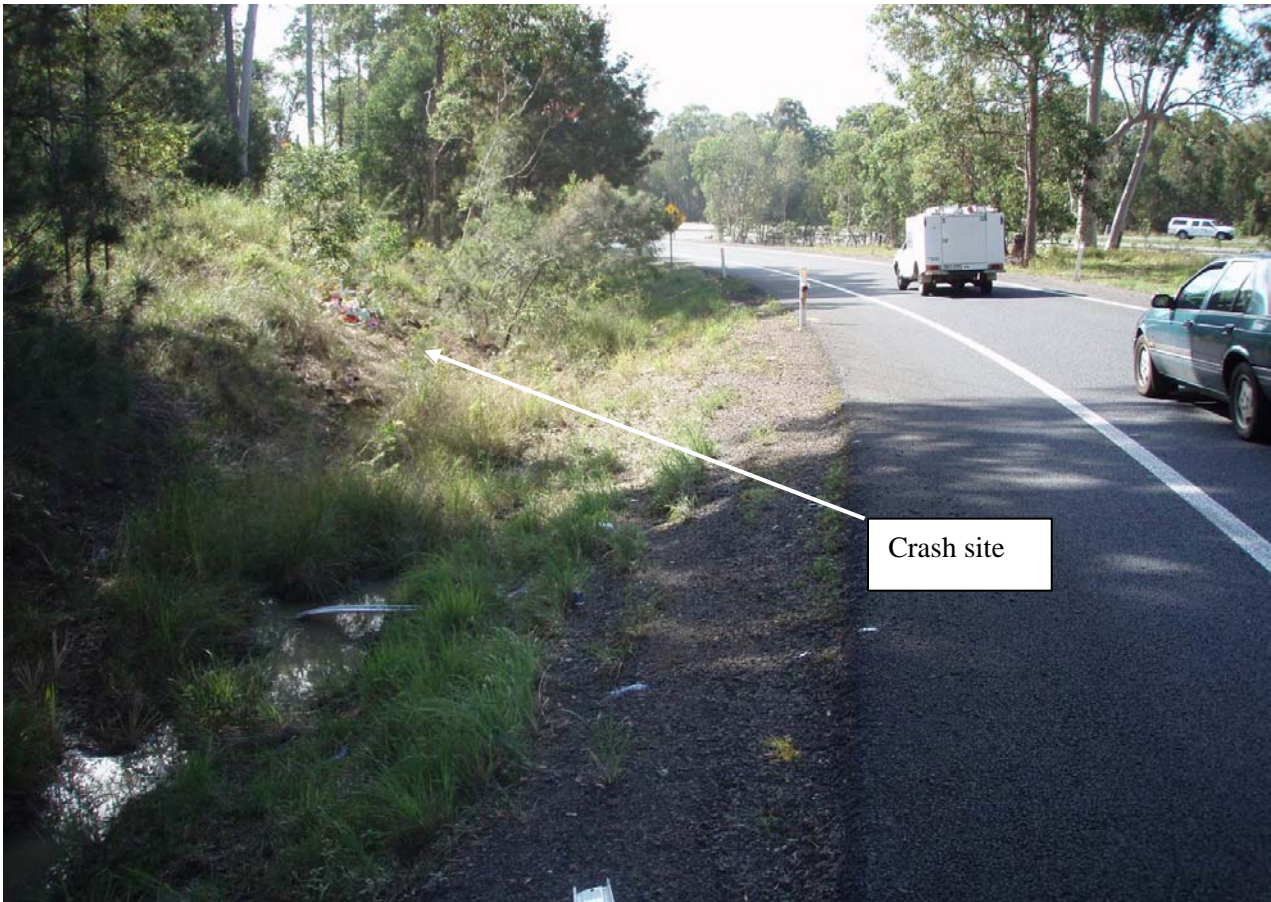
Photo 9 – Shoulder near crash site

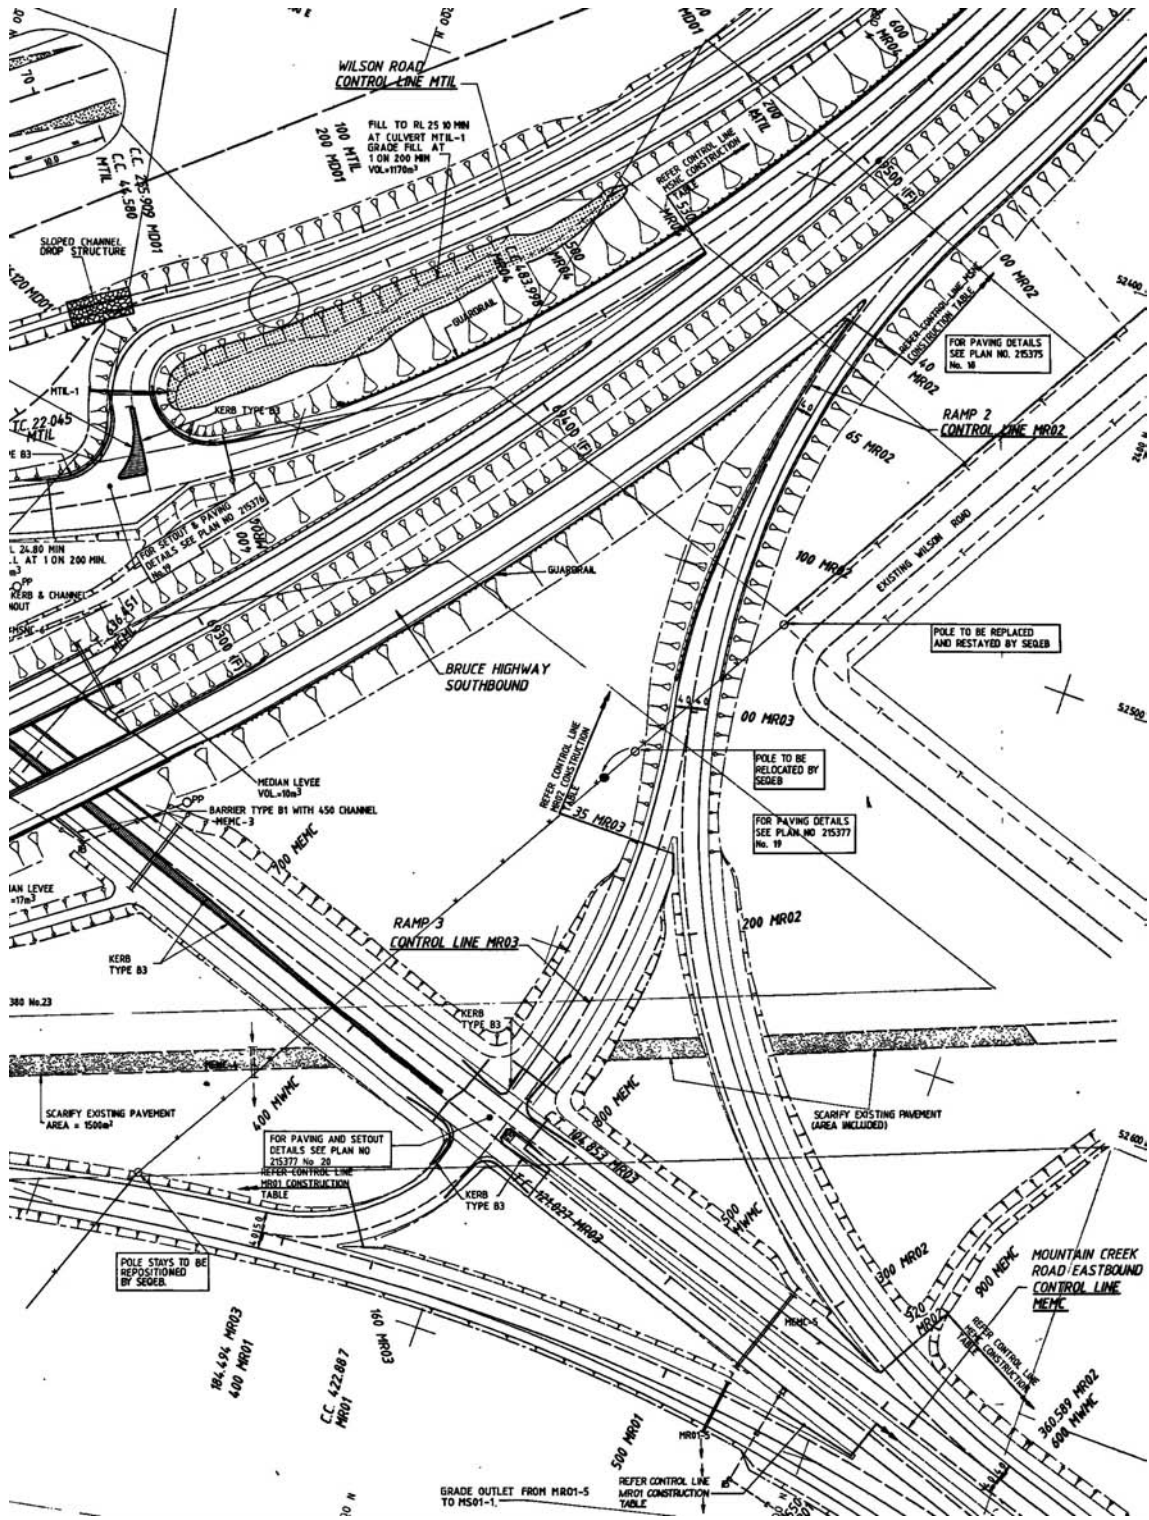
Figure 1 Original Ramp Layout

- Horizontal Alignment (see Figure 1)
  - Starts off the back of a right hand R1000 on the southbound Bruce Hwy with 3% superelevation on a 3.04% down-grade

- Reverse left hand R204 with 3% superelevation and with no spiral transition – initially there was no intervening tangent section. However, a 40m intervening tangent was introduced when the ramp terminal was revised in 2000 (see Figure 3).

- An entry transition for the R204 curve.
- Increase in superelevation to 5% or 6%, but this would preferably require closing of the connection to Wilson Rd because of the cross-over crown line and the proximity to the main exit from the Bruce Hwy.
- Standard diverge angle and deceleration length.

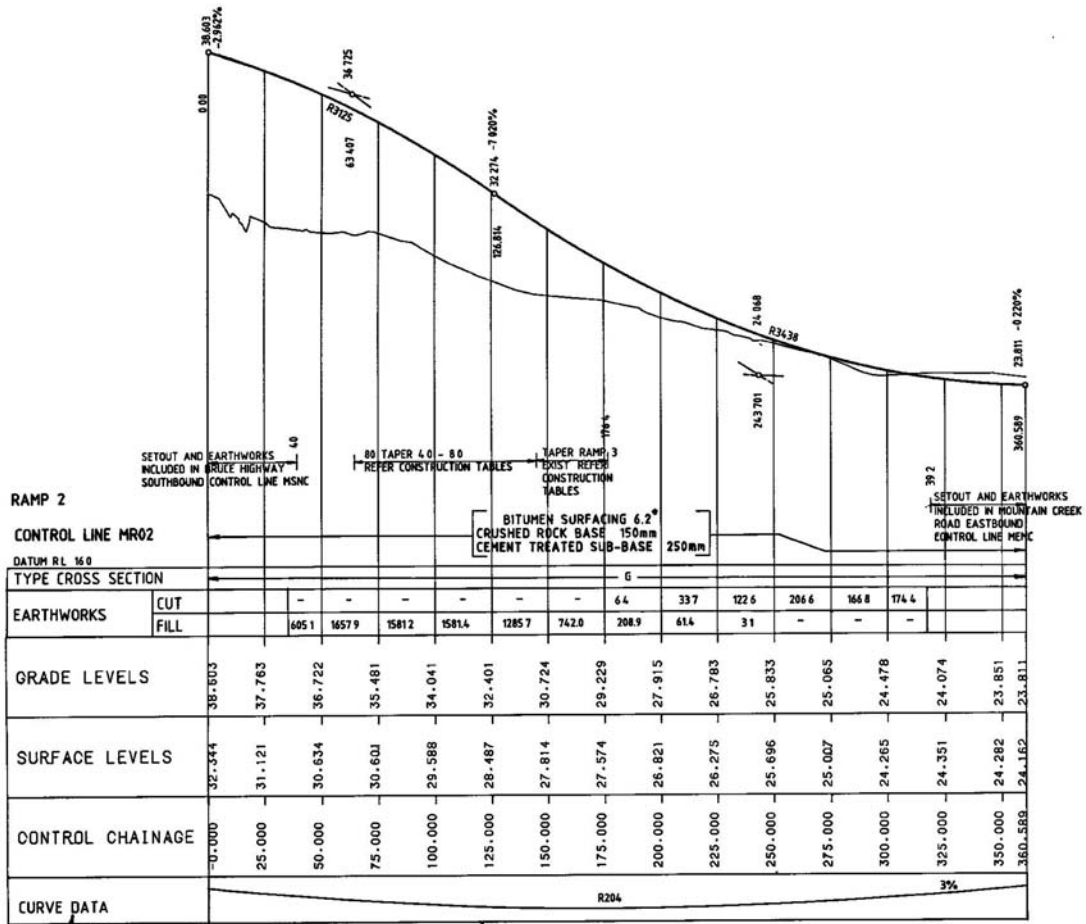
Figure 2 Ramp Vertical Alignment

- Vertical Alignment (see Figure 2)
  - 3% down-grade
  - R3125 crest vertical curve 126.8m long
  - 7.02% instantaneous down-grade at the common tangent point between the preceding crest vertical curve and the following sag vertical curve

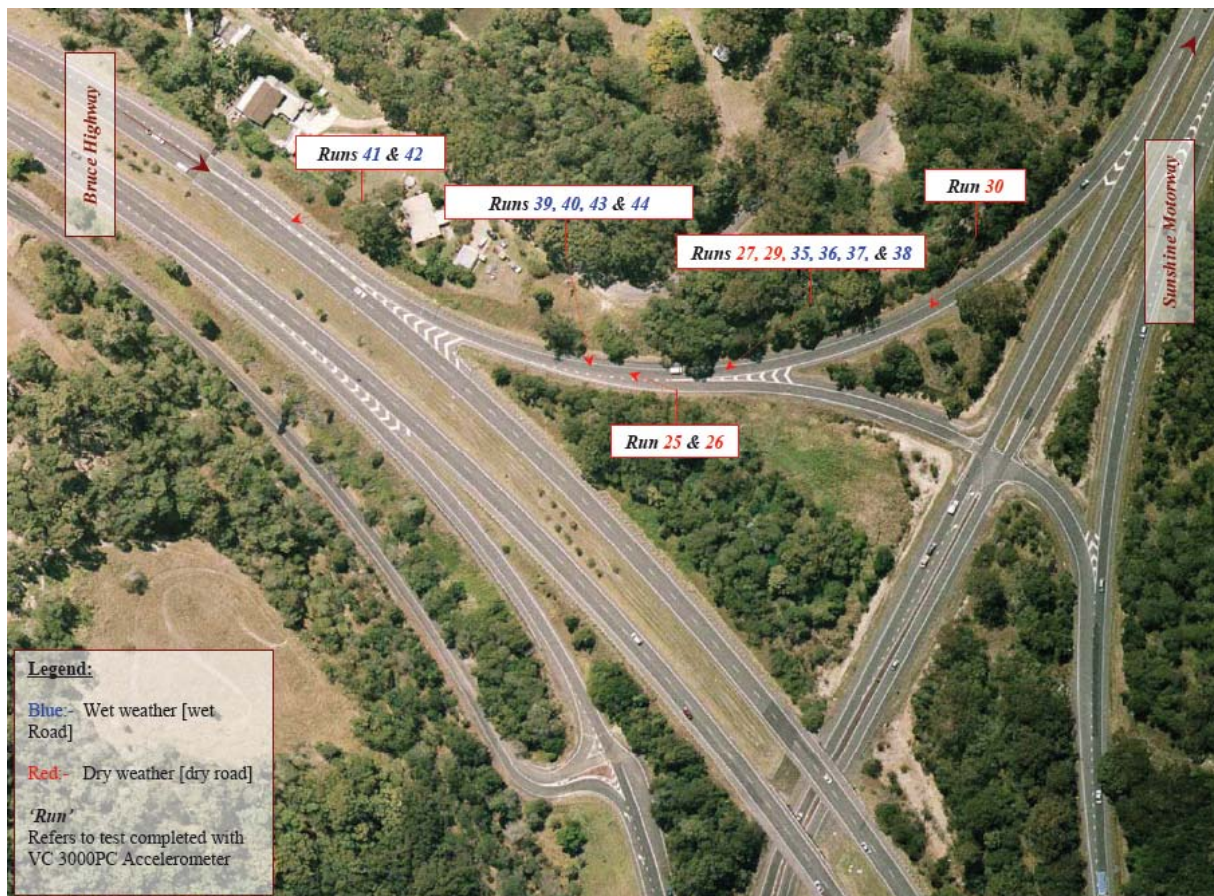
The aerial photograph below shows the general locality at which the skid tests were conducted.

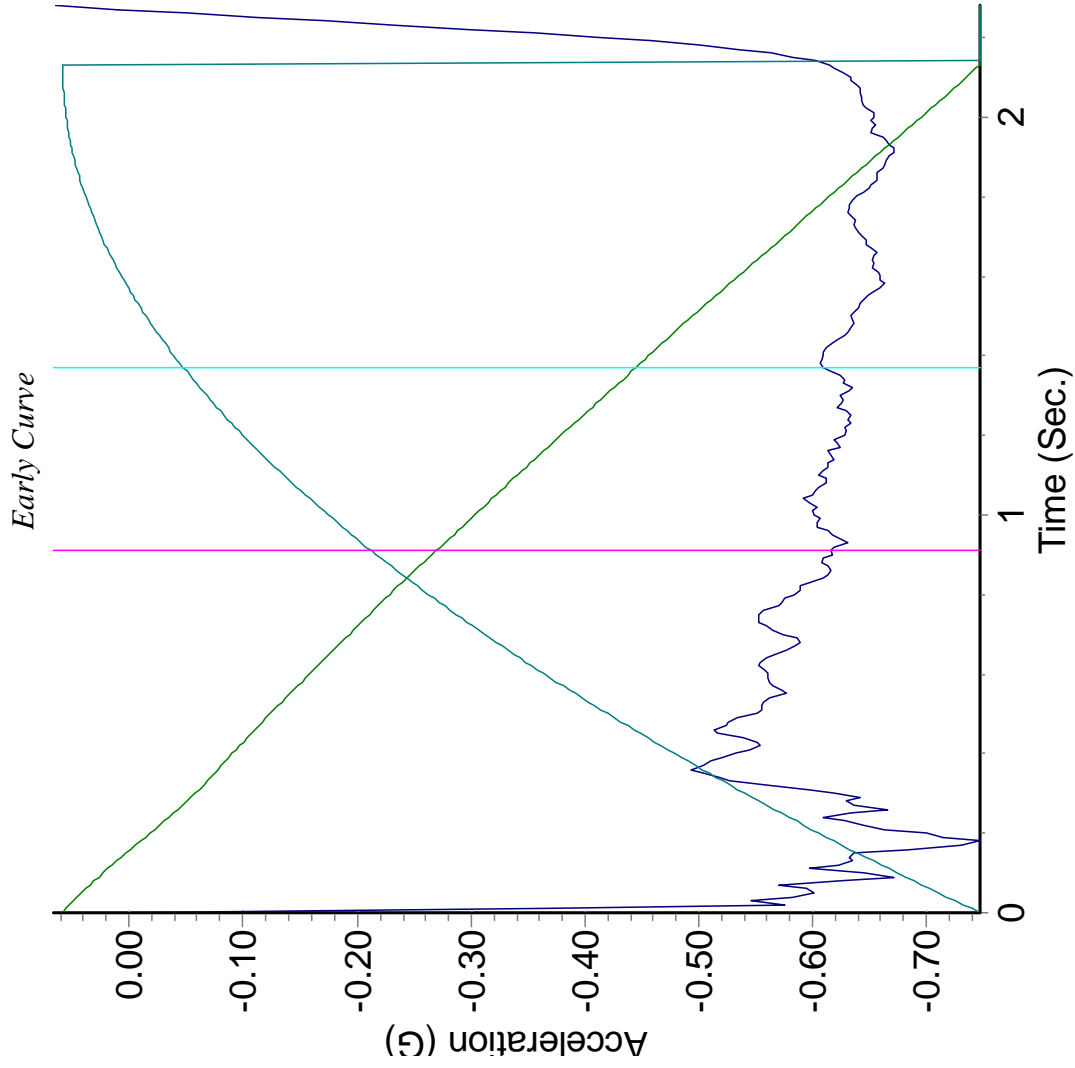
*Drag Factor Test – Dry Road*

Time 0.91 to 1.37  
648JDL 31/05/2007 25  
□ Avg Acceleration -0.617  
□ Avg Speed 22.313  
□ Avg Distance 10.775

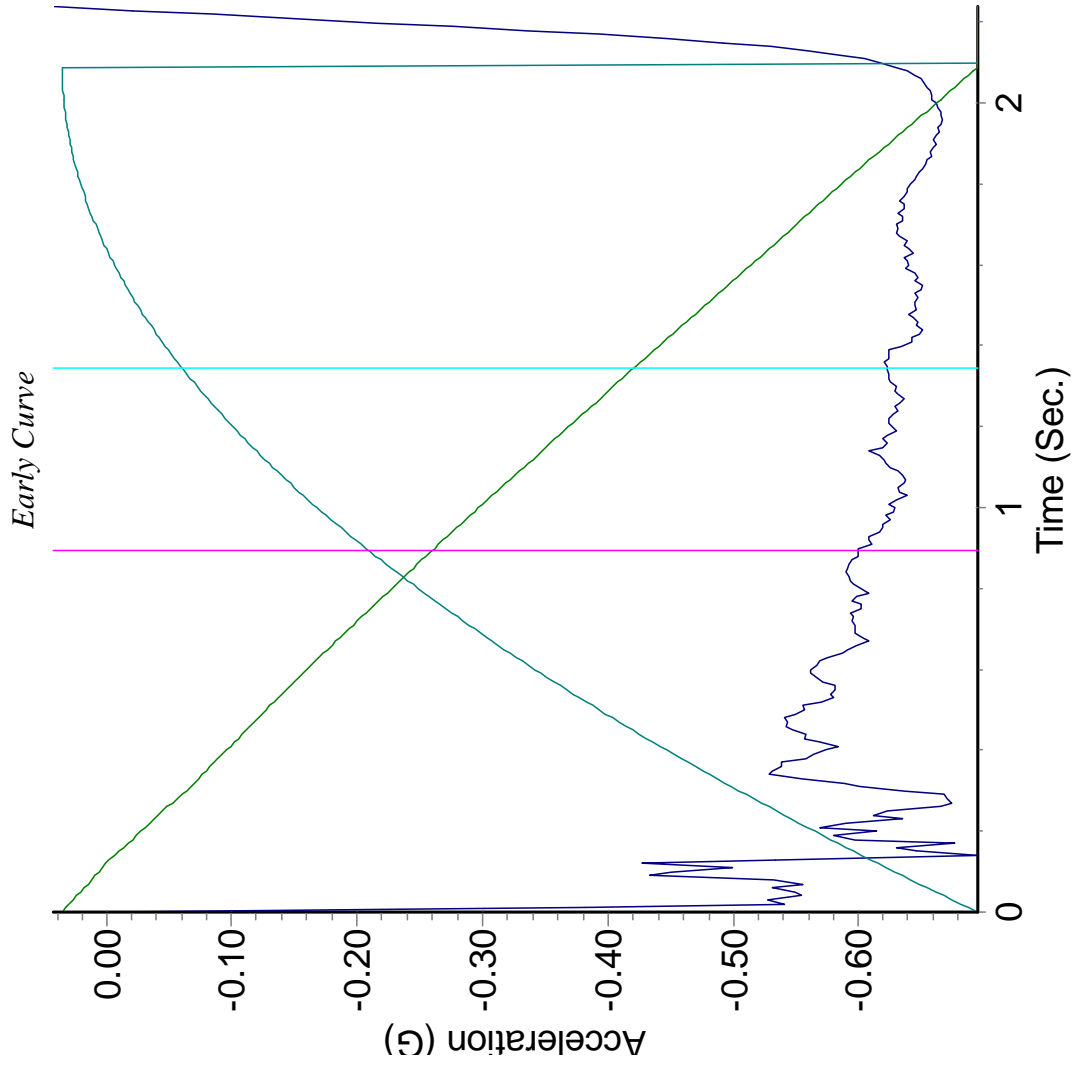
*Drag Factor Test – Dry Road*

Time 0.90 to 1.34  
648JDL 31/05/2007 29  
- Avg Acceleration -0.624  
- Avg Speed 21.943  
- Avg Distance 10.459

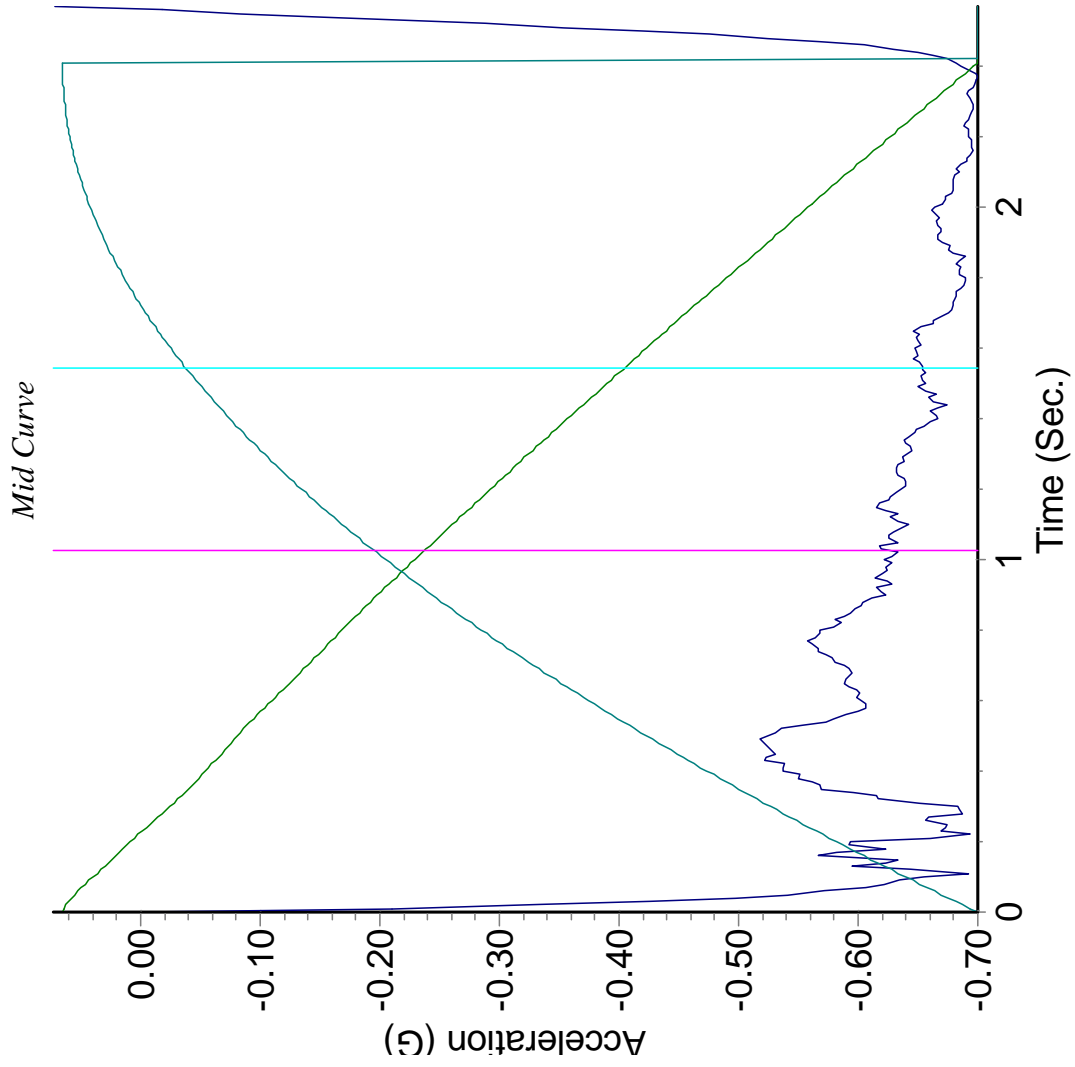
*Drag Factor Test – Dry Road*

Time 1.03 to 1.54  
648JDL 31/05/2007 26  
- Avg Acceleration -0.642  
- Avg Speed 26.694  
- Avg Distance 14.388

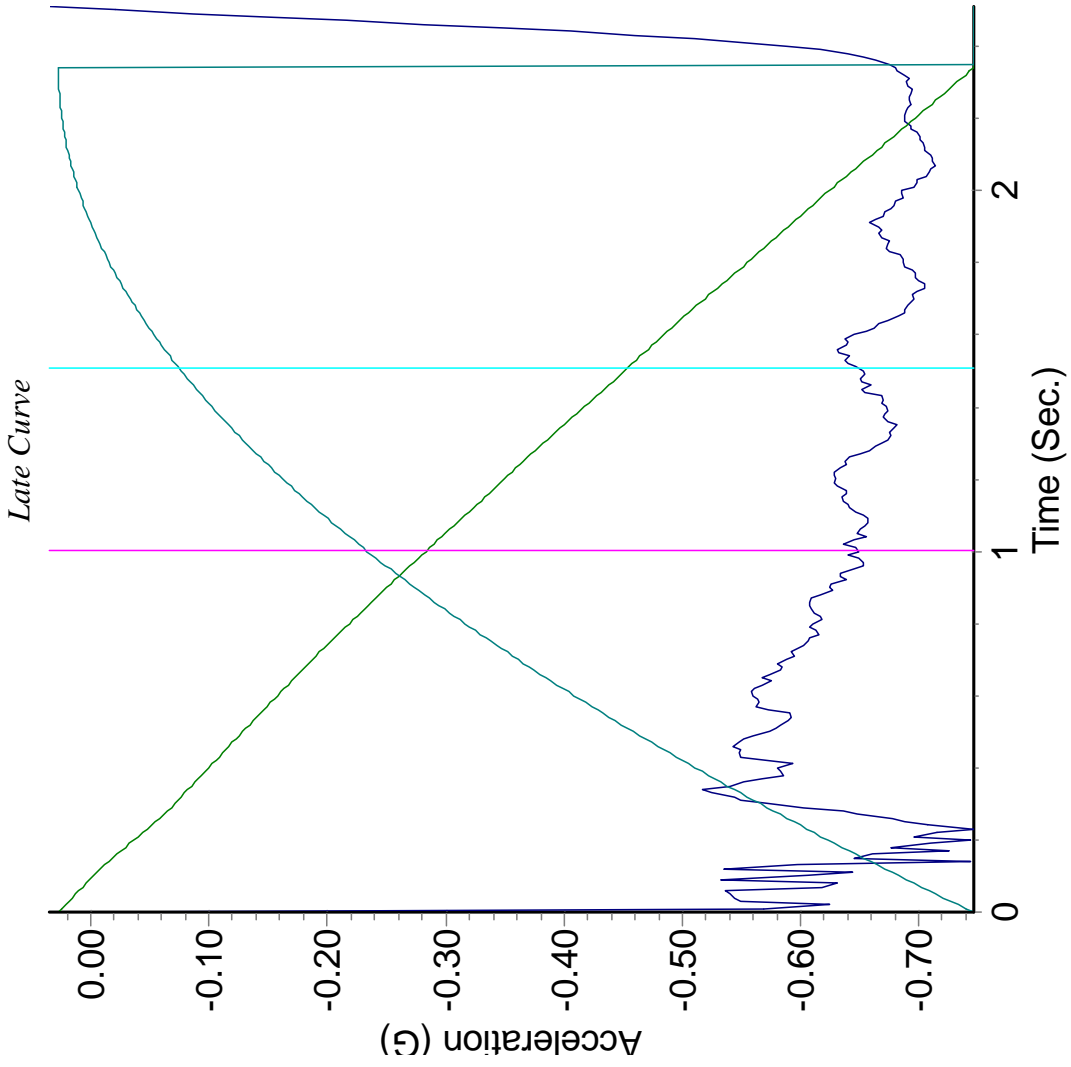
*Drag Factor Test – Dry Road*

Time 1.00 to 1.51  
648JDL 31/05/2007 27  
□ Avg Acceleration -0.653  
□ Avg Speed 25.945  
□ Avg Distance 13.766

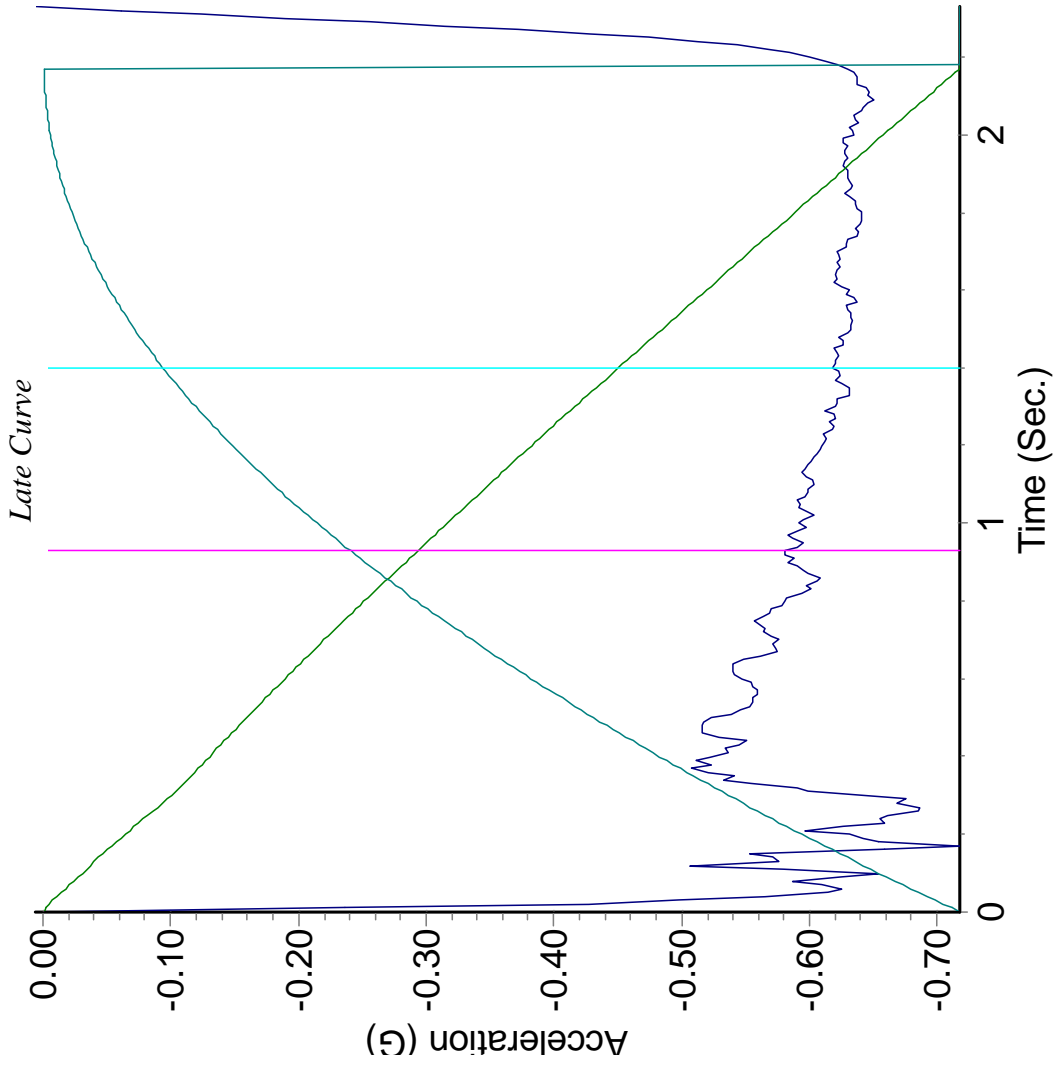
*Drag Factor Test – Dry Road*

Time 0.93 to 1.40  
648JDL 31/05/2007 30  
□ Avg Acceleration -0.606  
□ Avg Speed 22.254  
□ Avg Distance 11.018

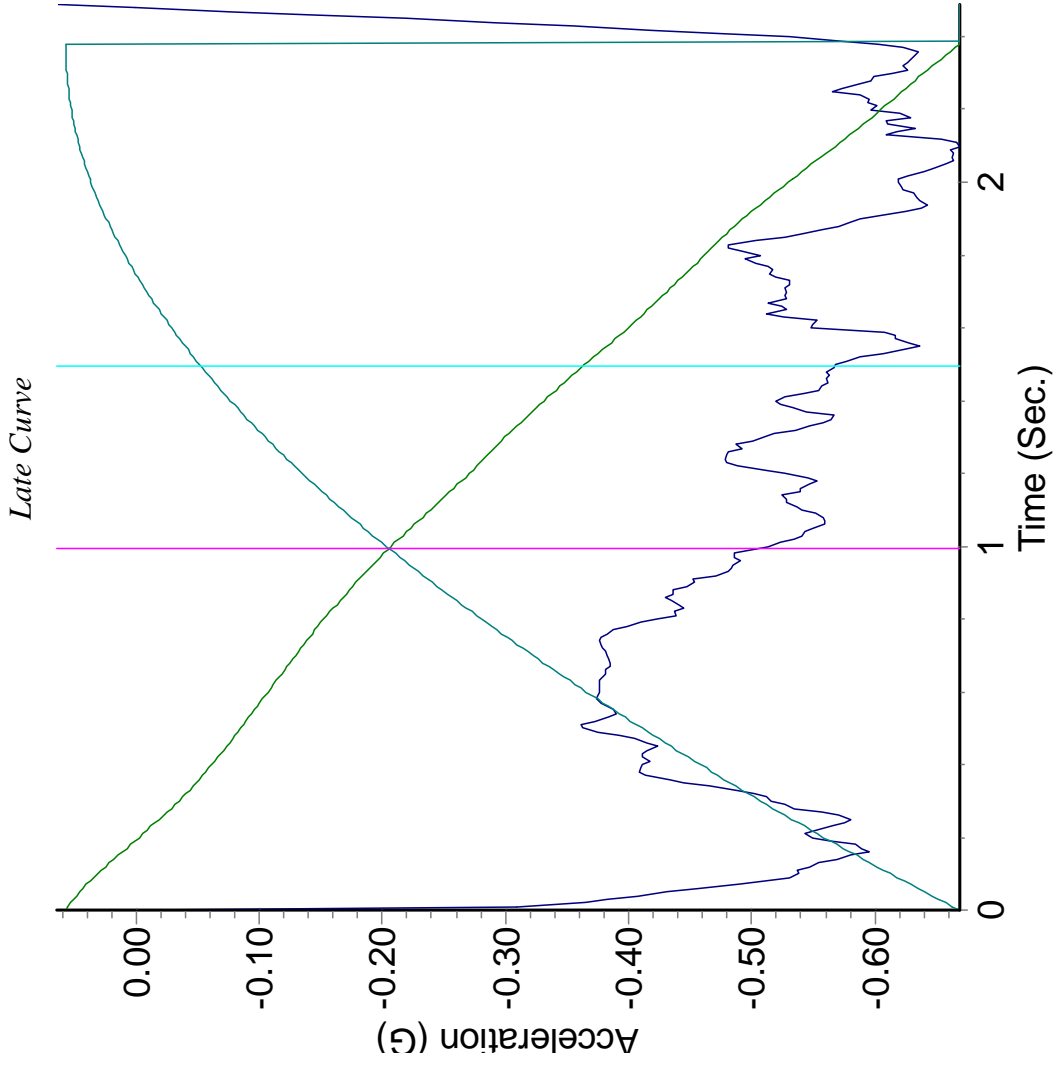
Drag Factor Test – Wet Road – Light Rain

Time 1.00 to 1.49

648JDL 5/06/2007 35

- Avg Acceleration -0.533
- Avg Speed 23.106
- Avg Distance 11.495

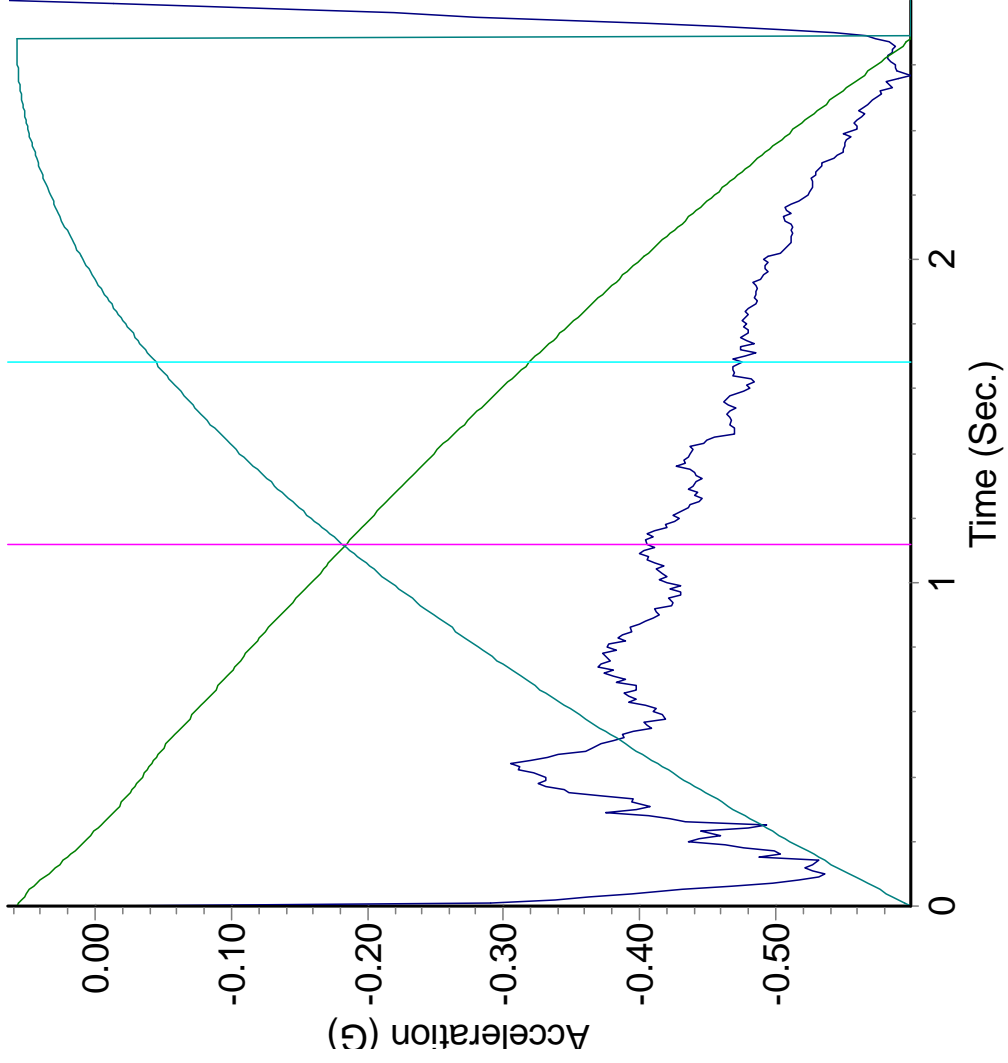
Drag Factor Test – Wet Road – Light Rain

Time 1.12 to 1.68

648JDL 5/06/2007 37

□ Avg Acceleration -0.448  
□ Avg Speed 23.125  
□ Avg Distance 12.906

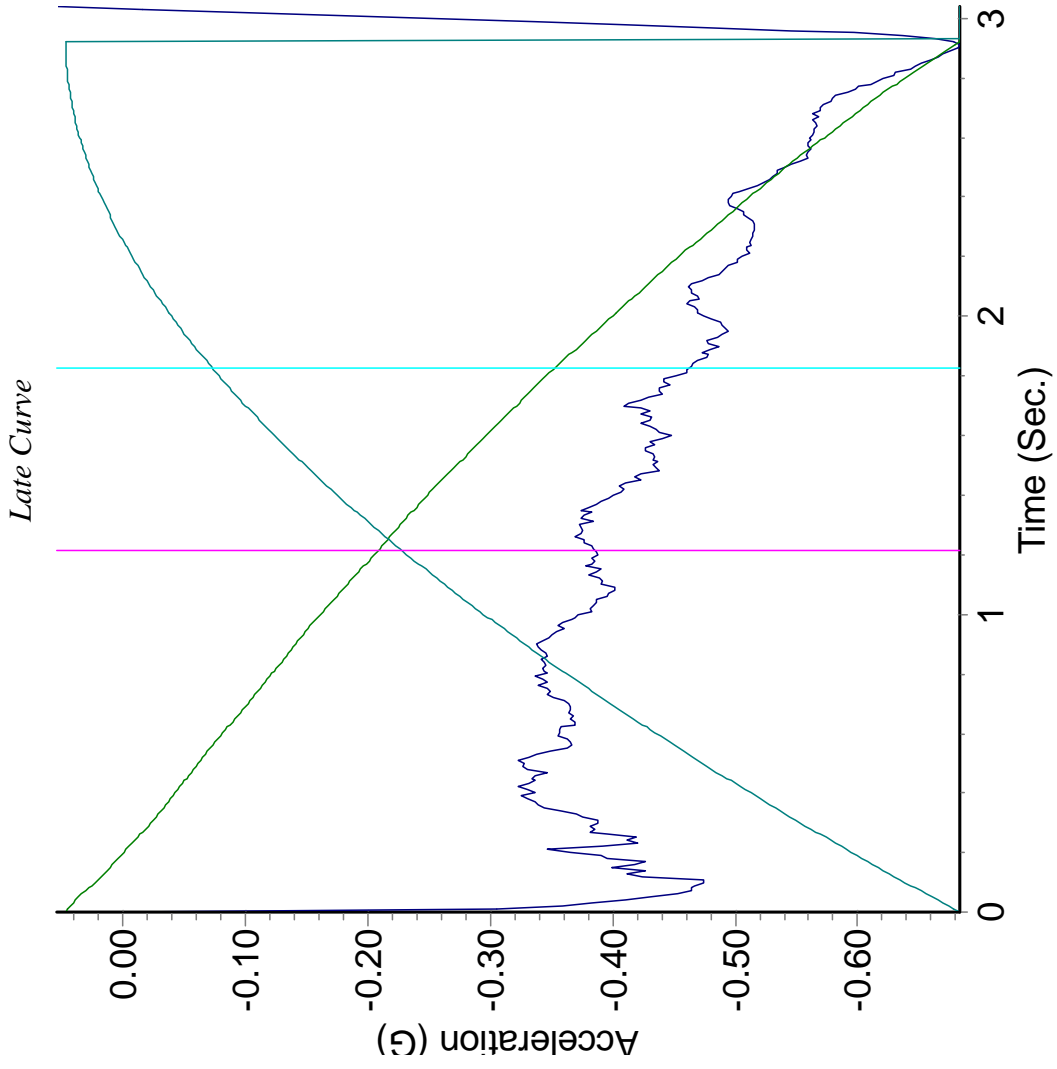
*Drag Factor Test – Wet Road – Light Rain*

Time 1.22 to 1.82  
648JDL 5/06/2007 38

□ Avg Acceleration	-0.415
□ Avg Speed	25.256
□ Avg Distance	14.903

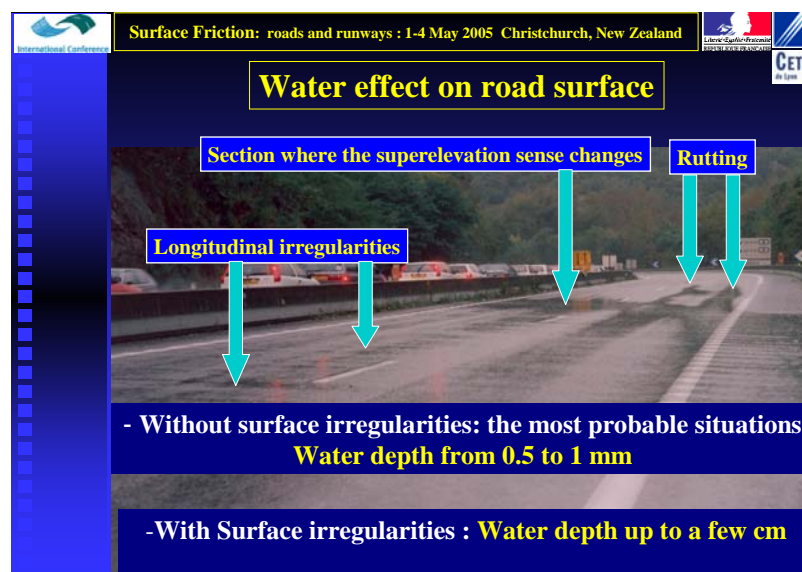
- Water has to be drained by the surface
- And also by the tyre

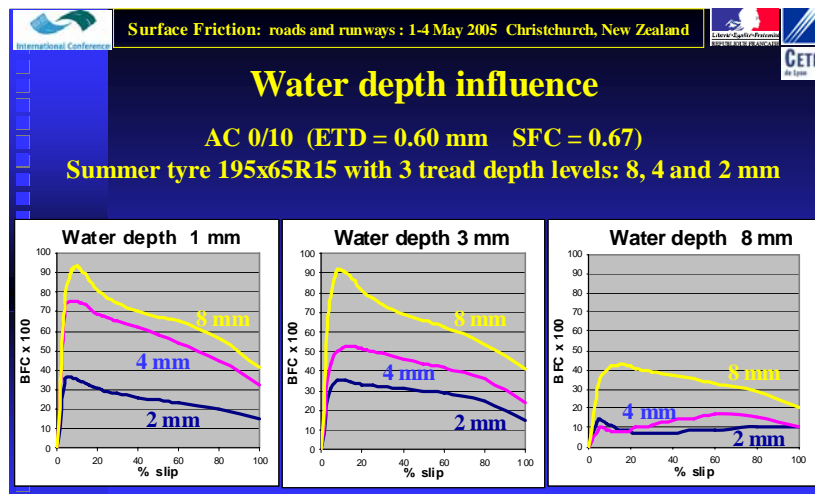
- Skid resistance is directly proportional to the area of contact between the tyre and road surface. When even small amounts of water are present even new tyres experience a reduction in contact area and therefore a reduction in skid resistance. This is where partial aquaplaning mechanisms begin to influence skid resistance.

- A 'just legal' tyre experiences a significant reduction in contact area at 90 km/h and therefore a significant reduction in skid resistance.
- As water depth increases so does partial aquaplaning with a corresponding reduction in skid resistance.
- Tyre wear has a definite impact
