Road Safety Performance Review 'Kuranda Range' Kennedy Highway (Road no. 32A)

Prepared for Department of Transport and Main Roads (Far North District)

7 January 2016

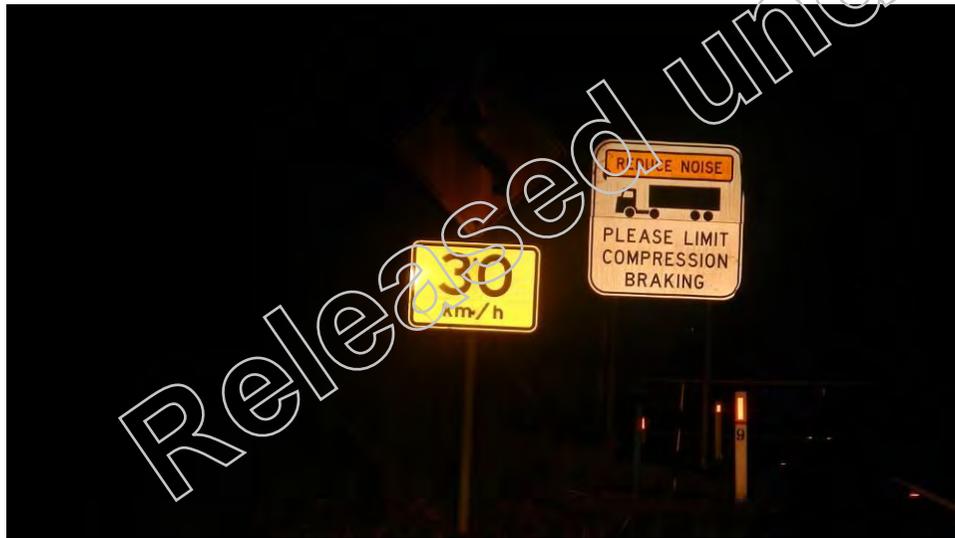
<p>Photograph 8: Example of dirty sign face (Reverse Curve above 30km/h Advisory Speed sign) that showed poor reflectivity during the night inspection (chainage 1.40km RHS).</p>

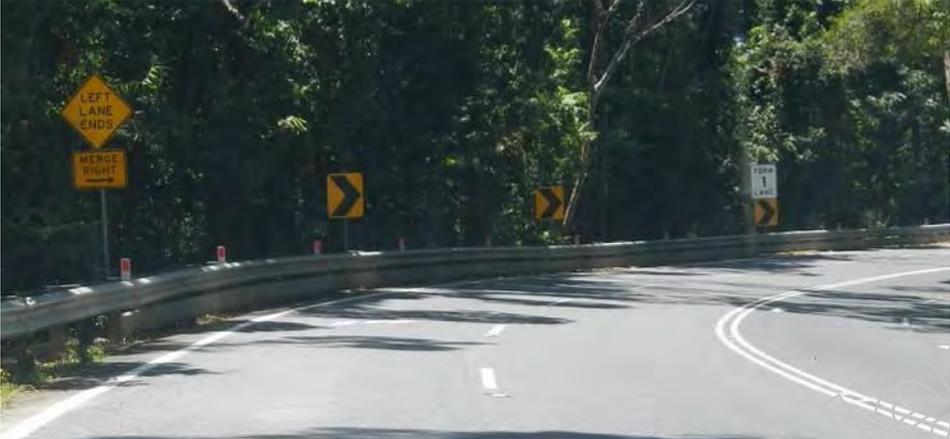
<p>Photograph 9: Example showing conflicting signage arrangements in the merge area of an overtaking lane (i.e. LEFT LANE ENDS / MERGE RIGHT sign vs FORM 1 LANE sign).</p>

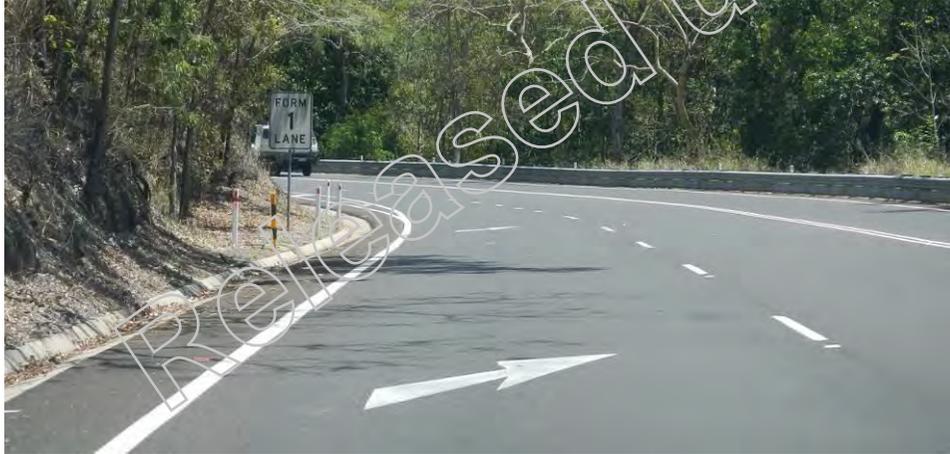
<p>Photograph 10: Example showing conflicting signs and pavement markings in the merge area of an overtaking lane (i.e. FORM 1 LANE sign vs merge arrows and continuity line).</p>

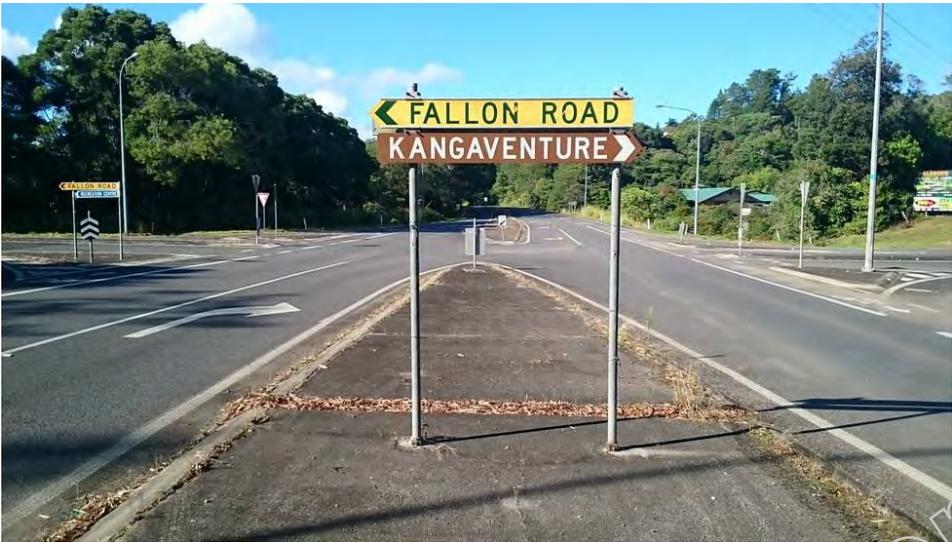
<p>Photograph 15: Road name signs installed at the Fallon and Warril roads intersection used a non-standard colour scheme, with no sign for Warril Road facing westbound traffic.</p>

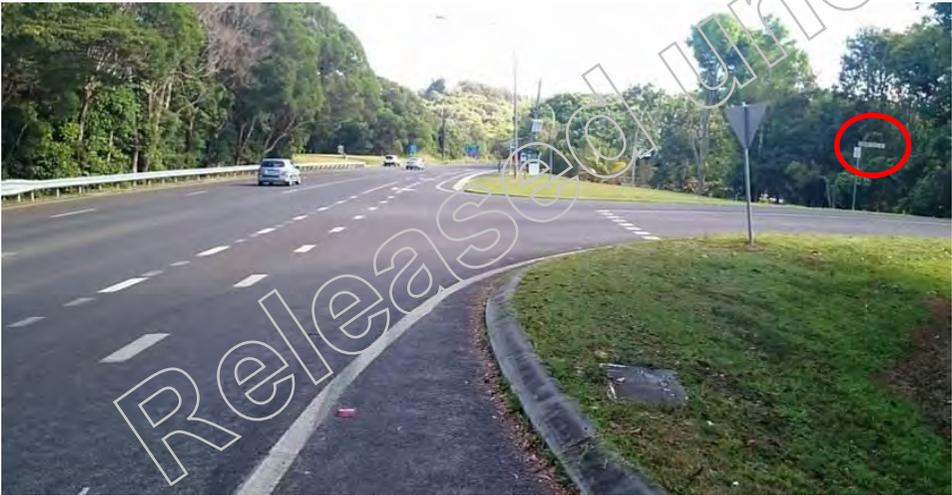
<p>Photograph 16: Eastbound view at the Green Hills Road intersection showing a street name sign (G5-1) with small font offset approximately 15m from the major leg.</p>

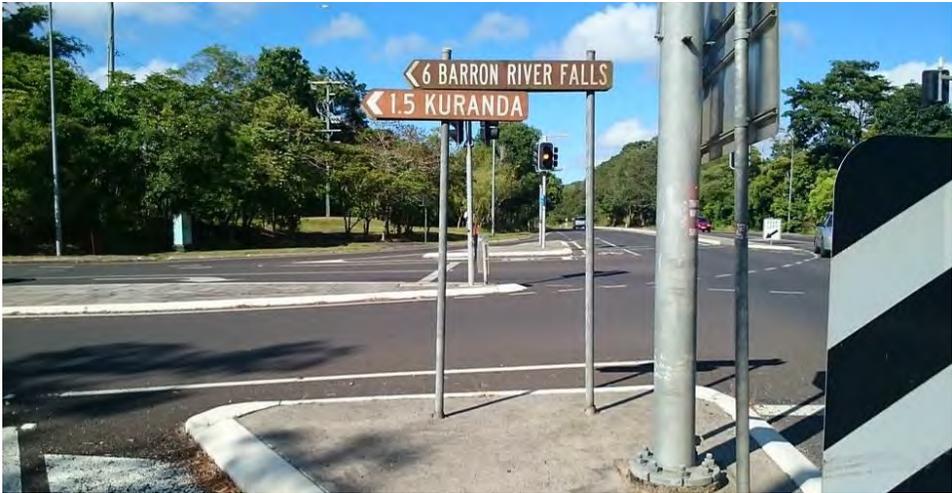
<p>Photograph 17: Intersection direction signs at the Rob Veivers Drive intersection used a non-standard colour scheme and was inconsistent with information shown on the advance signage. There were also no street name signs installed.</p>

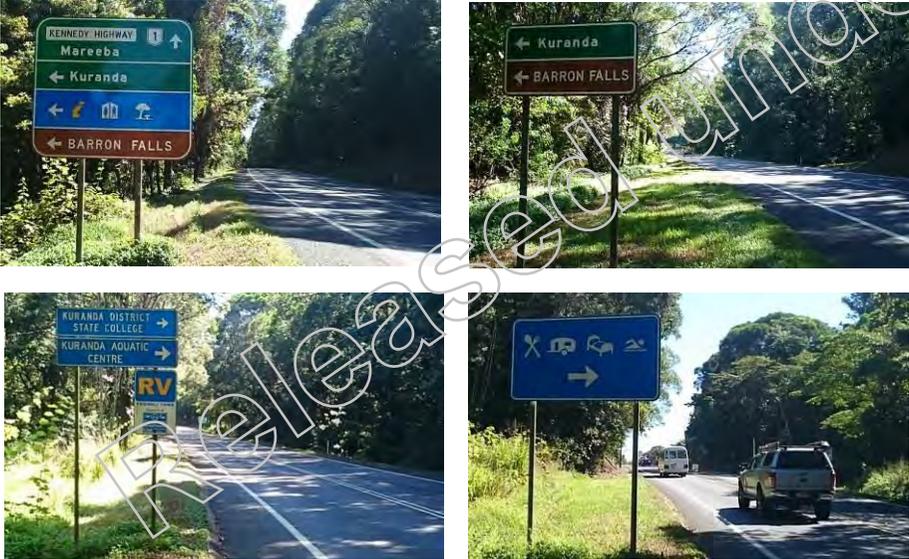
<p>Photograph 18: Examples showing some of the advance direction, service and tourists signs installed on approach to the Rob Veivers Drive/Myola Road intersection.</p>

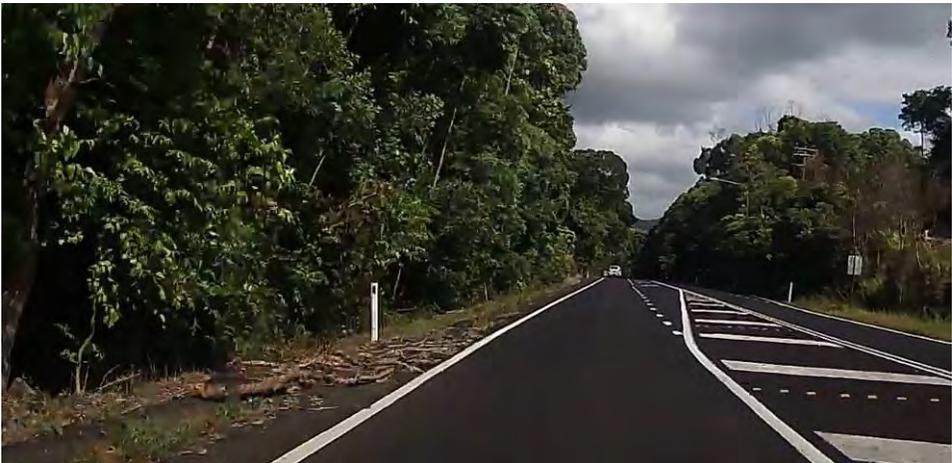
<p>Photograph 19: Westbound view on approach to the Saddle Mountain Road intersection showing the absence of an advance road name sign near the deceleration lane taper.</p>

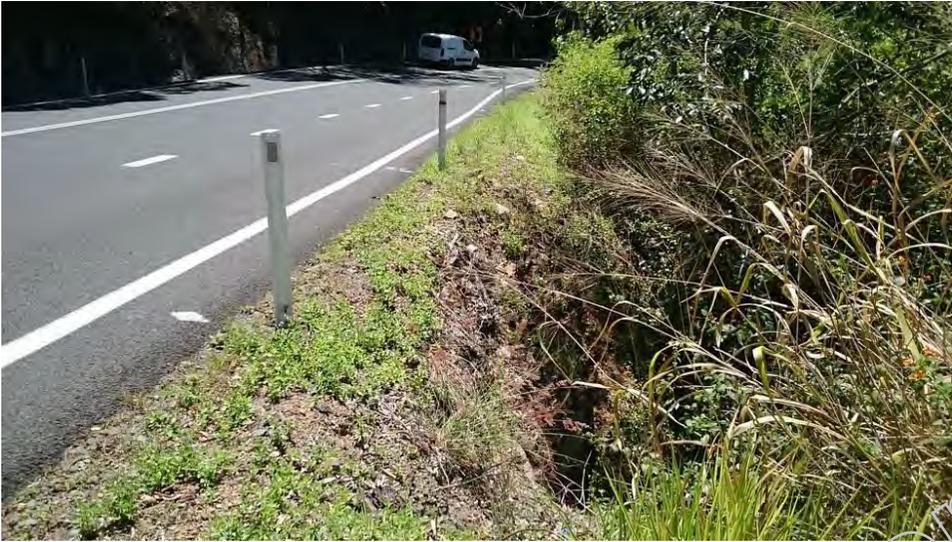
<p>Photograph 36: Example of high/steep-sided embankment situated within 1.5m of the traffic lane edge near chainage 3.0km LHS.</p>

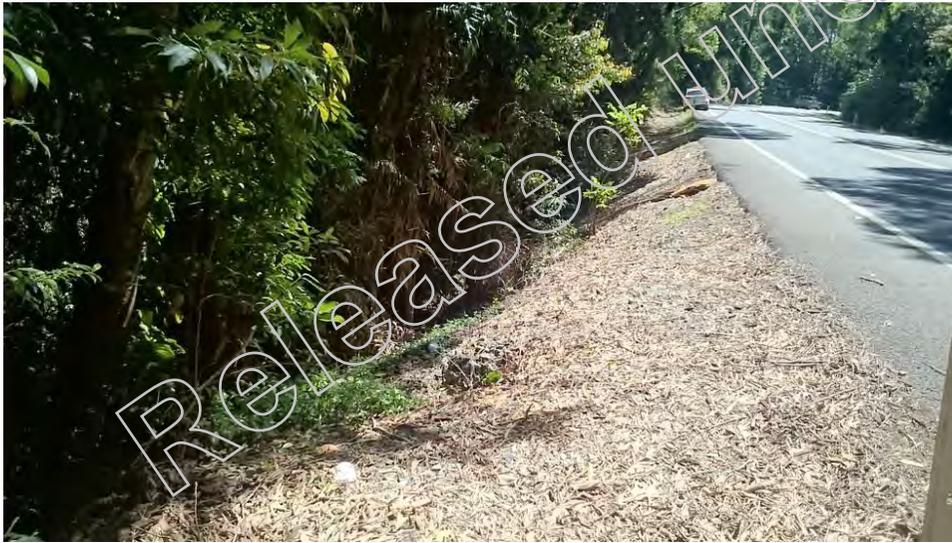
<p>Photograph 37: Example of where a vehicle had recently travelled over a high, steep-sided embankment at chainage 8.75km LHS.</p>

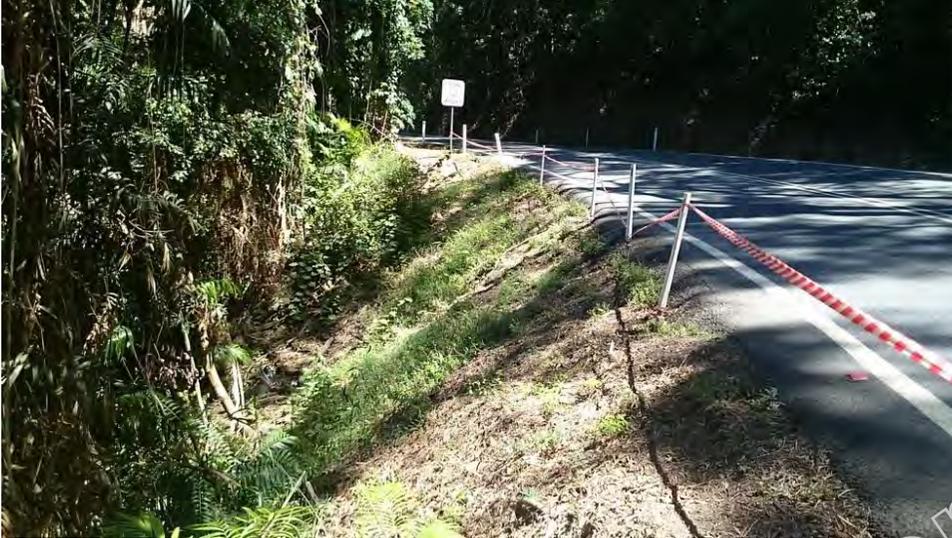
<p>Photograph 38: Example of where a vehicle had recently travelled over a high, steep-sided embankment at chainage 8.18km RHS.</p>

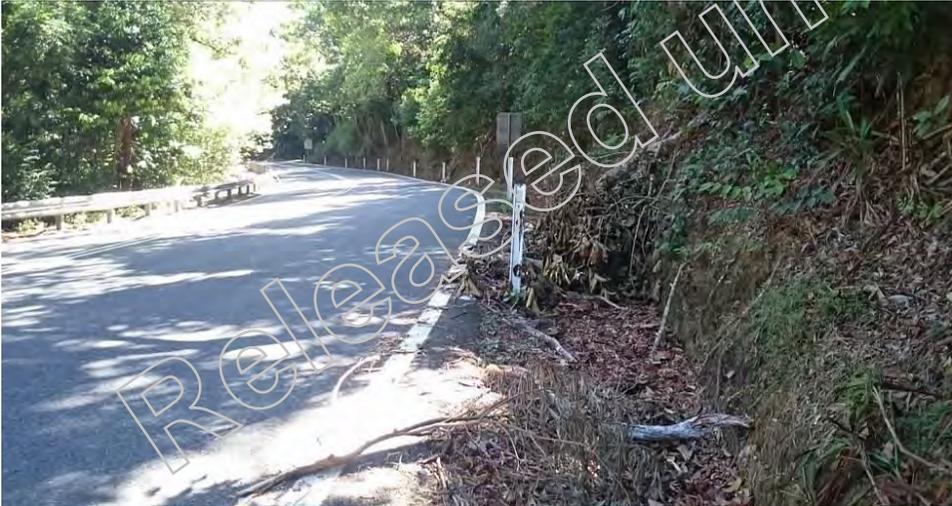
<p>Photograph 39: Example of where a tree had recently fallen onto the road at chainage 7.86km RHS.</p>

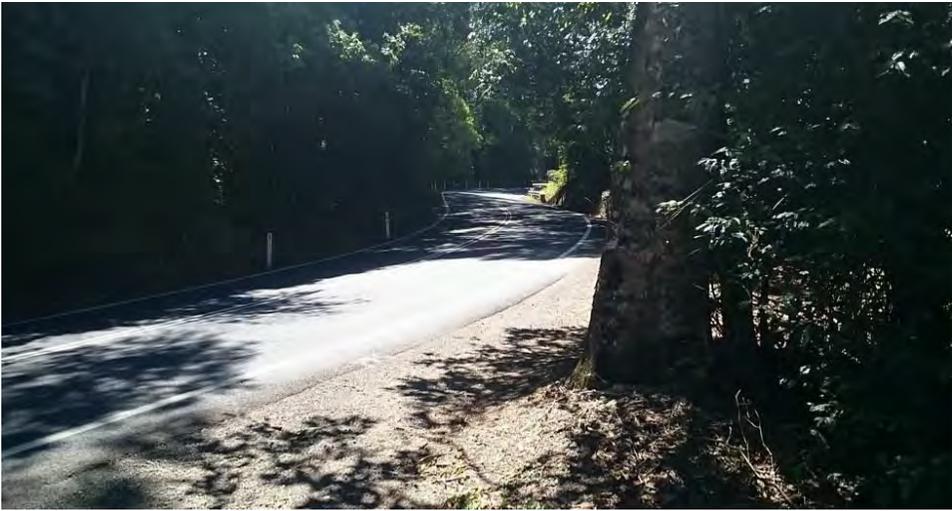
<p>Photograph 40: Example of a location where a large tree was situated 2m from the traffic lane edge on the outside of a horizontal curve at chainage 7.49km RHS.</p>

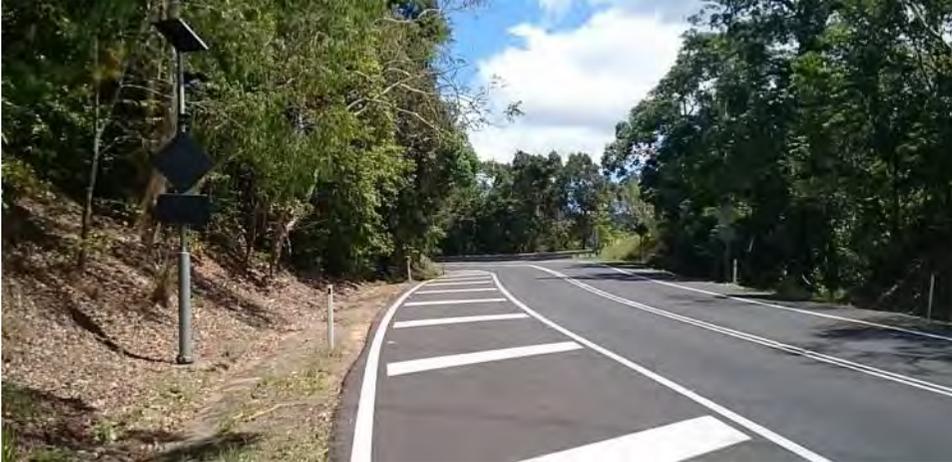
<p>Photograph 42: VAS installed on approach to a series of closely spaced curves when travelling up the range at chainage 4.82km LHS.</p>

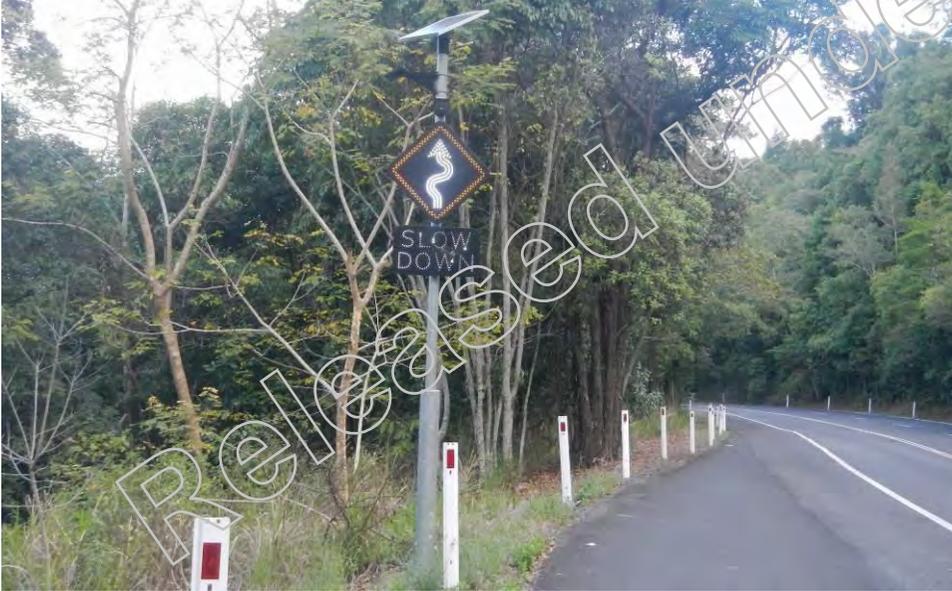
<p>Photograph 43: VAS installed on approach to a series of closely spaced curves when travelling down the range at chainage 4.69km RHS.</p>

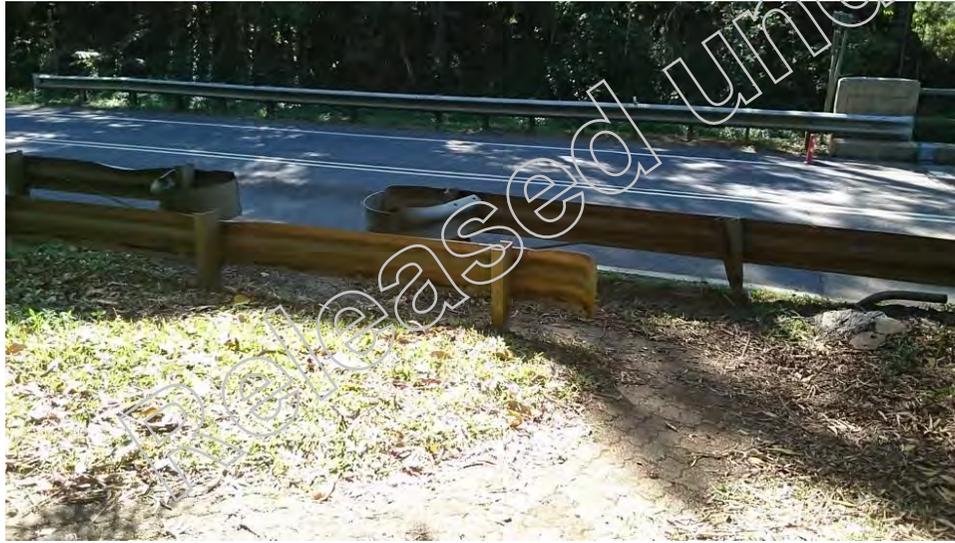
<p>Photograph 46: View looking north at the western abutment of the Barron River Bridge showing the path leading to the crossing point.</p>

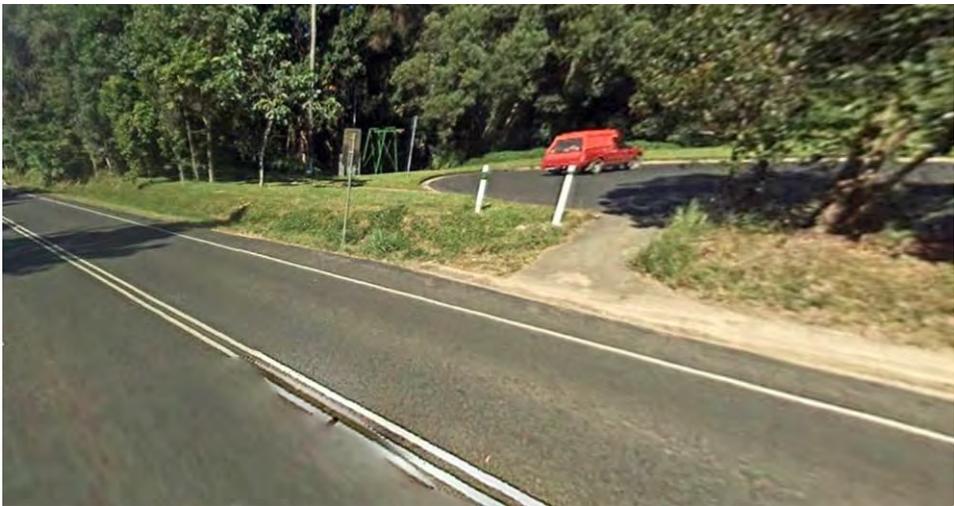
<p>Photograph 47: Eastbound view 60m west of the Barron River Bridge western abutment showing the alternative path that leads to a second informal road crossing.</p>

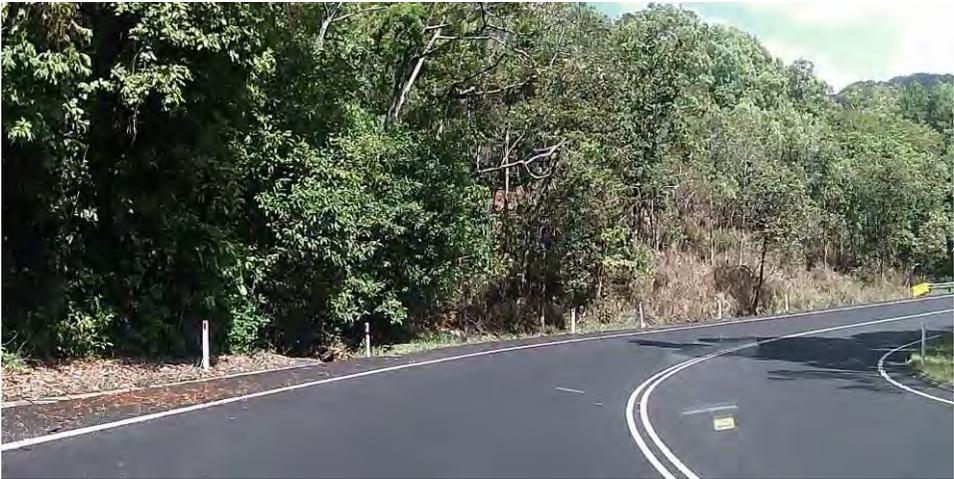
<p>Photograph 50: Eastbound view near chainage 1.13km showing the location where the mountain bike trail re-enters the Kennedy Highway.</p>

<p>Photograph 49: Westbound view near chainage 1.13km showing the location where the mountain bike trail re-enters the Kennedy Highway.</p>	<p>Recommendation 8.7.2.1:</p> <p>Arrange for a SHARE THE ROAD warning sign (TC1878) and supplementary plate (TC1864) (as illustrated in Figure 10) to be installed near chainage 1.21km RHS, which is prior to the point where the mountain bike trail terminates and cyclists re-enter the Kennedy Highway.</p> <p>Also arrange for a ROAD AHEAD (W6-8) warning sign to be installed beside the mountain bike trail, prior to its junction with the Kennedy Highway at chainage 1.13km.</p>

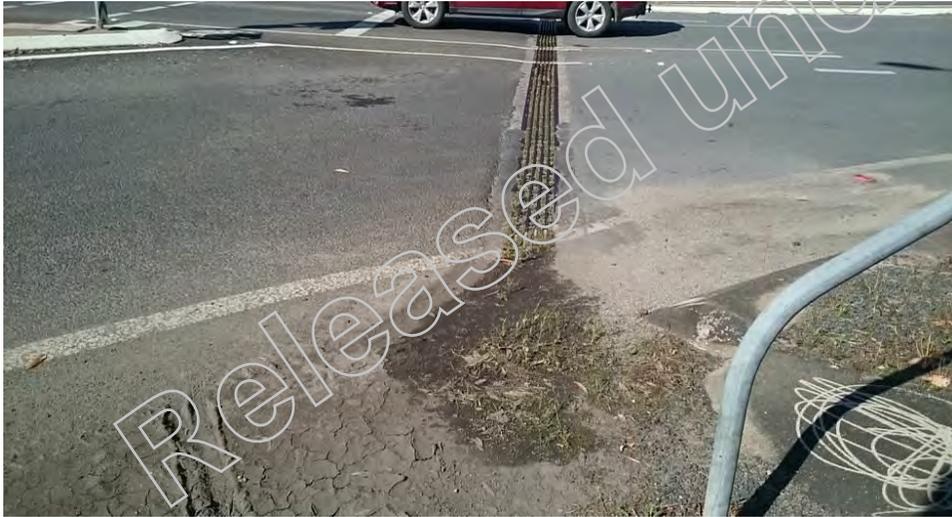
<p>Photograph 54: Example of gully pit and strip drain blocked with dirt at the Myola Road intersection.</p>

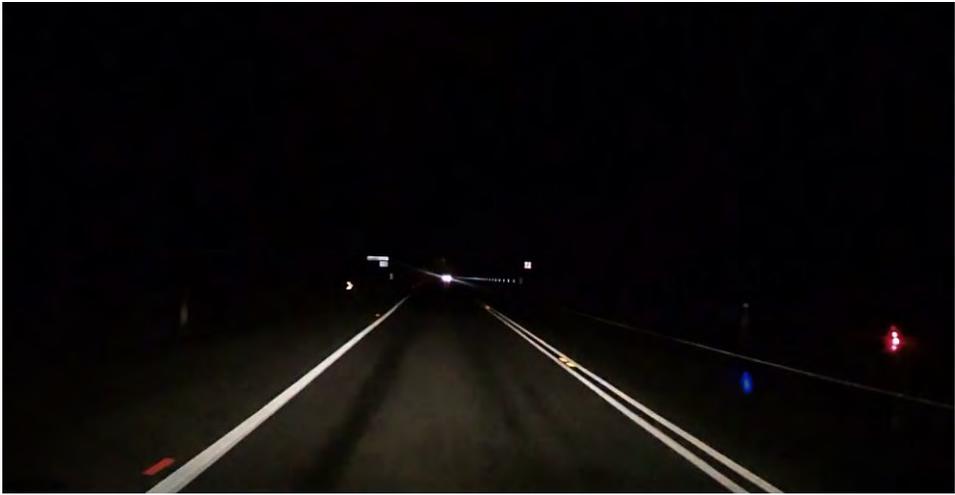
<p>Photograph 61: Eastbound view on approach to the western abutment of the Barron River Bridge showing the absence of lighting at the location where pedestrians cross</p>
