Memorandum

Our ref MSC 1546 - 2020
Your ref
Date 30 January 2020

Subject Rockhampton Ski Gardens Incident 1 January 2020

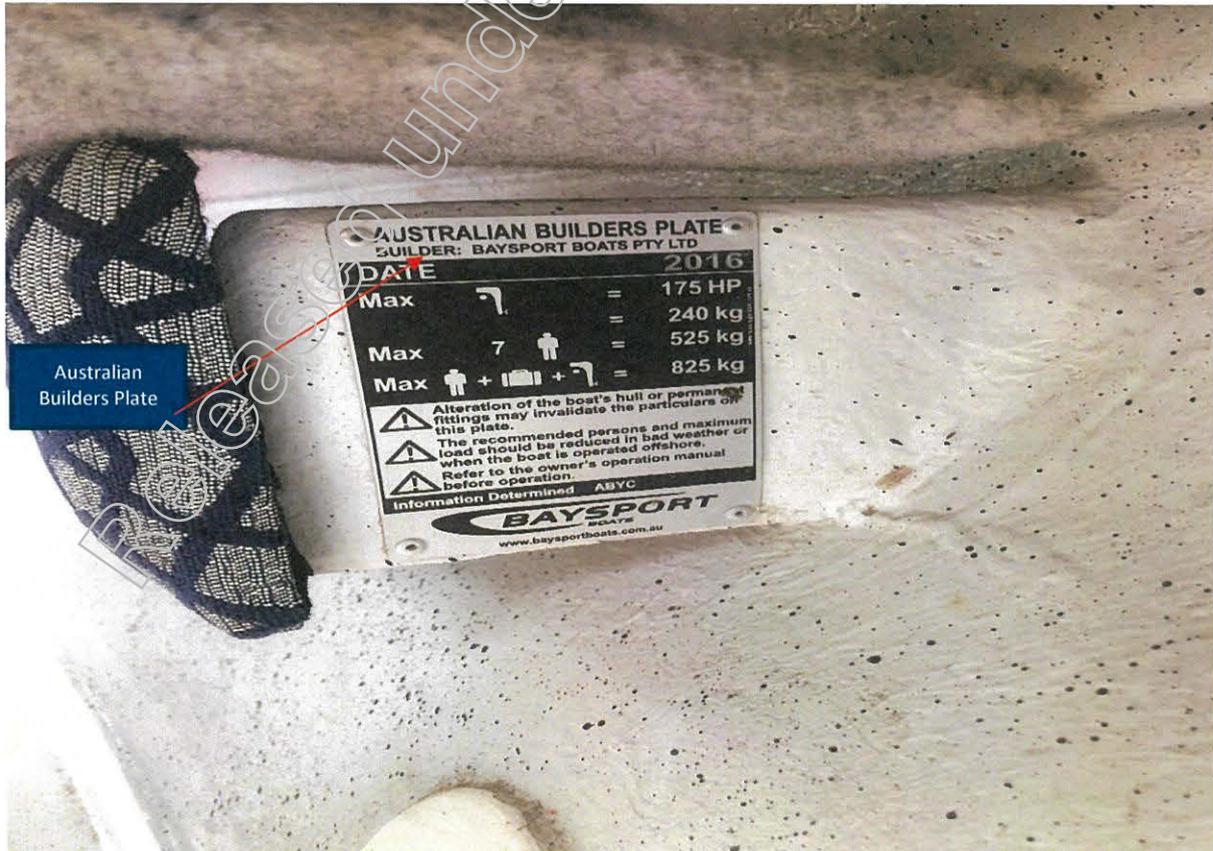
In regard to the builder's plate, the maximum persons stated is seven (7). The weight of seven passengers with luggage is taken into account when following the standards used for number of passengers. Queensland does not accept a child is half an adult. This will be discussed further in a report submitted by MSQ naval architect Mark Deveraux.

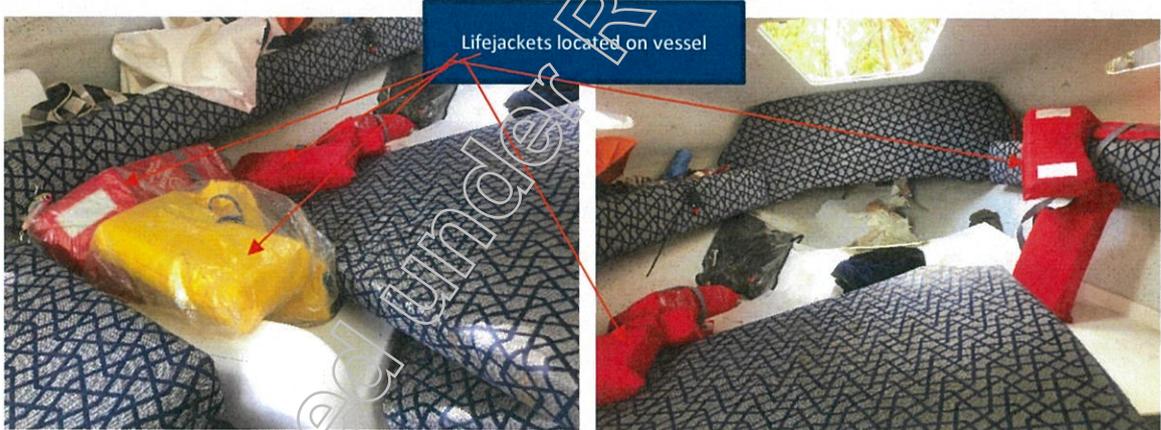
Investigators during their investigations found that the QPS had seized 6 life jackets, however, not all of the life jackets had been worn by all the children. It is unknown which child wore which lifejacket. In any case, the vessel being used was over 4.8 meters in length. The children would not have to wear life jackets on this vessel at the time of use.

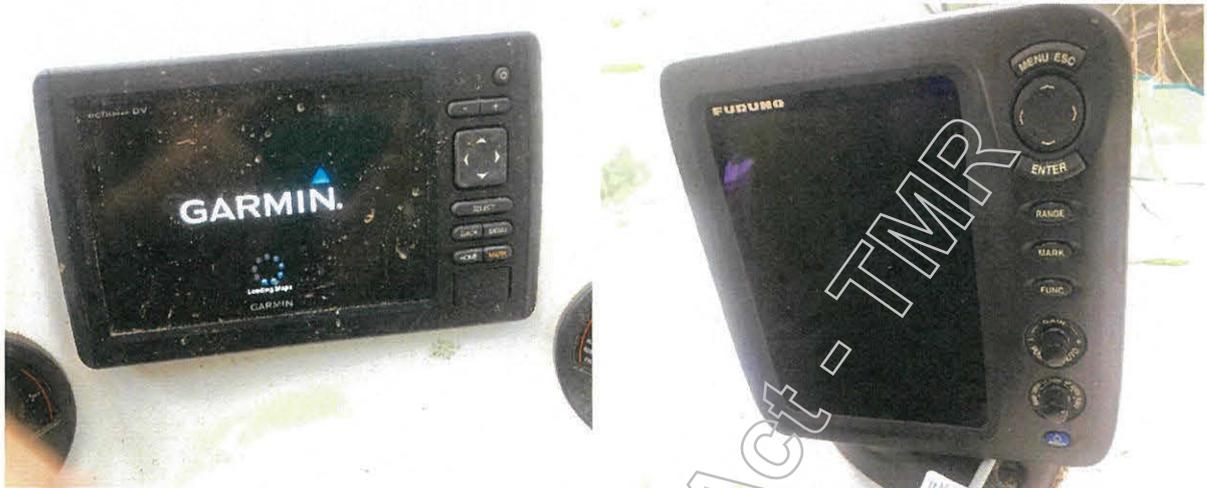
The Furuno depth sounder did not record any of the soundings on the day as it does not have a recording mechanism within its internal workings.

The Garmin GPS unit has recorded the day's travels on the water, however, did not record the last 200 meters of the vessel tracks before the incident occurred. It is unknown why the unit has not captured the last 200 meters of the vessels journey. However, the unit recorded the moment officers switched the unit on, when they attended the scene on 2 January 2020.

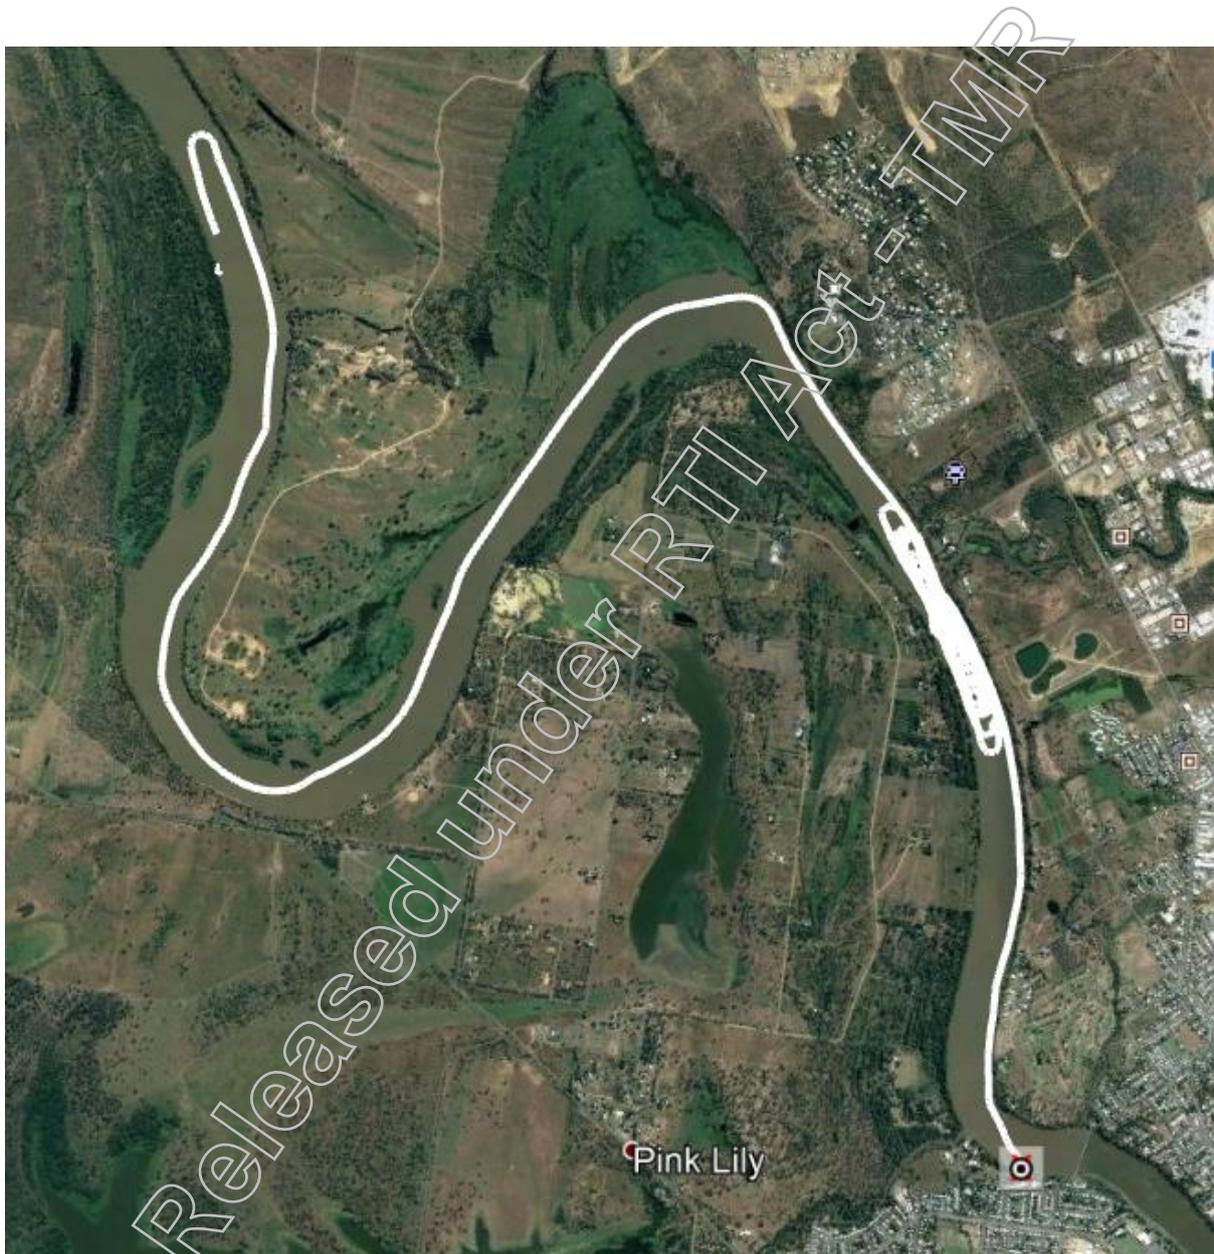
Diagram 7 - Active log 011 showing the vessel track for 1/1/2020.

On the day of the incident 1/1/2020, active log 011 recorded the vessel's movements from the time of launching at the ramp, then several ski runs and through to where the recording ends upriver.

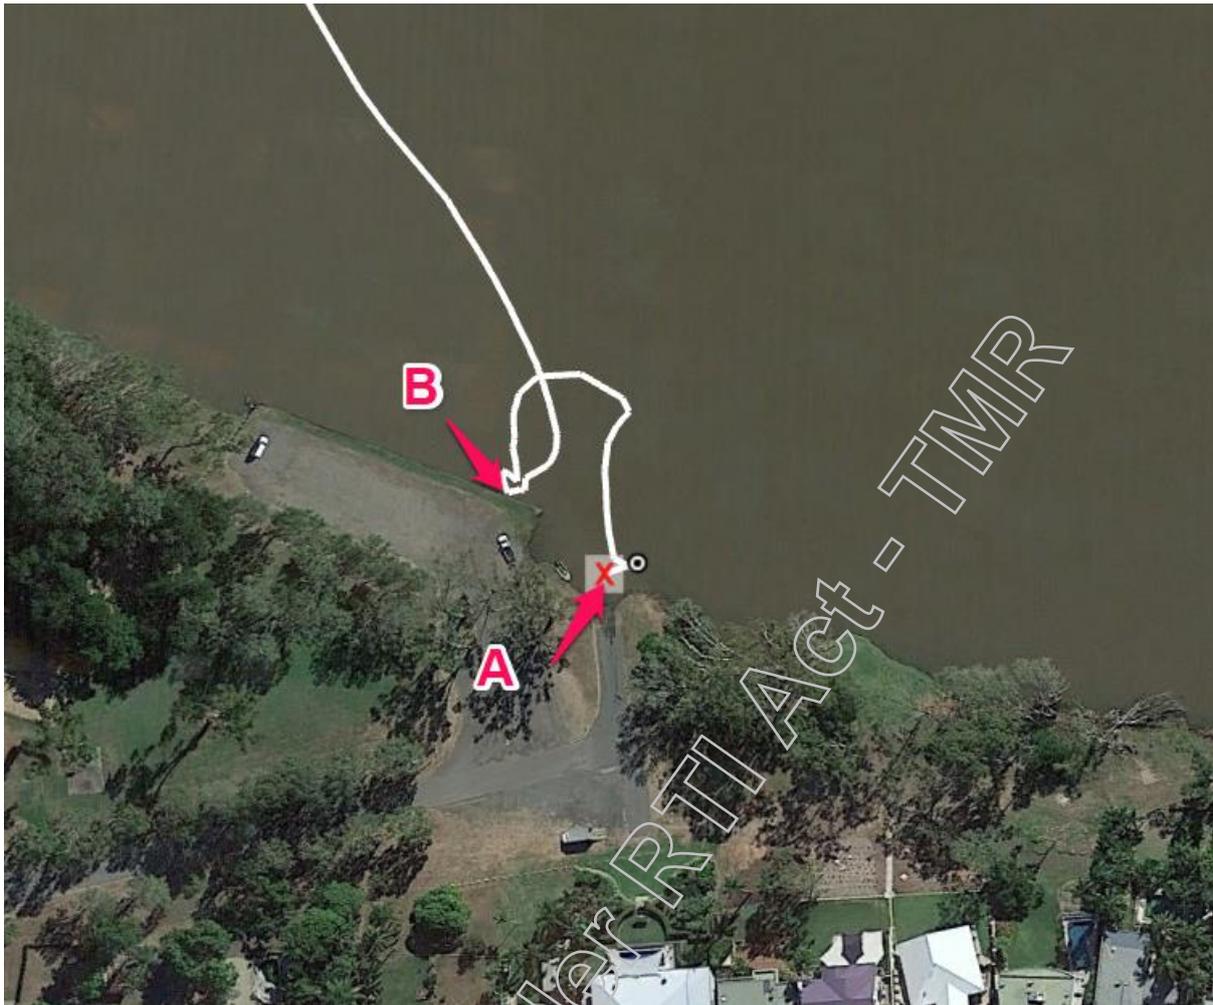
Diagram 8 shows at Point A launching at 12:41:24 on 1/1/20.

Point B alongside the bank probably picking up passengers at 12:46:12 1/1/20.

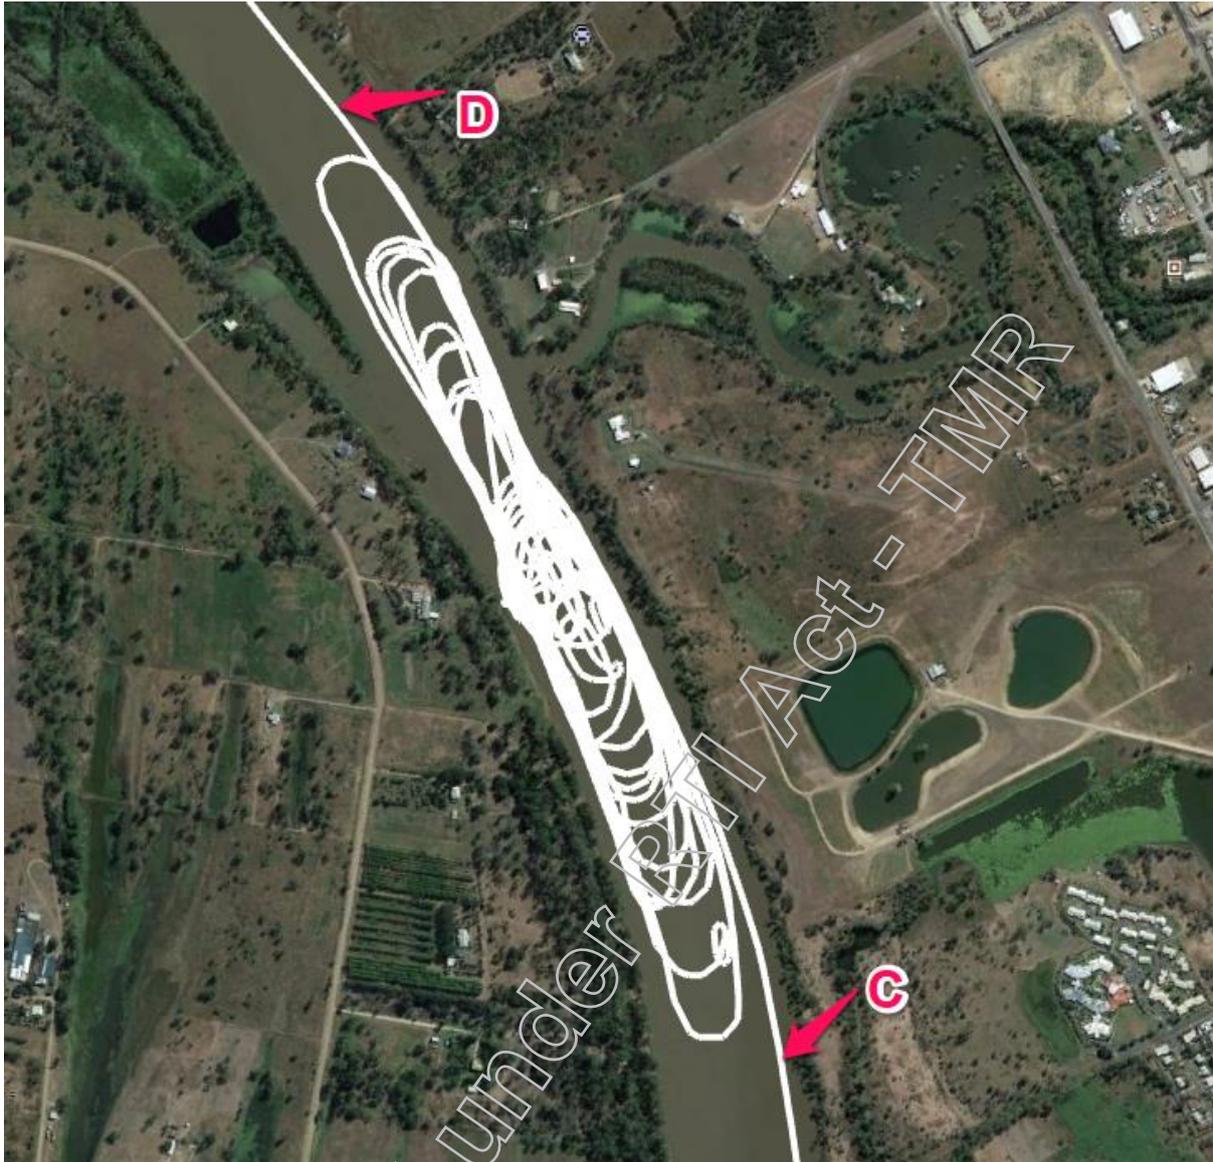
Diagram 9 shows the vessel doing several ski runs.
