Road Safety Audit Existing Stage

**Western Arterial Road
(Toowong – Everton Park)
Chainage 1.40km – 2.00km**

Prepared for Department of Transport and Main roads (Metropolitan Region)

Road Safety Audit (Existing Stage): Western Arterial Road U18B (Toowong – Everton Park), Chainage 1.40km – 2.00km

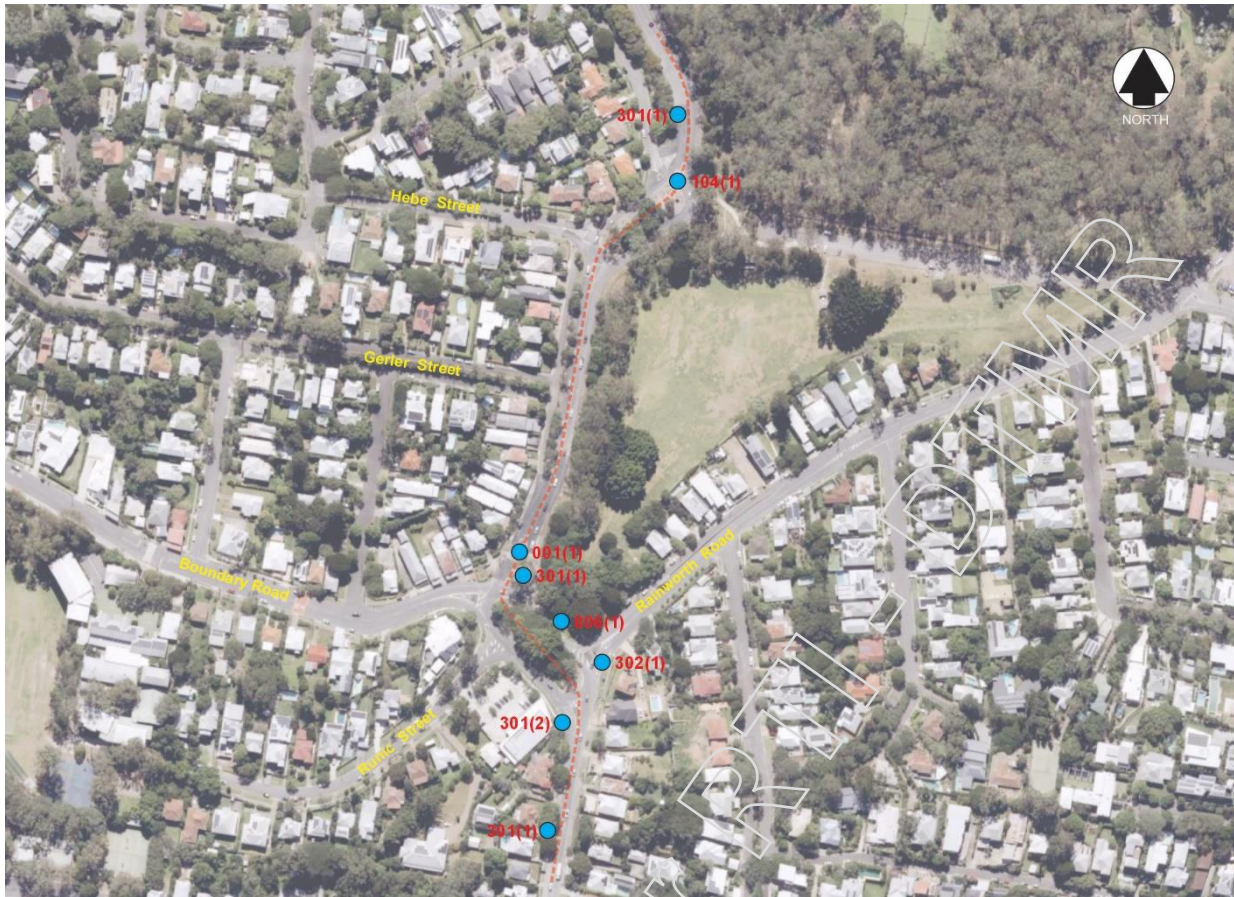
Figure 3: Location of recorded crashes.

Key findings from of the crash report are:

- Seven of the nine crashes involved multiple vehicles at intersections
- Six of the nine crashes involved vehicles failing to slow or stop at intersections, resulting in 'rear-end' type incidents
- Five of the nine crashes resulted in vehicle occupants requiring medical treatment
- Seven of the nine crashes occurred during daylight hours
- Two of the nine crashes occurred when the pavement surface was wet
- One incident involved a pedestrian being struck at the only marked 'zebra' crossing located within the audit site (just prior to daylight at approximately 5am).

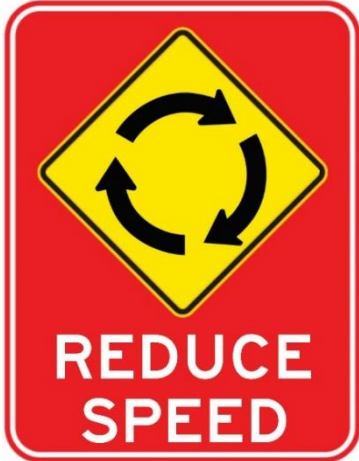
<p>Figure 6: Recommended Target Board (TC1308) with a ROUNDABOUT (W2-7) warning sign.</p>	<p>L = Unlikely S = Serious P = High (FSI)</p>

<p>Photograph 42: Existing warning sign on northbound approach to southern roundabout.</p>	<p>Recommendation 6.4.3.1: Remove the three existing ROUNDABOUT warning signs and posts. Install four (one on each approach to the northern and southern roundabouts) Target Board (TC1308) with a ROUNDABOUT (W2-7) warning sign. Consider in conjunction with Recommendation 6.4.2.1 (with regards to the existing REDUCE SPEED sign) and other approved signing works. Prioritise action accordingly.</p>

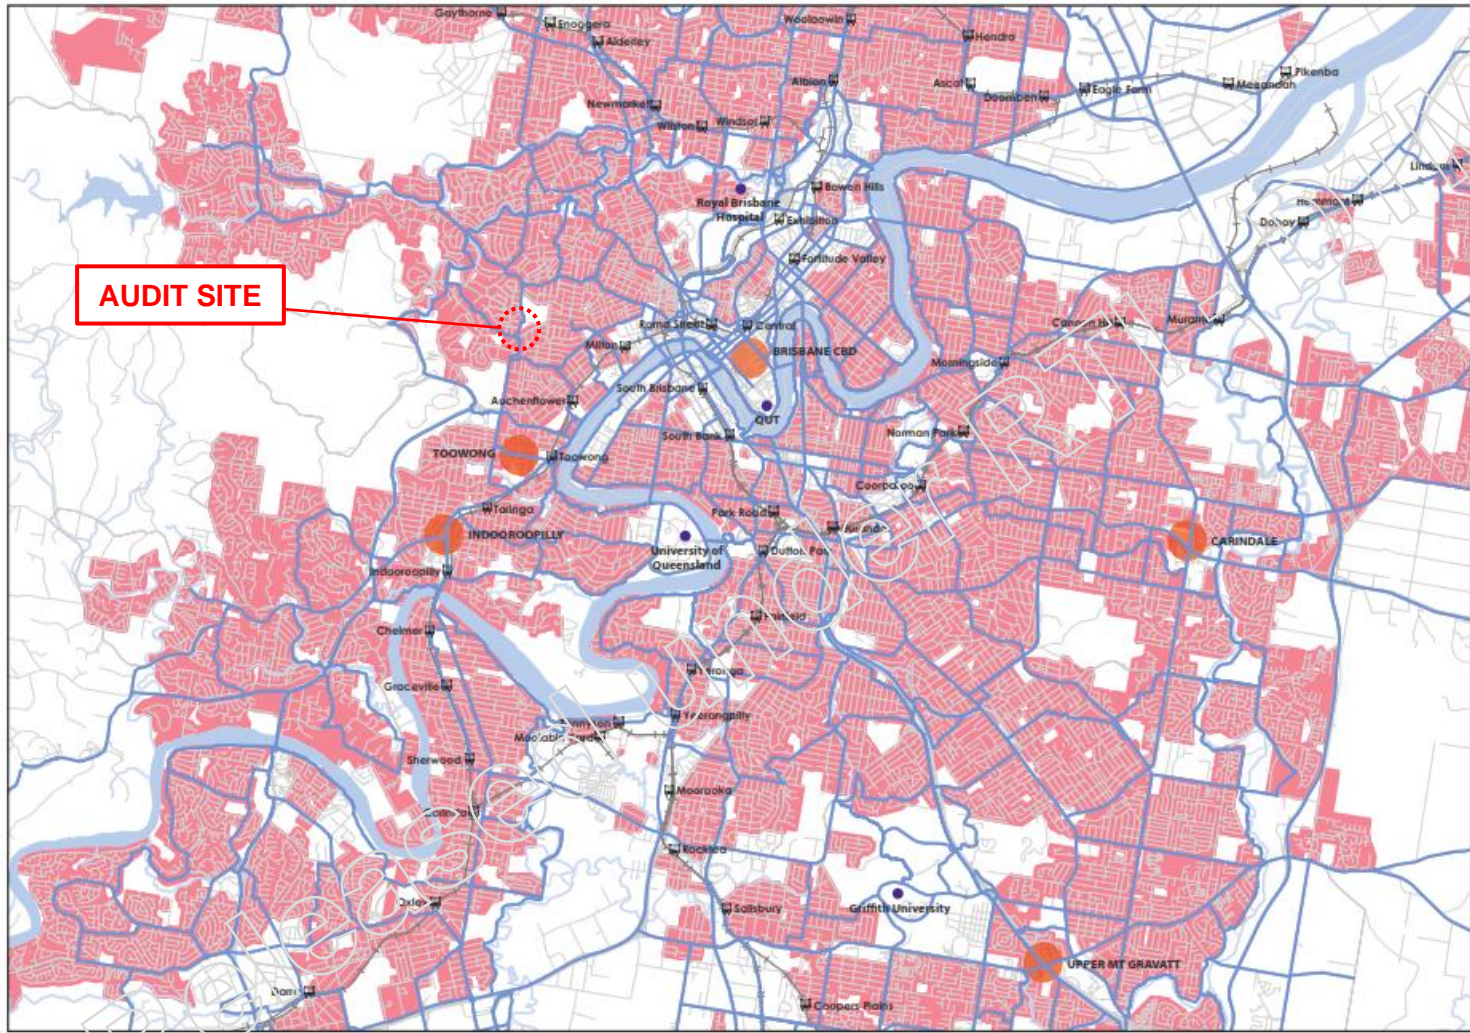
Item no.	Audit findings	Suggested action	Priority
6.8.3	<p>Dedicated bicycle lanes or formal shared bicycle/pedestrian paths were not provided throughout the audit site. TMR's <i>Principal Cycle Network Plan (2016)</i> indicate Western Arterial Road and Boundary Road (western leg off southern roundabout) are both principal cycling routes.</p> <p>During the day inspections a small number of on-road cyclists were observed navigating the southern roundabout. A number of cyclists were also observed to use off-road paths to cross Western Arterial Road at the 'zebra crossing' located on the northern leg of the southern roundabout.</p> <p>The layout of both roundabouts presented safety risks for on-road cyclists. Enhancing safety for cyclists would be highly beneficial and could be achieved using one or more toolbox treatments provided in TMR's guideline <i>Providing for people walking and riding bikes at roundabouts (2022)</i>.</p>	<p>Recommendation 6.8.3.1</p> <p>Review and verify the status of principal cycling routes in relation to the audit site. Where there is a need for enhanced cycling infrastructure within the audit site, incorporating appropriate toolbox treatments outlined in TMR guidelines as part of upcoming upgrade projects or future planning initiatives. Where funding is limited, consider a staged implementation and prioritise actions accordingly.</p>	<p>L = Unlikely S = Serious P = High (FSI)</p>

Figure 7: Extract from TMR’s *Principal Cycle Network Plan (SEQ) 2016*. As indicated on the map, Western Arterial Road and Boundary Road are identified as principal cycling routes.
