**Transport and Main Roads**

**Serious Injury Collision, St Vincents Road, Banyo  
14 September 2012**

**Final report, rail incident investigation TMR 4617**

**Publication date**  
April 2013

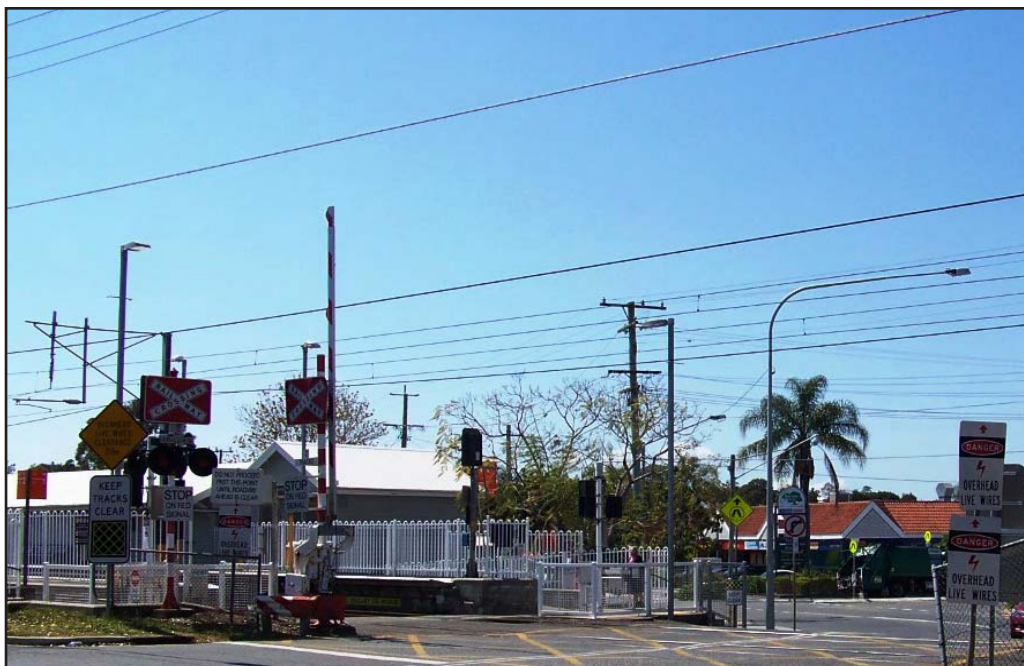
Figure 11: St Vincents Road level crossing

All of the recommended upgrades were completed in mid 2003 (refer to Figure 11). On 12 September 2012, the RTO assessed the St Vincents Road pedestrian level crossing as part of scheduled inspections. During this assessment, the RTO did not observe any issues relating to the road level crossing protection.
