Structures Inspection Manual

Part 3 - Appendix G: Breakdown of Complex and Non-Standard Structures

September 2016

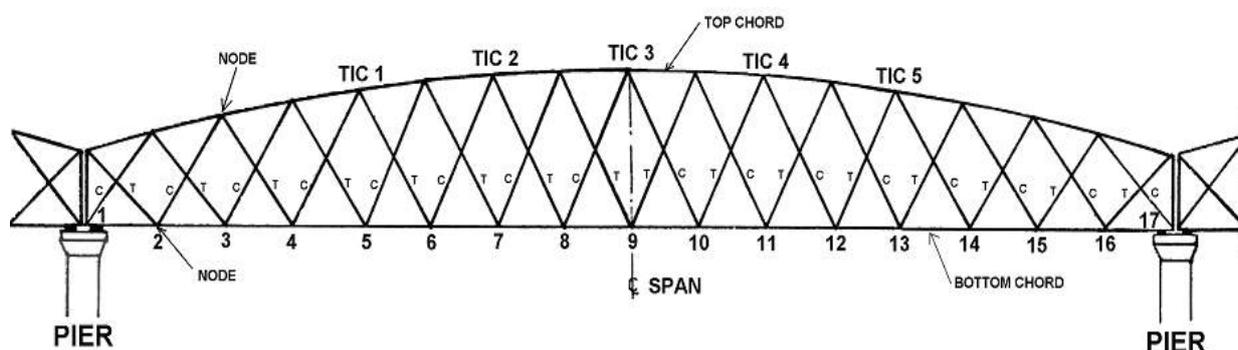
Figure G1: Extract from Burnett River Bridge Inspection

Figure G-1 shows an extract from a detailed inspection of the Burnett River Bridge. The extract shows the breakdown of a complex component (23S – Through Truss) into individual elements, and the rating of each element in accordance with the *Structures Inspection Manual*.

Above Bridge Inspection

BURNETT RIVER BRIDGE - TRUSS

CS = Condition State	C = Compression Member	T = Tension Member	BC = Bottom Chord
TC = Top Chord	N = Node	TIC = Tie Chord	BA = Bracing Angle
