Appendix D Non- Destructive Testing

**Queensland
Government**
Department of
Main Roads

3 Investigation of the "Lixi Profiler" (nuclear densometer) NDT Method

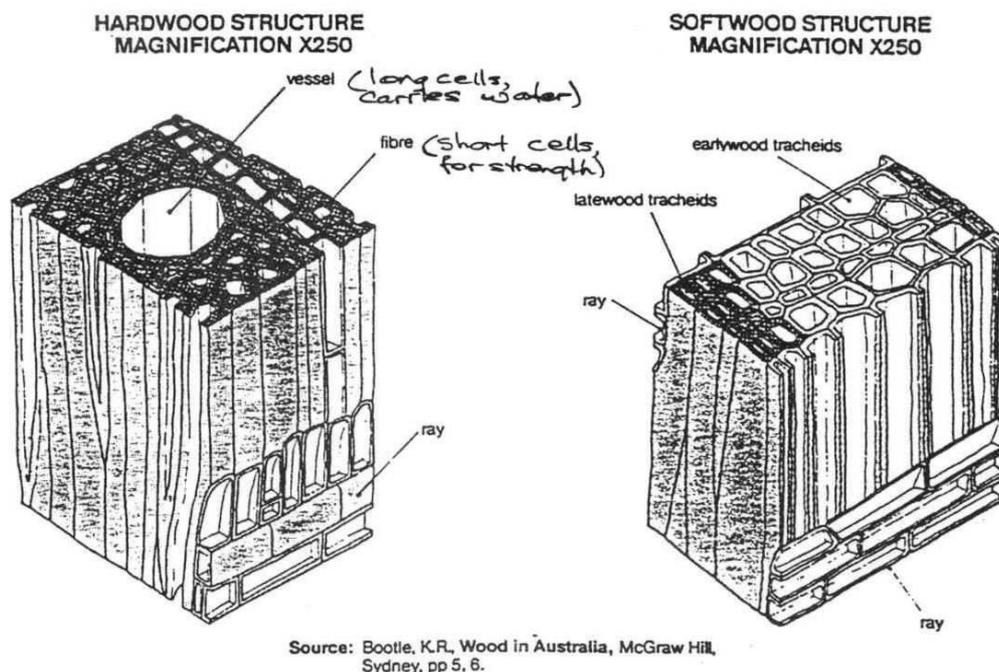
The structure of timber is essentially a collection of longitudinally oriented cellulose cells, cemented together by lignin, a complex polymer compound which also strengthens the cell walls. Figure 1 shows magnified structures for hardwood and softwood timbers and is included to show the general assemblage of wood cells. The structure of hardwoods is more complex than those of softwoods.

Figure 1 - Wood Structure

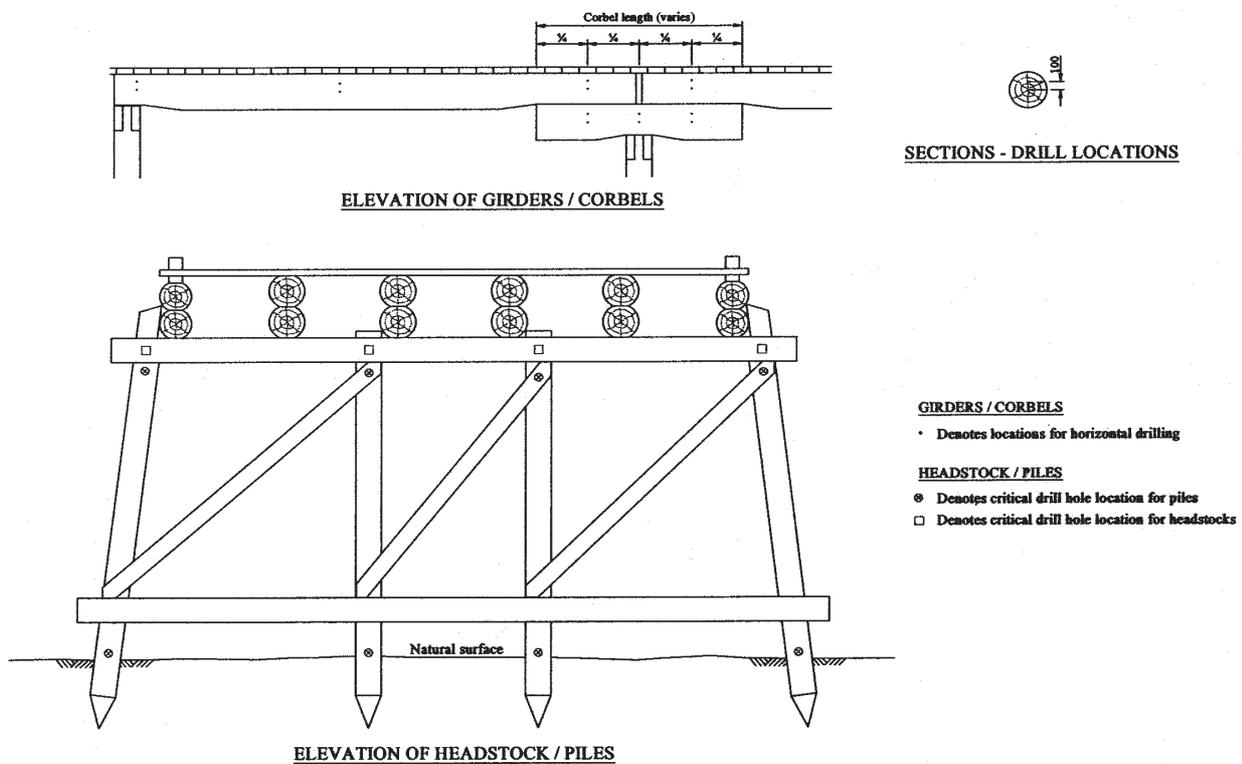
DRILLING REQUIREMENTS

Figure 3 – Guidelines for Drilling Timber Members

The following guidelines for drilling tests are provided in addition to the current guidelines detailed in the BIM, and should be read in conjunction with Figure 3. These guidelines have been developed by BAM based on typical deterioration of timber bridge members, critical locations for assessment of member capacity and guidelines developed by Road Traffic Authority of New South Wales (RTA) and Western Australia Department of Main Roads.

- At the initial inspection the drilling test holes should be made at the locations illustrated in Figure 3 and these holes should be plugged and probed at subsequent inspections to monitor and quantify progressive deterioration.
- Test holes should be plugged with wooden dowels, which have been treated with an approved preservative to reduce the potential for accelerated deterioration.
- Care should be taken to avoid drilling completely through the members, and horizontal drills should be inclined slightly upwards to allow drainage.
- It is recommended that drill holes be made perpendicular to the face of the member such that the recorded deterioration is relative to the section size.
- Two test holes are required to be made through the cross section of girder and corbel members to identify deterioration in the centre of the section and also v-shaped deterioration in the top of member.

- Where deterioration is identified in the girders from the drilling tests at the locations illustrated in Figure 3, then additional drilling tests should be carried out at 500mm intervals along the member until a sound section is identified.
- Where deterioration is recorded in the drilling test at the pile/headstock connection, an additional drill should be made approximately 500mm along the headstock from the centreline of the pile.
- It is recommended that material samples be taken and submitted to BAM for species identification as detailed in an Advice Note on Timber Species Identification and Visual Grading, to be released by BAM in January 2004.

- Where deterioration is identified in the girders from the drilling tests at the locations illustrated in Figure 3, then additional drilling tests should be carried out at 500mm intervals along the member until a sound section is identified.

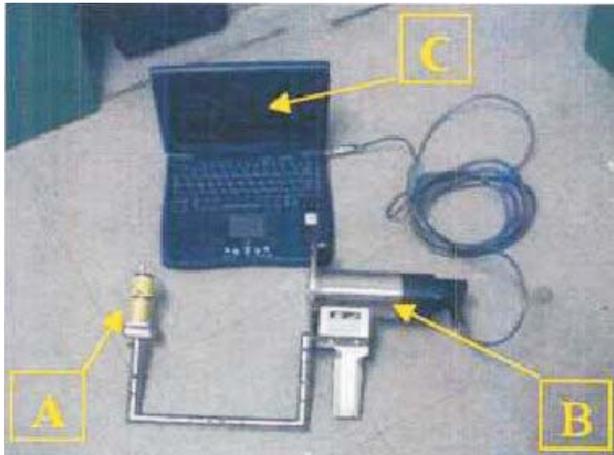
Figure 4a: "Lixi Profiler" Inspection system, consisting of an isotope (A), a micro channel-plate (MCP) detector (B), a laptop computer (C) running MS windows based proprietary software (Intico Pty Ltd)

The "Lixi Profiler" is a real time density measuring system, which produces a graph showing the net thickness of the timber section. The "Lixi Profiler" is illustrated in Figure 4 below. It uses a radioactive isotope, Gadolinium-153 (Gd-153) and generates a highly collimated beam of

radiation that penetrates through the timber section. The amount of radiation that reaches the detector opposite the source is proportional to the total thickness and average density of the material it passes through. The "Lixi Profiler" is calibrated against a solid section of girder timber and thus calculates and reports the thickness of the timber.

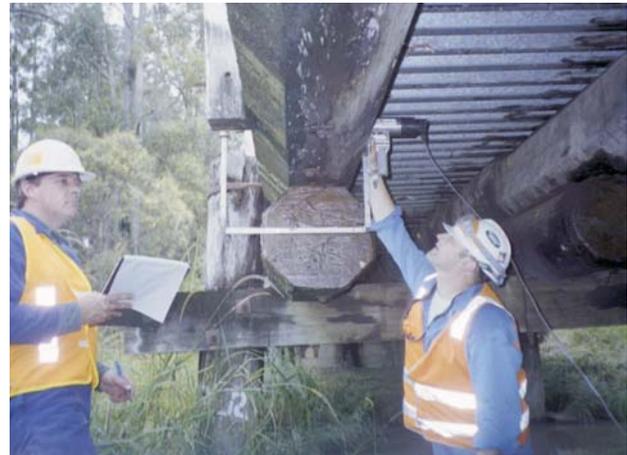
Figure 4b : "Lixi Profiler" in operation

For the purpose of the trials conducted to date the "Lixi Profiler" has been mounted in a U-shaped bracket and in some cases an extension arm has been attached to provide access to the girders from the ground level as illustrated in Figures 4b and 5a.

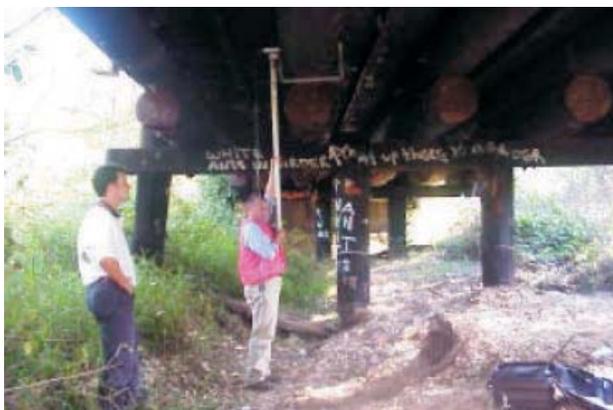
Figure 5a – General view of scanning with the "Lixi Profiler" (Intico Pty Ltd)

Initially the member is scanned longitudinally along the centreline of the cross section, to identify locations of deterioration in the centre of the member. Additional longitudinal scans at 50-100mm above the centreline of girders are also carried out to identify any deterioration in the top of the girder.

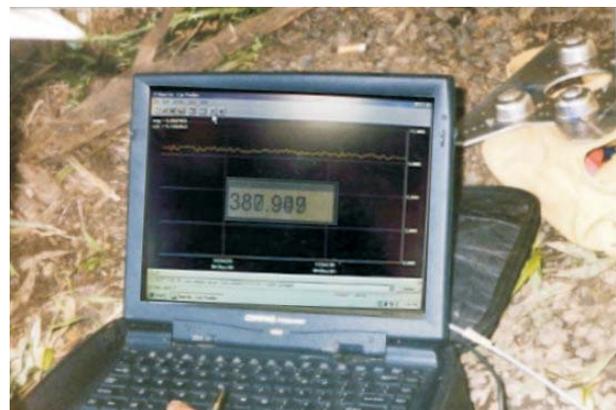
Figure 5b - Real-time results of the scan

In the field the real-time results of the scans are shown on the screen of the laptop computer as a determined material thickness in millimetres as illustrated in Figure 5b. In the trials conducted to date the thickness measurements have been recorded against the time of the scan. The real-time record of the scan allows areas of identified deterioration to be marked on the member for further investigation.

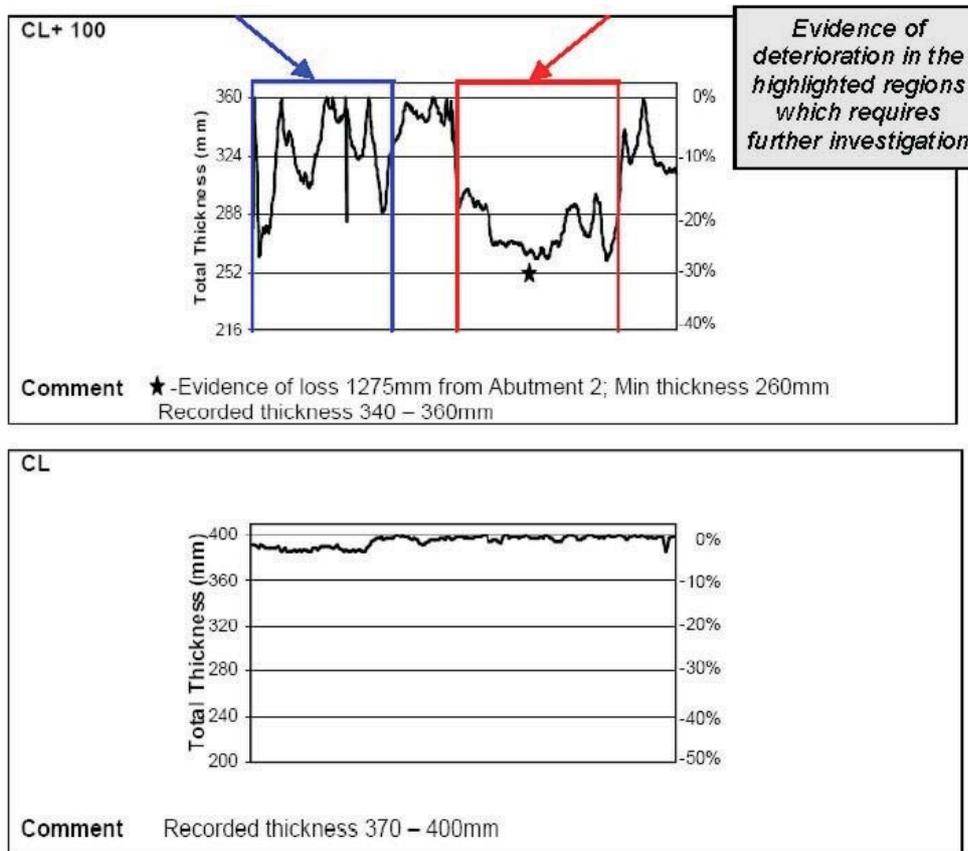
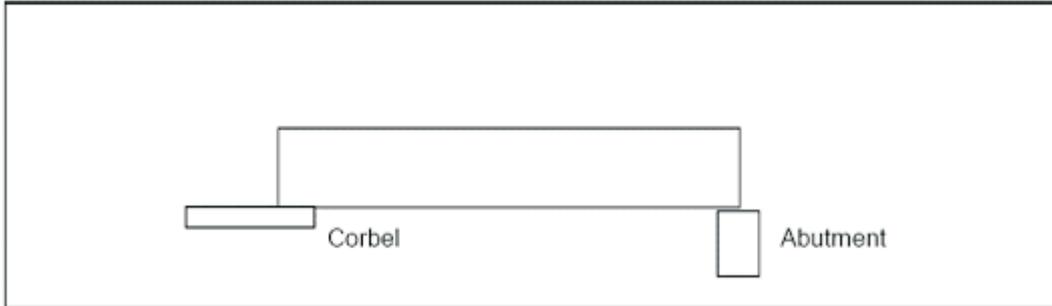
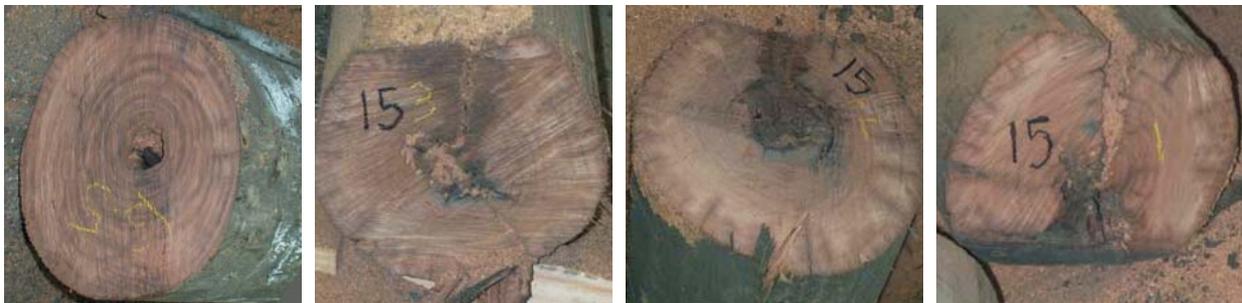
BRIDGE:	Bremer River
COMPONENT:	Girder 1
LOCATION:	Span 4

Figure 6 – Typical record illustrating the results of scans along a timber girder plotted against time and actual deterioration within the girder

The services provided by "Intico" for the trials conducted to date have included production of a report of the test scans. The records of the scans have indicated the determined material thickness and corresponding percentage loss of thickness against the time taken to complete the scan as illustrated in Figure 6. It has therefore been necessary to mark the location of deterioration on the member when it is identified. If the record of the scan is to be referenced at future inspections the location of deterioration needs to be adequately detailed on the record, thus it would be beneficial if the equipment was modified to provide a distance based record of the scan.

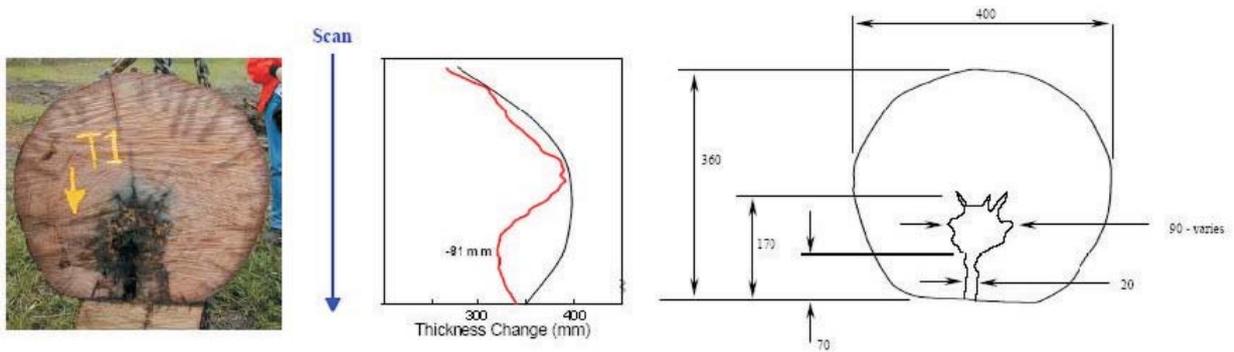
Thickness Loss	
Initial Longitudinal Scan	-60 mm
Transverse Scan (greatest loss)	-71 mm
Actual	-90 mm max

Figure G1-2: Details of Section T1 – Measurements and Appearance

Note – transverse scan shown is overlaid with approximate thickness indication for solid timber – this is an estimate only.

The results of a transverse scan with the "Lixi Profiler" are illustrated below in Figure 8. It is important that the outer dimensions of the member at the scan location are recorded and plotted (black line). The plot of the scan (red line) shows the recorded thickness through the member. Thus the change in thickness due to deterioration can be measured through the section and the location of the deterioration within the section identified.

Figure 7 - Transverse scans showing recorded deterioration and actual member cross section.

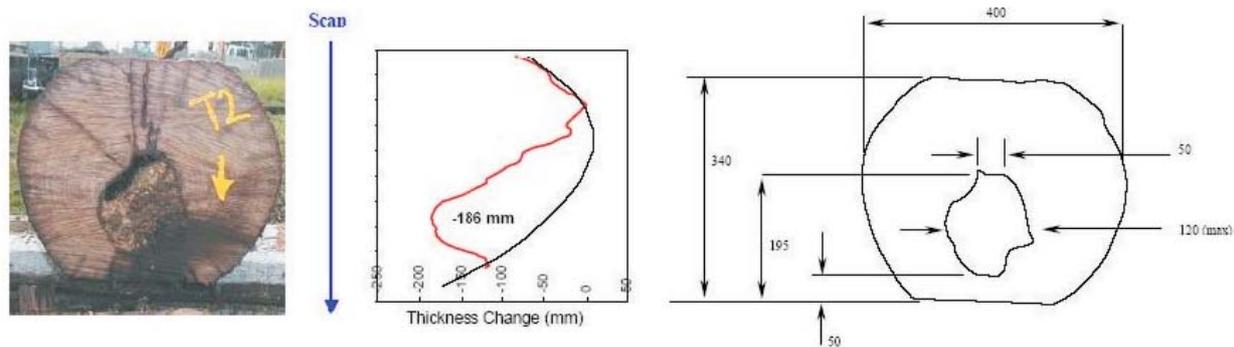
Thickness Loss	
Initial Longitudinal Scan	-80 mm
Initial Transverse Scan (before cut)	-80 mm
Transverse Scan after cut and cleaned	-110 mm
Actual	-120 mm max

Figure G1-3: Details of Section T2 – Measurements and Appearance

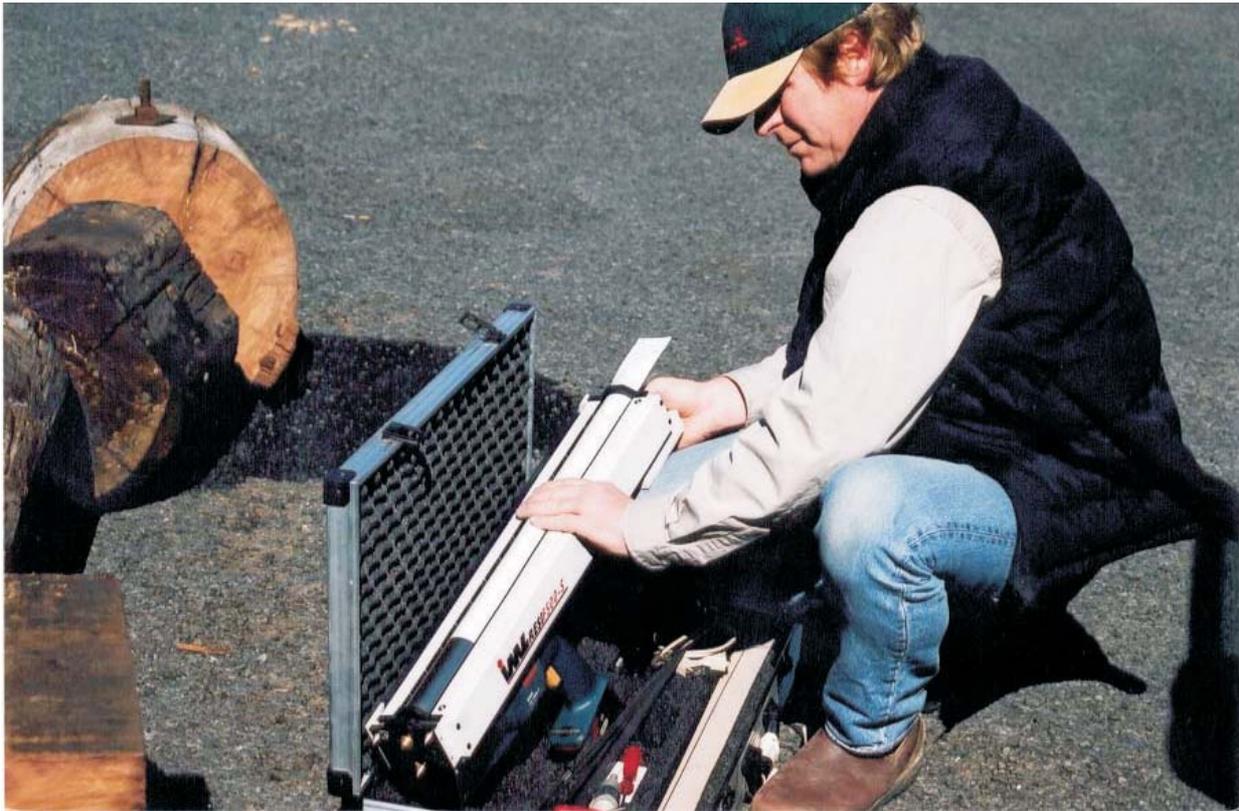
Figure 8- The "Resistograph" being loaded with paper to record the test.

The "Resistograph" drilling produces a real time print out and also stores the test results electronically. "TTA" processes the electronic data to highlight the deteriorated regions and provide comments on the assessment of the test.

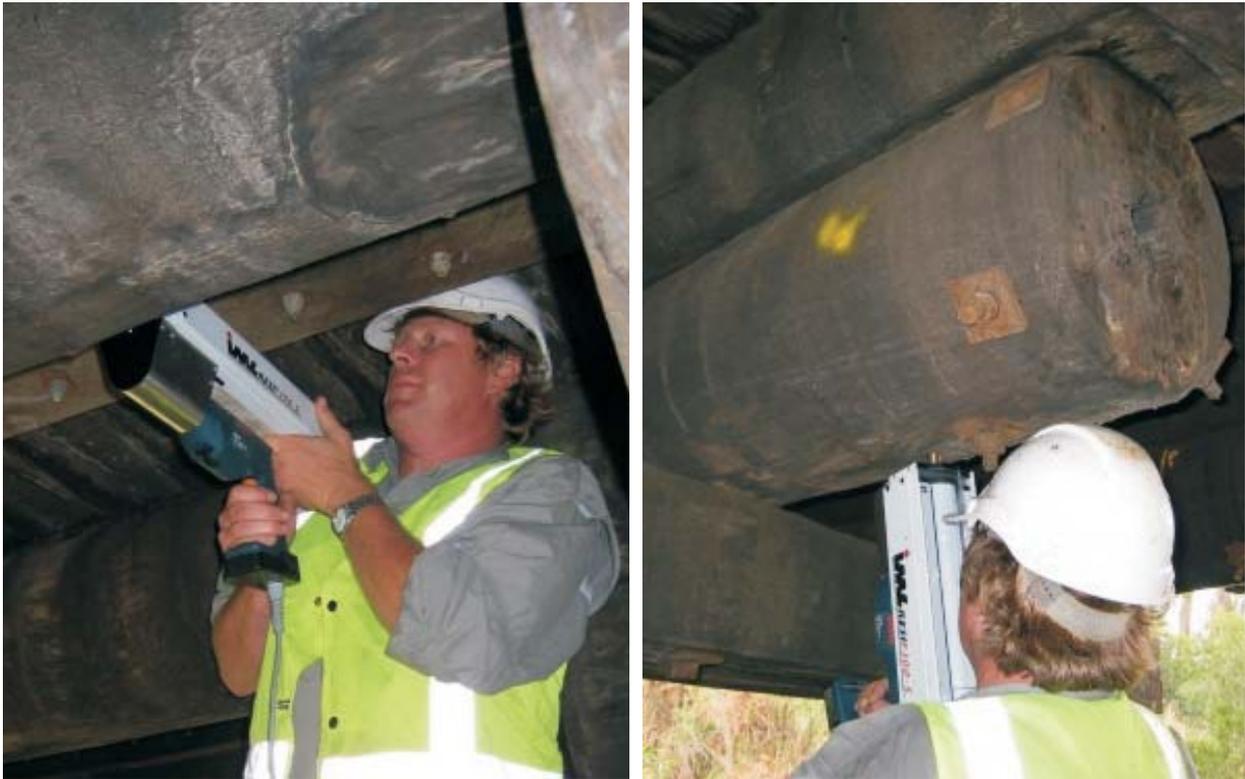
The "Resistograph" was aligned with the girder in accordance with the timber drilling guidelines.

Figure 9a - Horizontal test using the "Resistograph" Figure 9b - Vertical test using the "Resistograph"

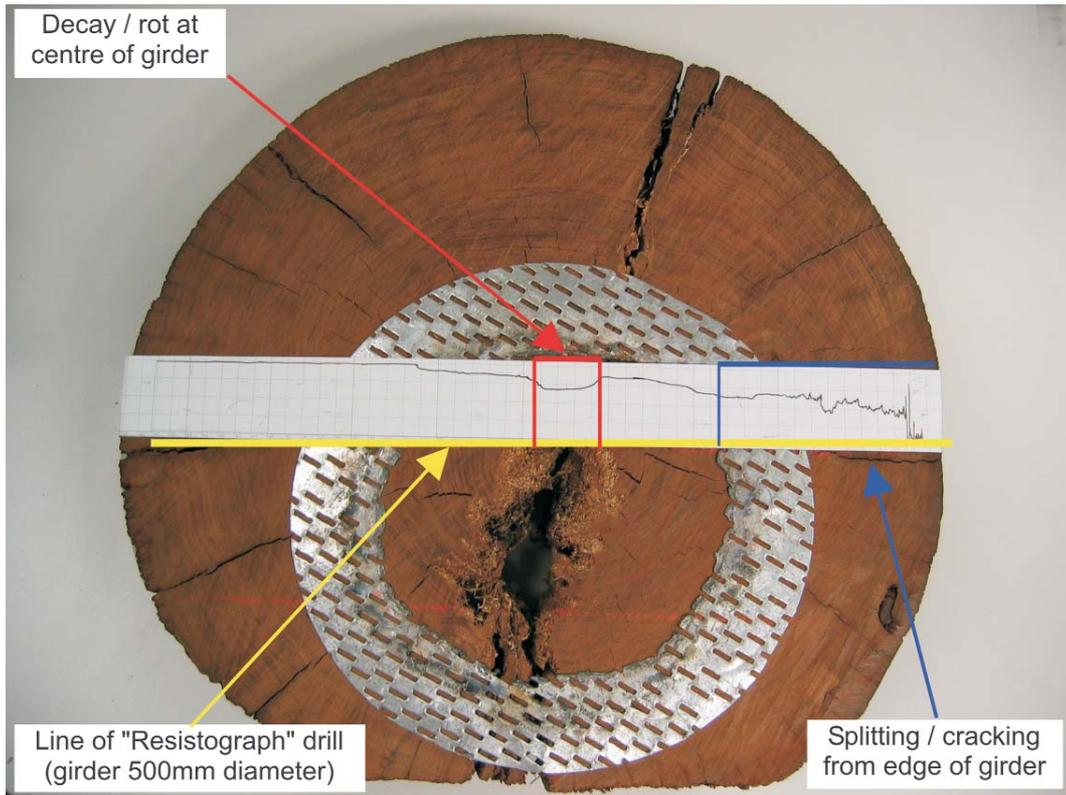
Figure 10 – Correlation between reduction in resistance and deterioration of section, in particular splitting/cracking from edge of girder and decay/rot in the centre of the section.

Several test members were cut into sections to verify the section properties. The correlation of the "Resistograph" test printout to the timber section is illustrated in Figures 10 and 11.

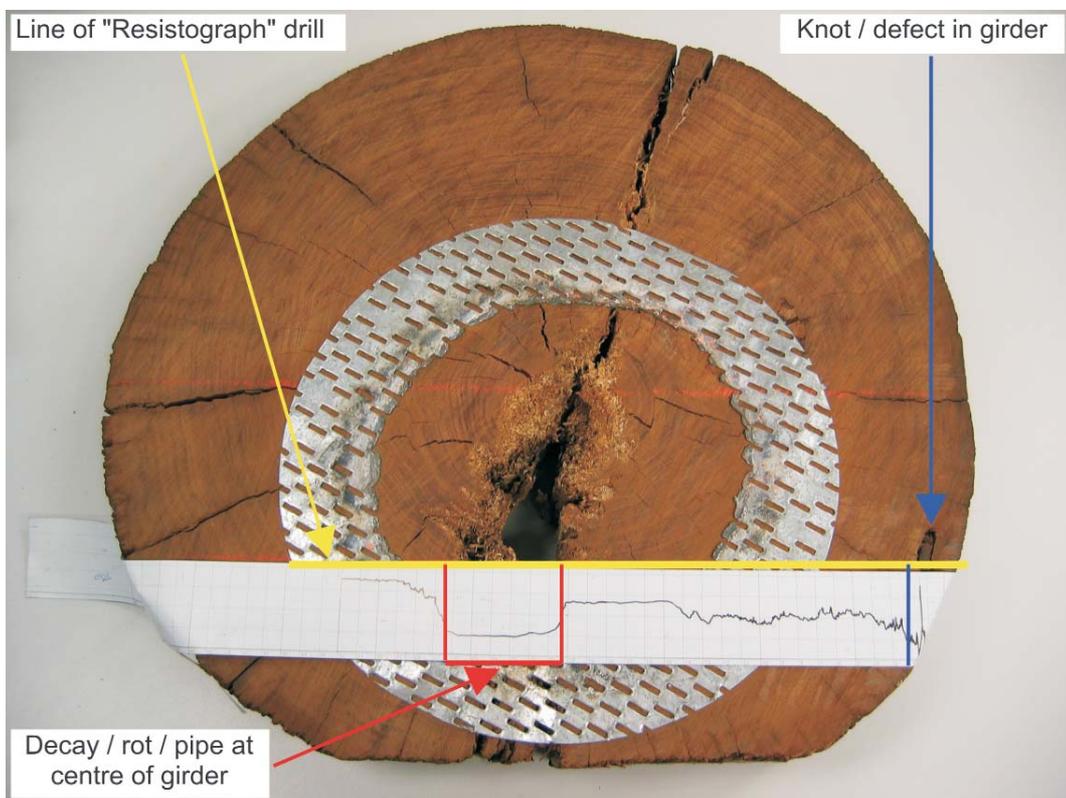
Figure 11 – Correlation between reduction in resistance and deterioration of section, in particular identification of knots/defects and decay/rot/pipe in the centre of the section.

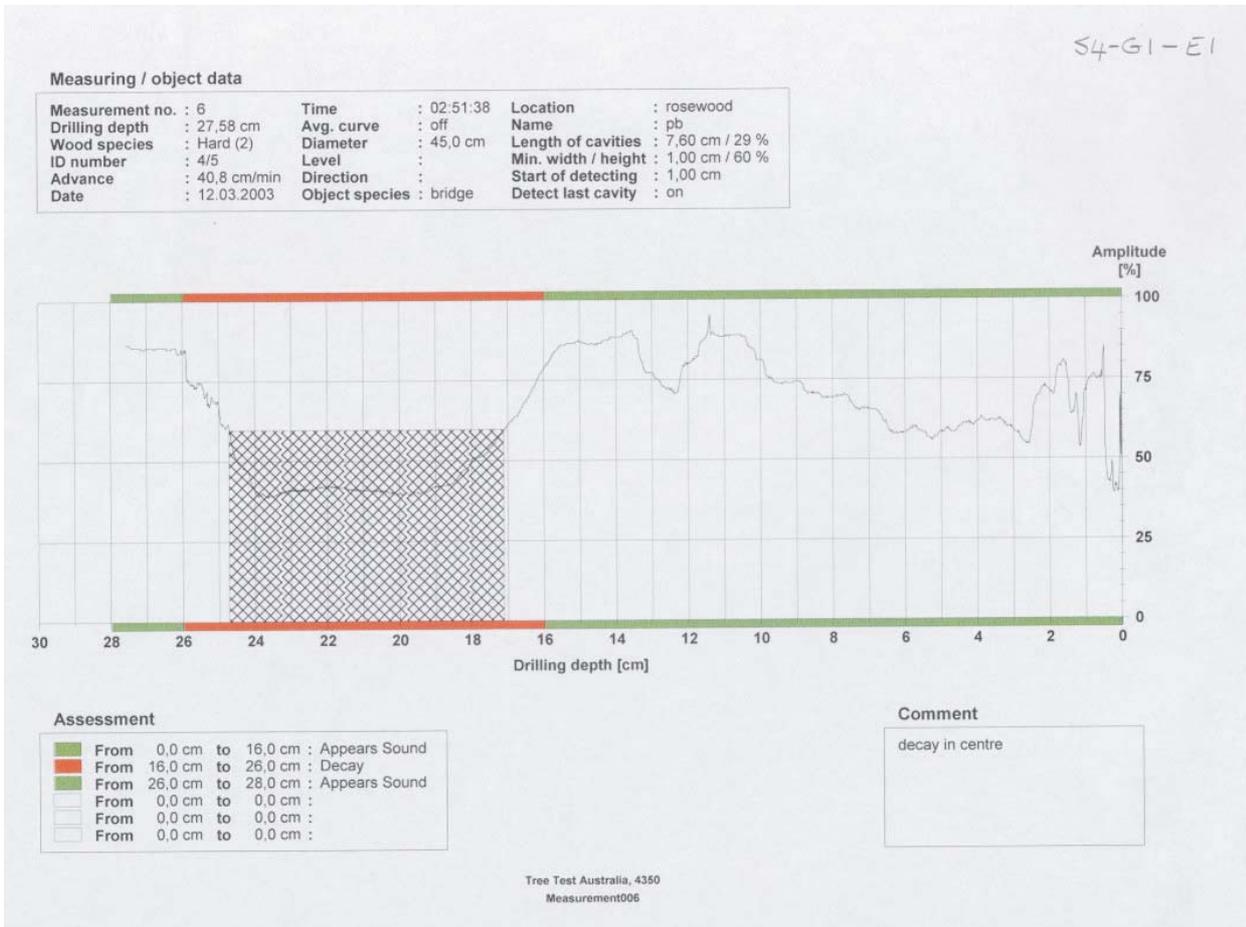
A typical processed drill report is shown in Figure 12. In general the results are presented clearly with both a visual and numerical interpretation of the degree of piping in the member. The use of this colour coding system provides the client with a detailed understanding of the state of the member.

Figure 12 - "Resistograph" processed drill record

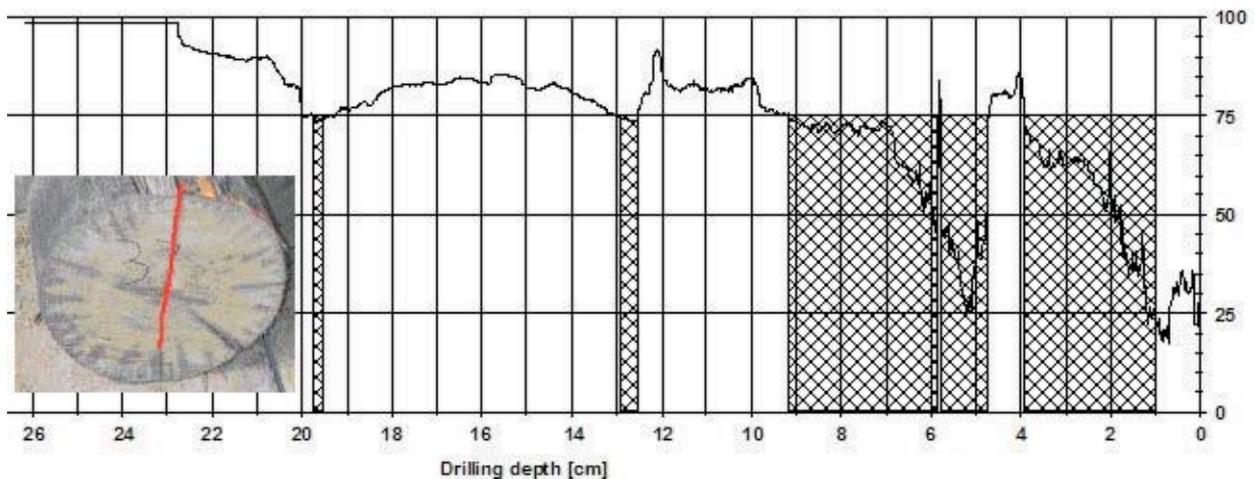
Figure 13 – Processed "Resistograph" test result with cracking in the outer 90mm of the section.

The red line on the picture of the girder in Figure 13 indicates the approximate "Resistograph" test path. Examination of the photo indicated that there are no voids in the first 1-9cm of the girder which were initially predicted from the "Resistograph" tests record. However, further examination of the cross-section revealed cracking extending towards the heart of the girder. Hence it was concluded that due to the timber being softer in the location around the cracks that the resistance is lower in the outer region of the girder.

Testing conducted in the laboratory on members with significant cracking defects, identified the importance of ensuring that the drill is not positioned directly on a crack or within 20mm of the crack to reduce the likelihood of the "Resistograph" following the path of least resistance, along the crack. This also highlighted the importance of conducting a visual inspection of the girder at the drill location and recording this information for use in conjunction with the "Resistograph" results, to ensure that cracks are correctly identified and not misinterpreted as pipe or rot defects within the member.

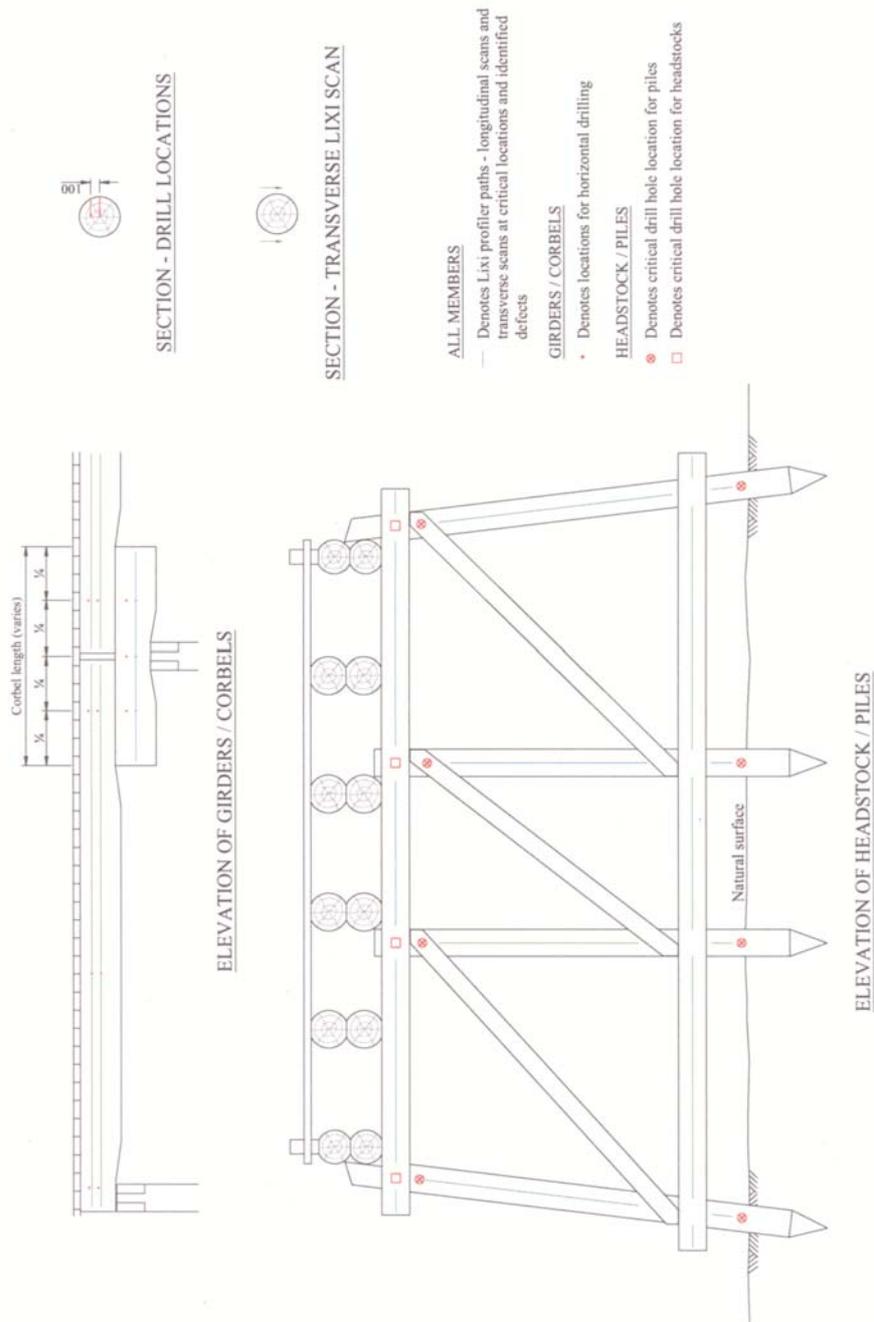
INSPECTION REQUIREMENTS

Figure 14 – Inspection Requirement

- Inspection of all members on a typical 4 span bridge with 4 girders per span and 3 piles per pier group will require approximately 126 drill holes using the "Resistograph" to drill at the locations illustrated in Figure 14. For a bridge which is easily accessible, it is estimated that it will take 2 days in the field to complete the inspection and cost approximately \$2000+GST. This cost includes the "Resistograph", 1 technician and associated reporting, and assumes that the District or RoadTek provide an assistant.

- The "Lixi Profiler" is required to be mounted in a centralizing jig/bracket and it is recommended that the record of the scan is distance-based.
- The recommended investigations using the "Lixi Profiler" and the "Resistograph" are described below and illustrated in Figure 14.

- Additional testing is also recommended at critical locations as illustrated in Figure 14 and at locations which appear suspect from visual inspection but were recorded as sound by the longitudinal scan, or any locations which were inaccessible with the "Lixi Profiler".
- All drilling should be conducted in accordance with the relevant guidelines for either the "Resistograph" or Conventional Drilling methods as detailed within this document.

- The recommended investigations using the "Resistograph" are described below and illustrated in Figure 14.
- Drilling tests with the "Resistograph" should be carried out at critical locations described in the BIM in addition to any areas which appear suspect.

- The "Lixi Profiler" is required to be mounted in a centralizing jig/bracket and it is recommended that the record of the scan is distance-based.
- The recommended investigations using the "Lixi Profiler" are described below and illustrated in Figure 14.

- Additional testing is also recommended at critical locations as illustrated in Figure 14 and at locations which appear suspect from visual inspection but were recorded as sound by the longitudinal scan.
