Part One Background

**Queensland
Government**

Department of
Main Roads

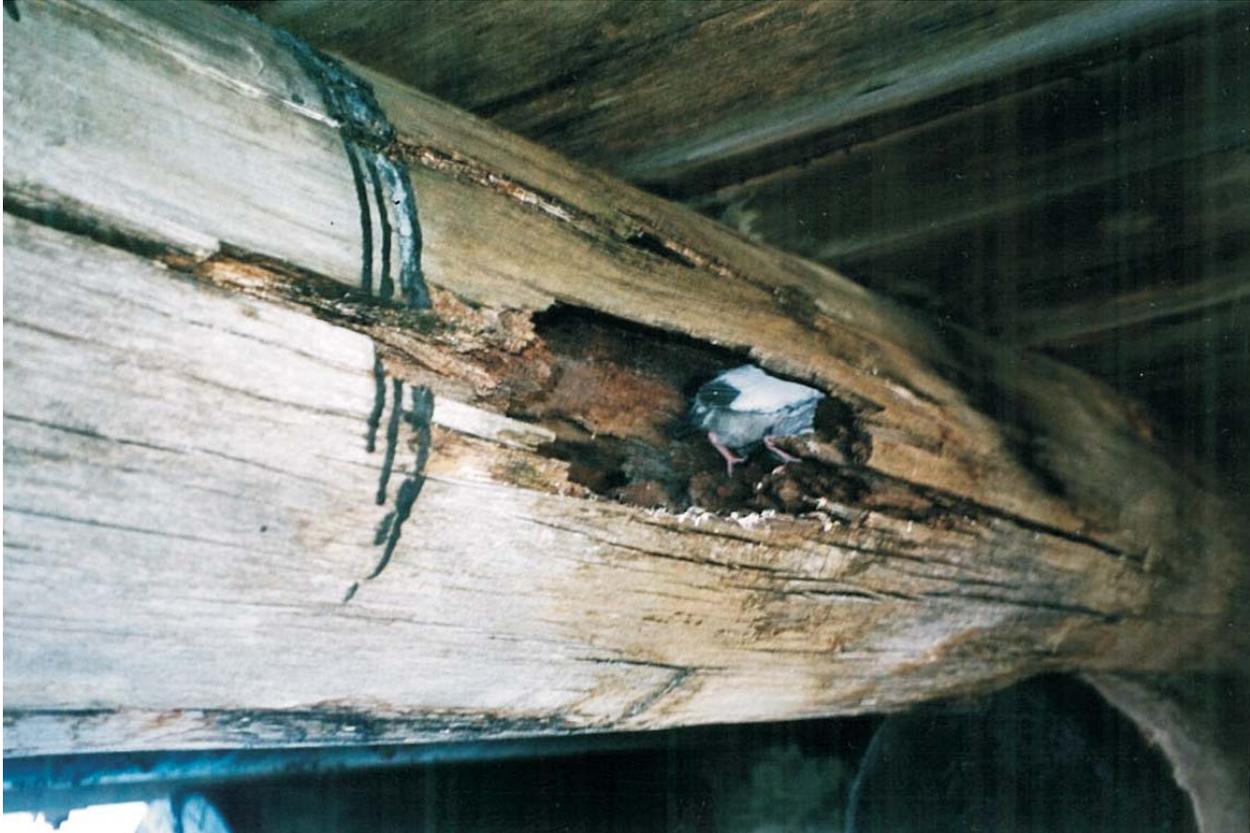
Figure 1.4(b) - Example

A Level 2 or 3 inspection has determined a timber girder to be in Condition State 4, with a major rot hole which is significantly affecting strength.

Severe rot hole in girder side

Referring to Part 3, Section 2.2 Timber Girders, for "severe surface decay and holes", the recommended activity is 22T2 - replace timber girder.

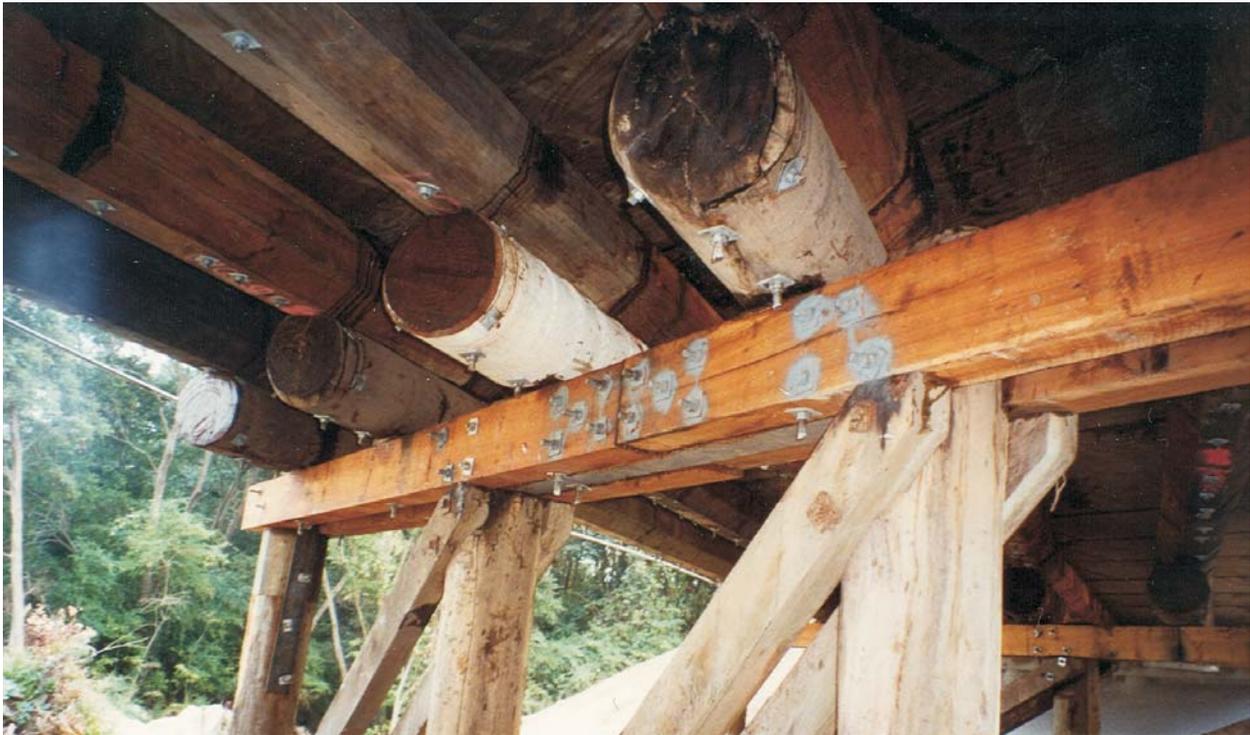
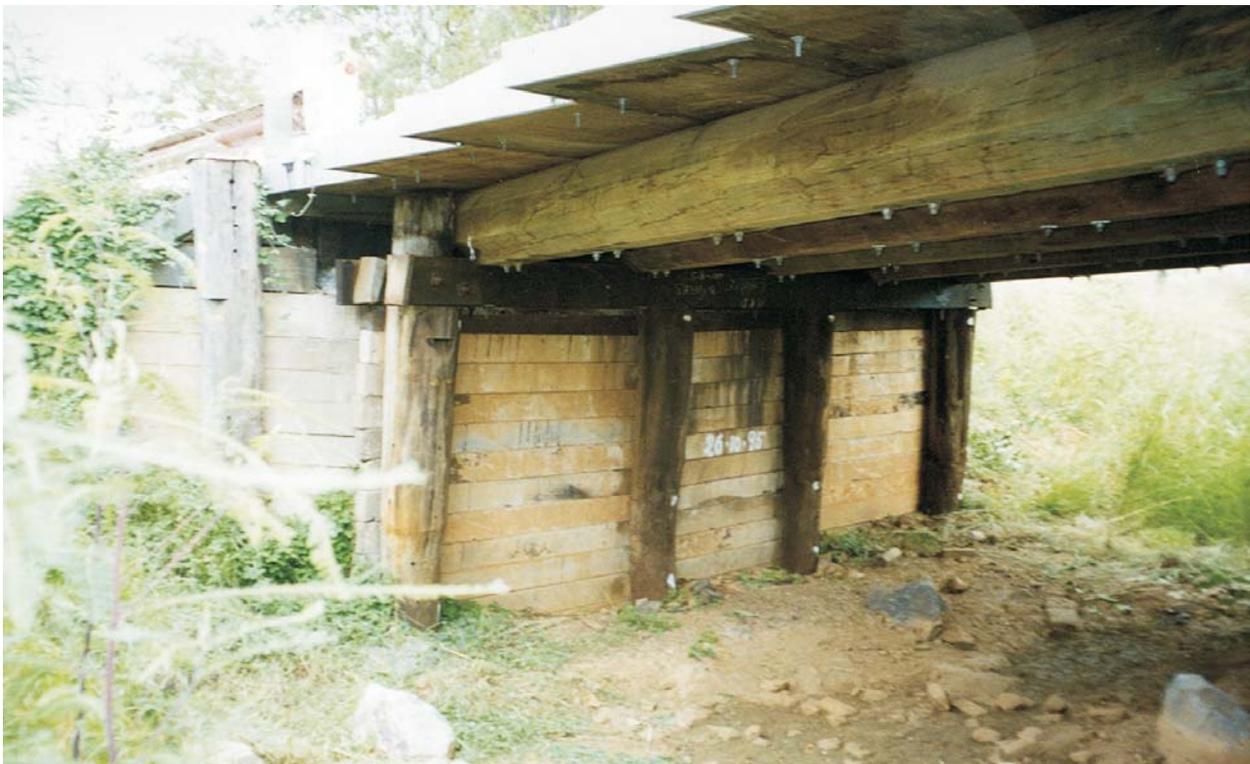
Figure 3.2(a) - Timber Bridge Photos (1)

Headstock - pier

Abut piles and backing slabs

Figures 3.2(a) & (b) show photos of the various components, while Section 3.3 includes a typical bridge drawing.

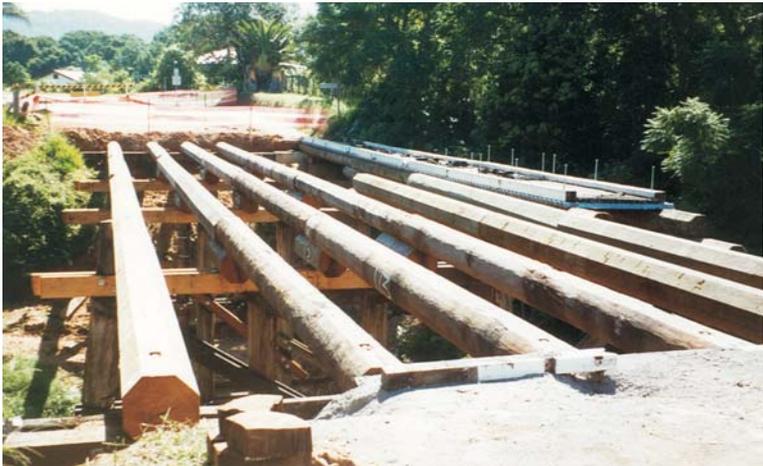
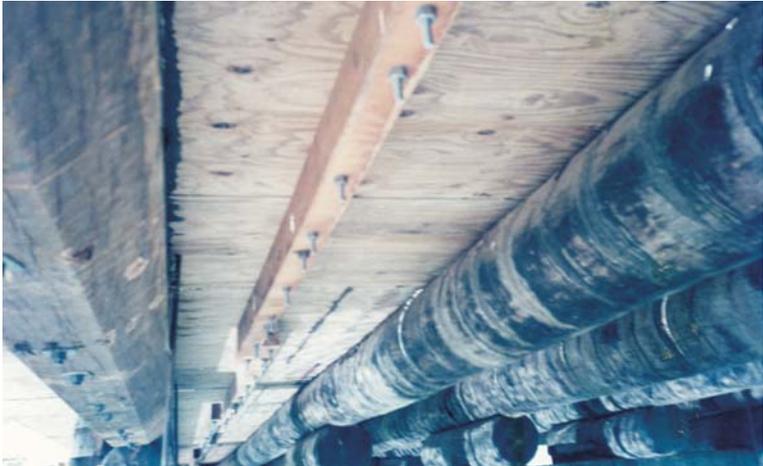
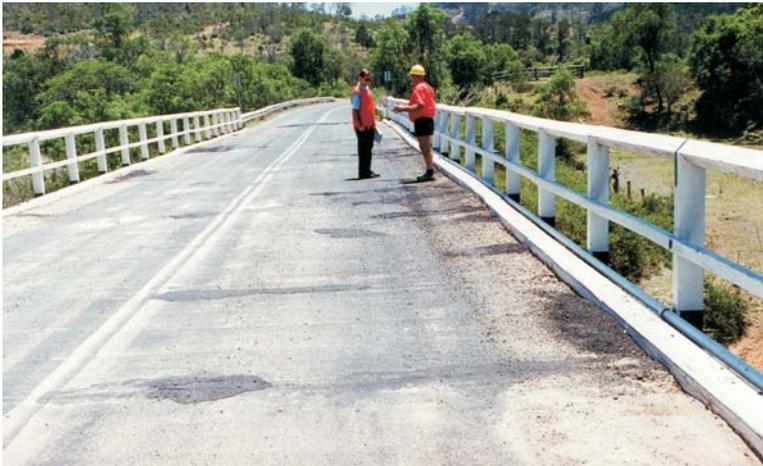
Figure 3.2(b) - Timber Bridge Photos (2)

Girders and corbels

Deck and distributors

Kerb and barrier

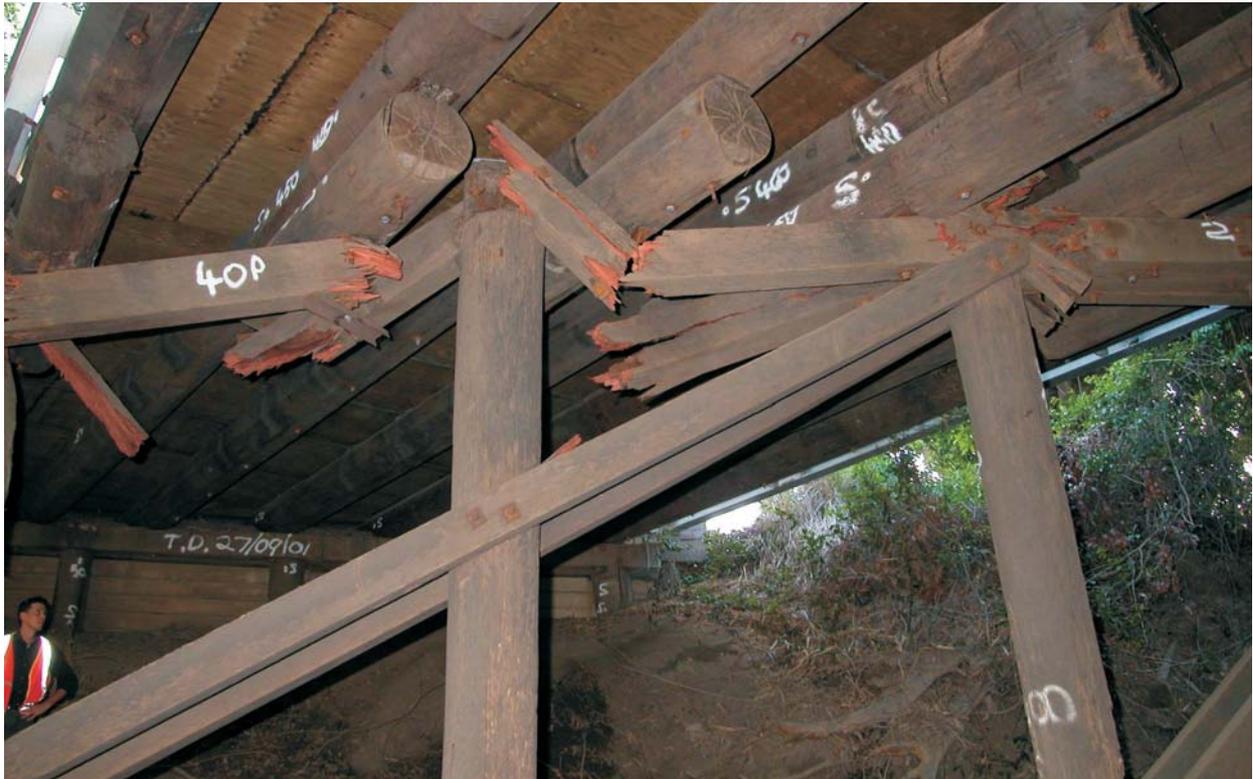
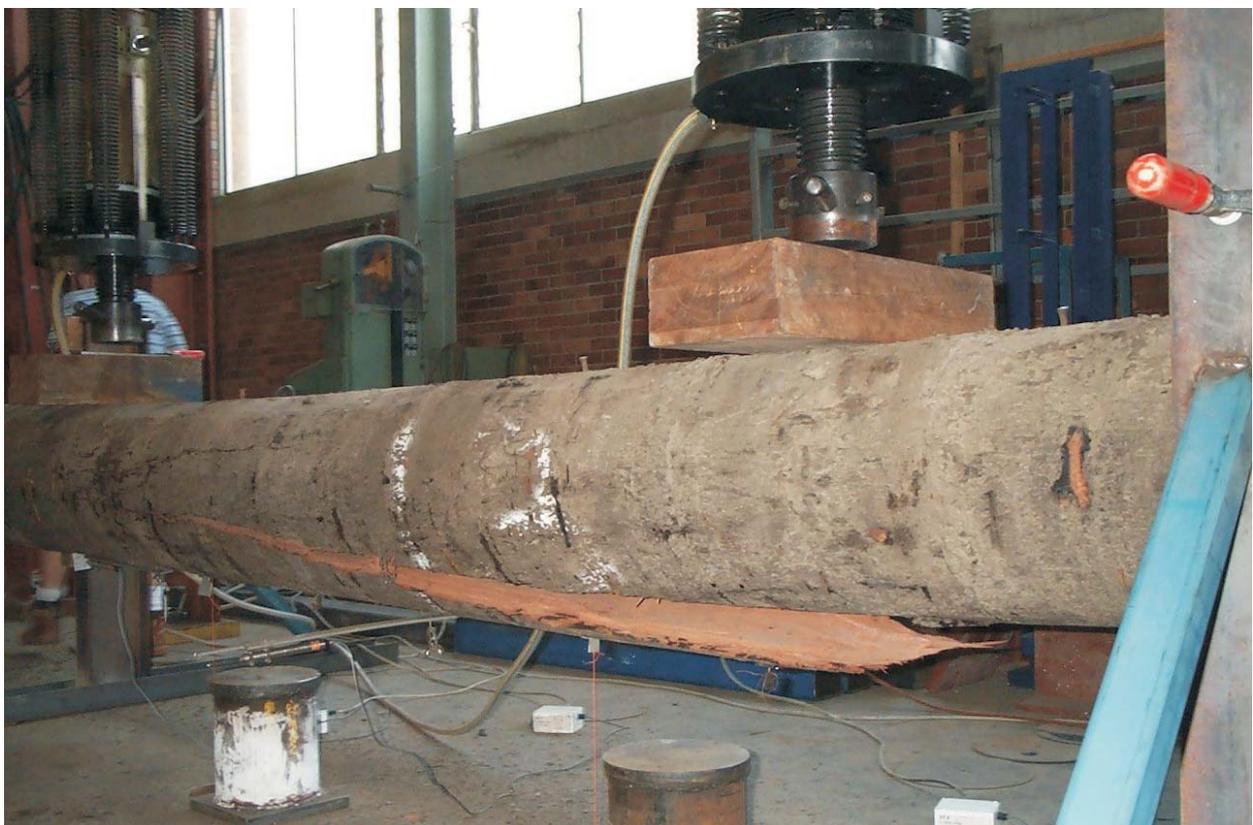
Figure 4.2(d) - Component Failures

Headstock Failure

Girder Failure

Refer also to Figure 4.2(d) for photographs of member failures.

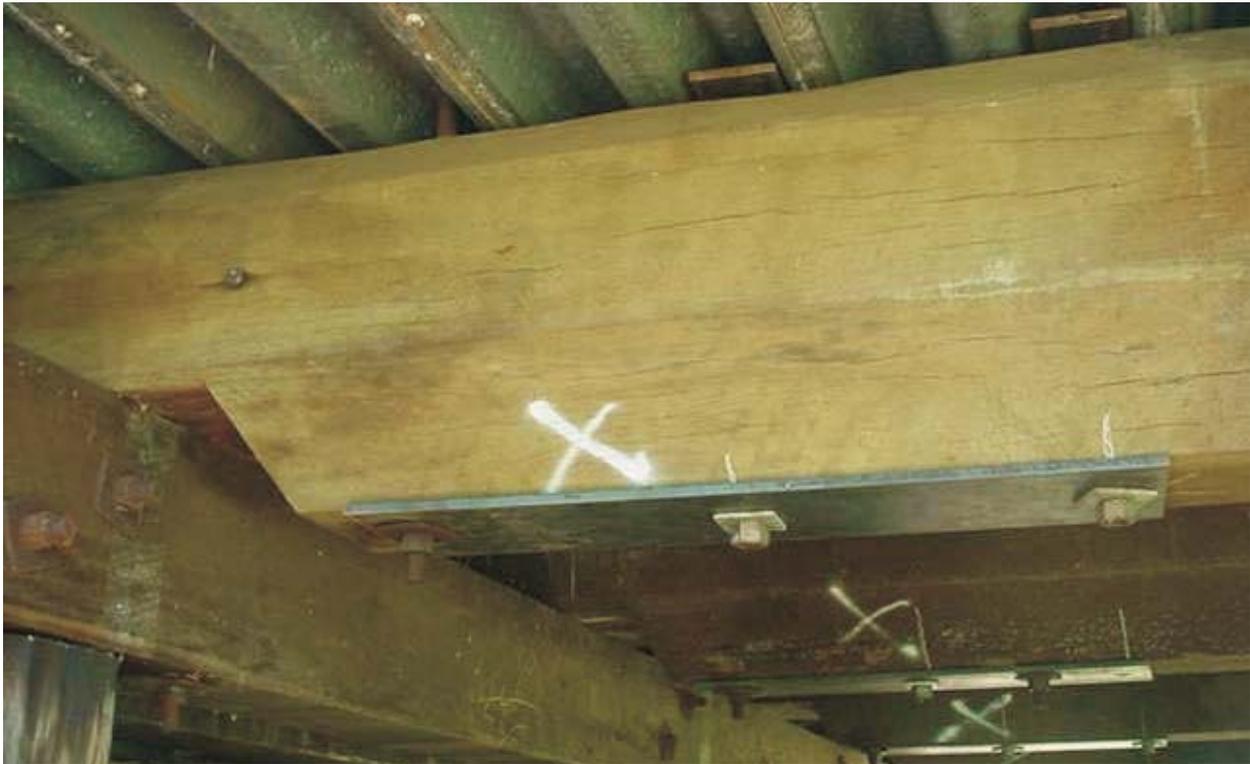
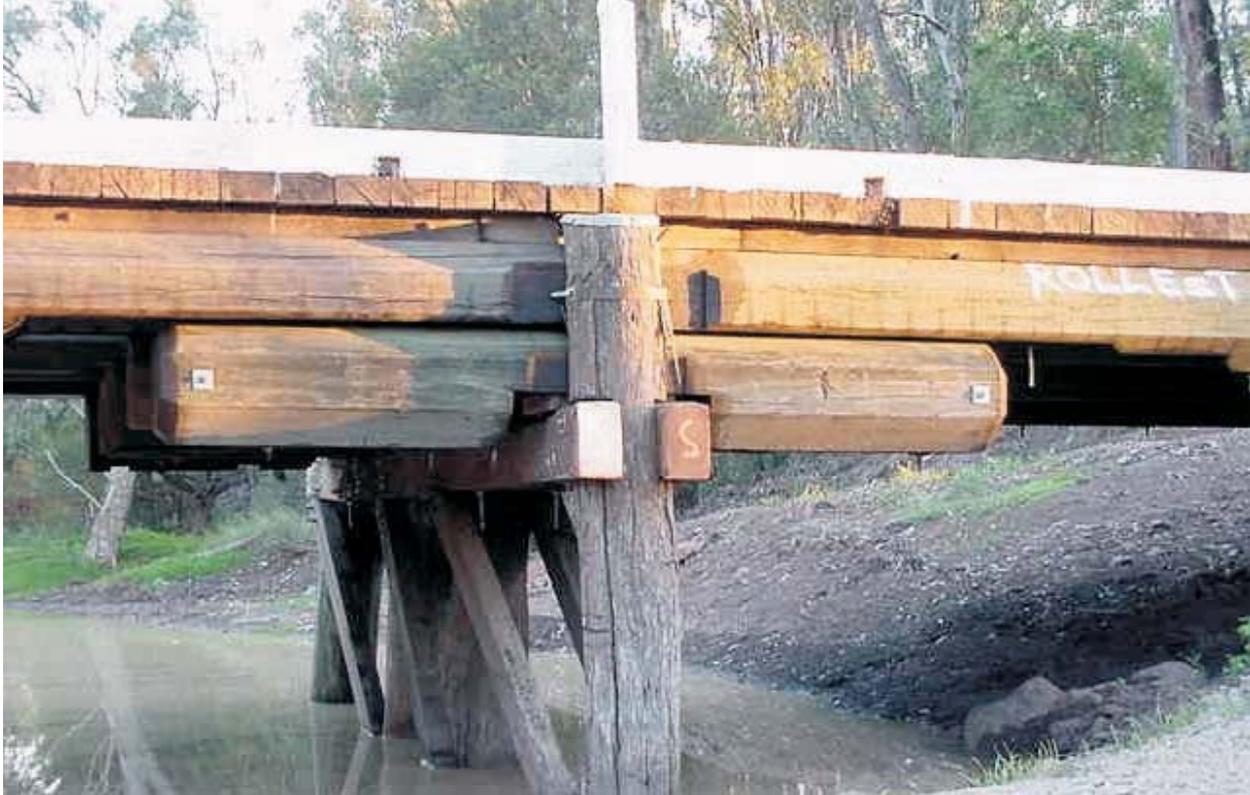
Figure 4.6(a) - Excessive Notching

Girder - Excessive Snipe

Corbel - Excessive Snipe

Figure 4.6(a) shows examples of excessive member cuts.

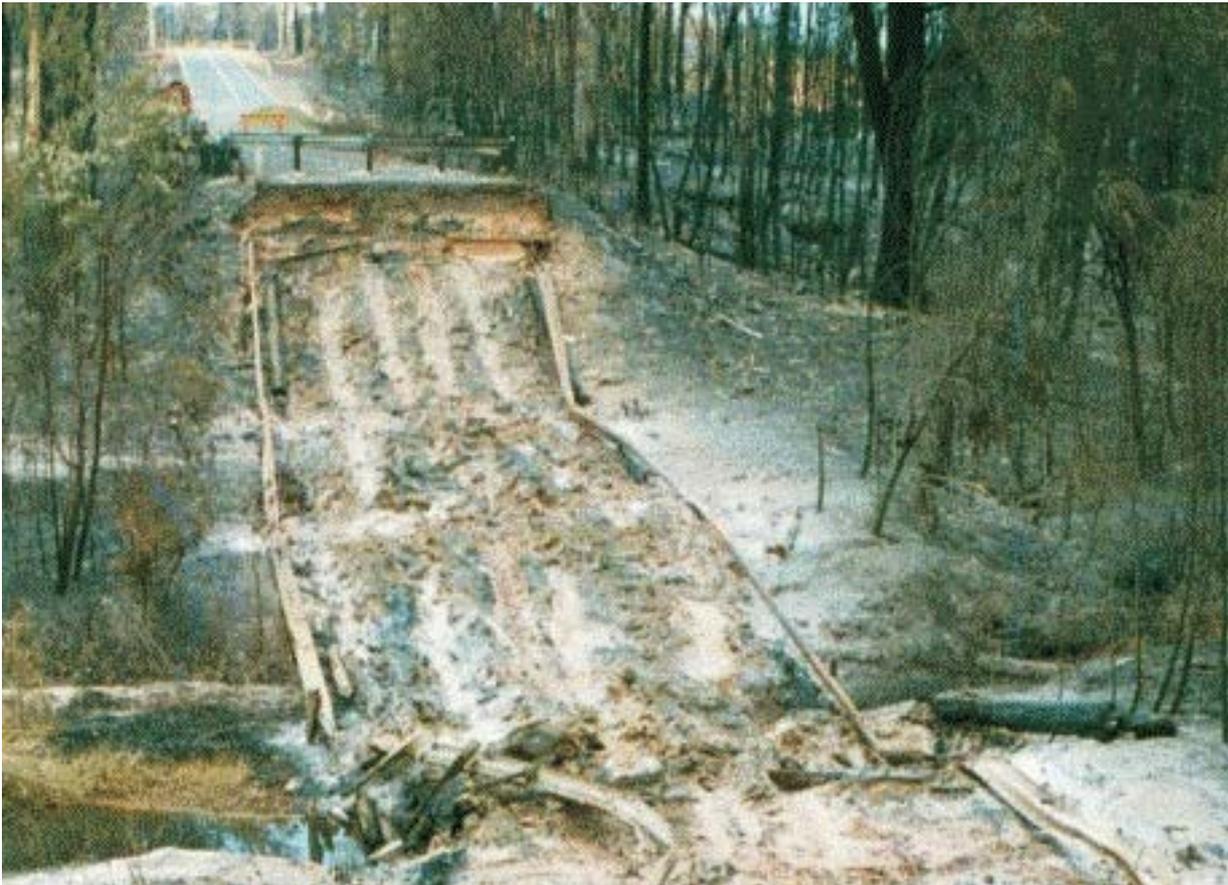
Figure 8.4(b) - Fire Destruction

Bushfire Result

Figure 8.4(b) shows the end result of a bushfire on a timber bridge.
