# Part Two Component Maintenance

Department of  
**Main Roads**

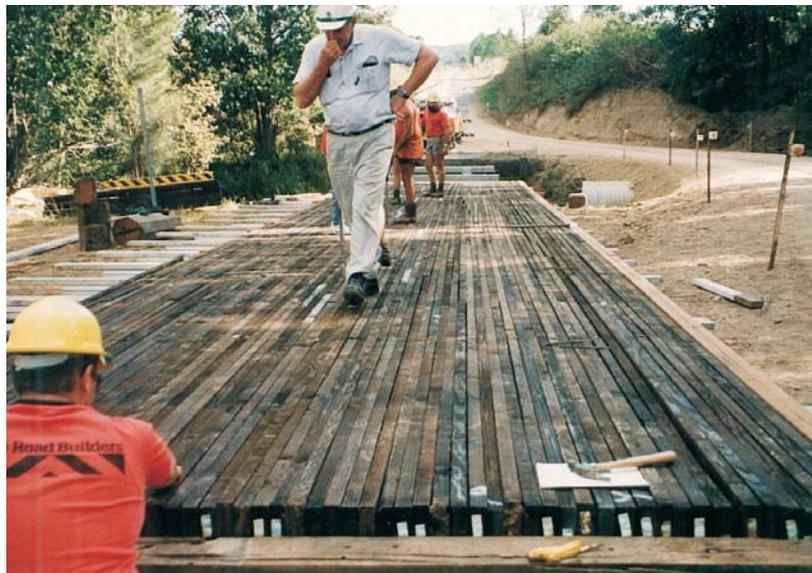
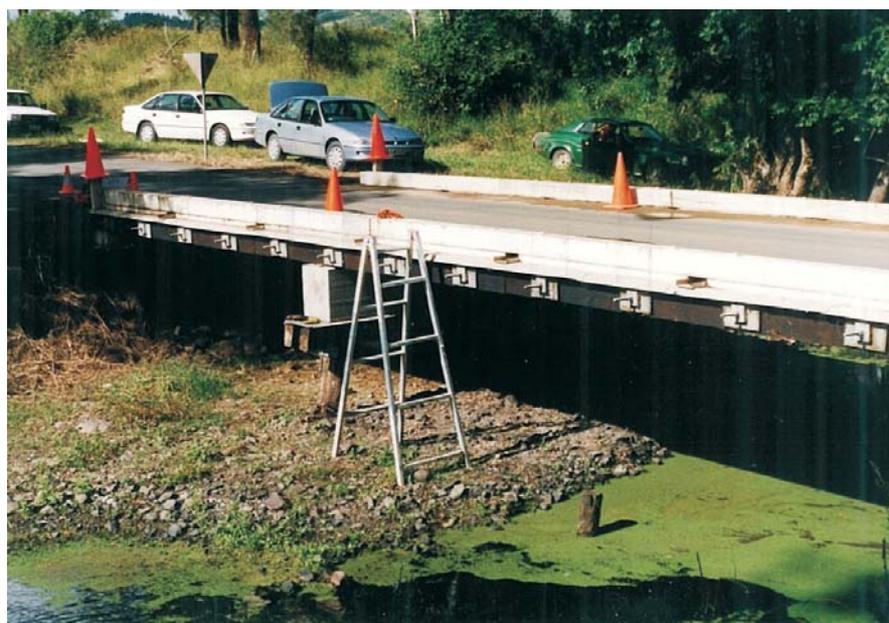
Figure 5.9(b) - Stress- Laminated Bridge

Only one stress-laminated timber bridge has so far been built in Queensland, consisting of timber slab composed of vertical timber boards laid longitudinally, stressed transversely together at intervals with conventional stressing bars to form a homogeneous slab - refer to Figures 5.9(a) & (b) for details. This stress-laminated deck replaced the original timber deck, girders and corbels and so spans from pier to pier.

**SECTION - DECK**

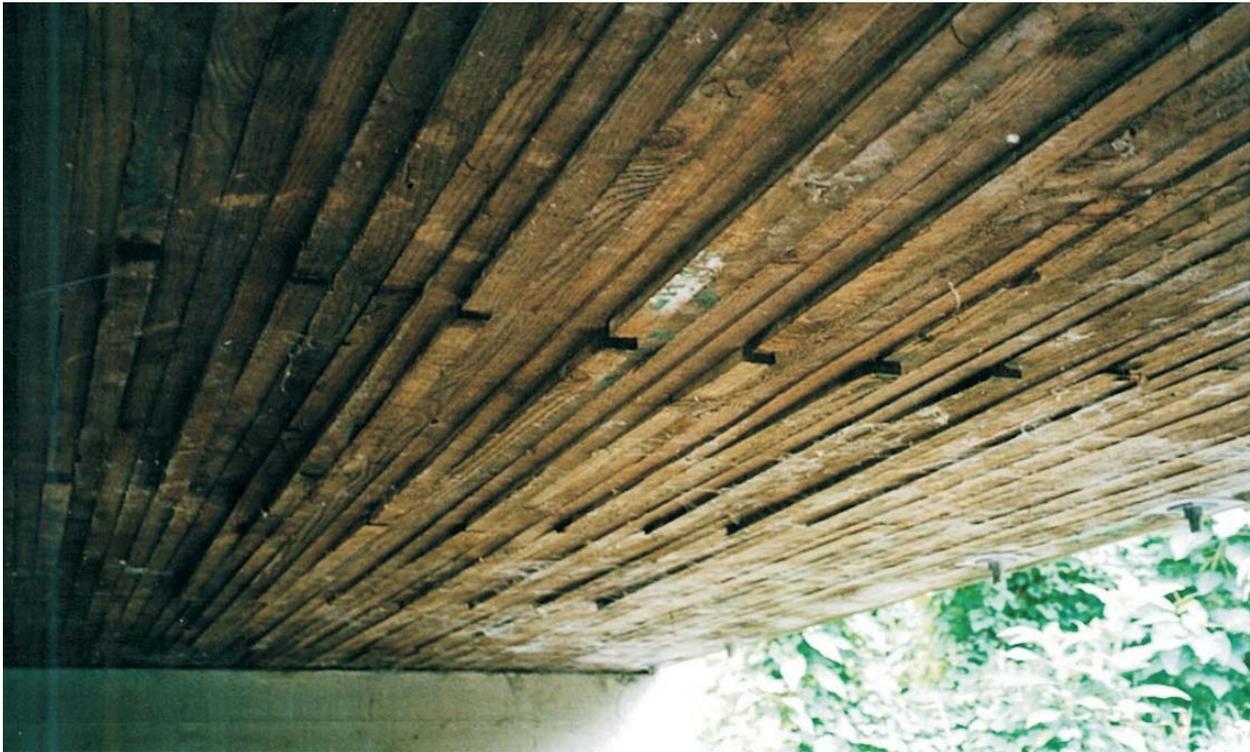
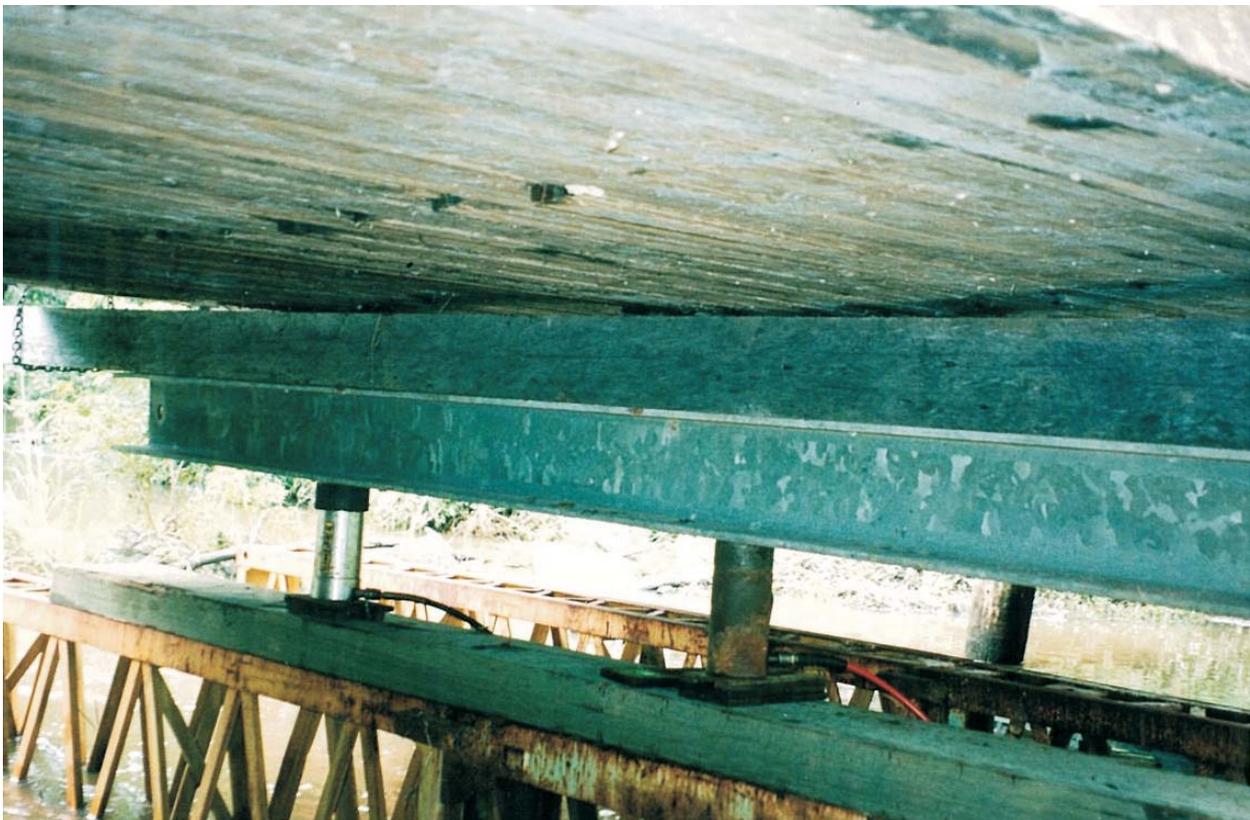
Figure 5.9(c) - S.L. Deck Failure

Slippage of laminates

Distorted soffit prior to Jacking level

If more than 1 or 2 laminates in a deck are found to have fractured, an engineering evaluation will be needed to determine the cause and consequent repair method. Because of the difficulty of replacing laminates (deck has to be supported and distressed), a fully designed replacement procedure will be necessary.

If laminate slippage has occurred due to inadequate transverse stressing, an attempt should be made to jack the deck soffit back to line before restressing, by jacking off falsework below the deck.

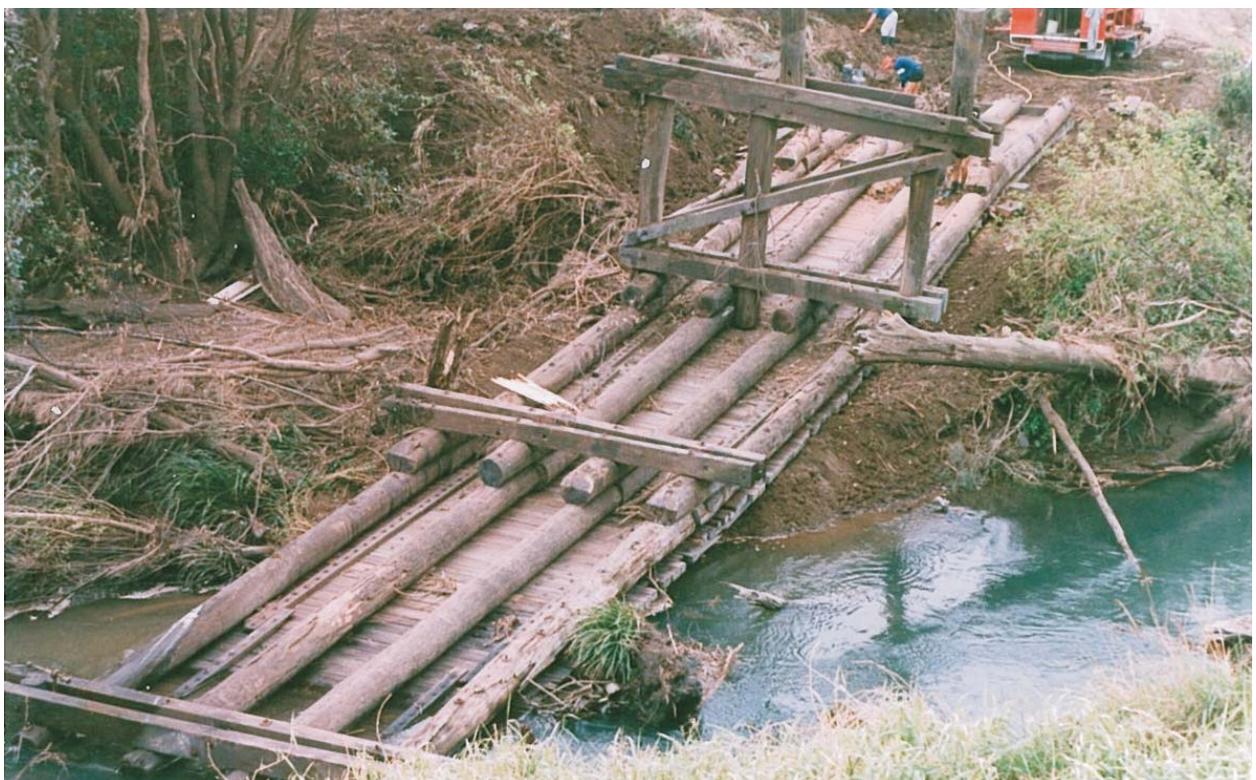
Figure 1.1(h) - Bridge Failure

Pier pile failure at top

Nearly intact Superstructure
