Denison Creek and Stockyard Creek Fauna Fencing

2019 and 2020 Koala Breeding
Season Technical Report

**Department of Transport and
Main Roads**

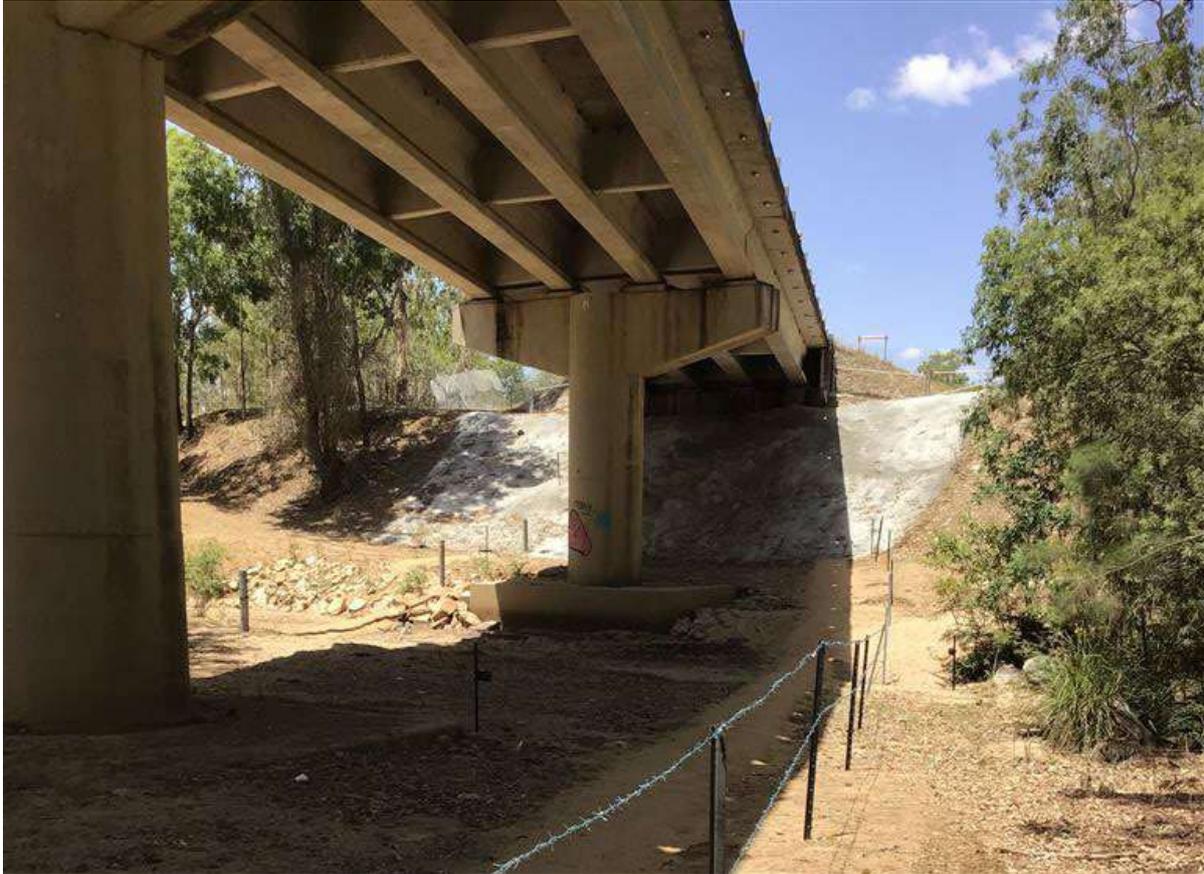
Figure 2: Setup example of sand plots, cameras, and barbed wire fencing at Denison Creek (Plot 6)

The above methods are further described in the following sections. Examples of setup of sand plots and cameras are shown in Figure 2 and Figure 3, including the cattle exclusion fencing (see Section 3.2.3).

- Two long plots over the width of the creek (except for the low flow channel) measuring approximately 50 m long and 1.5 m wide (see Figure 2)
- Four small plots on the stepped platforms at each of the two bridge abutments (two on each abutment). These plots were approximately 2 m long and 1.5 m wide,
- Four sand plots, on both sides of the road corridor, and both ends of the fencing. These plots were approximately 2 m long and 1.5 m wide

For installation of the sand plots, DTMR arranged for RoadTek to assist with importing clean and weed-free fine sand from a local provider. Black plastic was laid under the sand, to avoid growth through the sand plot and retain moisture as much as possible. No bait was used to attract animals to or over the plots. The sand plot setup is displayed in Figure 2 and Figure 3.

During the early stages of the monitoring at Denison Creek in 2019, it was found that at times there was high disturbance of the sand plots by cattle traversing through the area. The movement of cattle through the plots hampered the identification of other tracks. To limit this for the remainder of the monitoring period, Aurecon installed additional barbed wire fencing around the sand plots on 2 December 2019 (monitoring week 2), as shown in Figure 2 and Figure 3.

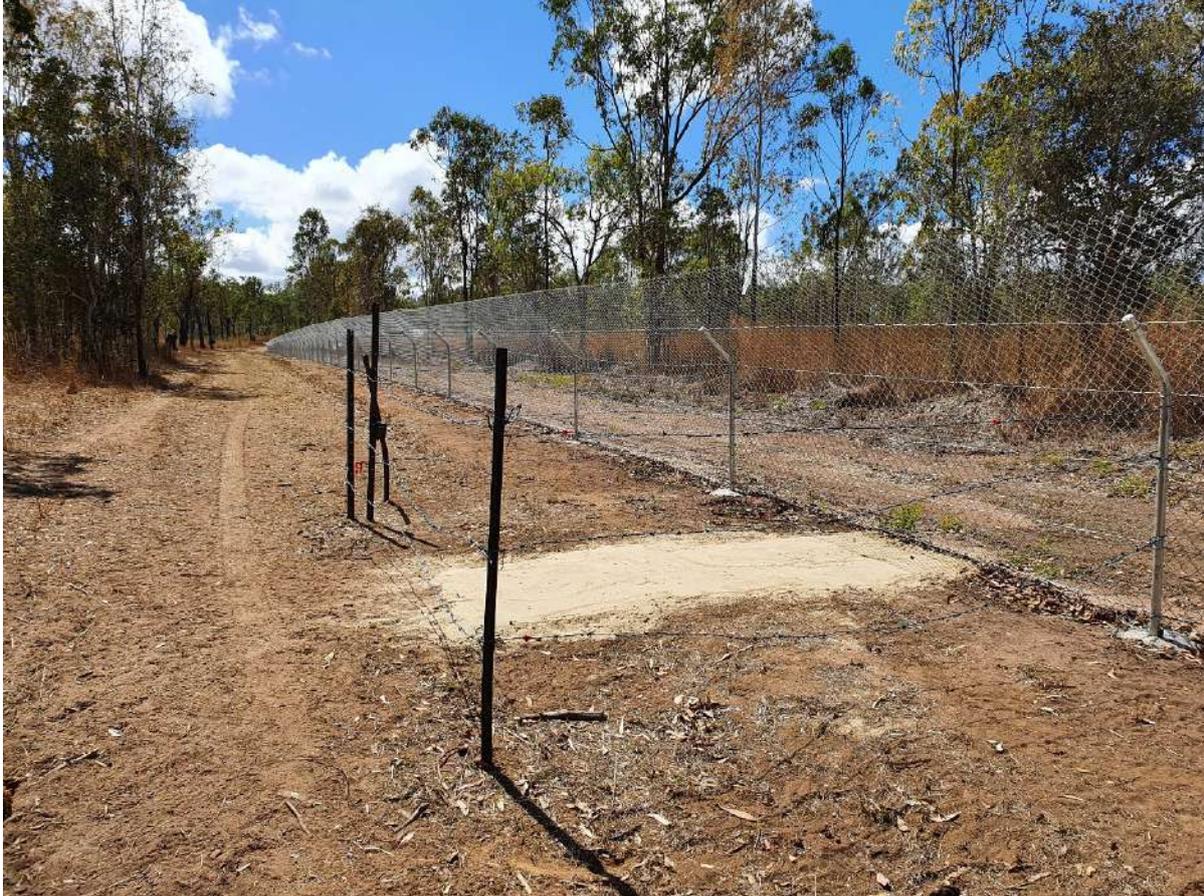
Figure 3: Setup example of sand plot, camera, and barbed wire fencing at Stockyard Creek (Plot 16)

- Four plots over the width of the creek (except for the low flow channel) measuring approximately 2 m long and 1.5 m wide
- Two sand plots, one on either side of the road corridor, along the fencing. These plots were approximately 1.5 m wide and 2 m long (see Figure 3)

In total 12 infrared cameras were installed within the study area at Denison Creek in 2019 (the locations are displayed in Table 1 and Figure 4 (for 2020 only) and Appendix E for 2019 camera locations. An example of the camera setup is shown in Figure 3.

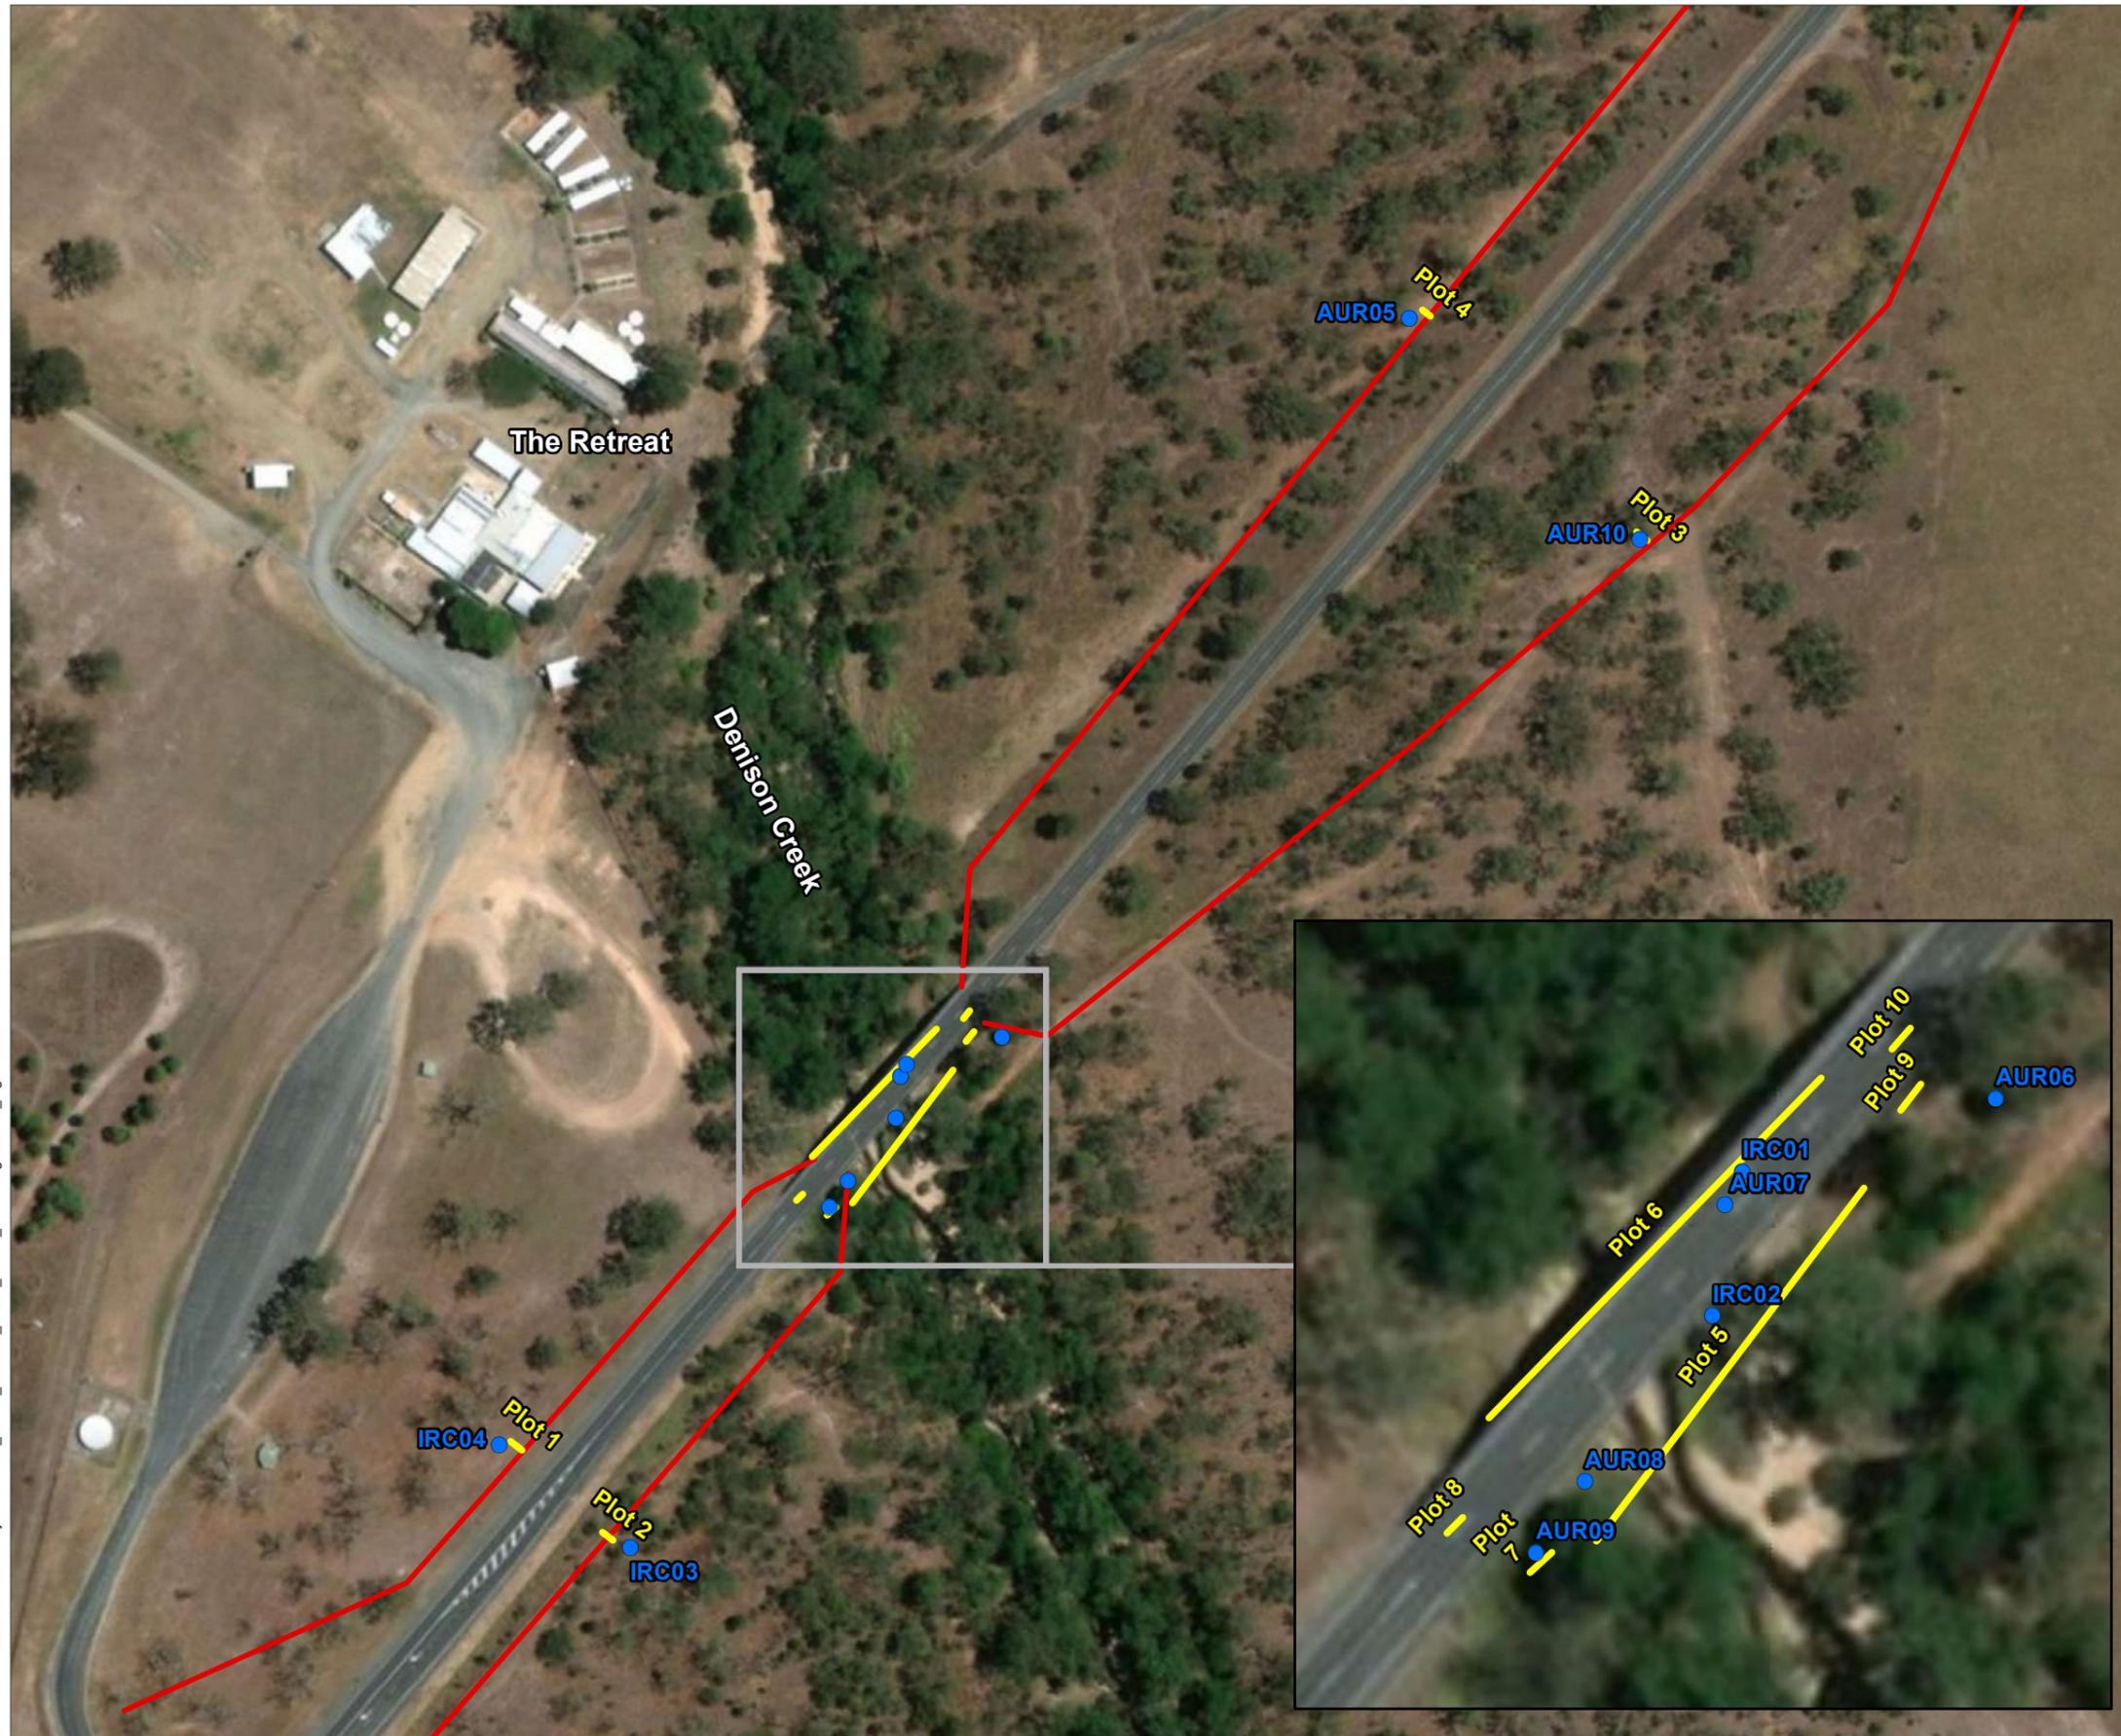
- Legend**
- Camera Locations
 - Sand Plot
 - Fauna Fencing

Figure 4: Sand Plot, Camera and Fauna Exclusion Fencing, Denison Creek

For both the monitoring periods at Denison Creek, 10 sand plots were installed near or under the bridge and perpendicular to the fauna exclusion fencing, as displayed in Figure 4 and listed below:

The majority of koala tracks were recorded on Plot 6 (15 tracks), followed by Plot 5 (10 tracks). These plots are in the creek bed at Denison Creek (see Figure 4 for plot locations). A total of 17 successful crossings (where koala tracks were found on two corresponding sand plots (ie plots 5/6, 7/8, 9/10), see Section 3.5.2 for definitions) were recorded in the 2020 monitoring period at Denison.

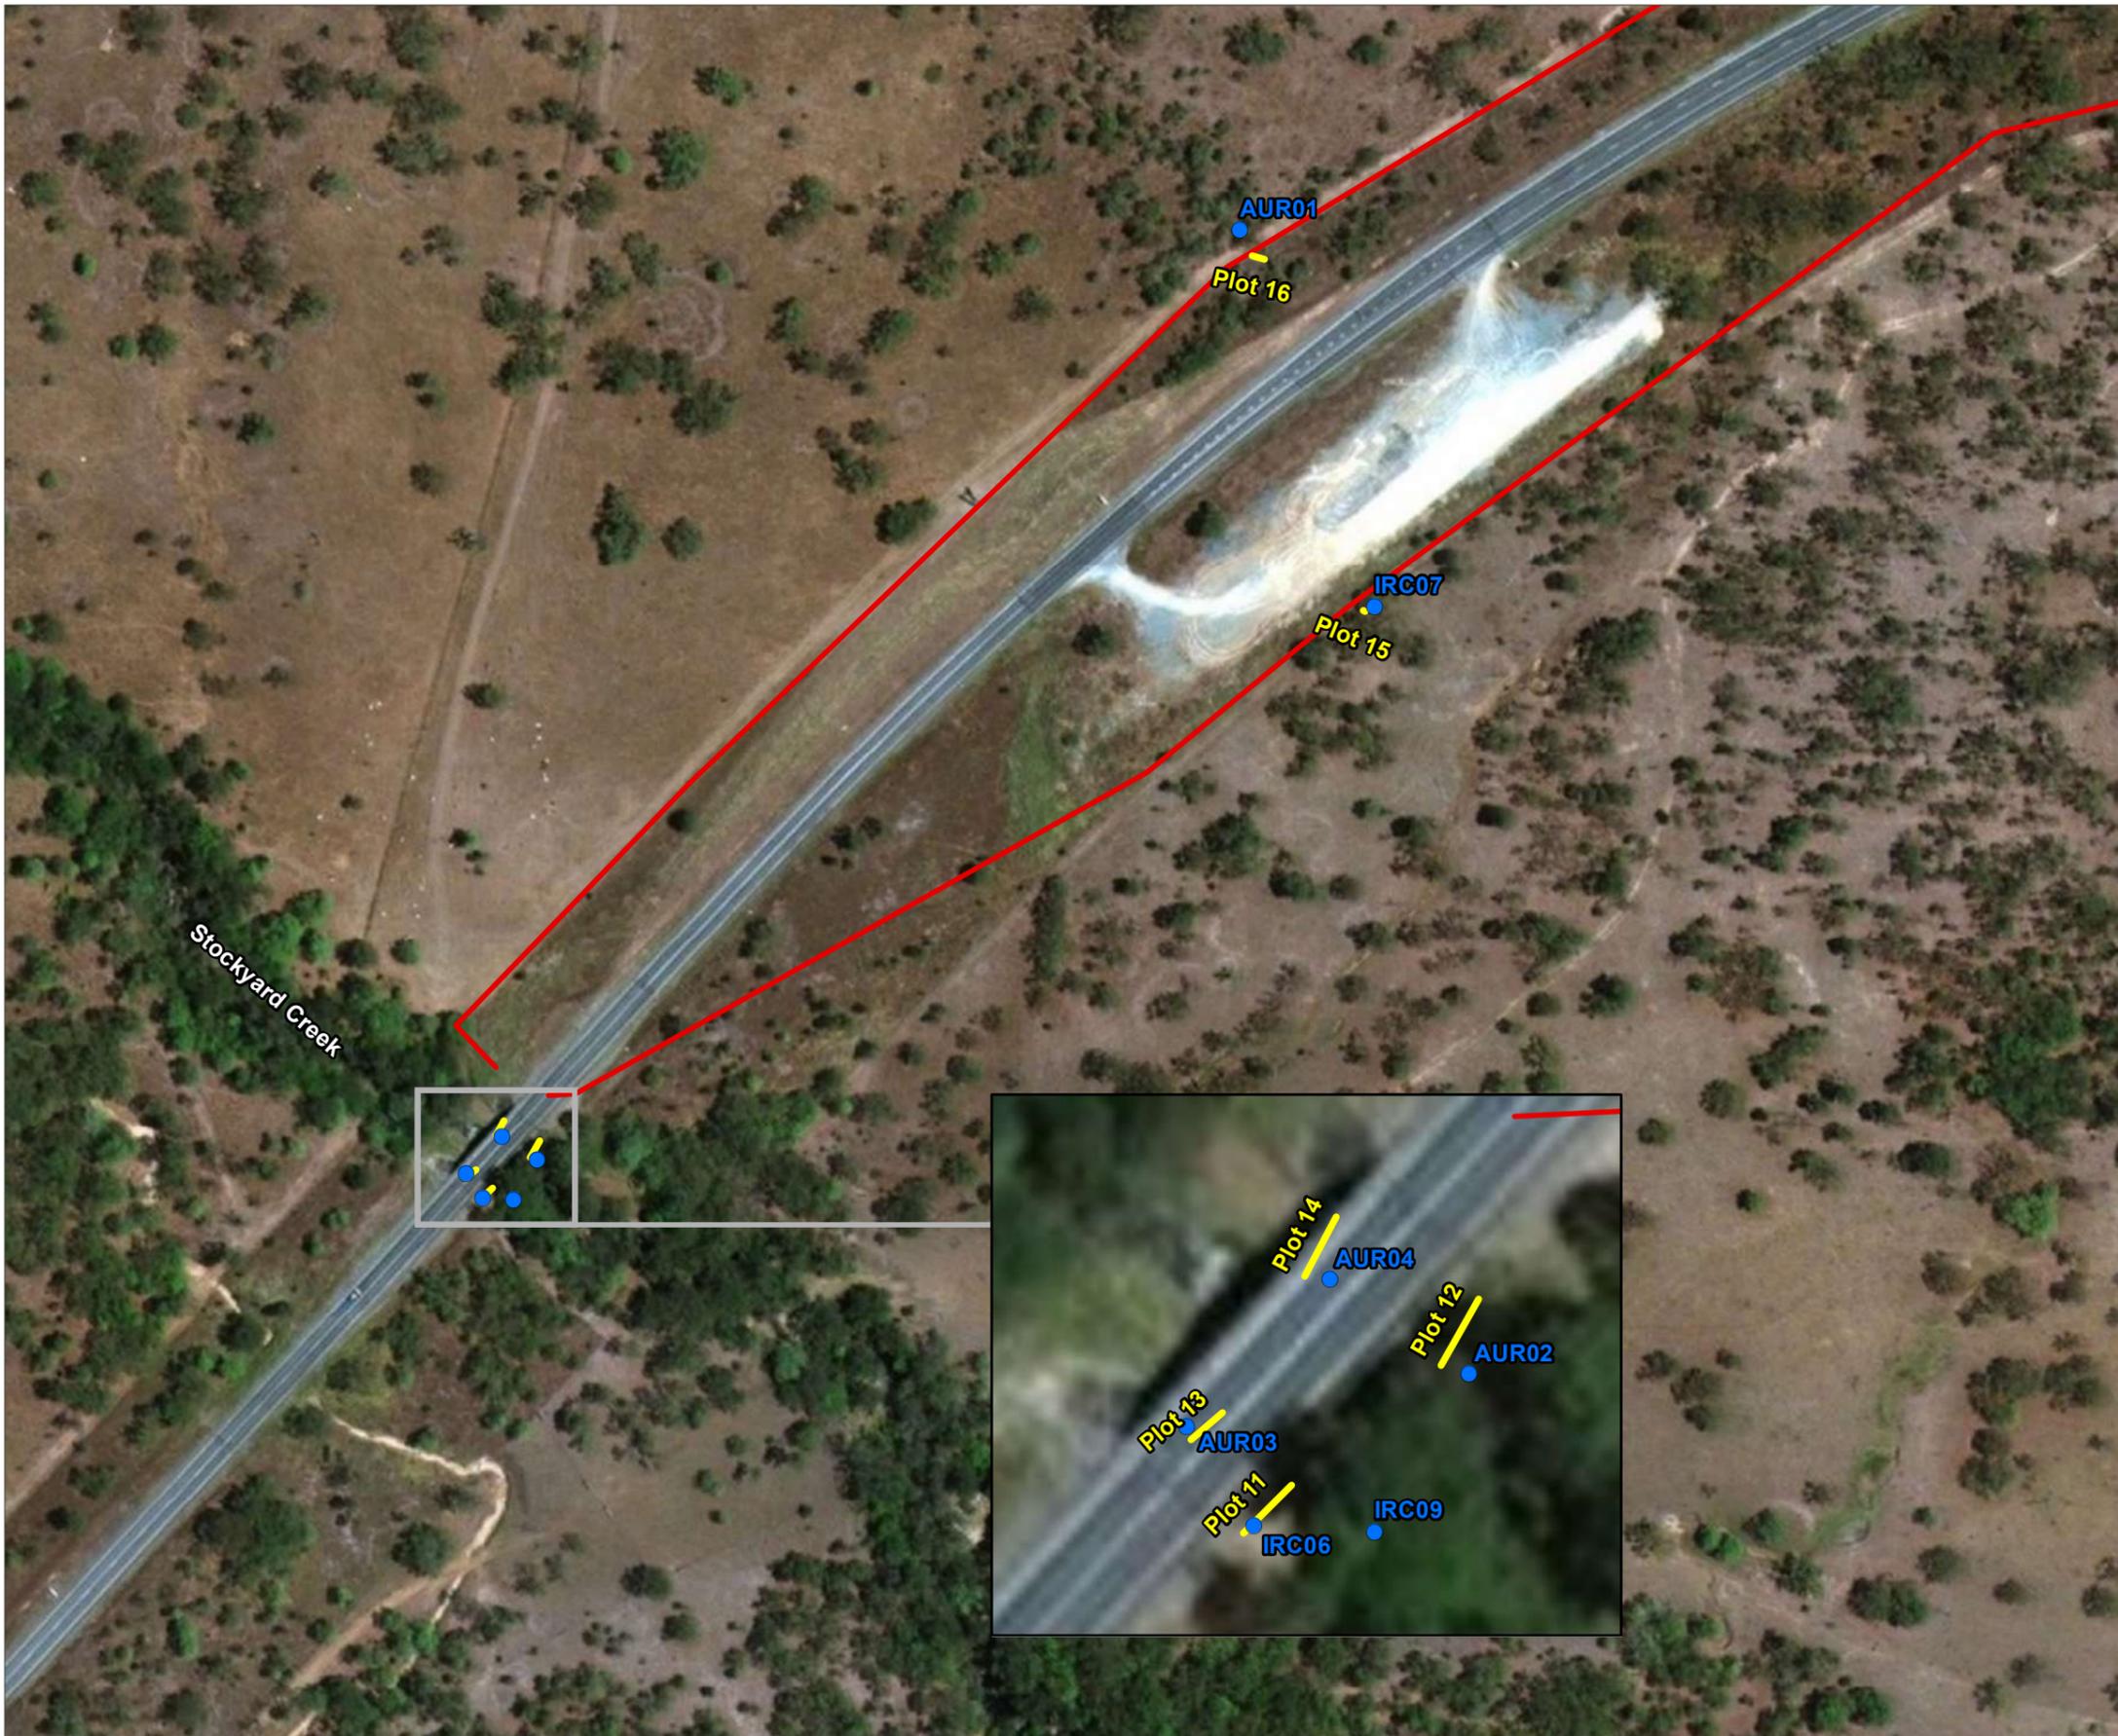
- Camera Locations
- ▬ Sand Plot
- ▬ Fauna Fencing

For the monitoring period at Stockyard Creek in 2020, six sand plots were installed near or under the bridge and perpendicular to the fauna exclusion fencing, as displayed in Figure 5 and listed below:

In the 2020 monitoring year, there were no recordings of koala tracks on Plots 13, 14, and 15 at Stockyard Creek (see Figure 21). Plot 11 (three tracks recorded) and Plot 12 (one track) are set up in the creek bed of Stockyard Creek (see Figure 5 for locations), while Plot 16 (three recordings) is located along the northern fauna exclusion fence line.

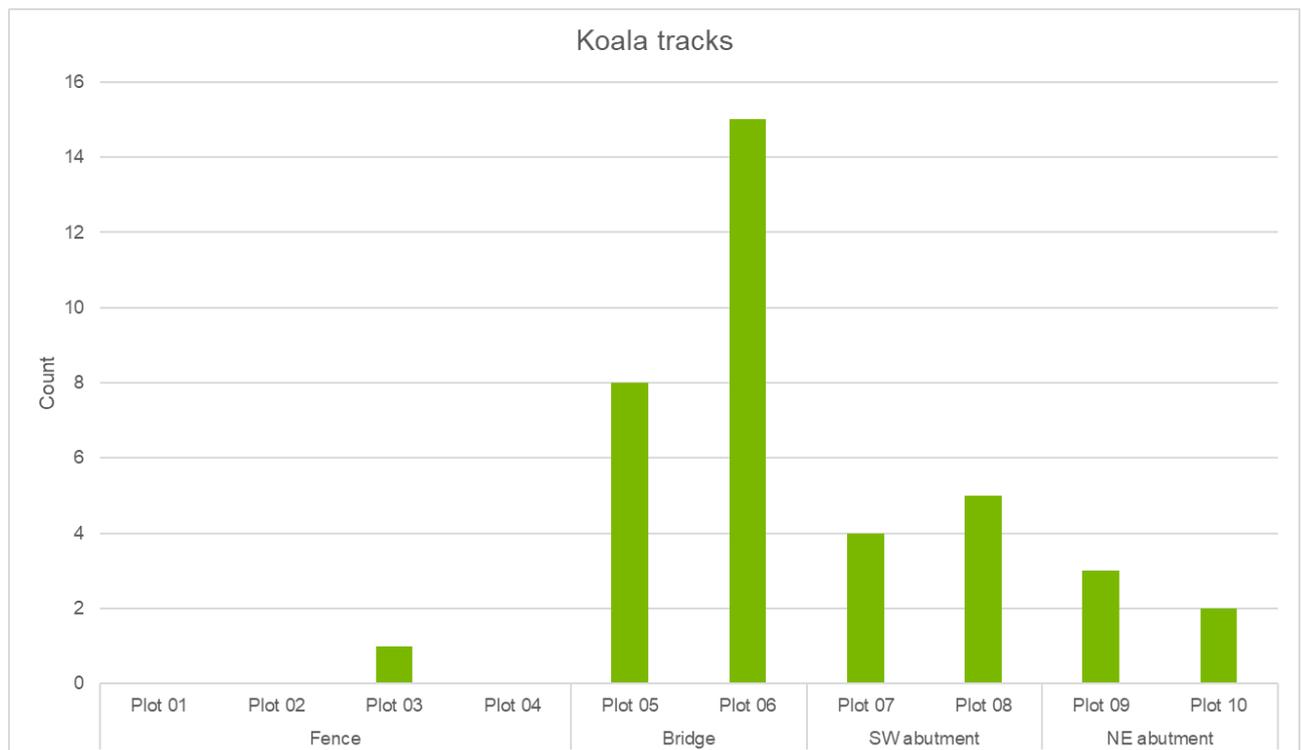
Figure 6: Recorded koala tracks on sand plots, Denison Creek 2019

Koala tracks were recorded using both the sand plots and the camera traps. In total there were 38 recordings of koala tracks on the sand plots at Denison Creek in 2019 (displayed in Figure 6), with six video and/or photo records of koalas. There were no koala tracks recorded on Plots 1, 2 and 4 during 2019. Video and photo records of koala traverses were most successful (in number of fauna captures) under the abutments where koalas were forced to traverse in a confined space.

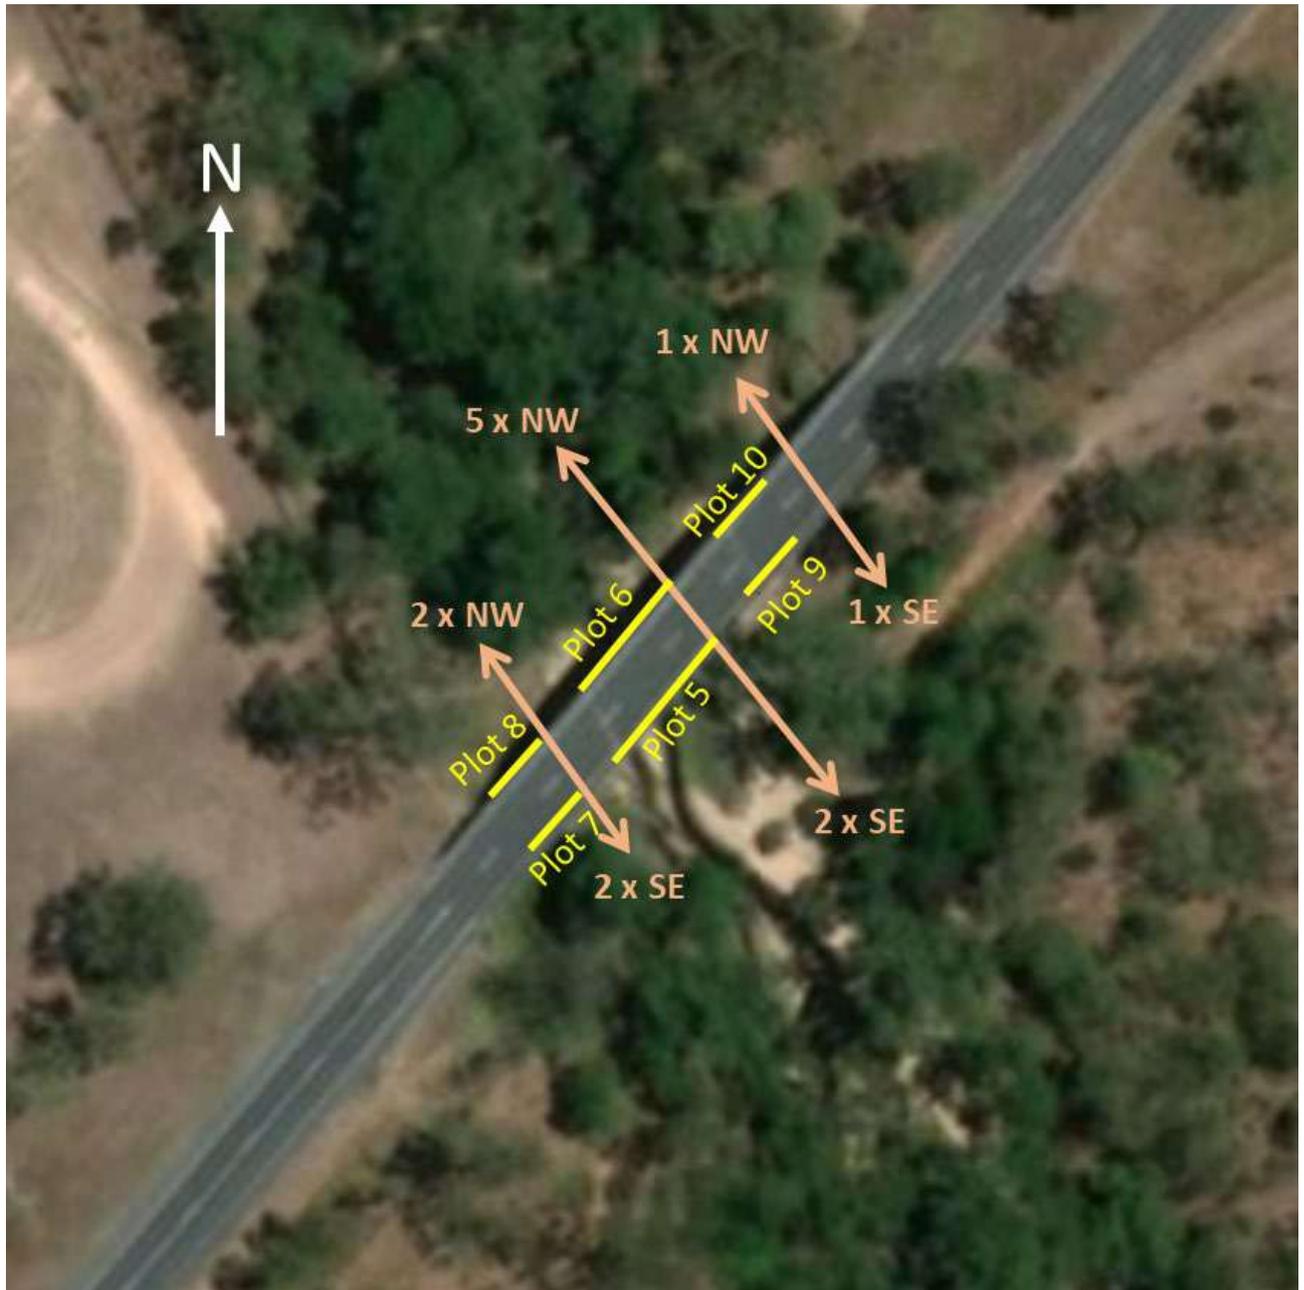
Figure 7: Koala crossings at Denison Creek 2019, showing travel directions over corresponding sand plots

Figure 7 shows the koala crossings where tracks were recorded on corresponding plots. Where the travel directions on corresponding tracks were not identical (ie one track going in a north-westerly (NW) direction

and the other going in a south-easterly (SE) direction) these were not counted as successful. Similarly, where tracks were only recorded on one of the two corresponding plots (ie tracks on Plot 5, but not on Plot 6) these were not counted as a successful crossing and are not included on the figure.

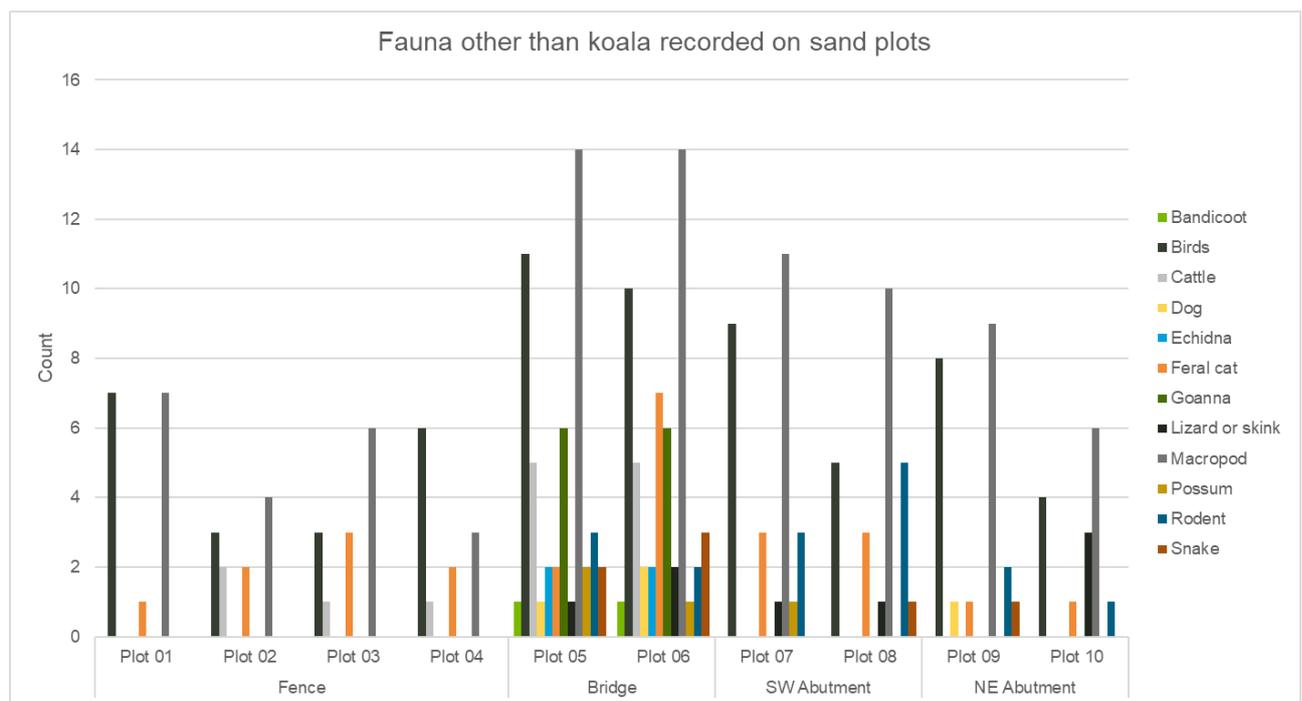
Figure 8: Tracks recorded for other species (non-koala), Denison Creek 2019

Figure 8 presents an overview of the frequency of recordings of tracks of other species recorded on the sand plots over the monitoring period. This shows that macropods were the most abundant (with 84 records), followed closely by birds (66 records). As with the koala tracks, Plots 5 and 6 (in the creek bed) were most frequently used (50 and 55 records, respectively, of a total of 246 records in 2019).

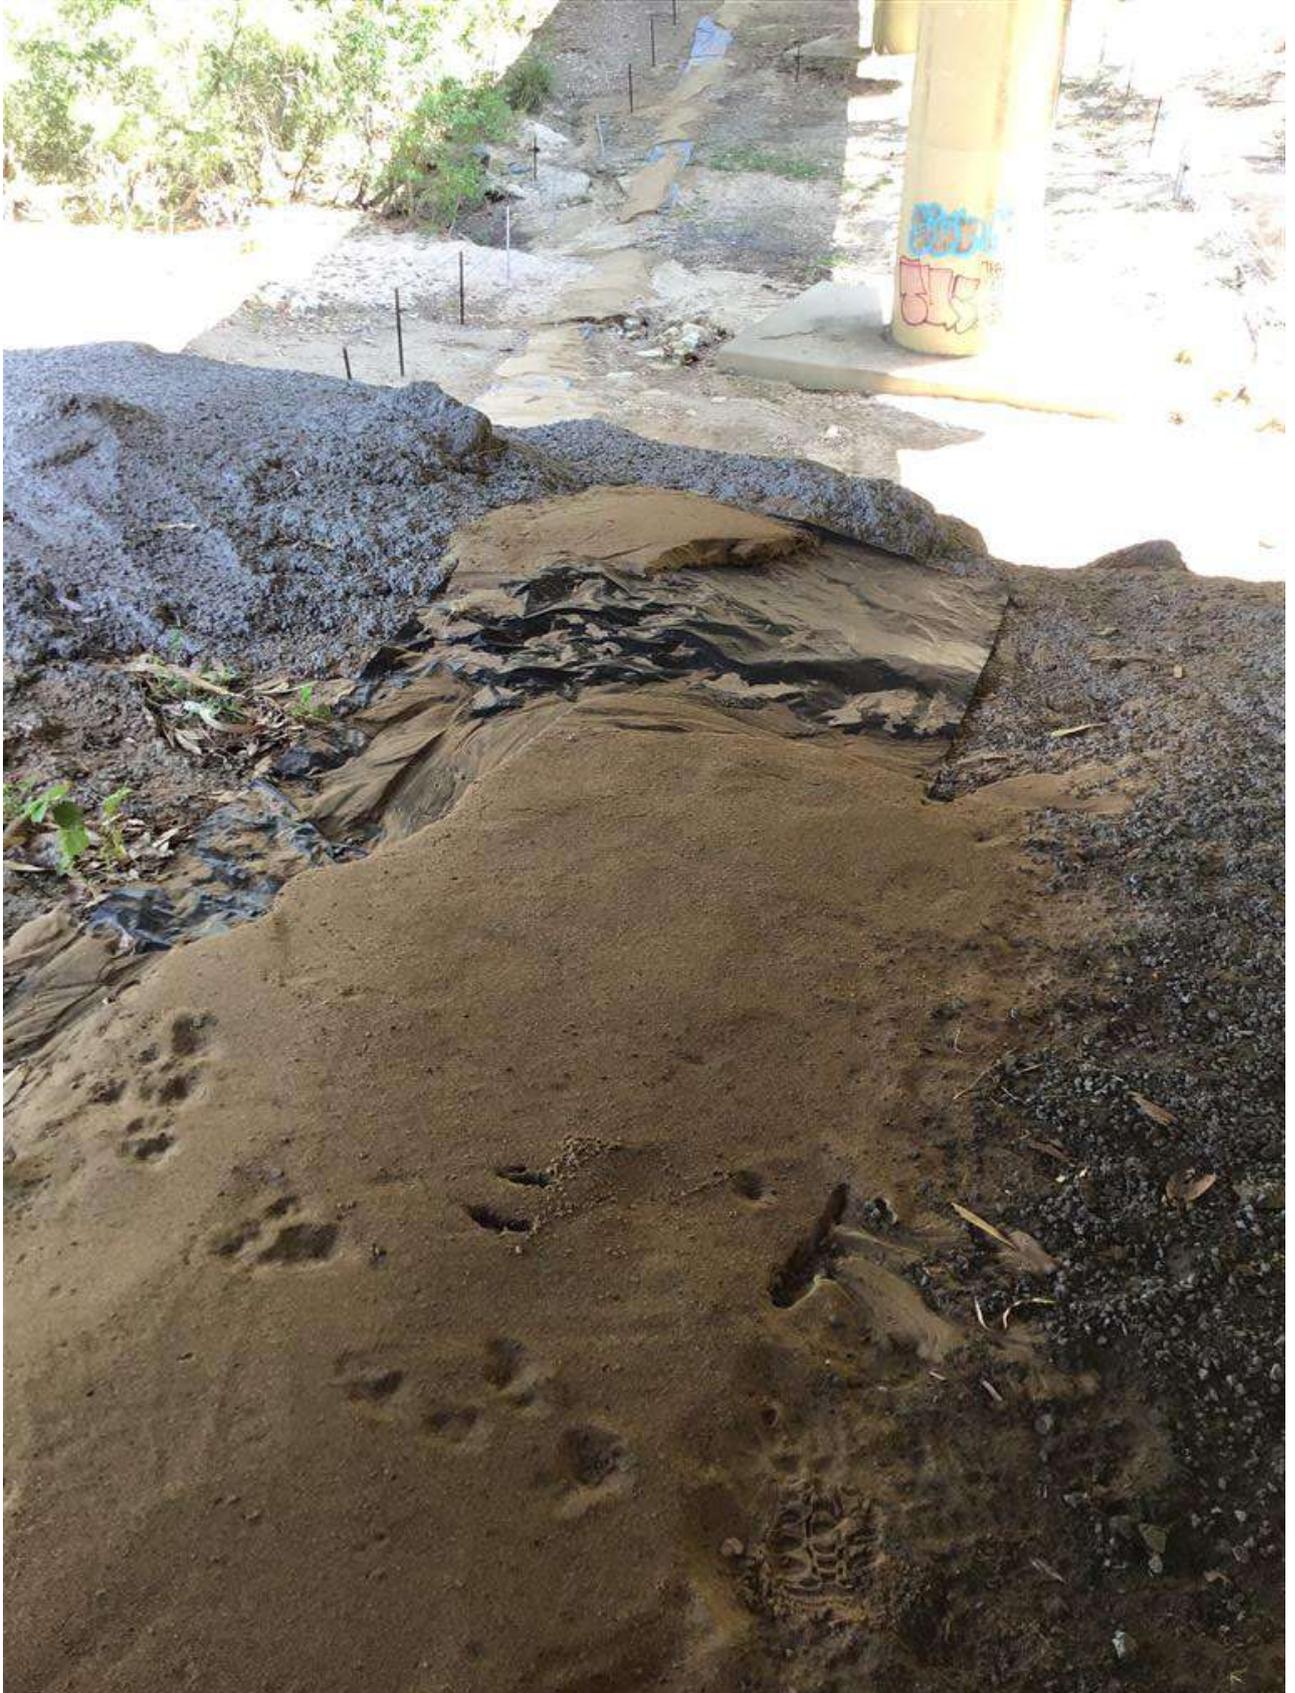
Figure 11: Rain damage at Plots 10 (abutment) and Plot 6 (creek bed), Denison Creek

In the final week of monitoring (16 and 18 December 2019) heavy rain washed away the sand plots within the creek bed and under the abutments at Denison (see examples of Plots 10 and 6, in Figure 11). As this was the last week of monitoring and no excess sand was available for repairs, the final day of monitoring relied solely on the camera footage.

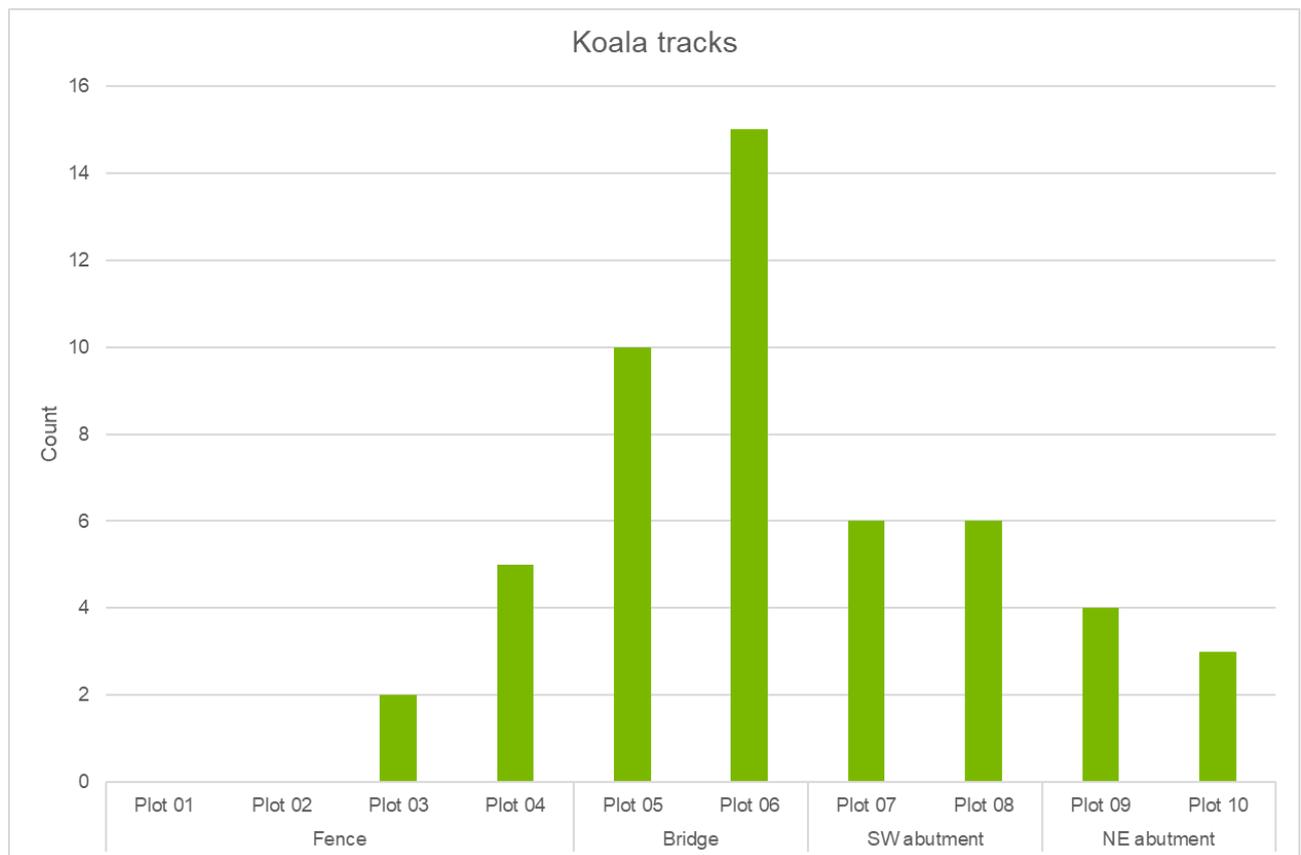
Figure 12: Recorded koala tracks on sand plots, Denison Creek 2020

Koala tracks were recorded using both the sand plots and the camera traps. In total there were 51 records of koala tracks on the sand plots in 2020 (displayed in Figure 12), with 18 video and/or photo recordings of koalas. There were no koala tracks recorded on Plots 1 and 2 during 2020. Video and photo records of koala traverses were most successful (in number of fauna captures) under the abutments where koalas were forced to traverse in a confined space.

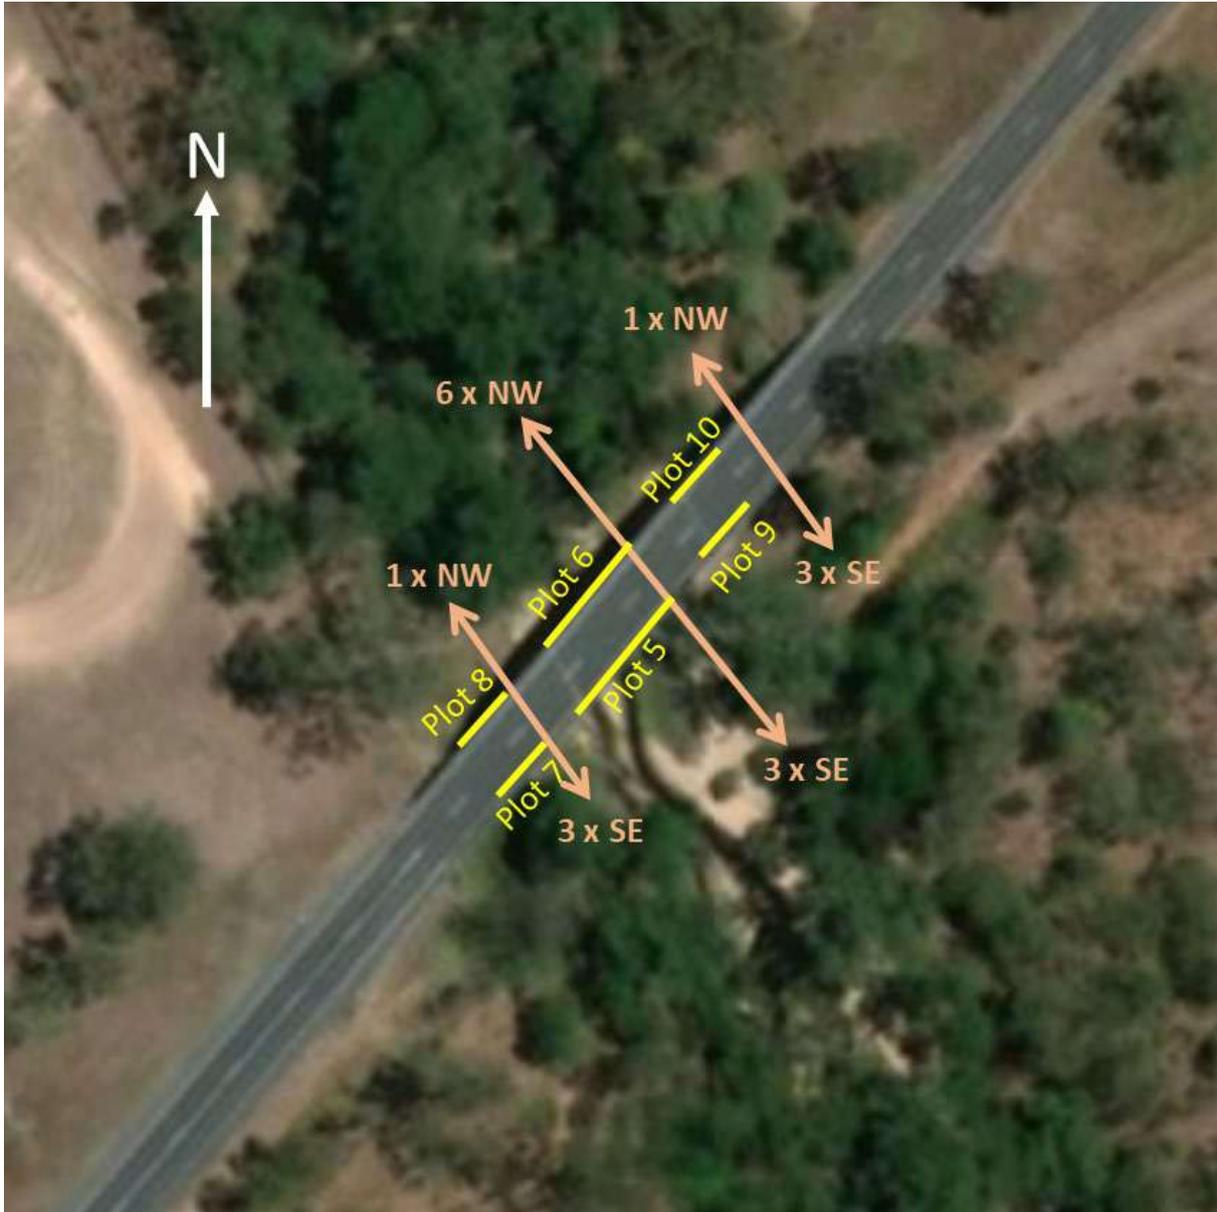
Figure 13: Koala crossings at Denison Creek 2020, showing travel directions over corresponding plots

Figure 13 shows the koala crossings, where tracks were recorded on corresponding plots. Where the travel directions of corresponding tracks were not identical (ie one track going NW, the other going SE) these were not counted as successful. Similarly, where tracks were only recorded on one of the two corresponding plots (ie tracks on Plot 5, but not on Plot 6) these were not counted as a successful crossing and are not included on the figure.

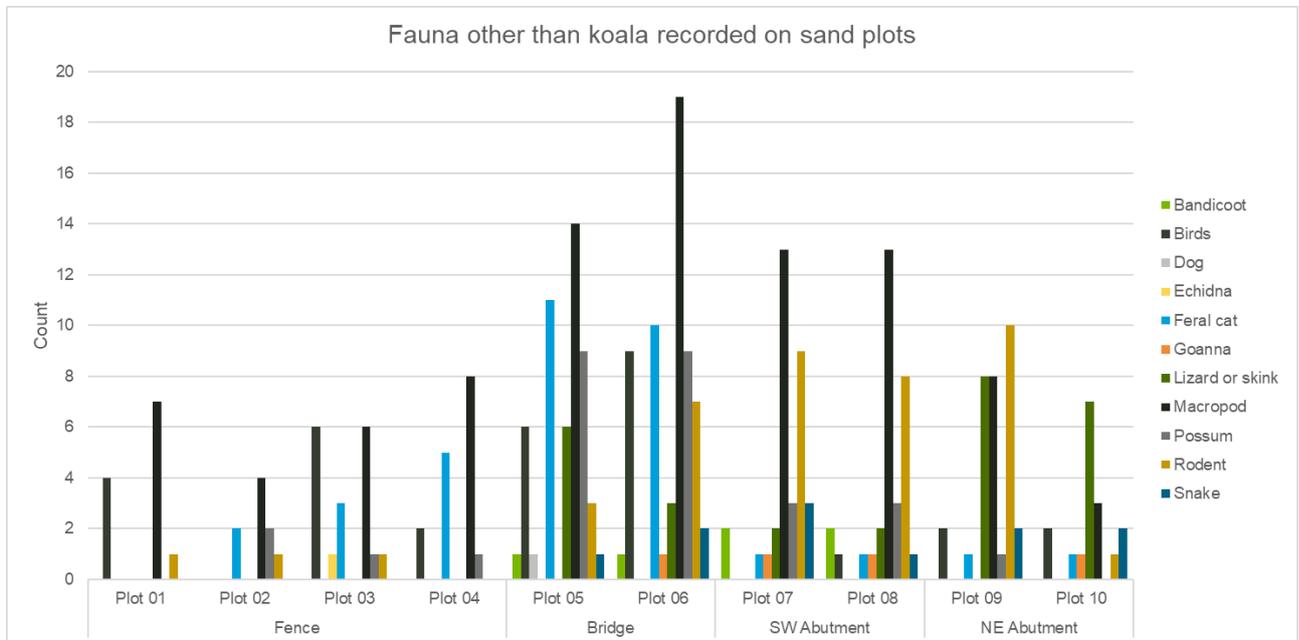
Figure 14: Tracks recorded for other species (non-koala), Denison Creek 2020

Figure 14 presents an overview of the frequency of recordings of tracks of other species recorded on the sand plots over the monitoring period. This shows that macropods were the most abundant (with 95 records). The next most abundant species were rodents (41 records), feral cats (35 records), and birds (32 records). As with the koala tracks, the Plots 5 and 6 (in the creek bed) were most frequently used (52 and 61 records, respectively, of a total of 283 records in 2020).

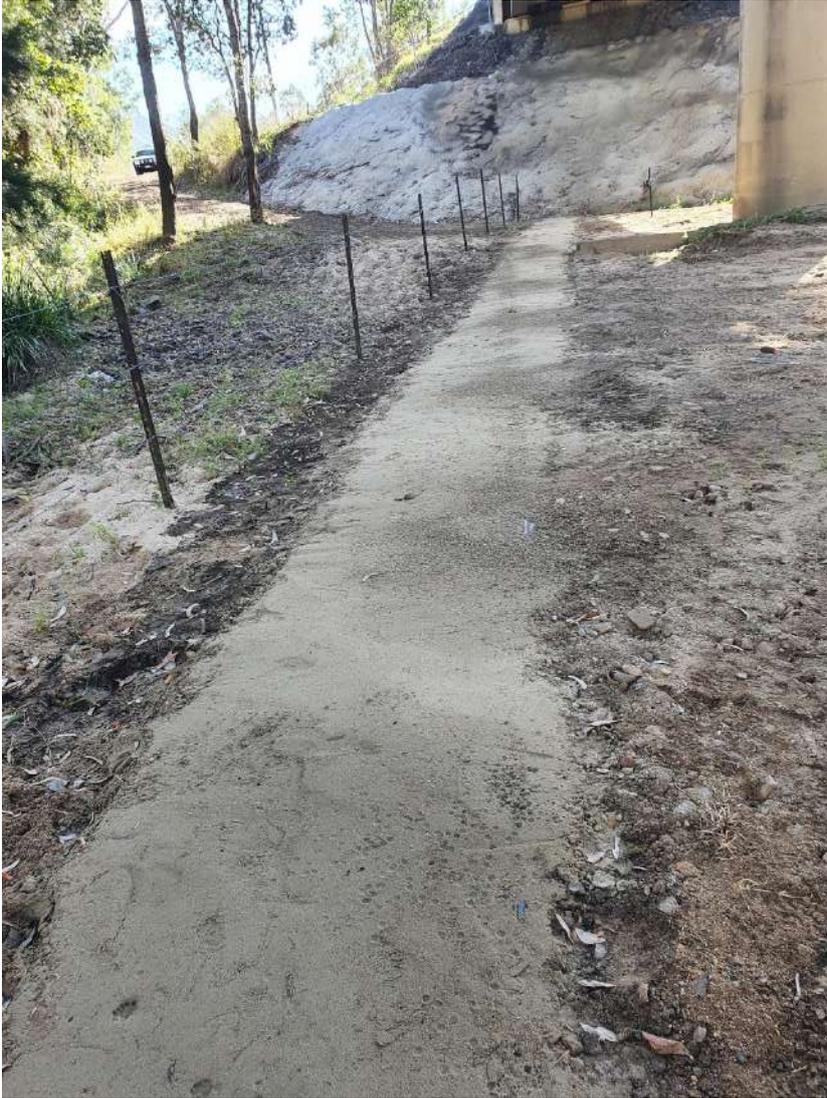
Figure 19: Rain damage at Plot 5, Denison Creek

Rain damage occurred on the long plots (Plots 5 and 6) under the Denison Creek bridge on several days during the 2020 monitoring period. The damage was predominantly due to runoff through the bridge drainage holes (see example of Plot 5 in Figure 19). This created several sections along the whole length of the plots in which the tracks became indistinguishable. As there was no workaround for this issue, the plots were smoothed out at the end of each monitoring day, and where sand was found to have washed away, it was replaced with excess sand.

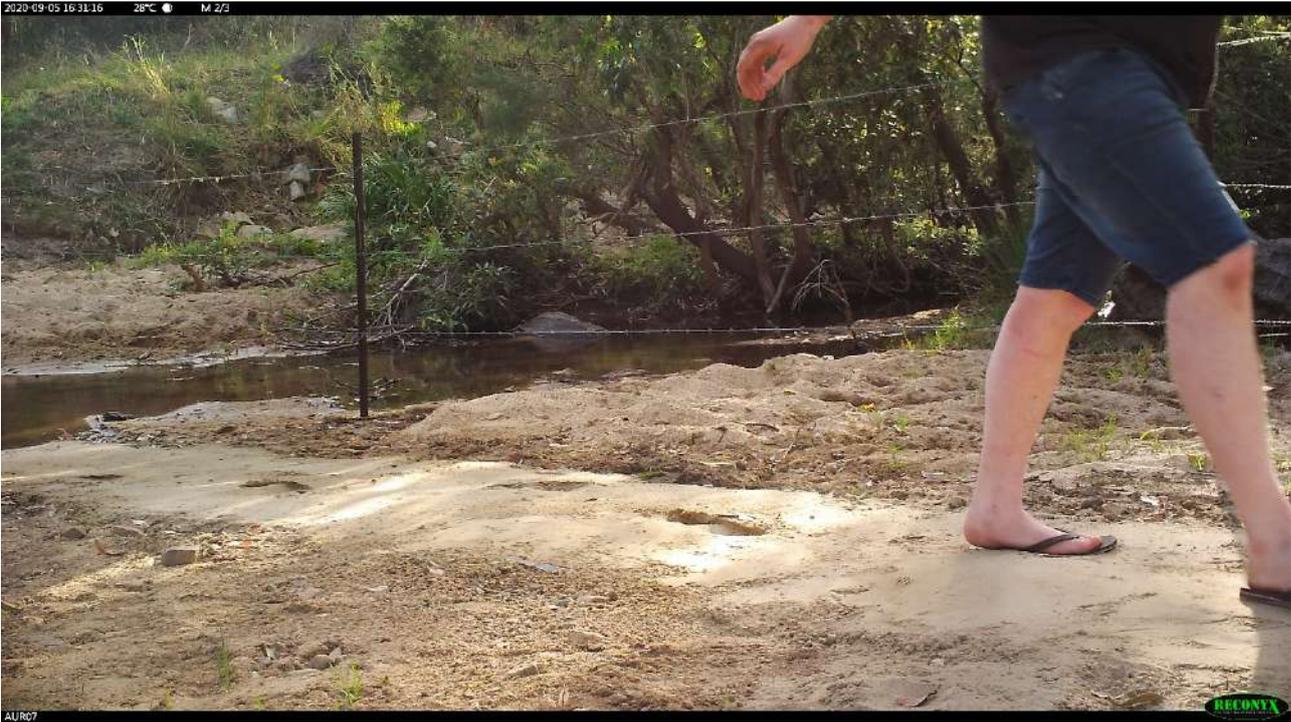
Figure 20: People traversing the full length of Plot 6, Denison Creek (Camera AUR07)

On 7 September 2020 it was found that several people had traversed the full length of Plot 6 in the creek bed at Denison Creek (Figure 20). This was likely associated with the large number of campers at a bike rally that was being held at the Retreat on the weekend of 5 September and did not occur again.
