Denison Creek and Stockyard Creek Fauna Fencing

2019 and 2020 Koala Breeding
Season Technical Report

**Department of Transport and
Main Roads**

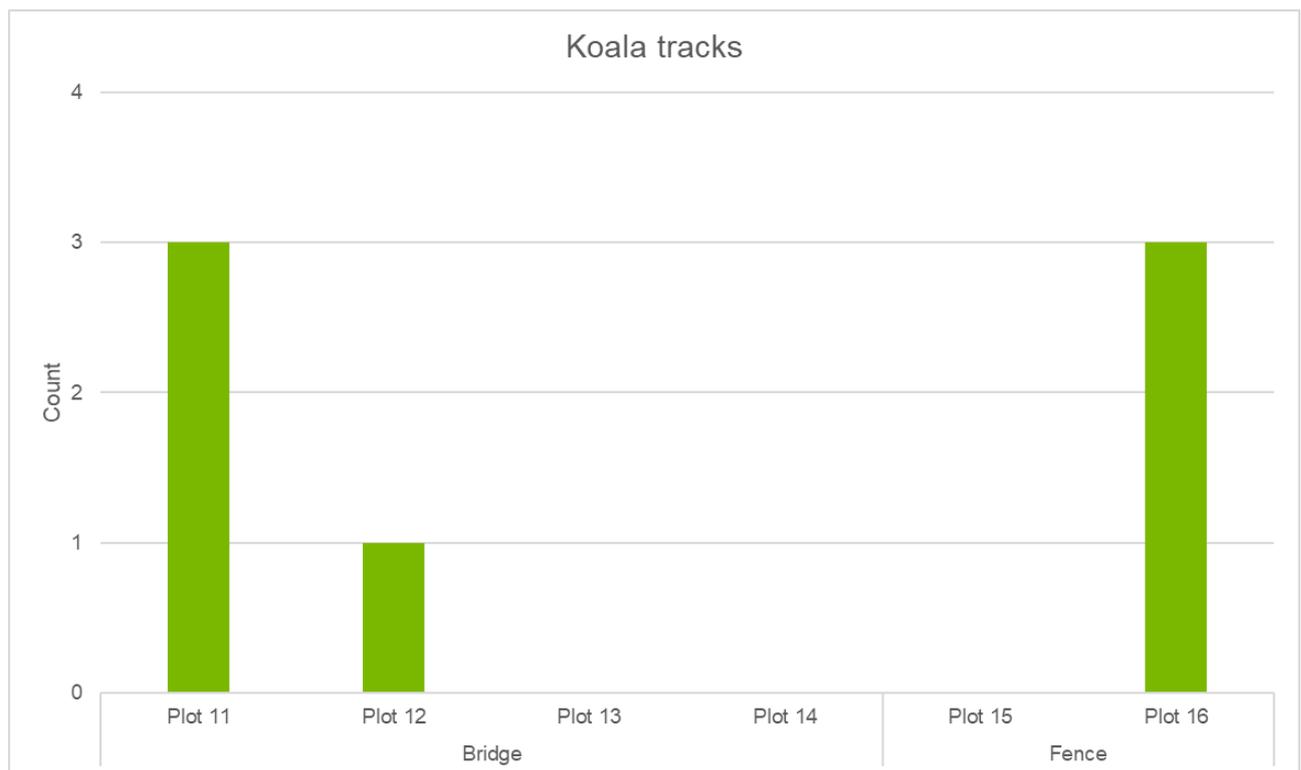
Figure 21: Recorded koala tracks on sand plots, Stockyard Creek 2020

Koala tracks were recorded using both the sand plots and the camera traps. In total there were seven koala tracks recorded on the sand plots or camera footage in 2020 at Stockyard Creek (as displayed in Figure 21). Five video and/or photo records were made of koalas, with one of the traverses on Plot 16 not recorded on the sand plot.

In the 2020 monitoring year, there were no recordings of koala tracks on Plots 13, 14, and 15 at Stockyard Creek (see Figure 21). Plot 11 (three tracks recorded) and Plot 12 (one track) are set up in the creek bed of Stockyard Creek (see Figure 5 for locations), while Plot 16 (three recordings) is located along the northern fauna exclusion fence line.

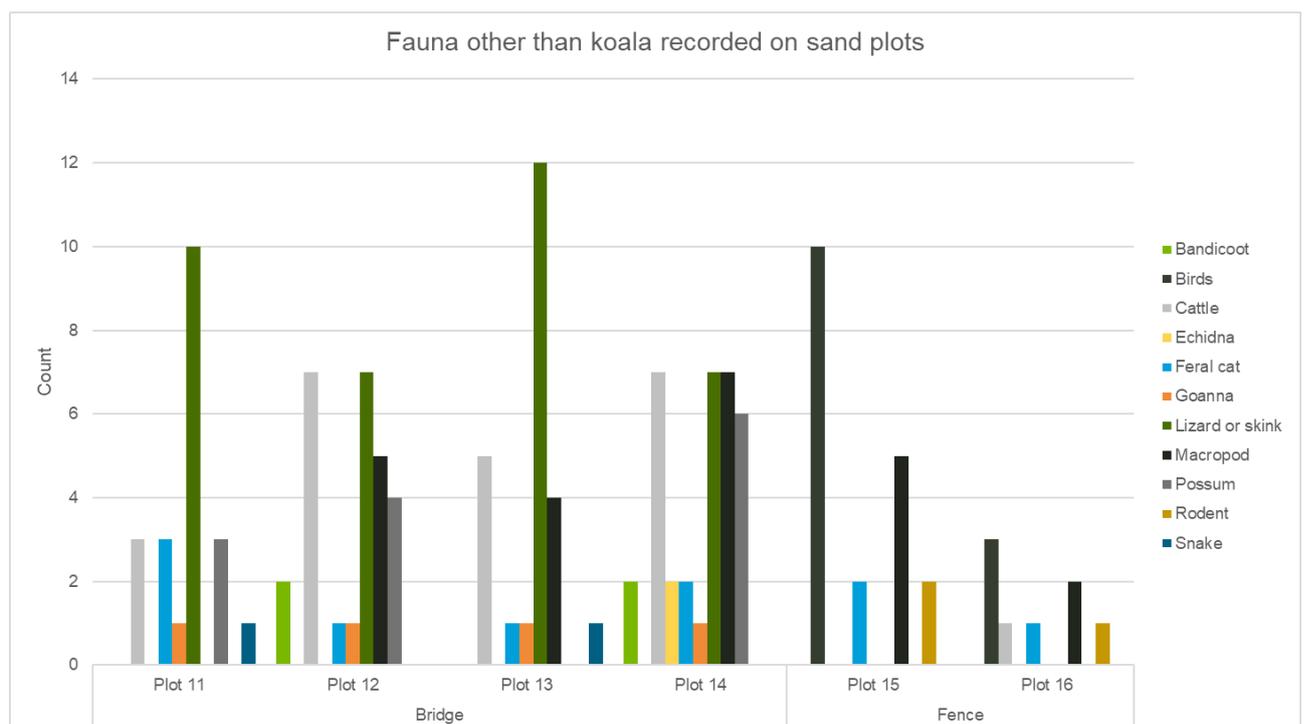
Figure 22: Tracks recorded for other species (non-koala), Stockyard Creek 2020

Figure 22 presents an overview of the frequency of tracks of other species recorded on the sand plots over the monitoring period at Stockyard Creek. This shows that lizards (including skinks) were the most abundant species (36 records), closely followed by macropods and cattle (23 records each). The plots in the creek bed were most frequently used (34, 28, 24, 24 records, respectively, for a total of 110 out of 139 recordings in 2020). Other tracks observed, not recorded or shown on the graph, belonged to beetles and other insects.

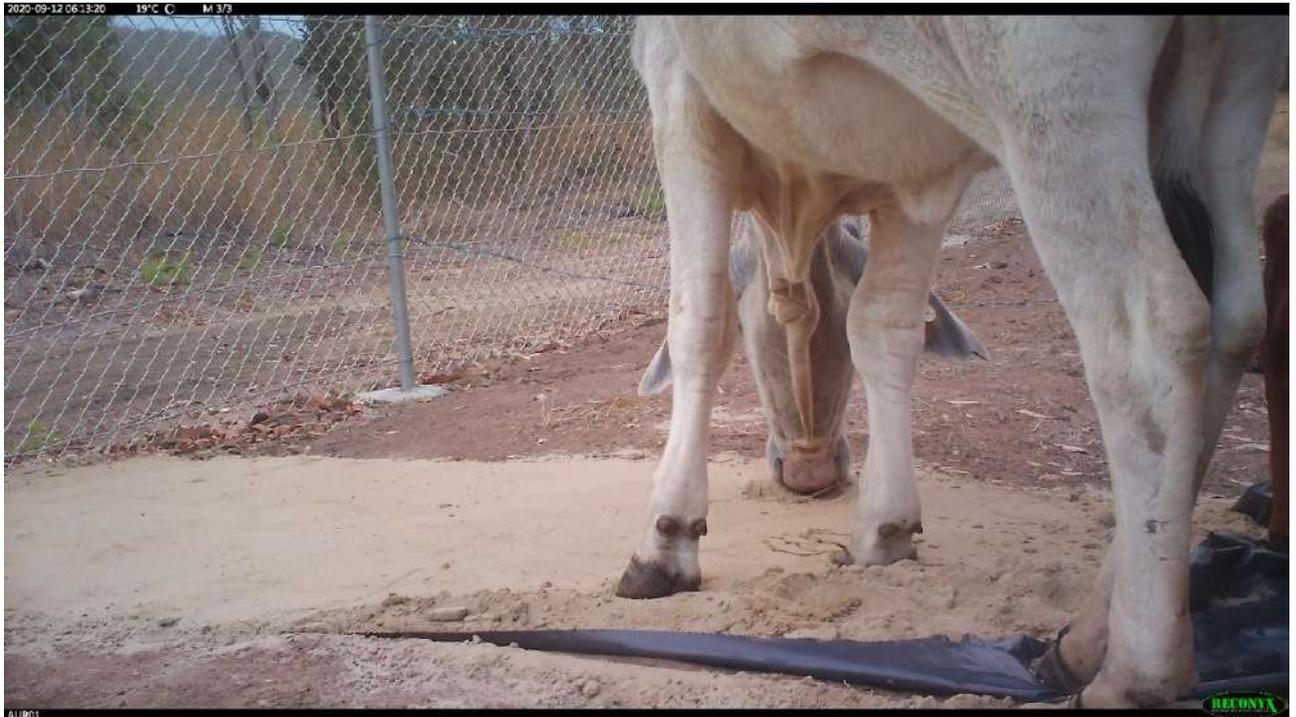
Figure 23: Cattle within barbed wire fencing at Plot 16, Stockyard Creek (Camera AUR01)

On Monday 14 September 2020, Plot 16 at Stockyard Creek (along the fence line) was found to have been destroyed by cattle, which had broken through the barbed wire fencing (Figure 23). The damaged plot (Figure 24) was repaired that day (Figure 25). The black plastic was slightly reduced in length to ensure cattle could not access it from outside the plot, and the barbed wire fencing was tightened to stop cattle from entering the plot again. This protection of this plot would have been more successful if the exclusion fencing was placed at a greater distance from the plot, however there was limited space available for the fence, which was adjacent to a vehicle access track fringed by trees.

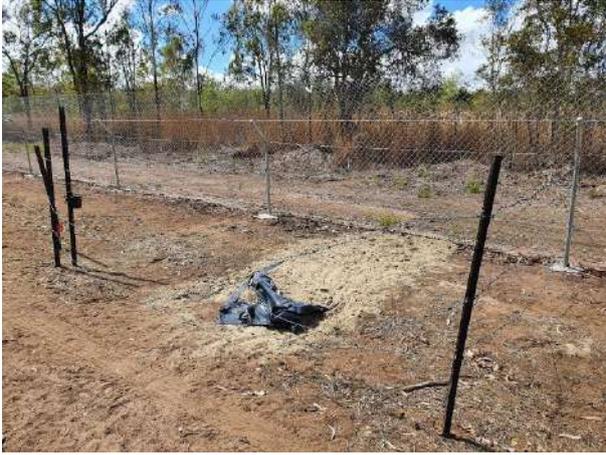
Figure 24: Cattle damage on Plot 16, Stockyard Creek

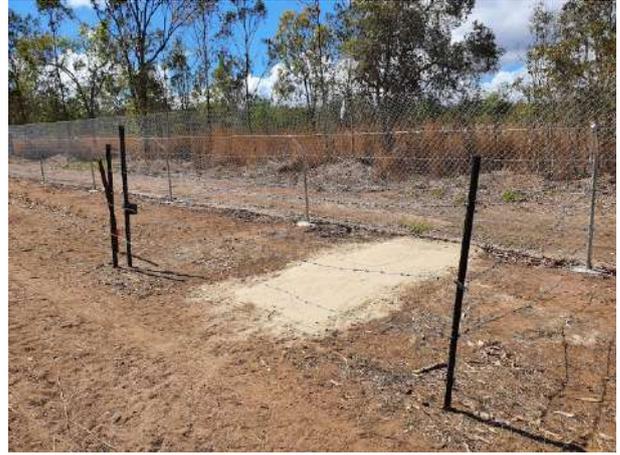
Figure 25: Plot 16 repaired after cattle damage, Stockyard Creek

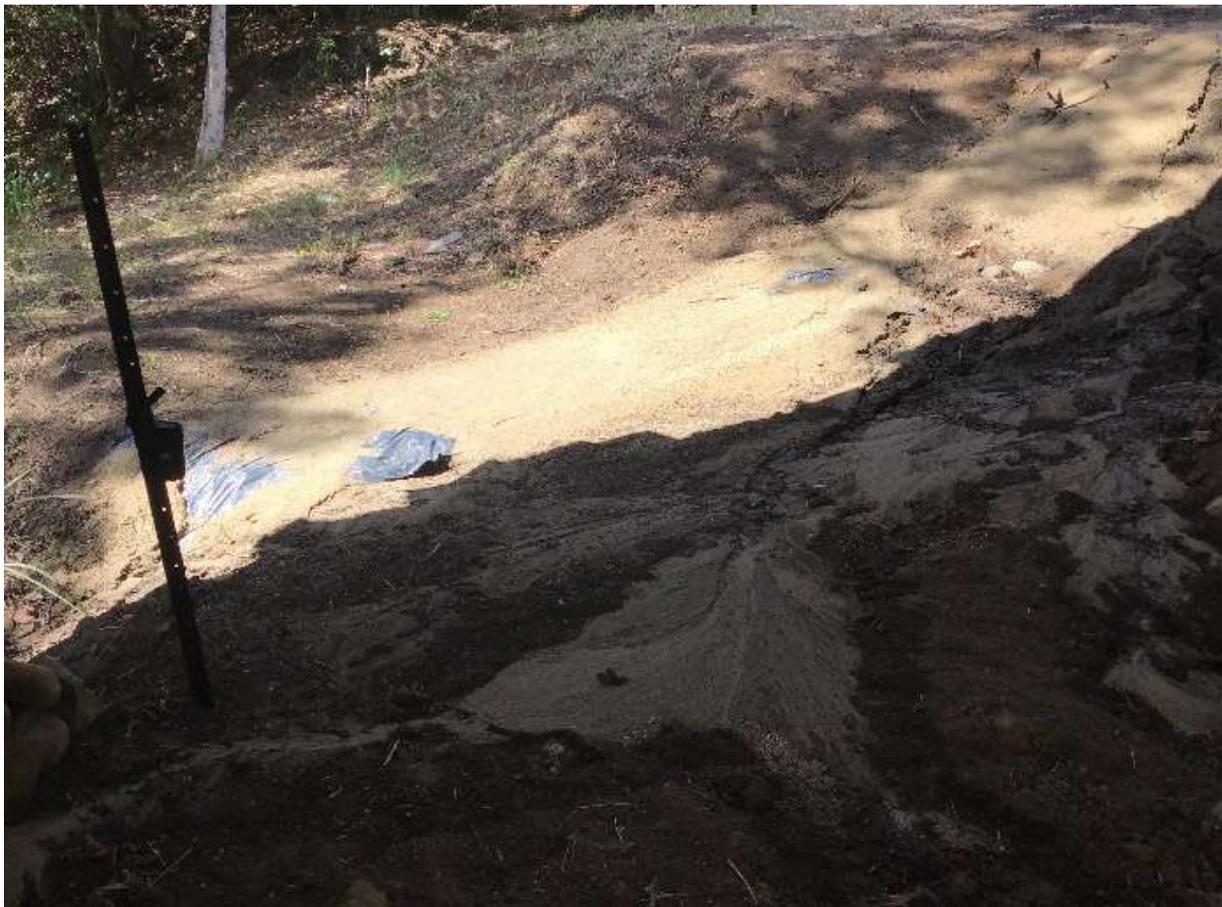
Figure 26: Rain damage at Plot 11, Stockyard Creek

On Friday 25 September 2020, three of four plots under Stockyard Creek were damaged by heavy rainfall (see example of Plot 11 in Figure 26). The Aurecon team re-installed these plots (see example of Plot 11 in Figure 27) on Monday 28 September using excess sand left at Stockyard Creek by RoadTek.

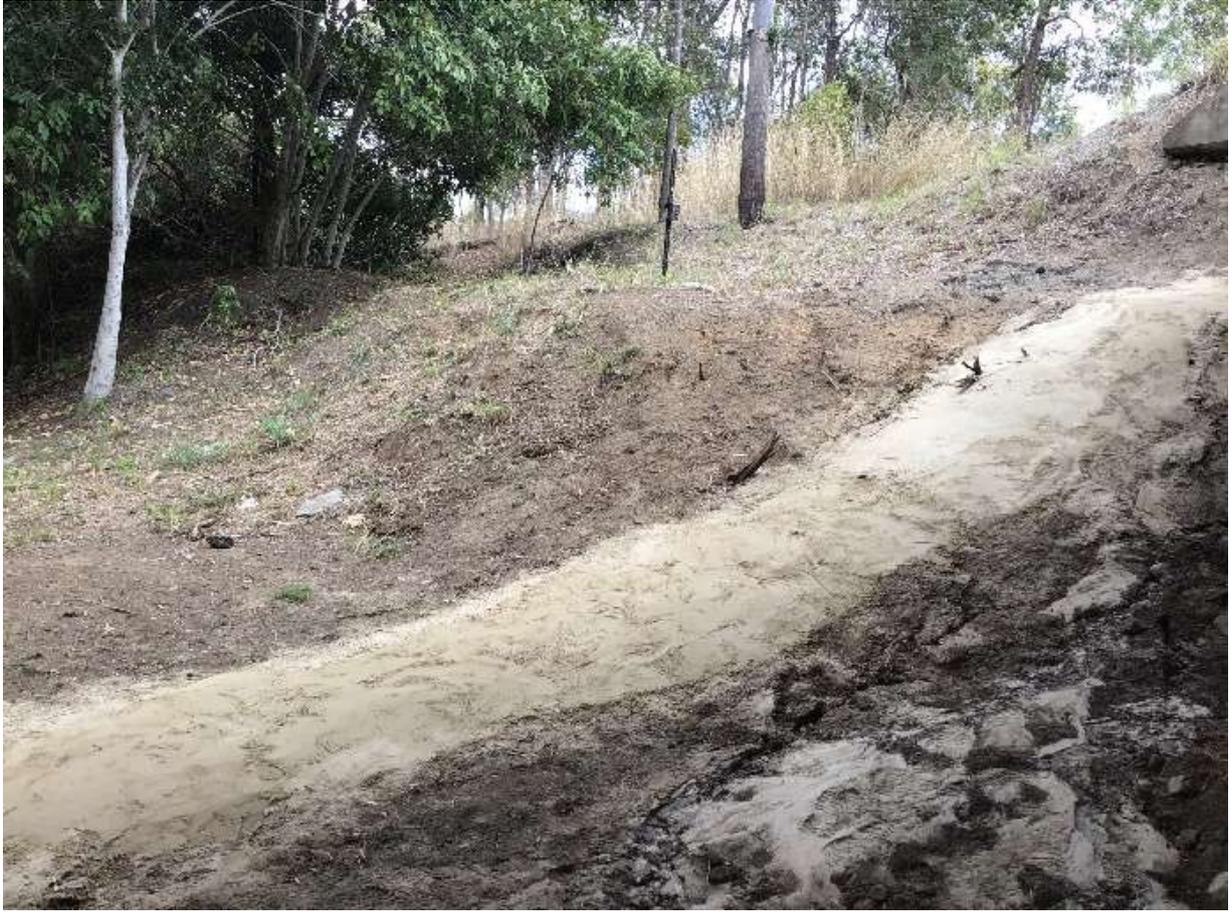
Figure 27: Plot 11 repaired after rain damage, Stockyard Creek

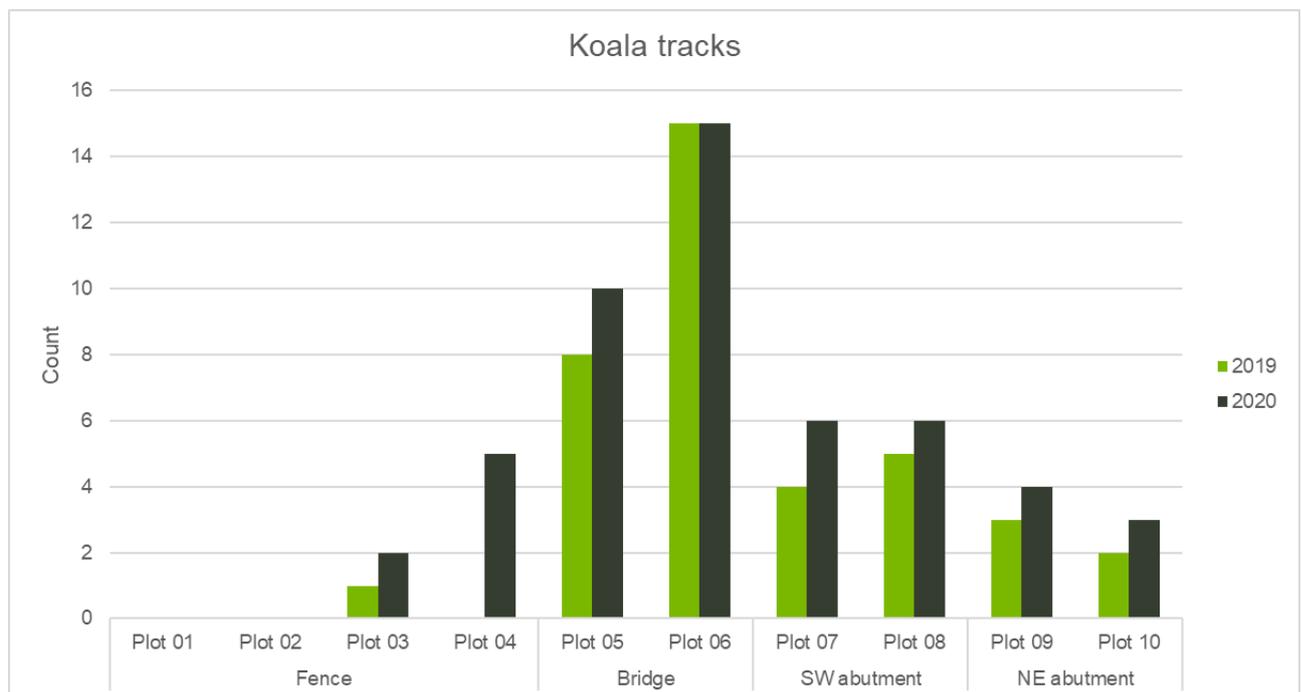
Figure 28: Koala tracks at Denison Creek in 2019 and 2020

The total number of koala tracks recorded on the sand plots at Denison Creek increased from 38 to 51, respectively between 2019 and 2020. A comparison of the 2019 and 2020 data (Figure 28) indicates comparable results between the two years. In both years, tracks were more abundant under the bridge compared to on the plots located at the fence lines. In neither year observations were made at Plots 1 and 2, along the fence line, with tracks only recorded at Plot 4 in 2020.

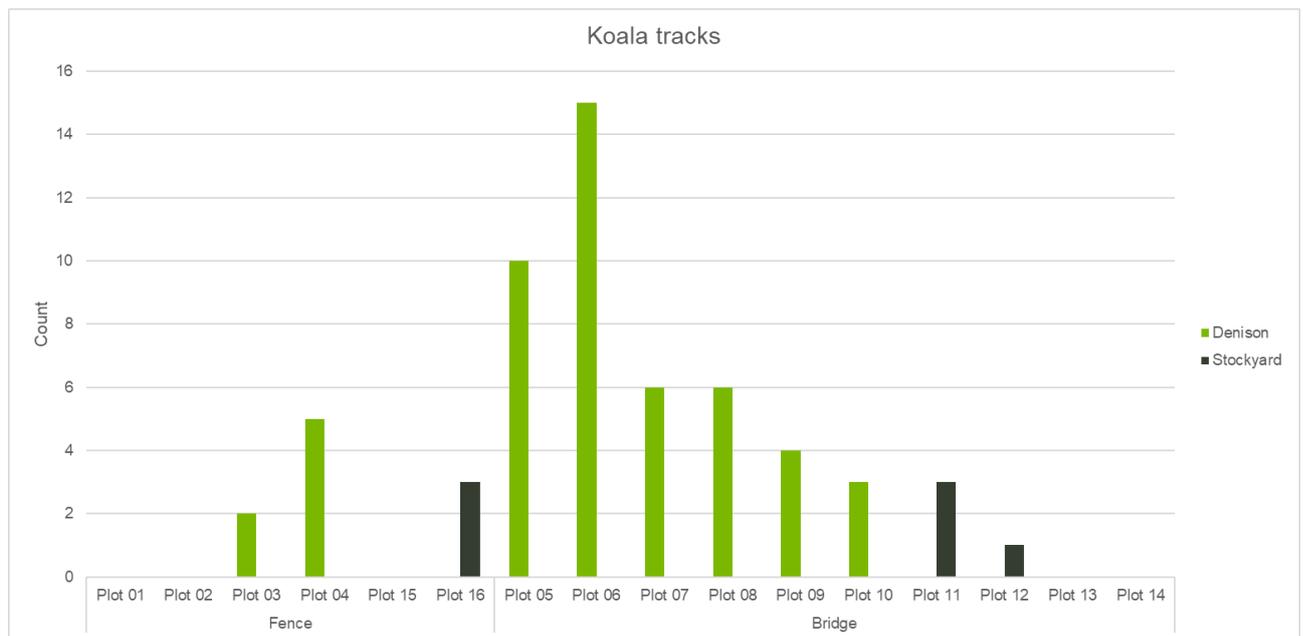
Figure 29: Koala tracks at Stockyard and Denison Creek, 2020

Significantly fewer koala tracks were recorded at Stockyard Creek in 2020 compared to Denison Creek in the same year (two-sample t-test: $p < 0.05$, see Figure 29). While there were 51 koala tracks recorded at Denison Creek in 2020, there were only seven koala tracks recorded at Stockyard Creek. Both locations had

five weeks of monitoring data, giving a mean number of koala tracks recorded for each location of 10.2 and 1.2, respectively, for Denison and Stockyard Creek.

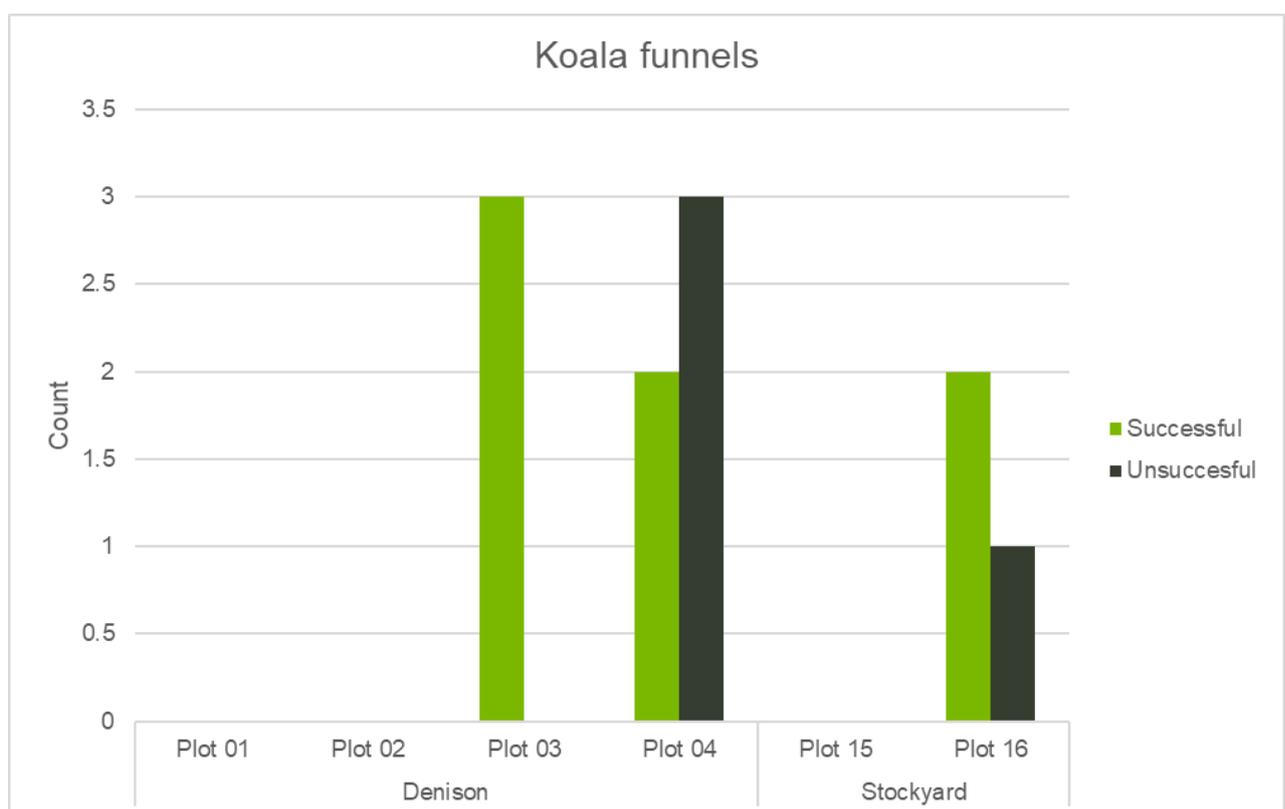
Figure 30: Comparison of successful koala funnelling at Denison and Stockyard Creek, 2019-2020

Funnelling occurred at Plots 1-4 at Denison Creek, and Plot 15 and Plot 16 at Stockyard Creek. No koala crossings were recorded at Plot 1, 2, and 15 (see Figure 30). The remaining plots had 11 tracks recorded in total, of which one was made in 2019 at Denison Creek, three at Stockyard Creek, and the remaining seven tracks were recorded at Denison Creek in 2020.

A total of seven tracks were considered to be successful funnels (Figure 30). While this constitutes 64% of all recorded funnels, there was no significant difference between successful and unsuccessful funnels (two-sample t-test: $p = 0.81$). The mean number of successful koala funnels recorded for each monitoring period was 0.25 and 0.8 per week, respectively, for 2019 and 2020 at Denison Creek and 0.4 at Stockyard Creek. Extrapolating this data to the entire breeding season indicates there would have likely been around seven and 21 successful funnels at Denison Creek, respectively for 2019 and 2020, and 11 at Stockyard Creek in 2020 over 26 months.

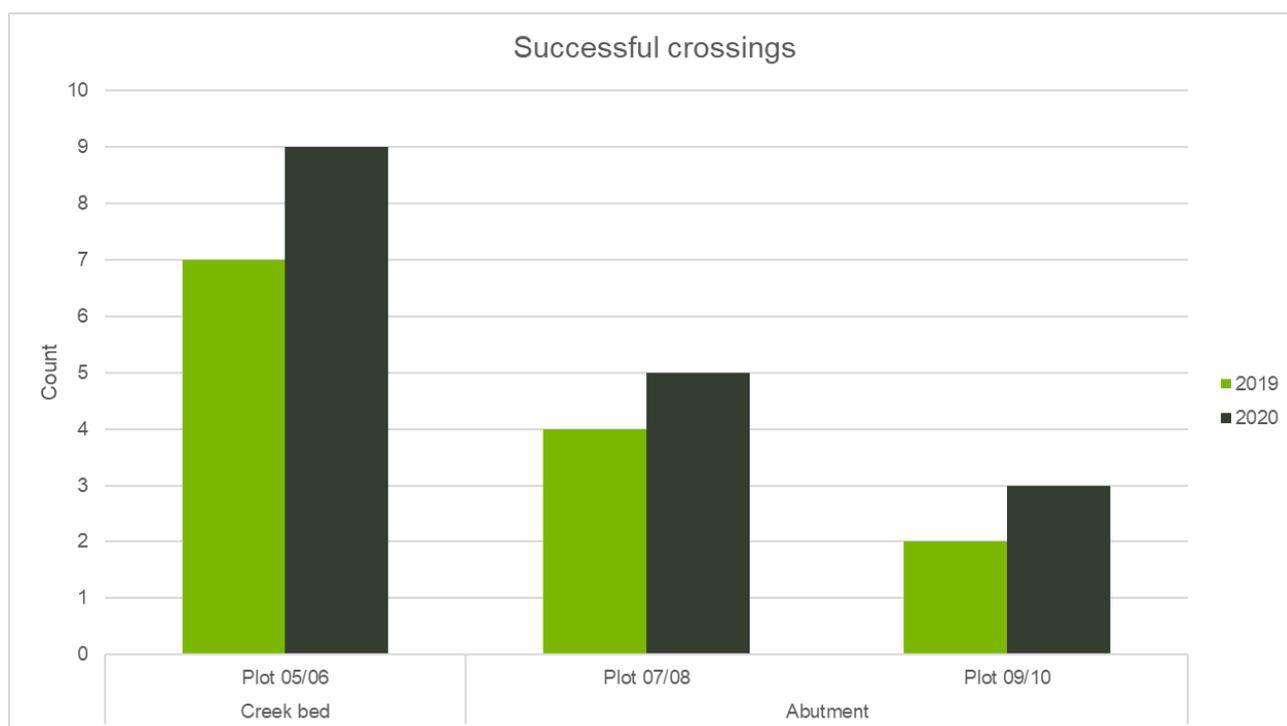
Figure 31: Comparison of successful koala crossings at Denison Creek, 2019-2020

There were 13 successful crossings recorded at Denison Creek in 2019, and 17 successful crossings recorded at Denison Creek in 2020 (Figure 31). The mean number of successful koala crossings recorded for each monitoring period was 3.25 and 3.4 per week, respectively, for 2019 and 2020. Thus, there was no significant difference found in the number of successful crossings (two-sample t-test: $p = 0.93$) at Denison Creek between the two years. Extrapolating this data to the entire breeding season indicates there would have likely been around 85 and 89 successful crossings at Denison Creek, respectively for 2019 and 2020, over 26 months.

Plot 5 and 6, in the creek bed, provided the most numerous successful crossings each year (seven and nine, respectively for 2019 and 2020; Figure 31).

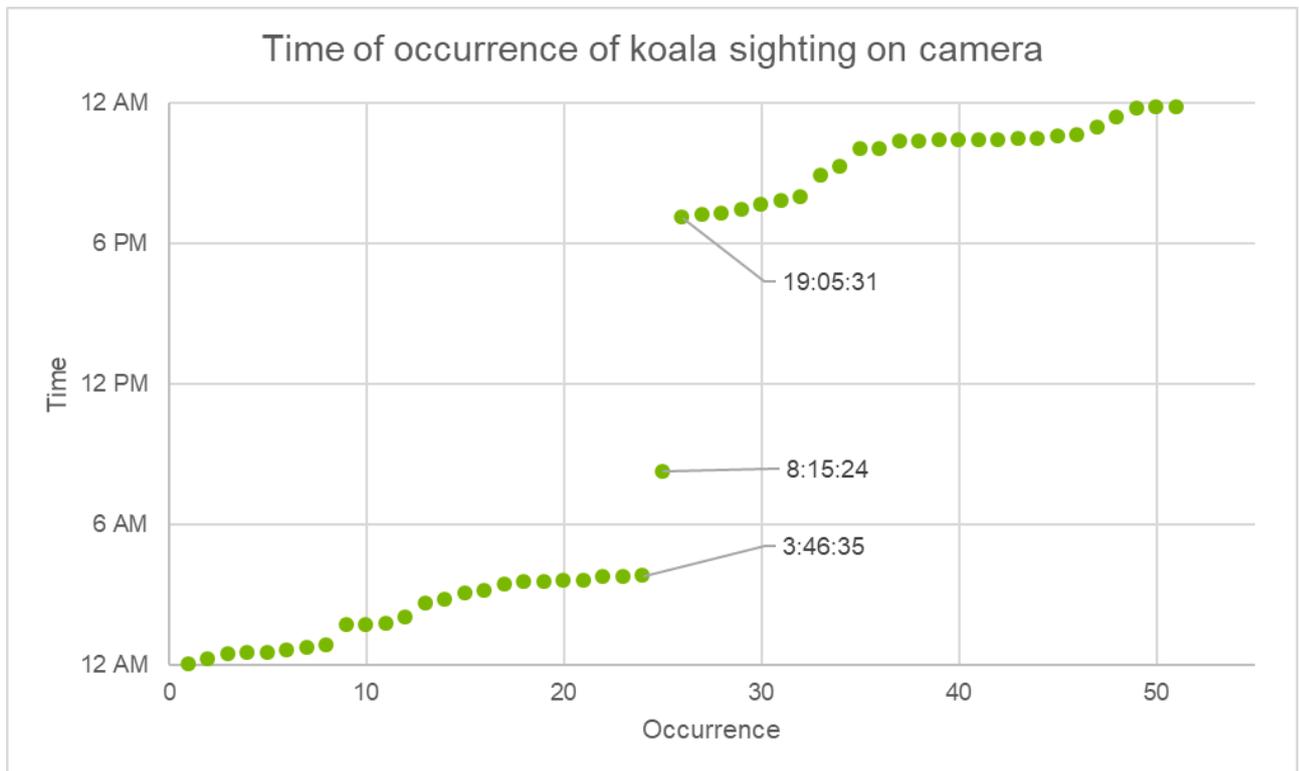
Figure 32: Temporal movement of koalas on camera

During the two-year monitoring period at Denison and Stockyard Creek the camera traps recorded the date and times at which fauna triggered the cameras. Figure 32 shows the times, sorted chronologically, at which each of the 51 koala records were taken with the motion sensor cameras. Koalas were recorded predominantly between 7 pm and 4 am, with a single recording at 8.15 am (see Appendix B, Camera AUR07, 20200909).

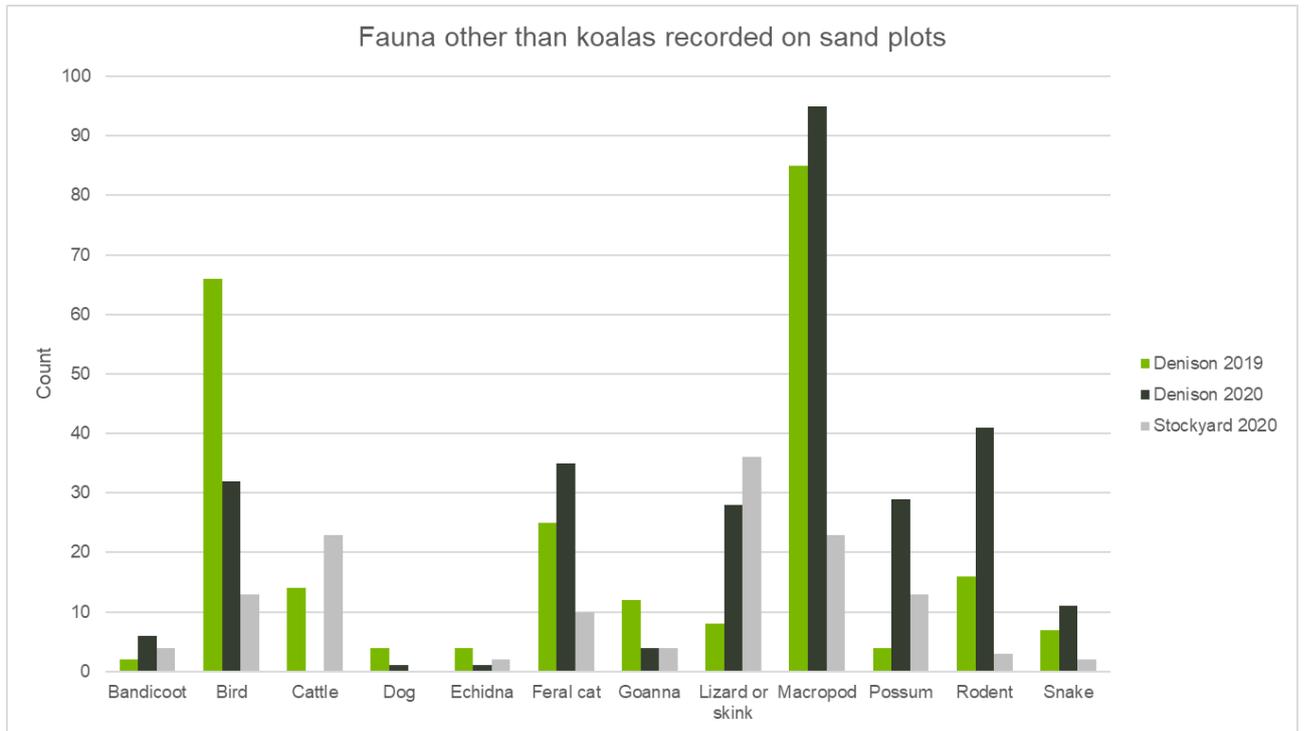
Figure 33: Species tracks recorded at Denison Creek and Stockyard Creek

A total of 12 taxa have been recorded via tracks in the Denison Creek sand plots and 11 taxa have been recorded via tracks in the Stockyard Creek sand plots (Figure 33).

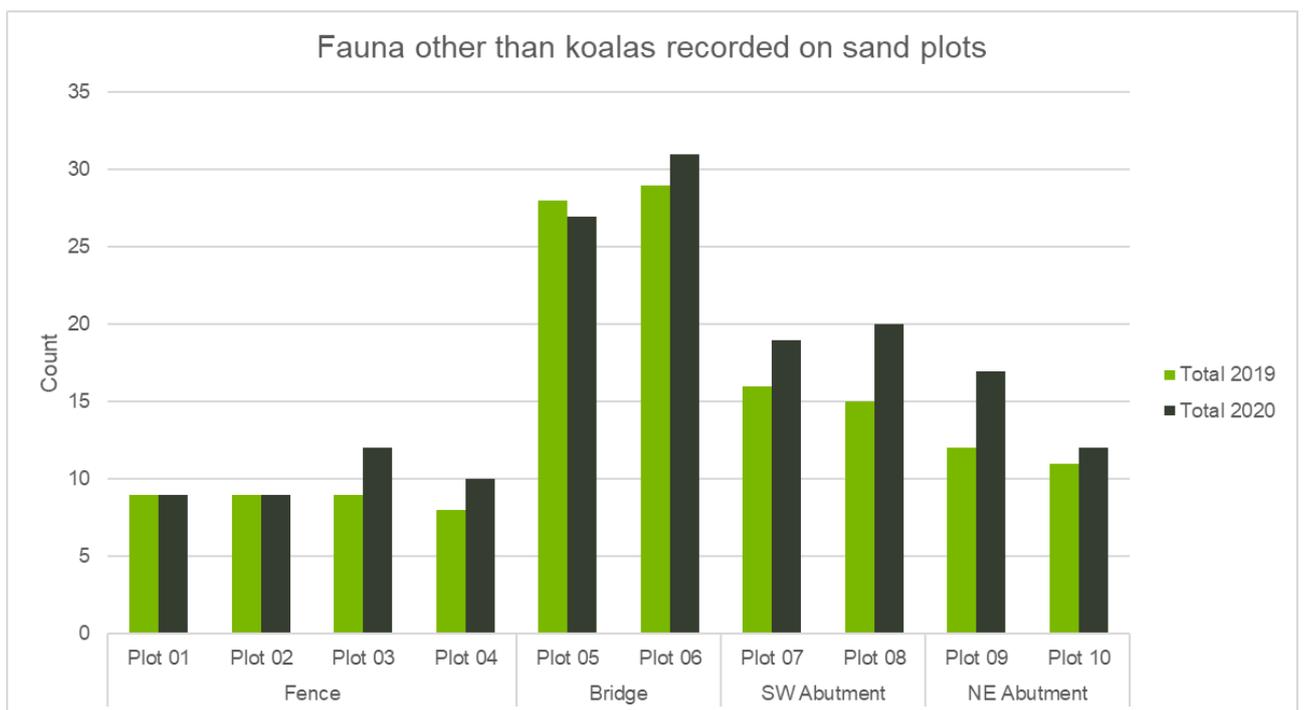
Figure 34: Total species tracks on sand plots at Denison Creek, 2019 and 2020

There was, however, a significant difference (two-sample t-test: $p < 0.05$) between the number of species recorded along the fence line (Plots 1 – 4) and in the creek bed (Plots 5 – 10) at Denison Creek (Figure 34). Although there is a difference between the number of species' tracks recorded at Stockyard (Figure 35) this was not significant (two-sample t-test: $p = 0.07$).

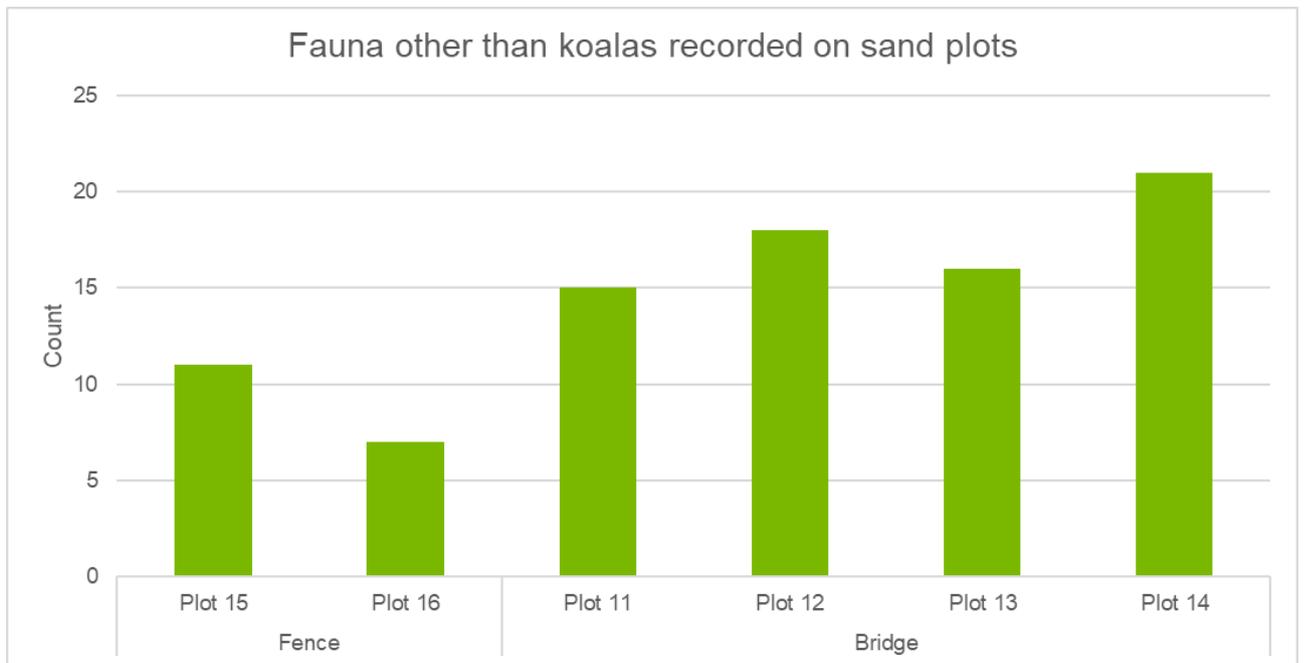
Figure 35: Total species tracks on sand plots at Stockyard Creek, 2020

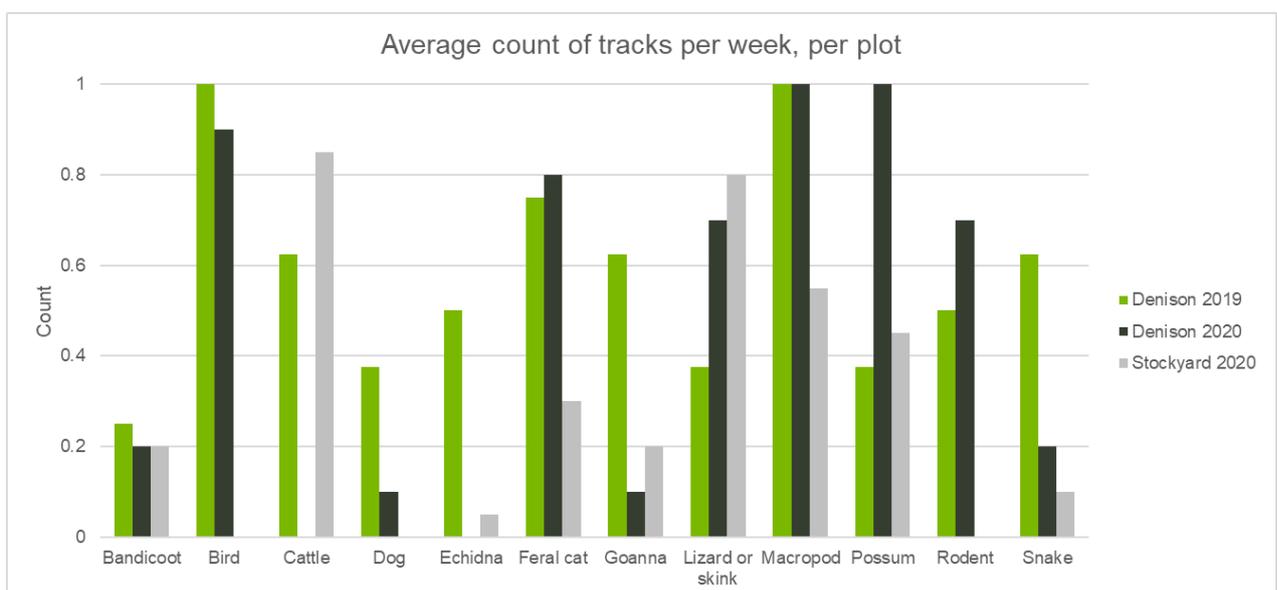
Figure 36: Average count of tracks per species per week per plot in the creek beds at Denison (Plots 5 and 6) and Stockyard Creek (Plots 11-14)

Within the creek beds at both Denison and Stockyard Creek all twelve species (other than koalas) were recorded. On average, the most frequently recorded species were macropods and birds at Denison Creek, with tracks recorded each week (Figure 36). Similarly, at Stockyard Creek tracks of cattle and lizards (or skinks) were recorded each week. Feral cats were recorded almost weekly at Denison Creek in both 2019 and 2020, however, their tracks were observed less frequently at Stockyard Creek.

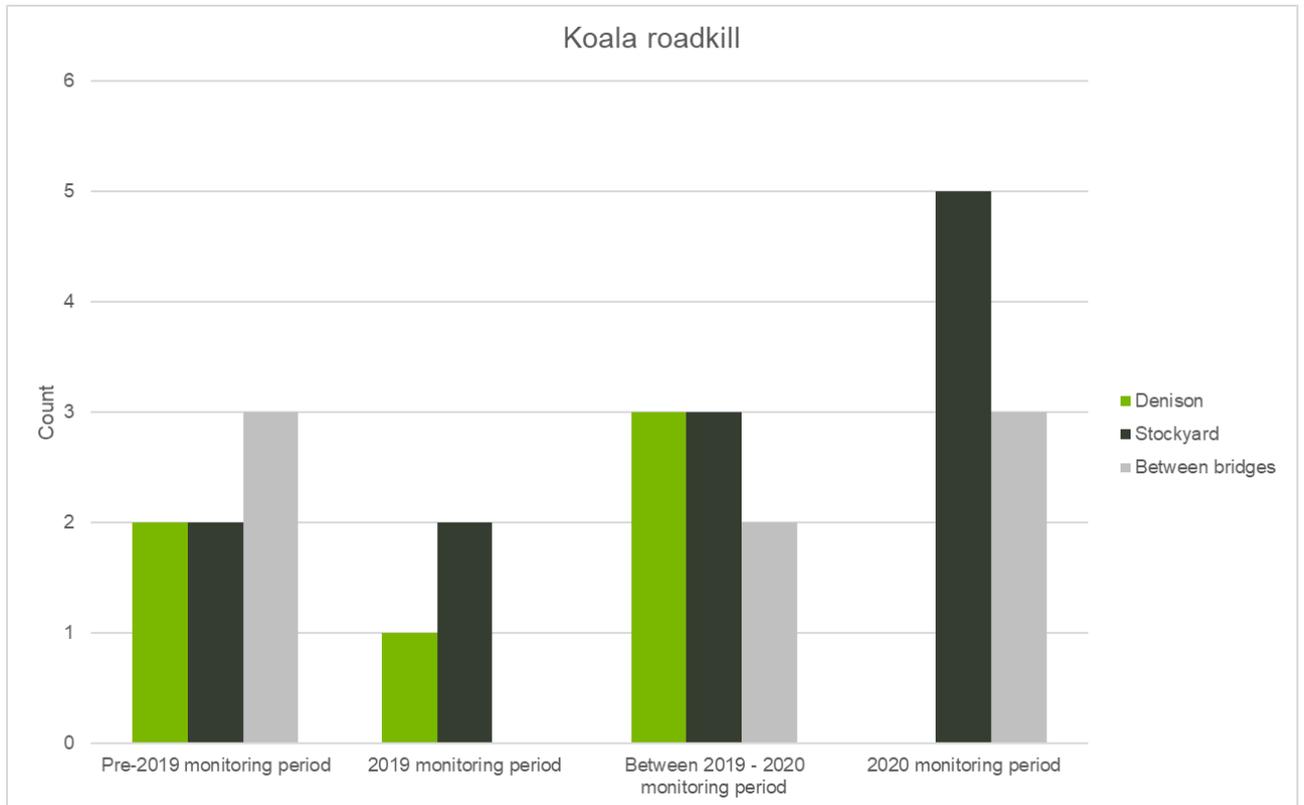
Figure 37: Koala roadkill records (from July 2019 to October 2020)

For the purpose of these analyses the koala roadkill data have been split in three groups; Denison, Stockyard, and between bridges (see Figure 37). There was no significant difference between the number of roadkill at Denison and Stockyard (two-sample t-test: $p = 0.32$). Although more roadkill recordings were made in the 2020 monitoring period, compared to 2019, this was not statistically significant (two-sample t-test: $p = 0.27$). Similarly, while there were 10 roadkill recorded during the 2020 breeding season, compared to nine during the 2019 breeding season, this difference was not significant (two-sample t-test: $p = 0.15$). There was, however, a significant difference (two-sample t-test: $p < 0.05$) between the number of roadkill recorded prior to (seven roadkill), and during (19 roadkill) the breeding seasons over 32 and 31 weeks, respectively, for which data was available, at a mean of 0.12 and 0.61 roadkill recorded per week, respectively, prior to and during the breeding seasons. This result is not unexpected, given the increase in koala activity and movement during the breeding season (Ellis et al, 2018 and references therein).

The number of road-killed koalas at Stockyard Creek in the five-week 2020 monitoring period (five animals, including three recorded north of the site) was considerably higher, on average, than the number of BioCollect roadkill records for that location in the preceding 18 months (seven animals) (refer Figure 37). This is unlikely to reflect a genuine increase in the koala mortality rate, as the 2020 monitoring period involved intensive, targeted surveillance, whilst the previous records (pre-fence installation) were collected opportunistically. However, there were no road kills at all at Denison Creek during the 2020 monitoring
