**Manual**

**Criteria for Inspection, Life Extension and Rehabilitation  
of Circular Corrugated Metal Culverts**

**November 2015**

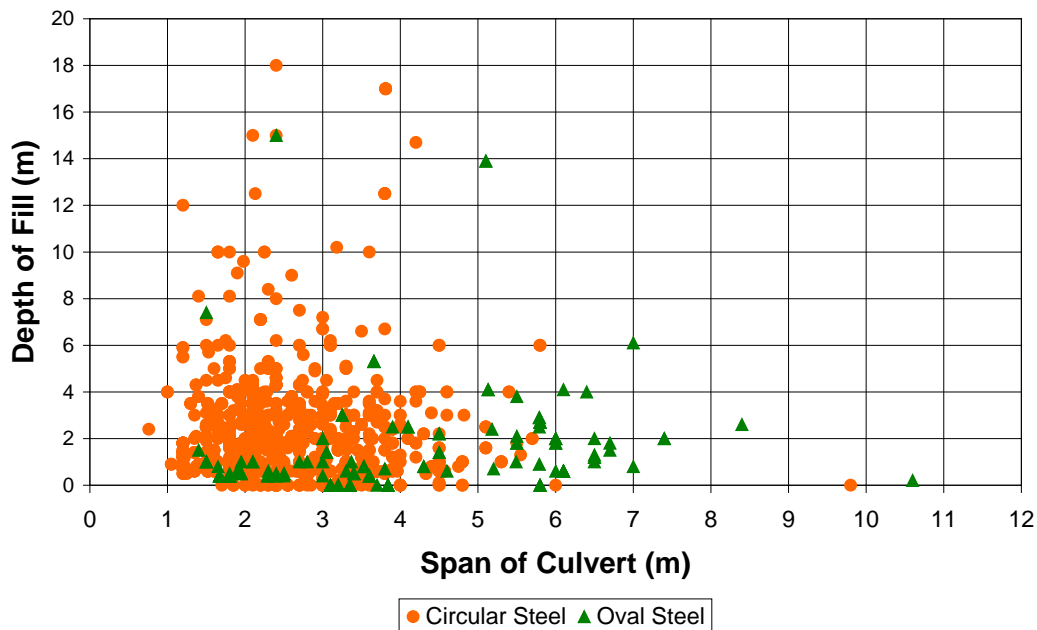
**Figure 1.2 – Transport and Main Roads metal culverts: depth of fill versus span for circular and oval culvert (Jan 2011)**

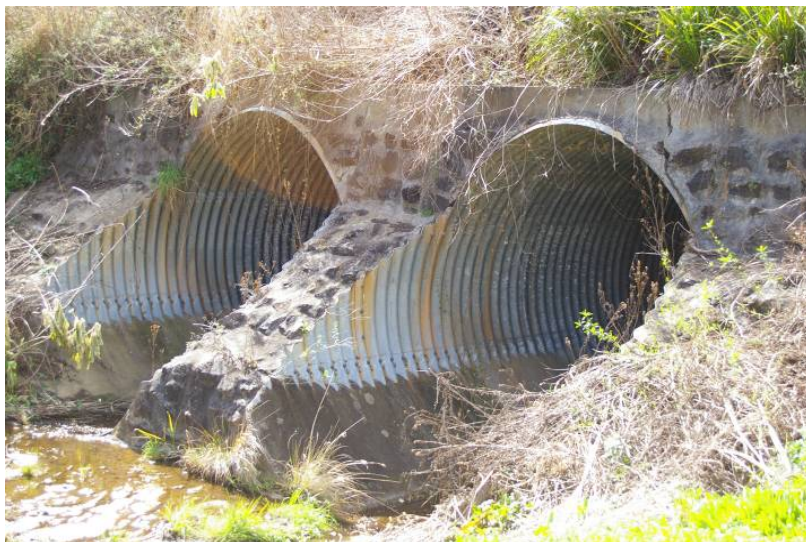
**Figure 3.1.1.1 – Multi-plate culvert**

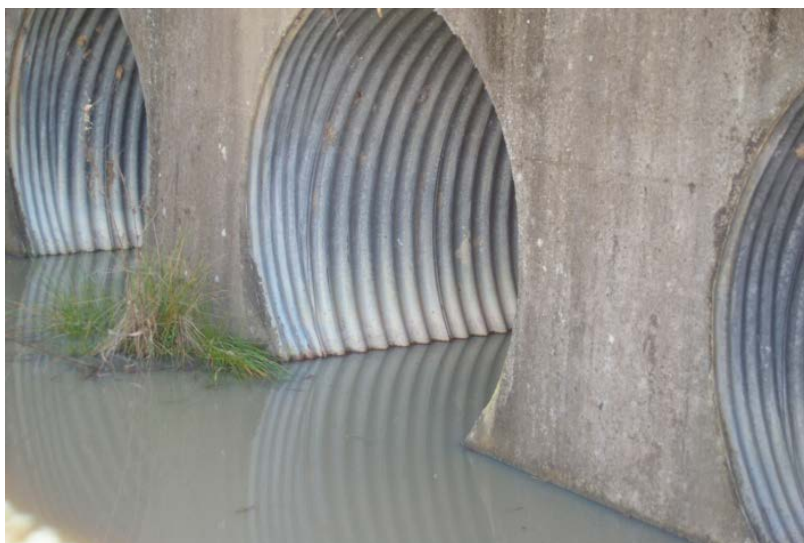
These culverts are helically wound by machinery which decreases installation time (refer Figure 3.1.1.2). Metal thickness is thinner than the plate culverts, and is typically 3 mm or less. They are therefore more susceptible to corrosion and to distortion during backfilling operations in construction.

**Figure 3.1.1.2 – Helically wound culvert**

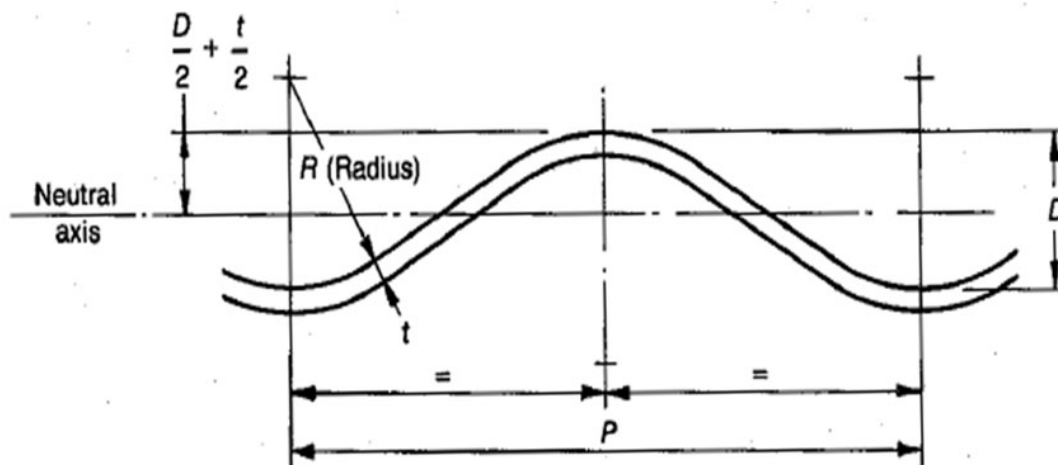
**Figure 3.1.3 – Corrugations for steel pipes (Source: AS 1762-1984)**

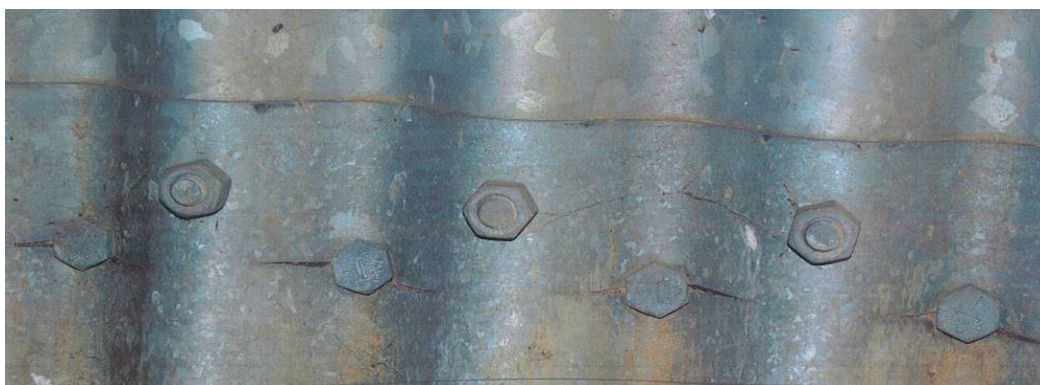
**Figure 3.1.8.2 – Cracks in metal plate (Source: ConnDOT, 2000)**

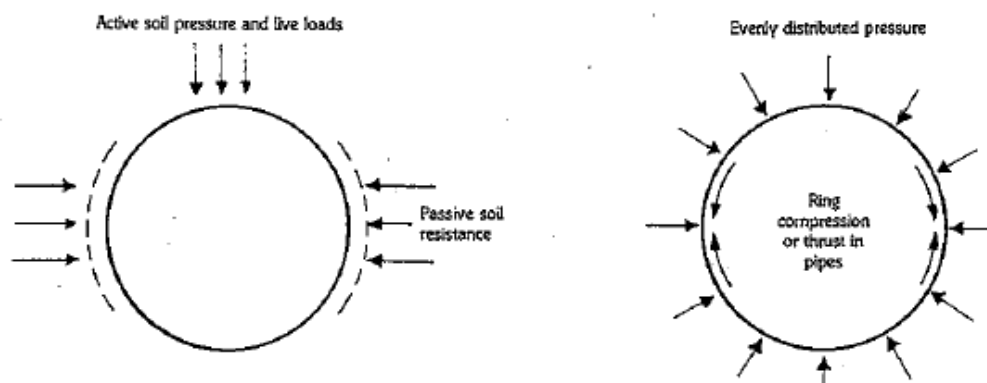
**Figure 3.1.8.3 – Ring compression theory (Source: ConnDOT, 2000)**

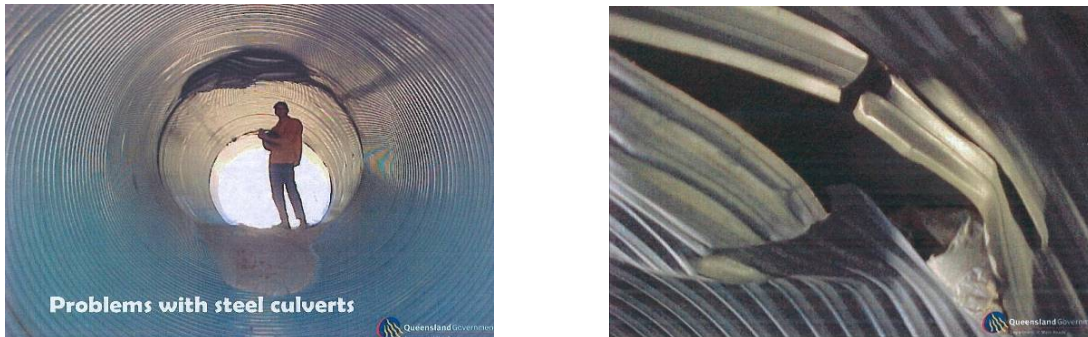
**Figure 3.1.8.5 – New culvert damage**

Significant distortions occurring during construction should be recorded in construction files or earlier inspection reports. Unfortunately, construction records may be difficult to access after several decades. Determining when damage occurred may require structural engineering advice.

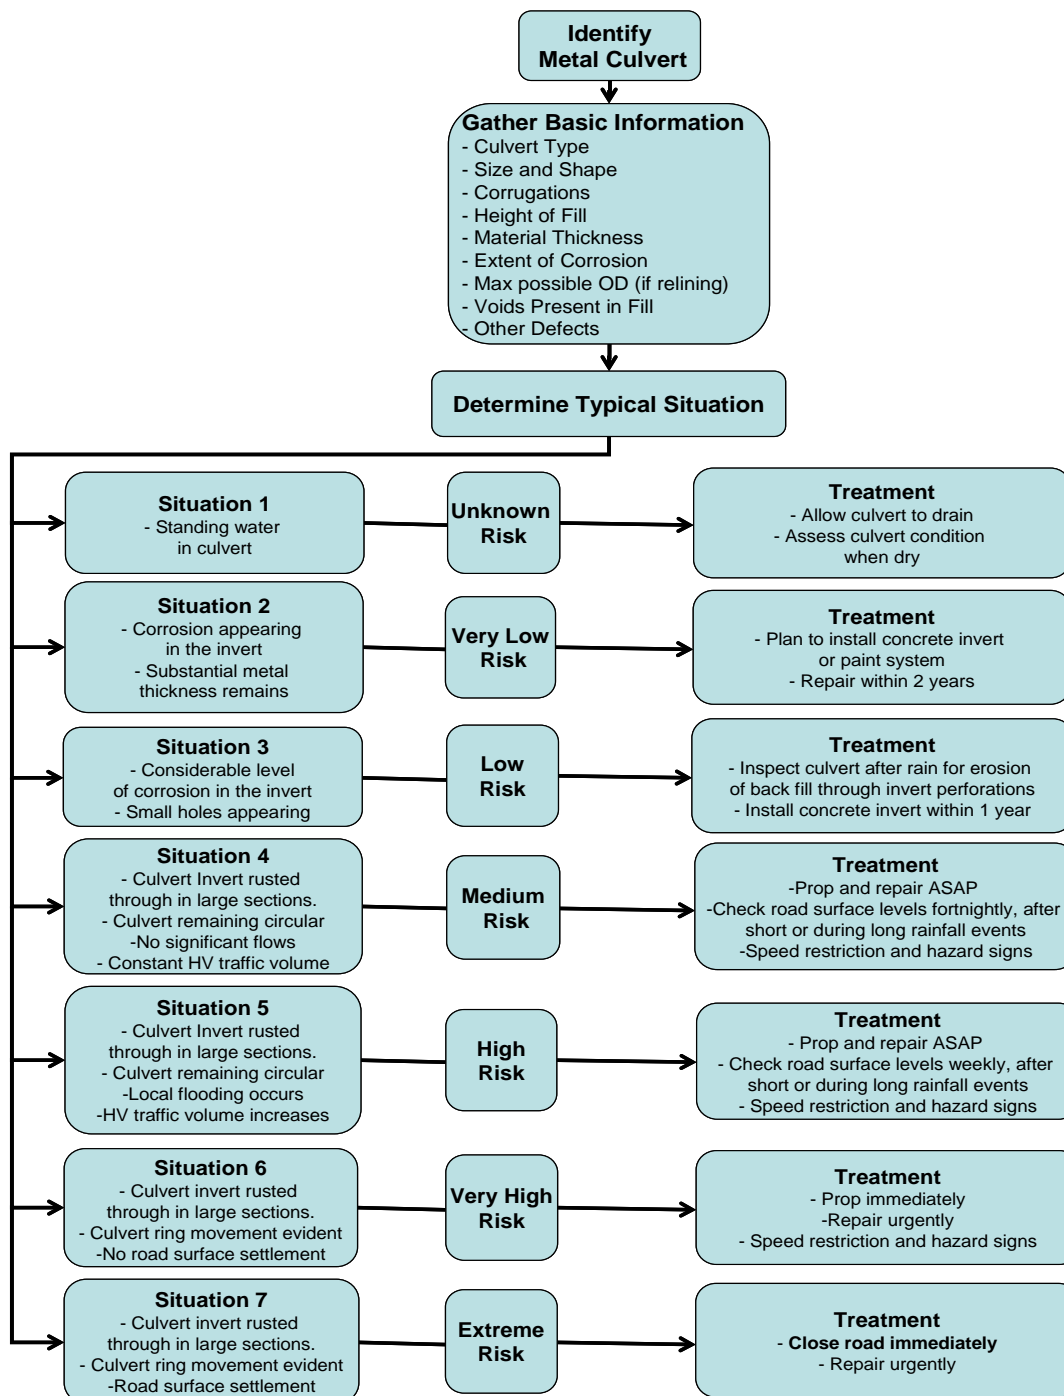
**Figure 3.2 – Summary of typical culvert situations**

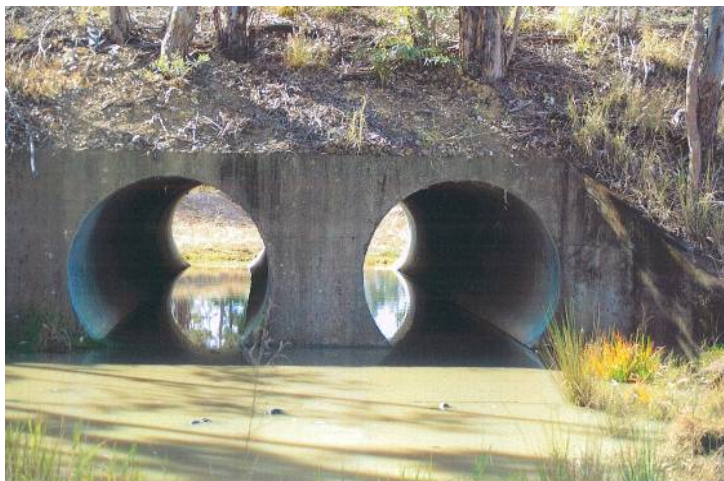
**Figure 3.2.1.1 – Standing water in culvert**

Survey downstream levels and the consult land owner. If practical, cut a low flow channel that will allow the culvert to drain. If a blockage is caused by cattle or vehicles pushing the bank into the stream bed, negotiate a preventative strategy such as:

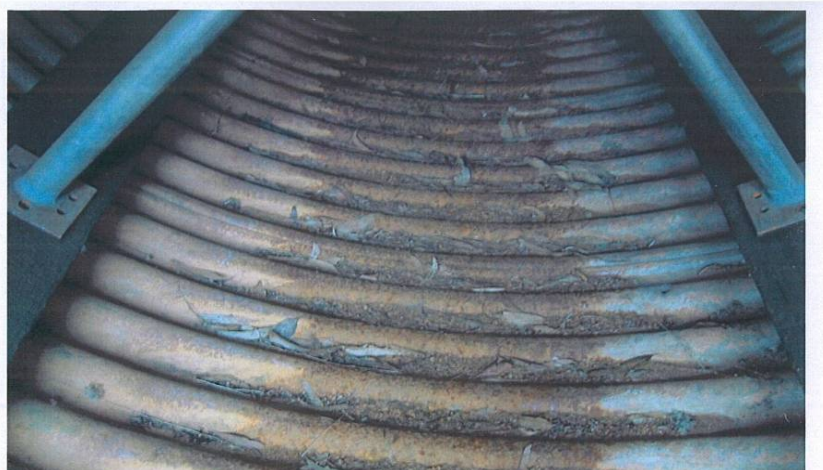
**Figure 3.2.2.1 – Culvert showing significant corrosion in invert**

Note: Propping as shown is not necessary in this condition.

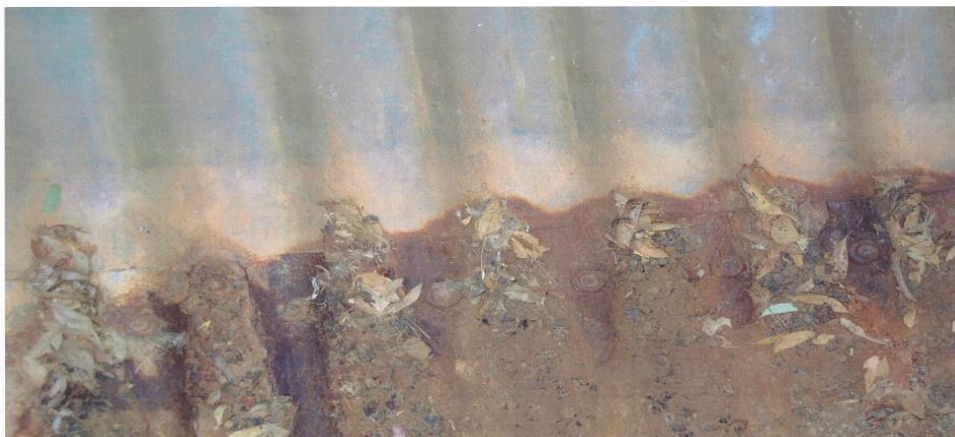
**Figure 3.2.3.1(a) – Heavy corrosion in invert**

Note: Small perforations to metal culvert.

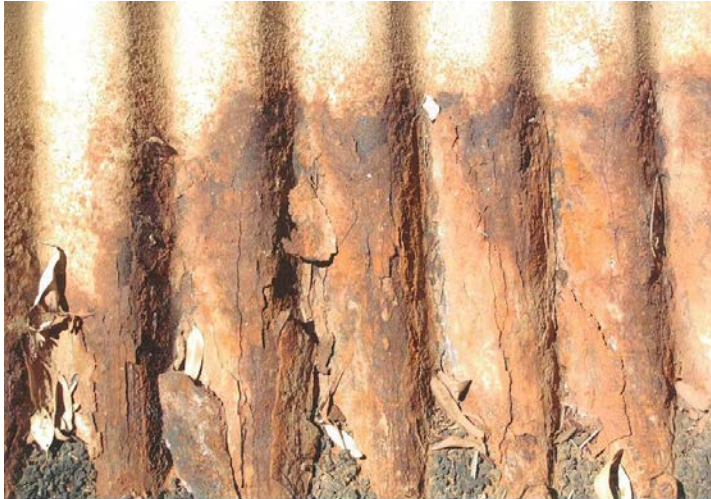
**Figure 3.2.3.1(b) – Heavy corrosion**

Note: Considerable loss of metal thickness.

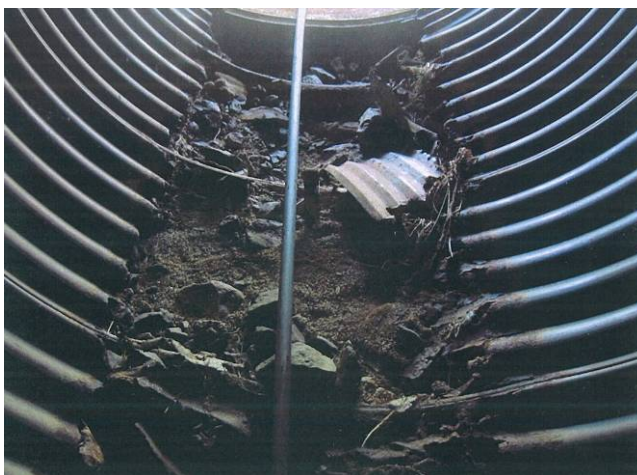
**Figure 3.2.4.1 – Culvert invert corroded away**

Note loss of granular bedding material in invert.

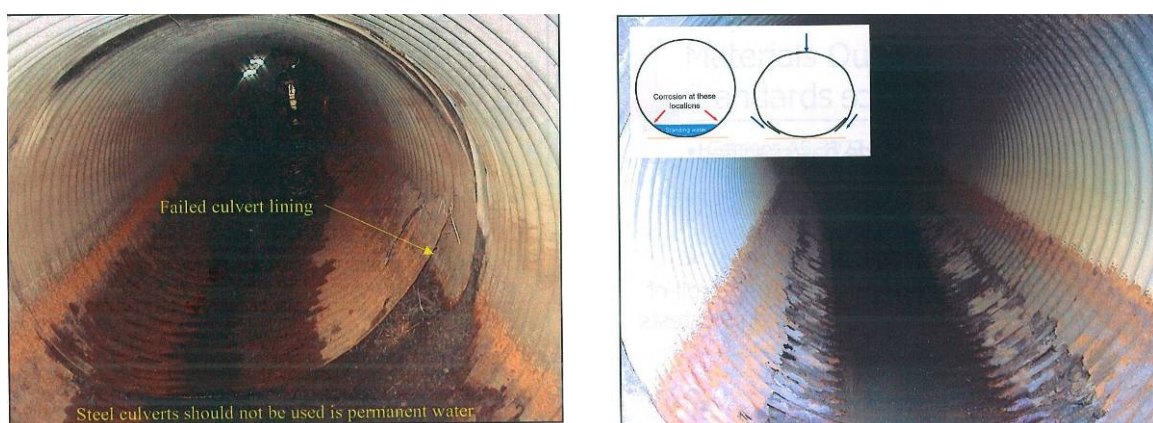
**Figure 3.2.6.1 – Culvert ring movement**

- Inform Regional/District Management immediately
- Seek structural engineering advice – send photos of culvert
- Prop the culvert immediately if safe to do so
- Put speed restrictions and hazard identification signage in place to ensure adequate stopping sight distance should a hazard develop, and
- Urgent repairs will be necessary.

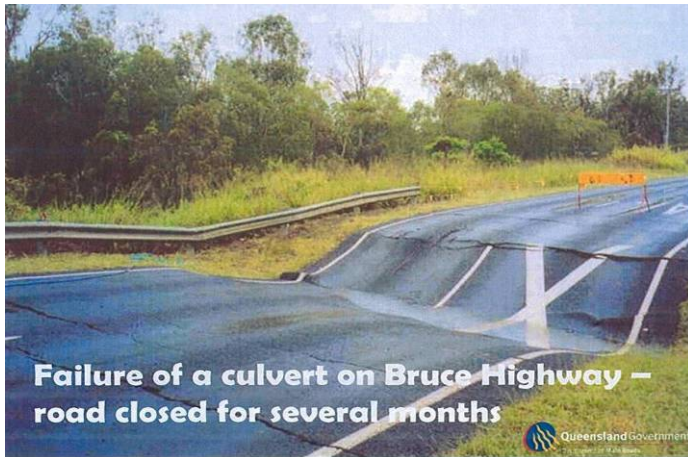
**Figure 3.2.7.1 – Culvert soil arch failure**

- As given for very high risk.

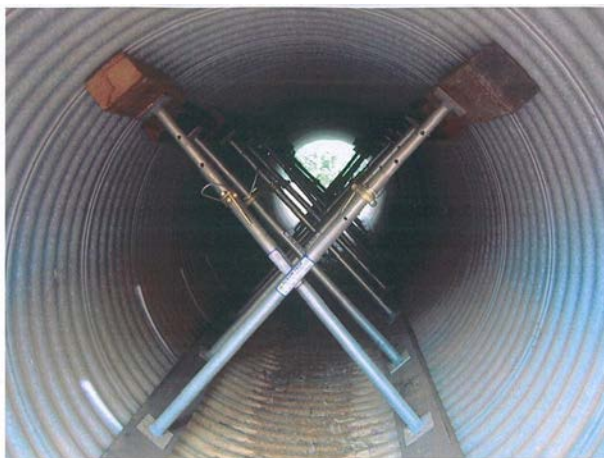
**Figure 4.2 – Example of emergency propping**

Note: This culvert had not failed and props were installed pending a full structural assessment.

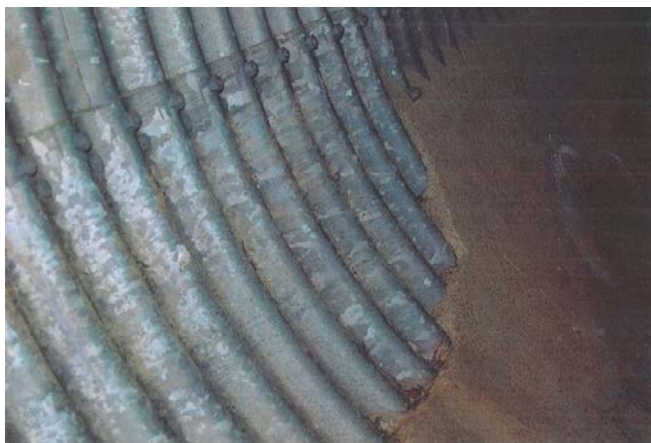
**Figure 4.5 – Failed thin concrete lining**

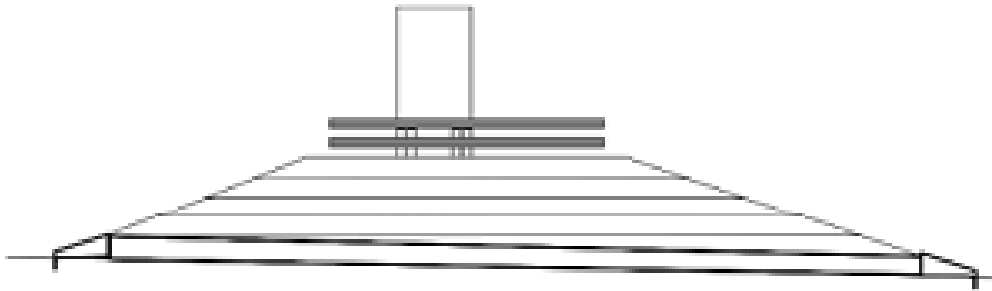
**Figure 5.1(a) – Culvert replacement with traffic diversion: remove & replace with a new culvert with road closed**

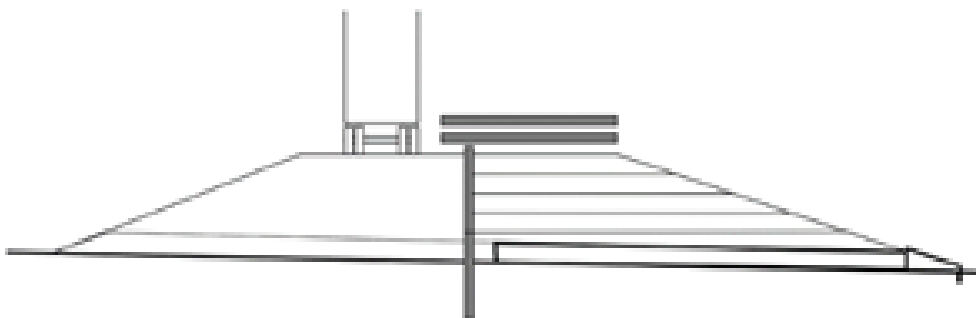
In some cases it may be possible to close half the road and replace half the culvert before repeating the procedure on the other half of the road (refer Figure 5.1(b)). This strategy may be useful in lowly trafficked routes with small depths of cover.

**Figure 5.1(b) – Culvert replacement with traffic diversion: Remove & replace with a new culvert with partial road closures**

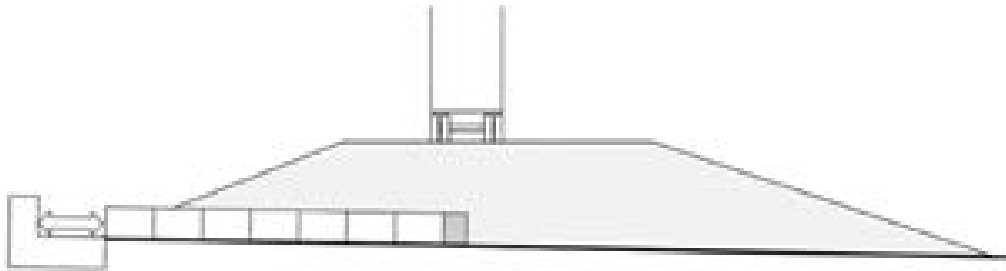
**Figure 5.2 – Culvert replacement under traffic**

- (a) Replace culvert on an adjacent alignment (micro tunnelling, auger boring, pipe jacking) under full traffic

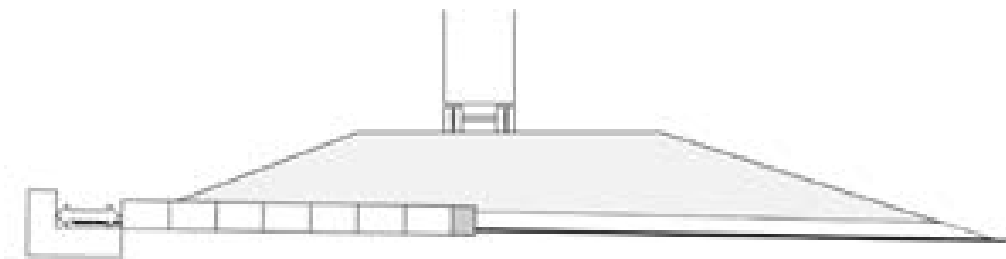
- (b) Replace culvert on the same alignment (pipe jacking) under full traffic

Advantages of this method are that the culvert replacement can be conducted under traffic, and the replaced culvert is a new culvert with the diameter selected for the site.

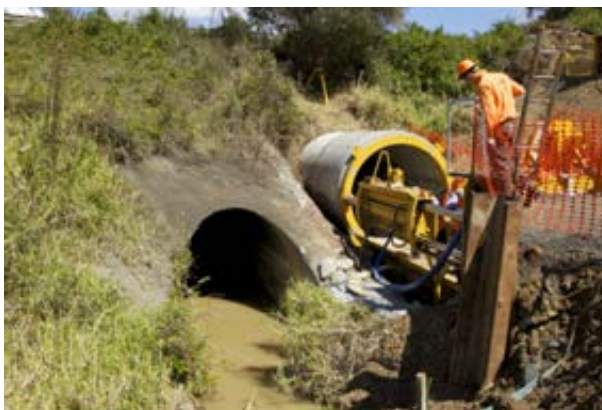
**Figure 5.2.1 – Replacing the first of two barrels of a corrugated metal culvert using pipe jacking (Warrego Highway, Mindin Range)**

(a) thrust block and hydraulic rams

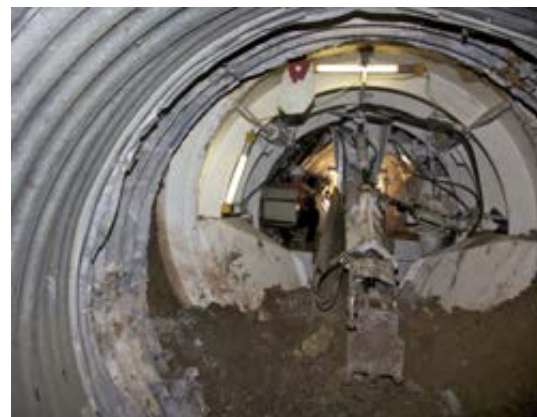
(b) jacking shield

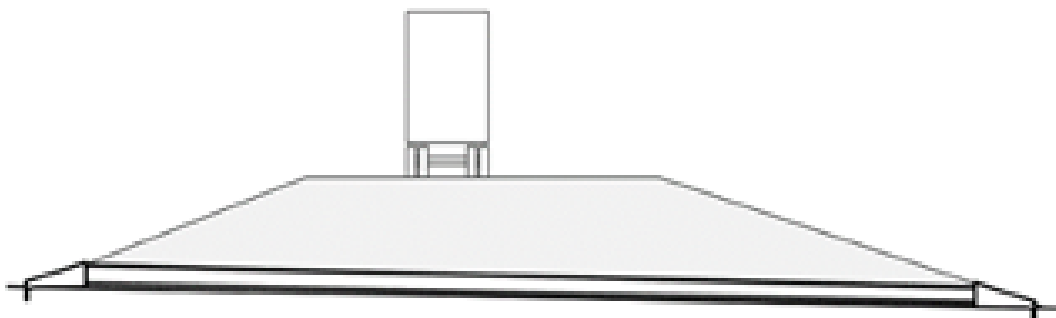
**Figure 5.3 – Culvert rehabilitation under traffic – reline culvert on the same alignment under full traffic**

A common advantage of relining culverts is that the culvert rehabilitation can be conducted under traffic. The approach eliminates the excavation associated with replacement options.

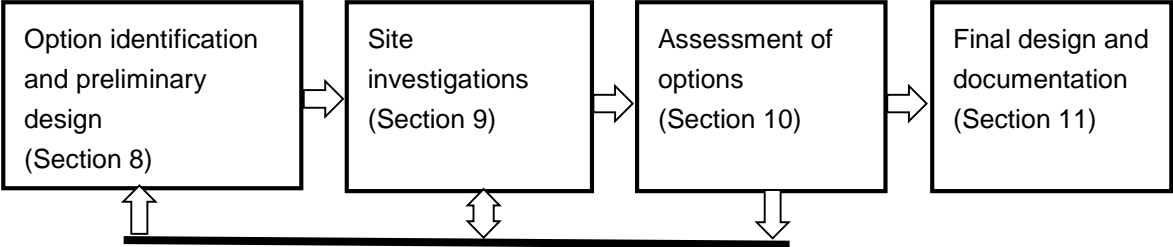
**Figure 7 – The rehabilitation design process**

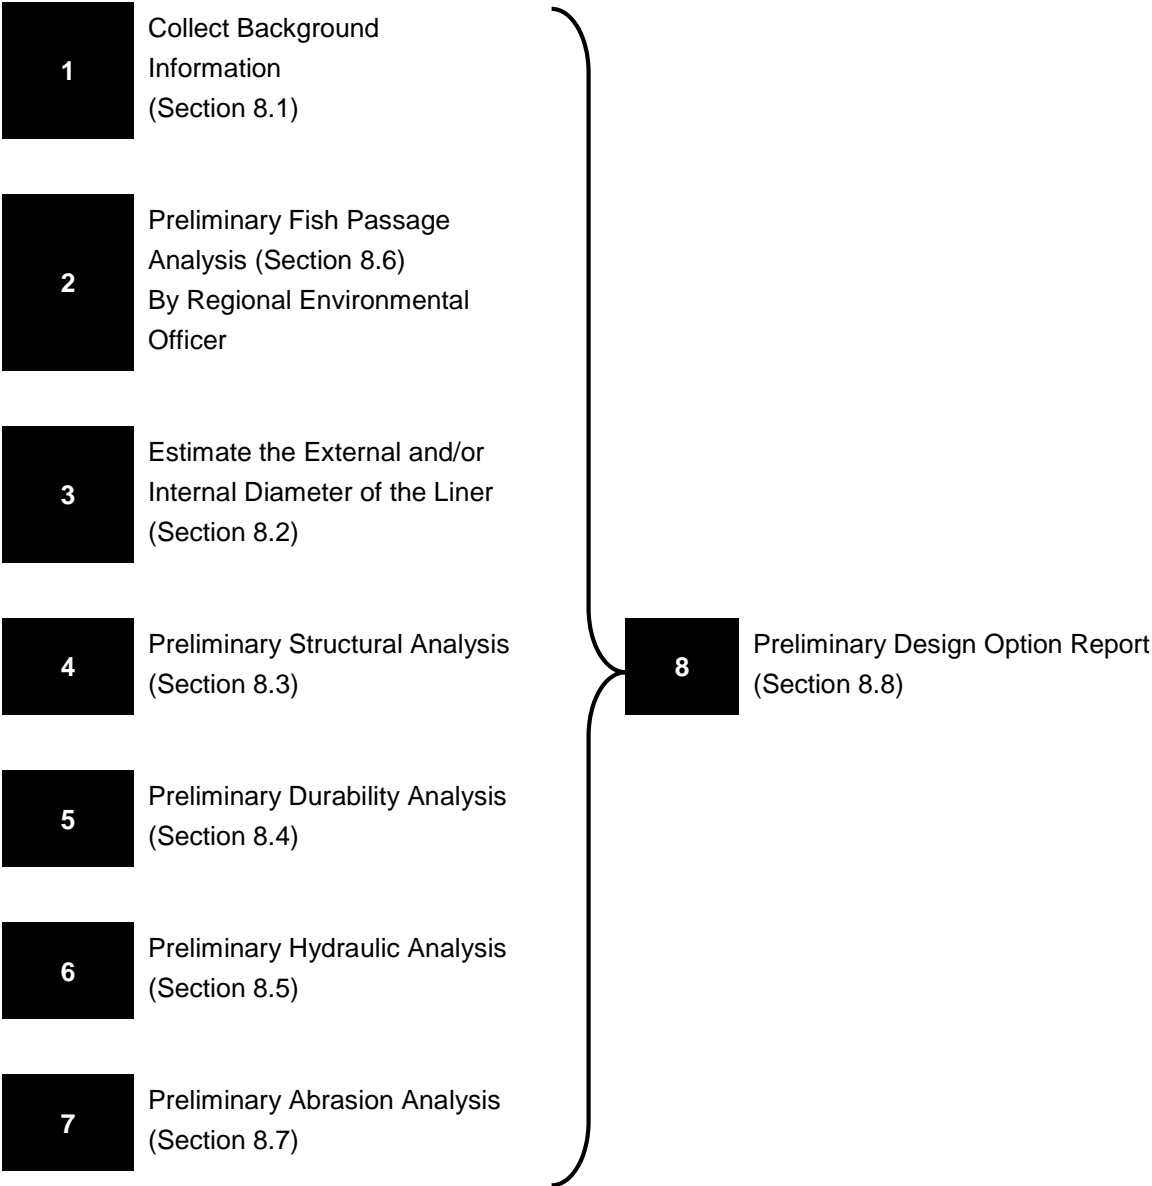
The procedure to identify the rehabilitation option/s most likely to satisfy the construction, structural, durability and hydraulic restraints of a particular site is illustrated below in Figure 8.1 and described in the sections identified.

**Figure 8.1 – Overview of rehabilitation option identification and preliminary design**

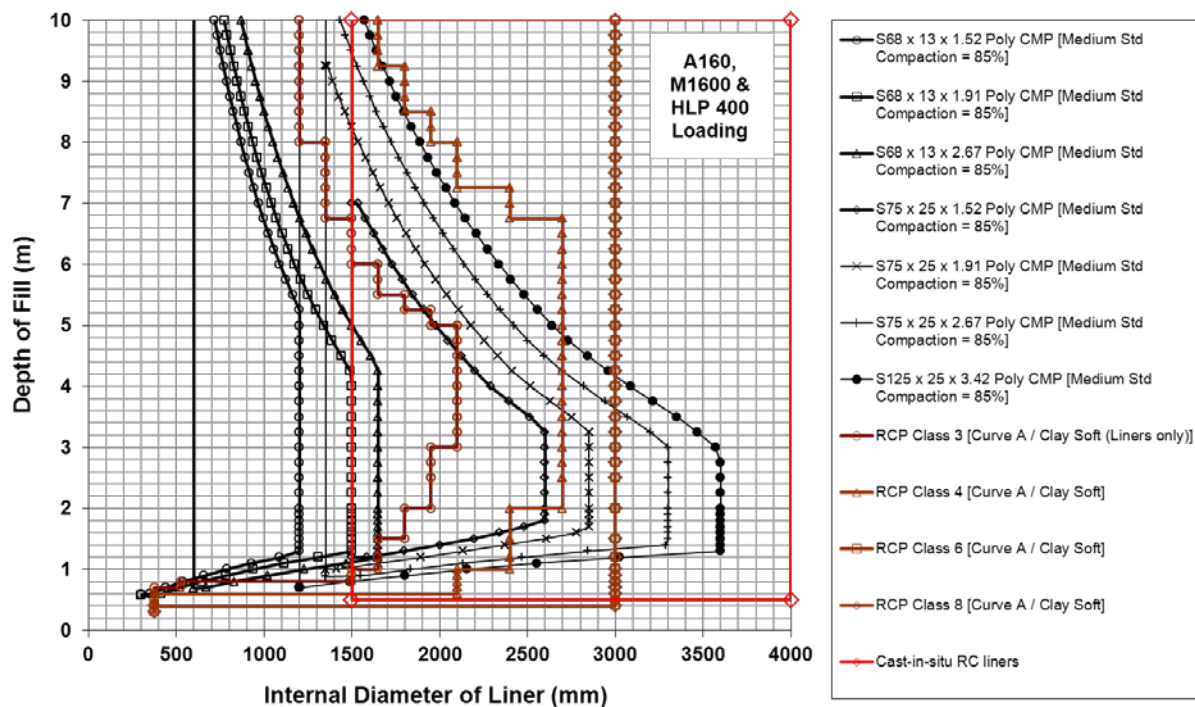
**Figure 8.3.1 – Depth of fill above the crown of a culvert versus the internal diameter of the culvert for selected lining options and soil conditions<sup>9</sup>**

Some examples of liner selection based on Figure 8.3.1 are presented in Table 8.3.1(b).

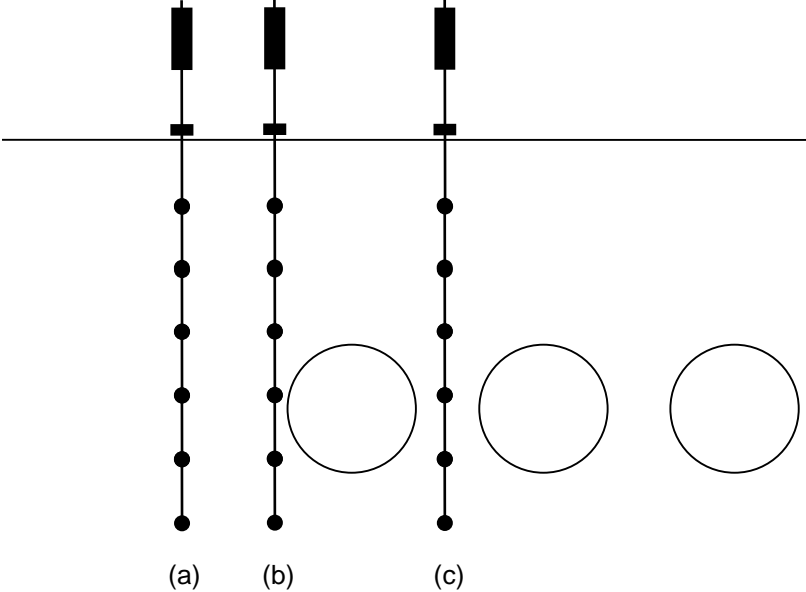
**Figure 9.8 – Geotechnical sampling locations at 1 m centres: (a) 1.5 m from face of culvert, (b) as close as possible to the culvert, and (c) between culverts**

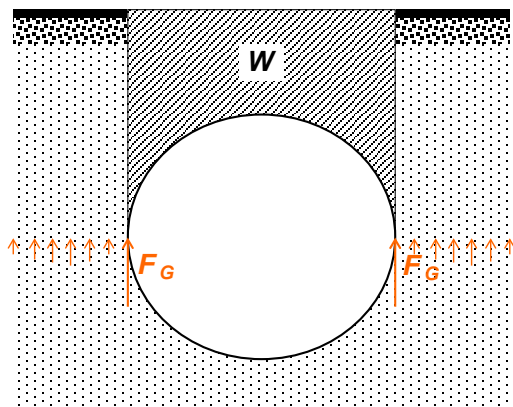
**Figure A1 – Soil prism (W) and ring compression force (F<sub>G</sub>)**

Vertical equilibrium indicates that the weight of the soil above the springline must be resisted by integral of the vertical soil pressures and  $2F_G$ . If there are no shear stresses along the vertical boundaries of W, then  $K = 1.0$  and  $F_G = 0.5W$ .

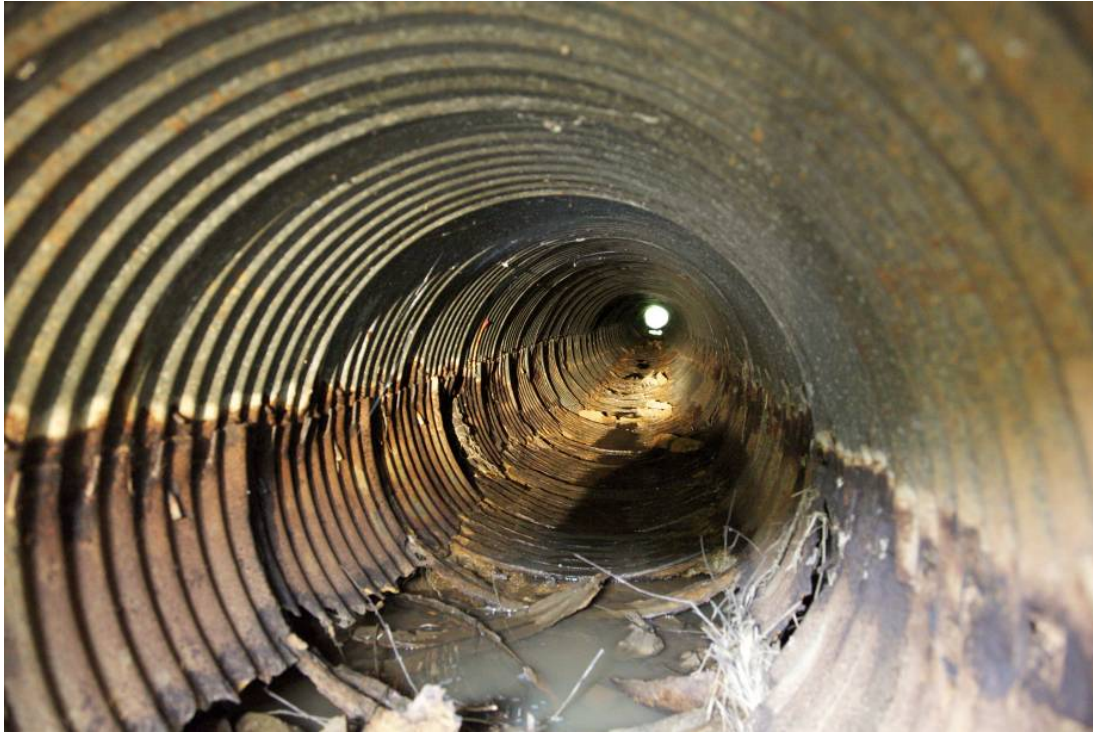
**Figure A2 – A deteriorated invert in a corrugated metal culvert showing substantial perforations**

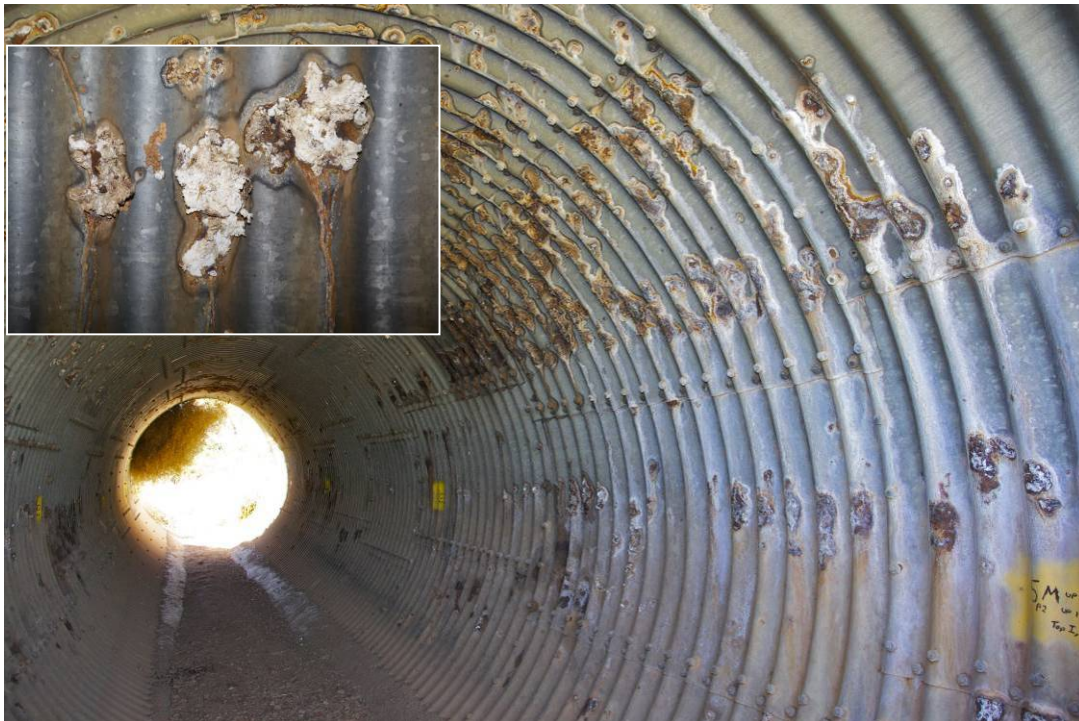
**Figure A3 – A culvert exhibiting perforations due to corrosion to the upper portion of the culvert**

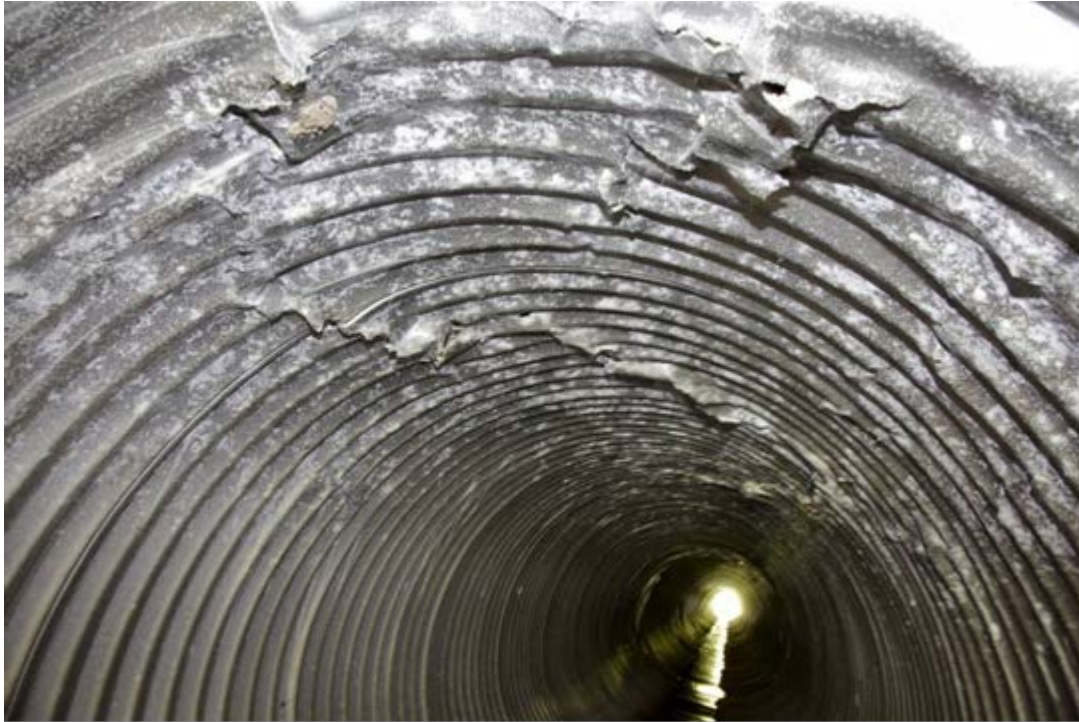
**Figure A4 – An aluminium culvert exhibiting local crushing due to corrosion of the upper portion of the culvert**

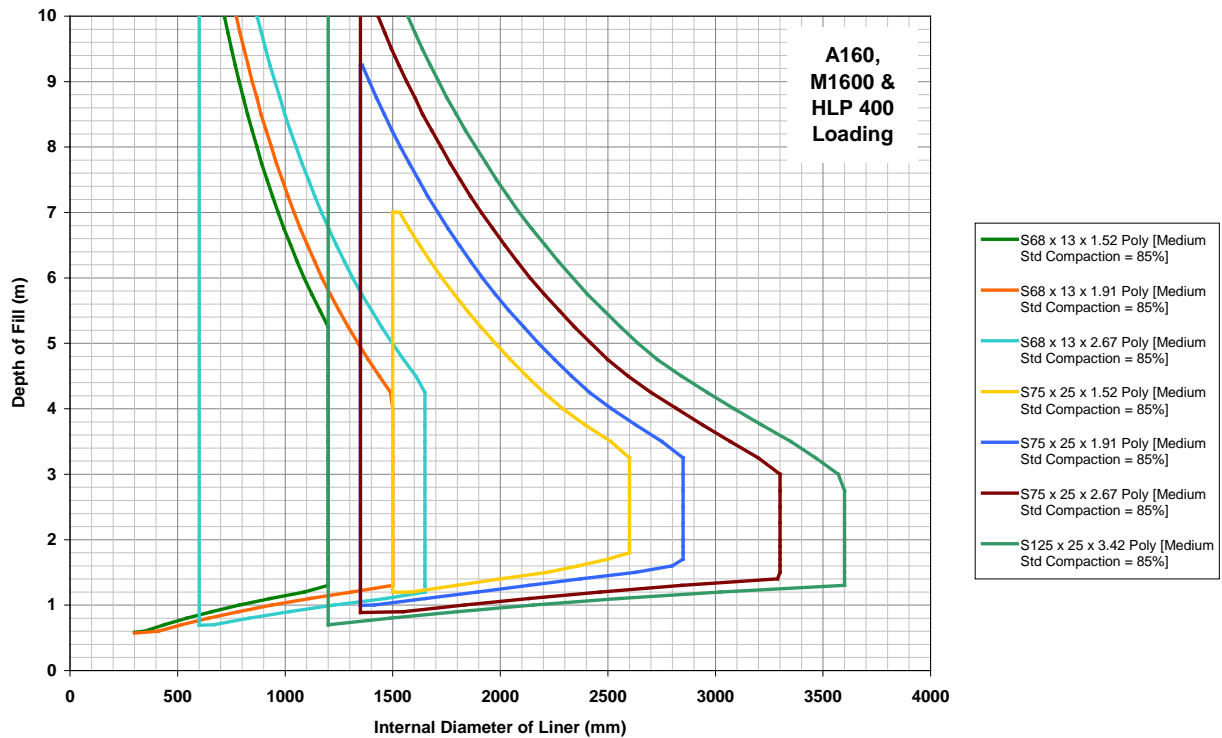
**Figure D1 – Design charts for polymer precoated corrugated metal culverts designed to AS 2041.1 (medium soils to 85% standard compaction)**

The Secant modulus of soil stiffness ( $E_s$ ) used in the calculation is derived from AS 2041.1:2011 Table 5.5.1(B) for the soil type under consideration (refer Table 15).

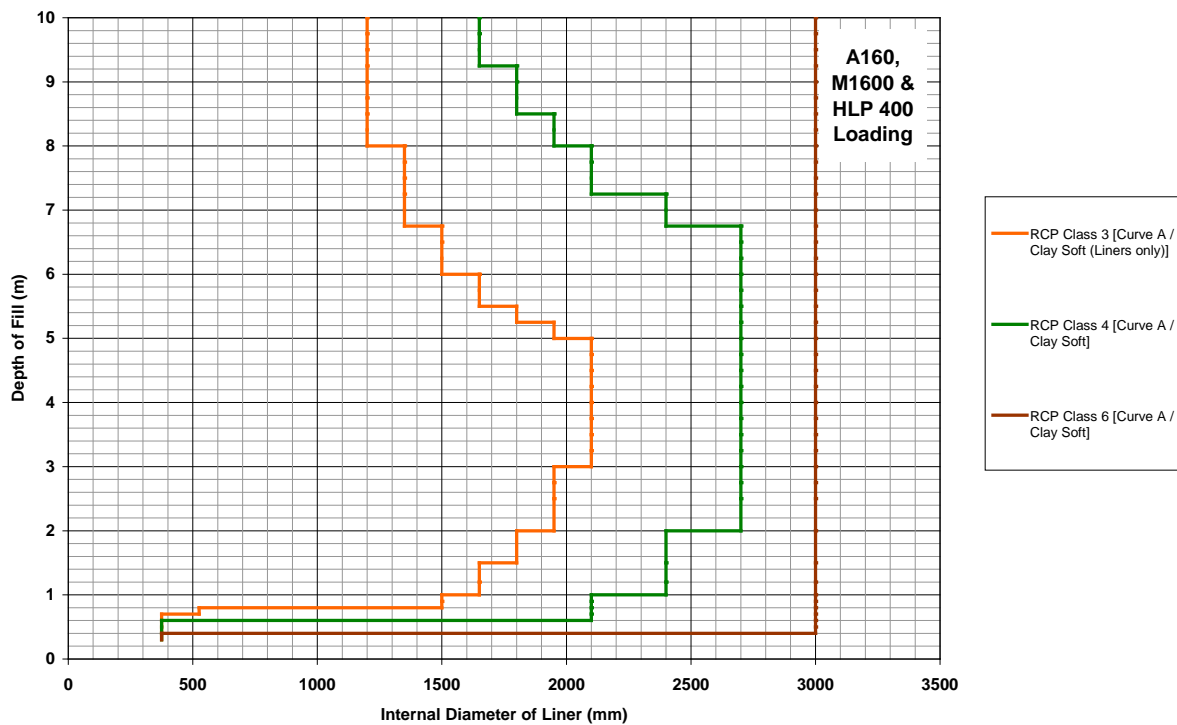
Note: applicable only to single barrel culverts used in a pipe jacking scenario. The results are non-conservative for other scenarios such as multiple parallel pipe jacked pipes, pipes installed in trenches, or under embankments.

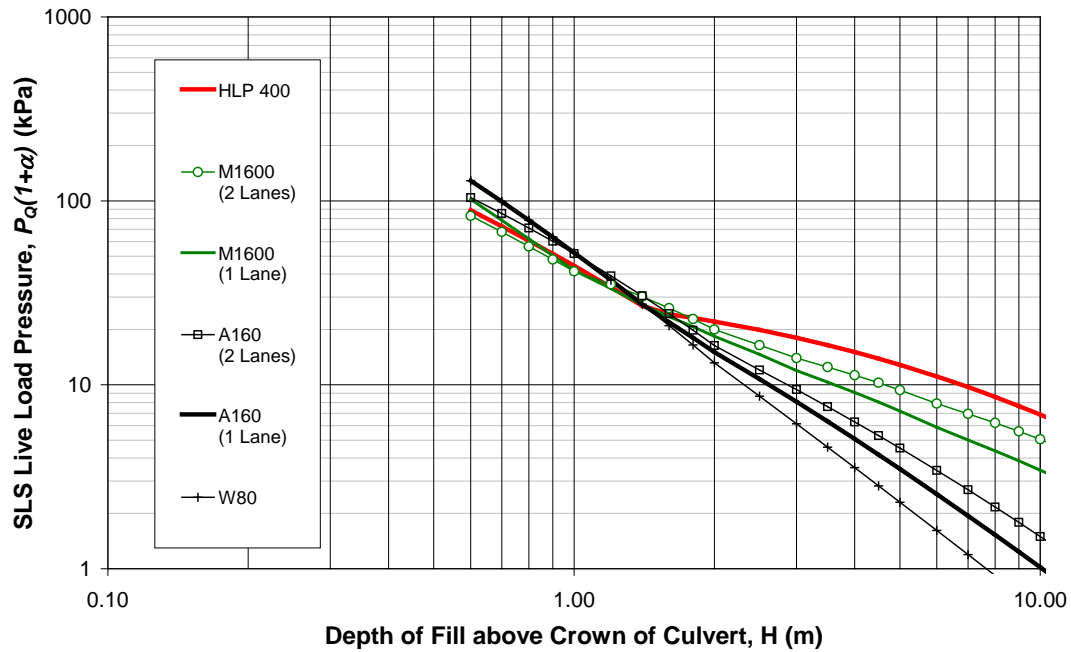
**Figure E1 – Serviceability limit state live load pressure versus depth of fill above the crown of the culvert**

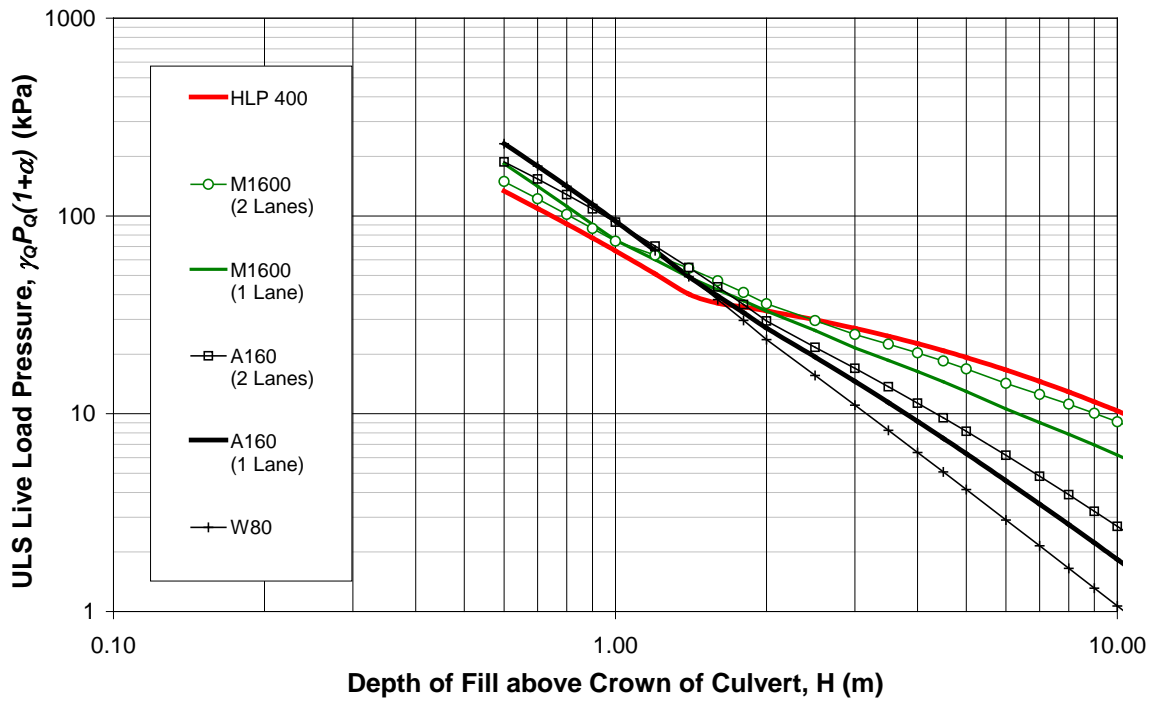
**Figure E2 – Ultimate limit state live load pressure versus depth of fill above the crown of the culvert**

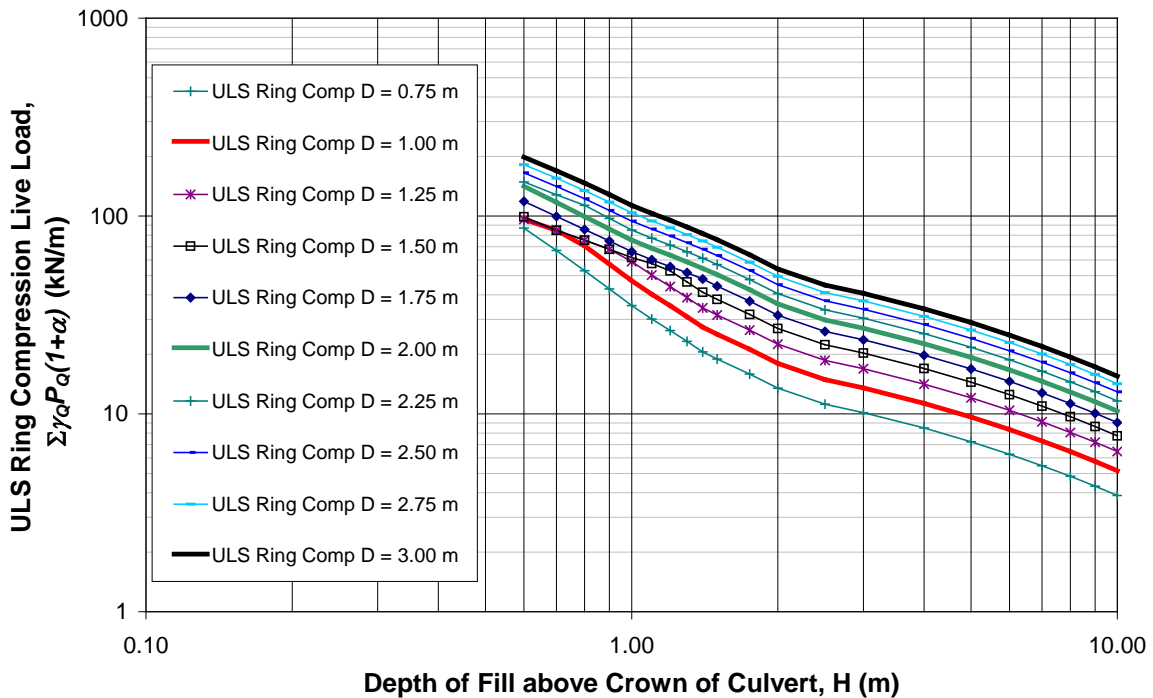
**Figure F1 – Ultimate limit state ring compression force versus the depth of fill above the crown of the culvert for selected culvert diameters for W80, A160, M1600 and HLP 400 loads**

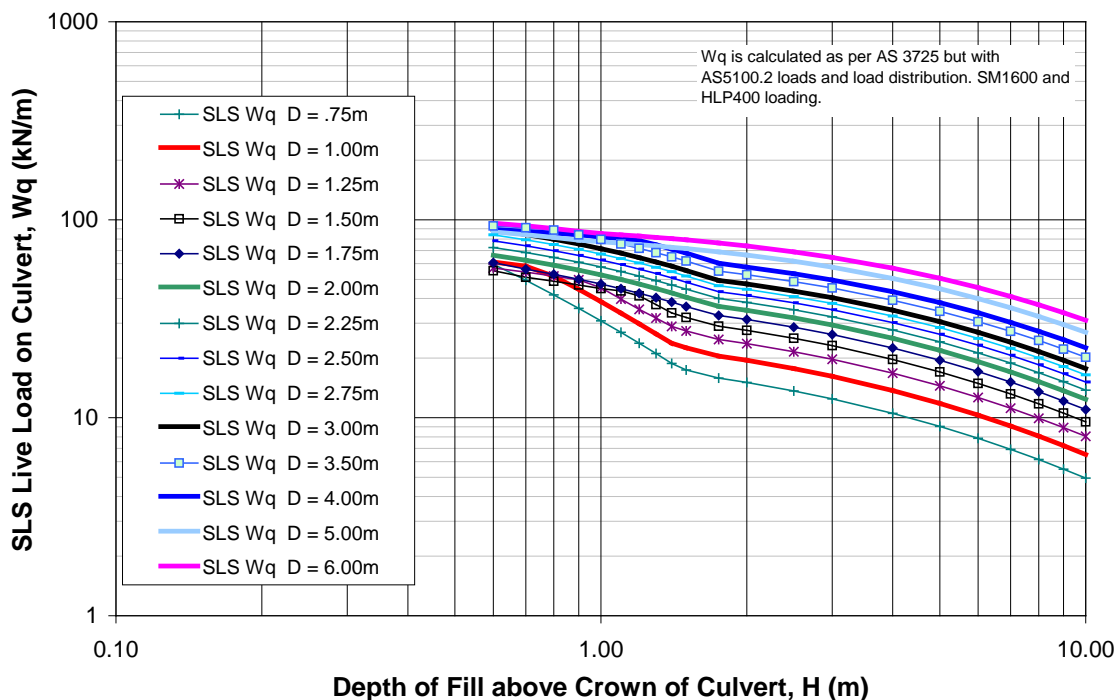
**Figure F2 – Serviceability limit state working load on culvert due to live load ( $W_q$ ) versus the depth of fill above the crown of the culvert ( $H$ ) for selected culvert diameters for W80, A160, M1600 and HLP 400 loads**

The working load on the culvert due to live load ( $W_q$ ) for various depths of fill and culvert diameters is presented in Table F2 and Figure F2 where  $W_q$  is as defined in AS 3725 Design for installation of buried concrete pipes.

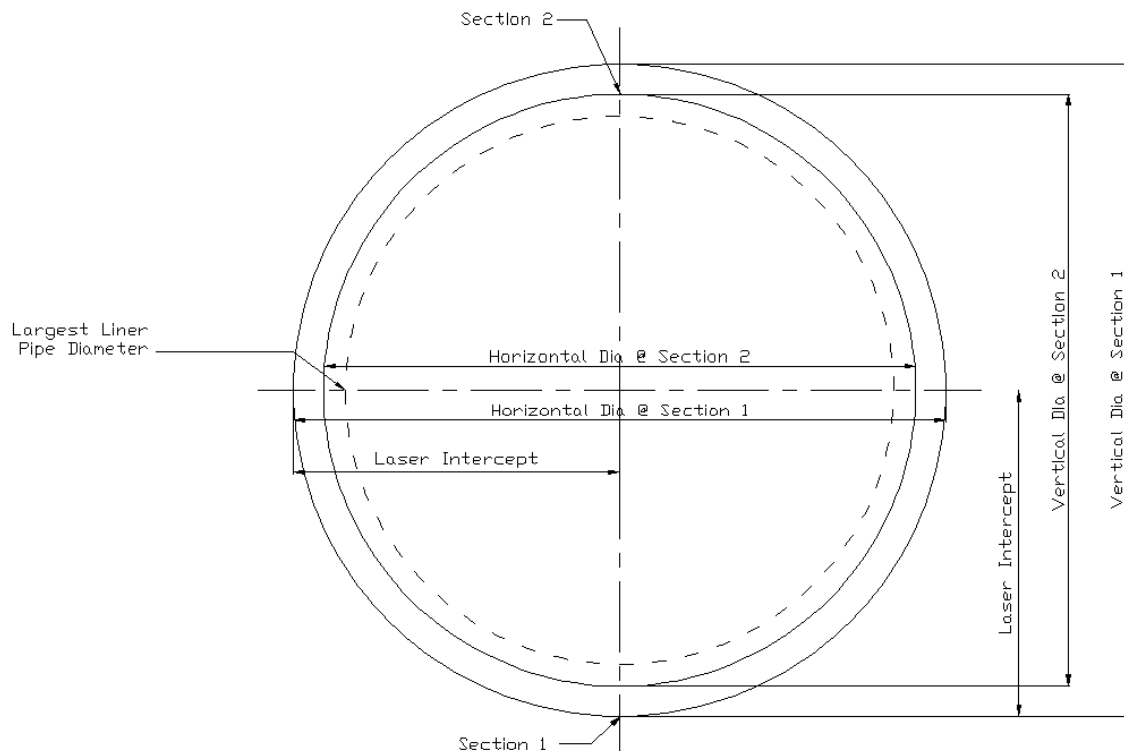
The dimensions can be plotted, and the largest straight internal tube determined.

- Plot all horizontal, vertical and diagonal diameters and laser intercepts
- Measure the largest included circle
- Choose a liner based on suitable construction clearances and grout thickness requirements.
