**Manual**

**Criteria for Inspection, Life Extension and Rehabilitation  
of Circular Corrugated Metal Culverts**

**November 2015**

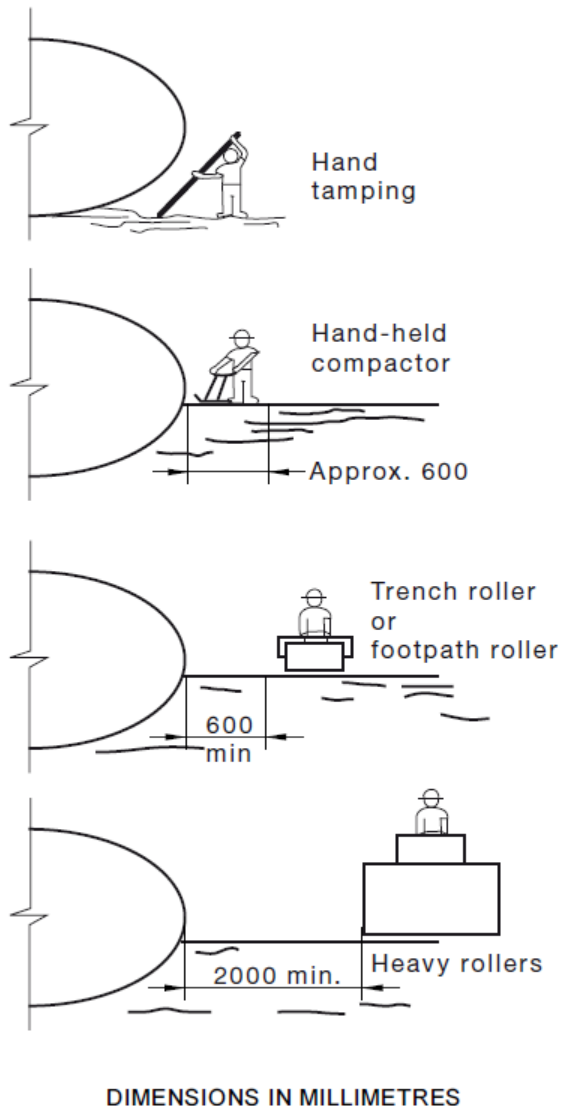
**Figure J1 – Typical use of compaction equipment (AS 2041.2 Figure 2.12.1)**

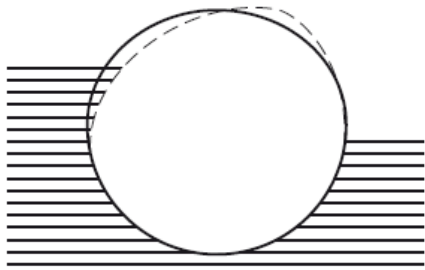
**Figure J2 – Structure movements during backfilling (AS 2041.2 Figure 2.12.2)**

Excessive filling on only one side may cause the structure to shift

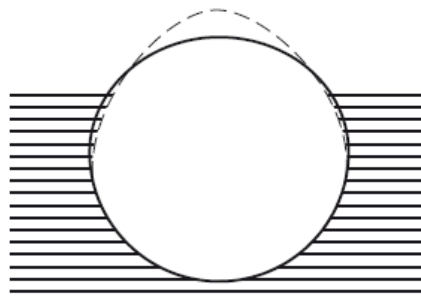
Heavy equipment too close to the structure may cause lateral shift or drawn peaking (as shown)
