Eton Range Realignment

Project newsletter August 2017 – Cyclone Debbie repair works

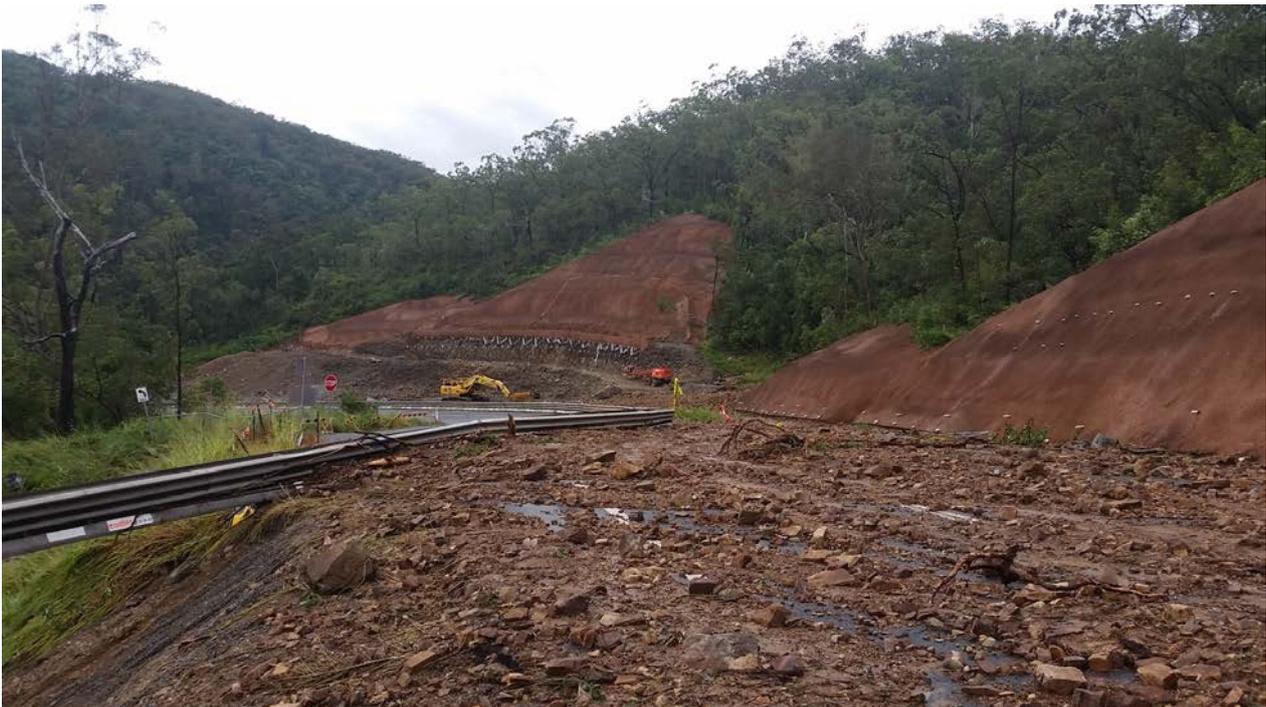
The Eton Range Realignment Project sustained significant damage during Severe Tropical Cyclone Debbie in March 2017. Heavy rainfall associated with the cyclone caused a total of 19 landslips across the range, including two major slips which closed the range to single lane operation from March until July 2017.

Debris spread across the Eton Range after Cyclone Debbie.

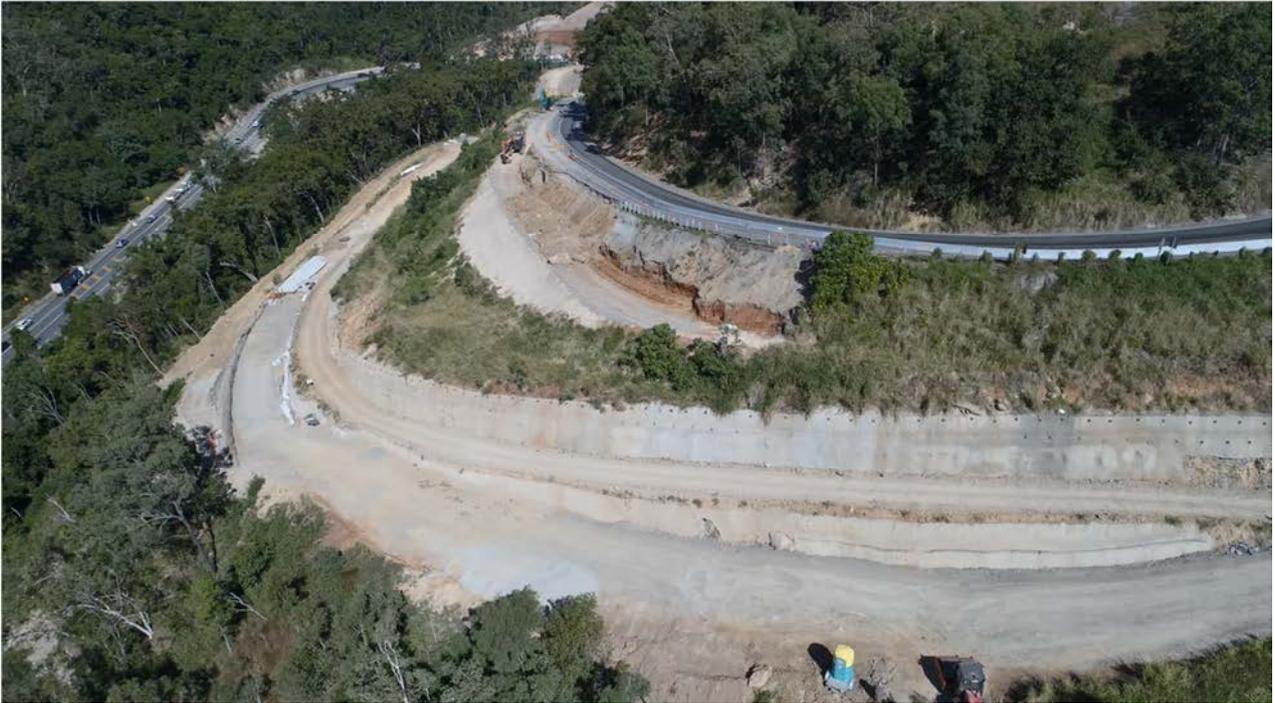
Progress of repair works in June to one of the major slips impacting traffic.

In repairing two major slips below the existing Peak Downs Highway, it was initially thought that temporary soil nails would be required to stabilise the existing roadway. Through further geotechnical assessments and monitoring, this lengthy treatment was avoided and an embankment solution was used instead to reinstate the road shoulder and open the range back to two-way operation.

- Removal of debris on the Peak Downs Highway from the upper landslips
- Road surface repairs
- Excavation of loose material and debris from landslips below the Peak Downs Highway (within the reinforced earth embankment works)
- Reinstatement of construction access tracks
- Installation of temporary shotcreting and rock fall netting for some landslip locations below the existing road for safety of construction plant working below
- Reinstatement of the existing road shoulder and supporting embankment of the Peak Downs Highway.
