**Technical Note 159**

# **Treatment of non-compliant Underground Wiring Systems (UWS) in Brownfield Installations**

**December 2024**

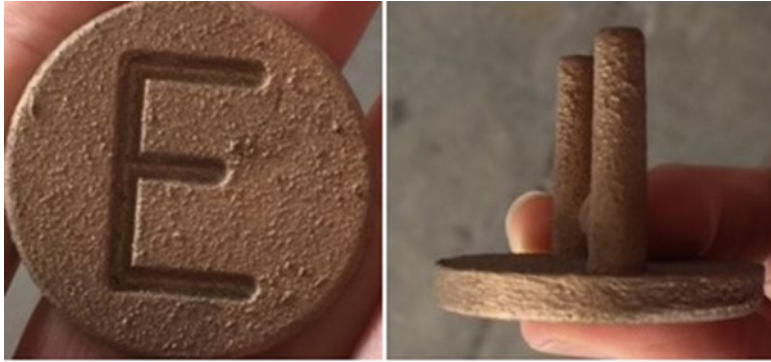
**Figure 4.5.2(a) – Brass E-markers**

E-marker (Figure 4.5.2(a)) labels shall be used to alert other parties of the existence of underground electrical conduits. These labels shall be placed in accordance with SD1149. Where new concrete is applied, additional marking with the words electric cable or similar may be stamped along the length of the concrete. Refer to Figure 4.5.2(b).

- **Material:** Metallic material not susceptible to rust, suitable for damp or wet environments.
- **Adhesive:** No adhesive; instead, use rivets or screws for permanent fixing to ensure it remains in place despite water or mud, ensuring it does not pose a trip hazard.
- **Size:** Large enough to be easily readable.
- **Print:** Laser-etched or engraved to prevent fading over time.
- **Text:** Clear and legible font detailing the necessary information or warning.
- **Finish:** Non-reflective finish to avoid glare and ensure readability.

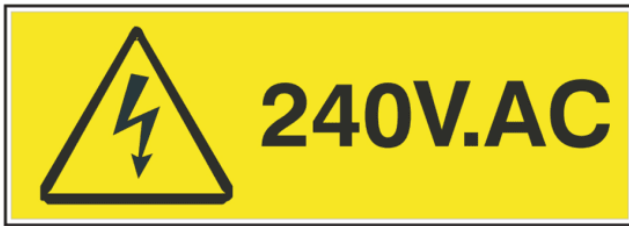
**Figure 4.5.3 – In-pit label**

Below are general characteristics of the proposed labelling in the pit, for the purpose of alerting presence of electrical cables in a non-HD conduit. An example is shown in Figure 4.5.3 following.

- **Material:** Heavy-duty hard plastic suitable for damp or wet environments.
- **Fixings:** Non-metallic fixtures must be used, such as zip ties for permanent fixing to ensure it remains in place despite water or mud.
- **Size:** Large enough to be easily readable, yet appropriate for the size of the pit.
- **Colour:** High contrast for visibility in low-light conditions common in pits.
- **Print:** Waterproof and fade-resistant ink to prevent fading over time.
- **Text:** Clear and legible font detailing the necessary information or warning.
