Technical Note 159

**Treatment of non-compliant Underground Wiring
Systems (UWS) in Brownfield Installations**

July 2025

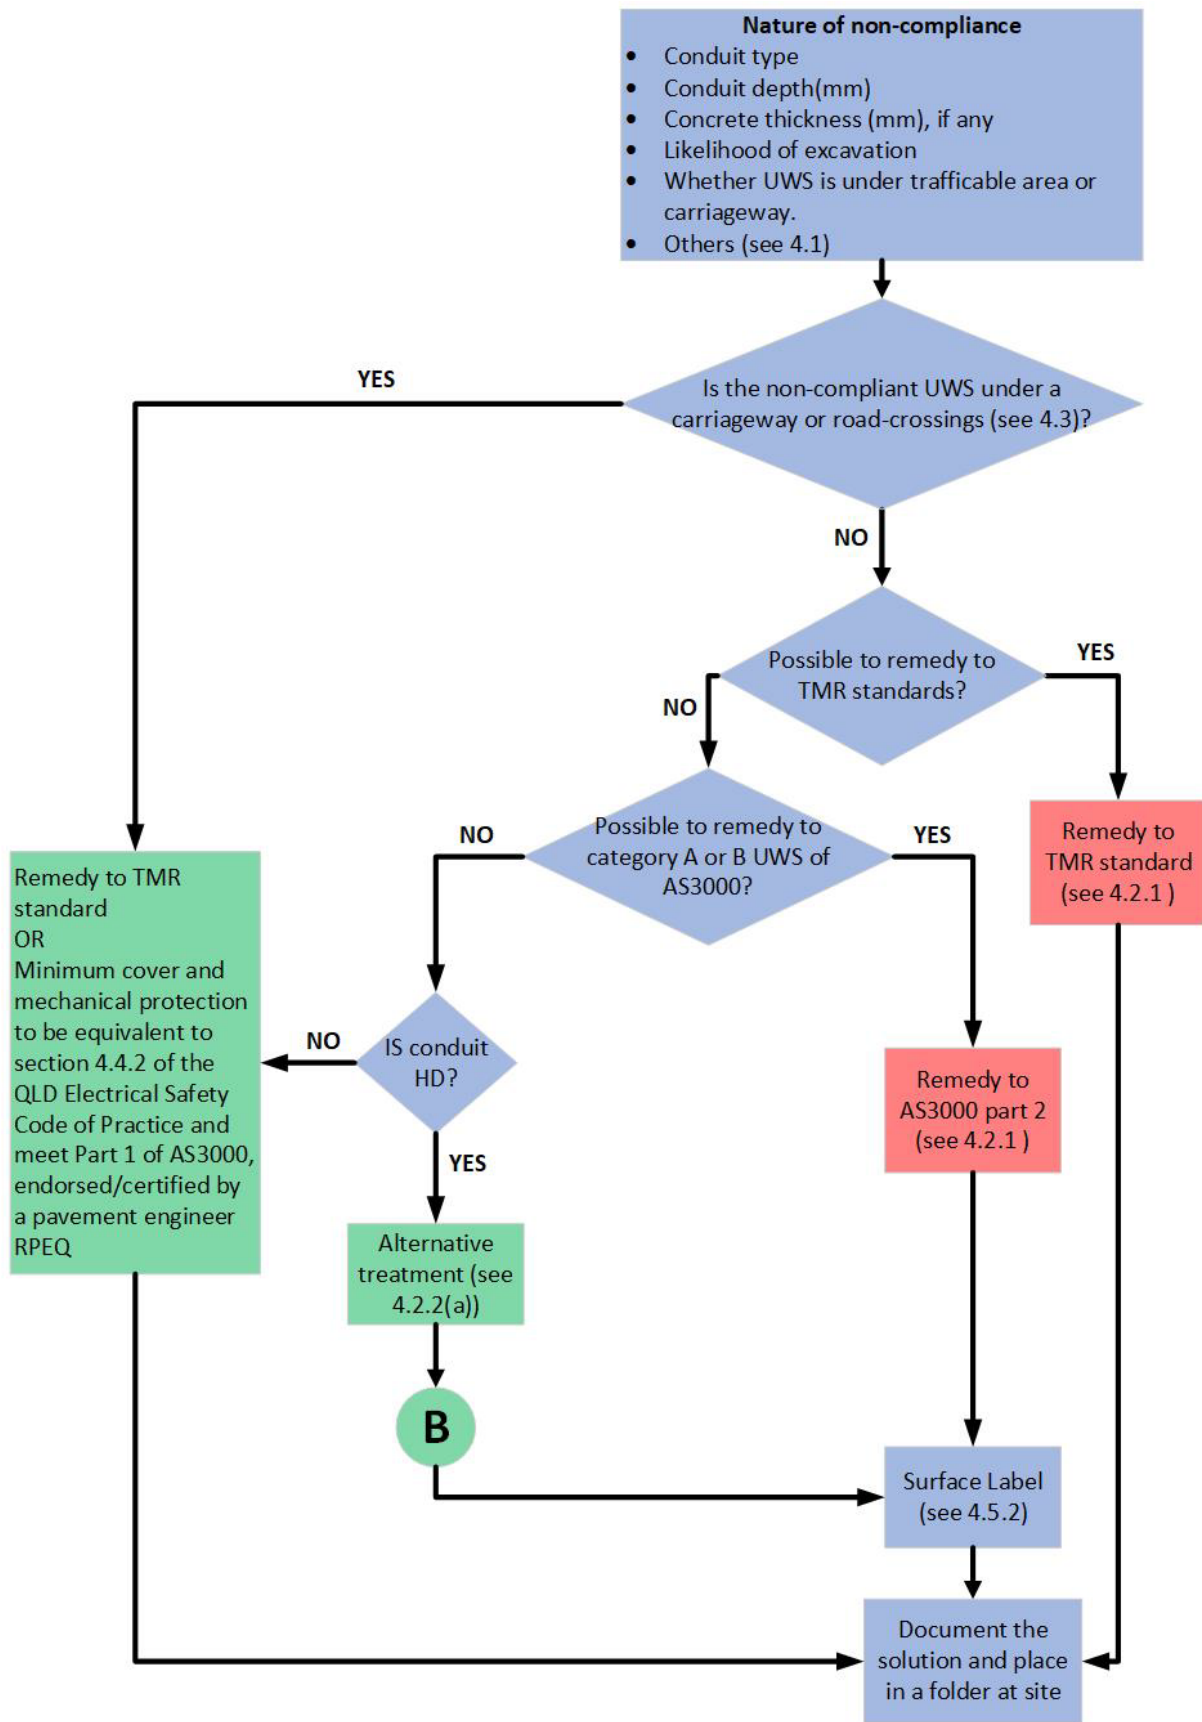
Figure 4.2 – Brownfield under-depth underground wiring systems treatment overall process

Where it is not possible to achieve compliance with the department's Standard Drawings 1149 and 1421 or AS/NZS 3000 Part 2, other treatment options that would mitigate the electrical risk must be considered, such as compliance with AS/NZS 3000 Part 1. For Brownfield sites, remediation to UWS that meets Category A or B of AS/NZS 3000 should be considered as viable options. The treatment options are as shown in Figure 4.2.

Throughout the remediation process as shown in Figure 4.2 and Figure 4.4(a), labelling has been prescribed as an additional measure to alert other parties of the existence of an electrical service. The two types of labels are underground and above-ground labels / markers.

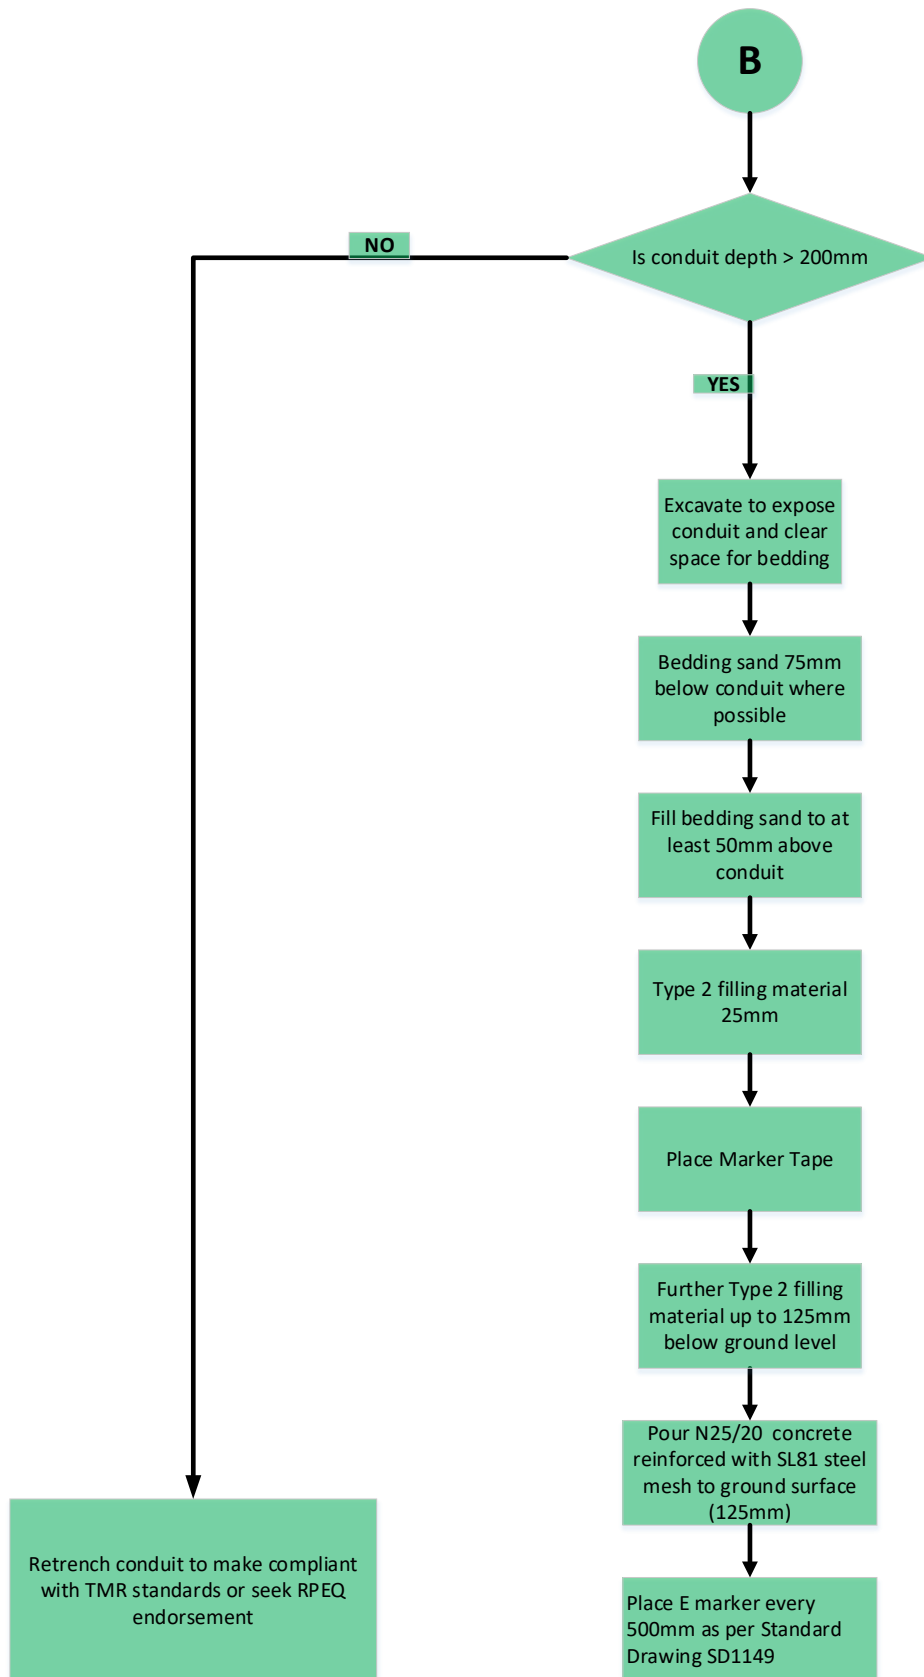
Figure 4.4(a) – Alternative HD conduit treatment process (to be read in conjunction with Figure 4.2)

The alternative process and associated details are shown in Figure 4.4(a) and Figure 4.4(b).

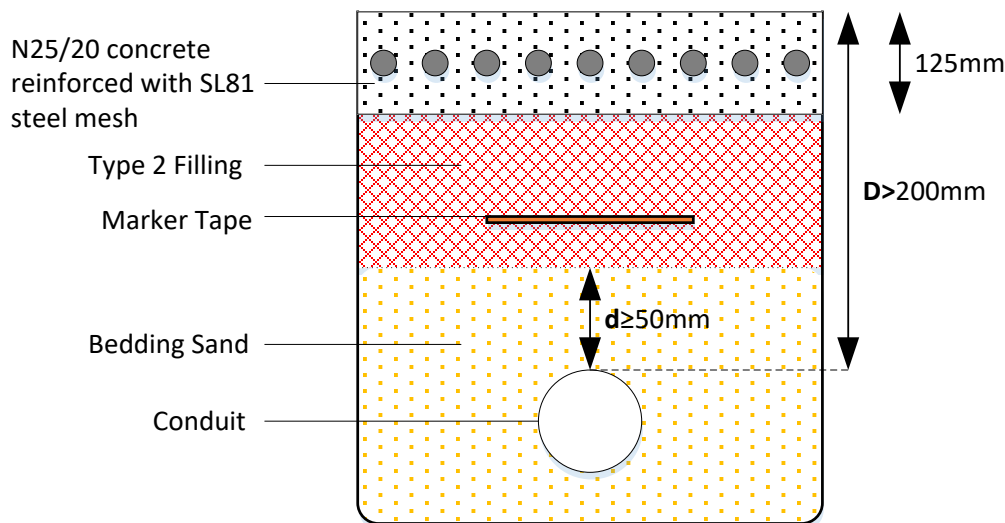
Figure 4.4(b) – Alternative treatment detail (not to scale)

The concrete cover for the alternative treatment shall be N25 / 20 and of minimum thickness 125 mm, reinforced by SL 81 steel mesh.

The bedding sand and Type 2 filling are as specified in Standard Drawing 1149.

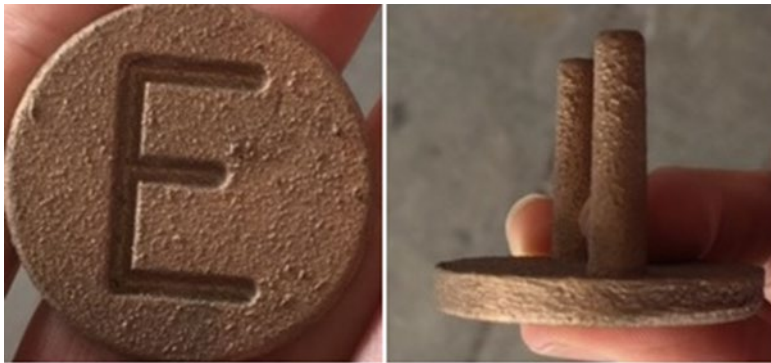
Figure 4.5.2(a) – Brass E-markers

E-marker (Figure 4.5.2(a)) labels shall be used to alert other parties of the existence of underground electrical conduits. These labels shall be placed in accordance with SD1149. Where new concrete is applied, additional marking with the words electric cable or similar may be stamped along the length of the concrete. Refer to Figure 4.5.2(b).

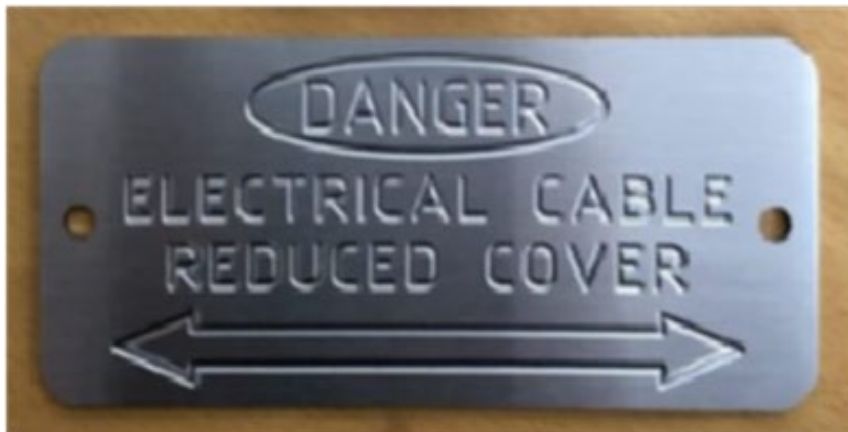
Figure 4.5.2(b) – Above ground marker with wording

- **Material:** Metallic material not susceptible to rust, suitable for damp or wet environments.
- **Adhesive:** No adhesive; instead, use rivets or screws for permanent fixing to ensure it remains in place despite water or mud, ensuring it does not pose a trip hazard.
- **Size:** Large enough to be easily readable.
- **Print:** Laser-etched or engraved to prevent fading over time.
- **Text:** Clear and legible font detailing the necessary information or warning.
- **Finish:** Non-reflective finish to avoid glare and ensure readability.

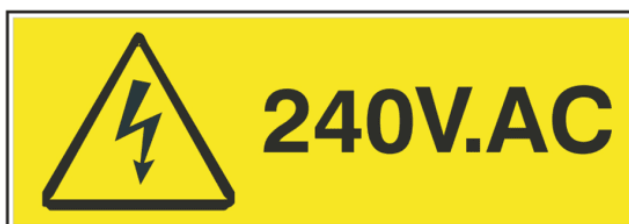
Figure 4.5.3 – In-pit label

Below are general characteristics of the proposed labelling in the pit, for the purpose of alerting presence of electrical cables in a non-HD conduit. An example is shown in Figure 4.5.3 following.

- **Material:** Heavy-duty hard plastic suitable for damp or wet environments.
- **Fixings:** Non-metallic fixtures must be used, such as zip ties for permanent fixing to ensure it remains in place despite water or mud.
- **Size:** Large enough to be easily readable, yet appropriate for the size of the pit.
- **Colour:** High contrast for visibility in low-light conditions common in pits.
- **Print:** Waterproof and fade-resistant ink to prevent fading over time.
- **Text:** Clear and legible font detailing the necessary information or warning.

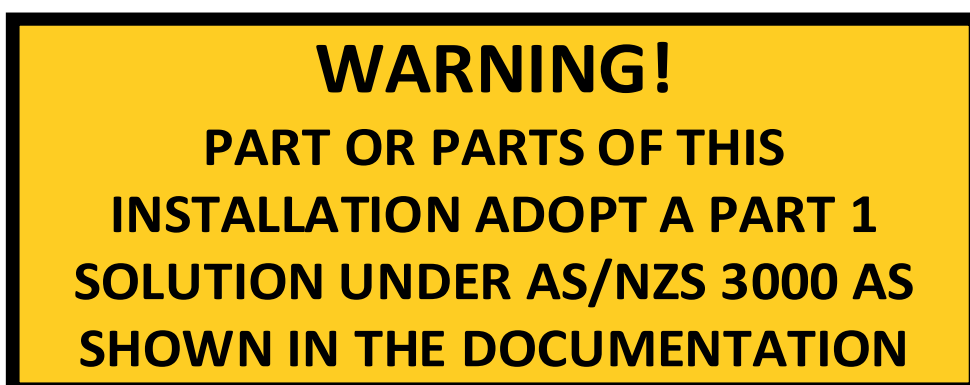
Figure 4.5.4 – Part 1 designation label

Part 1 designation labels (Figure 4.5.4) shall be affixed to the electrical switchboard, traffic signal controller or Intelligent Transport System (ITS) cabinet as appropriate. Following are general characteristics.

- **Material:** UV-resistant laminated polyester or equivalent, ensuring longevity in various indoor conditions.
- **Adhesive:** Permanent, pressure-sensitive adhesive, or screws, to ensure the label remains affixed for an extended period.
- **Size:** Appropriate to the switchboard or Traffic Signal Controller's size, ensuring visibility and readability.
- **Colour:** Contrasting, typically using a combination of bright and dark colours (for example, dark text on yellow background, or white text on a red background) for high visibility.
- **Print:** Waterproof and fade-resistant ink.
- **Text:** Clear and legible font detailing the specific information or warning.
- **Finish:** Gloss or matte lamination for added protection against abrasions.

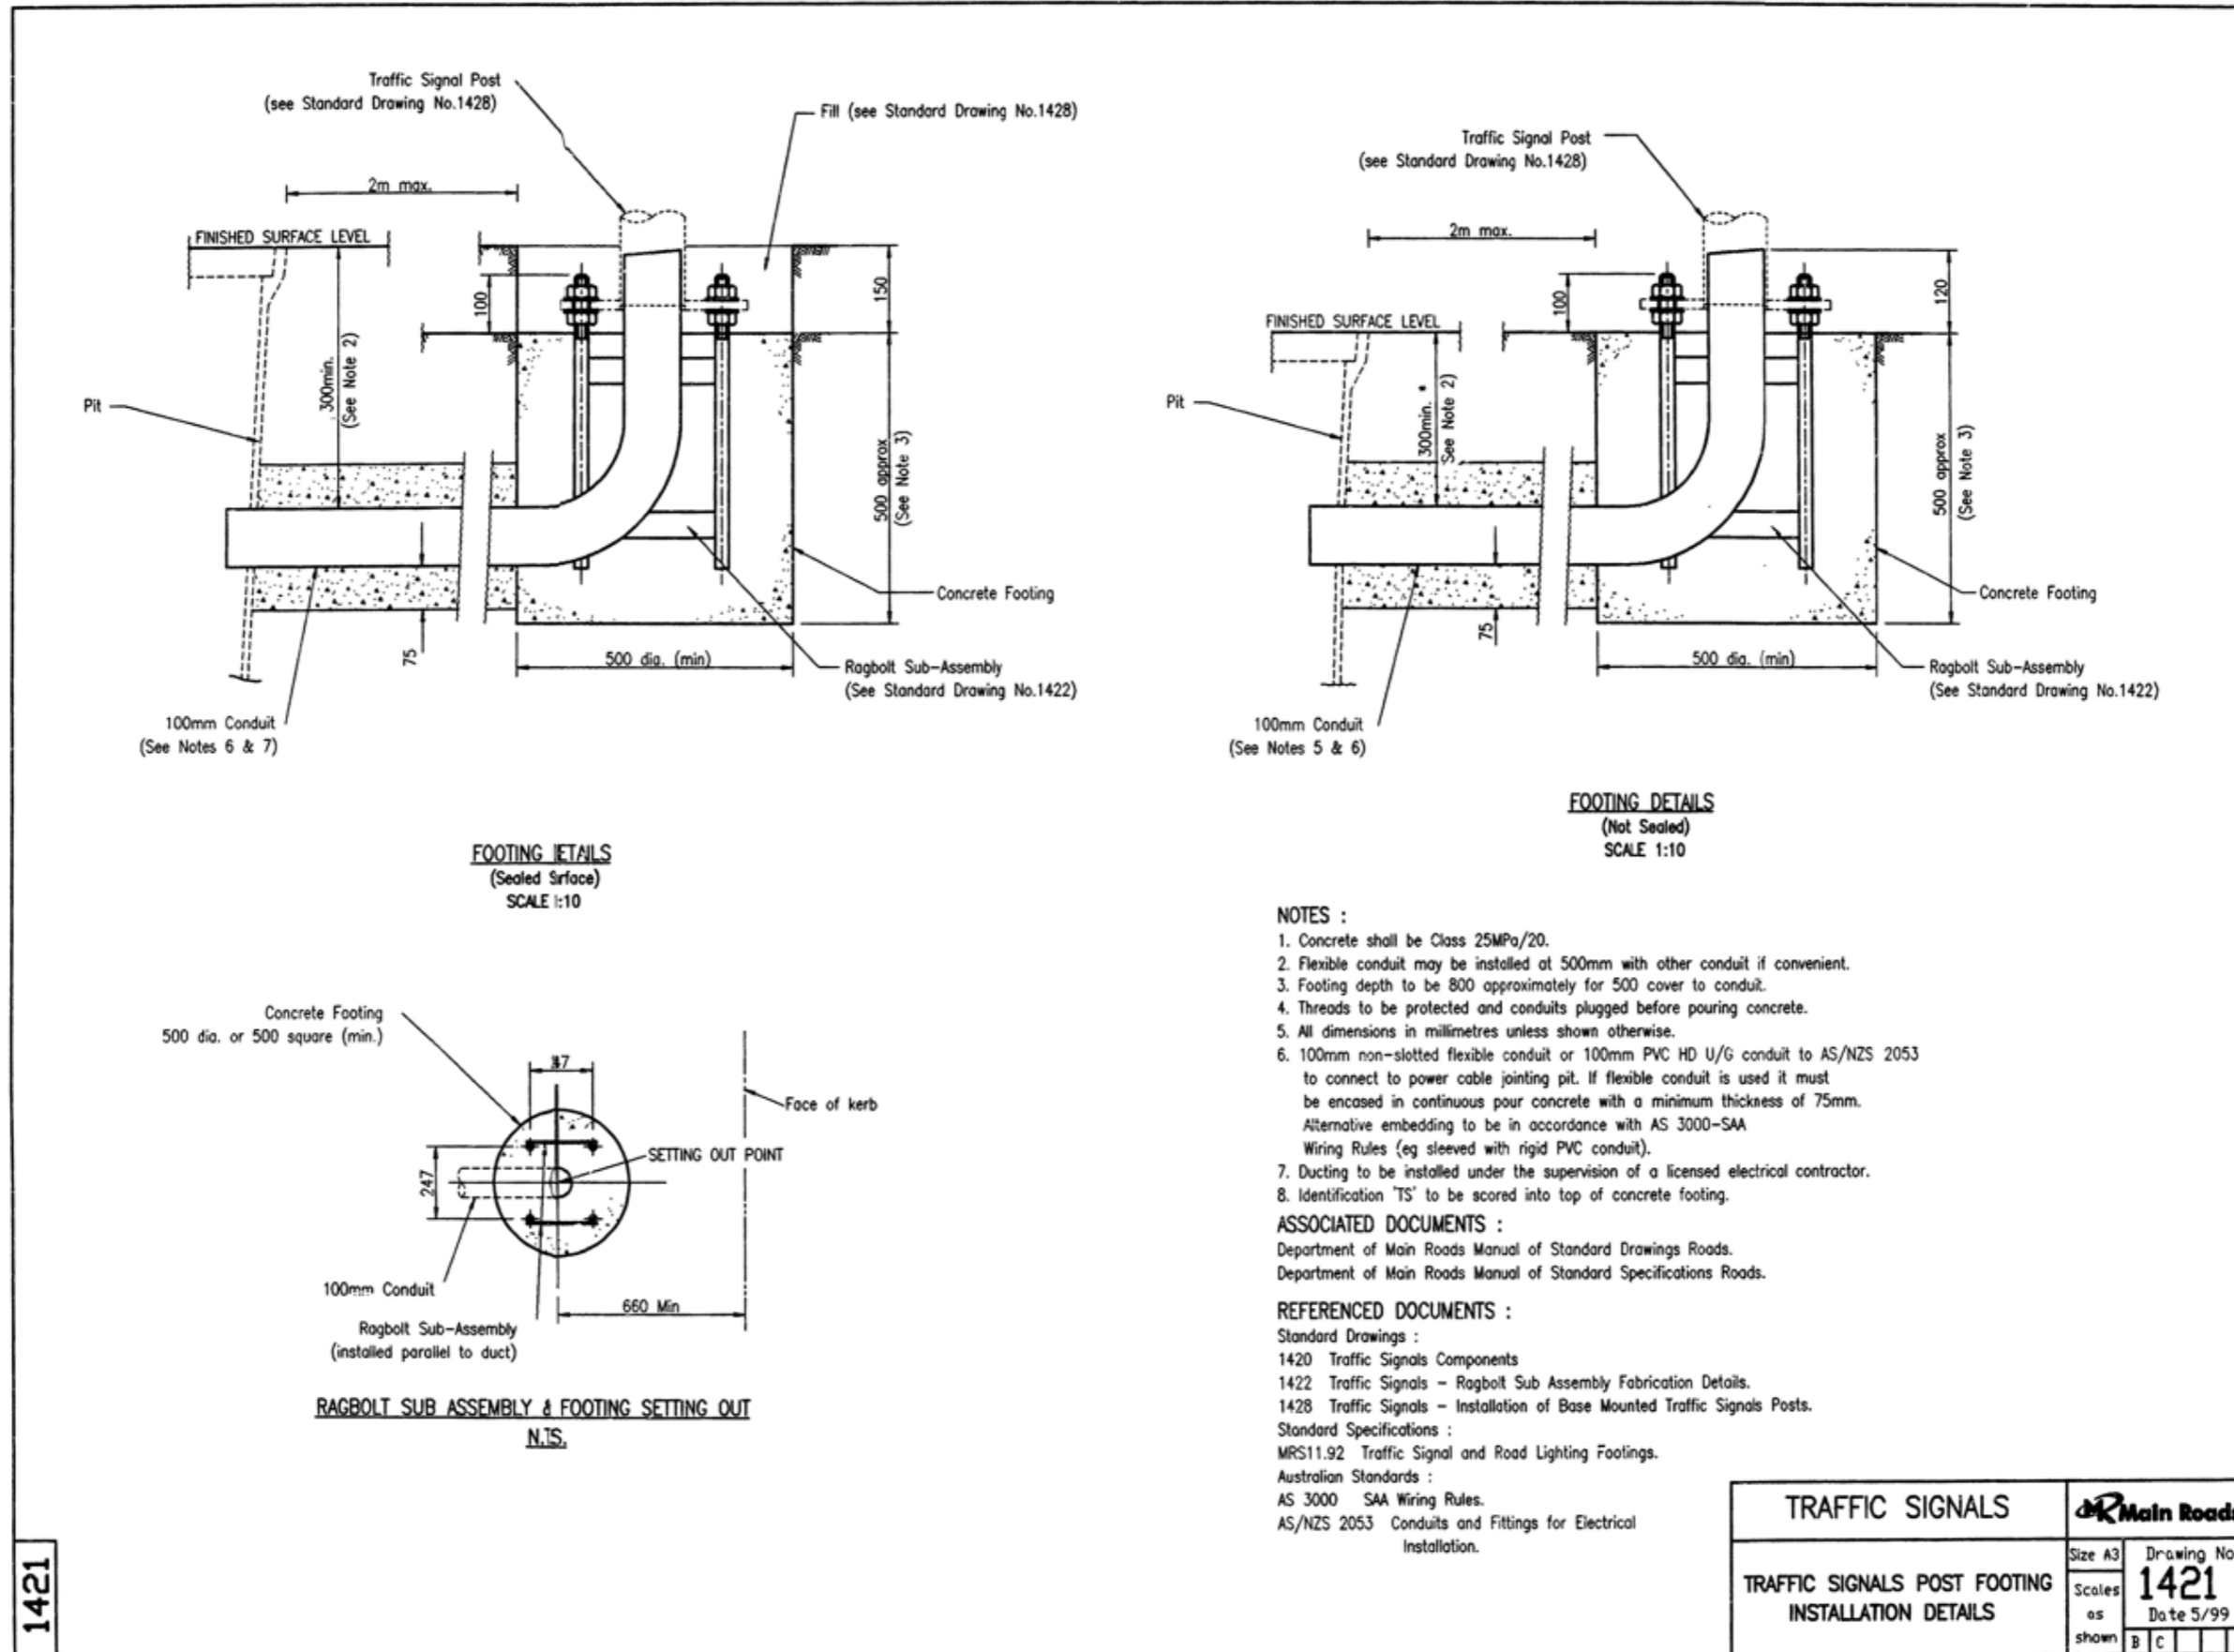
Appendix A – Legacy SD1421-SD1999 (Superseded in 2006)

TRAFFIC SIGNALS		Main Roads	
TRAFFIC SIGNALS POST FOOTING INSTALLATION DETAILS	Size A3	Drawing No	1421
	Scales as shown	Date	5/99
		B	C
