Bridge Information System
Structure Level Report

Structures Management Plan SMP1

Structure Id 7799	Name Barron River
Crossing Name 	Alt. Name Post #255
Structure Type Bridge	Owner Transport and main Roads
Construction Type Girder/Beam	District 403 Far North
Construction Material Steel	LGA Id

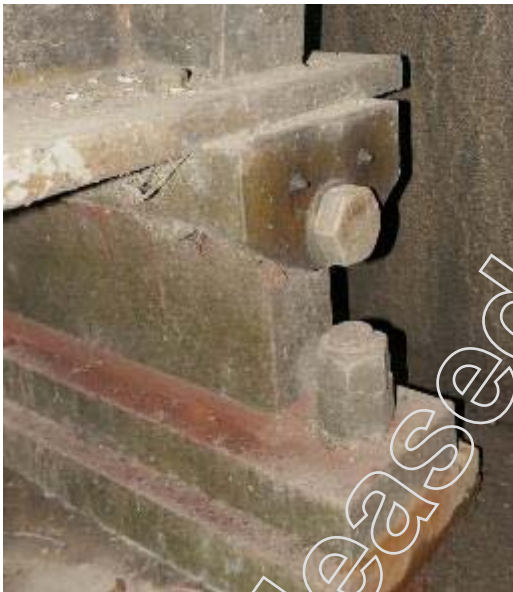
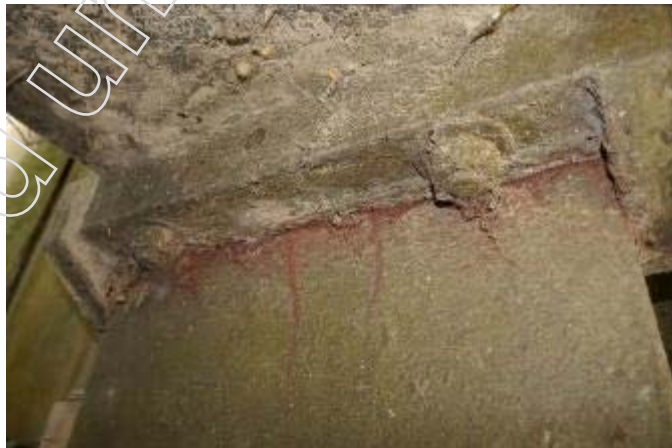
(a) General arrangement

(b) View of underside of bottom flange, sole plate and rocker plate

Figure 11 Barron River Bridge: Kuranda abutment downstream rocker bearing. Note: Grease nipples, 'red' iron oxide dust from fretting of rocker rubbing on sole plate (28 May 2018)

The fretting corrosion evident at Kuranda abutment rocker bearings suggests the bearings may be suffering significant wear with the rockers 'eating into' the sole plate or vice versa¹¹. There is also some suggestion that the rocker may be wearing into the base plate at some locations. For example, Figure 18 (Figure 14 of Barron River Defect Options Report #1 (Appendix C)) suggests a possible wear depression in the base plate. The Defect Options Report #1 also summarises the measurements between the base plate and the edge of the curved rocker surface (e.g., Figure 17 of Appendix C). A comparison of these field measurements with the

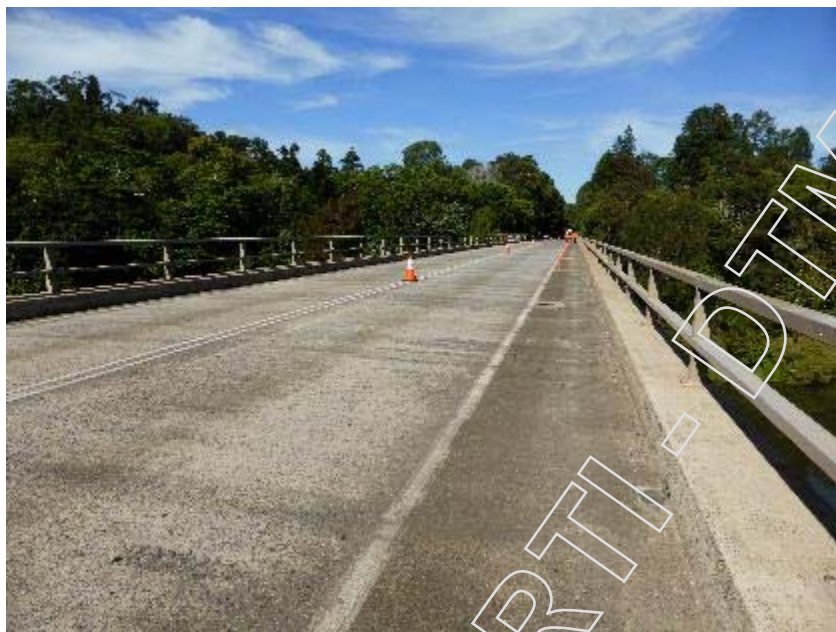
The traffic travels directly on the concrete deck which has a cross fall of 1 in 4. There is a 1.4m wide marked lane for pedestrians on the right side. Overall, the deck surface appeared to be in reasonable condition. (Refer to Photo 1, Appendix A).

Photo 1: Bridge deck

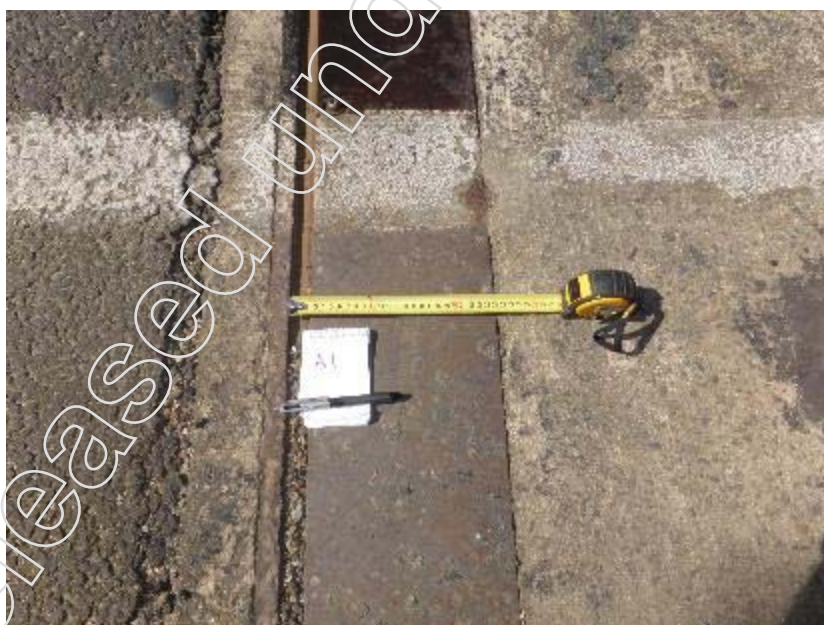
Photo 2: Abutment 1 expansion joint

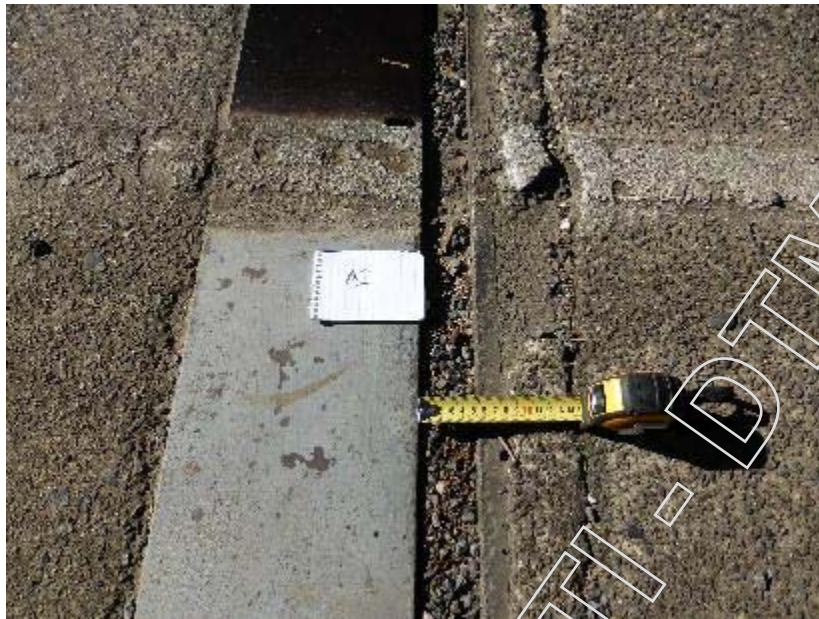
Photo 3: Abutment 2 expansion joint

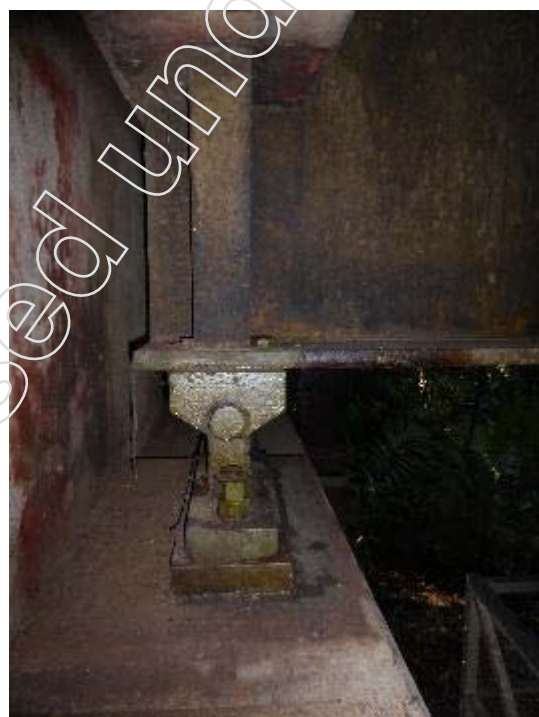
Photo 10: A1 expansion bearing

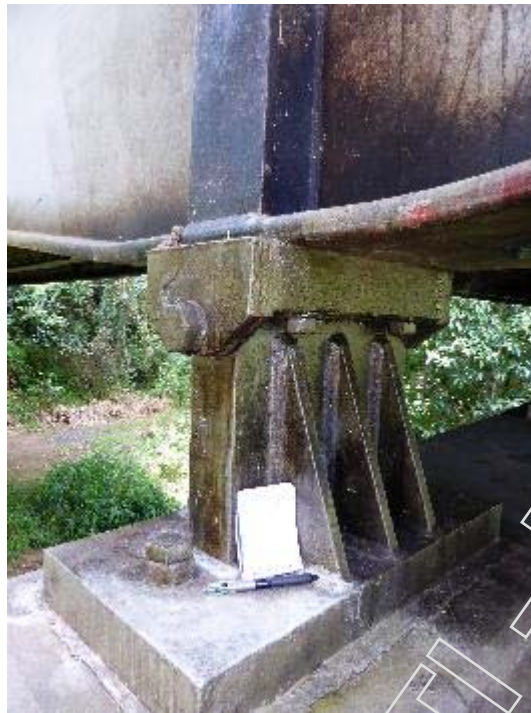
Photo 11: P1 fixed bearing

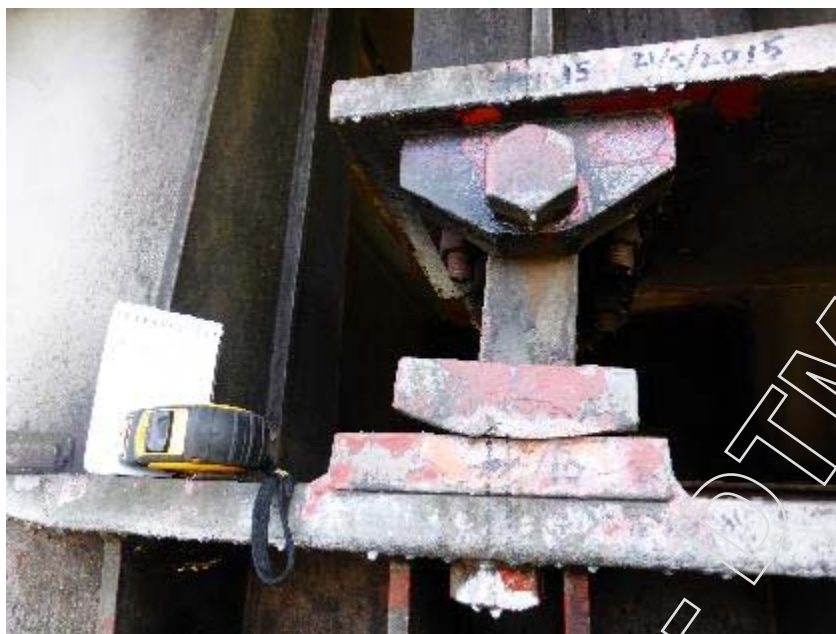
Photo 13: Suspended span (P1-P2) expansion bearing.

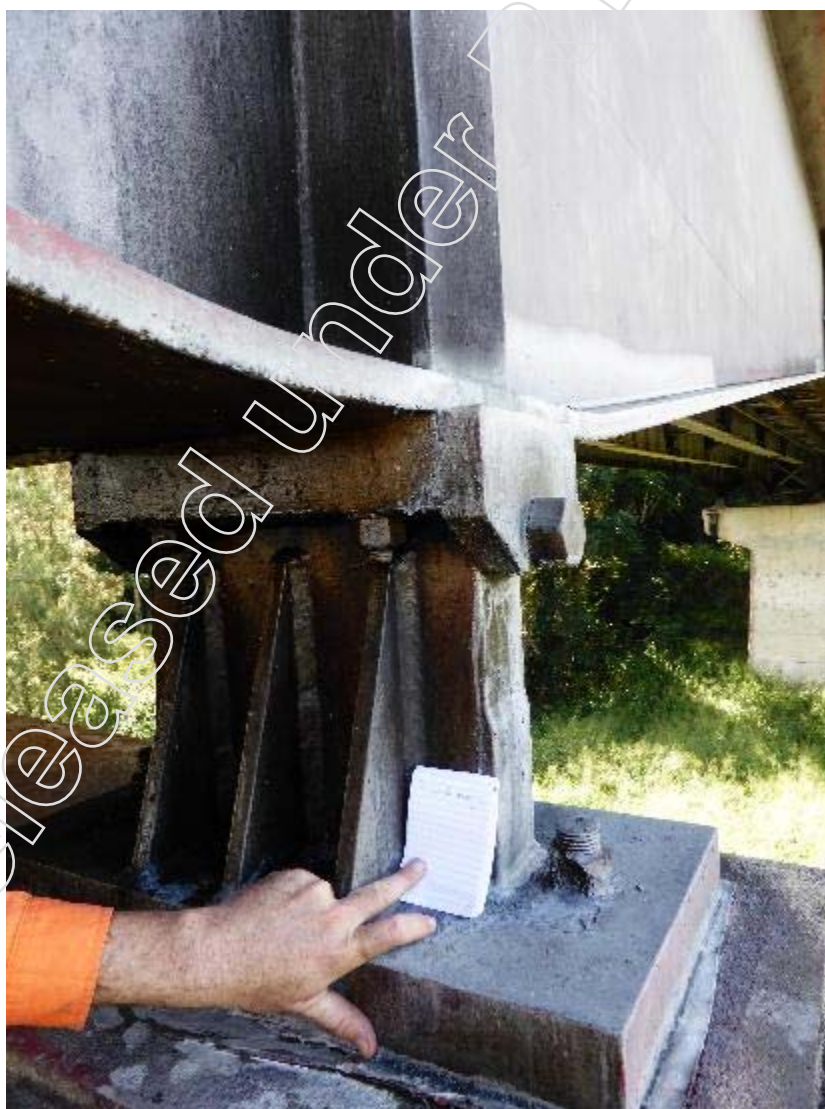
Photo 14: P2 fixed bearing

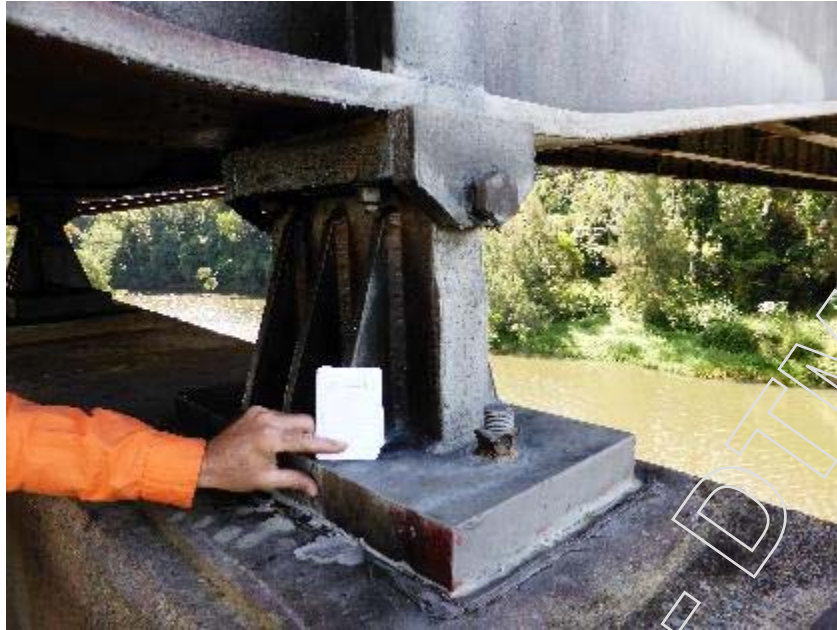
Photo 15: P3 fixed bearing

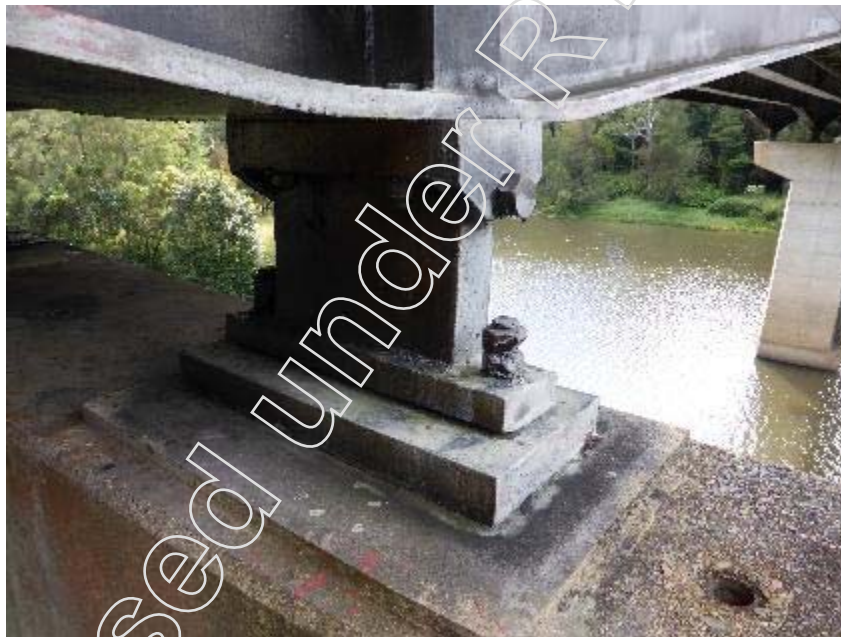
Photo 16: P4 fixed bearing

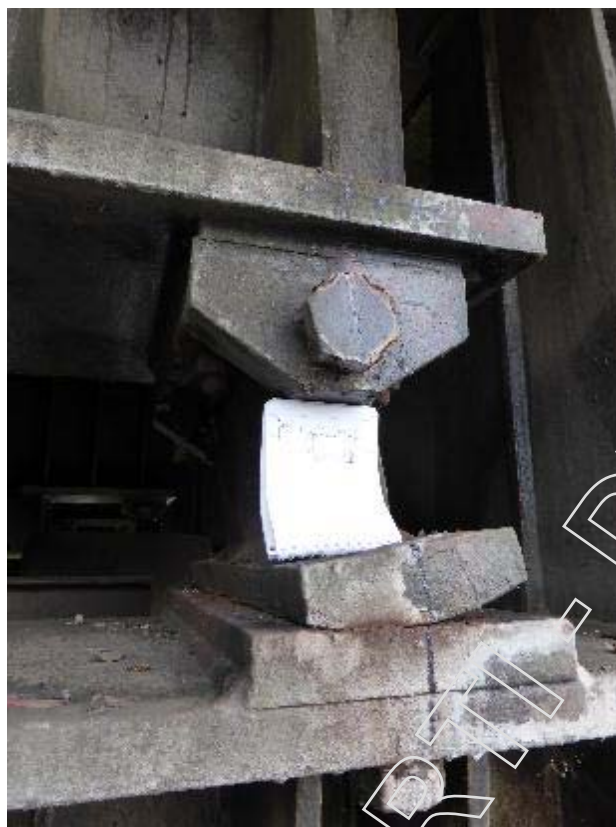
Photo 17: Suspended span (P4-P5) expansion bearing

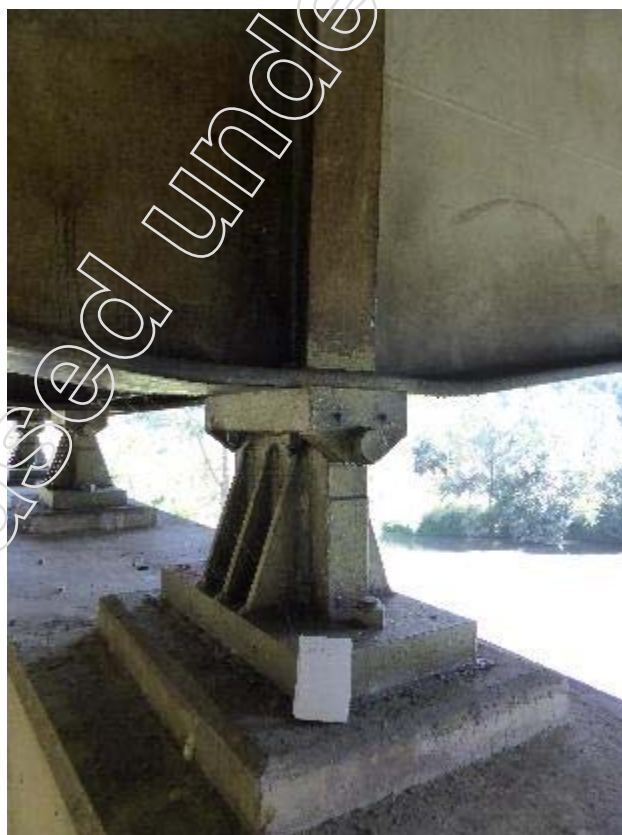
Photo 18: P5 fixed bearing

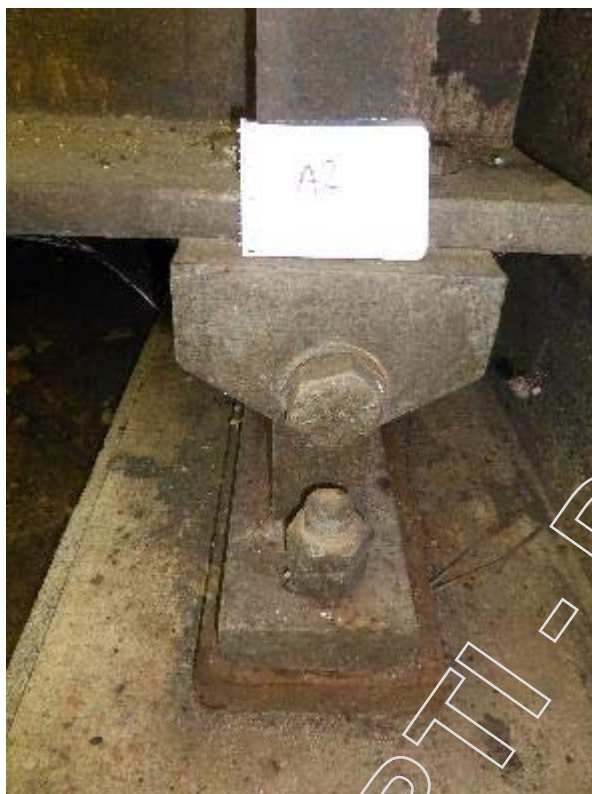
Photo 19: A2 expansion bearing

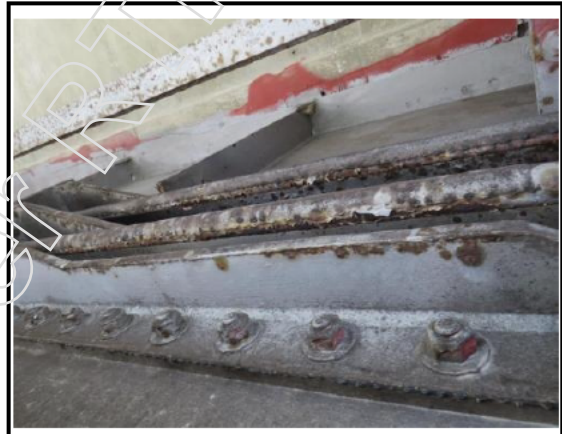
ST S 3 G 4

Protective coating failing on tension bars

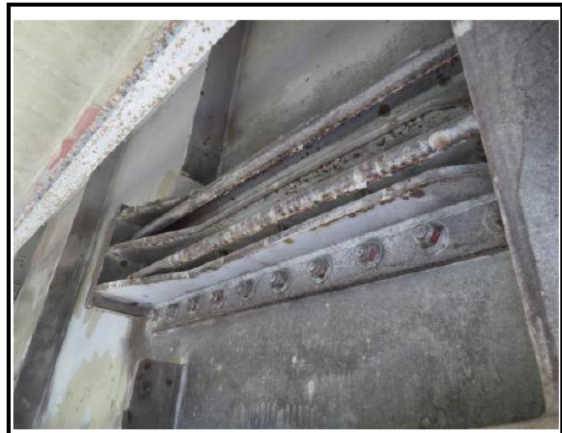
ST S 3 G 4

Protective coating failing on tension bars

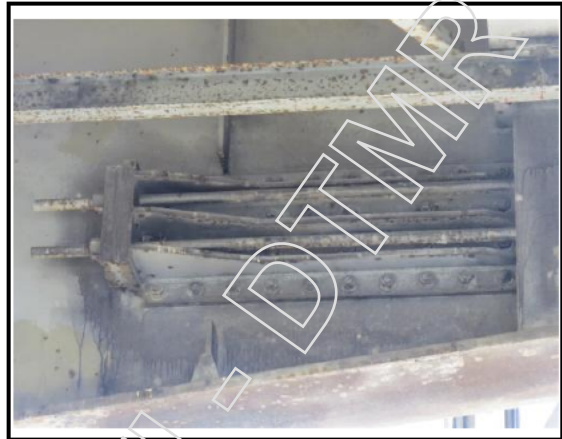
ST S 3 G 4

Protective coating failing on tension bars

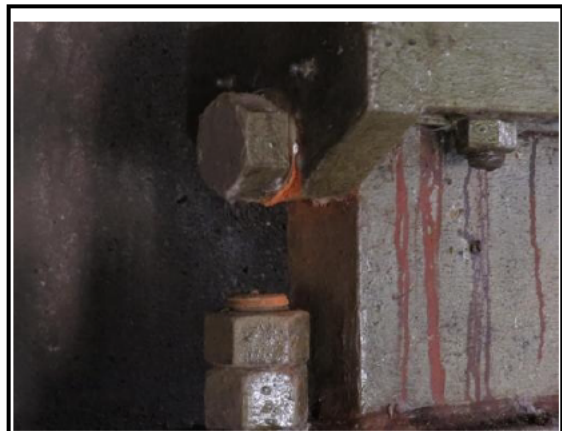
O A 1 B 1

B1 Leaching stains on hinge

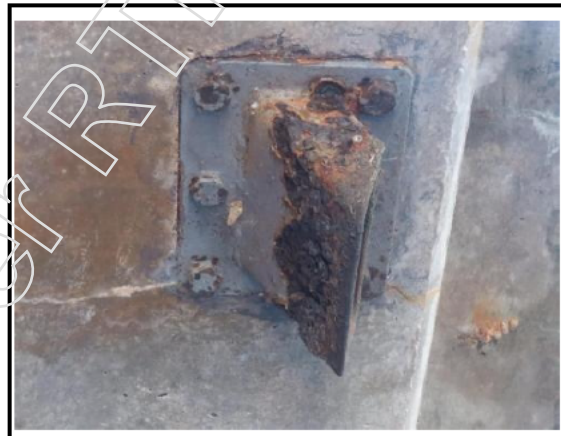
Rust scupper outlet

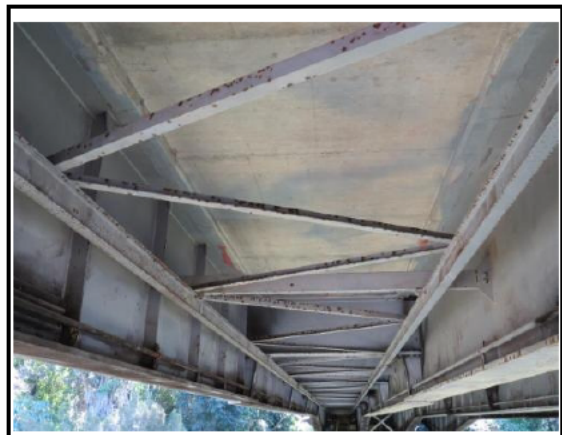
O S 2 G 4

Spot rust on Span 2 G3 & G4 & unused gantry frame

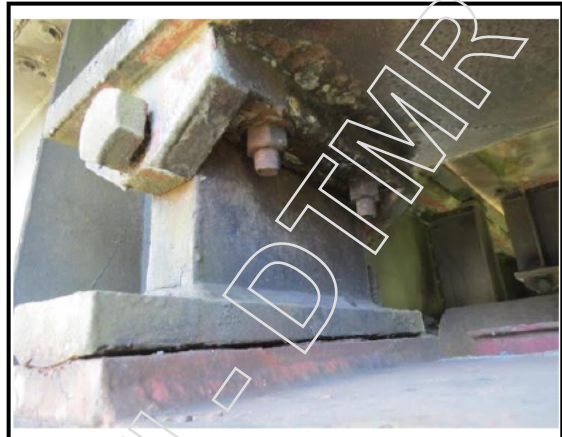
O P 2 B 1

Pier 2 B1 Span 2 G1 E2 corrosion at top attachments

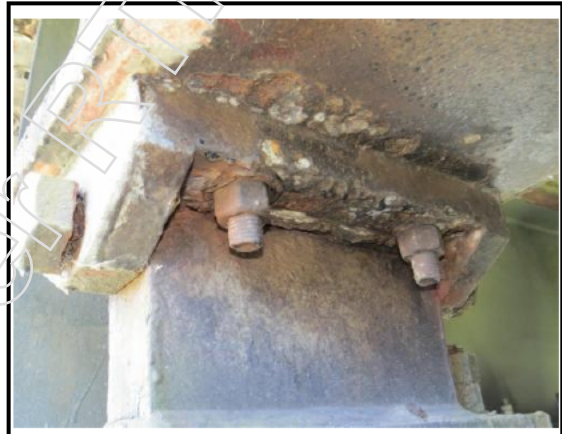
O P 2 B 1

Pier 2 B1 Span 2 G1 E2 corrosion on top attachments

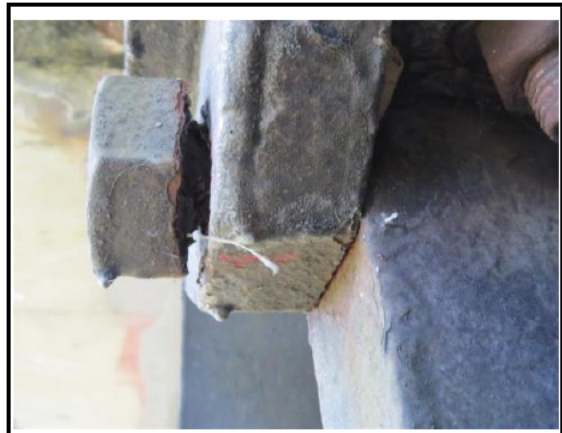
O P 2 B 1

Pier 2 B1 Span 2 G1 E2 corrosion on hinge bolt

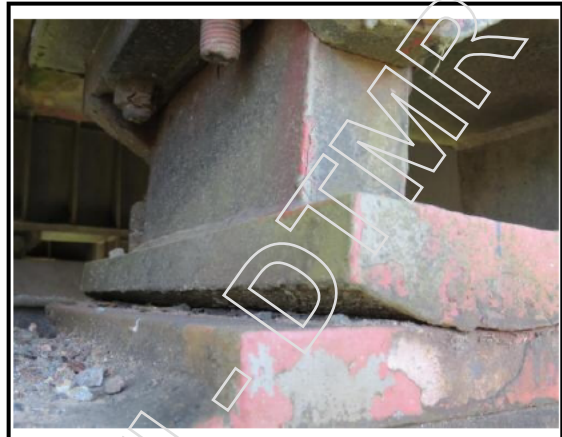
Pier 2 B1 Span 2 G1 E2 corrosion on rocker & sole plate

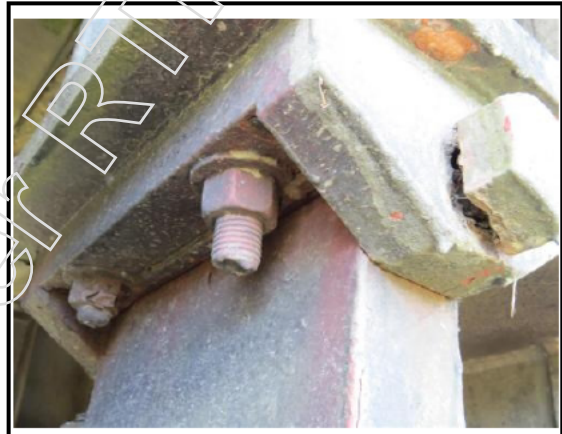
Pier 2 B1 Span 2 G1 E2 corrosion on top attachments & hinge bolt

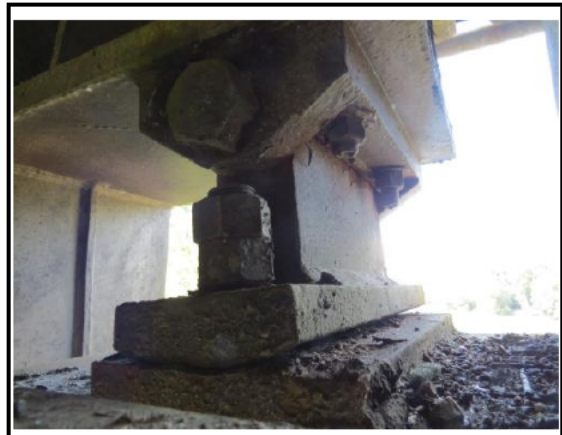
Pier 2 B1 Span 2 G1 E2 corrosion on top attachments & rocker & sole plate

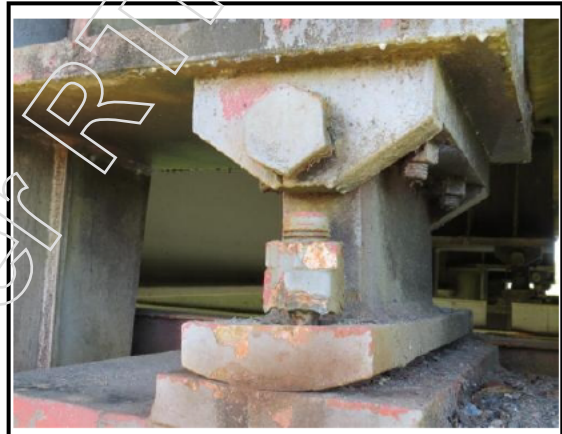
O P 2 B 4

Pier 2 B4 Span 2 G4 E2 corrosion on lower attachment

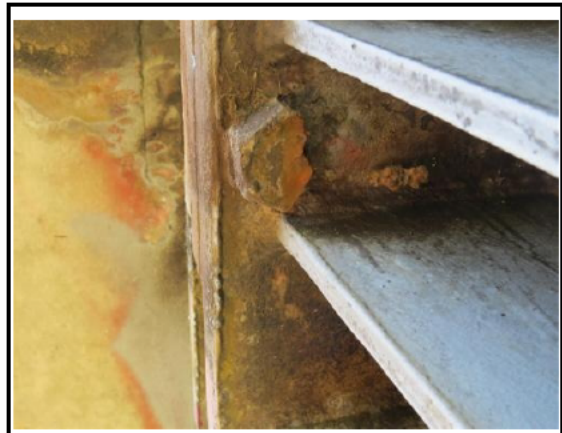
O P 2 B 4

Pier 2 B4 Span 2 G4 E2 corrosion on lower attachment bolt

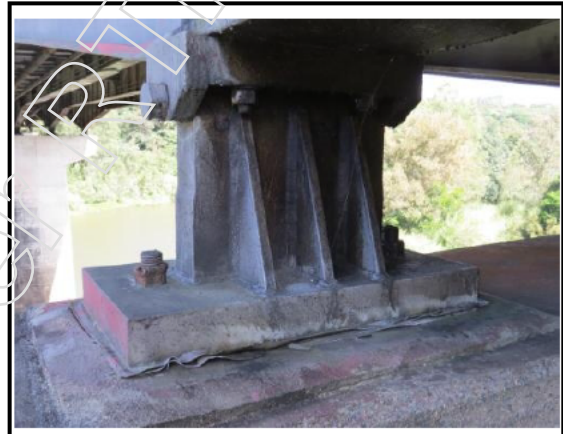
Pier 2 B1 on top of Pier 2 decay on lower attachment

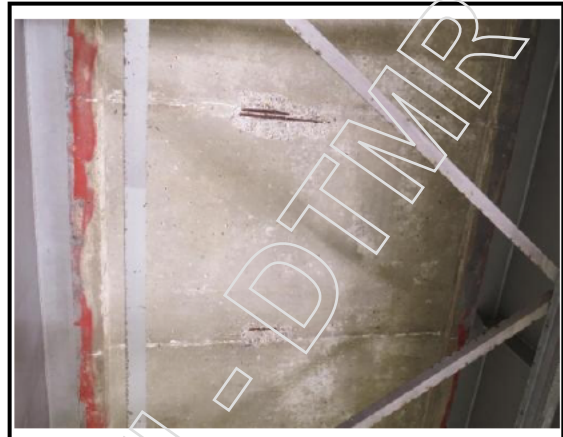
O S 3 D

Small spalls in bay 4 at E1

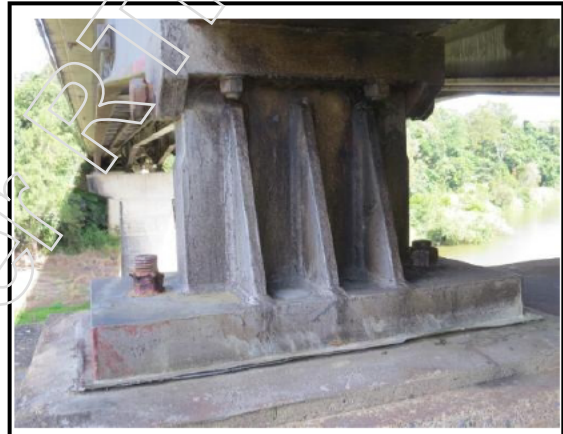
O P 3 B 1

B1 on top of Pier 3 decay on lower attachment

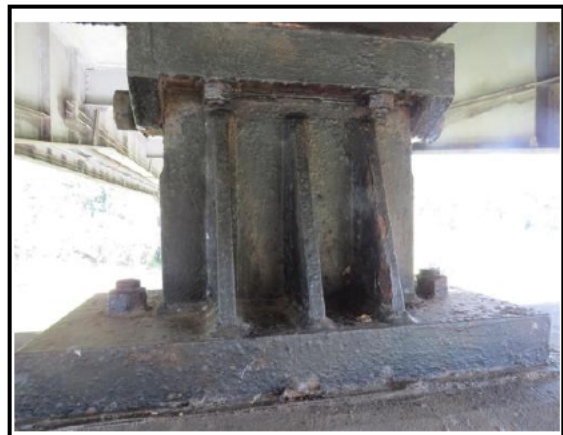
O P 3 B 3

B3 on top of Pier 3 corrosion of flanges

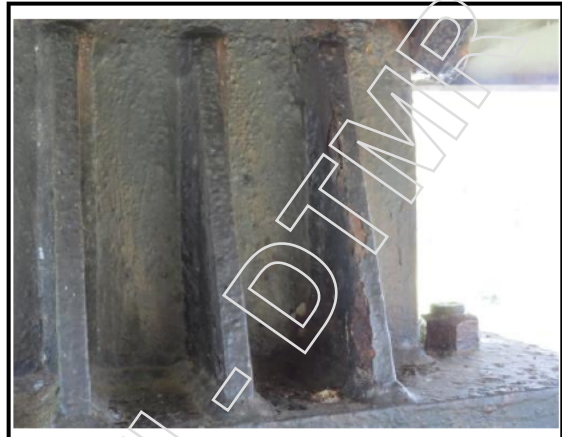
O P 3 B 3

B3 on top of Pier 3 corrosion of flange

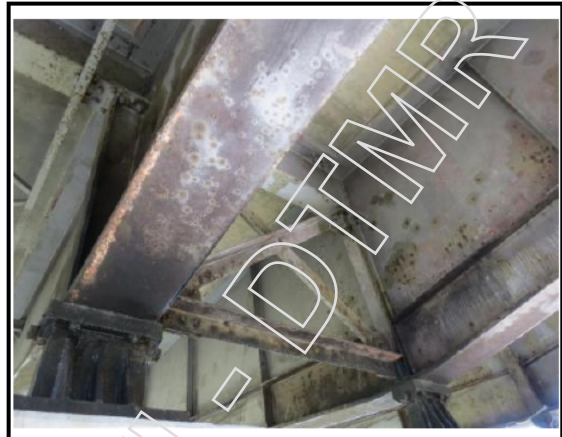
Span 3 G2 E2 some spot rust & minor pitting untreated

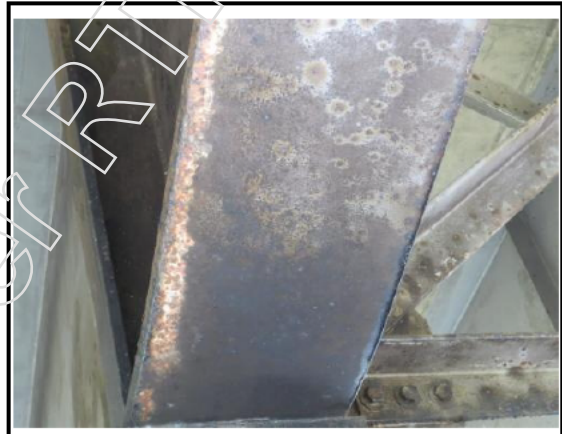
Span 3 G2 E2 some spot rust & minor pitting untreated

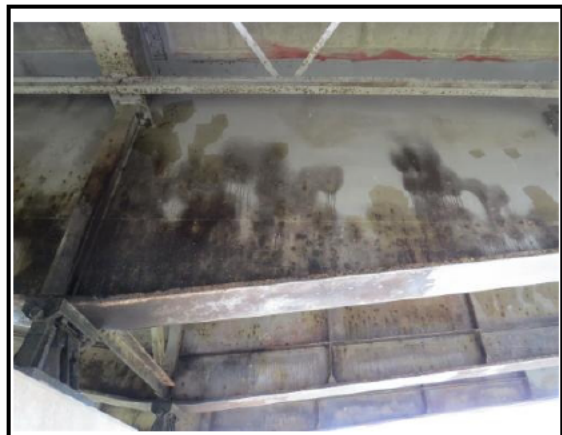
Span 3 G2 E2 some areas of spot rust treated & untreated

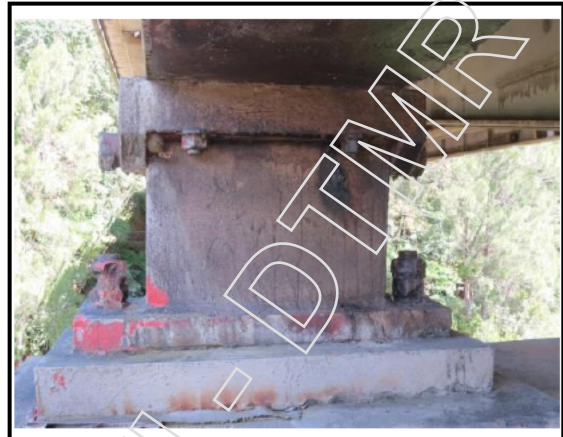
B1 on top of Pier 4 corrosion & decay on attachments

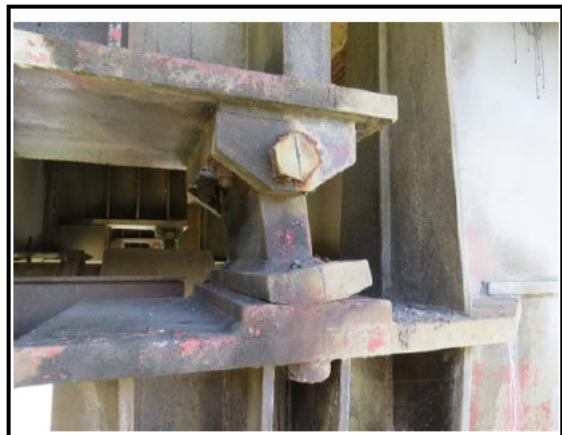
Pier 4 B1 Span 5 G1 E1 decay around hinge bolt & possible over rotated.

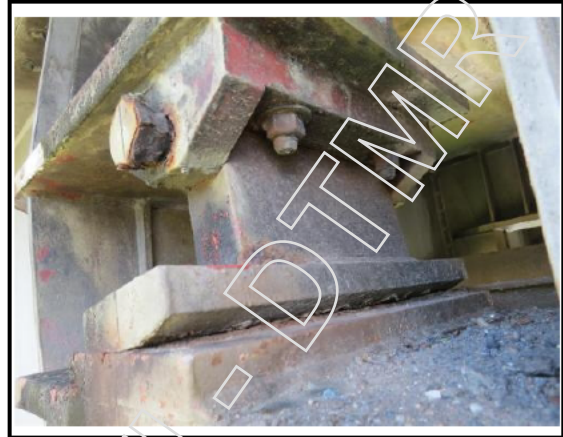
Pier 4 B1 Span 5 G1 E1 decay around hinge bolt & possible over rotated.

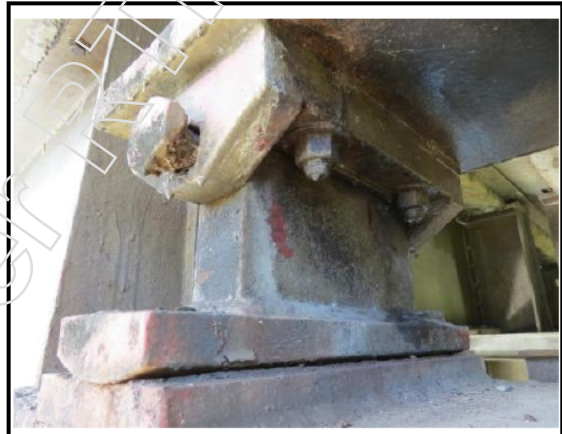
Pier 4 B4 Span 5 G4 E1 decay around hinge bolt & lower anchor missing

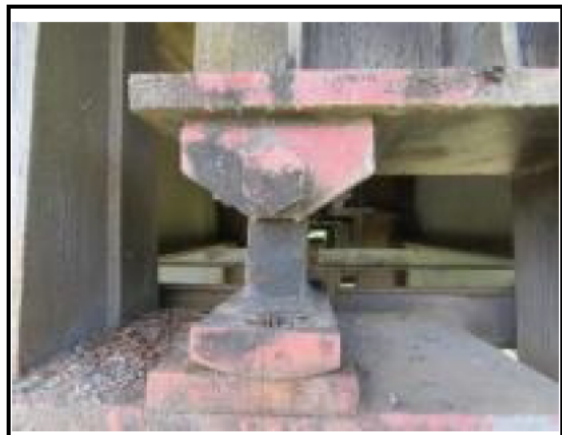
Pier 4 B4 Span 5 G4 E1 decay around hinge bolt & lower anchor missing

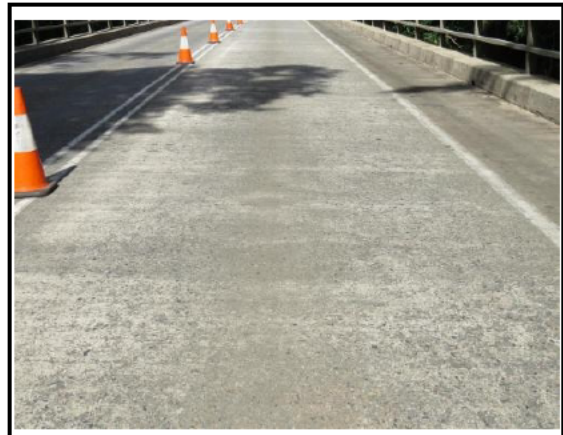
Showing general abrasion & minor cracks in WS, applicable throughout all spans

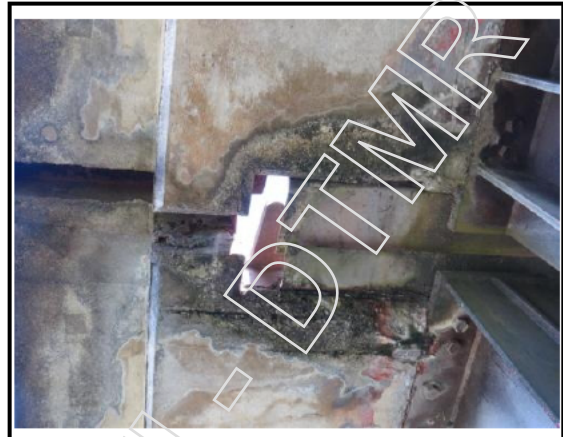
Spalls in deck around soffit of the finger joint

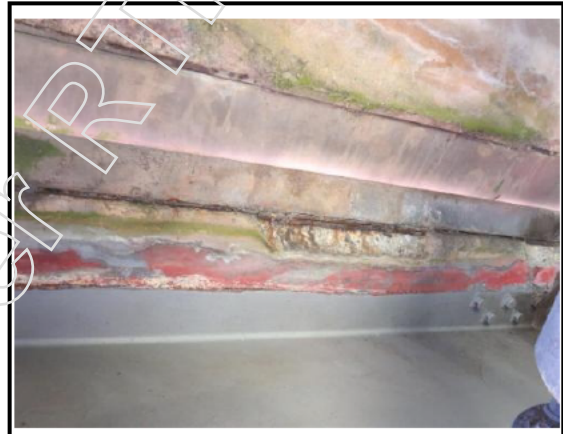
Spalls in deck around soffit of the finger joint

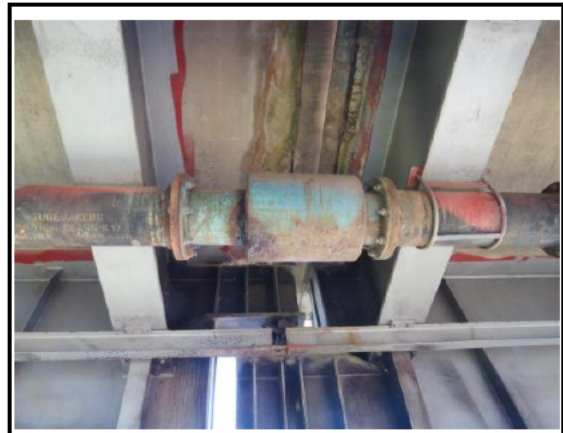
Water main joiner rusty

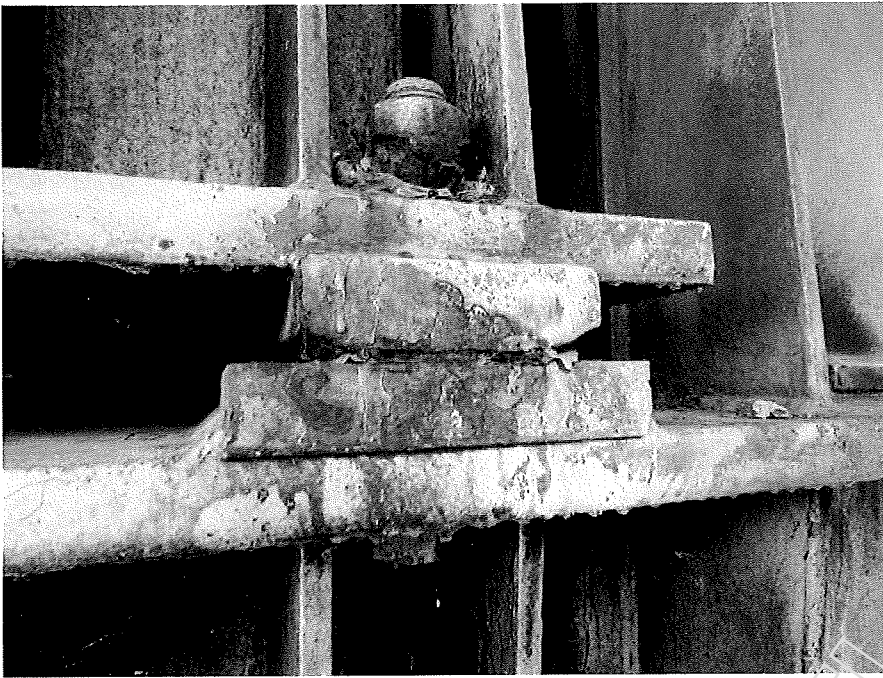
Figure 9 View of Span 2 Fixed Hinge bearing

The fixed hinge bearings are situated at locations 3 and 9, refer to Figure 1. The bearings consist of a curved upper plate which allows the bridge drop-in span to rotate. The main defect with this bearing is corrosion of the holding down bolt and the corrosion of the contact surfaces between the curved plate and the sole plate, refer to Figure 9, Figure 10 and Figure 11.

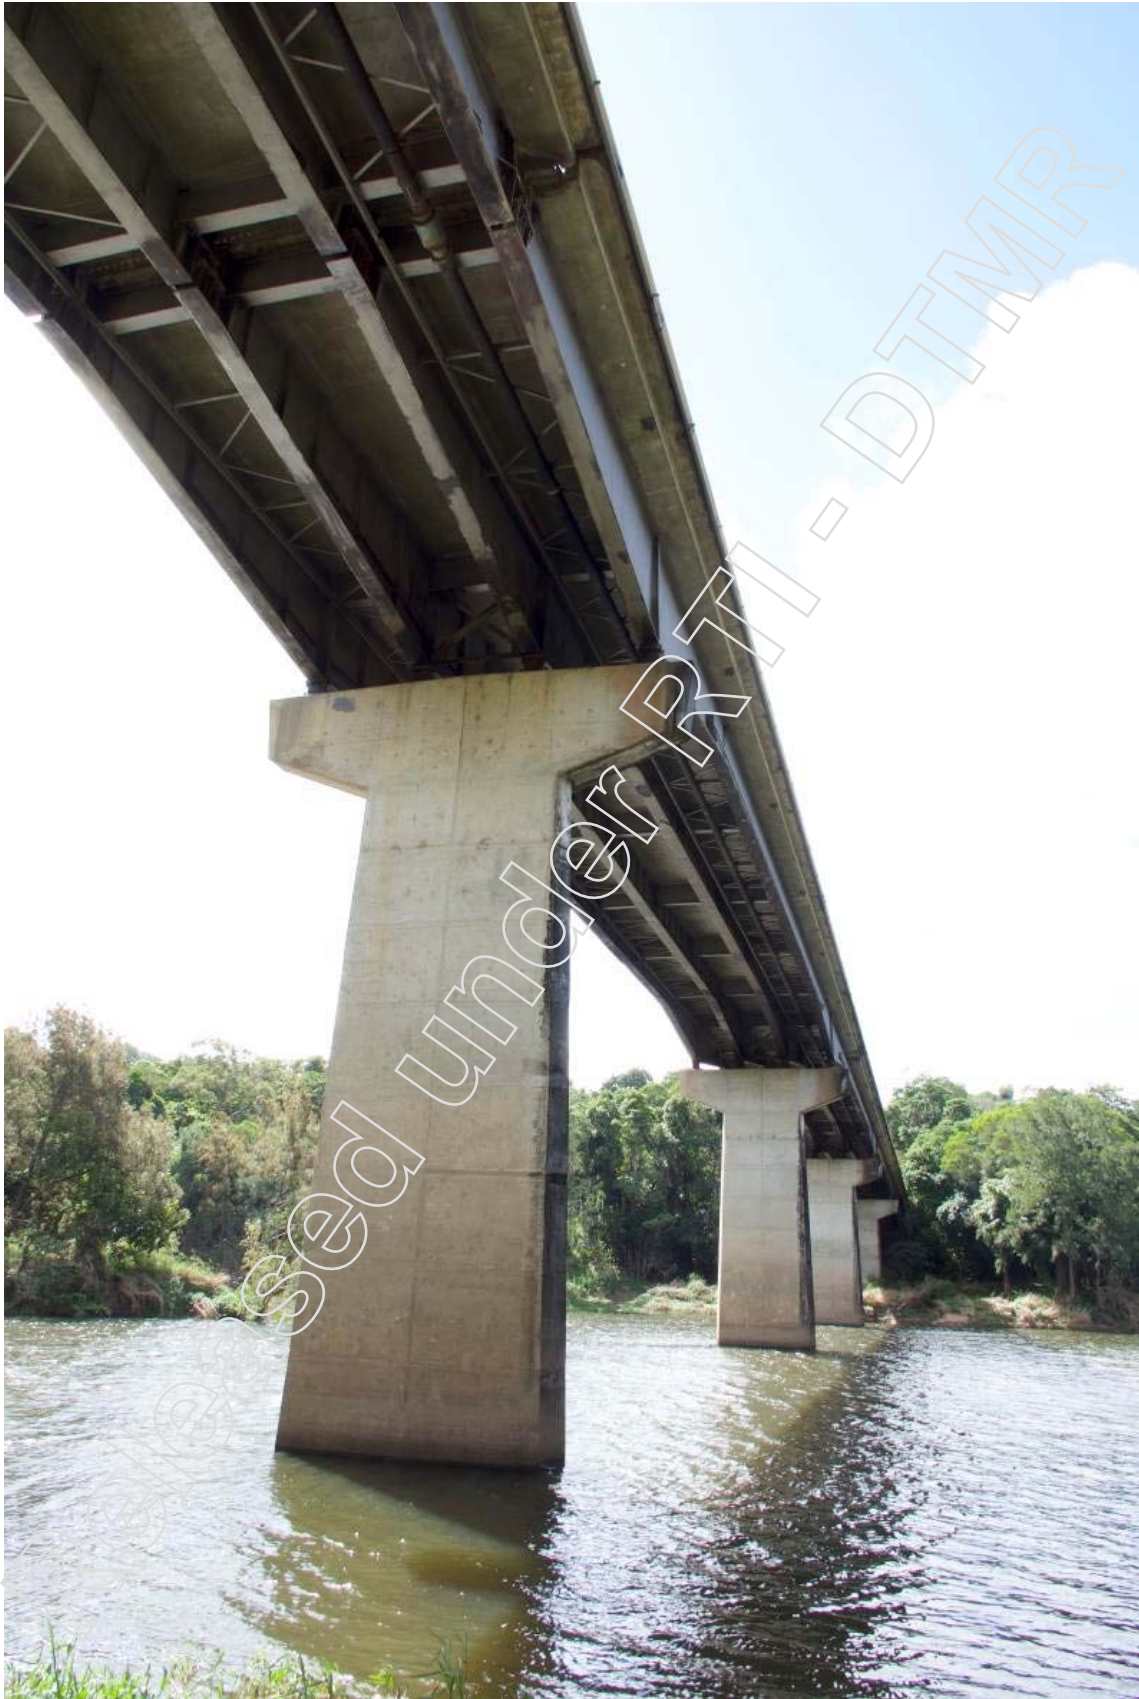
Figure 1 Bridge over Barron River at Kuranda: View of underside of deck looking towards Cairns abutment

There is ongoing deterioration, although the condition of the steelwork and bearings currently appear better than a decade ago (2008 Level 2 Inspection). For example, there is significantly less active rust visible and much less debris around the bearings (and plants growing in the debris) in 2018 compared with 2008.

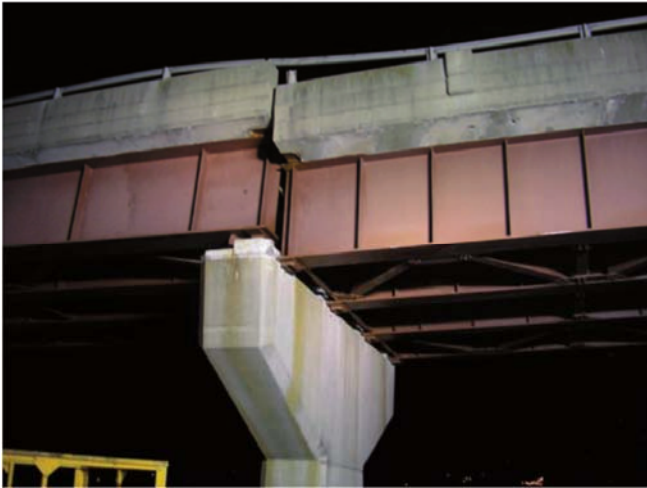
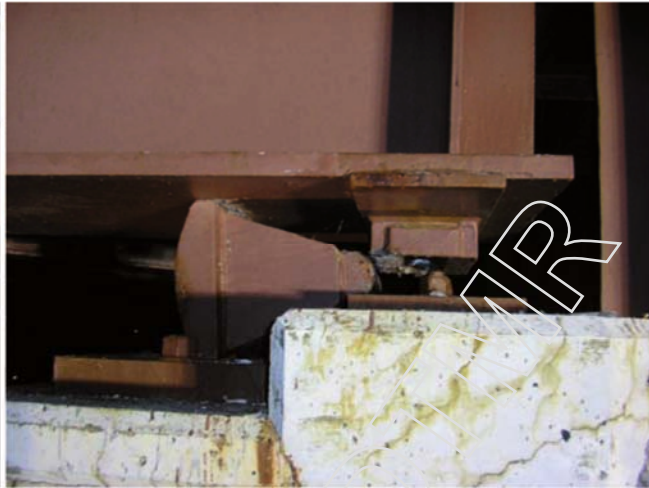
Figure 9 Rocker bearing failure at Dunn Memorial Bridge Interchange, Aibany NY, 27 July 2005 (NYSDOT, 2005; Cohen & Wetzck, 2016)

Failures appear to be uncommon, although the two failures illustrated in Figure 9 and Figure 10 indicate all the bearings can collapse together and that spans can fall.

(a) 8 rocker bearings at a double expansion joint collapsed dropping main span by 625 mm (25 inches), which was wedged onto the edge of the pier.

(b) Topped rocker bearings

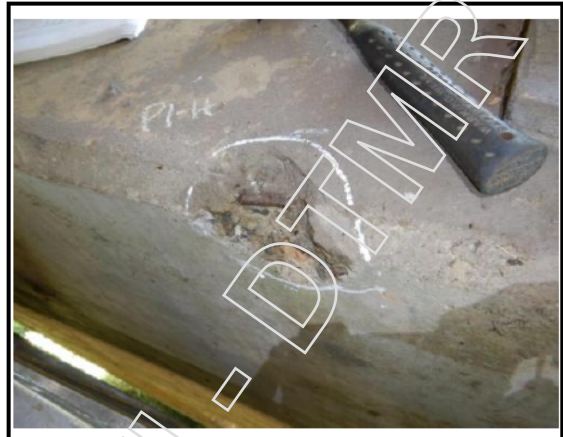
O P 1 H

Minor spall in P1 H

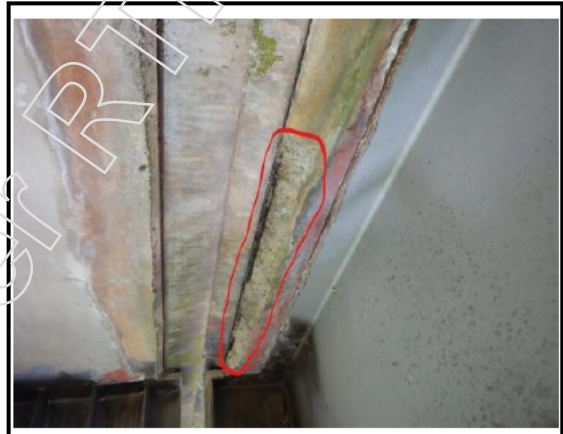
O S 2 D

Spalling in S2 deck under finger joint

O	S2	D1	20 C	3	3								
Moderate spalls with exposed and corroded reo at soffit under finger joint in D2 and D4 (030 - typical). Requires treatment of reinforcement.													
O	S2	G4	22 S	3	3						X		
<p>Structure undergoing investigations due to brittle failure/fatigue concerns. Several sites have undergone testing, specifically welds at splice joints, cross girder-girder interfaces and at stiffeners. Refer to Sketch 18 - Post inspection Tech note and Sketch 19 - Summary Plans.</p> <p>Initial visual inspection detected minor surface discontinuities in G1 splice 1, G4 splice 1, G1 splice 2, G2 at XG2 interface, G3 splice 3, and G4 splice 4 (refer to Sketch 19).</p> <p>MPI and ultrasonic testing post removal of lead coatings later showed cracking in: - S2 G4 splice 2 (lower) up to 3mm in length. Refer to Sketch 25.</p> <p>Girders appear otherwise fair (031). Possible breakdown of coating. Refer to Sketch 18 for coating levels across structure.</p>

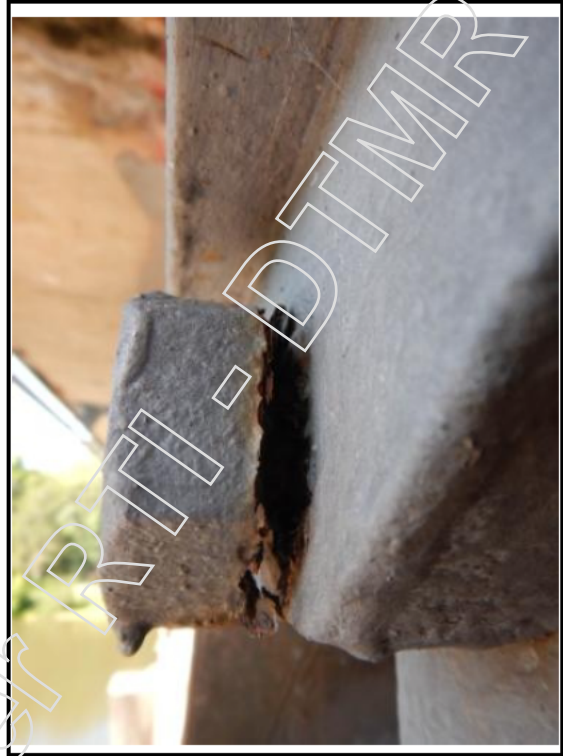
O	P	2		1
---	---	---	--	---

Corrosion in hinge pin

O	P2	B1	43 S	3	4						X		
B1 - CS4. Lower attachment on downstream side has completely corroded away (033). Corrosion evident in hinge pin (034) - unable to determine extent of loss of section.													
O	P2	B4	43 S	3	4						X		
B4 - CS4. Lower attachment on downstream side has completely corroded away (036). Corrosion evident in hinge pin. Corrosion in hinge pin appears severe.													
O	S2	W	71 C	3	3					X			
Significant localised build up S2 E2 on the downstream side relative to original readings (024, 031). Localised scours and build up in other areas. Refer to scour soundings report. Monitor.													
O	P2	B1	40 C	3	3						X		
Fixed bearings located on pier 2.													
<p>B1 - CS3. Outside anchor nut has severe loss of section (037). Minor corrosion evident under coating. Previous L3 inspection recommendation of replacement of anchor nuts yet to be carried out.</p> <p>B4 also has corrosion and minor loss of section in outside anchor nut (038).</p> <p>Bearings have been coated since previous L2 inspection.</p>

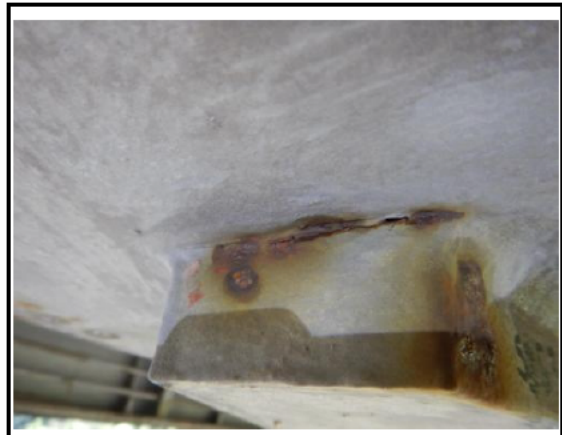
O S 3 G

Example of corrosion at S3 splice welds

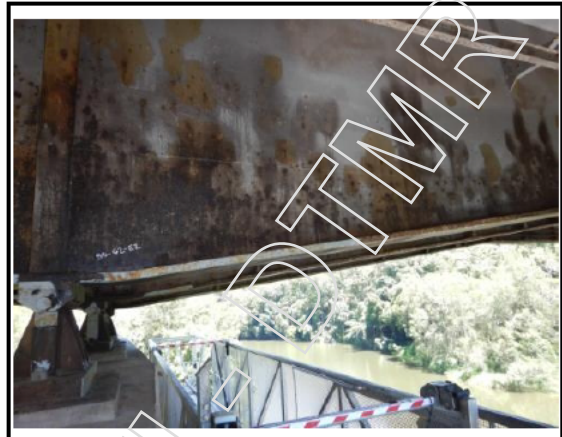
O S 3 G

Example of corrosion in S3 girders

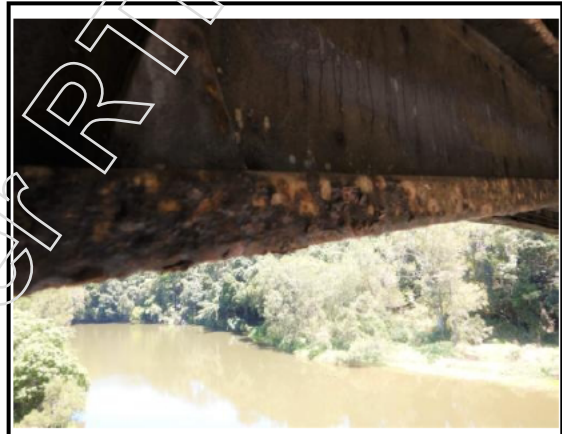
O S 3 G

Example of corrosion in S3 girders

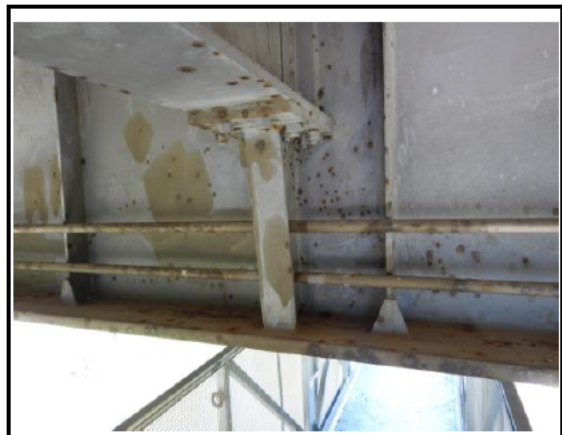
O S 3 XG

Typical spot corrosion in XG3 and stressing bars

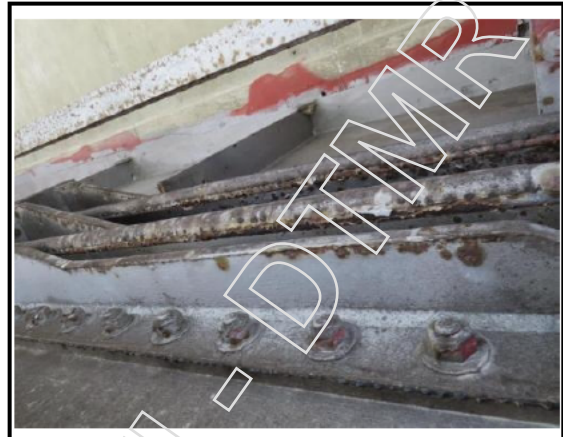
Coating failure in stressing bar ends

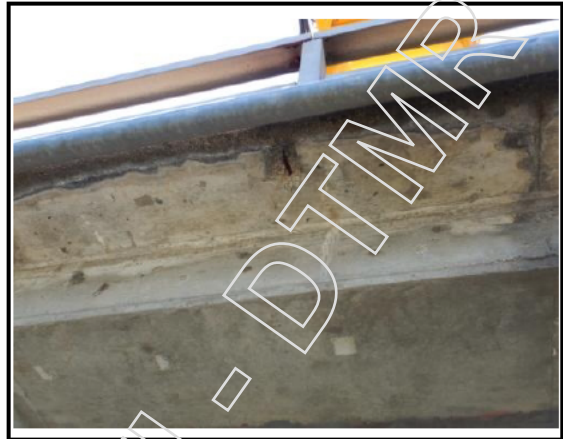
O S 4 D

Example of spalling in S4 deck

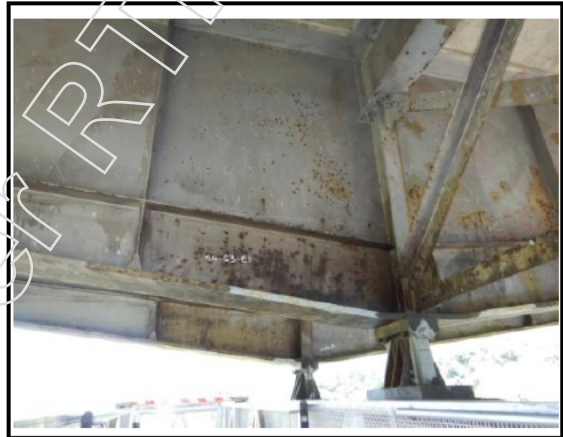
O S 4 G

Example of spot corrosion in S4 girders

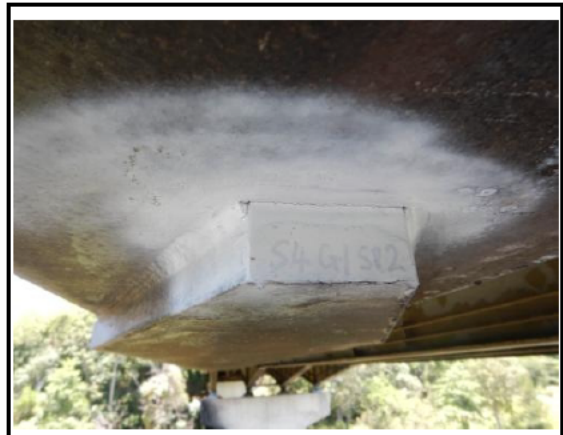
O S 4 G 1

Example of cracks in welds at S4 splice 2 in girders

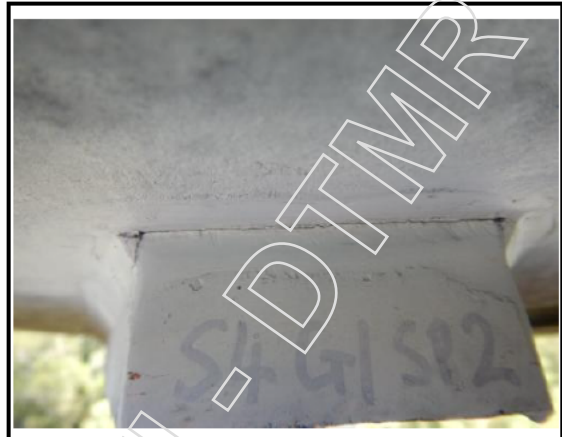
O S 4 G 2

Example of cracks in welds at S4 splice 2 in girders

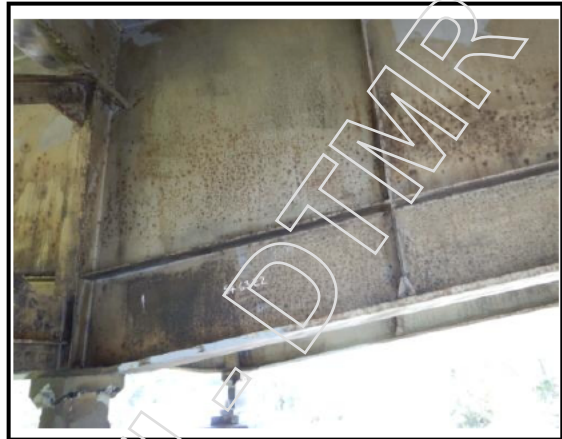
O S 4 G

Example of spot corrosion in S4 girders
